Inspection Photos

API: 071-09921

Operator: VECTA OIL & GAS LTD

Inspection Date: 4/6/2023

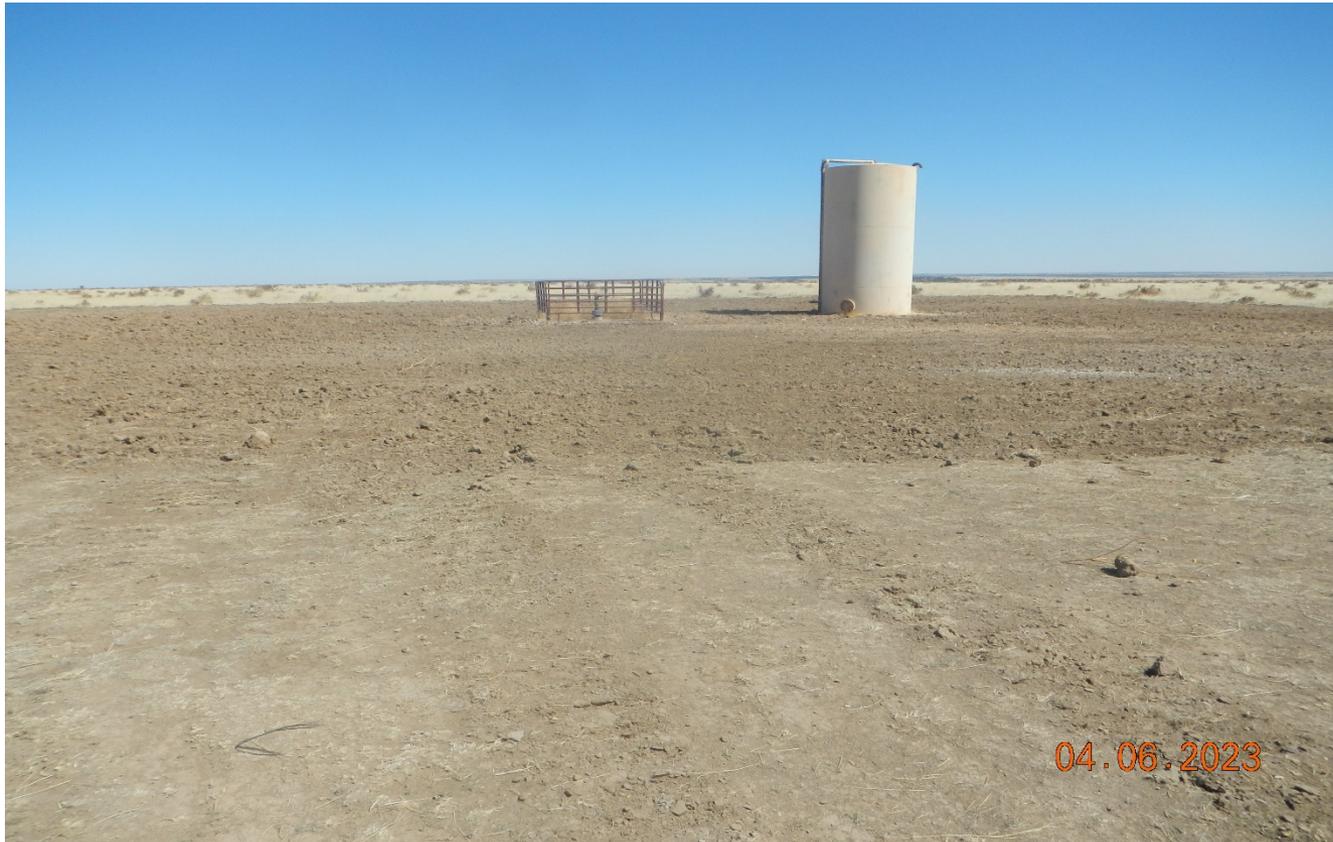
Photo 1. Facing north toward the wellsite. Most all of the equipment has been removed.

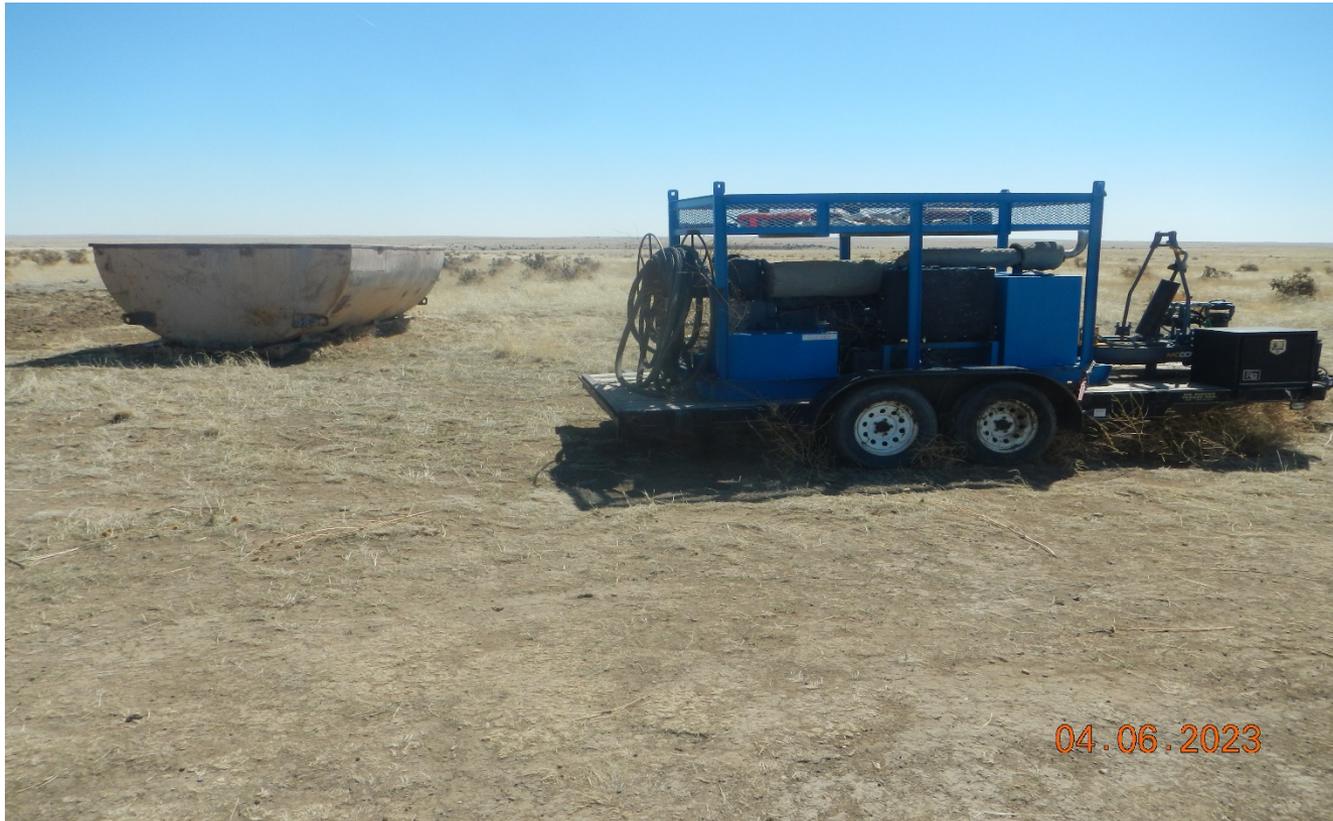
Photo 2. There are still a few pieces of equipment that need to be removed.

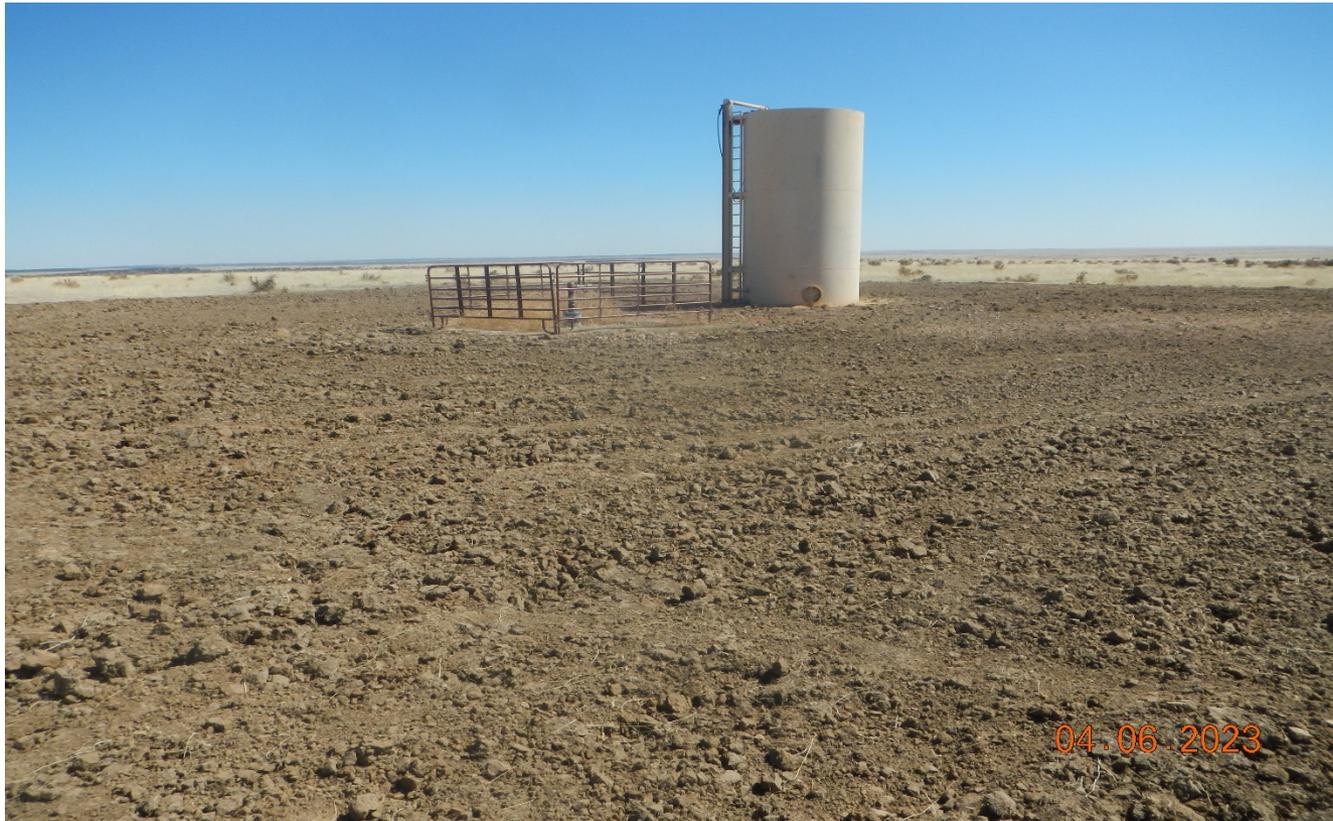
Photo 3. The compacted soils were ripped but unsure if cross-ripping was performed to 18inches. Disturbed soils will need to be seeded and stabilized.
