Inspection Photos

April 5, 2023

Location Name: QUARTER CIRCLE-66S94W/33NESE

Inspection Document #: 702801420

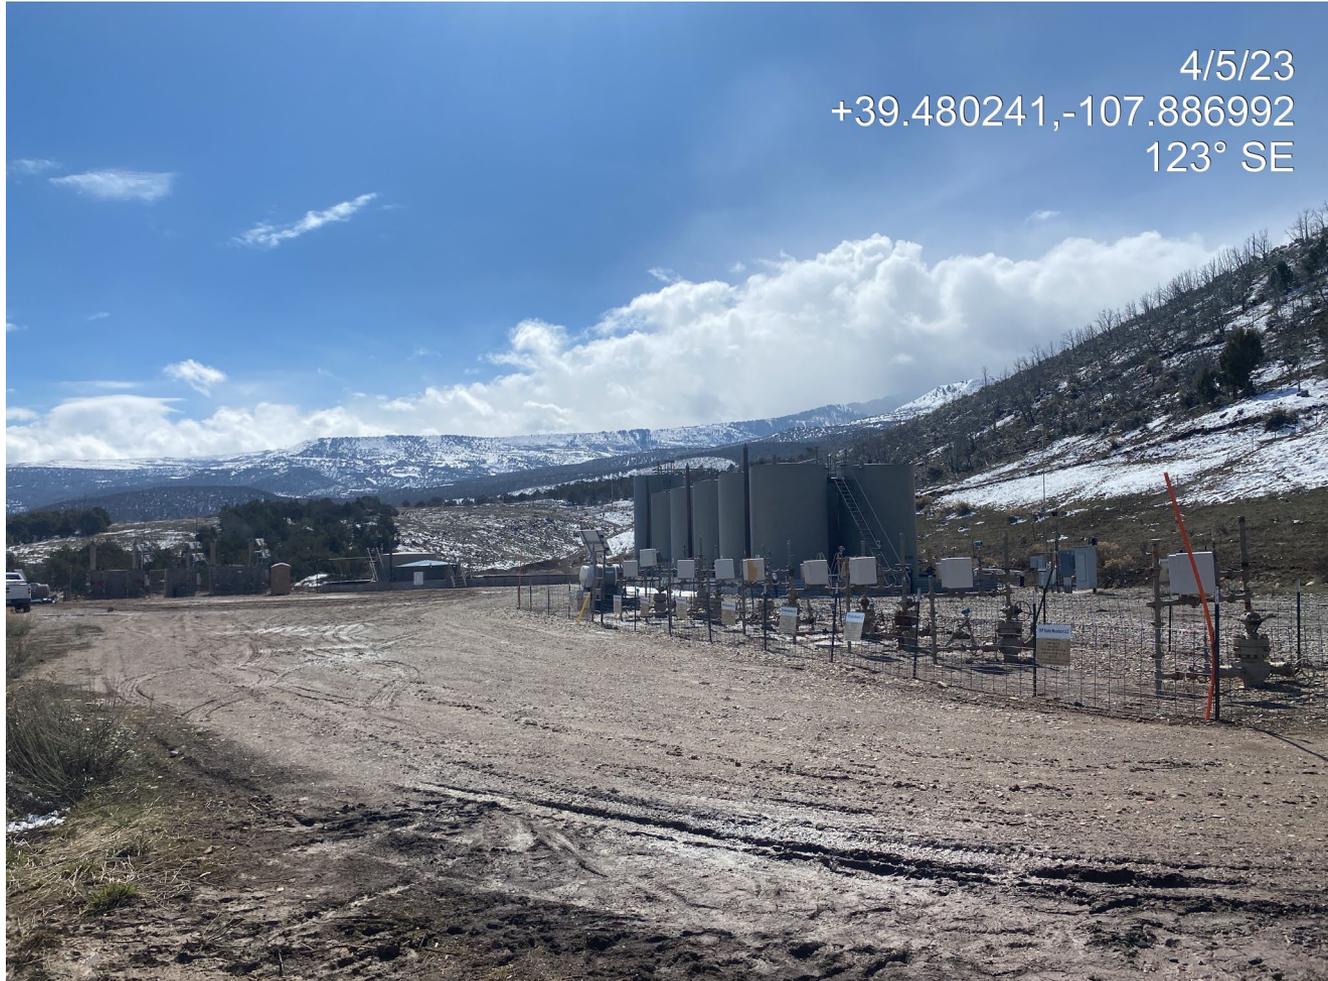
Photo 1. Photo taken from the west shows an overview of the location.

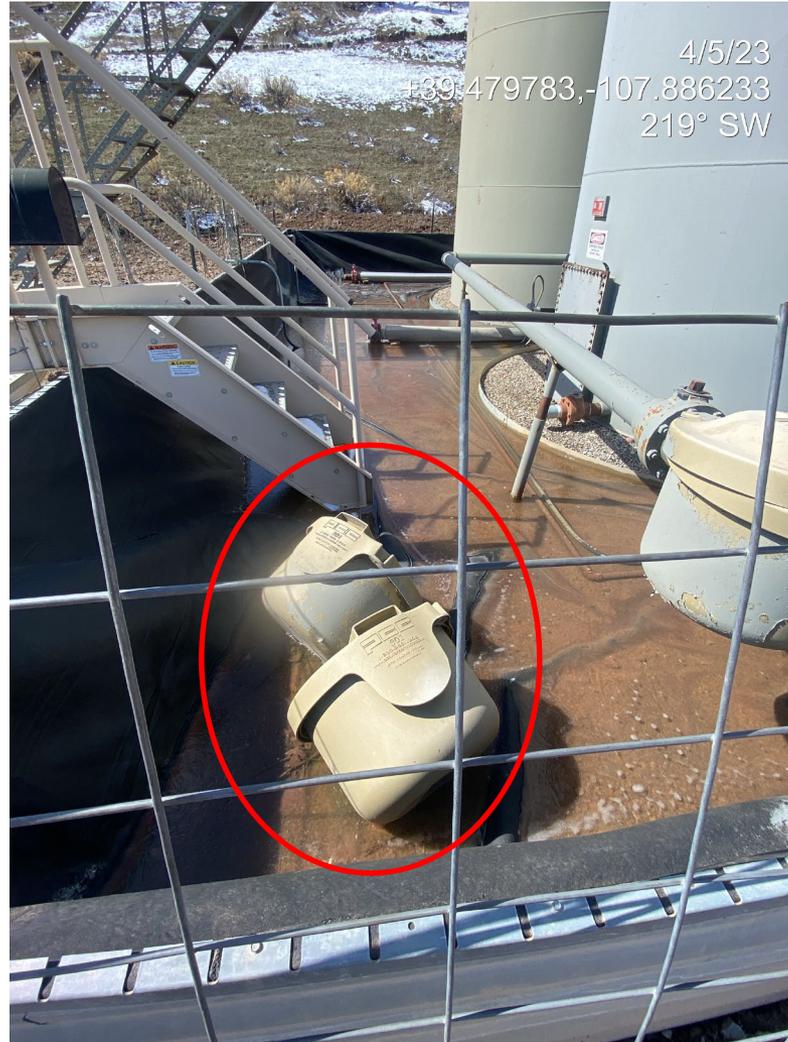
Photo 3. Photo shows unused equipment within the southernmost tank battery secondary containment.

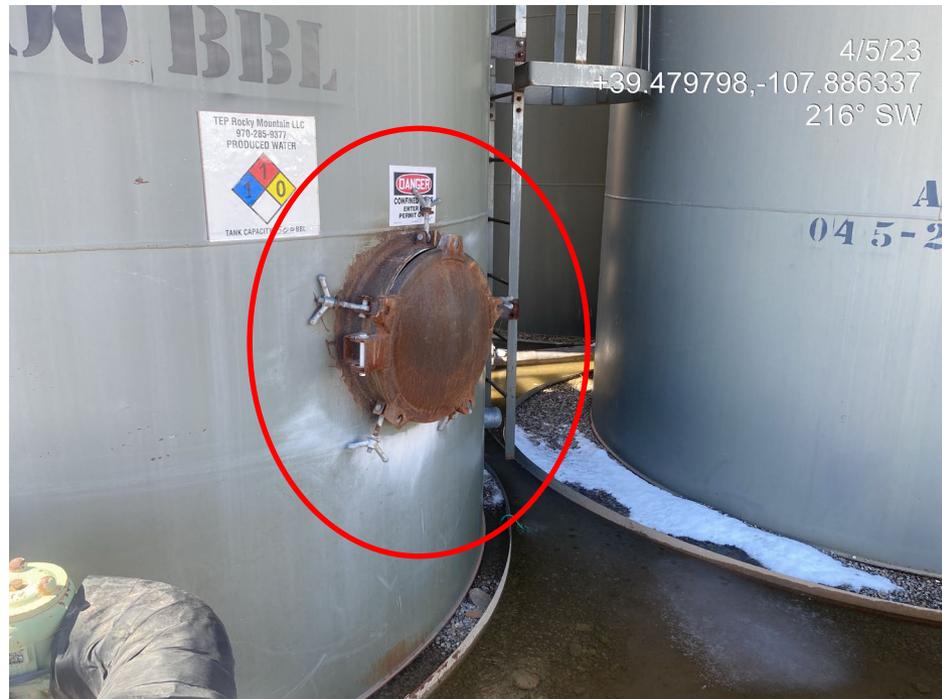
Photo 4. Photo shows a tank manway cover is not fastened and partially ajar.

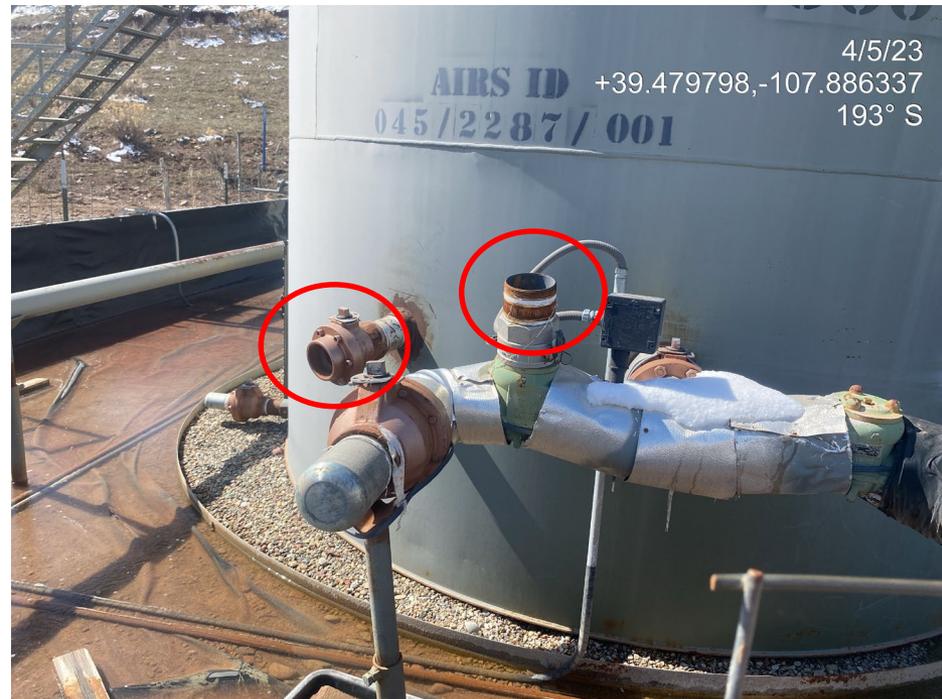
Photo 5. Photo shows bull plugs not installed on a tank line.

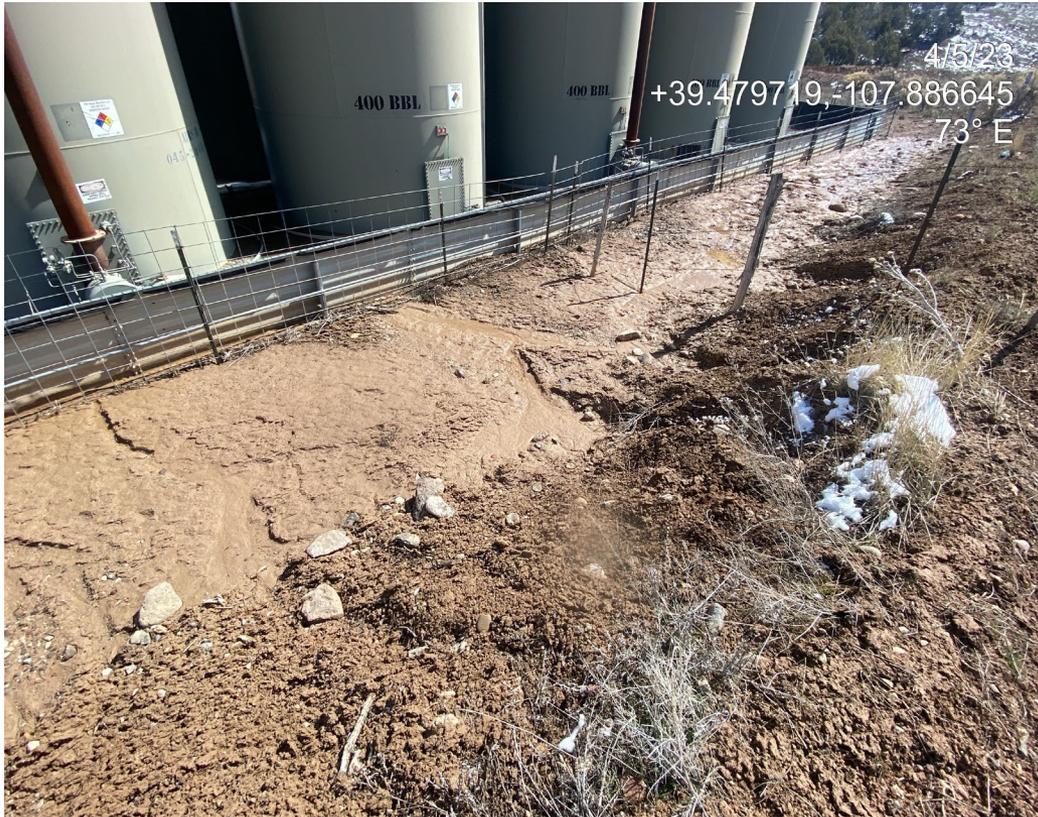
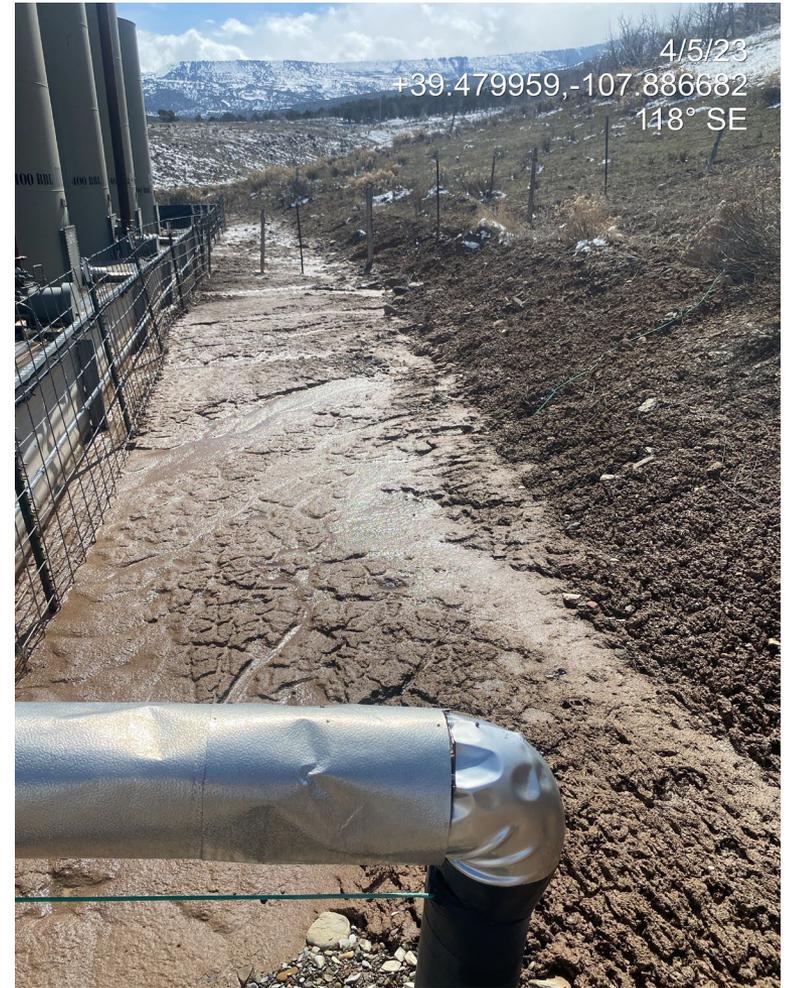
Photo 6. Photos show a berm at the south of the location is not stabilized. Rill erosion and sediment transport are evident.

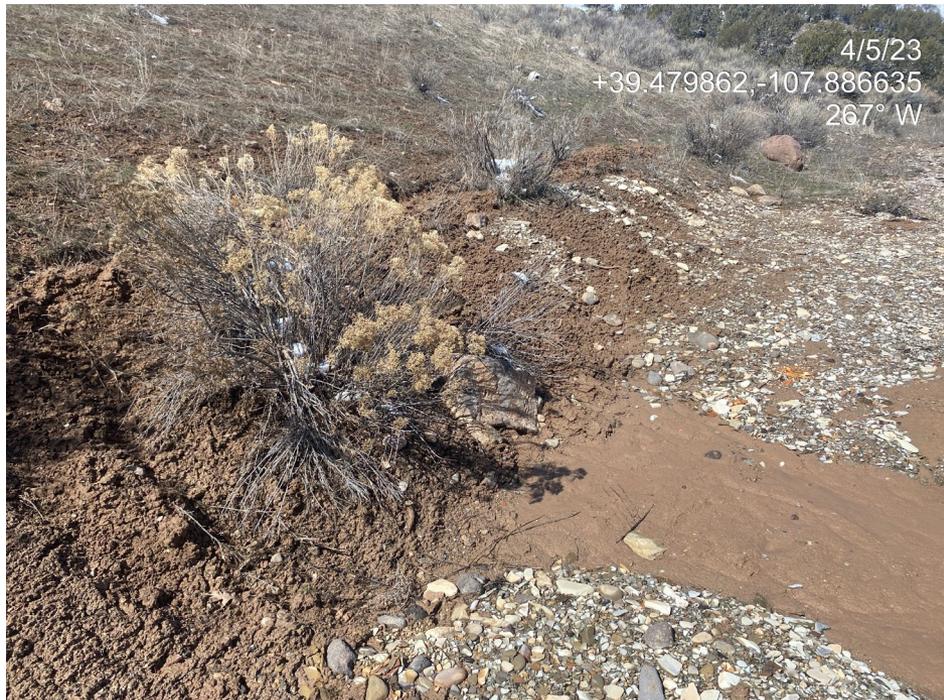
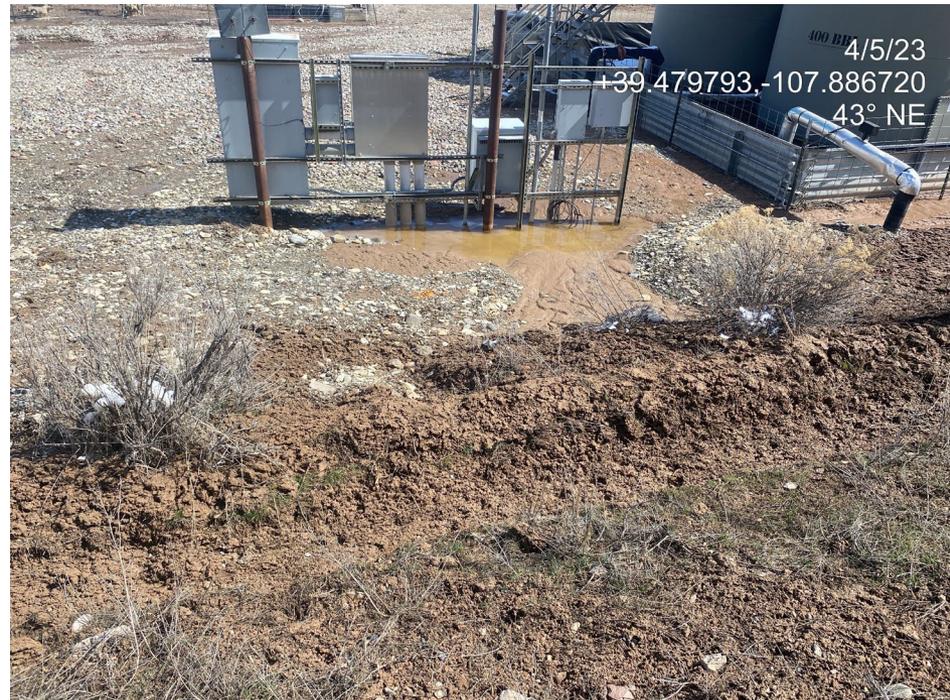
Photo 7. Photos show a berm at the south of the location is not stable. Rill erosion and sediment transport are evident.

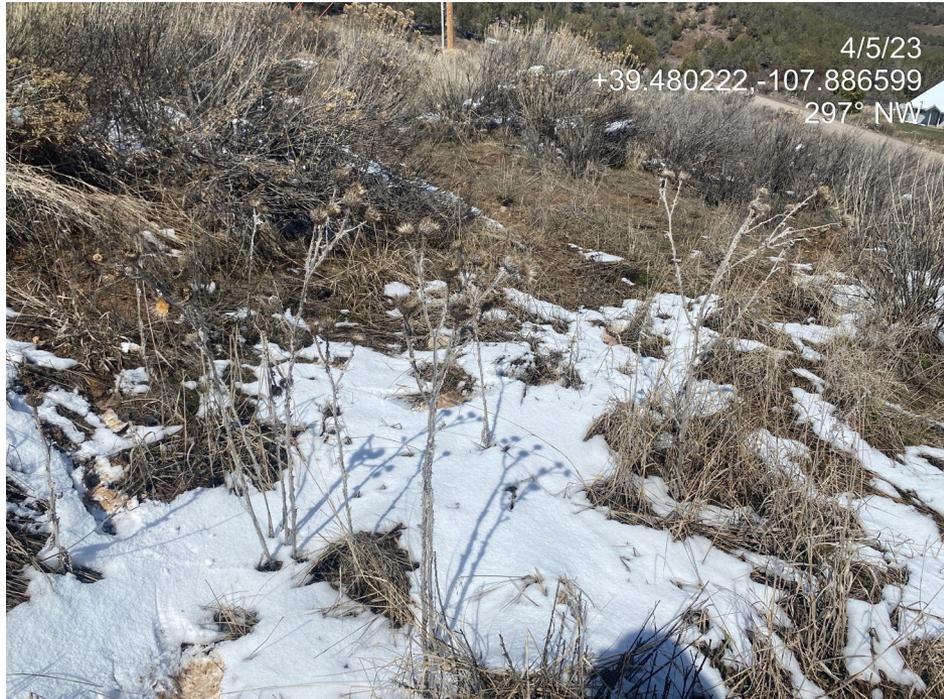
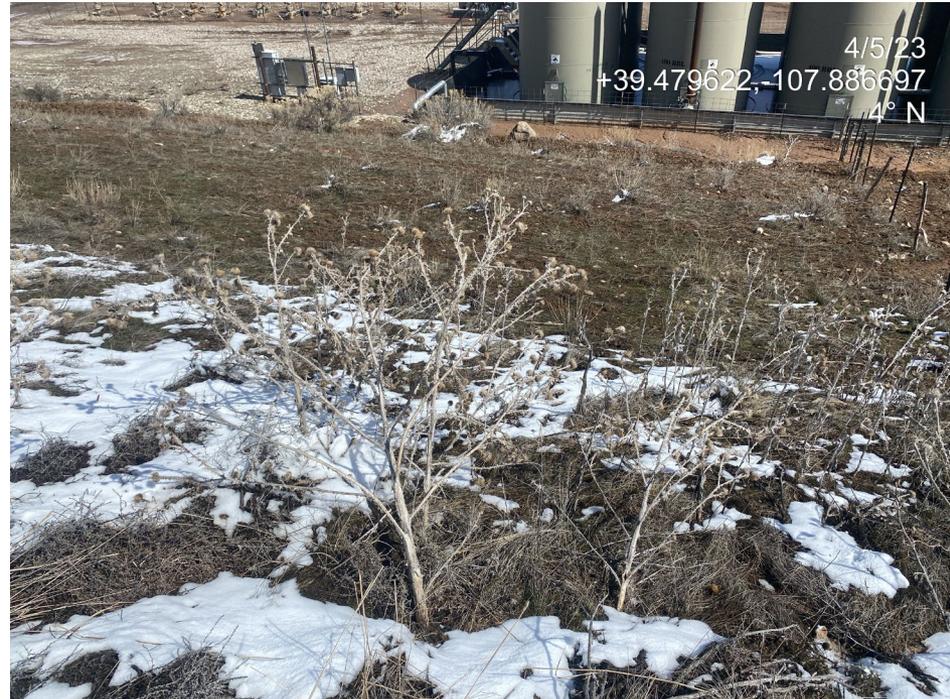
Photo 8. Photos show Scotch thistle in the northern (left) and southern (right) interim areas.

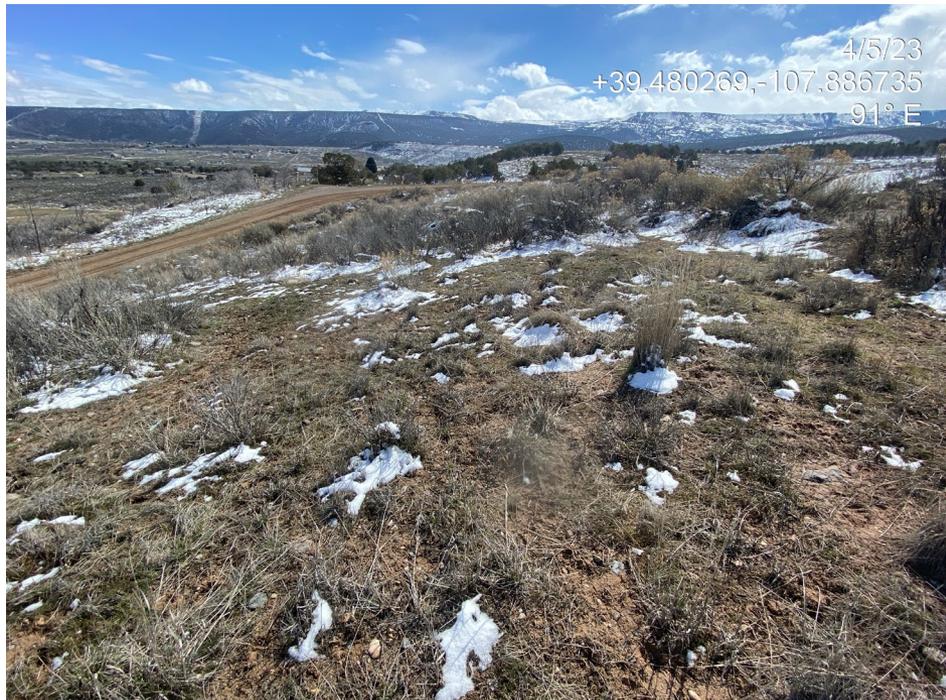
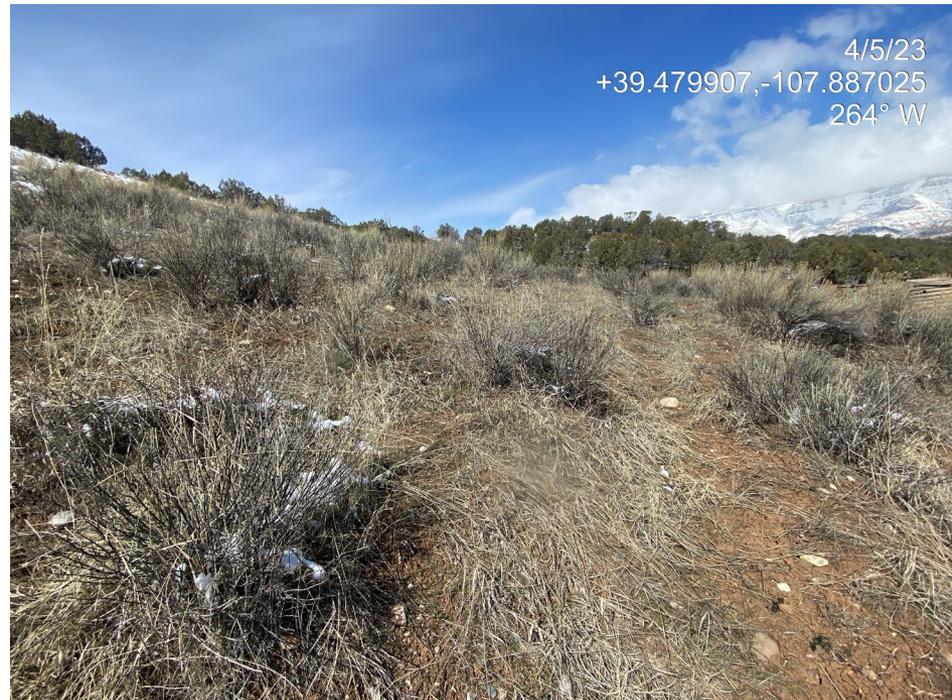
Photo 9. Photos show northern (left) and southern (right) interim areas.
