Inspection Photos

April 5, 2023

Operator: TEP Rocky Mountain LLC - #96850

Location Name: QUARTER CIRCLE RANCH-66S94W/33NENE

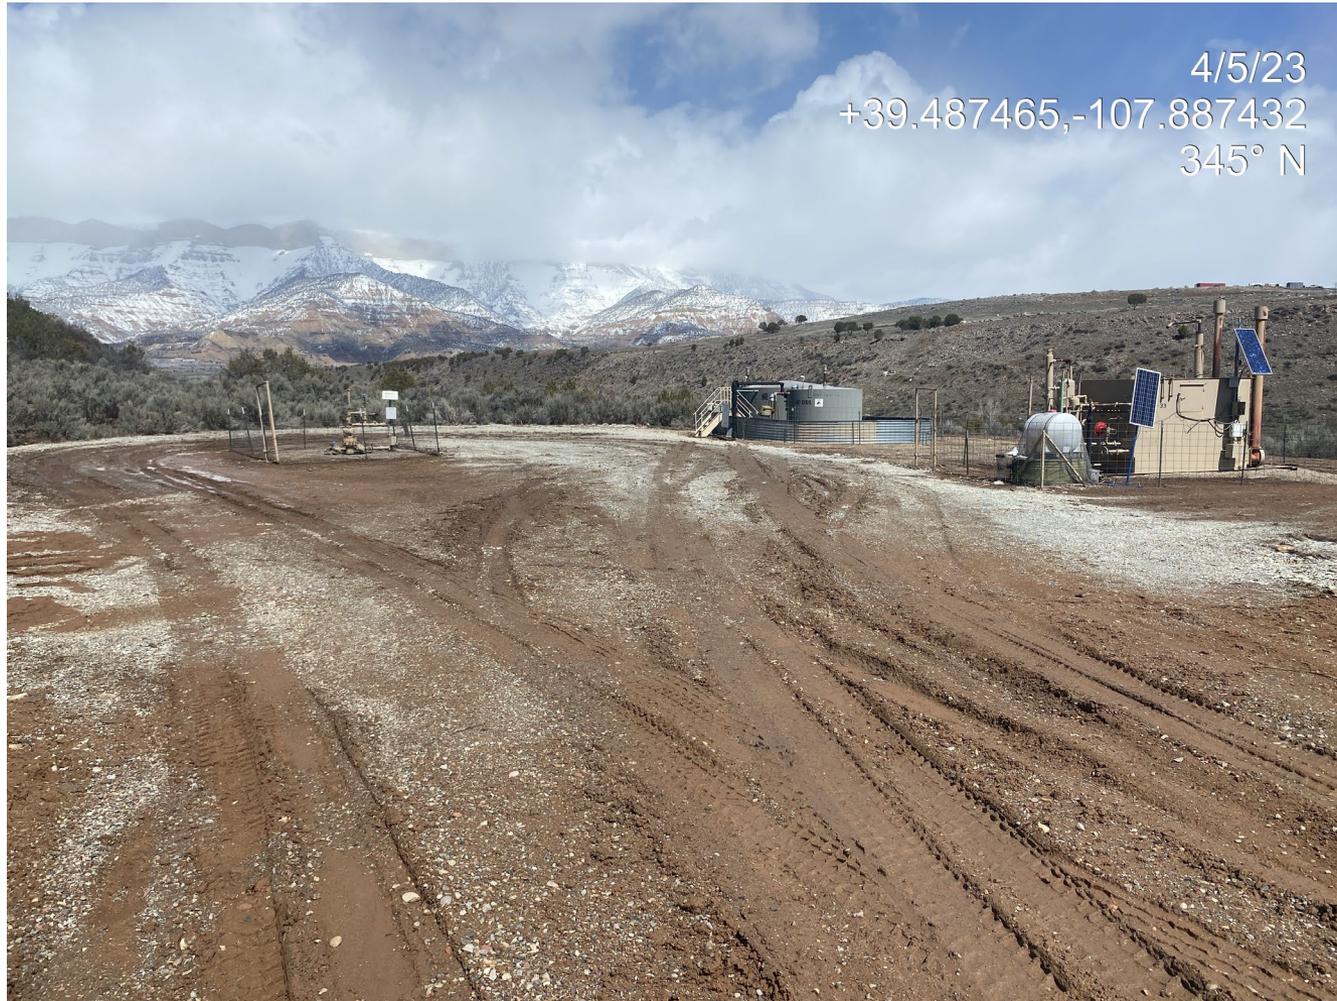
Photo 1. Photo taken from the entrance shows an overview of the location.

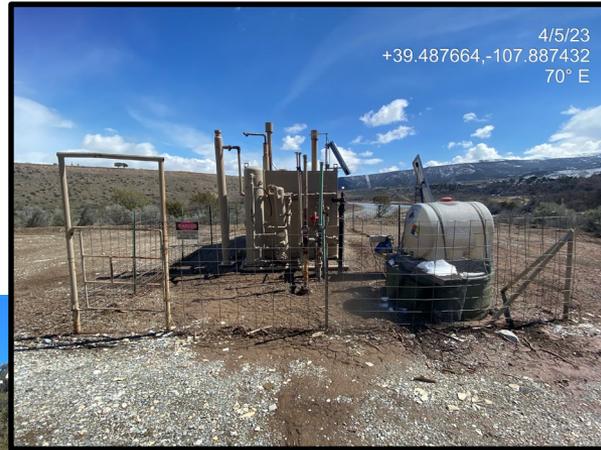
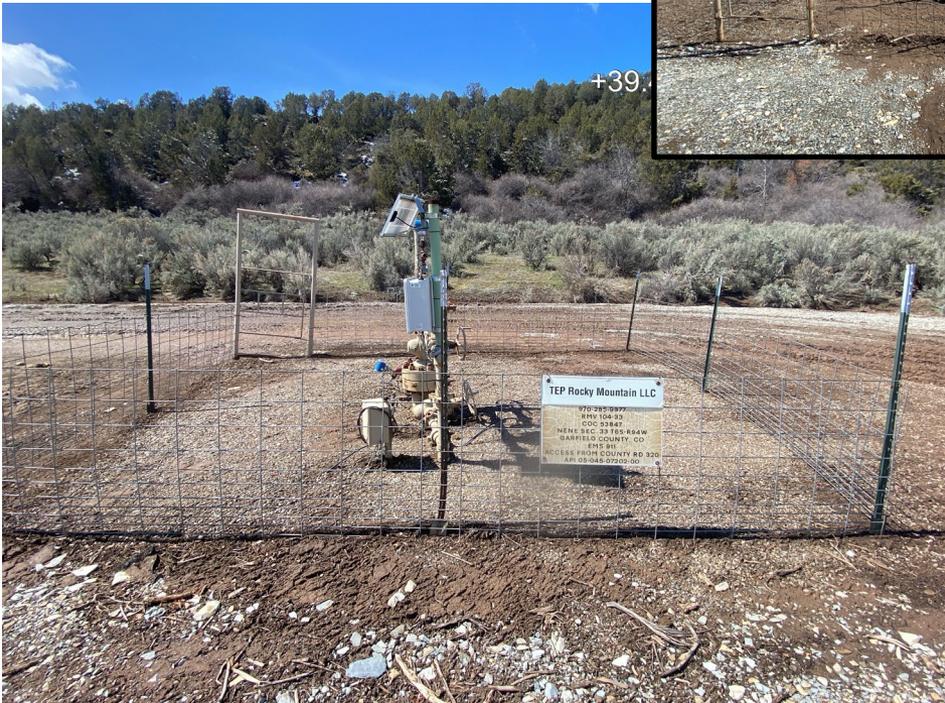
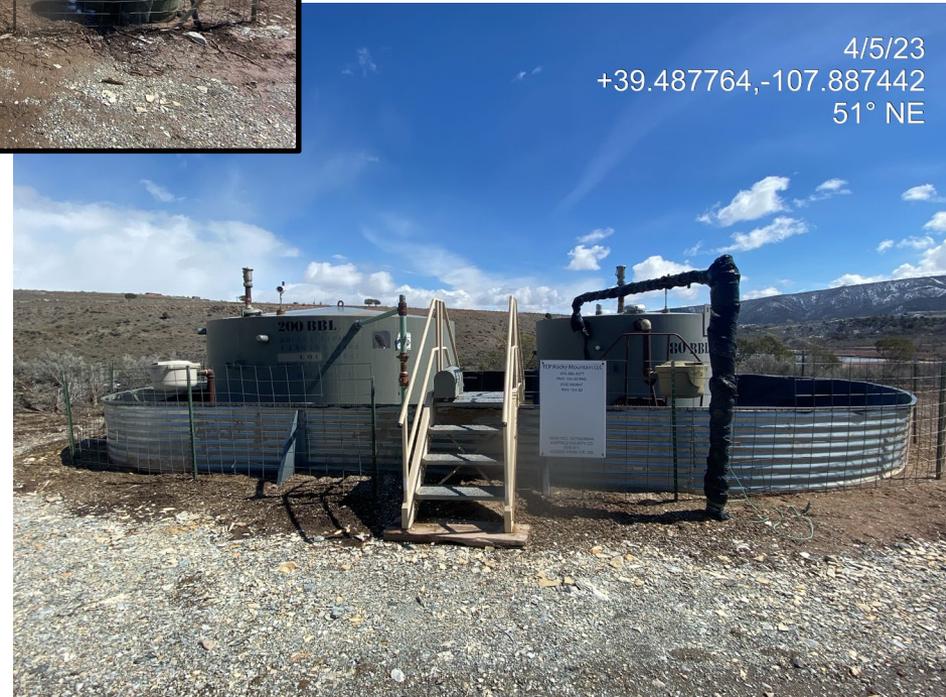
Photo 2. Photos show production areas.

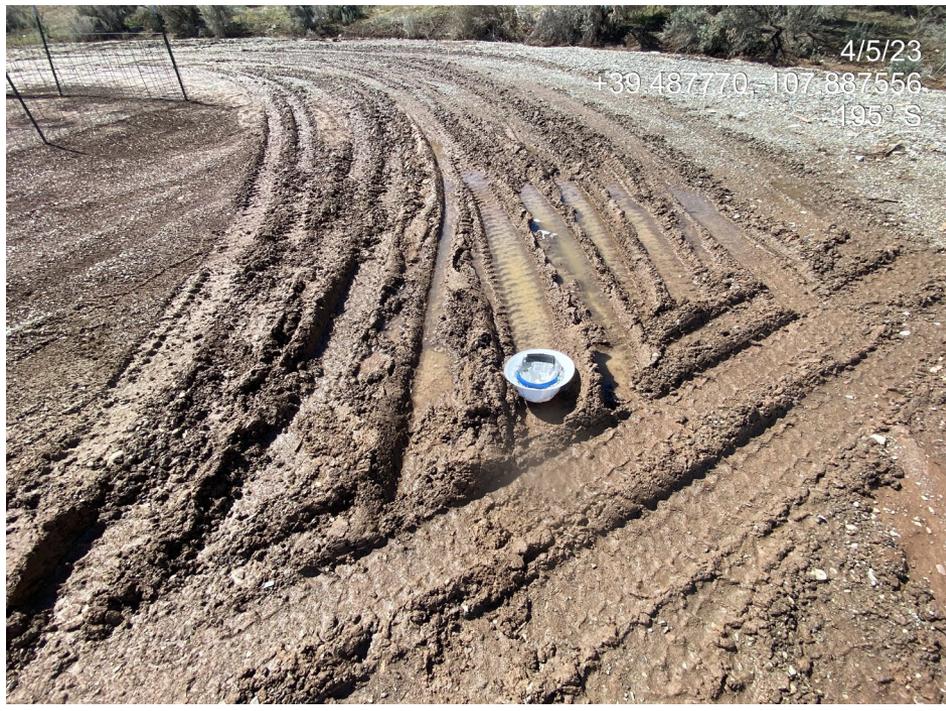
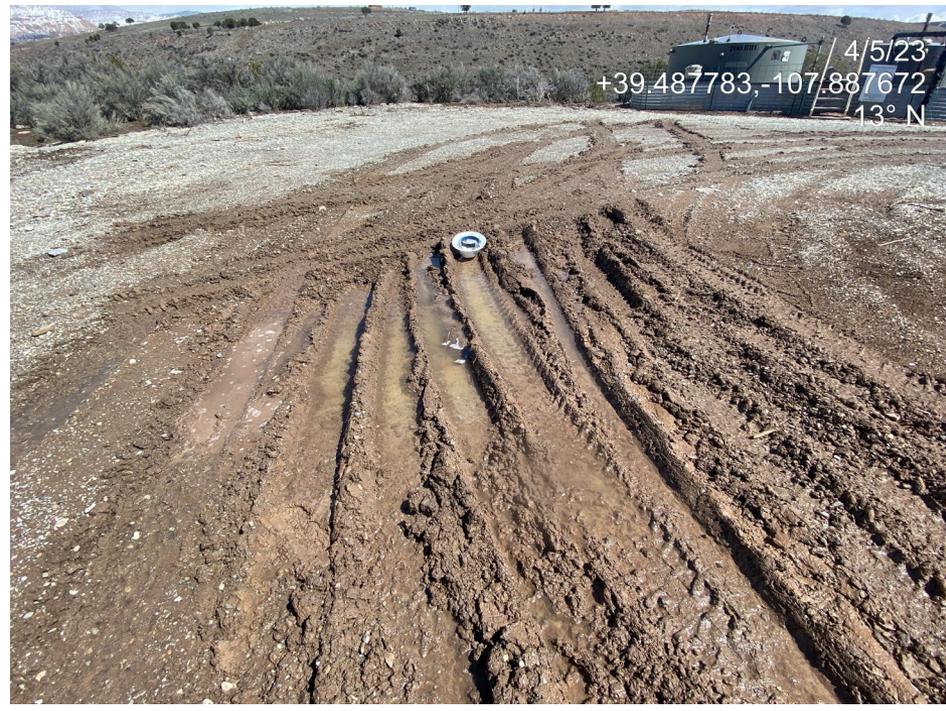
Photo 3. Photos show lack of stabilization of the working pad surface (ruts).

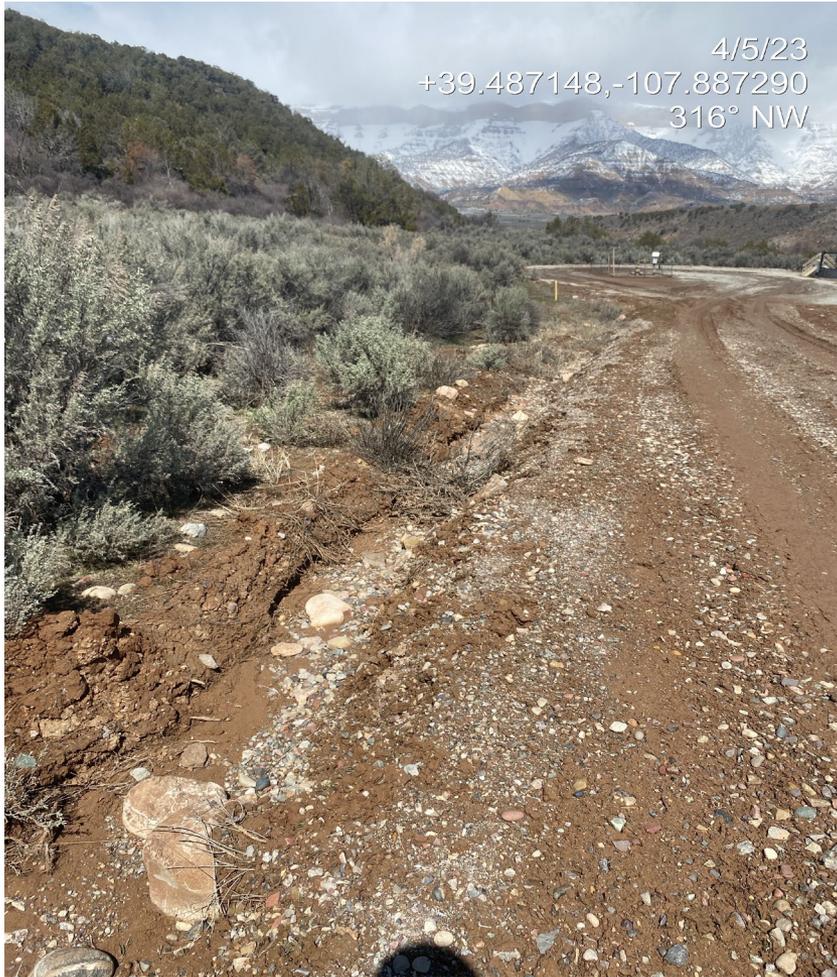
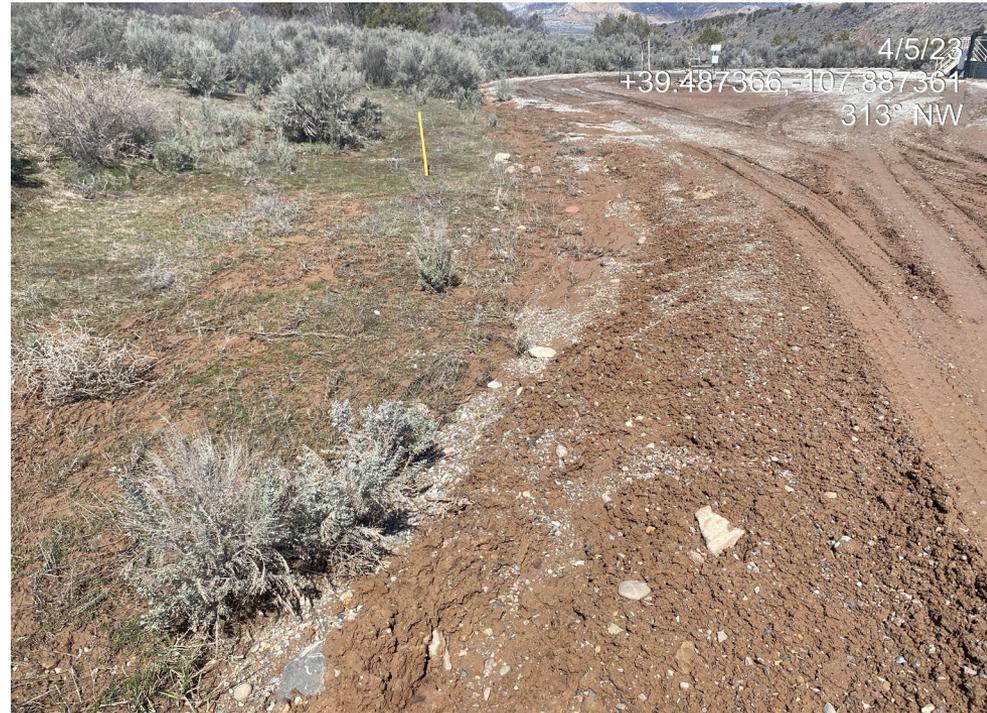
Photo 4. Photo shows the edge of the access road is unstable. The ditch is full of sediment and the ditch itself is eroding.

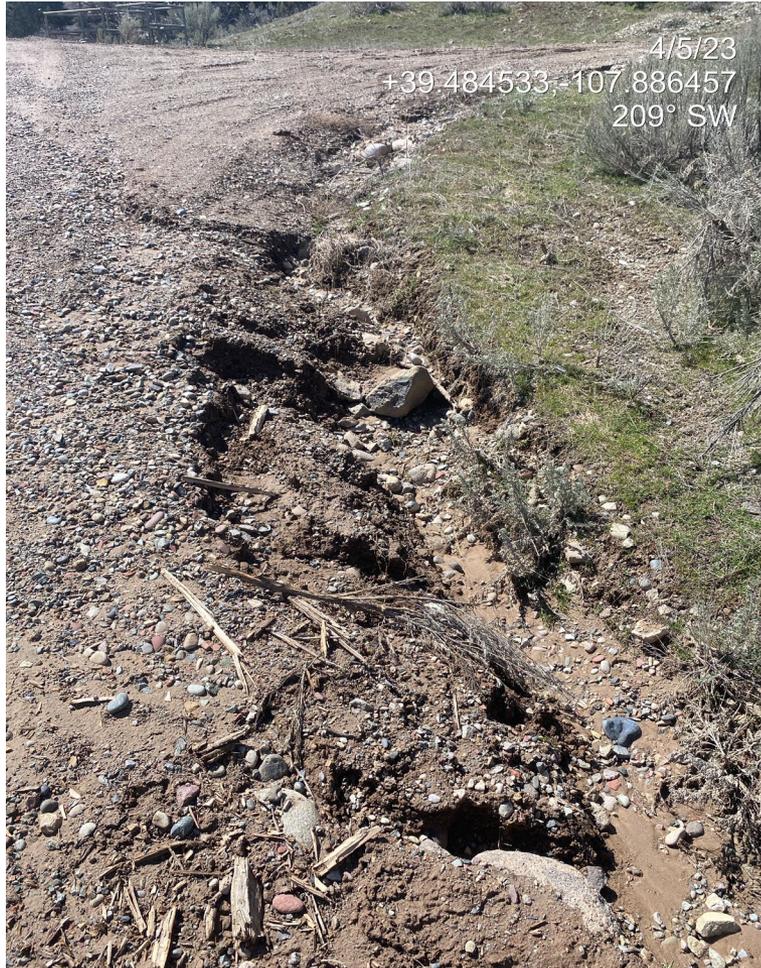
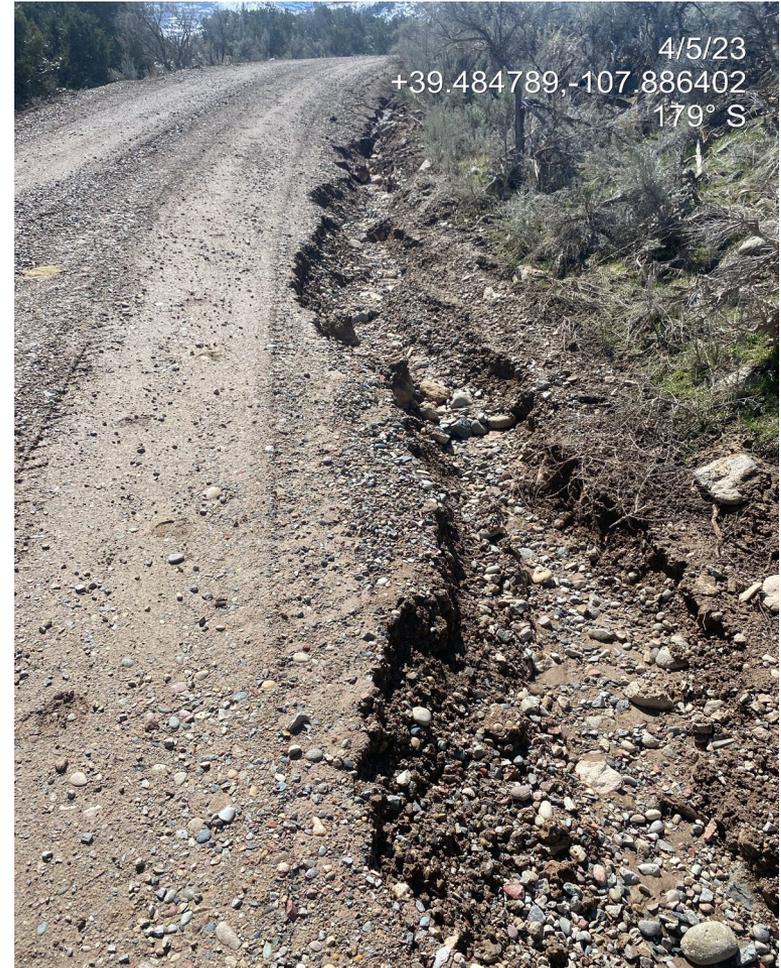
Photo 5. Photo shows the edge of the access road and ditch are unstable. Portions of the road are sloughing off.

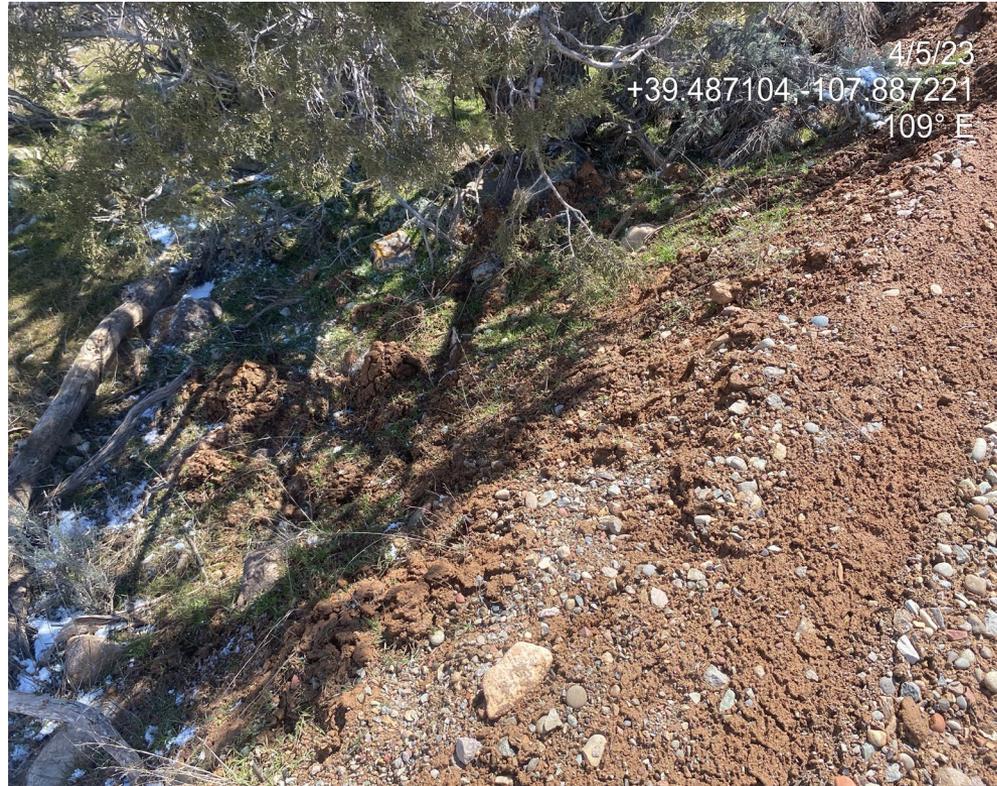
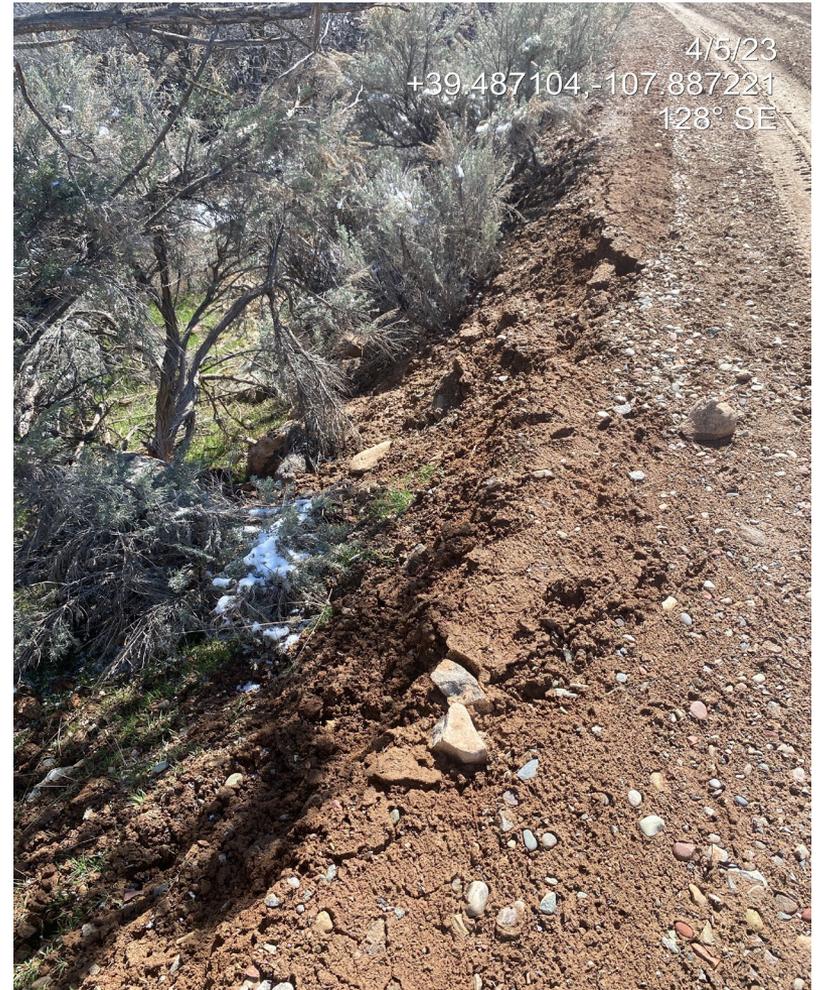
Photo 6. Photo shows the edge of the access road is unstable. Portions of the road are sloughing off.

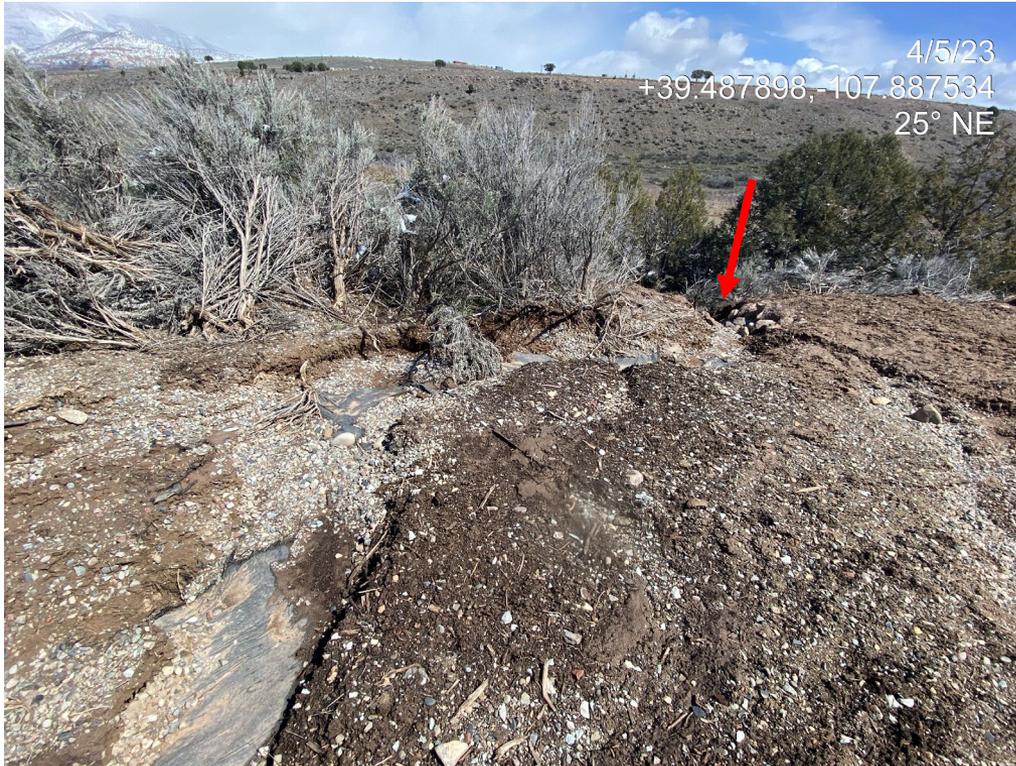
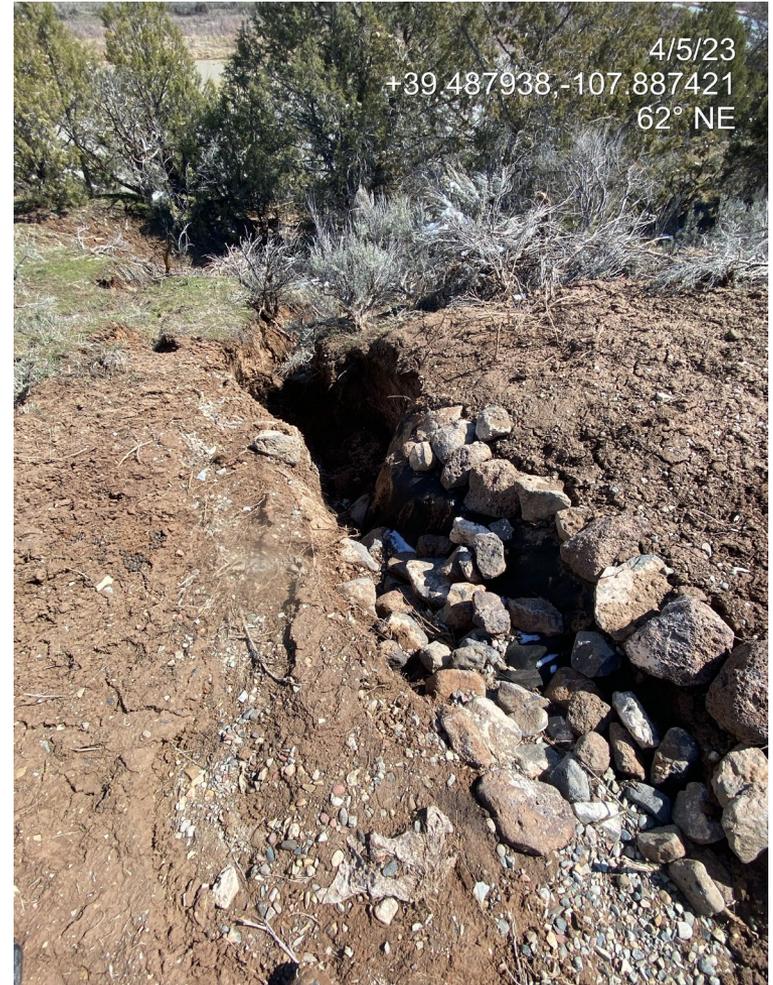
Photo 7. Photo taken from the northeast, behind the tank battery shows erosion degradation where a ditch leads to an outlet (arrow and left).

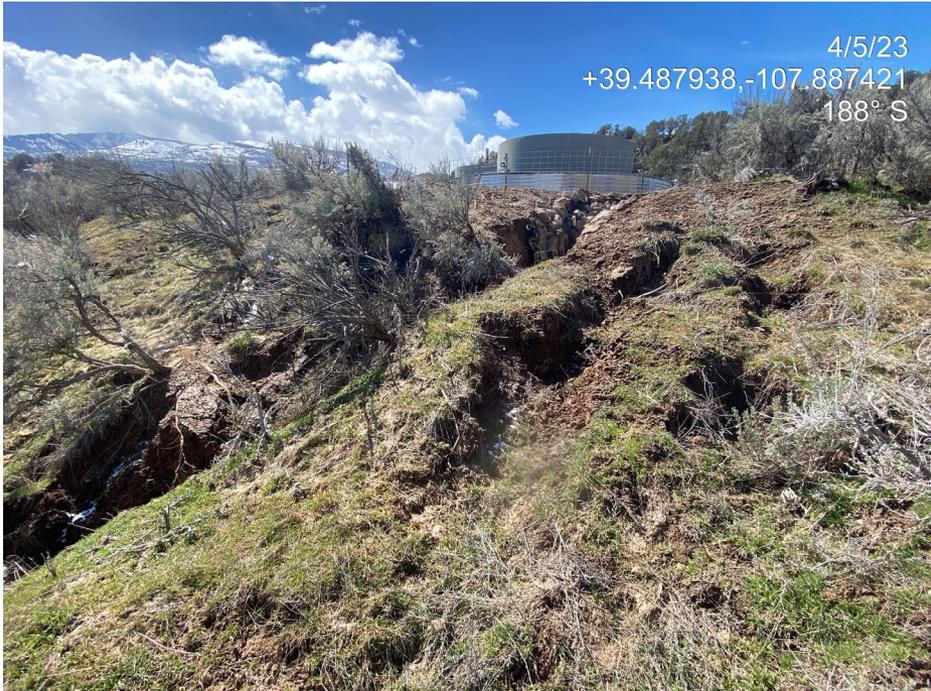
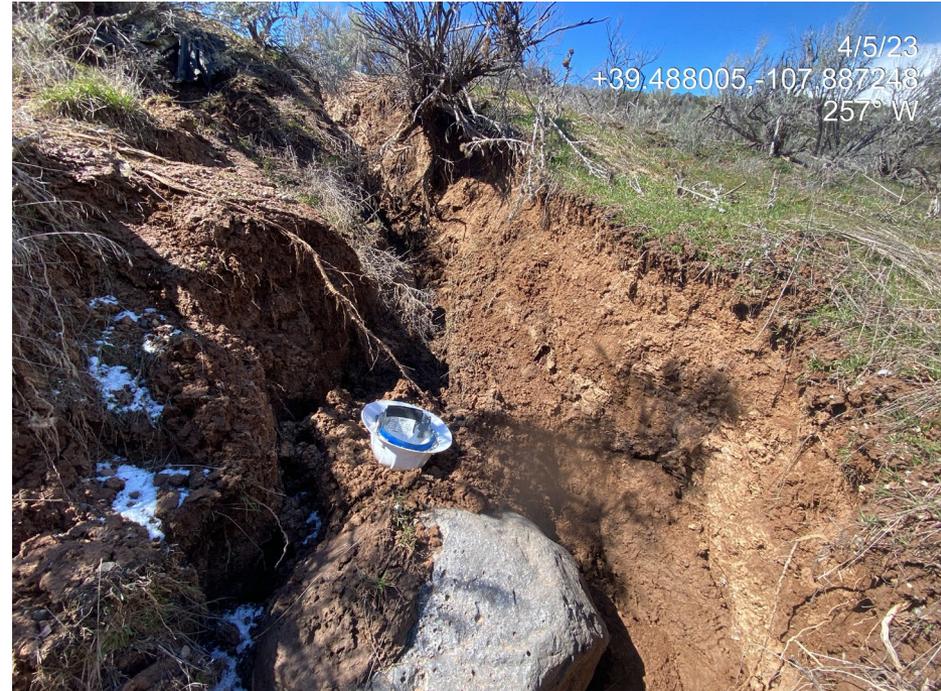
Photo 8. Photo taken from the northeast, behind the tank battery shows erosion degradation downslope of the ditch and outlet pictured in Photo 7.

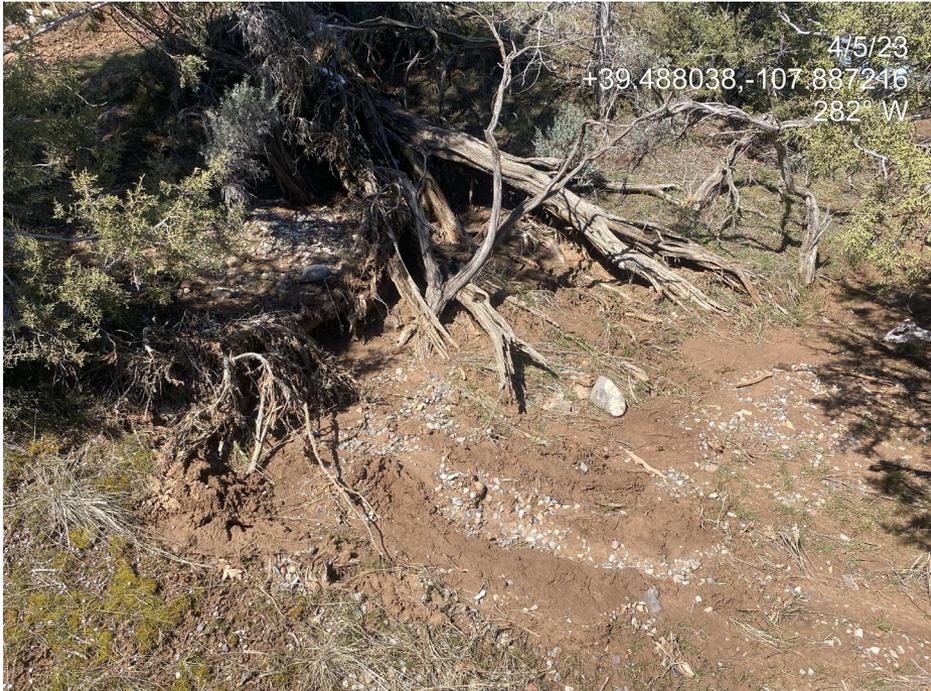
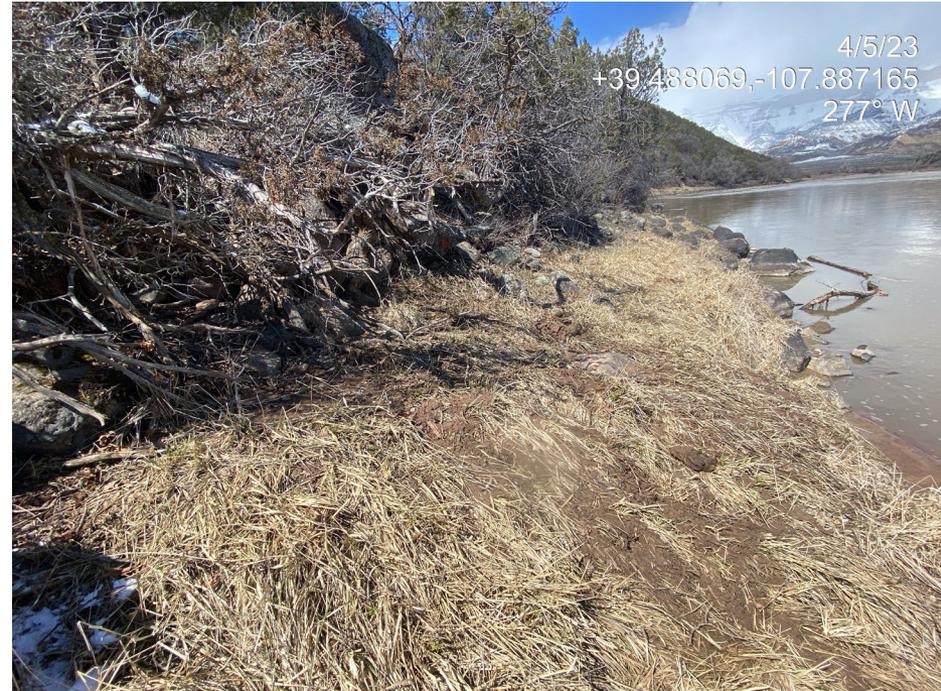
Photo 9. Photo taken downslope from Photos 7 and 8 shows erosion degradation and sediment accumulation offsite, including on the river bank and in the river.

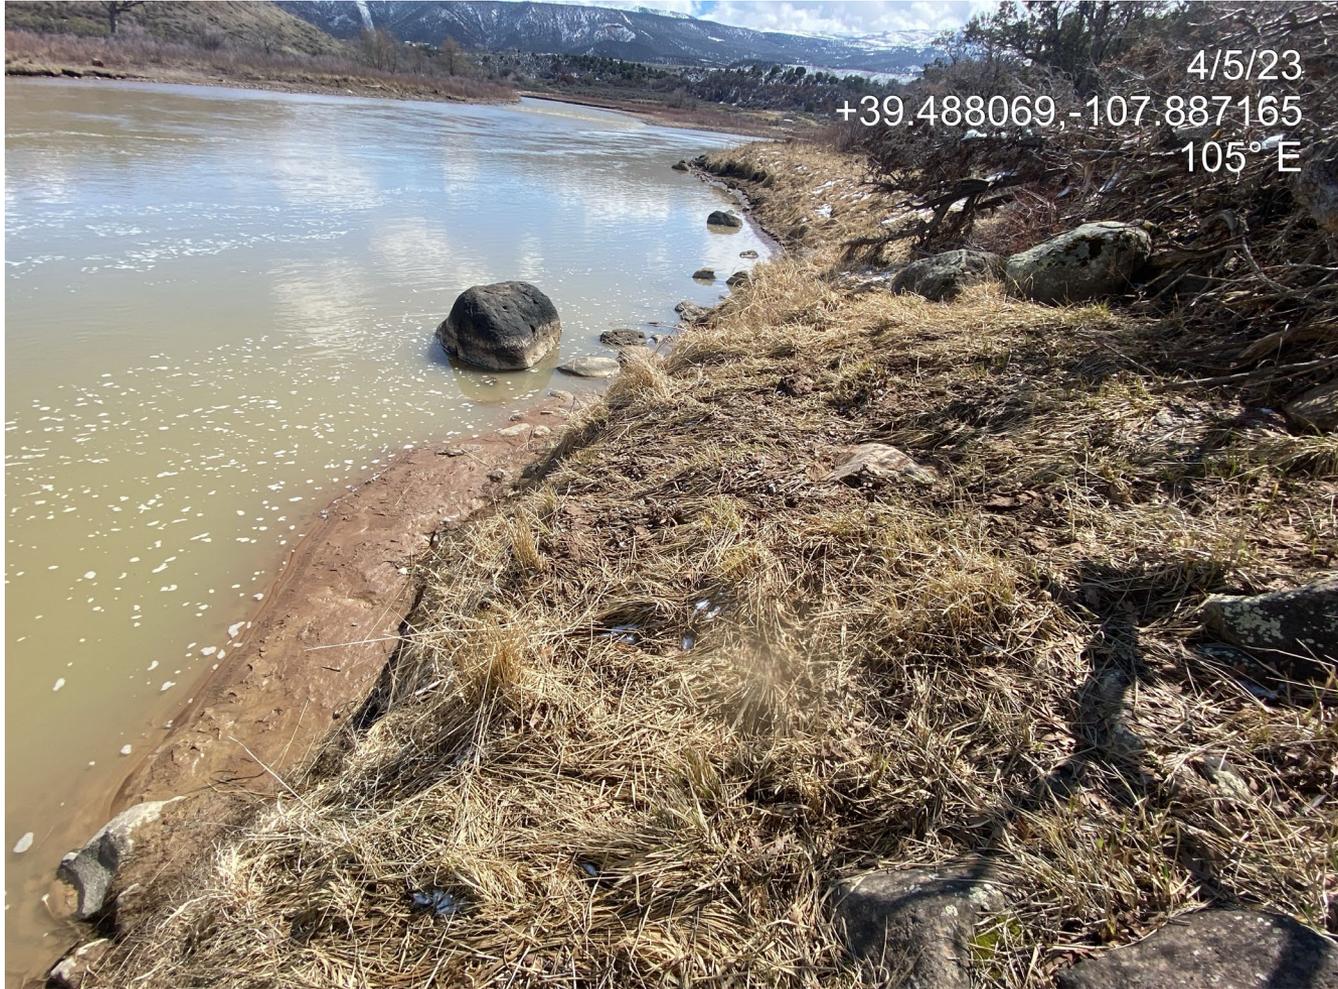
Photo 10. Photo taken downslope from Photos 7 and 8 shows where the location stormwater BMPs are discharging sediment on the river bank and in the river.

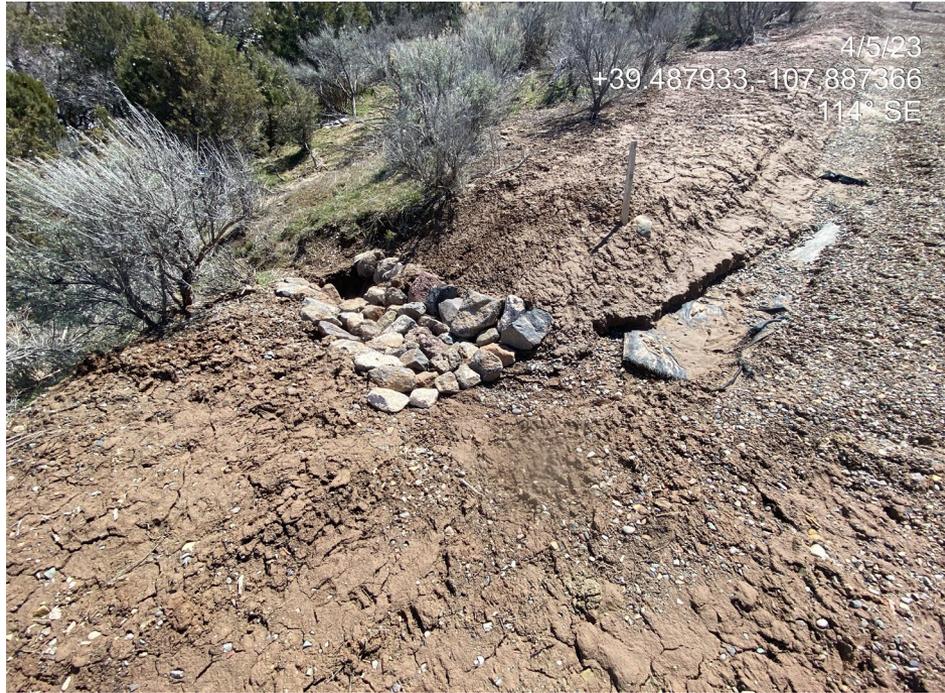
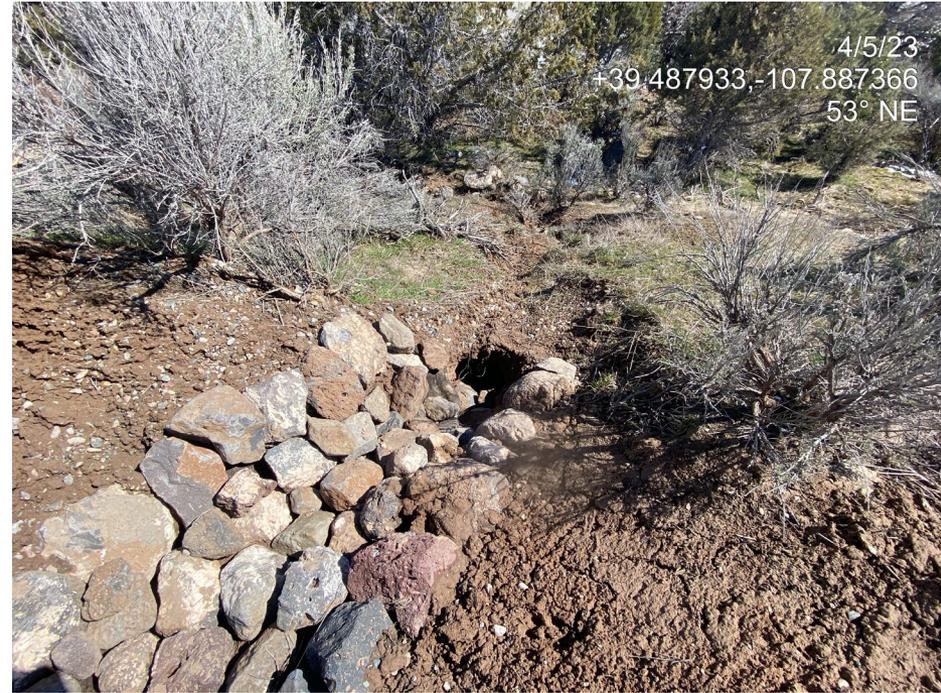
Photo 11. Photo taken from the northeast, behind the tank battery shows erosion degradation where a ditch leads to an outlet.

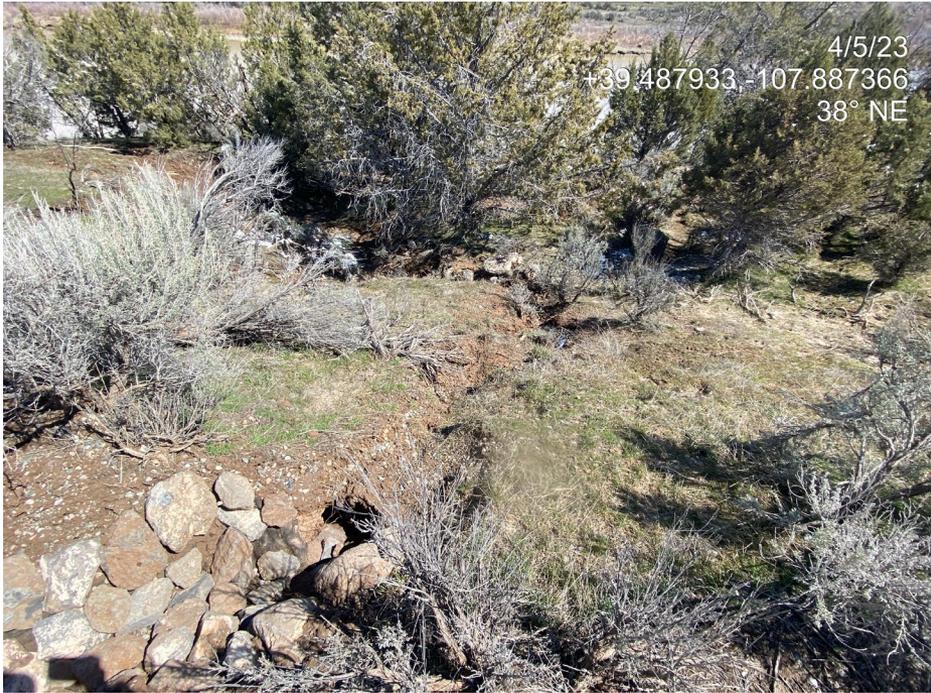
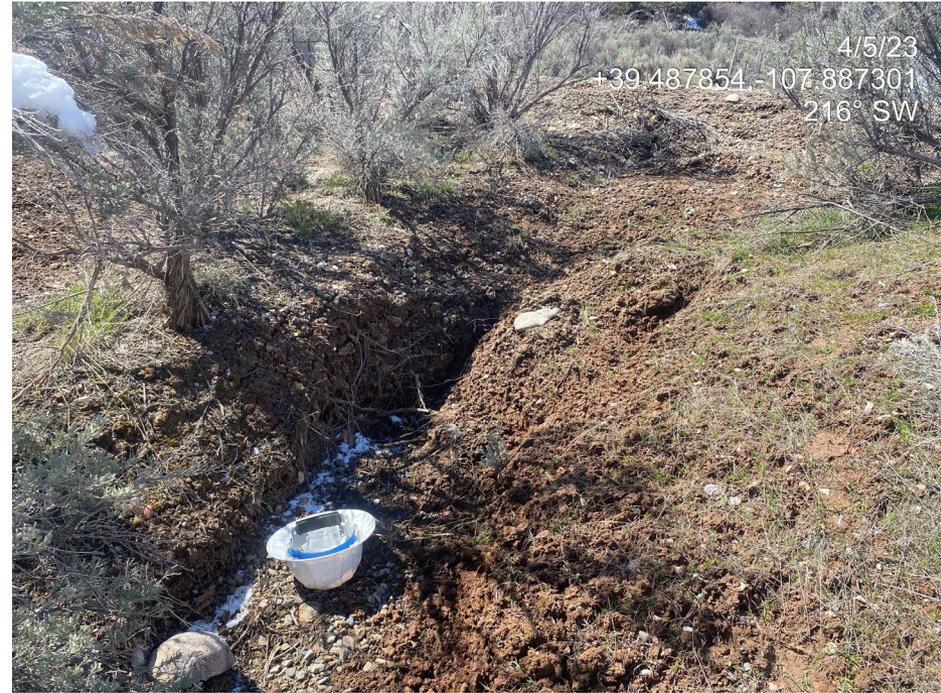
Photo 12. Photo taken from the northeast, behind the tank battery shows erosion degradation downslope of the ditch and outlet pictured in Photo 11.

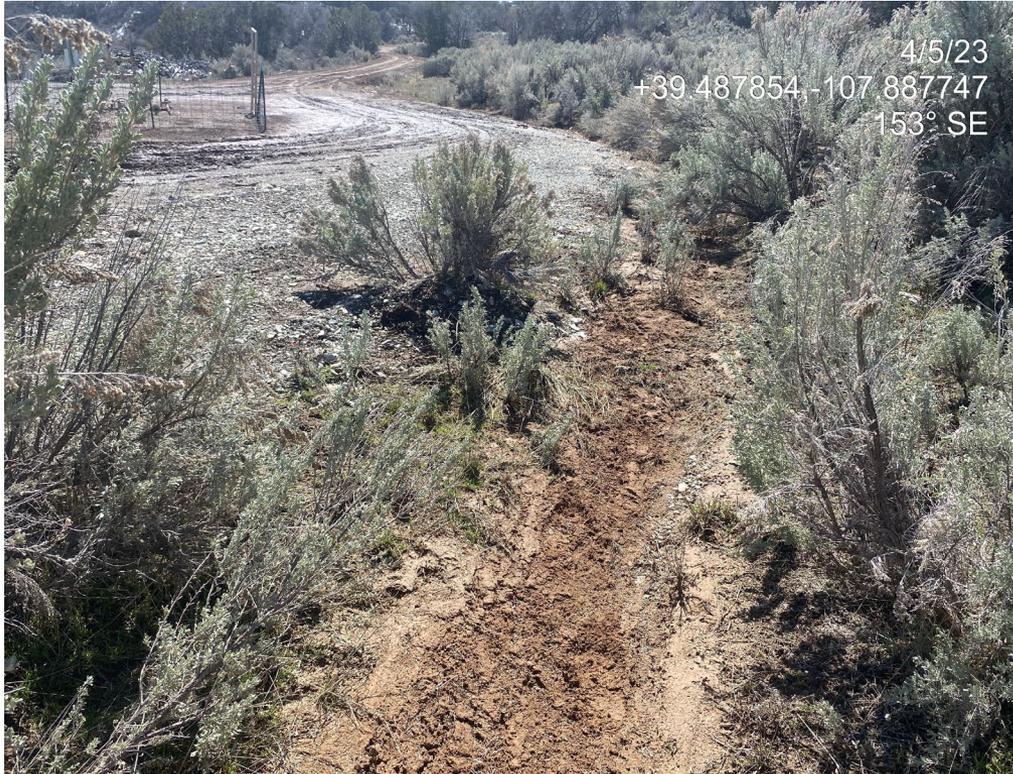
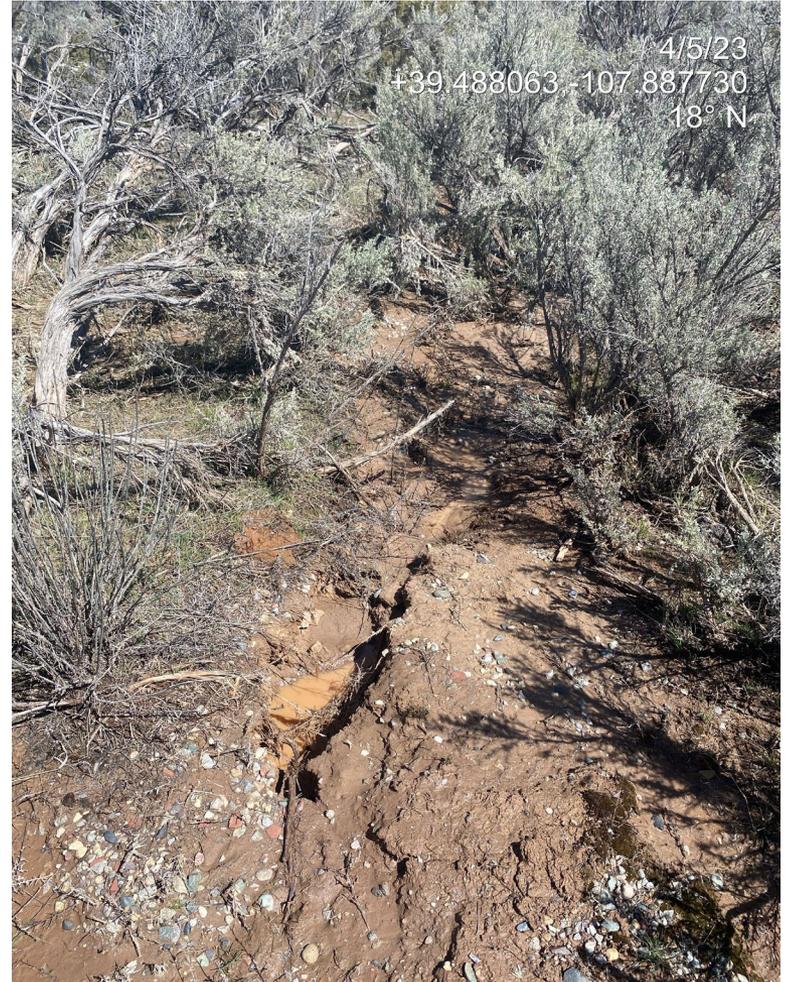
Photo 13. Photo taken from the northwest, shows where the access road ditch/western location perimeter ditch is causing offsite degradation to the north in the form of scouring, rills and a gully.

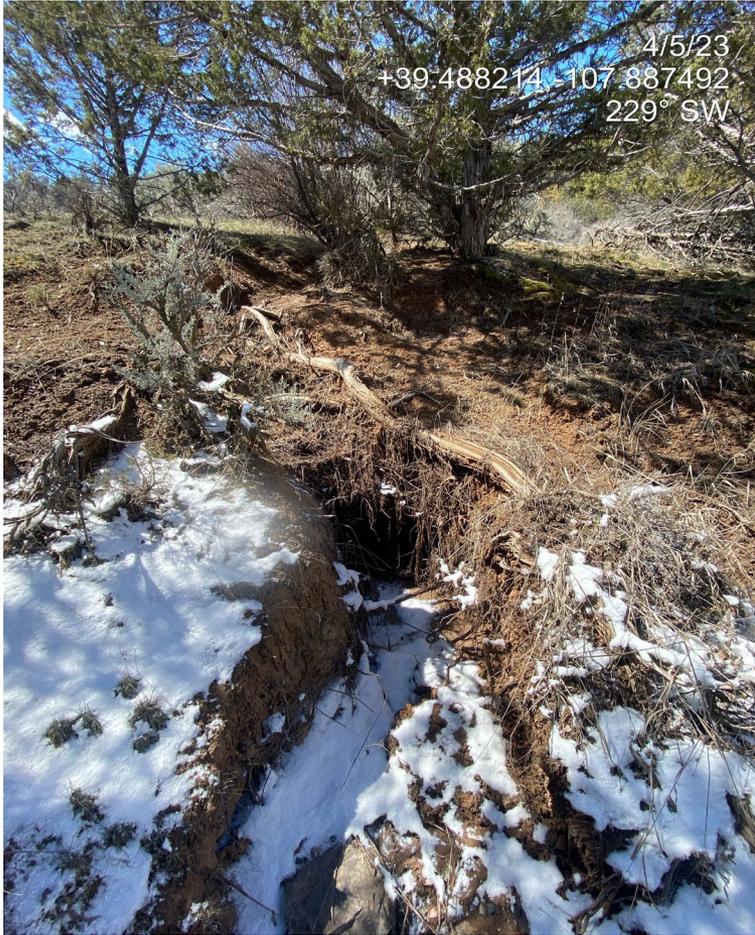
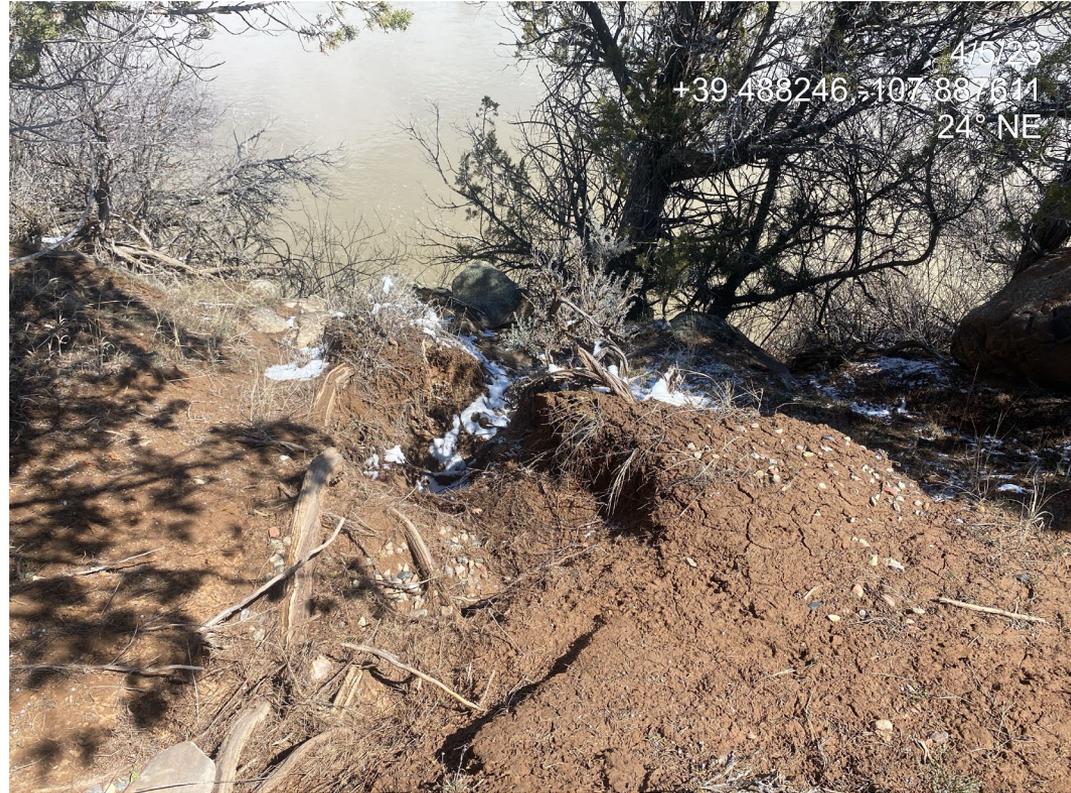
Photo 14. Photo taken from the northwest, shows where the access road ditch/western location perimeter ditch is causing offsite degradation to the north in the form of scouring, rills and a gully.

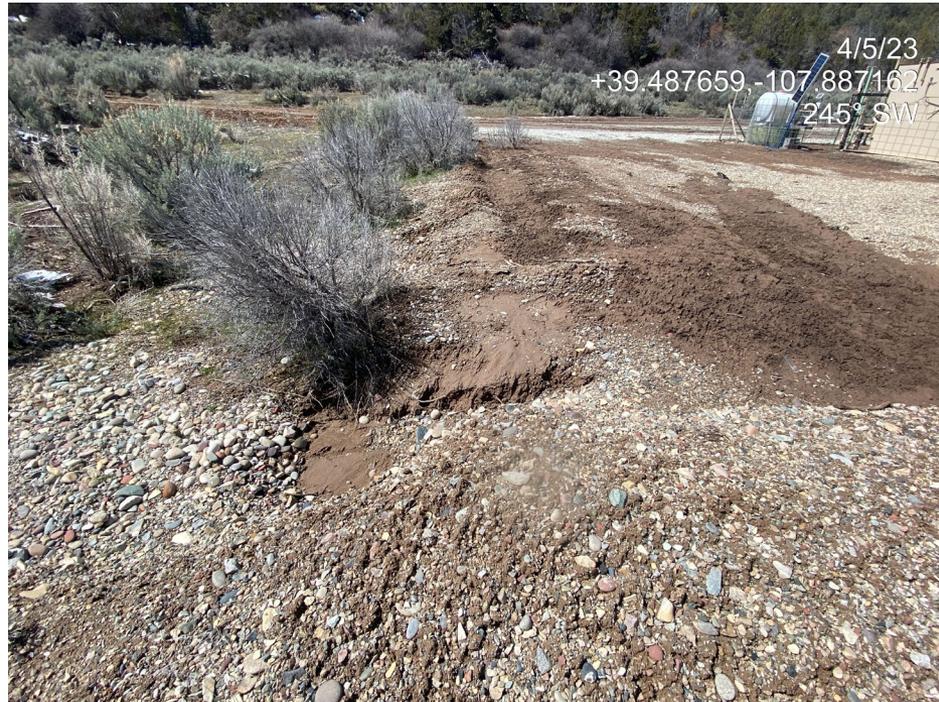
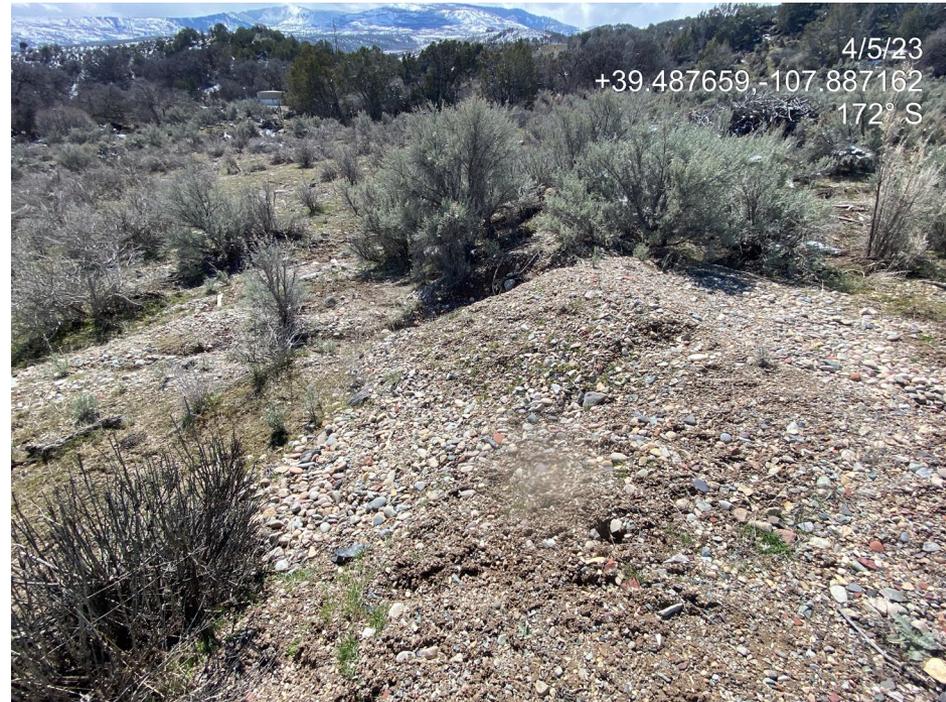
Photo 15. Photo taken from the southeast, shows erosion degradation (rills) throughout the southeastern portion of the location and migrating offsite.
