Stormwater Inspection

Date: 03/31/2023

Location ID: 317498

Inspection Document #: 708200091

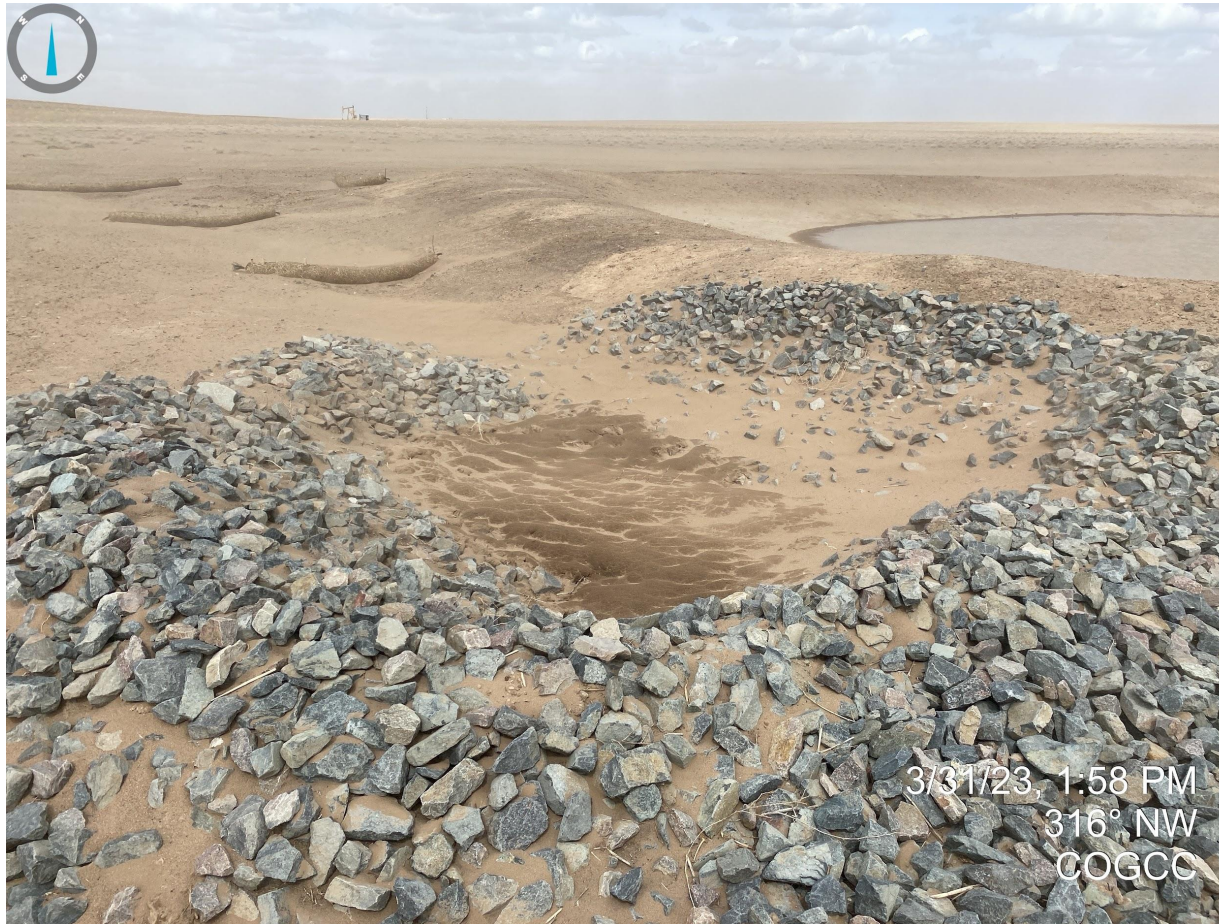
Photo 1. Sediment trap and straw wattles installed in the area previously experiencing erosion issues. It appears the Stormwater BMPs will be sufficient at controlling and managing stormwater for this location.

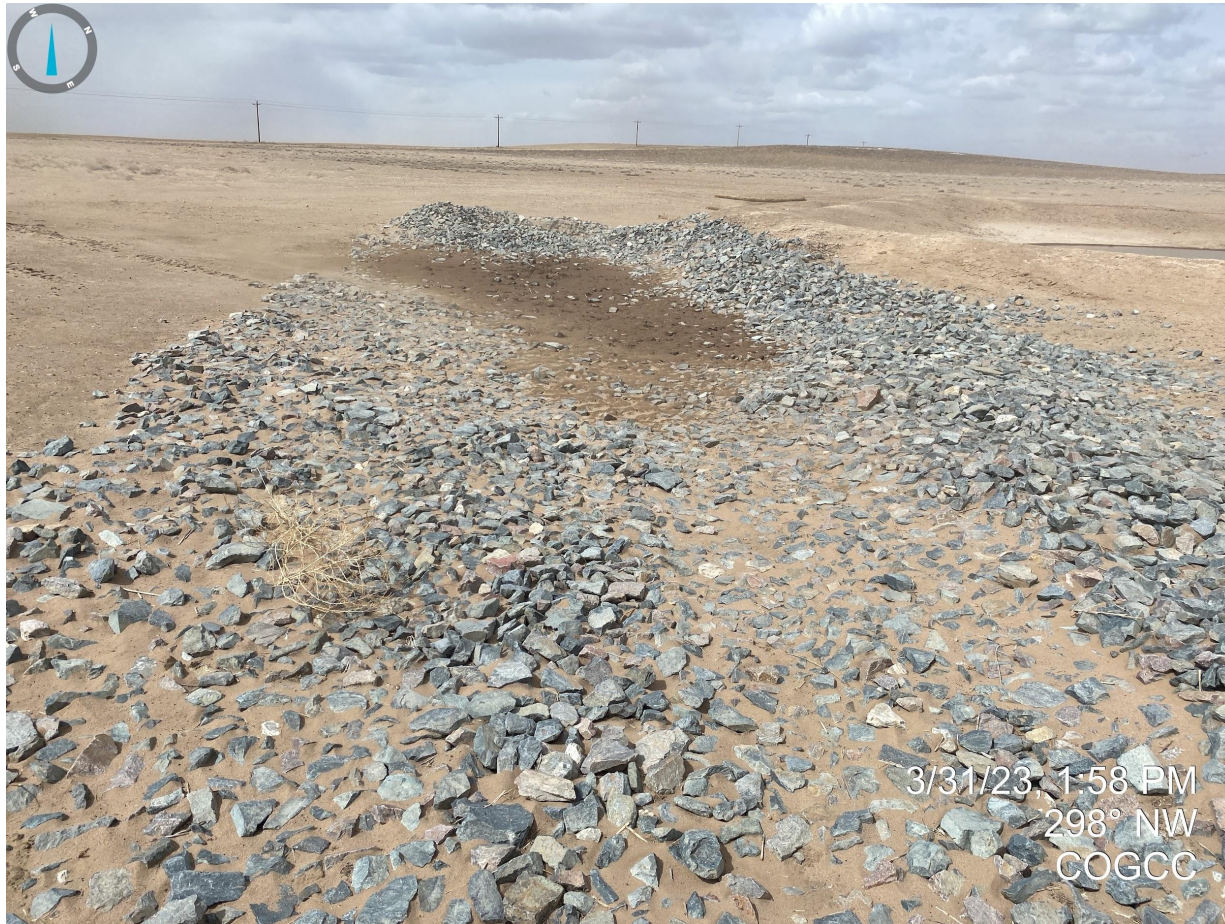
Photo 2. Rip rap structure/water bar placed at the entrance to the pad.

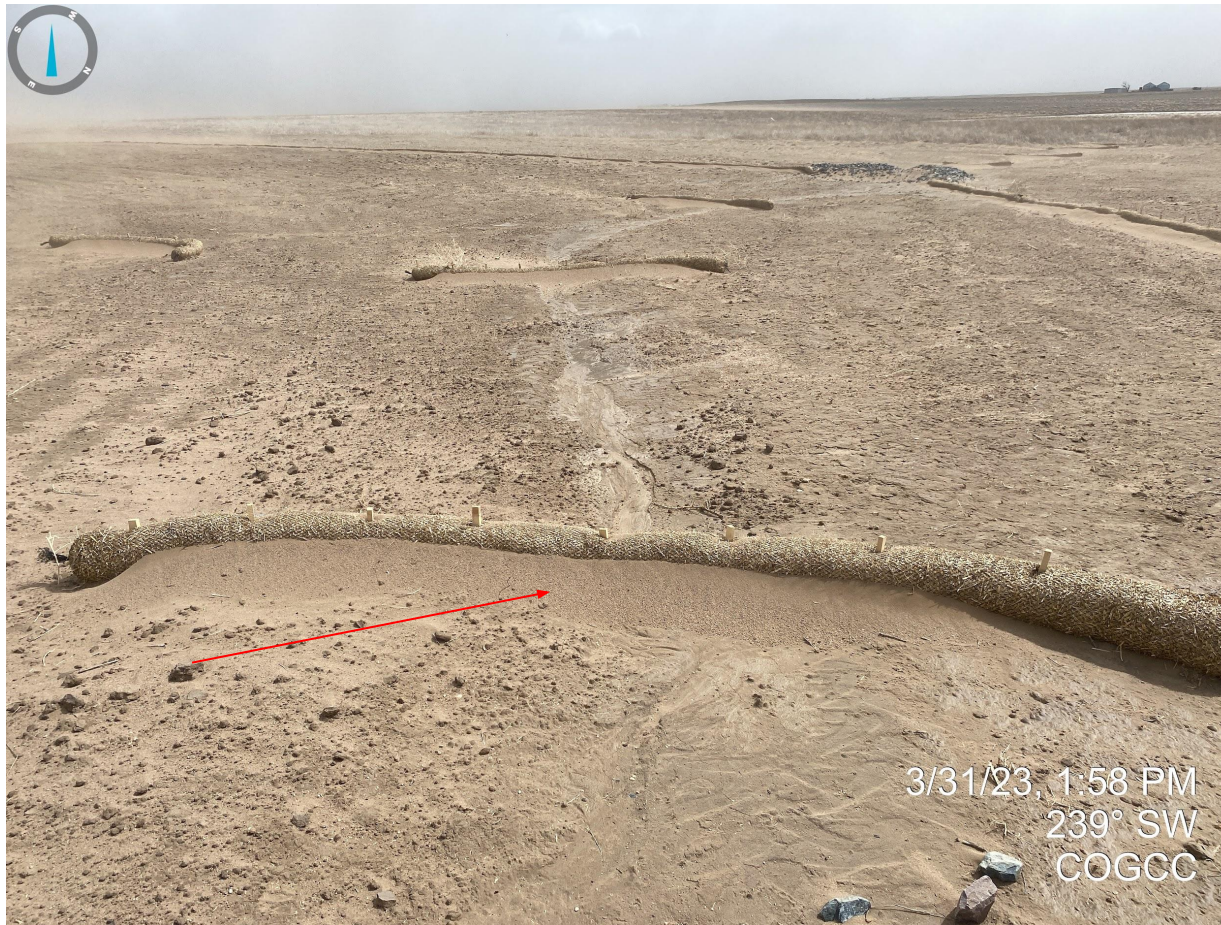
Photo 3. Straw wattles placed as check dams within the eroded areas. Blow sand from high winds have accumulated within the straw wattles and will require maintenance to ensure the BMPs are properly functioning.

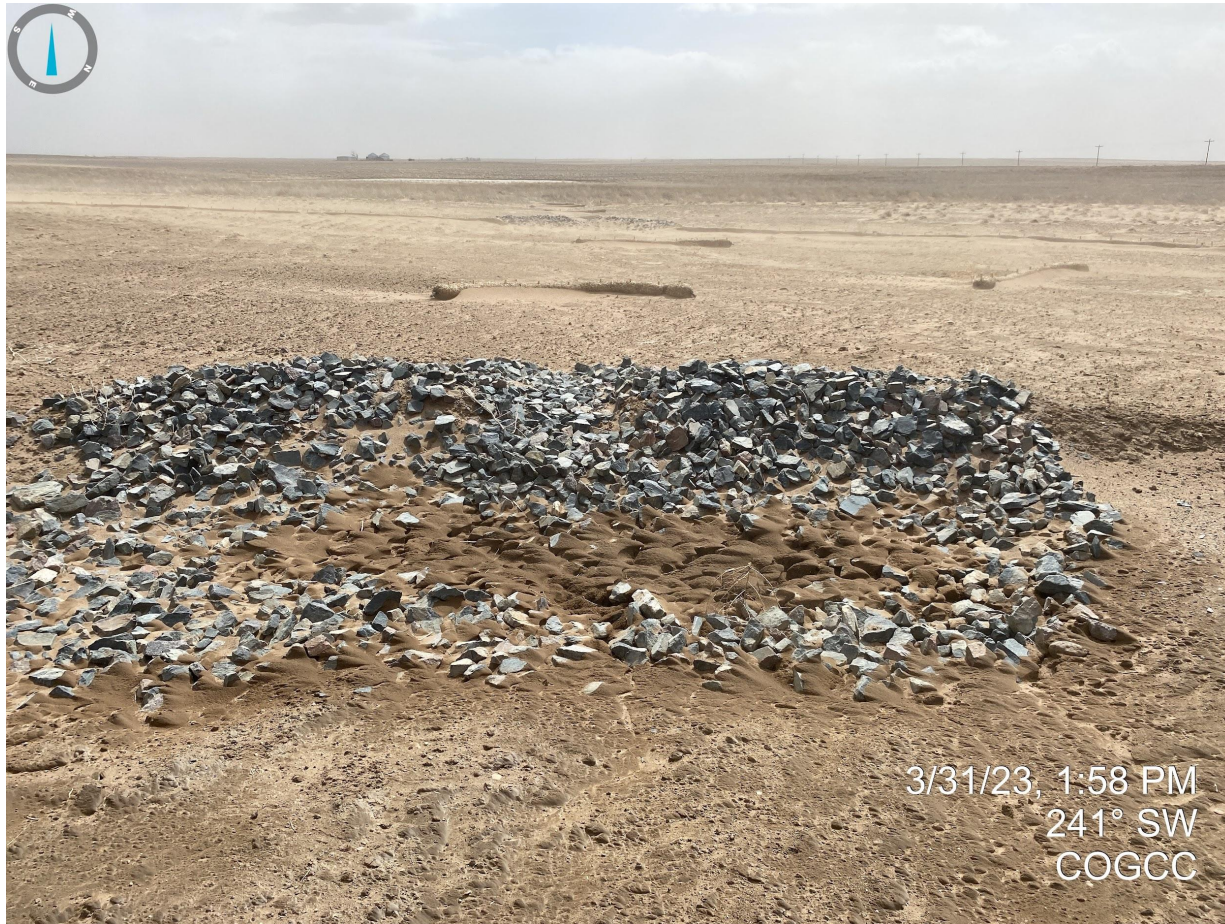
Photo 4. Sediment trap installed at the southern end of the location appears to have been stabilized with rip rap material.

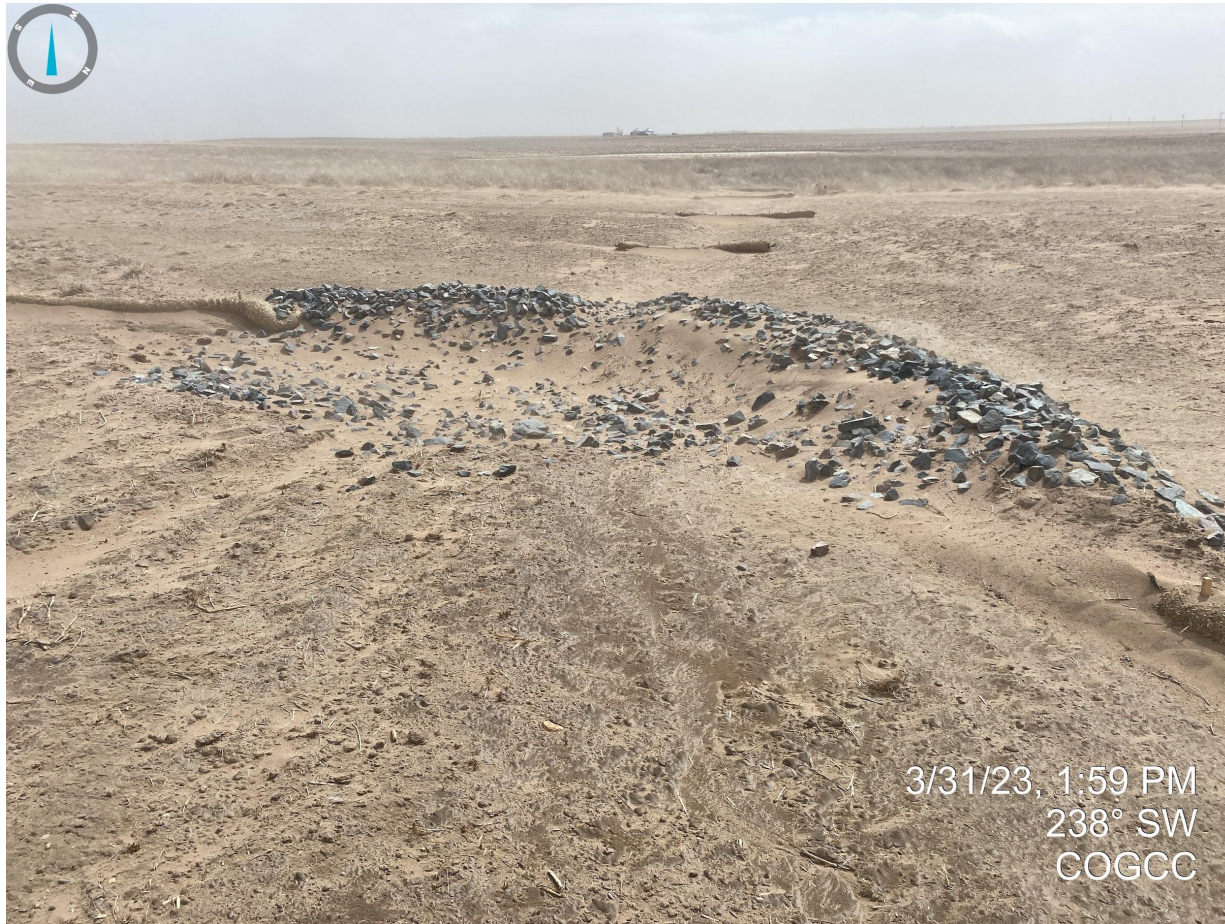
Photo 5. Additional sediment trap placed within the recently reclaimed portion of the location.

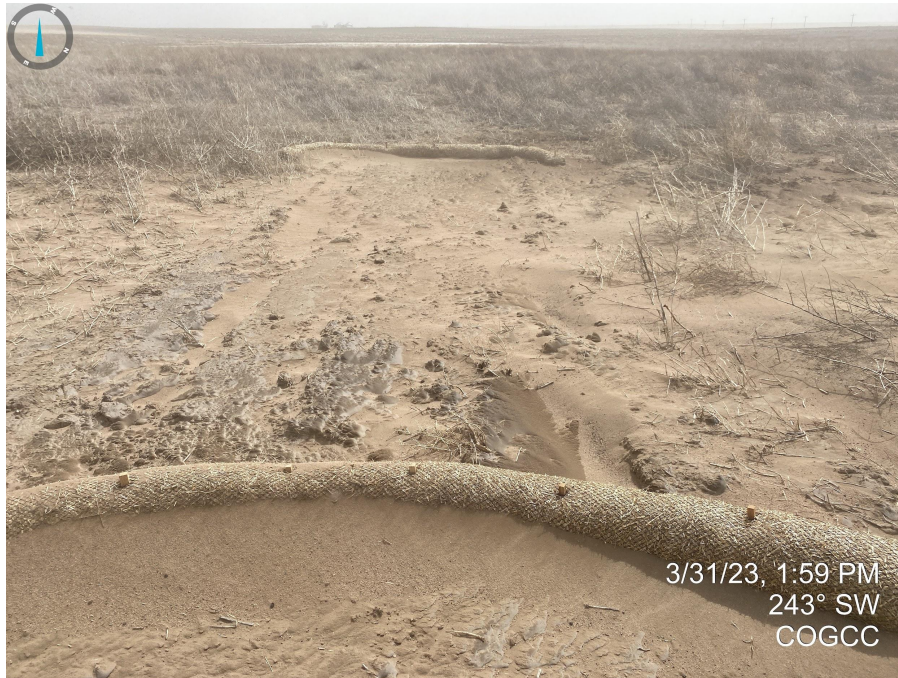
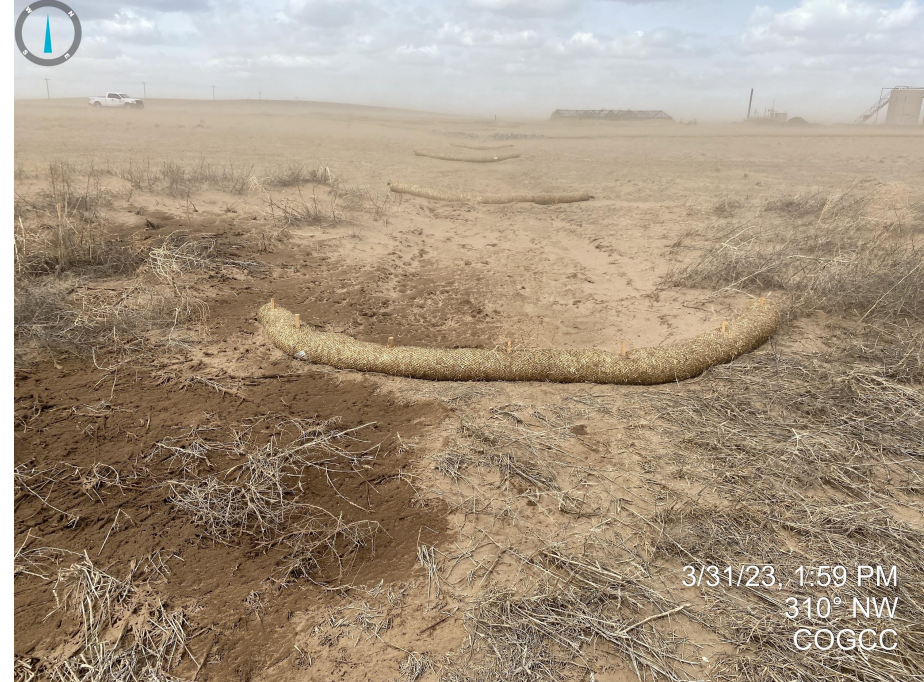
Photos 6 & 7. Taken from the southern end of the location. It appears the operator has removed the sediment that migrated off location and installed straw wattles as BMPs. Maintenance on straw wattles will be required to remove deposited blow sand.

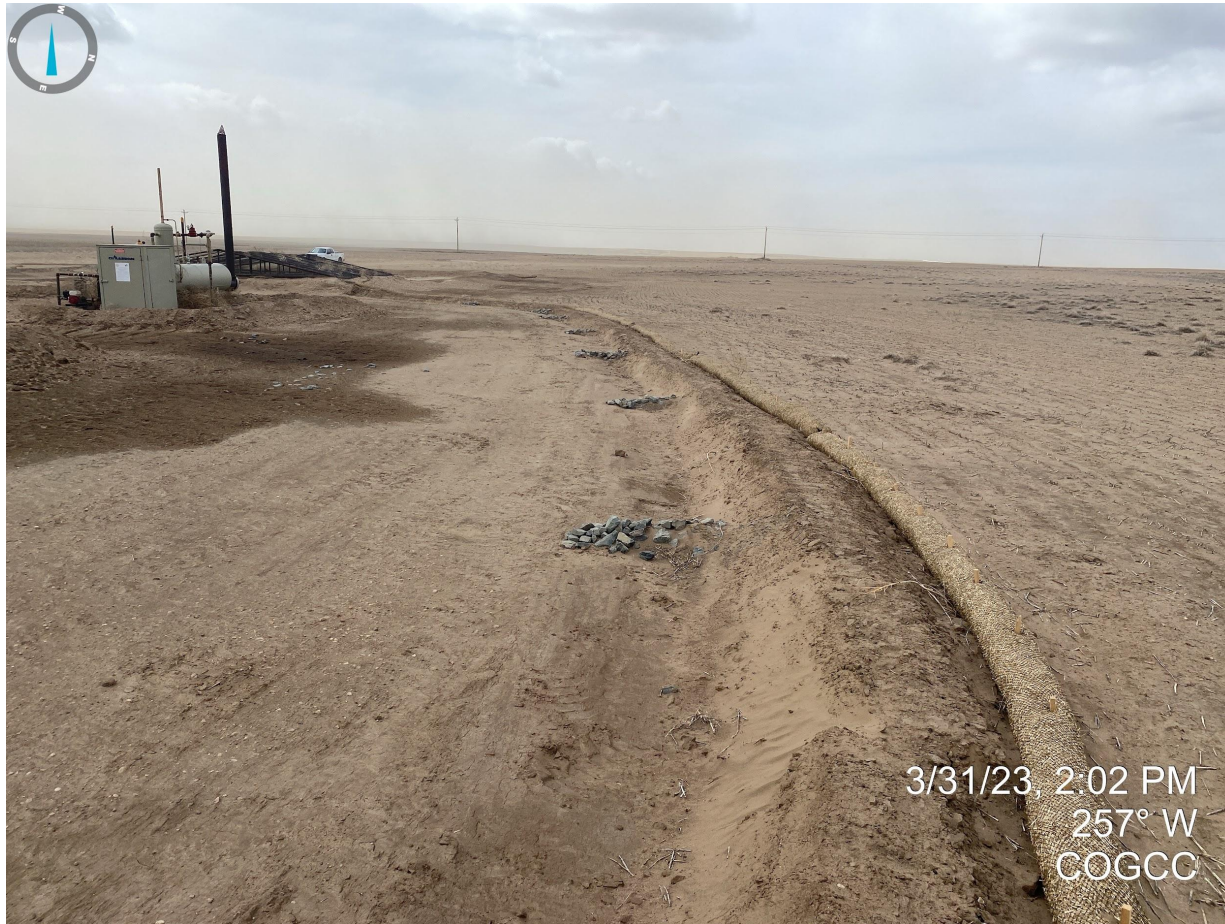
Photo 8. Berm and ditch BMPs appear to have been compacted and additional BMPs have been implemented (check dams within ditch and straw wattles placed on the exterior portion of the berms).

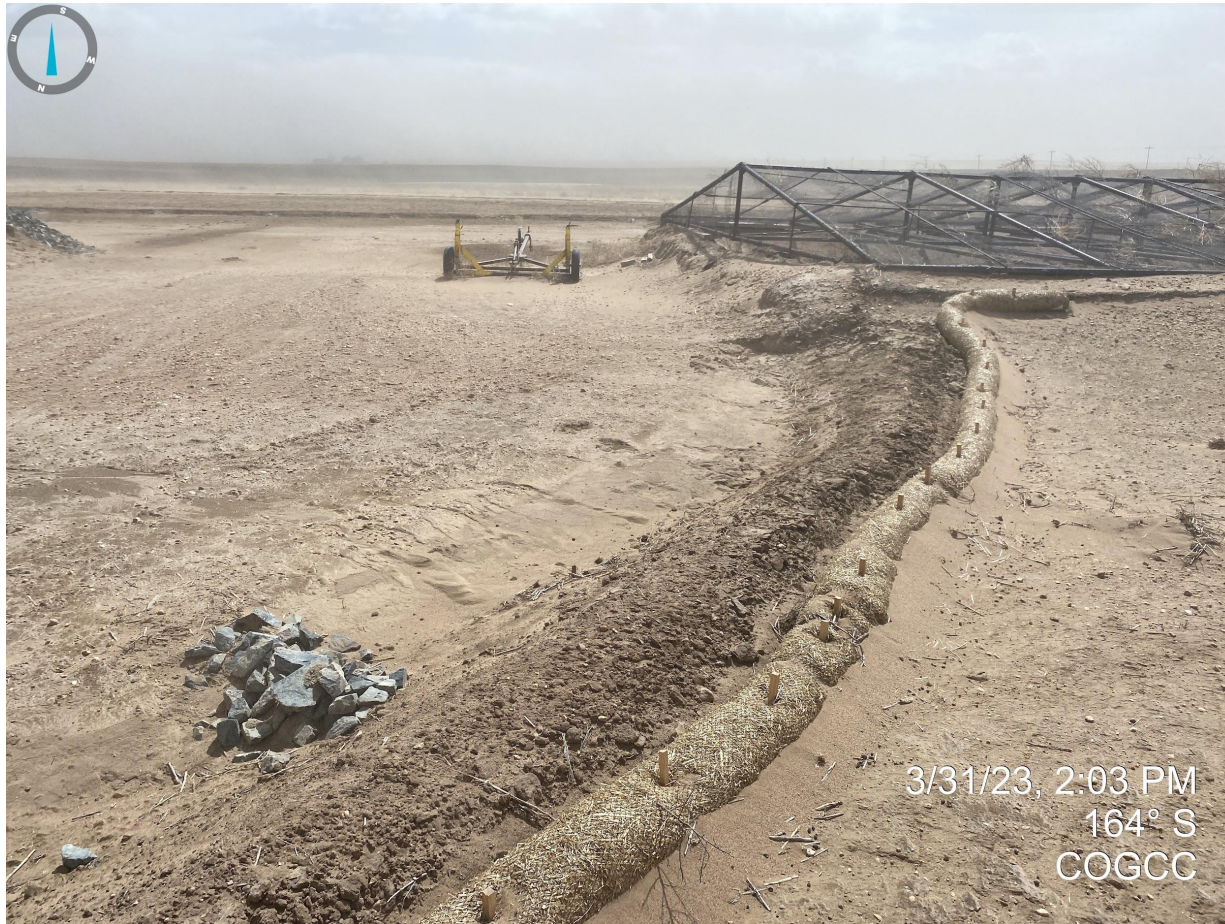
Photo 9. See comments in Photo 8.

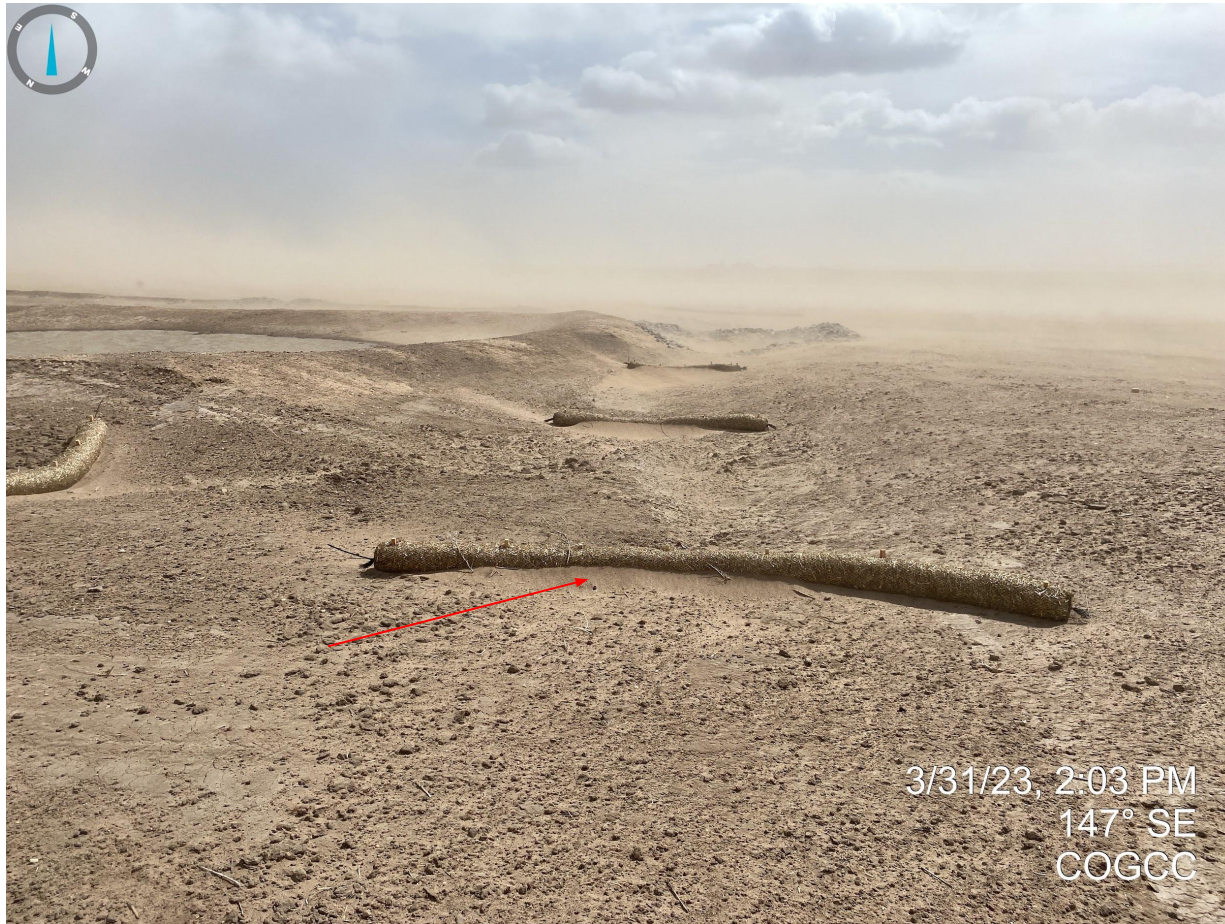
Photo 10. Facing southeast from the northwest corner of the location. Straw wattles will need to be maintained to ensure they are properly functioning in the future.

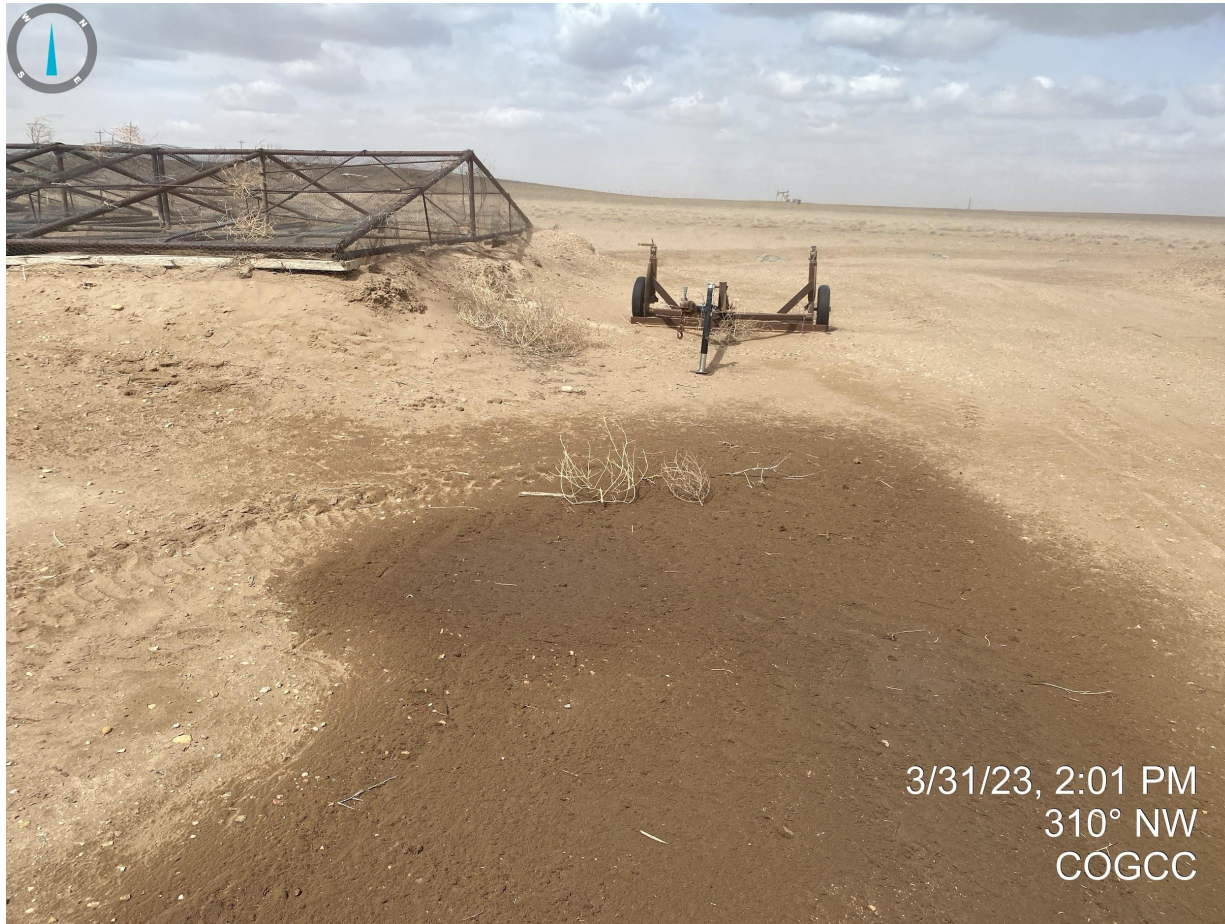
Photo 11. Road maintainer/drag observed being stored on location and will need to be removed. As a reminder, locations cannot be used to store equipment.
