Construction and Stormwater Inspection

Date: 04/03/2023

Operator: NAVEX RESOURCES LLC - 10360

Inspection Photos
Location Name: Travis 1-10
Location ID: 483129

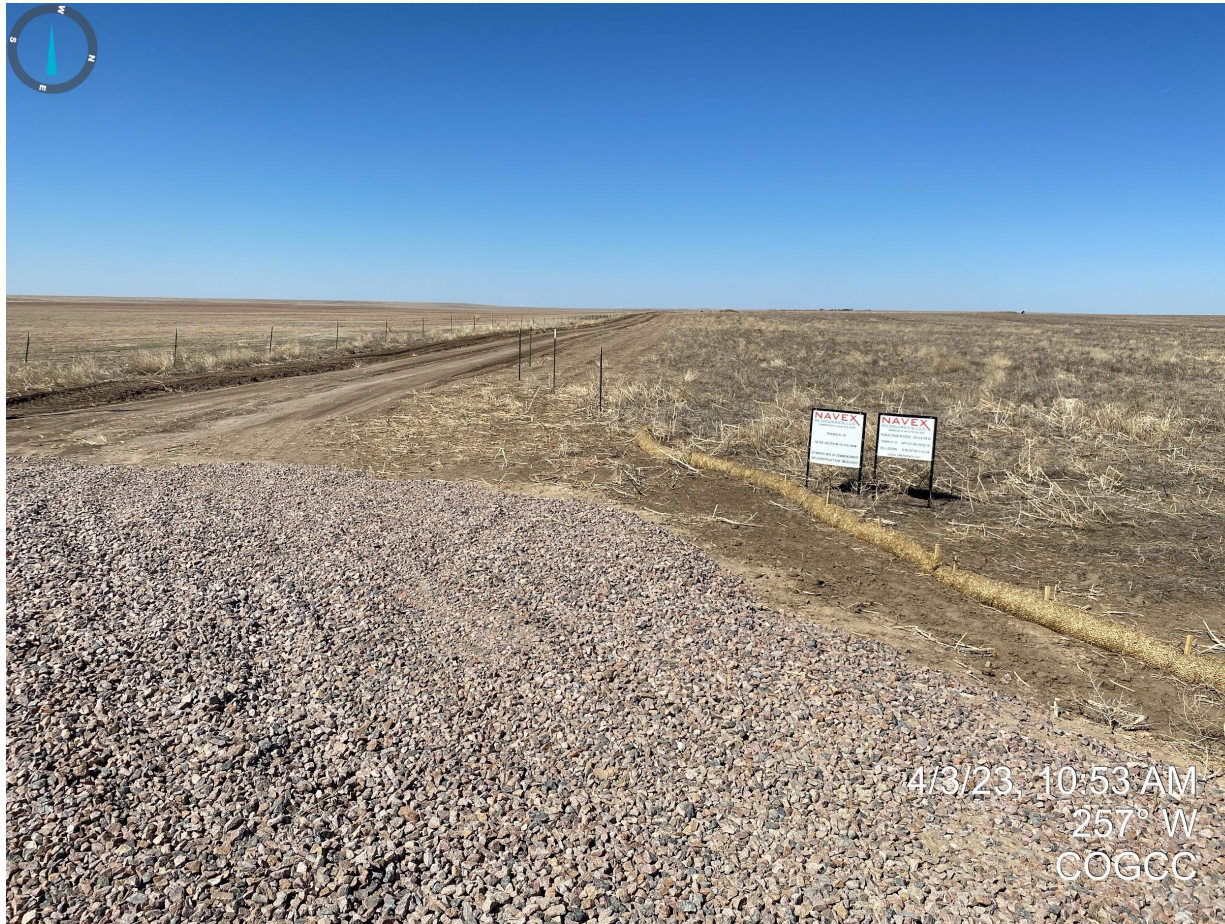
Photo 1. Location signs and approved Form 2A posted at the entrance to the location.

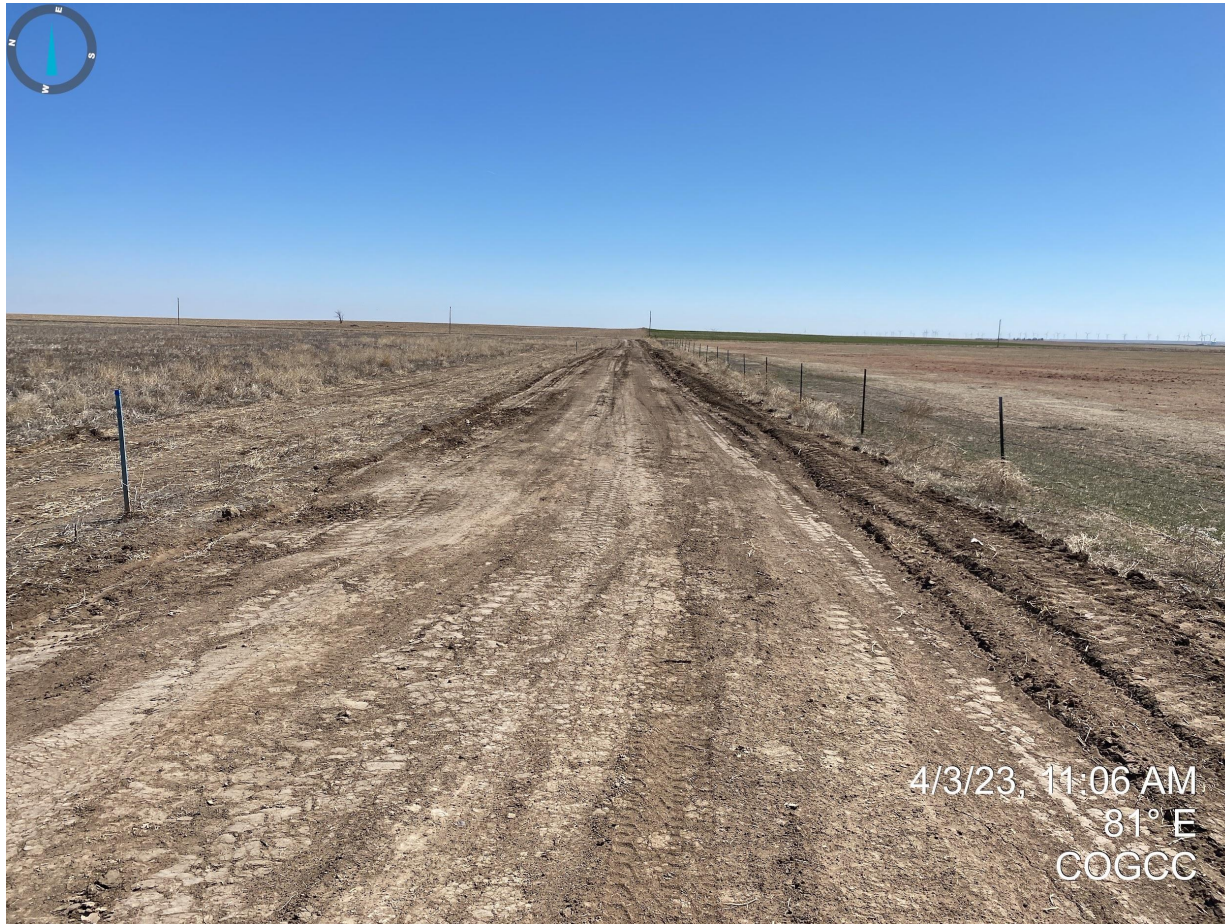
Photo 2. Facing east along the access road. It does not appear that all of the topsoil has been salvaged from the access road. See Photos 3 & 4 for additional information.

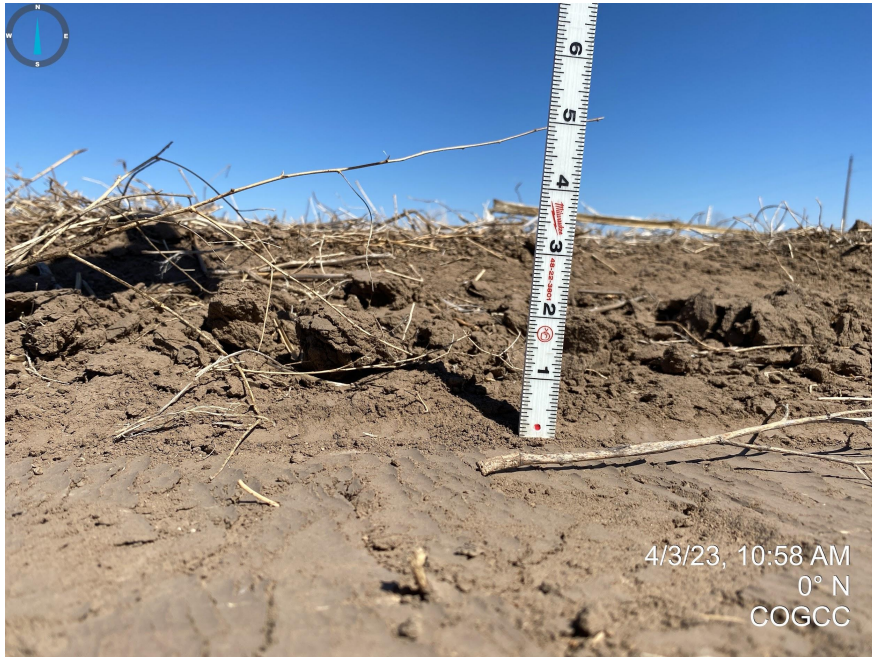
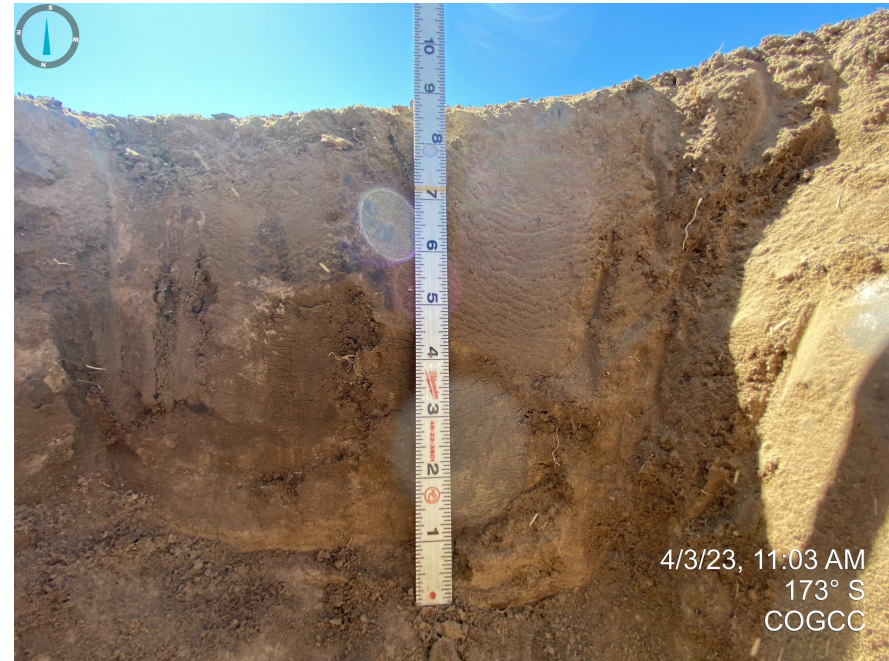
Photos 3 & 4. Close up photos of topsoil salvaged from the access road. Left photo illustrates approximately 3" of topsoil have been salvaged from the access road portion. Right photo depicts pothole from access road illustrating approximately 6" of topsoil remain that will need to be salvaged.

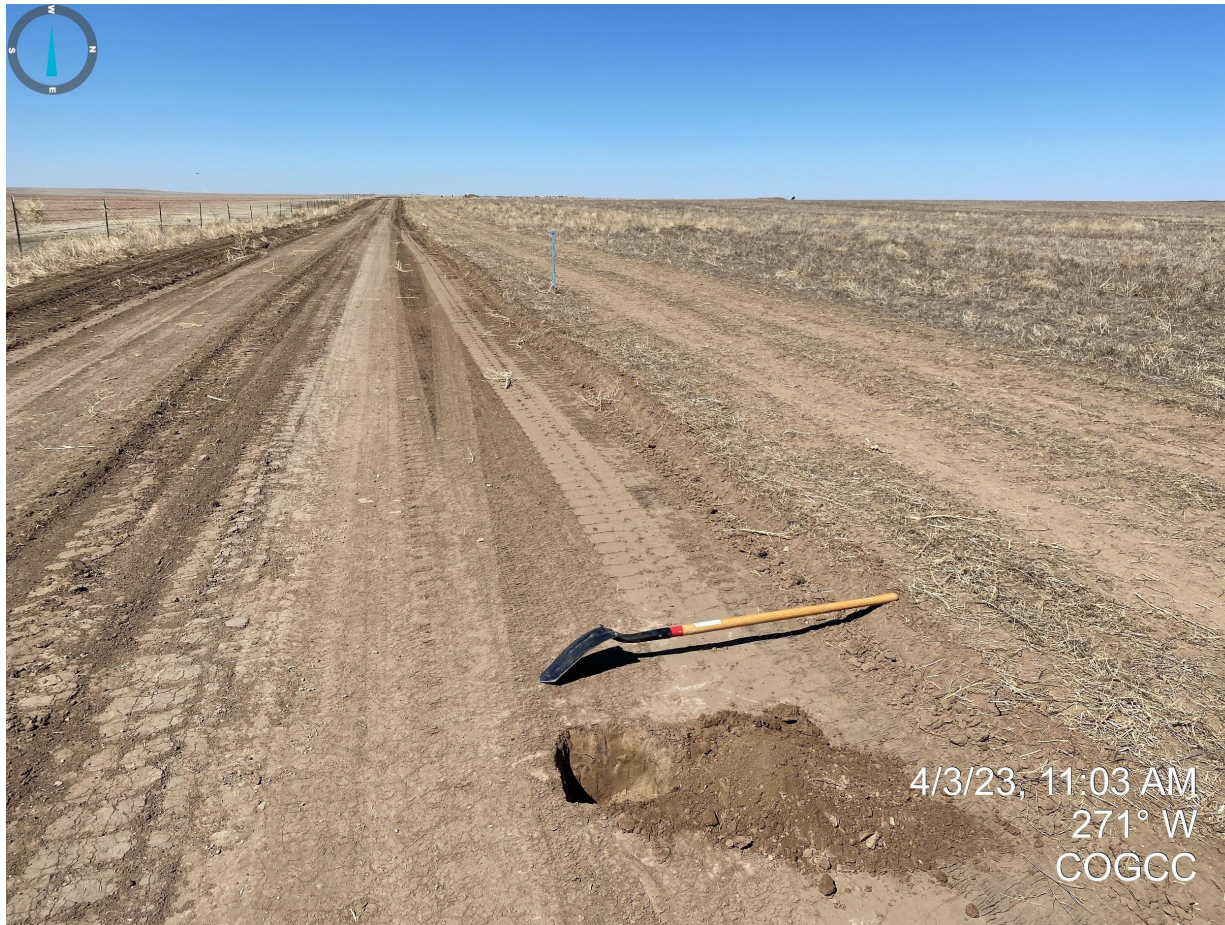
Photo 5. Overview of pothole from access road.

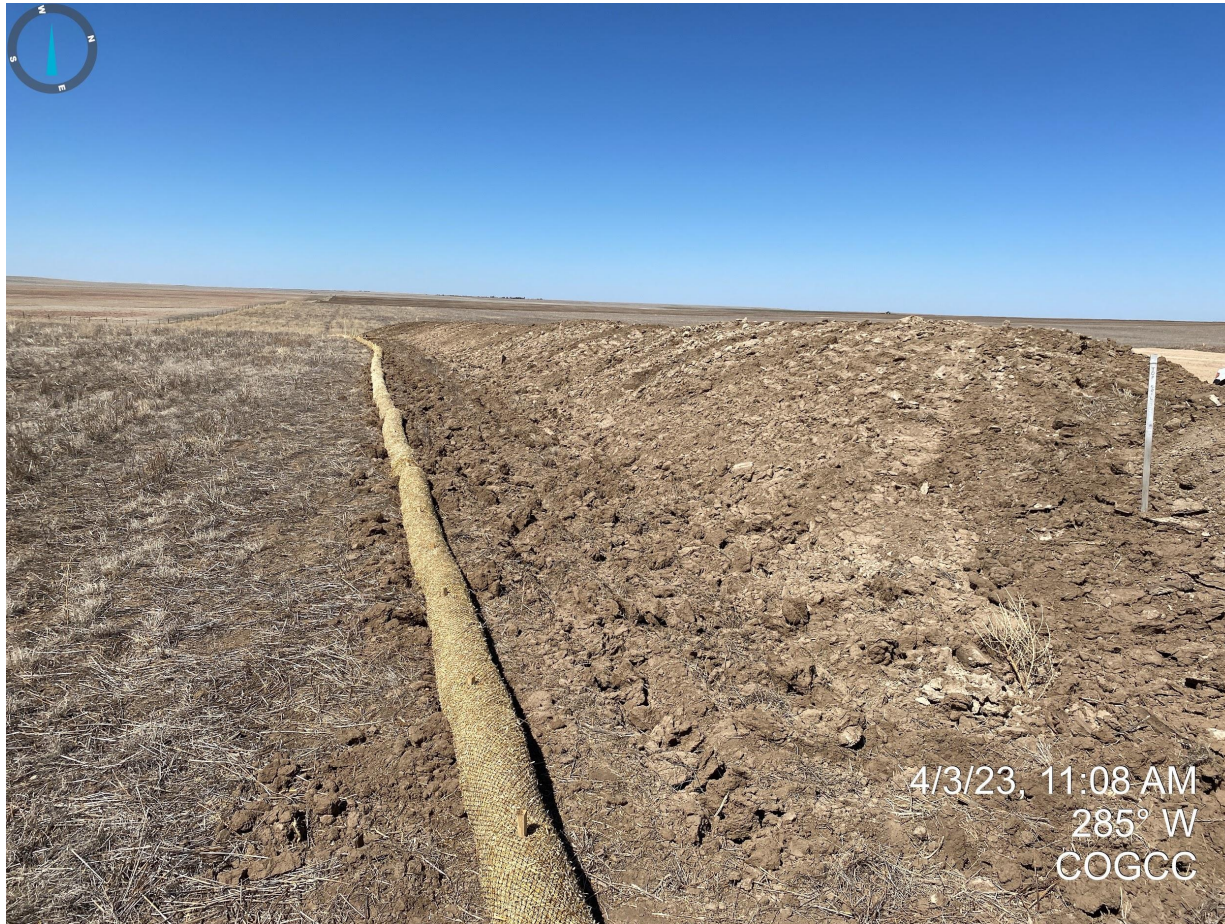
Photo 6. Facing west from the southeast corner of the location. Photo illustrates that the topsoil stockpiles have been temporarily stabilized with equipment tracking; longer term stabilization techniques should be implemented. Additionally, temporary stormwater BMPs (scarifying and straw wattles) observed around the entire pad.

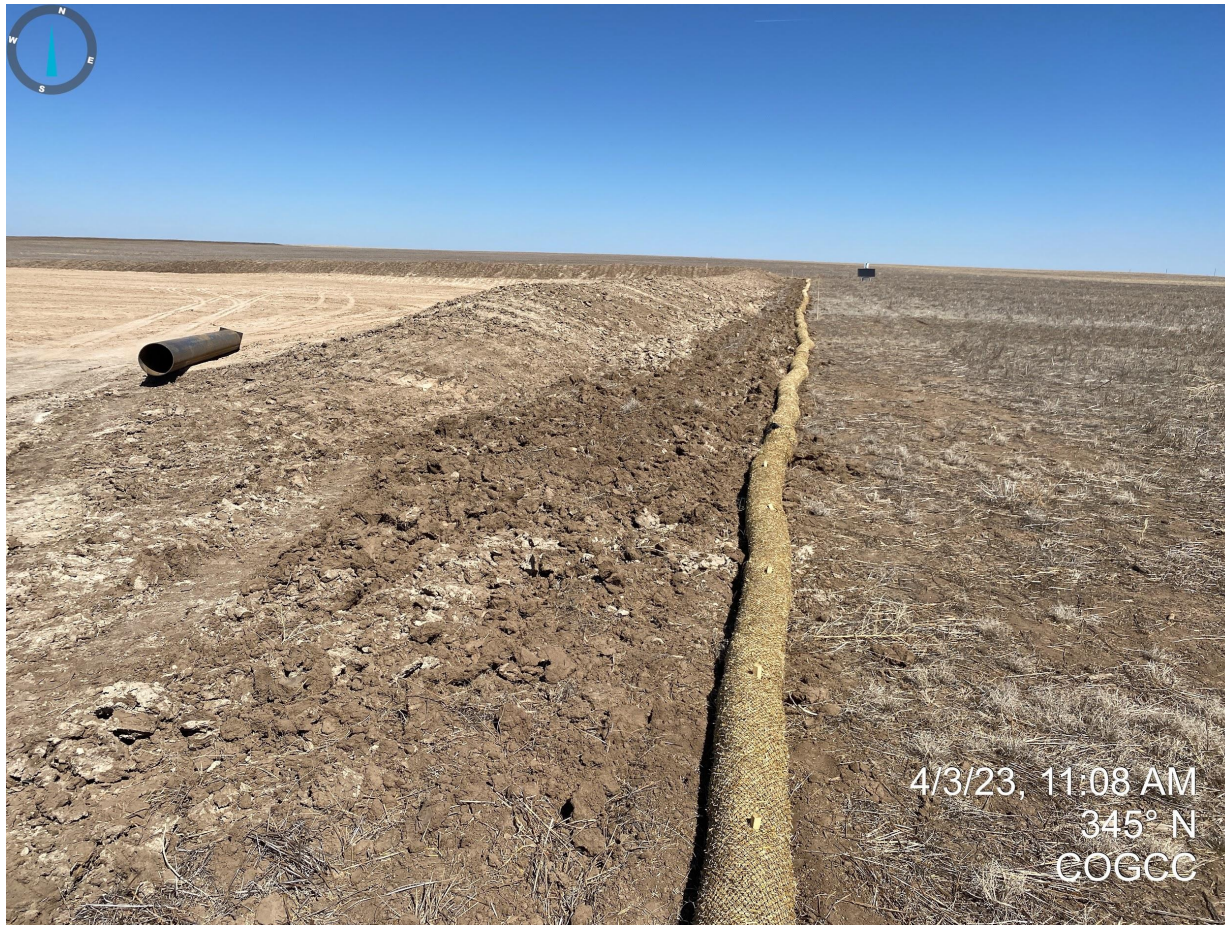
Photo 7. Taken from the southeast corner; see comments in Photo 6.

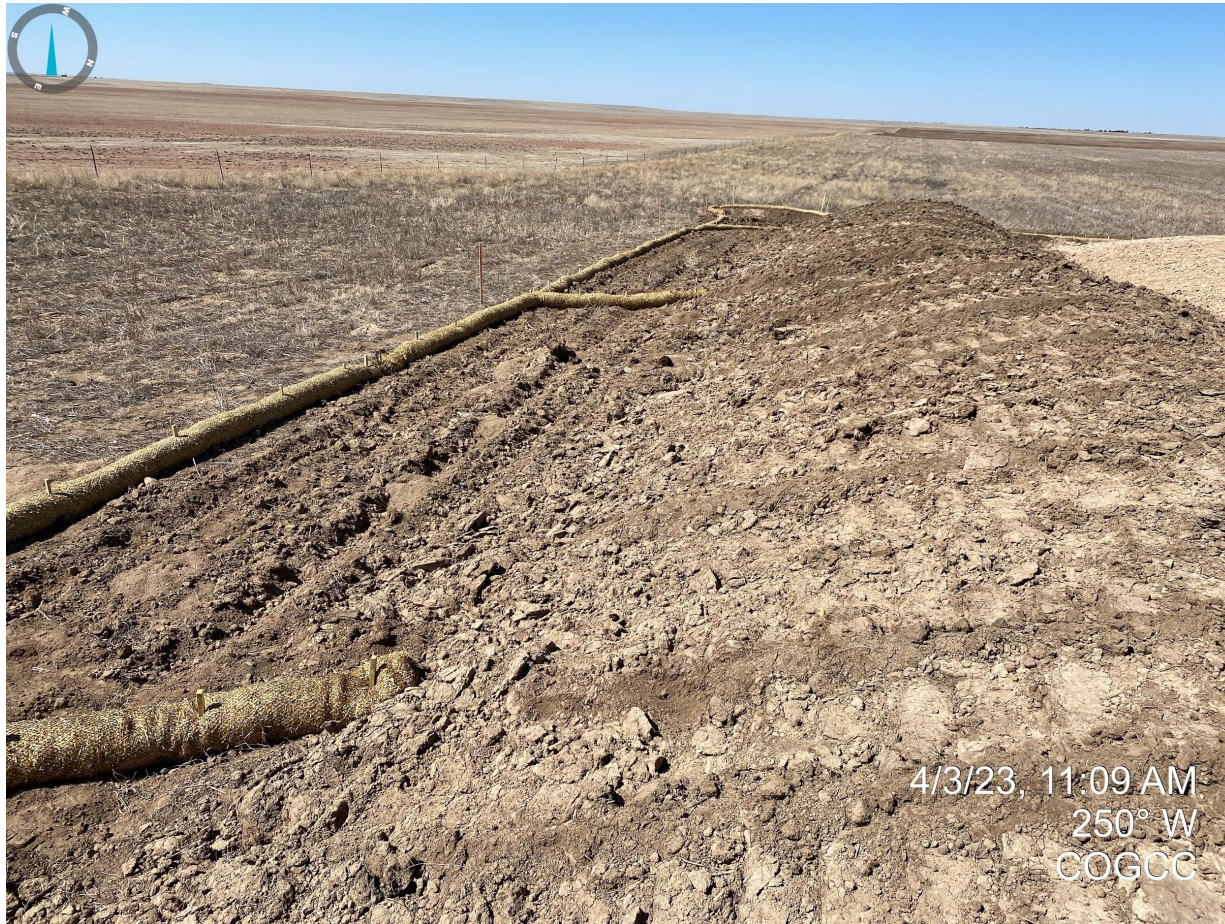
Photo 8. Facing west from the southern portion; see comments in Photo 6.

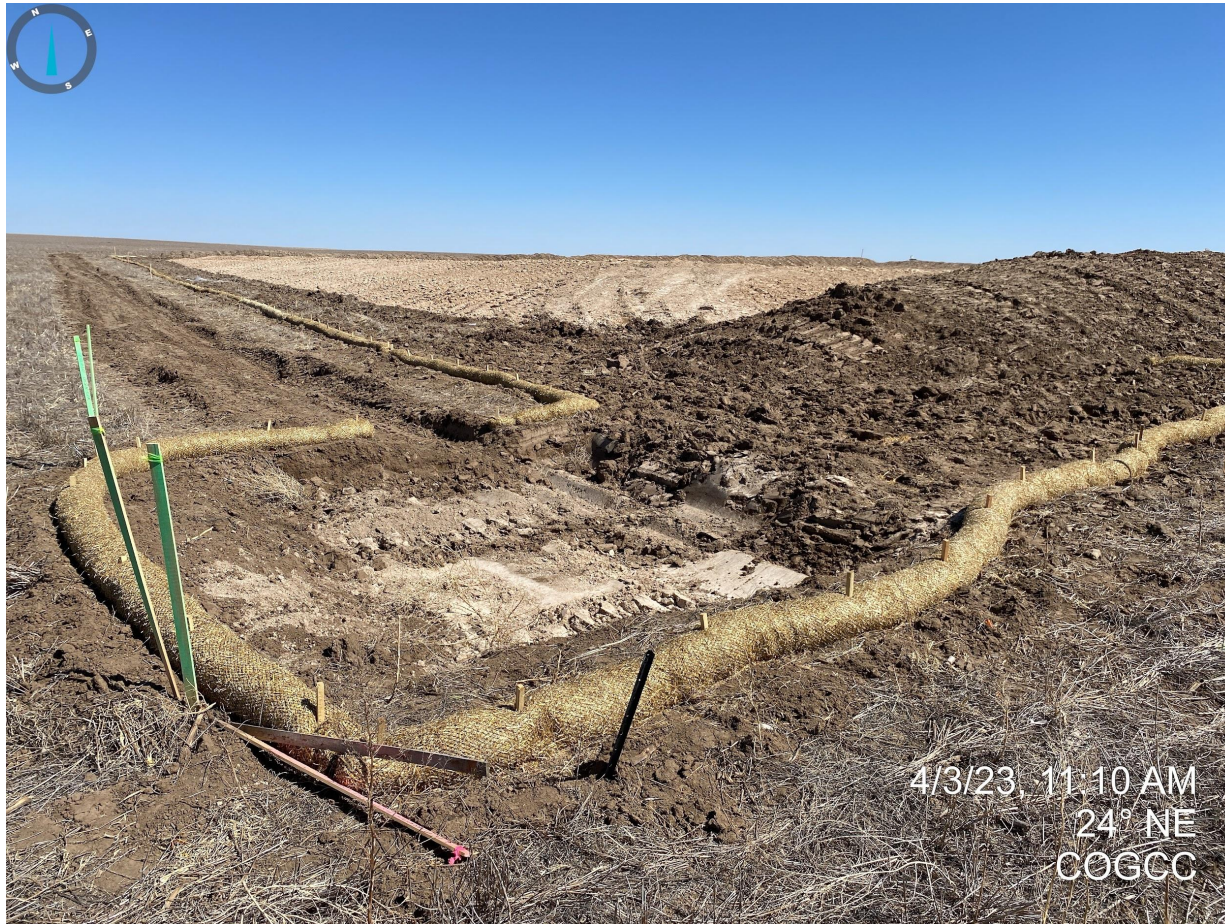
Photo 9. Facing northeast from the southwest corner; see comments in Photo 6.

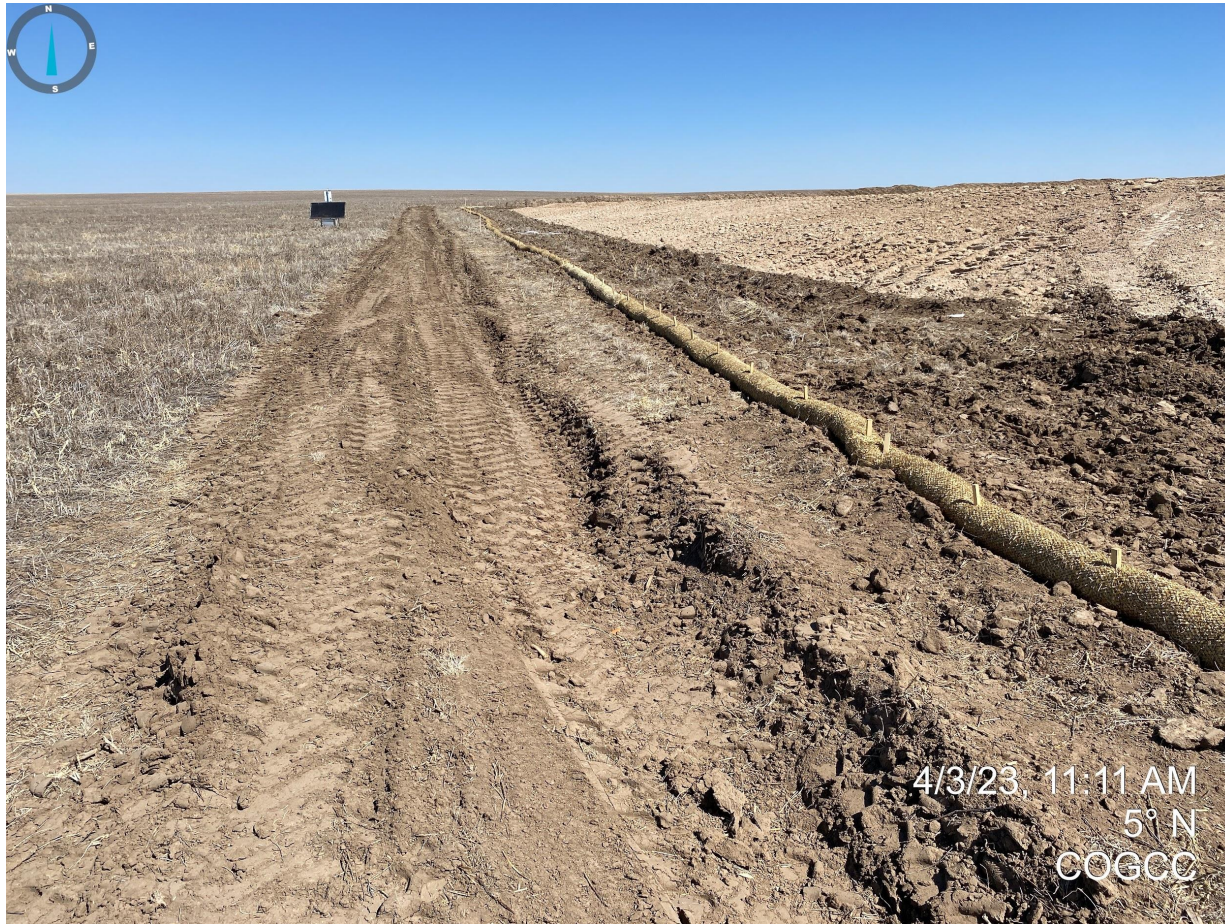
Photo 10. Western stormwater ditch BMP: see comments in Photo 6.

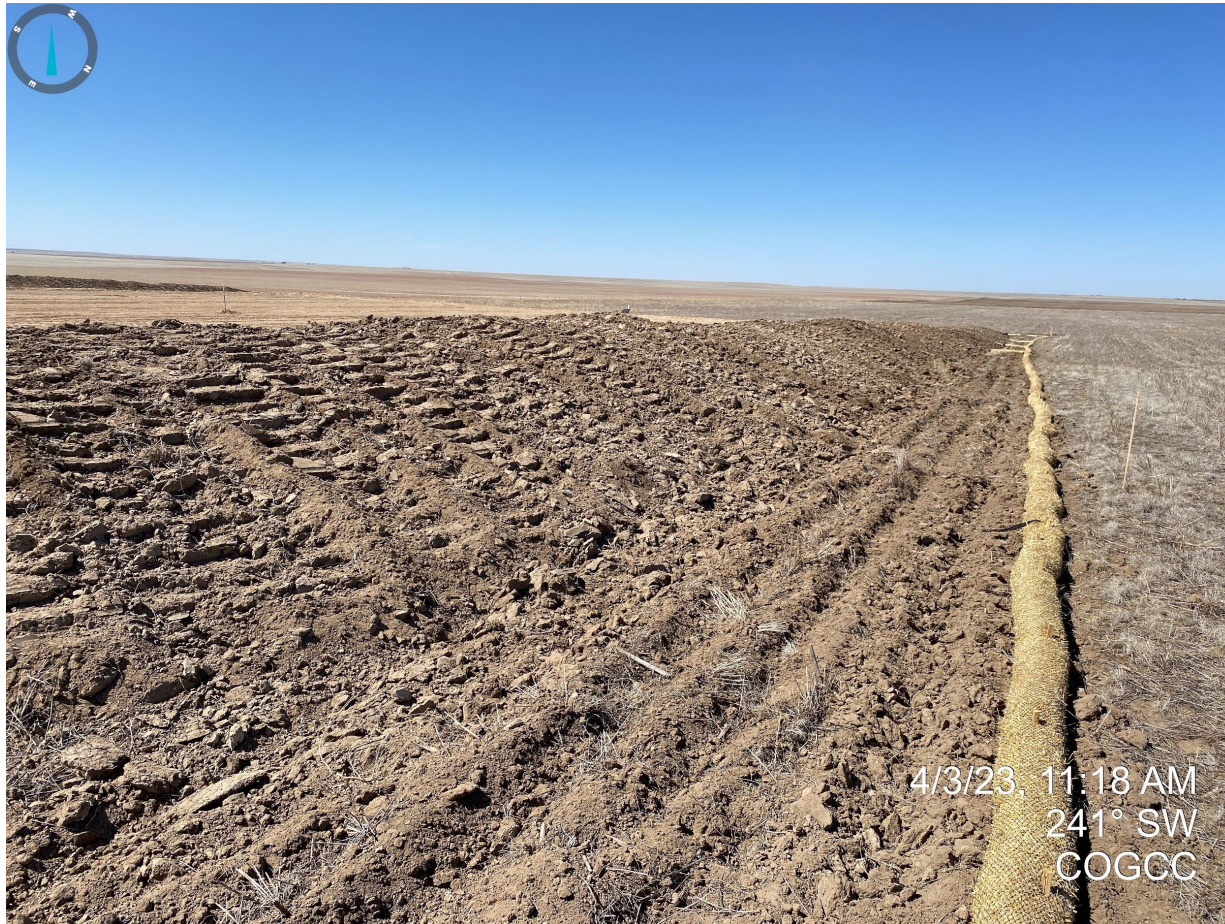
Photo 11. Facing southwest from the northern portion; see comments in Photo 6.

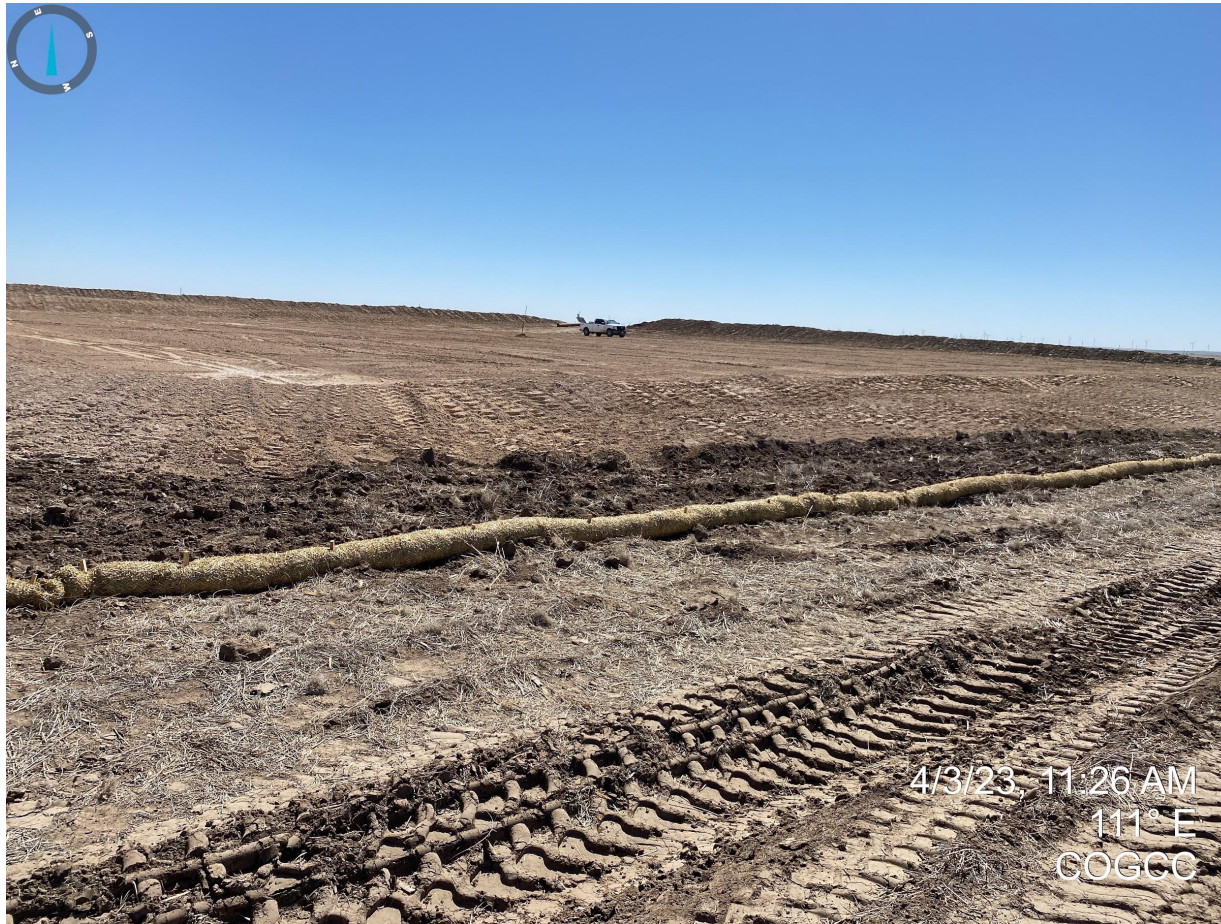
Photo 12. Facing east towards the drilling pad. Photo illustrates cut and fill slopes appear to be stabilized with stormwater BMPs implemented at the western edge of the disturbance area; scarifying, straw wattles, and ditch and berm pictured.

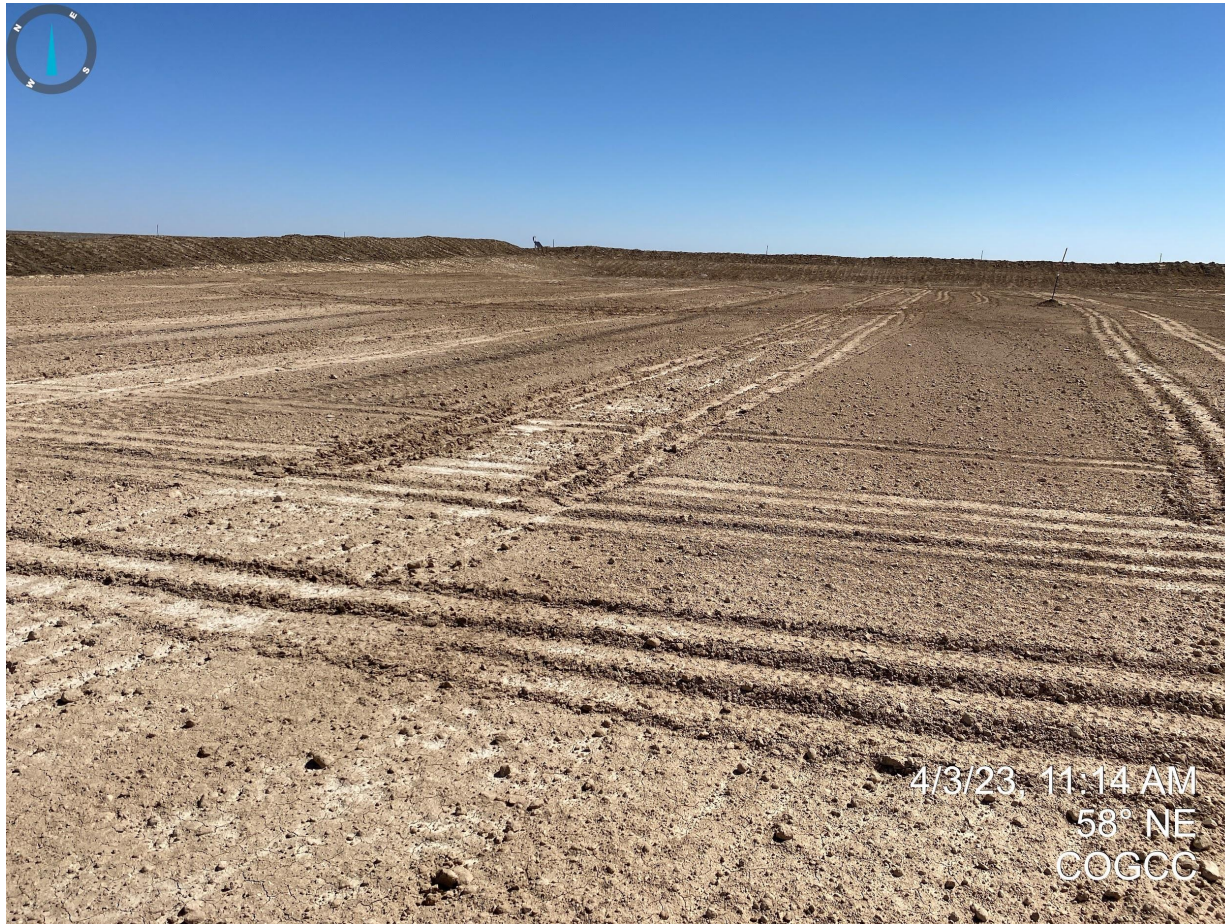
Photo 13. Overview of drilling pad.
