Construction and Stormwater Inspection

Operator: NAVEX RESOURCES LLC - 10360

Location ID: 483130

Inspection Photos
Location Name: Pfaffly 1-12
Location ID: 483130

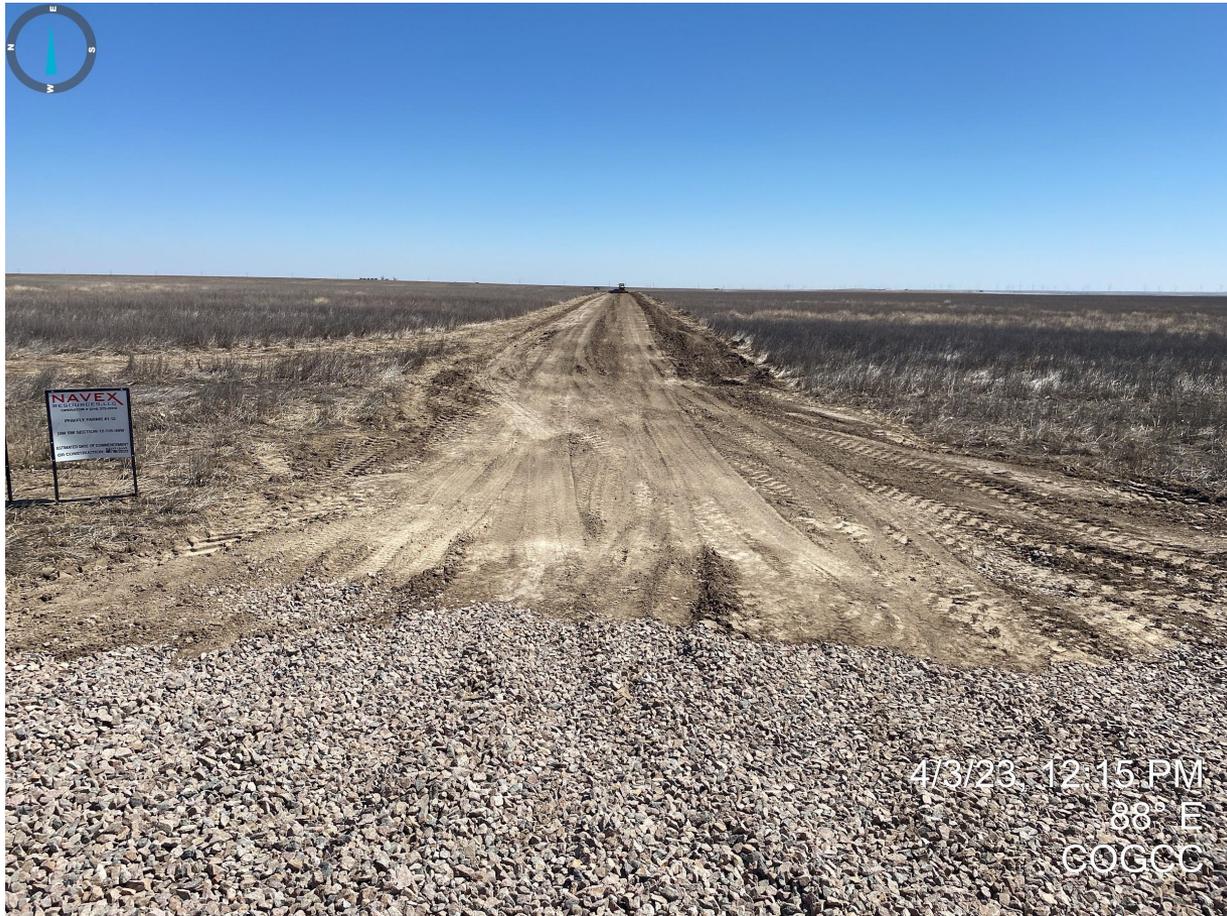
Photo 1. Taken from the location entrance. Location signs and an approved copy of the Form 2A posted on location. Also pictured, vehicle track out pad.

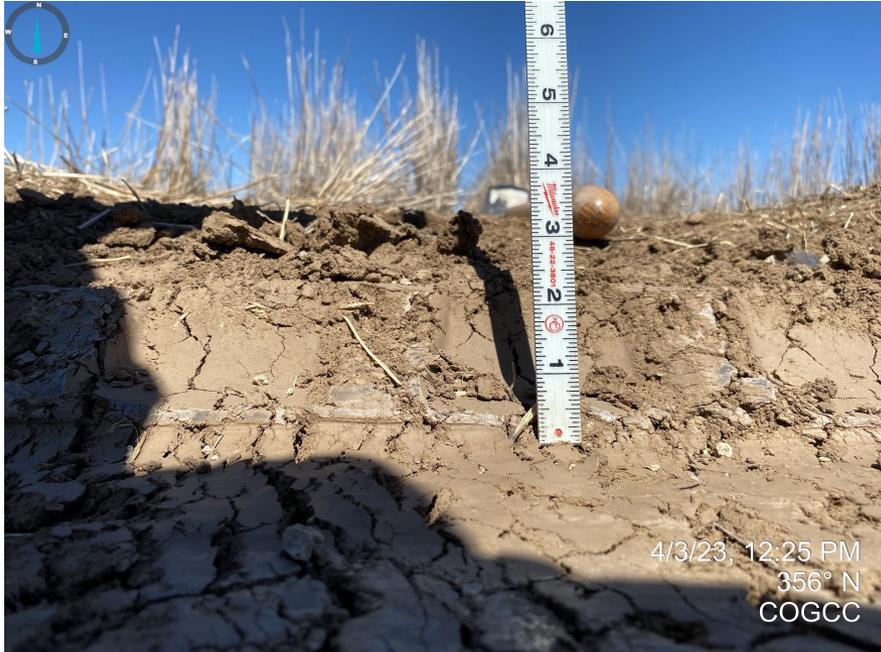
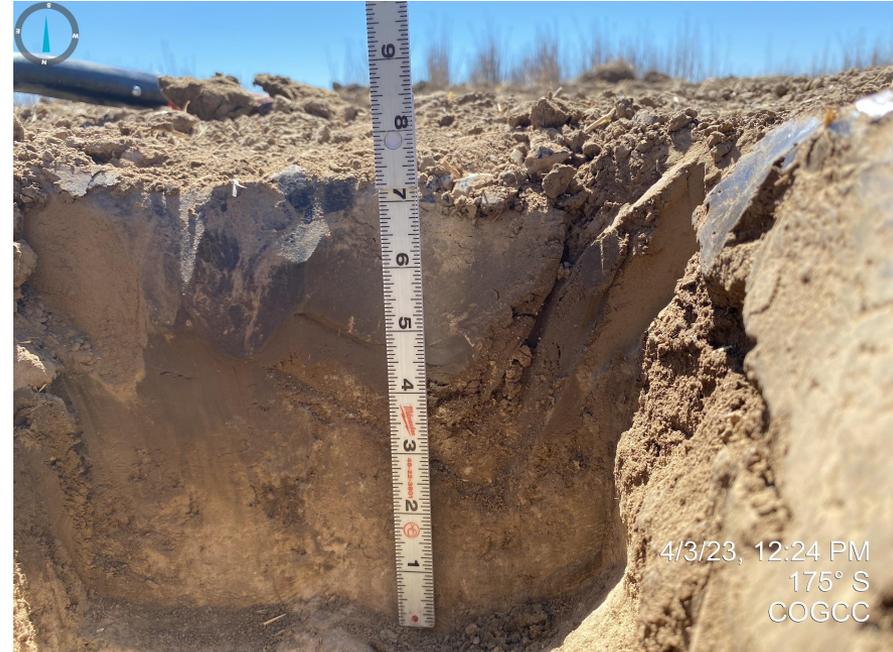
Photos 2 & 3. Close up photos of soil pothole taken from access road. Left photo illustrates that approximately 3” of topsoil were salvaged from the access road. Right photo depicts approximately 5” of topsoil remains on the access road and will have to be salvaged to be in compliance with Rule 1002.b.

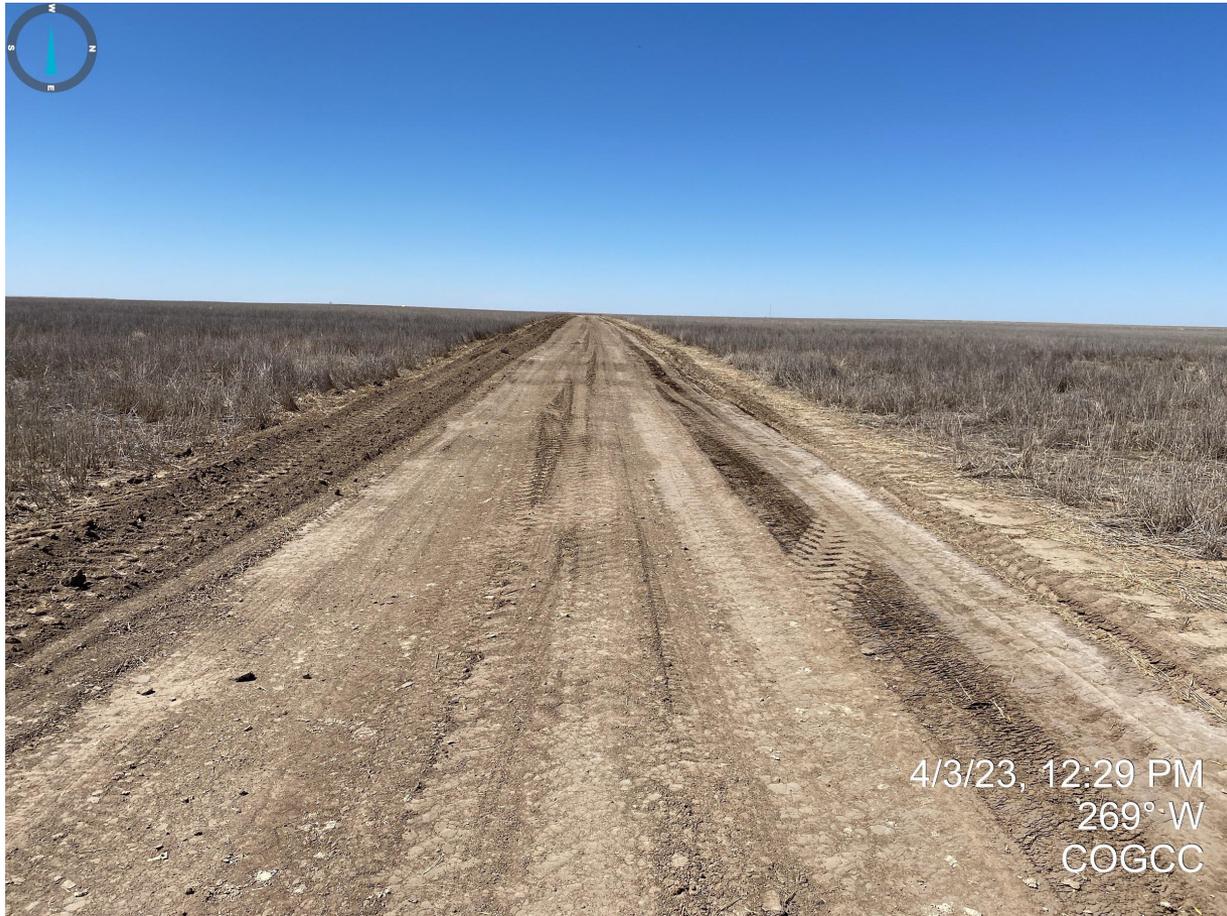
Photo 4. Overview of access road, illustrating that approximately 3" of topsoil was salvaged and stored on the southern side of the road.

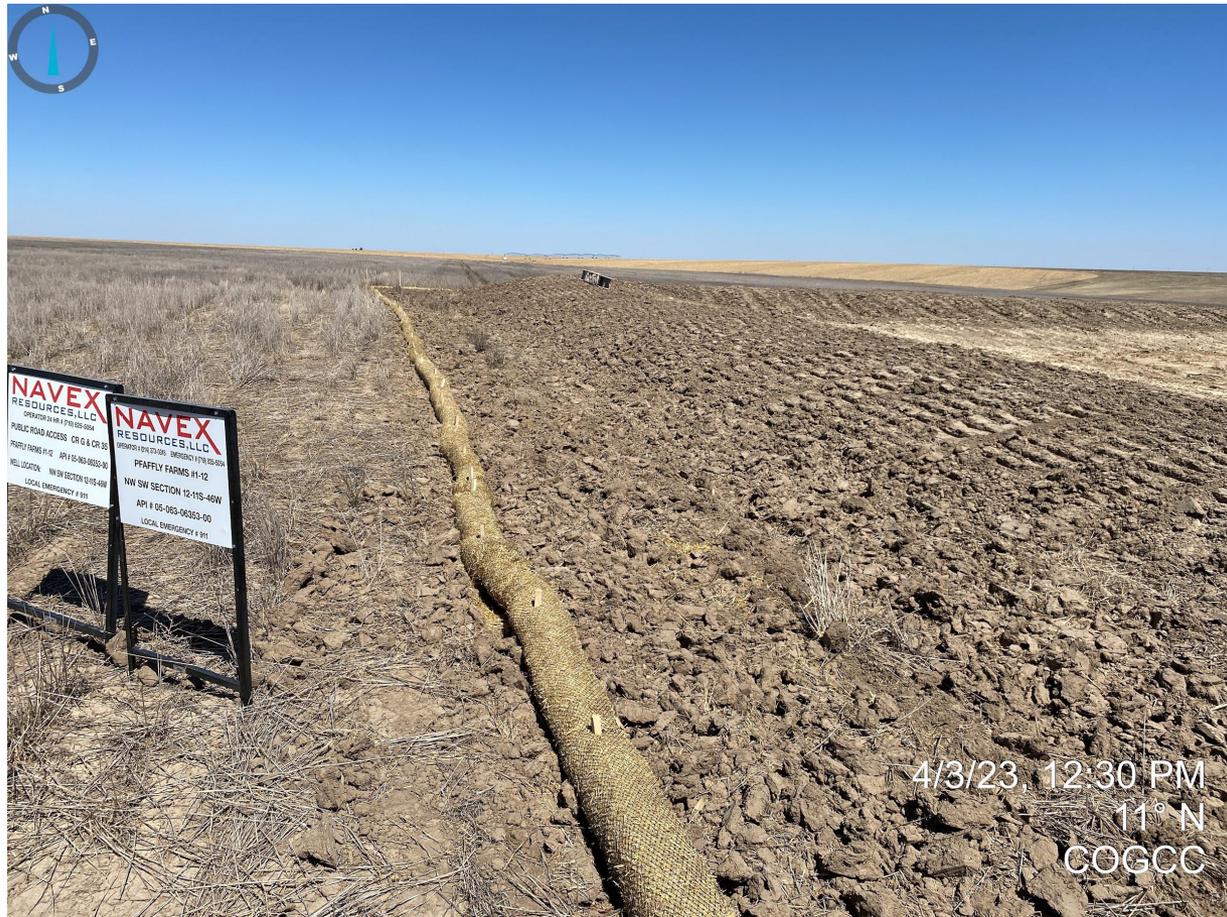
Photo 5. Facing north near the access road/location entrance. Photo illustrates that temporary stormwater BMPs (scarifying and straw wattles) were implemented. Photo also illustrates topsoil stockpiles salvaged from the pad area have been temporarily stabilized with equipment tracking observed.

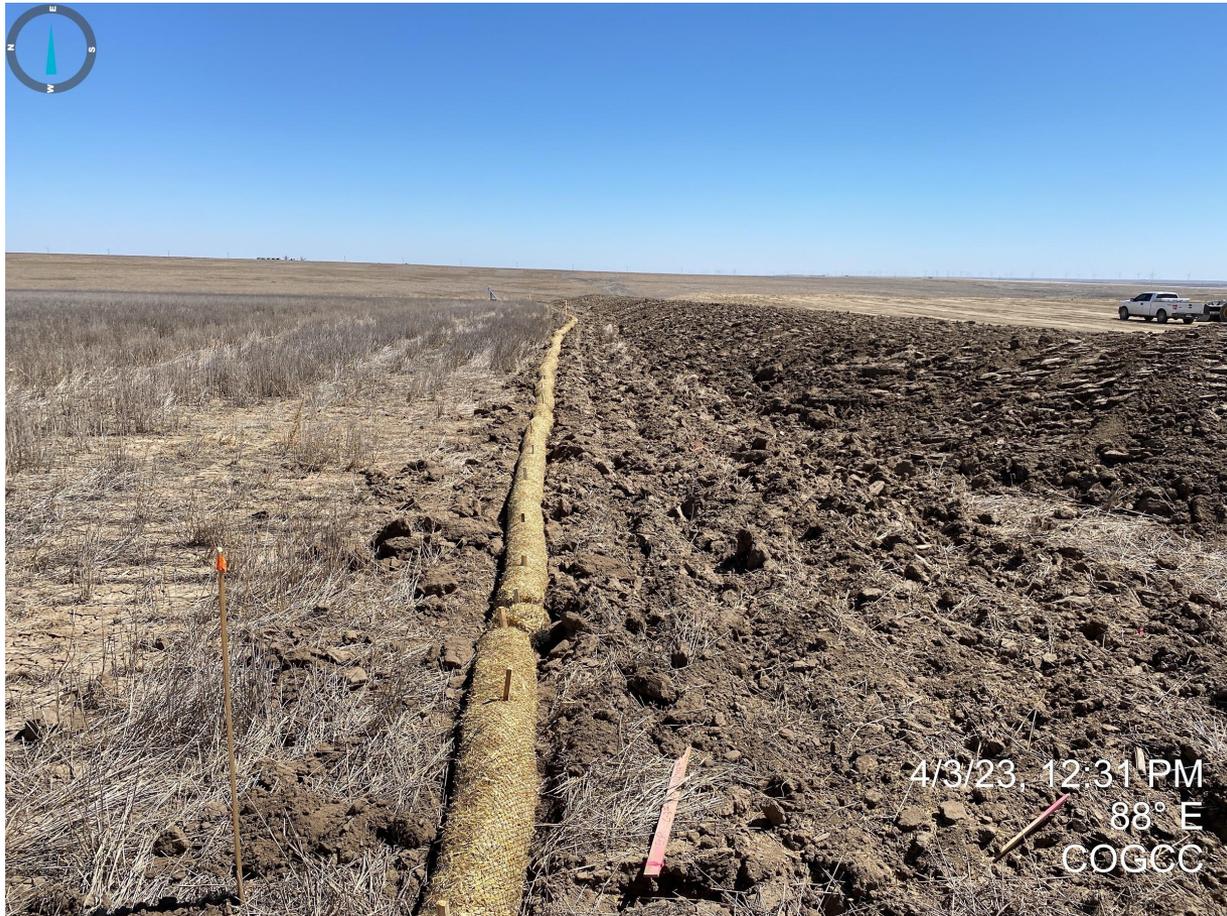
Photo 6. Facing east from the northwest corner; see comments in Photo 5.

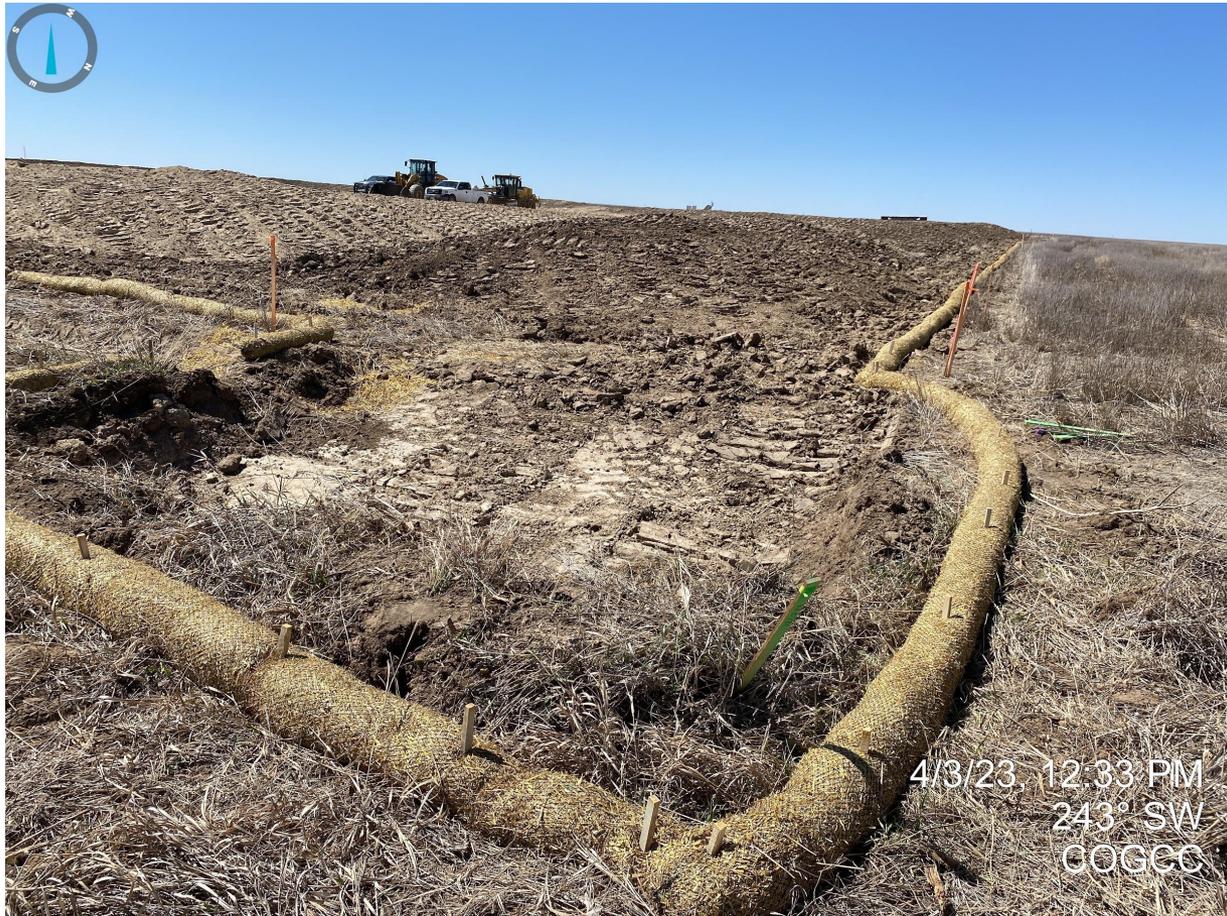
Photo 7. Facing southwest from the northeast corner; see comments in Photo 5.

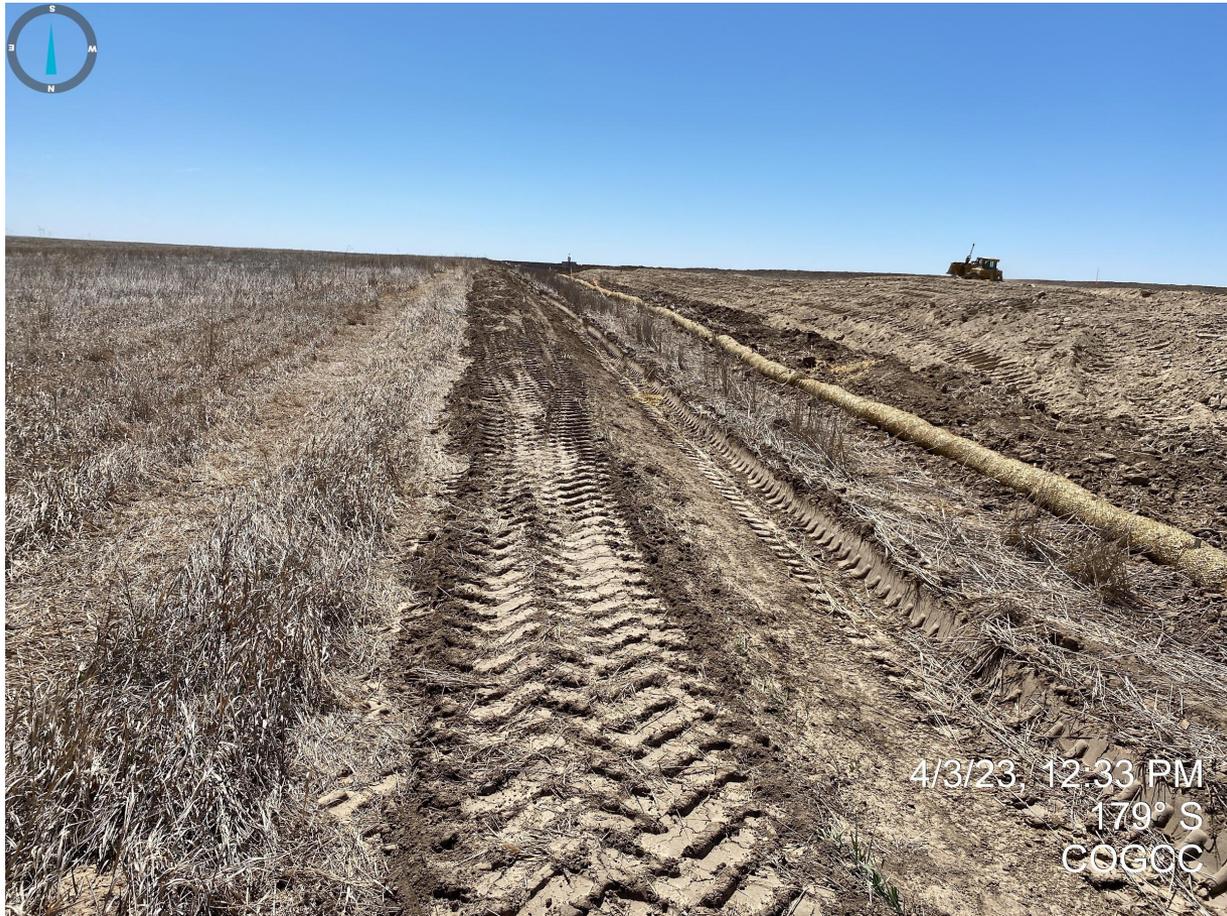
Photo 8. Facing south from the northeast corner. Photo illustrates stormwater ditch BMP on the downslope/eastern portion of the drilling pad.

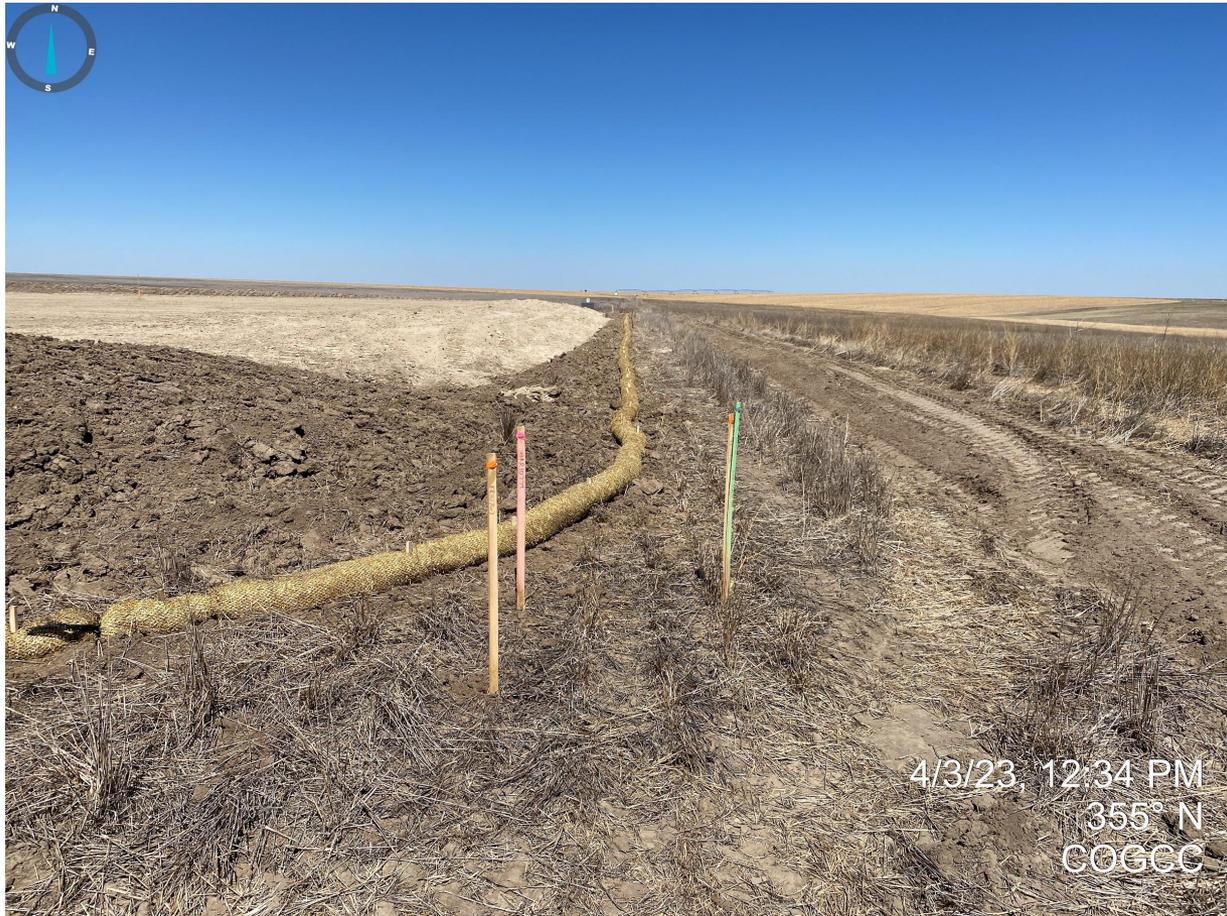
Photo 9. Facing north from the southeast corner of the location. See comments in Photo 5.

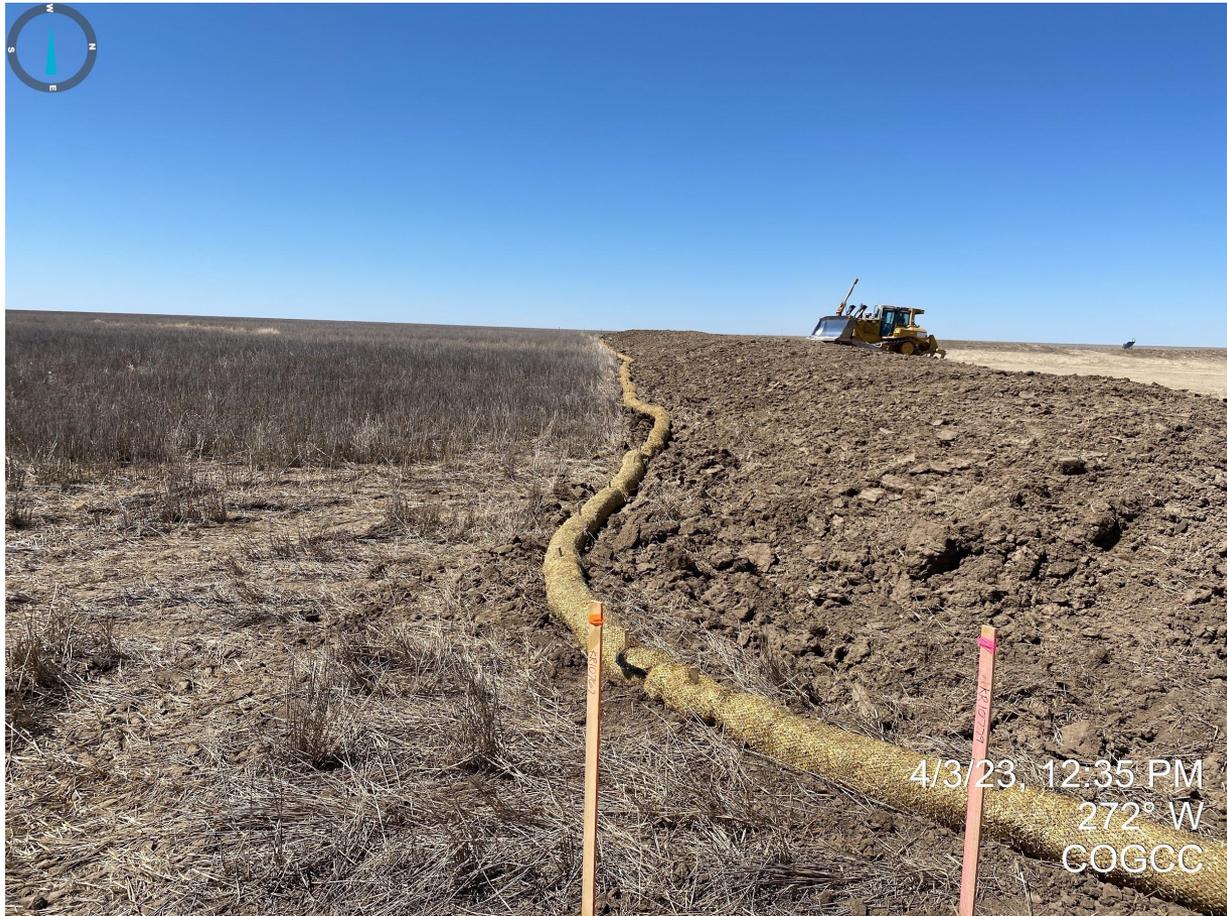
Photo 10. Facing west from the southeast corner; see comments in Photo 5.

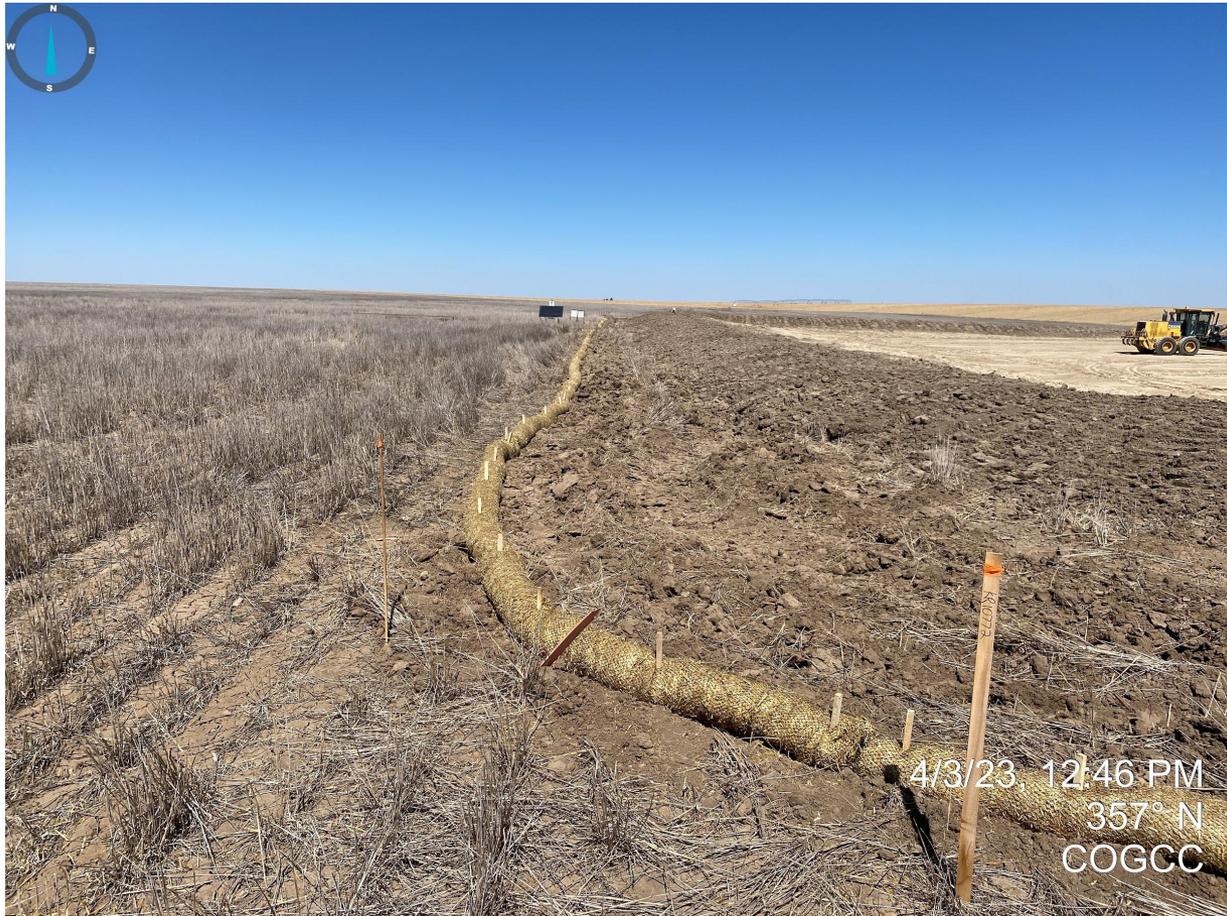
Photo 11. Facing north from the southwest corner, see comments in Photo 5.

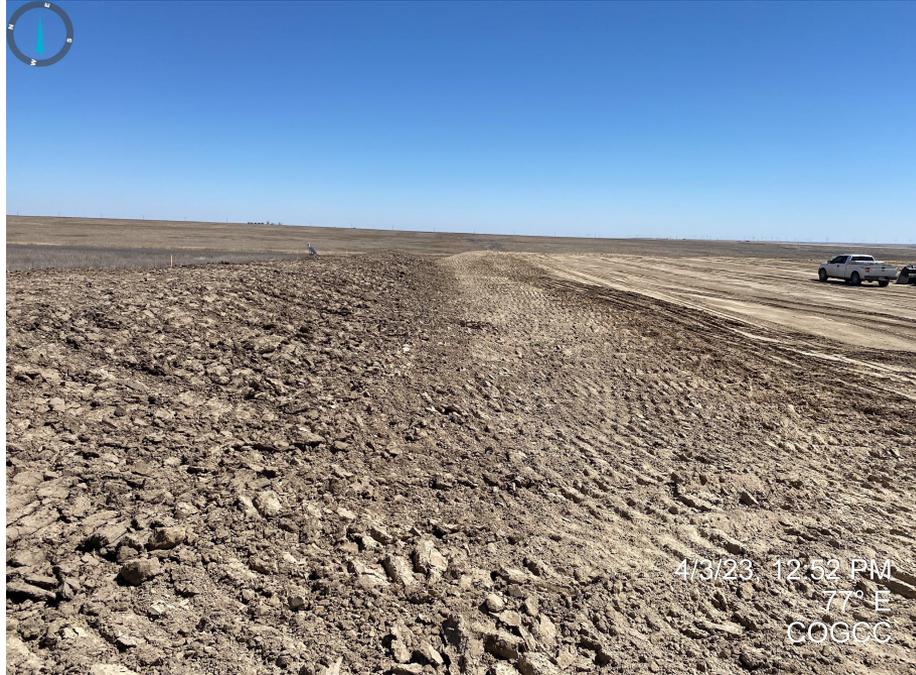
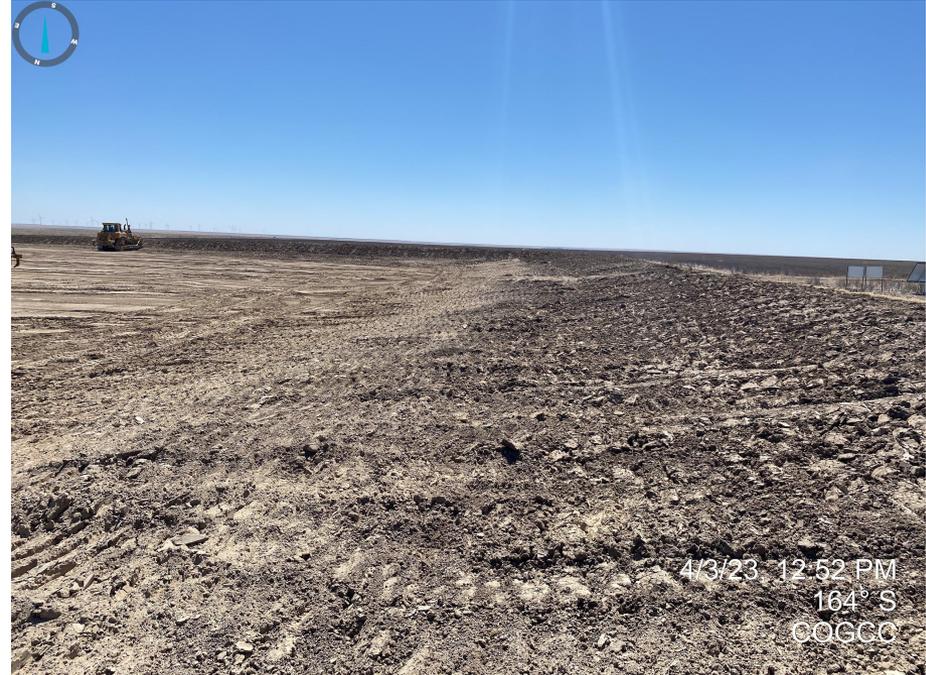
Photos 12 & 13. Overview of drilling pad from the northwest corner of the pad.
