Inspection Photos

Location Name: TEP ROCKY MOUNTAIN LLC CLOUGH RMV 93-21 Pad

Location ID: 324047

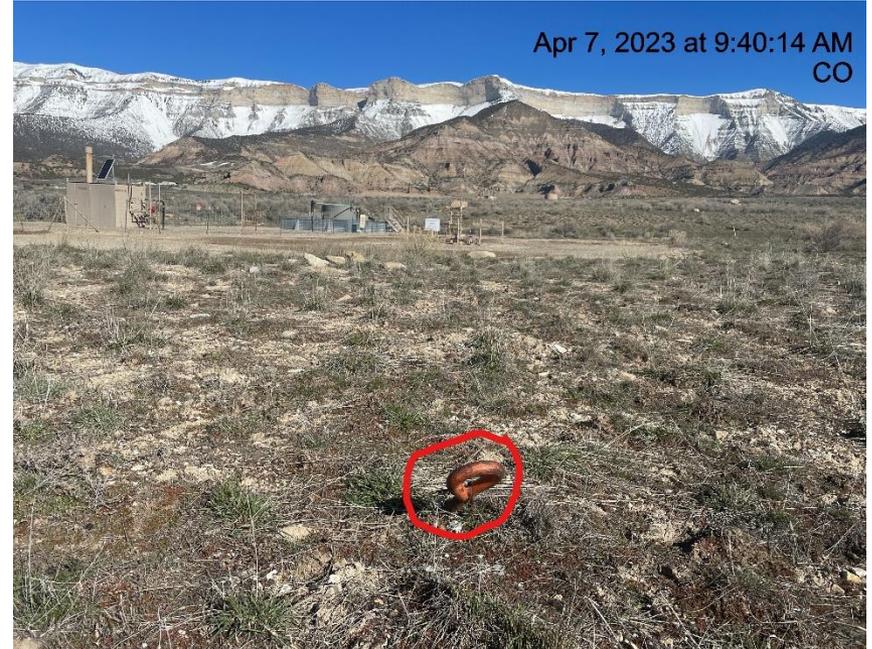
Photo # 4505 Unmarked deadman

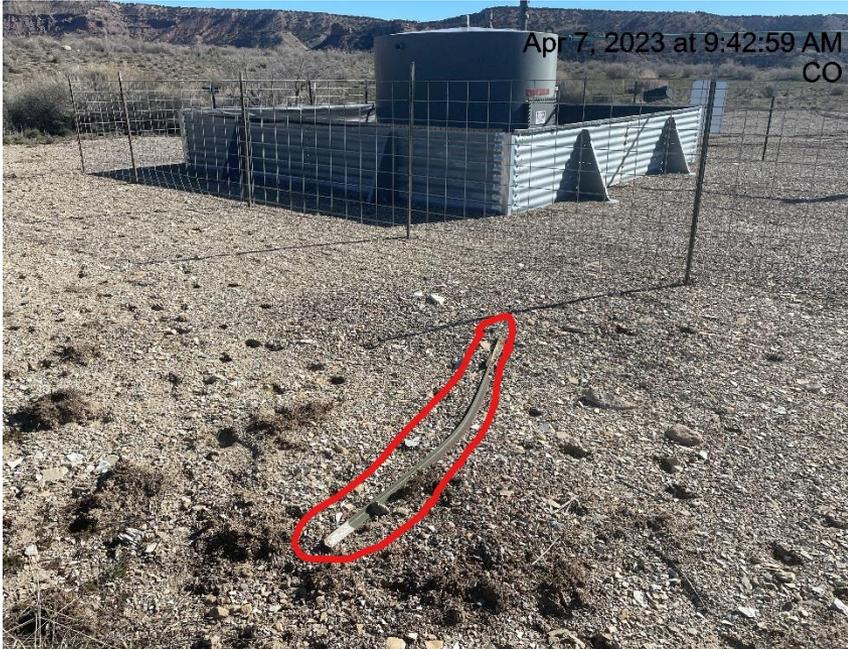
Photo # 4507 Debris

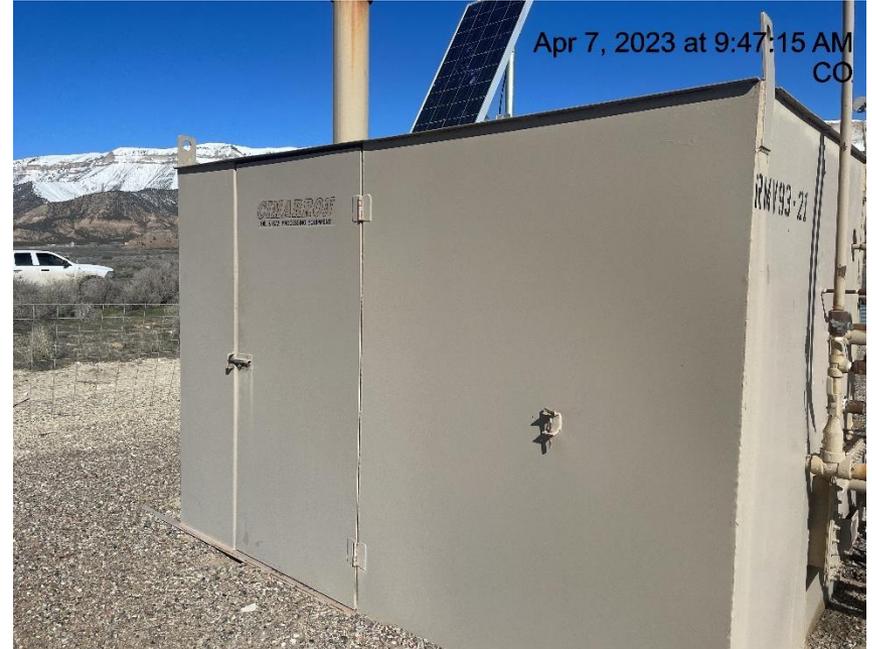
Photo # 4508 Meter calibration info not conspicuously posted

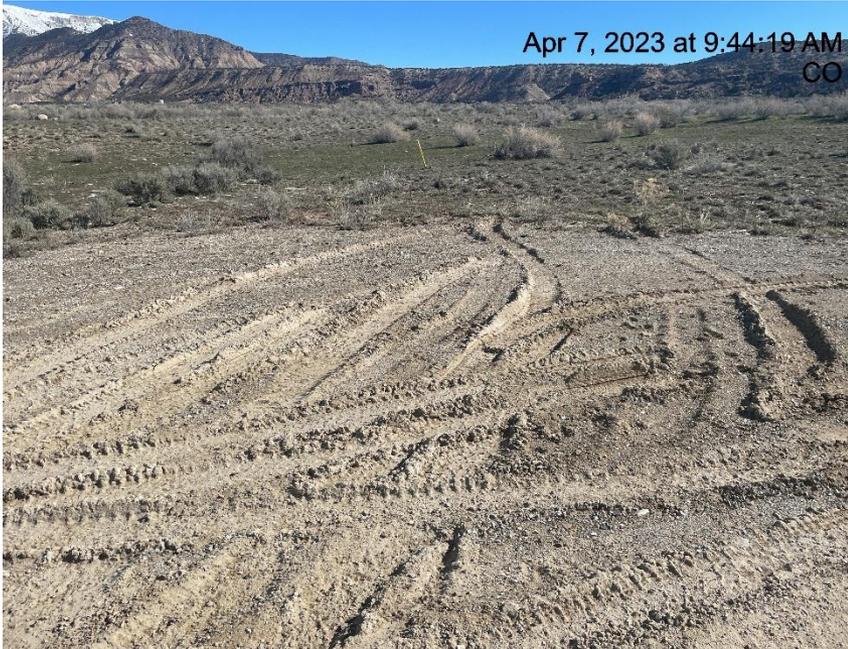
**Photo # 4509 Lack of stabilization/Insufficient tracking
BMP's**

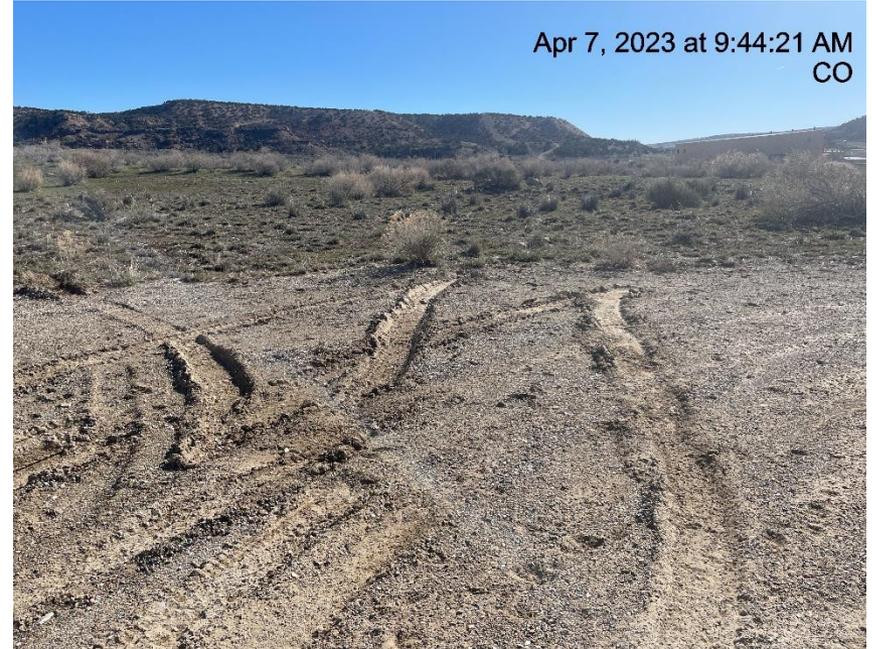
**Photo # 4510 Lack of stabilization/Insufficient tracking
BMP's**

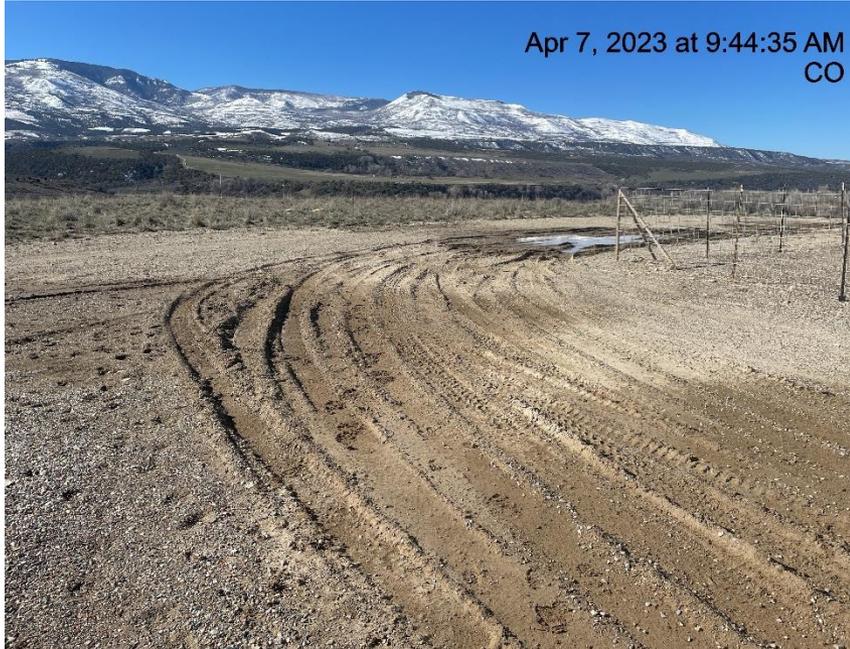
**Photo # 4511 Lack of stabilization/Insufficient tracking
BMP's**

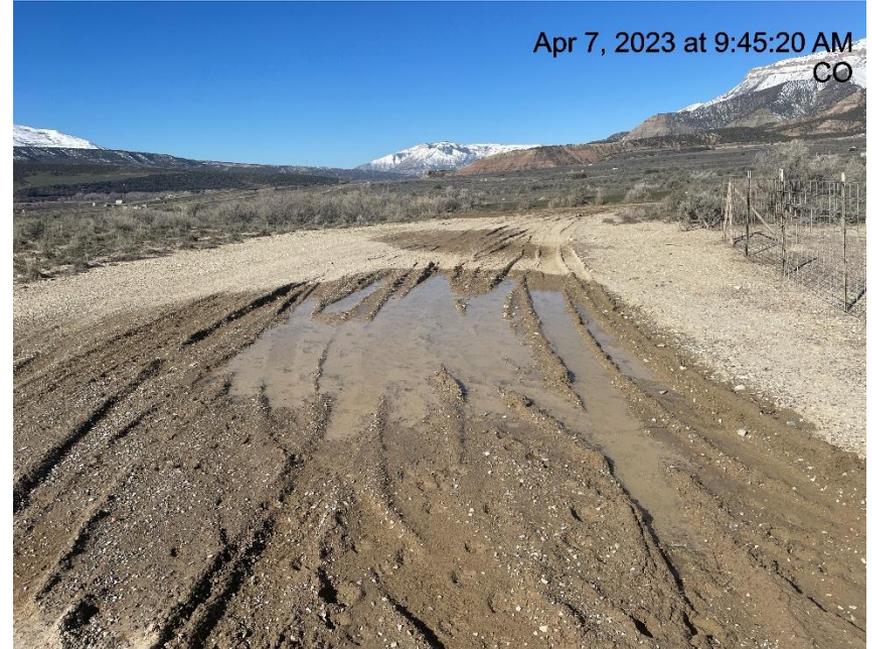
**Photo # 4514 Lack of stabilization/Insufficient tracking
BMP's**

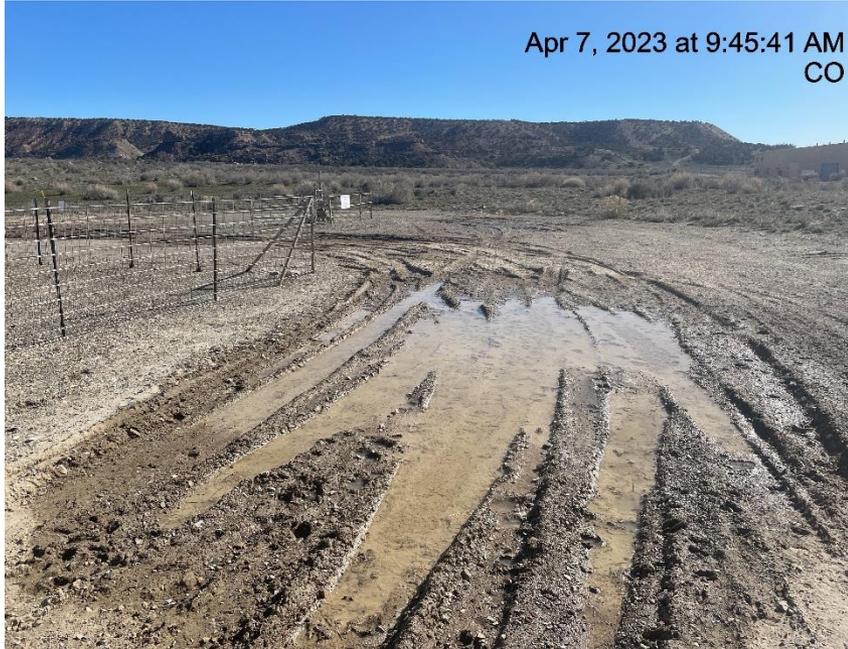
**Photo # 4515 Lack of stabilization/Insufficient tracking
BMP's**

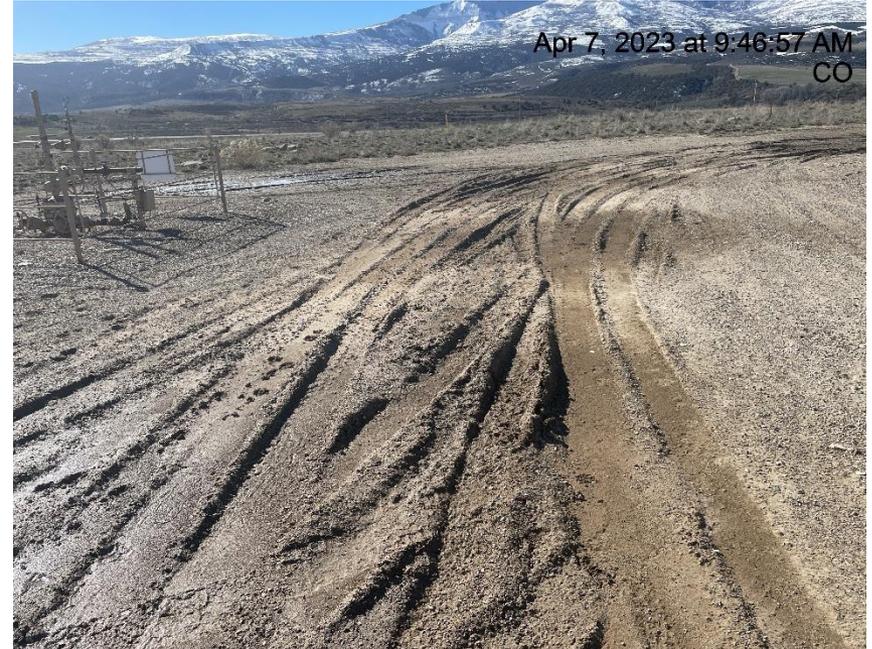
**Photo # 4518 Lack of stabilization/Insufficient tracking
BMP's**

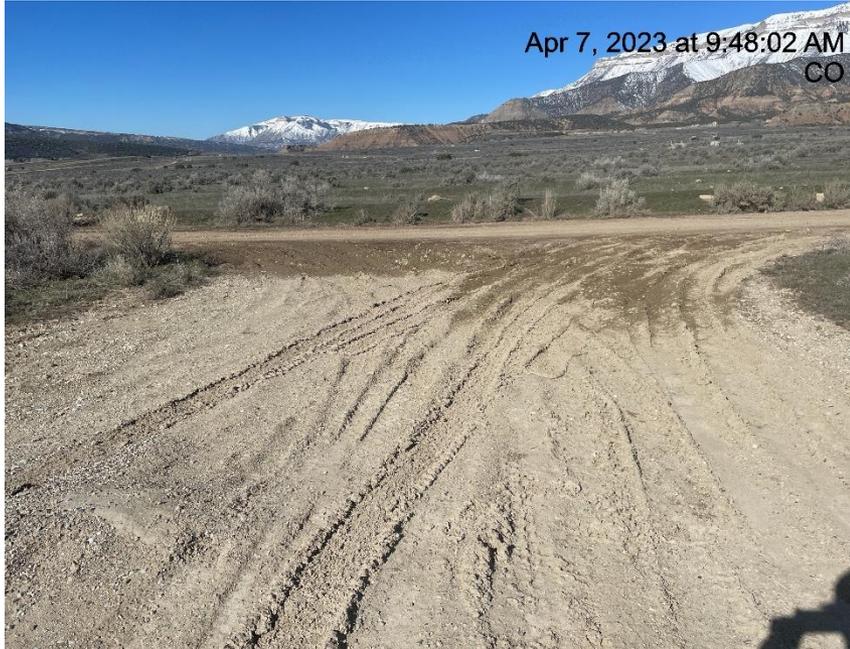
**Photo # 4520 Lack of stabilization/Insufficient tracking
BMP's**

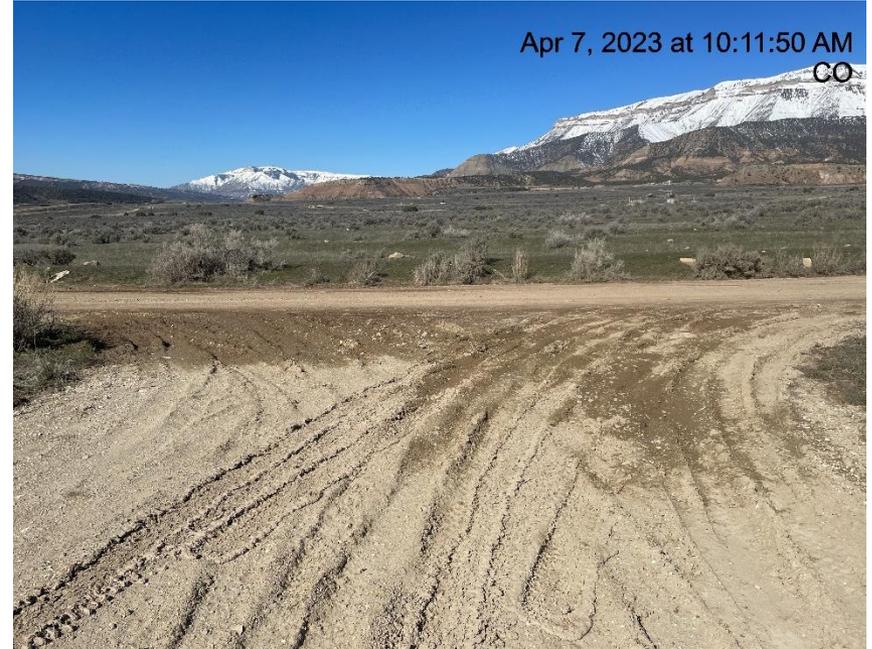
**Photo # 4521 Lack of stabilization/Insufficient tracking
BMP's**

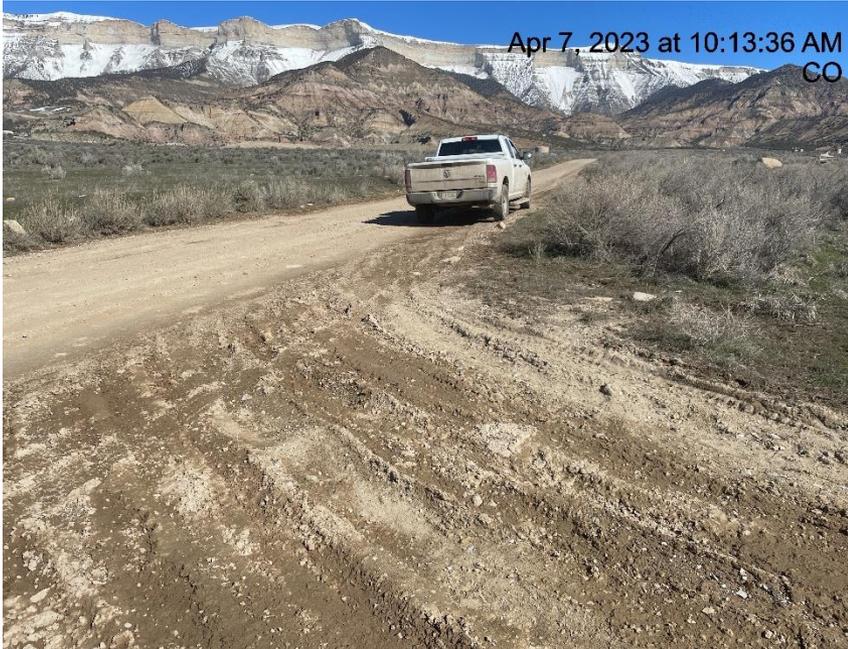
**Photo # 4522 Lack of stabilization/Insufficient tracking
BMP's**

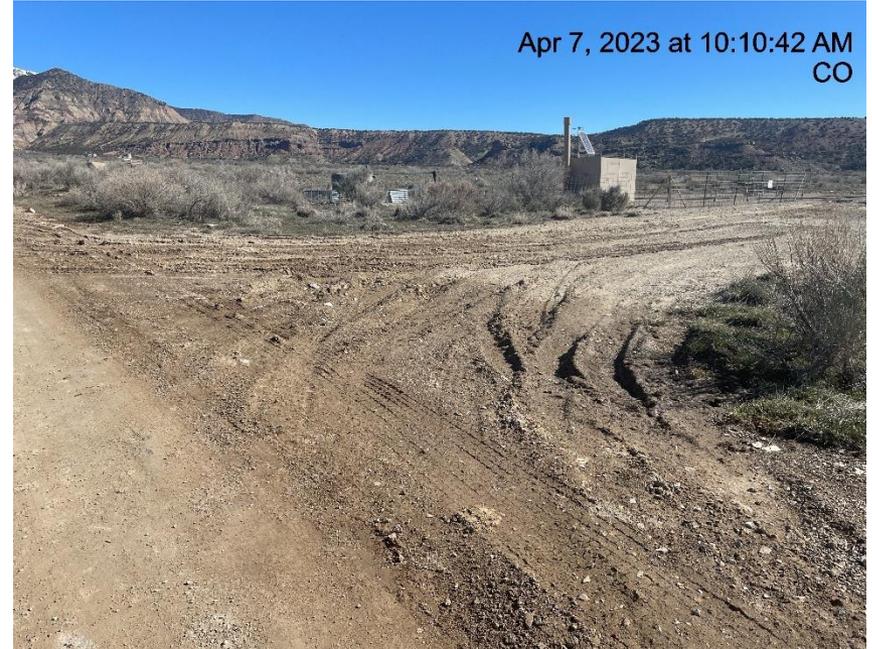
**Photo # 4524 Lack of stabilization/Insufficient tracking
BMP's/vehicle tracking**

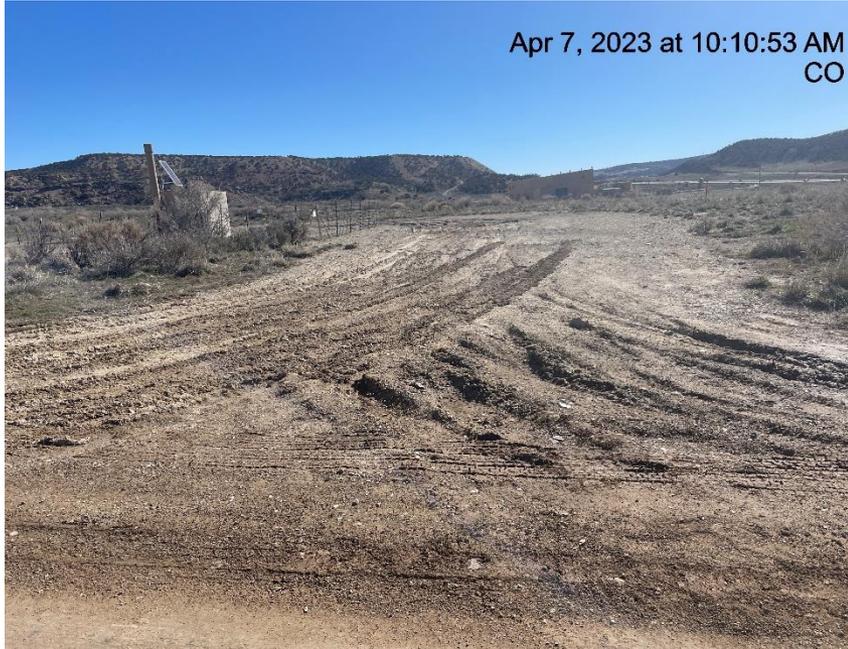
**Photo # 4525 Lack of stabilization/Insufficient tracking
BMP's**

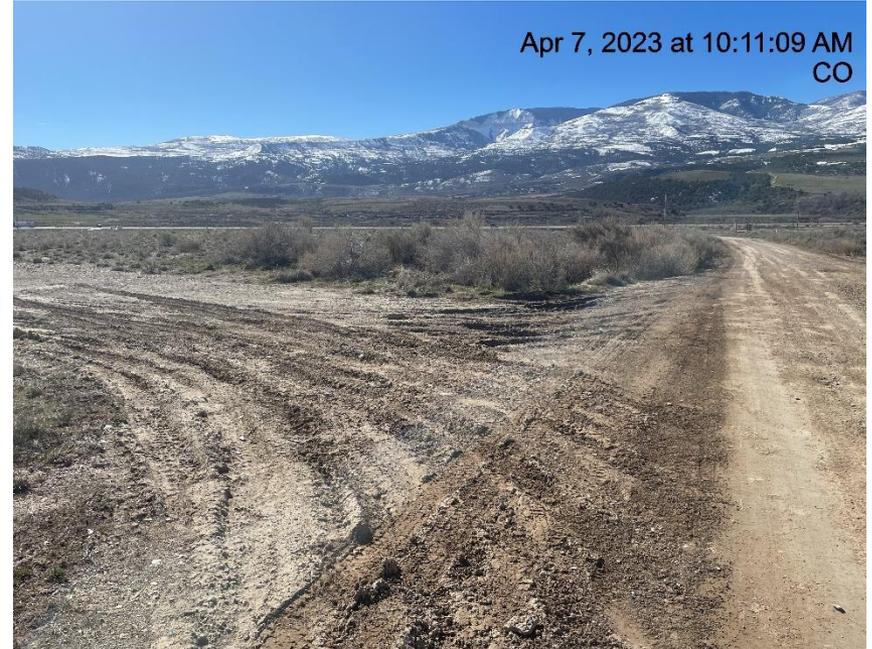
Photo # 4526 Vehicle tracking/Insufficient tracking BMP's

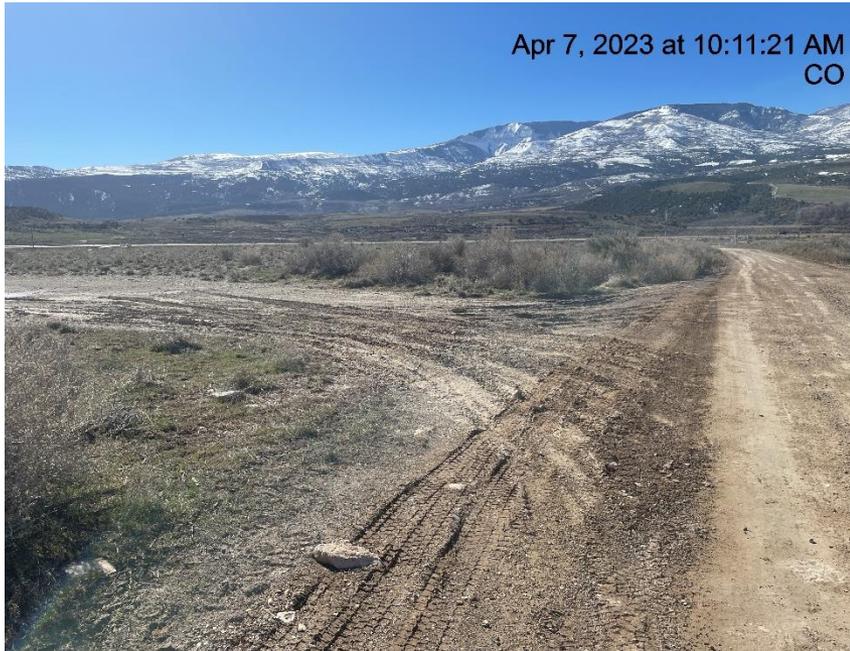
Photo # 4527 Vehicle tracking/Insufficient tracking BMP's
