## Inspection Photos

Location Name: TEP ROCKY MOUNTAIN LLC CLOUGH RWF 524-21 pad

Location ID: 335244

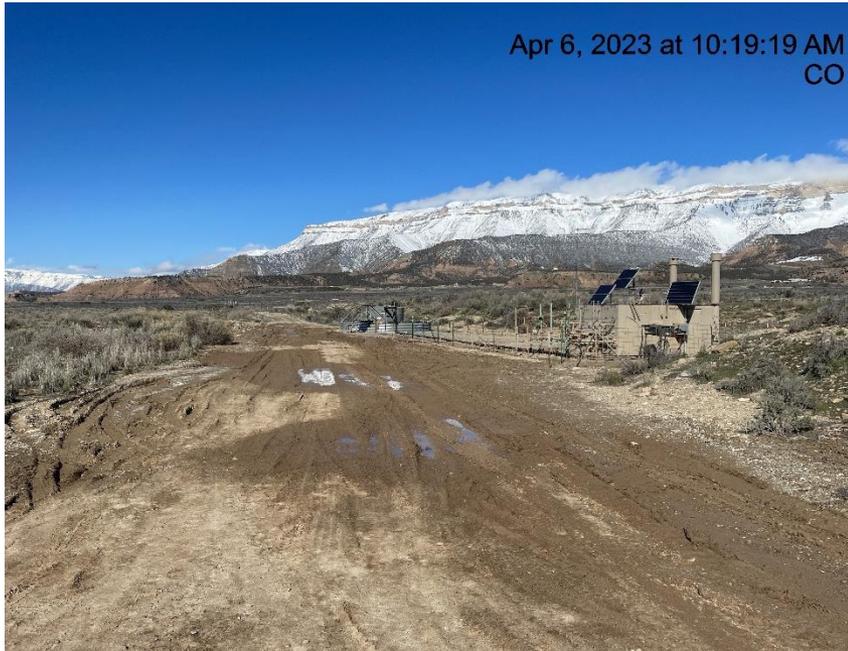
Photo # 4464 From entrance to location.

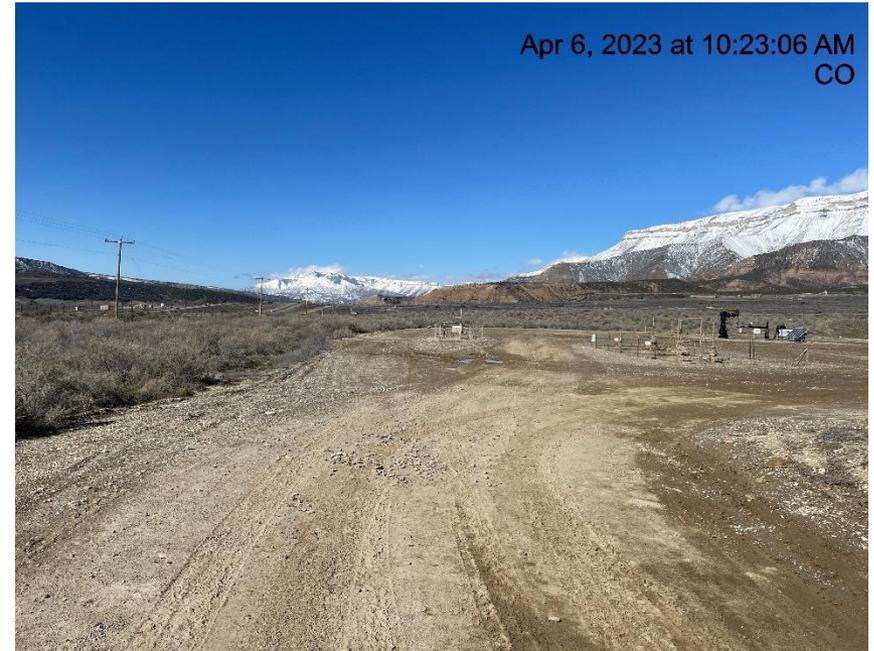
Photo # 4467 From entrance to location

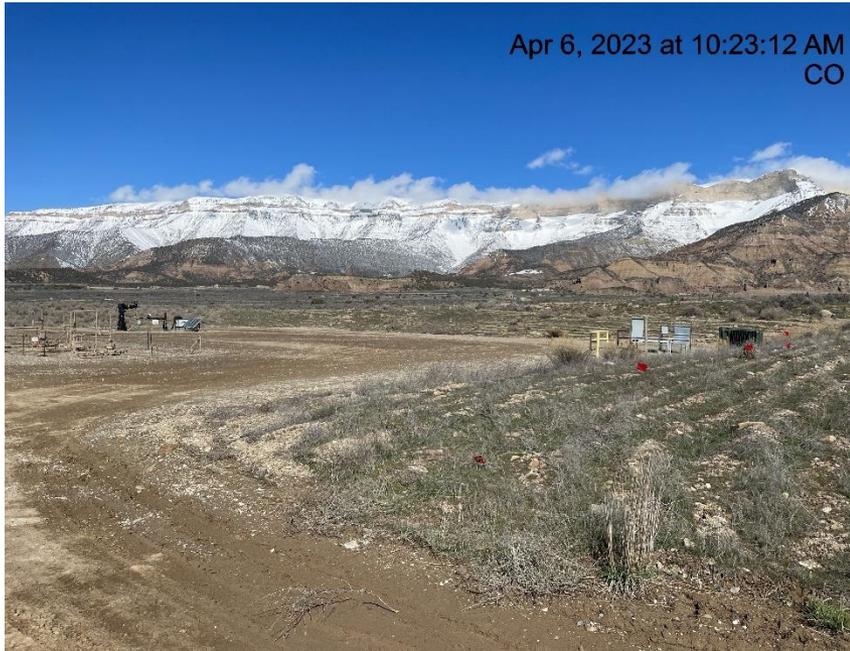
Photo # 4468 From entrance to location

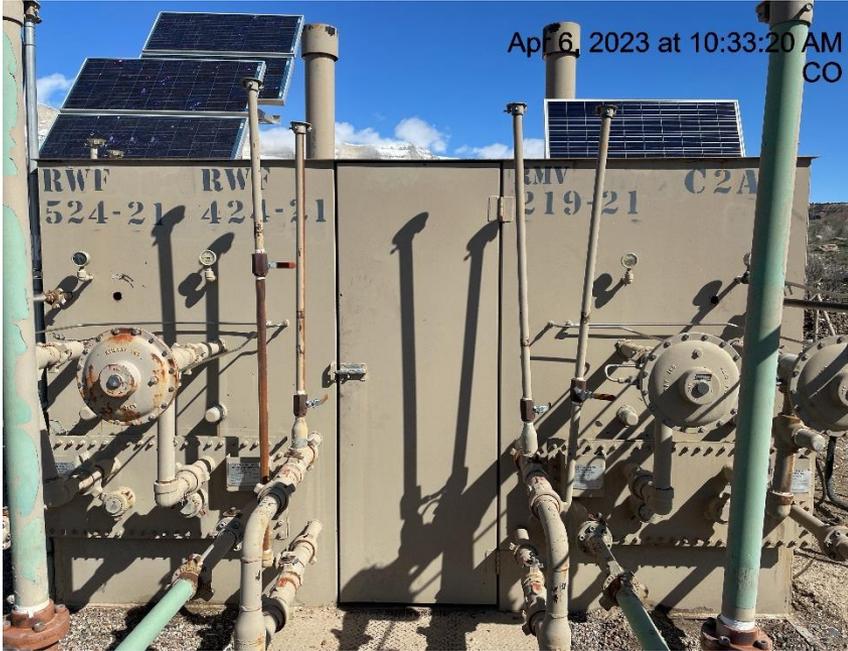
**Photo # 4480 Meter calibration info not conspicuously posted**

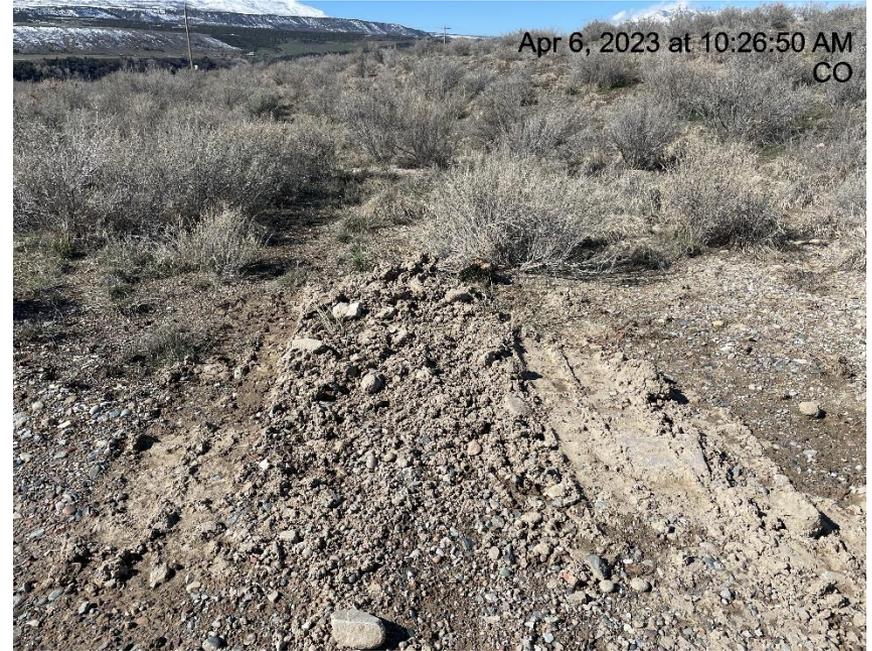
**Photo # 4472 Failure to minimize surface disturbance/vehicle tracks into interim area/transport of sediment.**

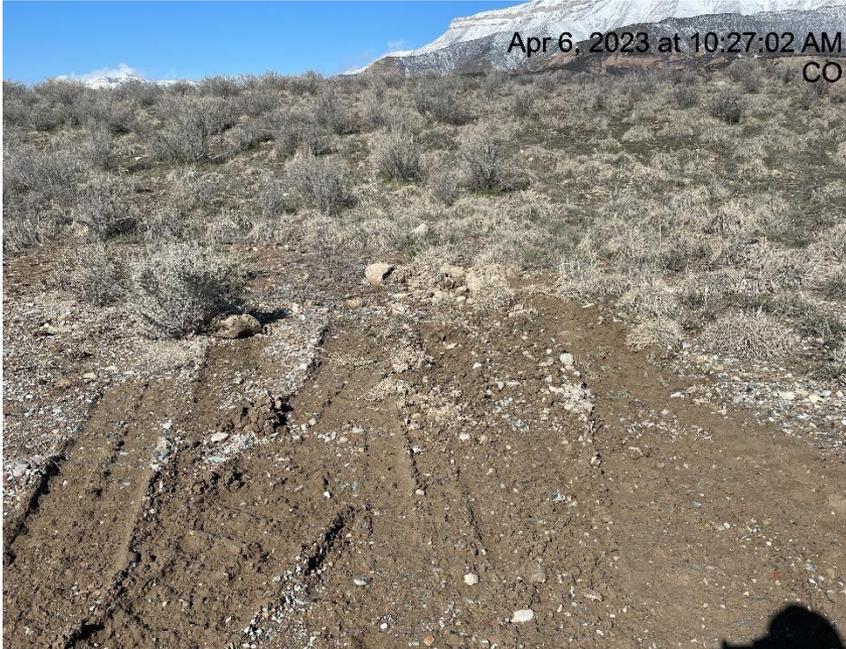
**Photo # 4473 Failure to minimize surface disturbance/vehicle tracks into interim area/transport of sediment.**

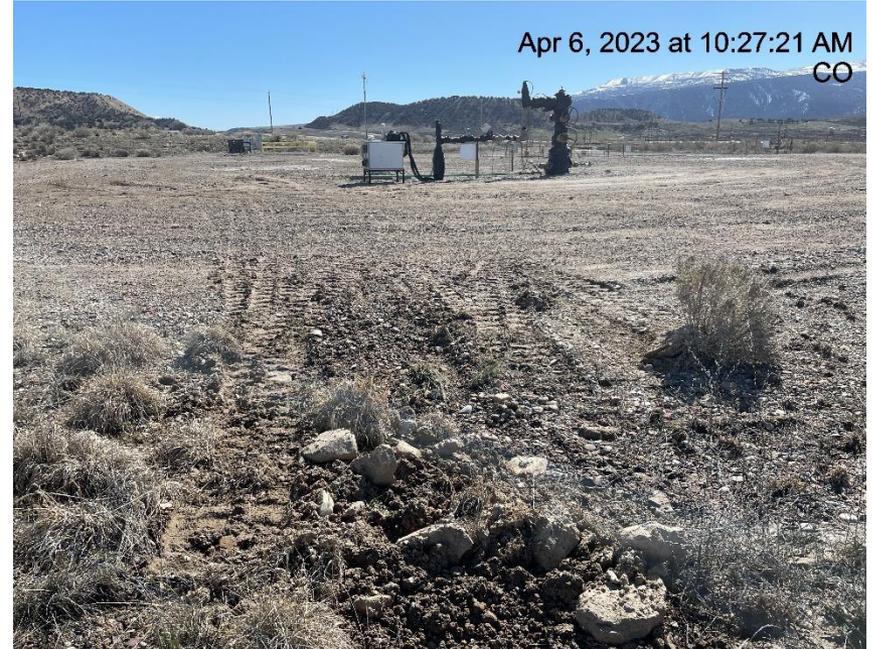
**Photo # 4474 Failure to minimize surface disturbance/vehicle tracks into interim area/transport of sediment.**

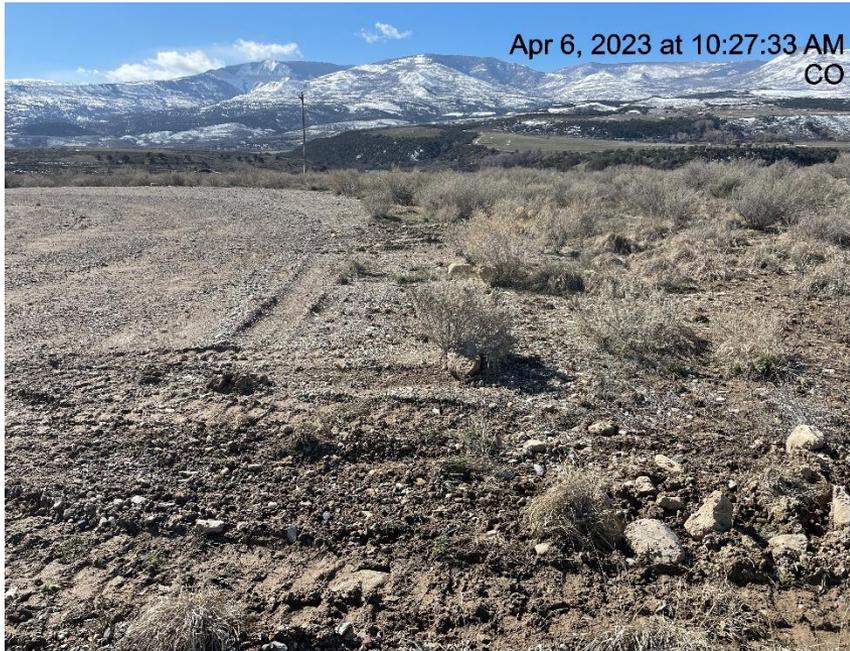
**Photo # 4475 Failure to minimize surface disturbance/vehicle tracks into interim area/transport of sediment.**

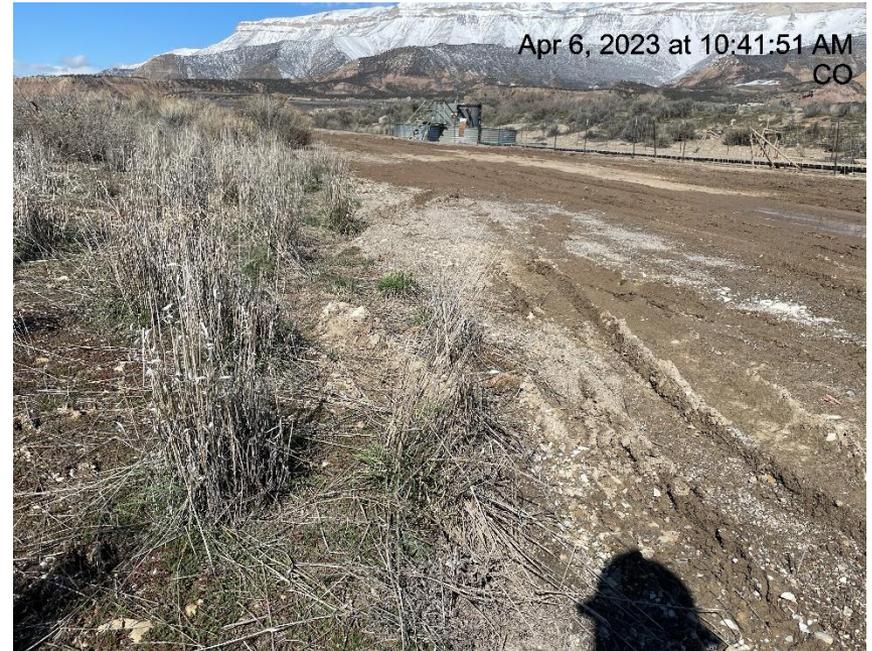
**Photo # 84 Failure to minimize surface disturbance/vehicle tracks into interim area**

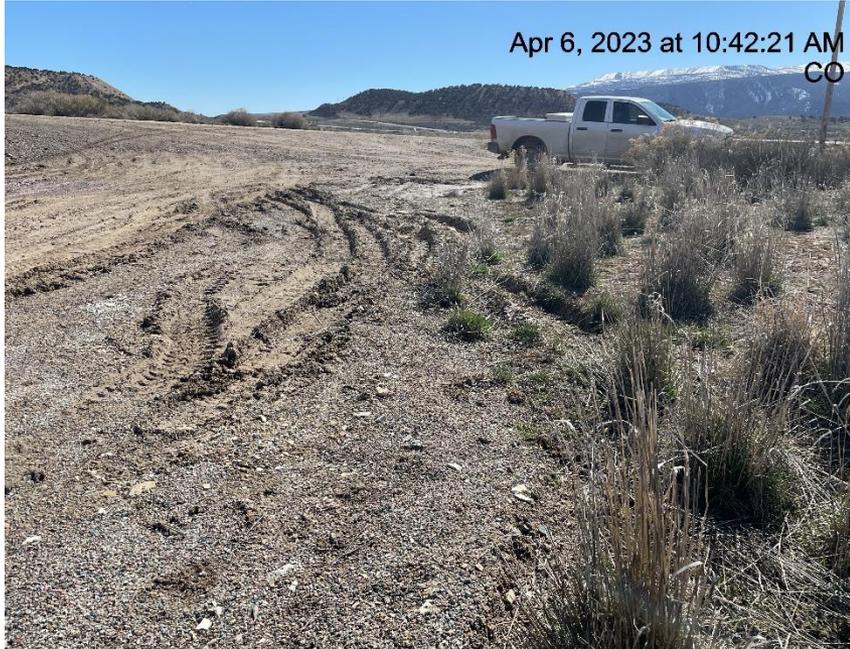
**Photo # 4496 Failure to minimize surface disturbance/vehicle tracks into interim area**

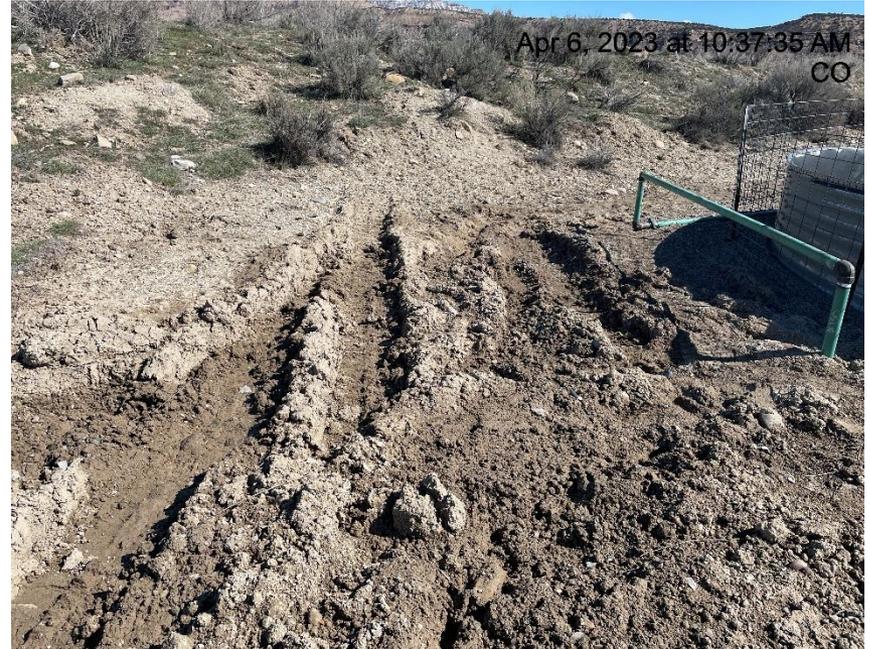
**Photo # 4483 Lack of stabilization/compaction**

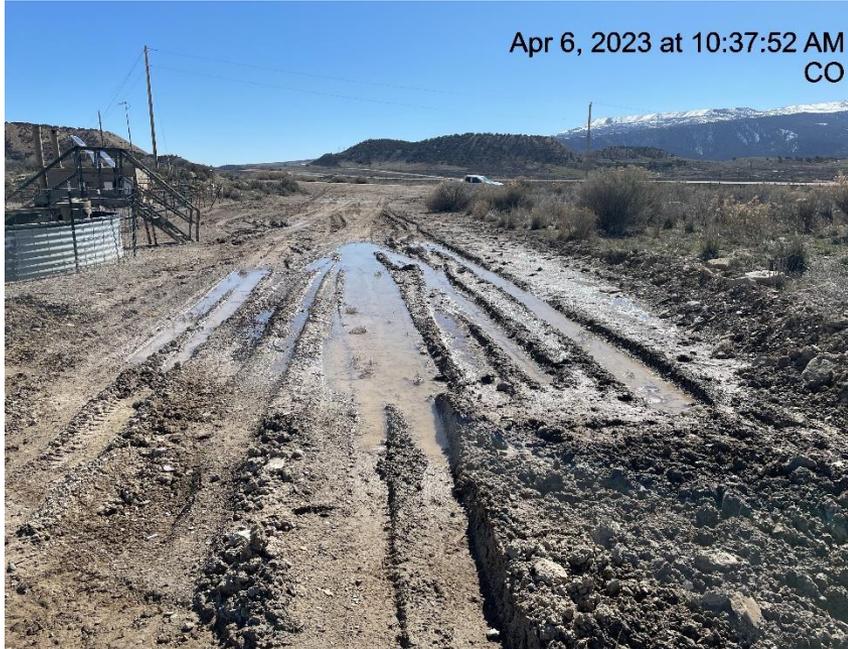
**Photo # 4484 Lack of stabilization/insufficient tracking  
BMP's**

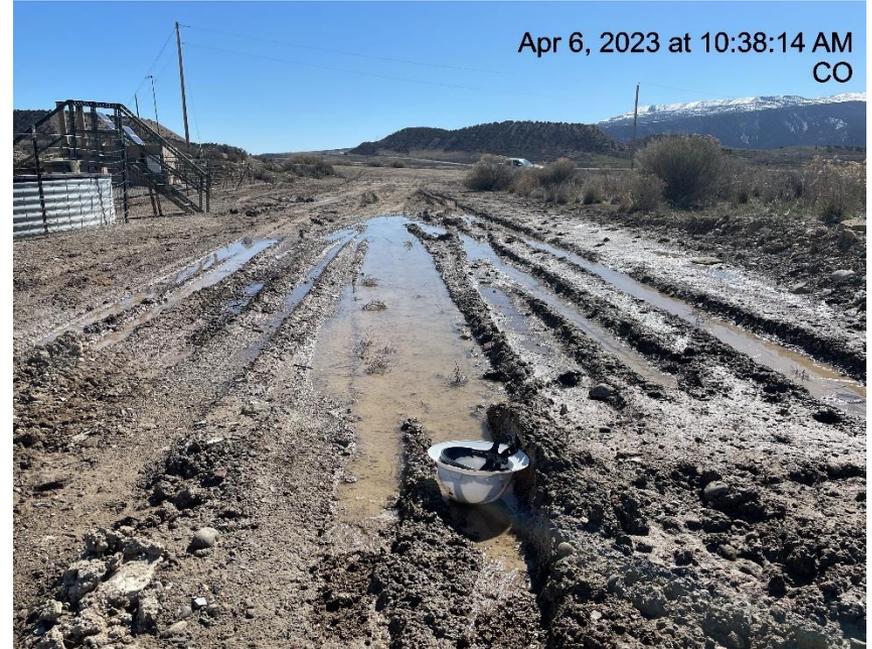
**Photo # 4485 Lack of stabilization/insufficient tracking  
BMP's**

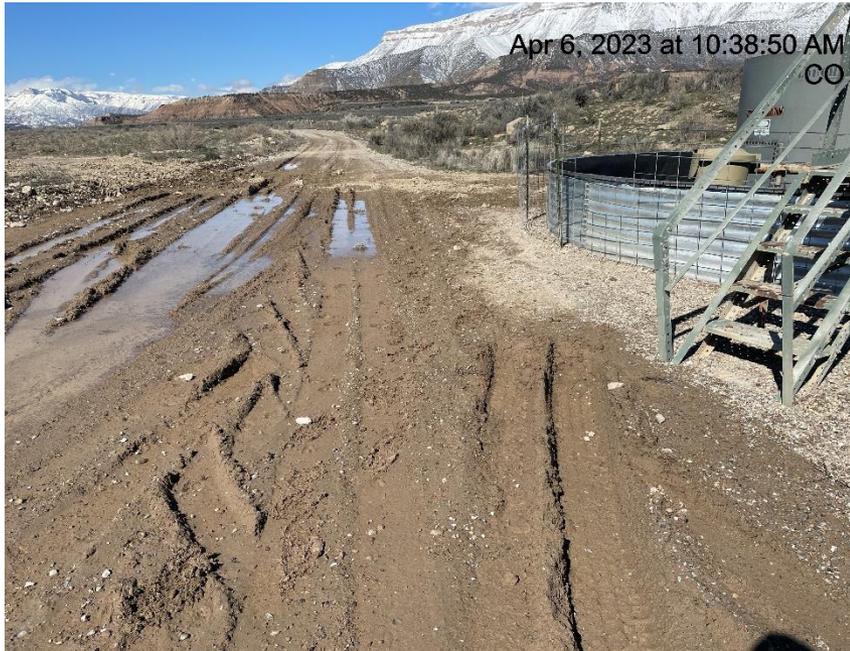
**Photo # 4486 Lack of stabilization/insufficient tracking BMP's**

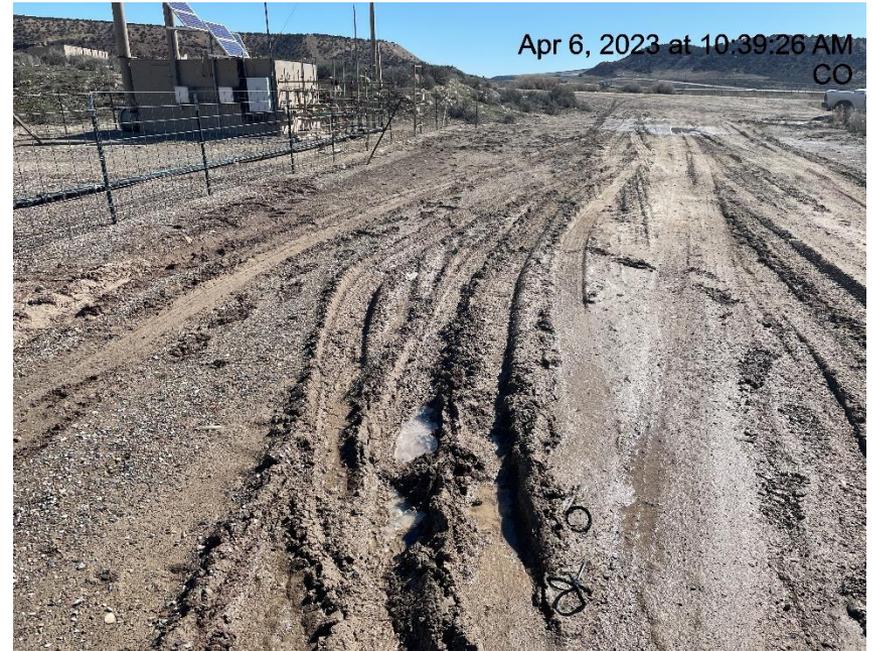
**Photo # 4488 Lack of stabilization/insufficient tracking BMP's**

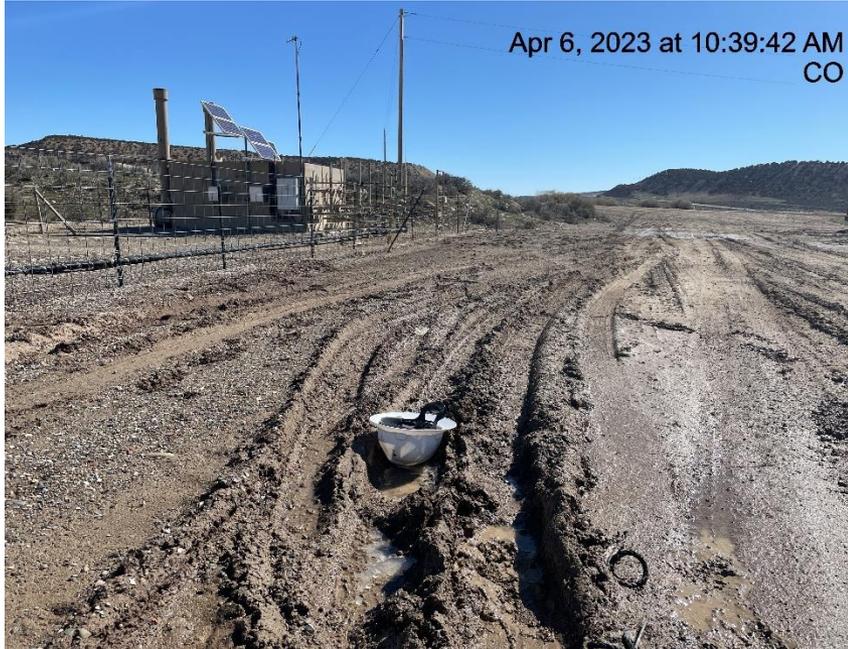
**Photo # 4489 Lack of stabilization/insufficient tracking  
BMP's**

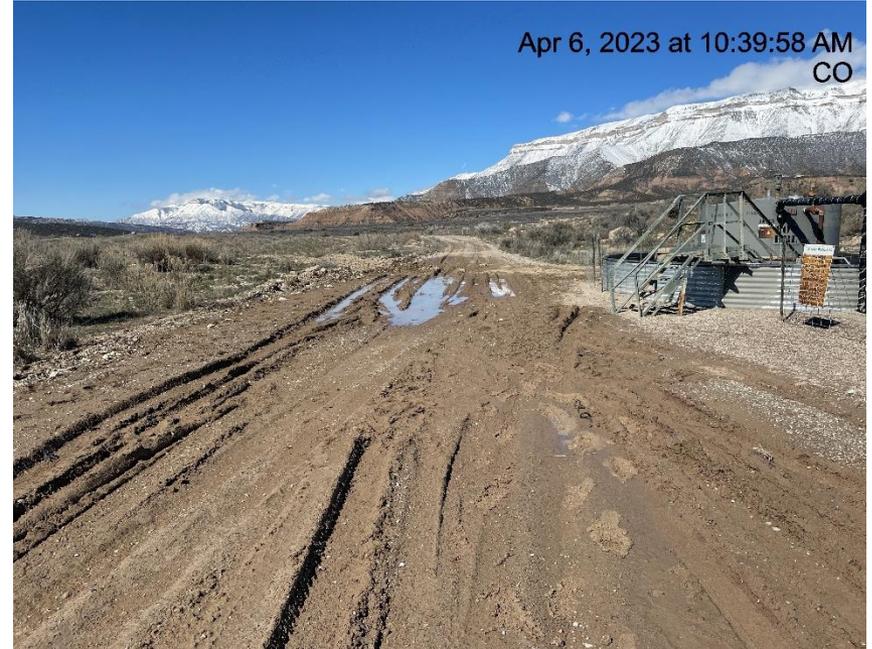
**Photo # 4490 Lack of stabilization/insufficient tracking  
BMP's**

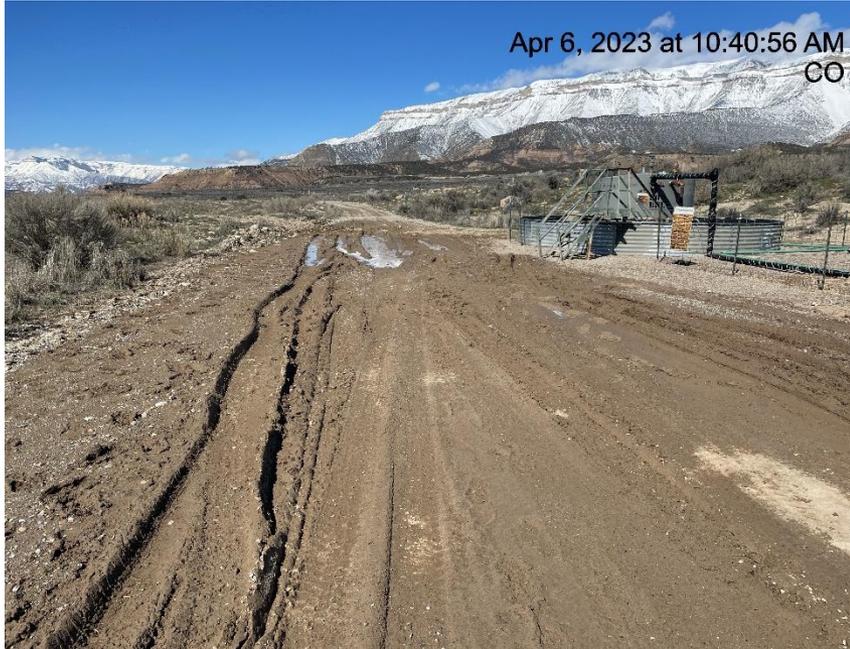
**Photo # 4491 Lack of stabilization/insufficient tracking  
BMP's**

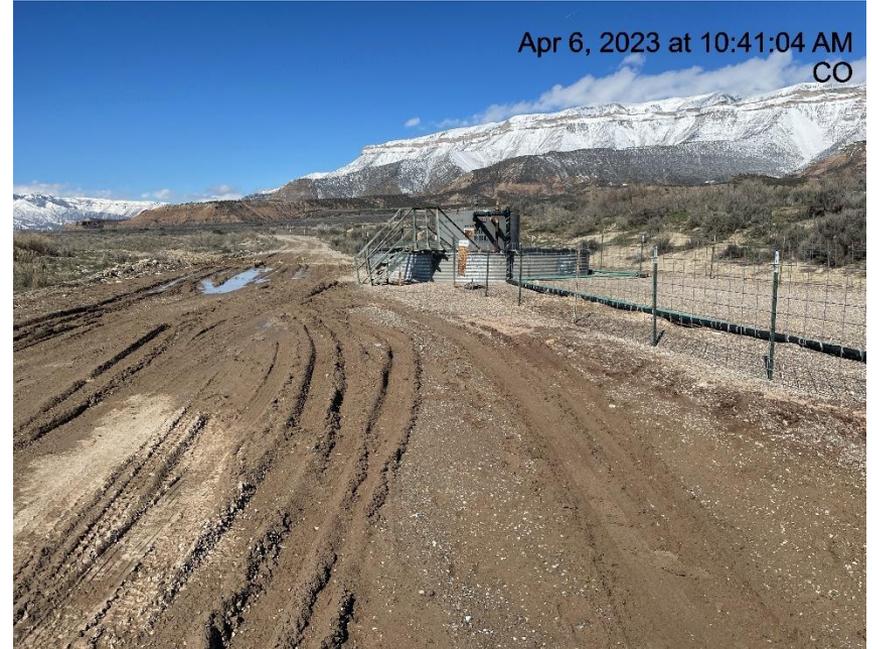
**Photo # 4492 Lack of stabilization/insufficient tracking  
BMP's**
