Inspection Photos

Location Name: TEP ROCKY MOUNTAIN LLC CLOUGH RMV 94-21 Pad

Location ID: 335210

COLORADO
Oil & Gas Conservation
Commission
Department of Natural Resources

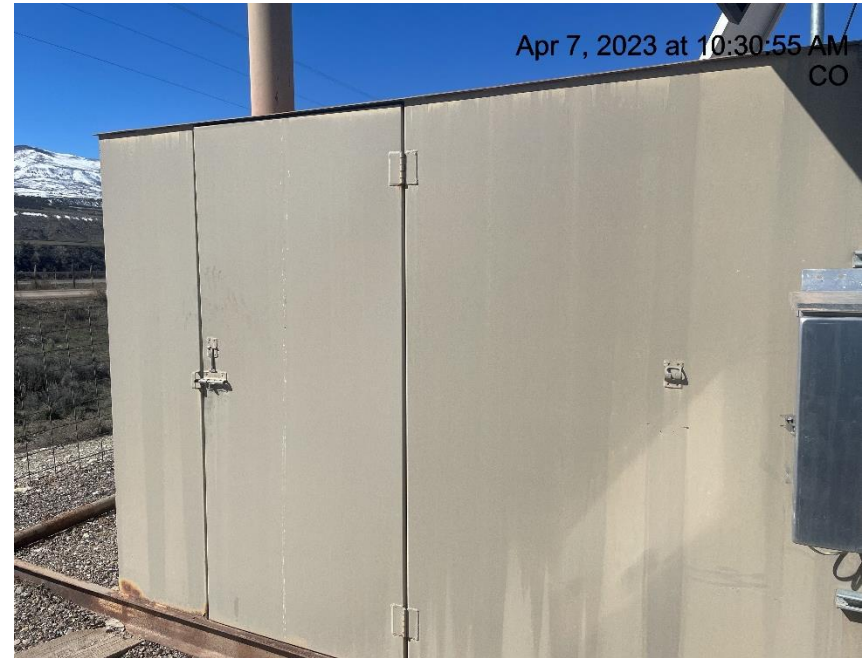
Photo # 4545 Meter calibration info not conspicuously posted

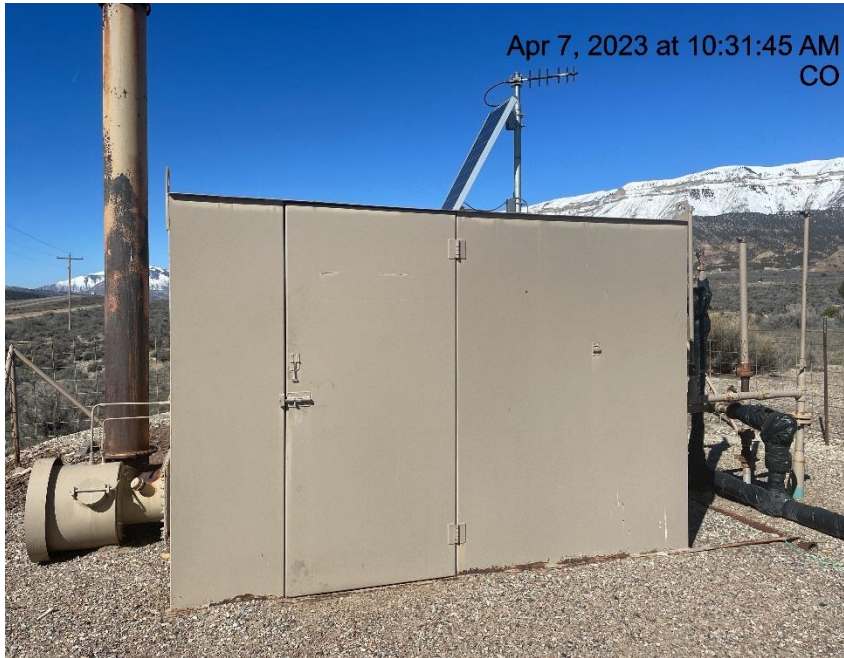
Photo # 4546 Meter calibration info not conspicuously posted

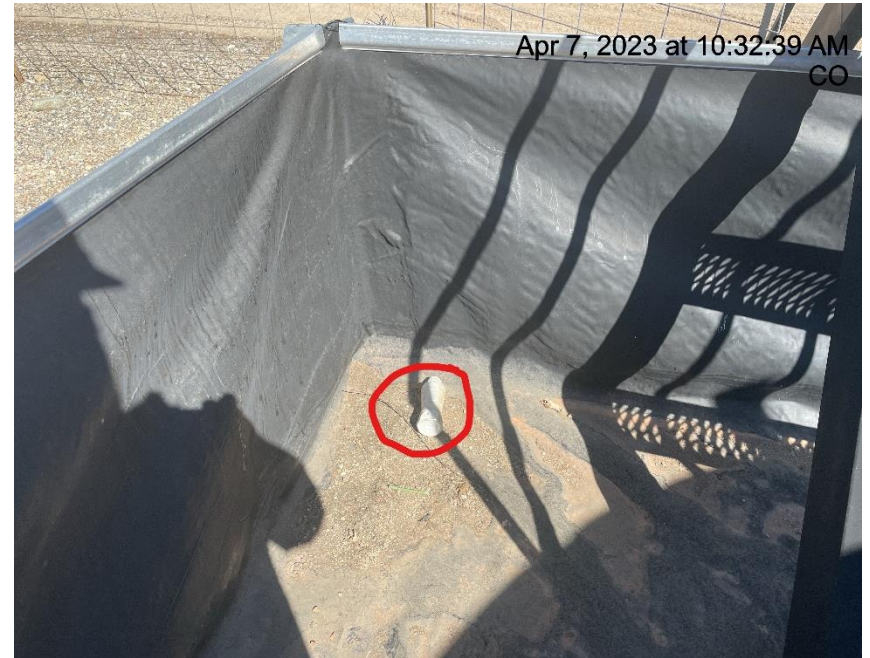
Photo # 4547 Debris

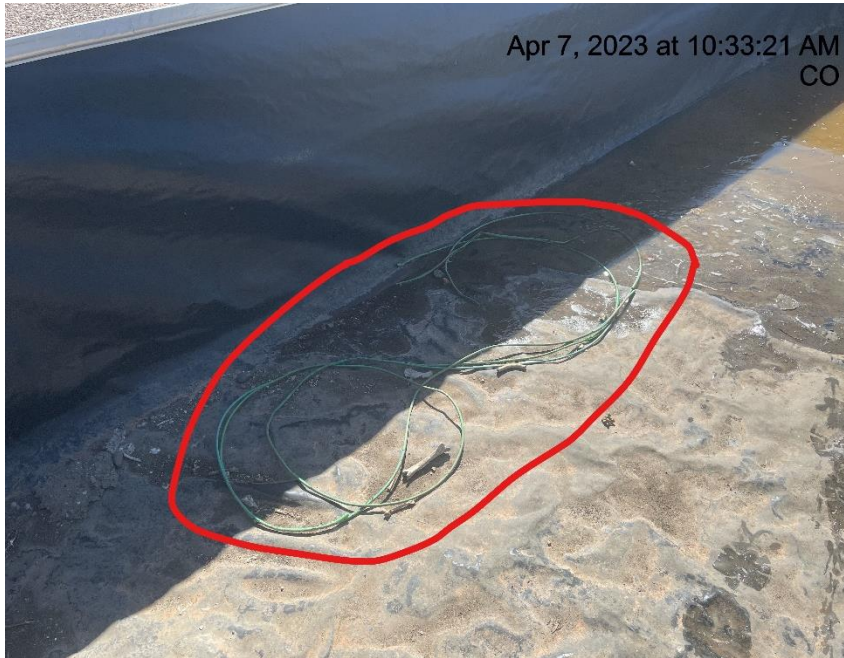
Photo # 4548 Debris

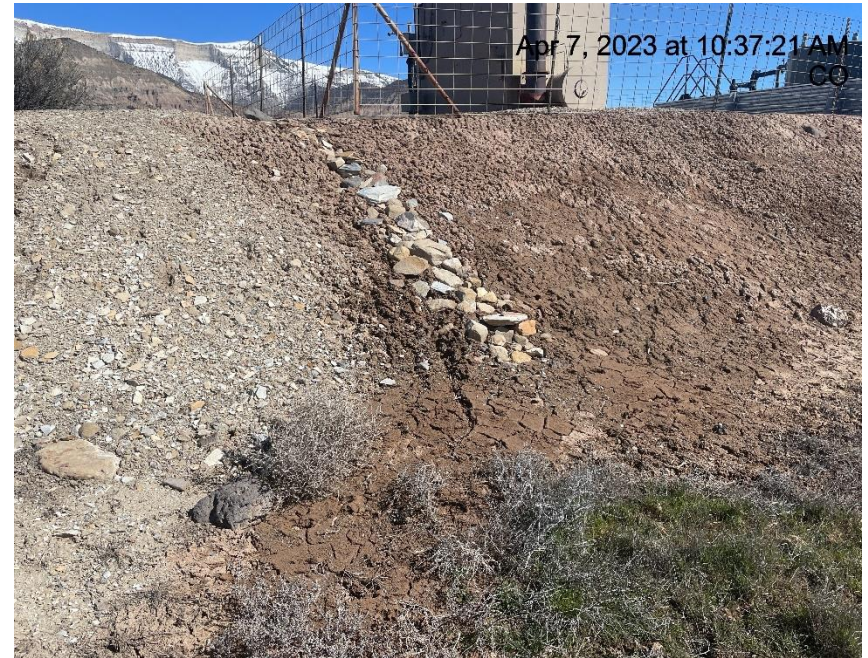
Photo # 4551 Erosion/transport of sediment off location/insufficient BMP's

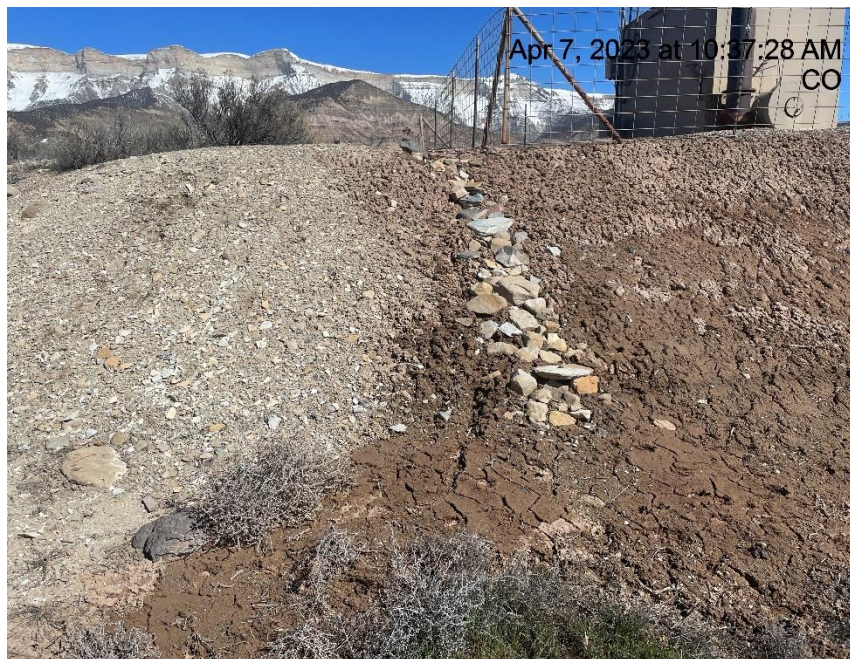
Photo # 4552 Erosion/transport of sediment off location/insufficient BMP's

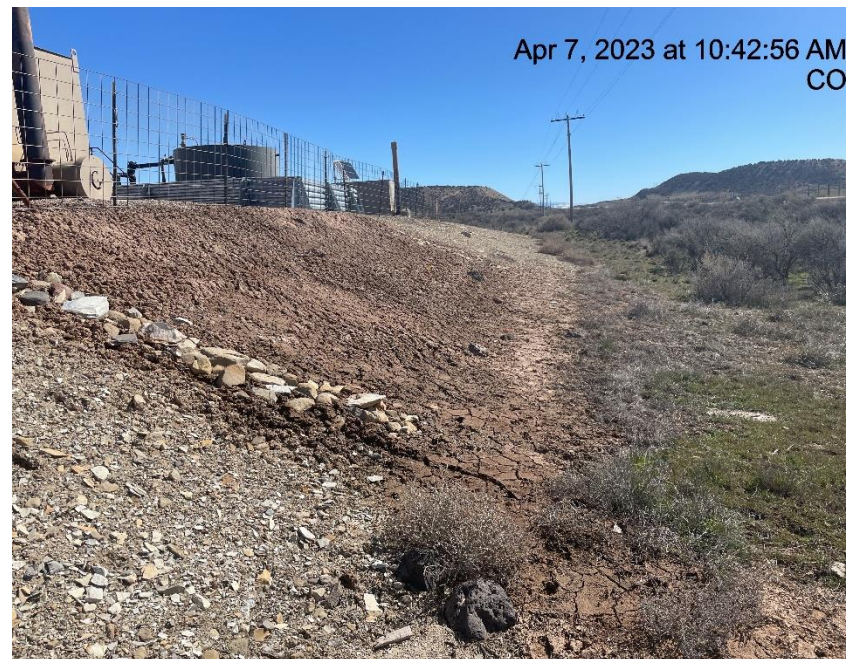
Photo # 4564 Erosion/transport of sediment off location/insufficient BMP's

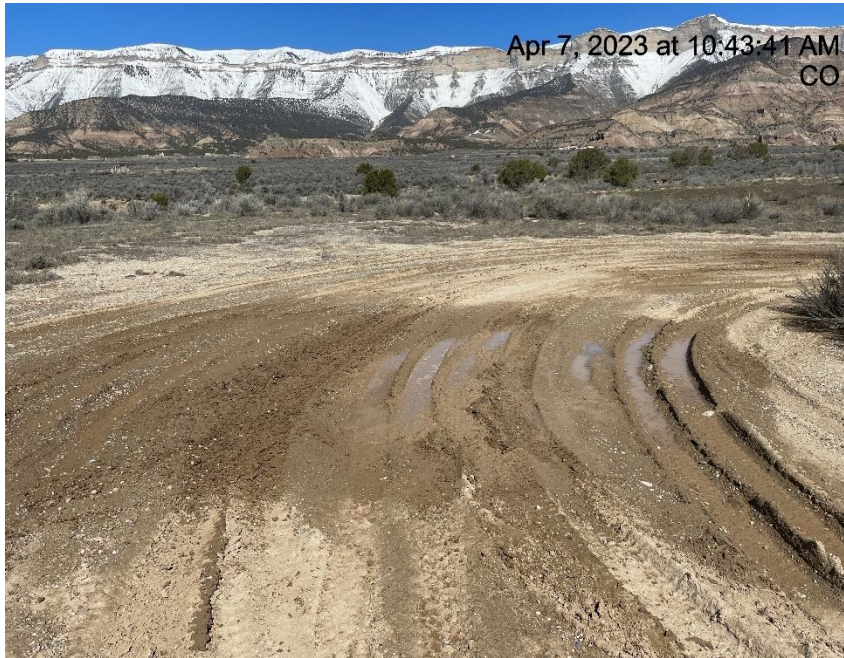
Photo # 4565 Lack of stabilization/compaction/Insufficient tracking BMP's

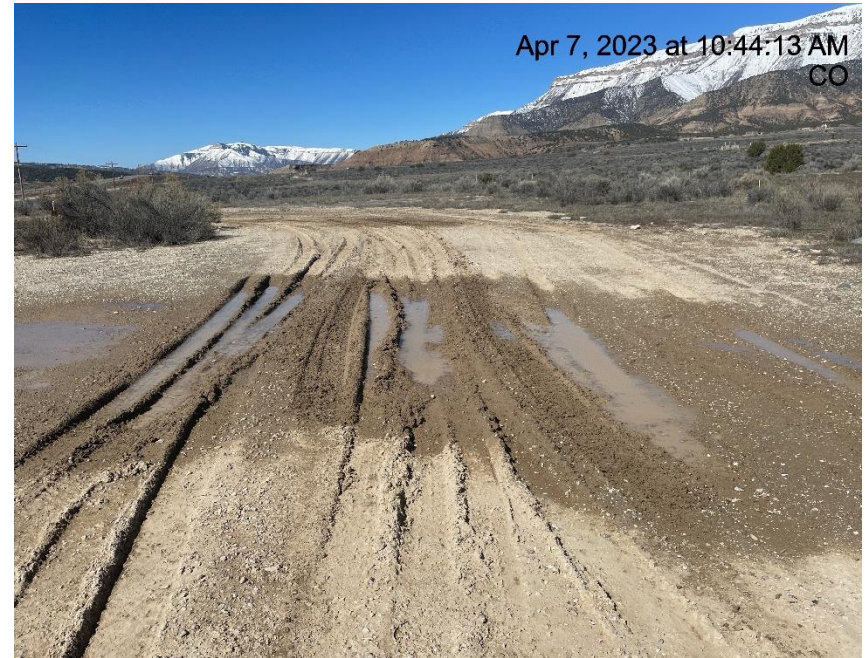
Photo # 4566 Lack of stabilization/compaction/Insufficient tracking BMP's

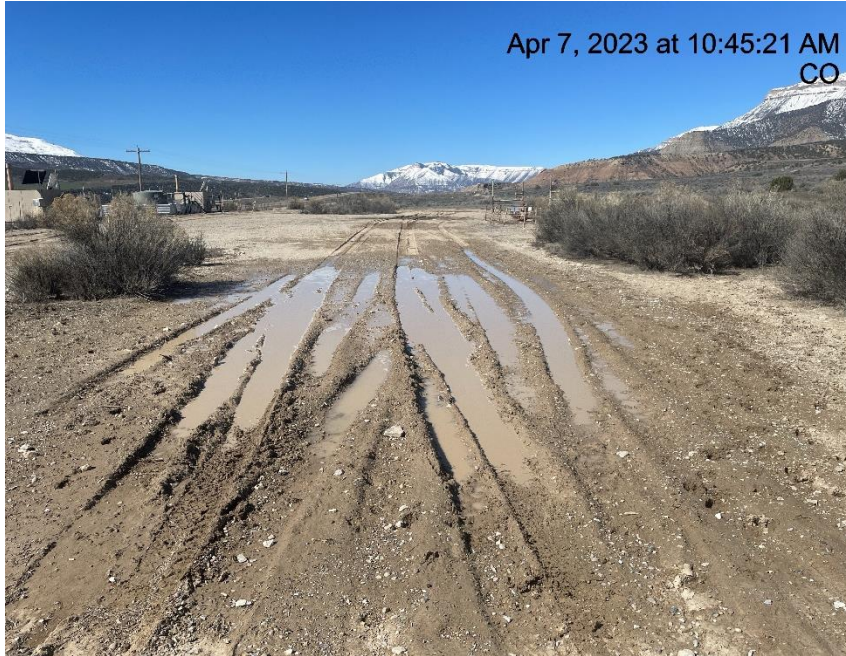
Photo # 4568 Lack of stabilization/compaction/Insufficient tracking BMP's

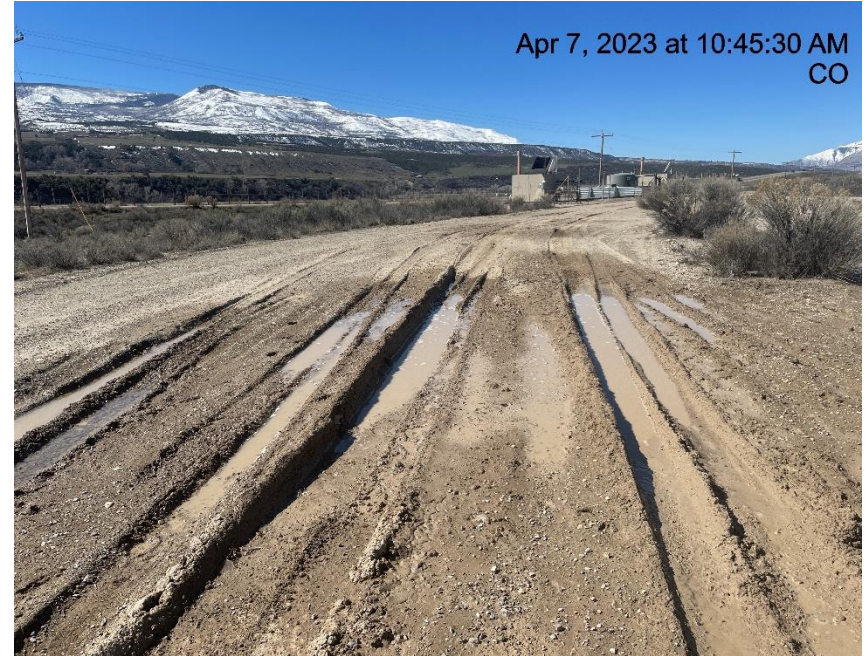
Photo # 4569 Lack of stabilization/compaction/Insufficient tracking BMP's

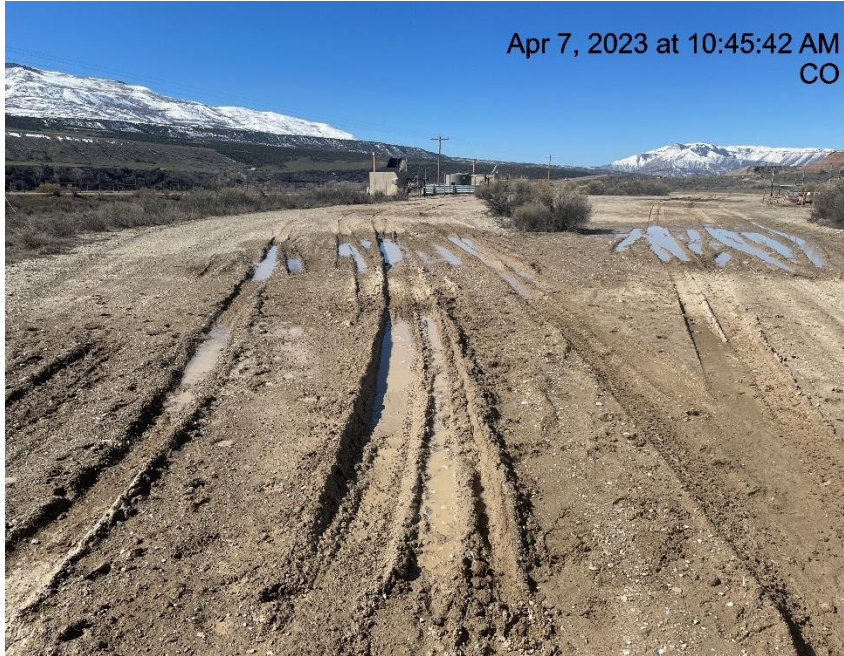
**Photo # 4570 Lack of stabilization/Insufficient tracking
BMP's**

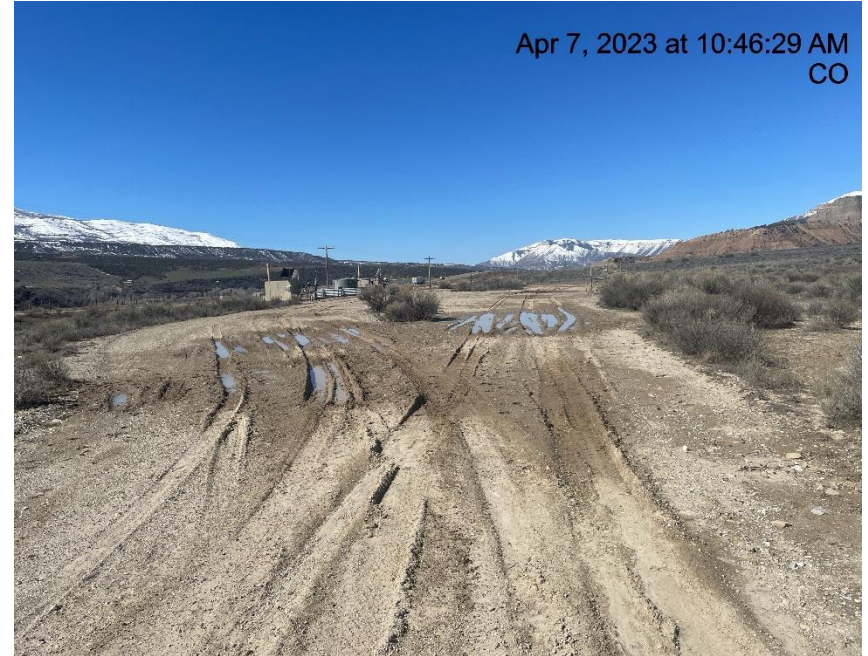
**Photo # 4574 Lack of stabilization/Insufficient tracking
BMP's**
