Inspection Photos
location: 416625
Inspection
Date:4/7/2023

COLORADO
Oil & Gas Conservation
Commission
Department of Natural Resources

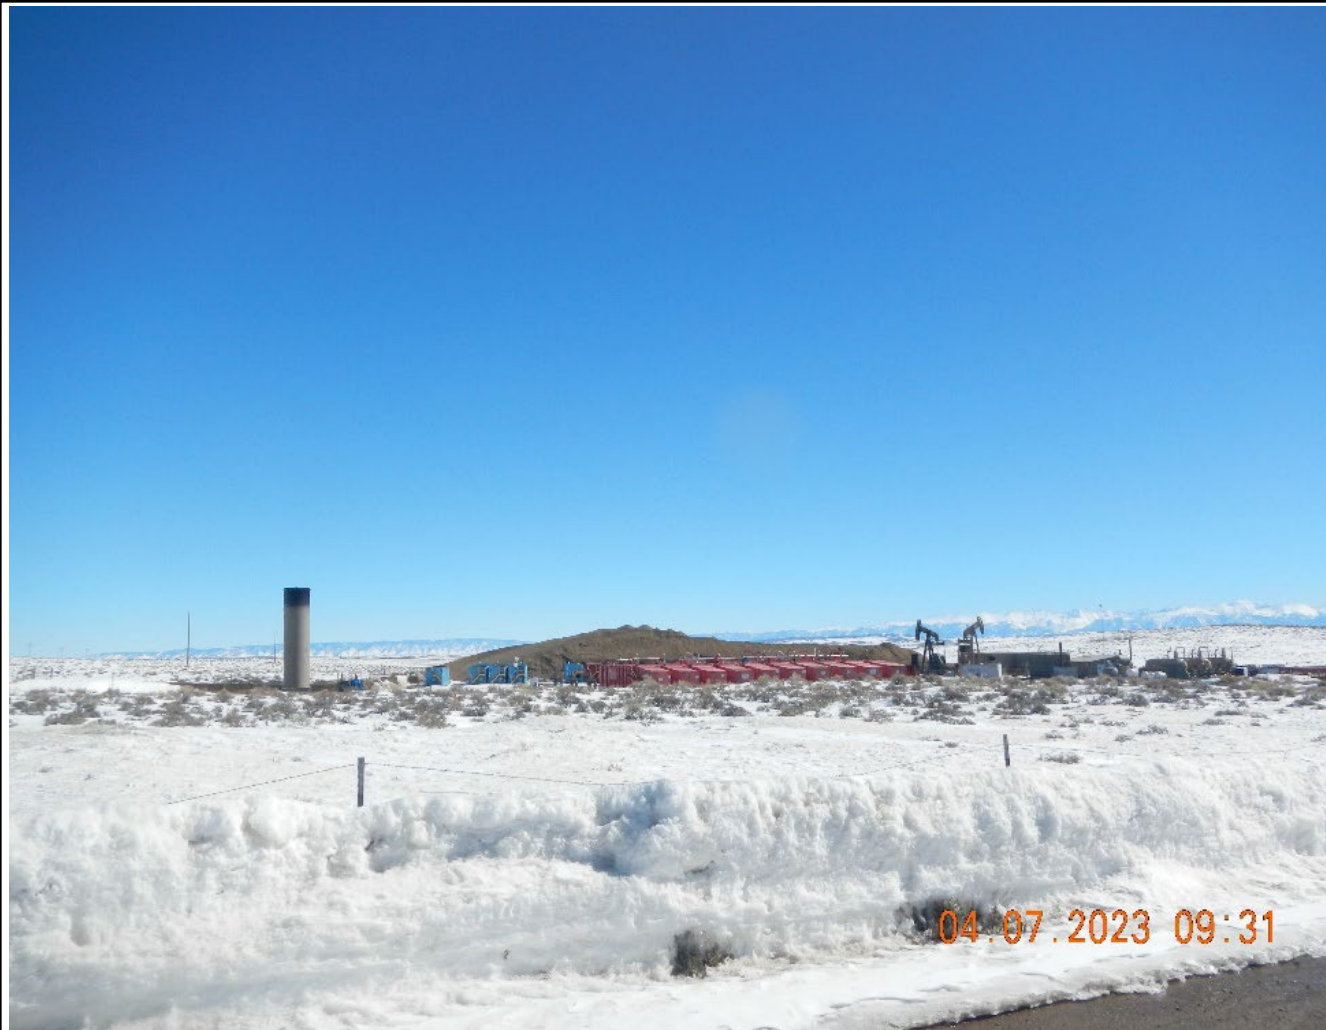
Photo #1 Overview of location from access road.

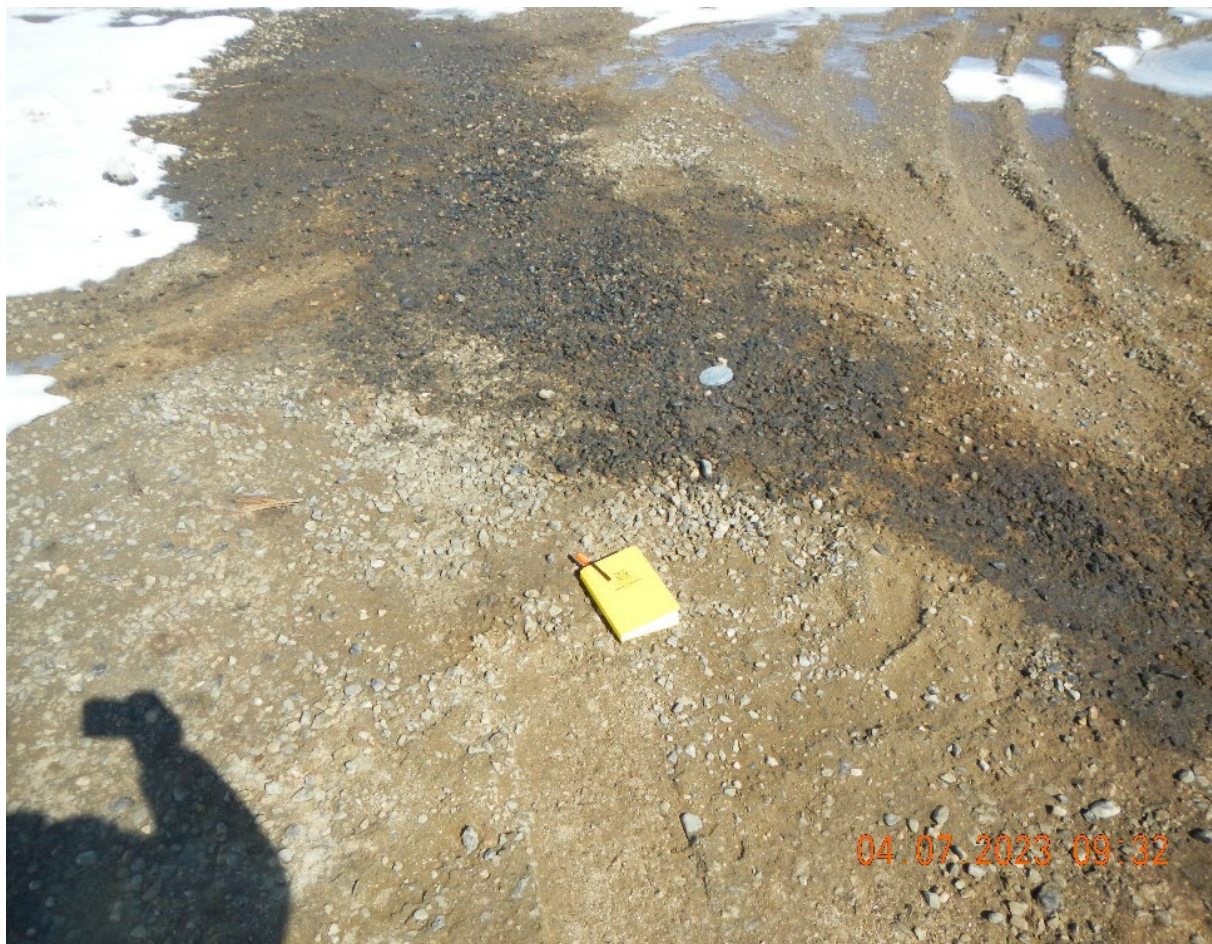
Photo #2 Southwest most corner of location. Staining on ground. Corrective Action; This area shall be documented on a Remediation workplan (Form 27).

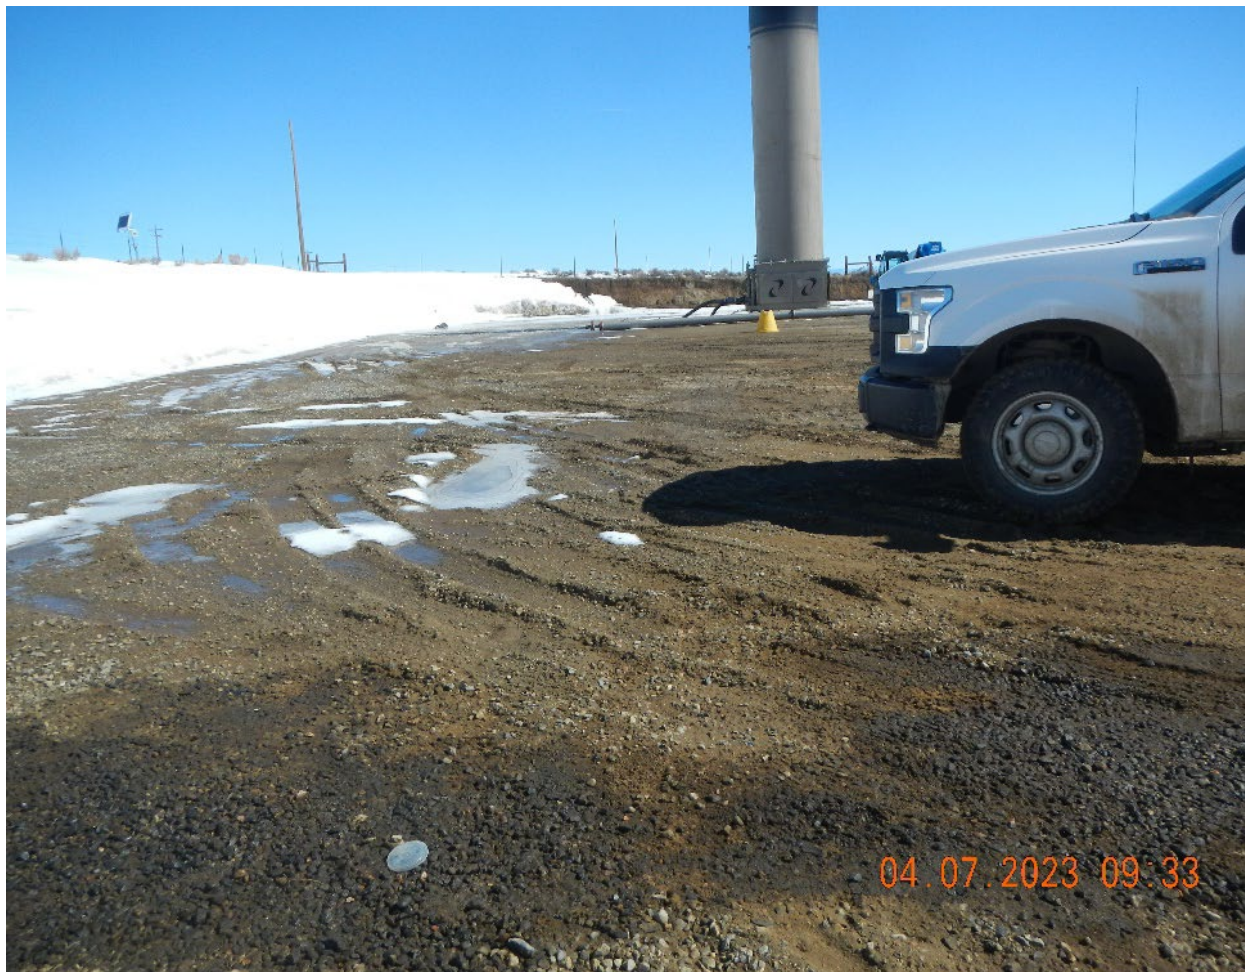
Photo #3 same staining as Photo #2 location boarder on left is western most boarder. Corrective Action; This area shall be documented on a Remediation workplan (Form 27).

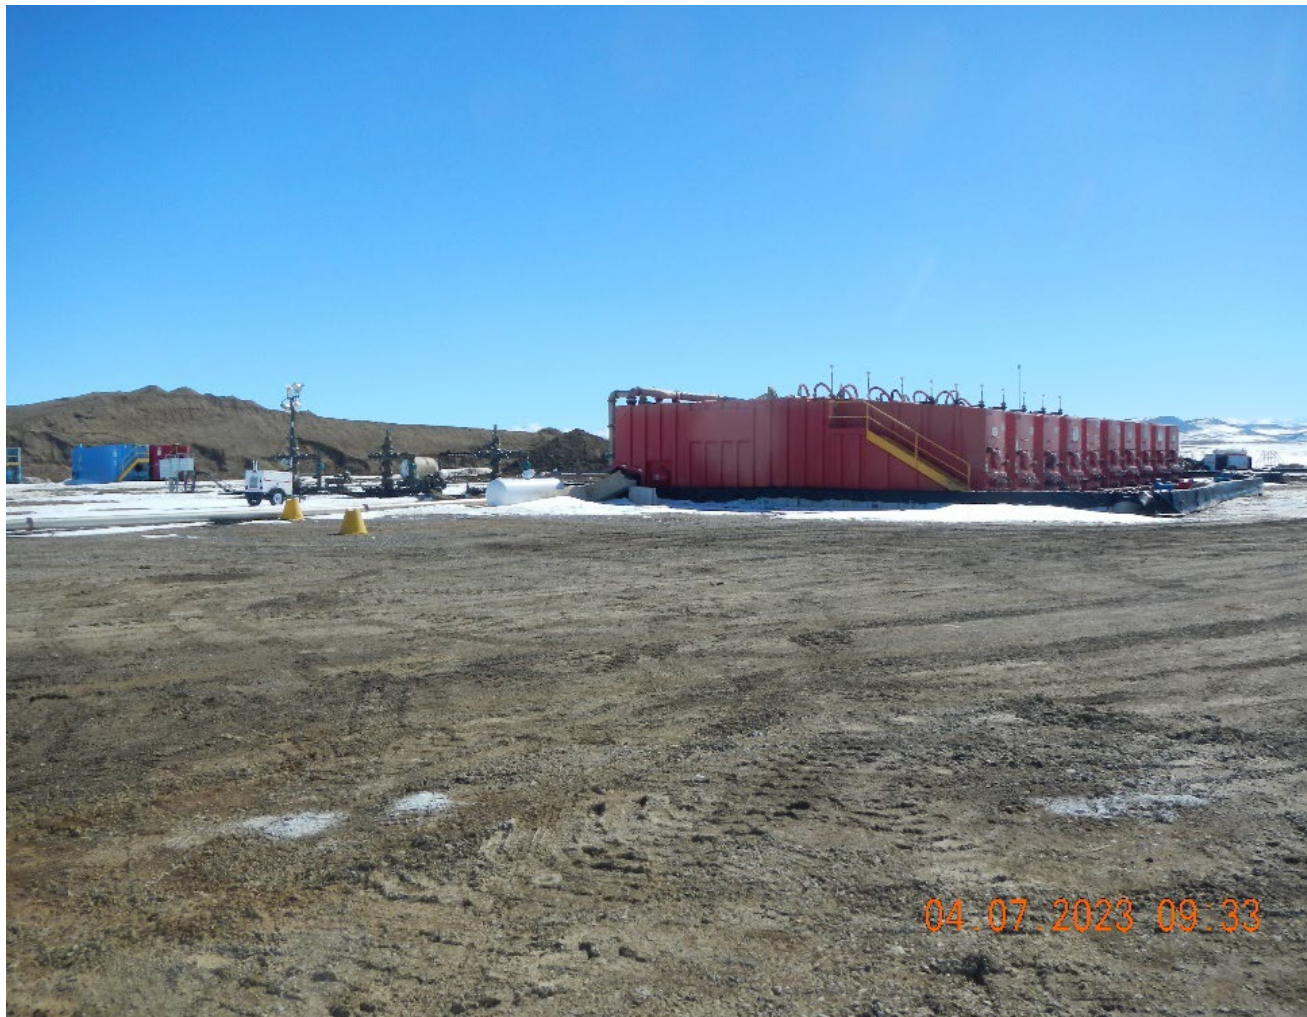
Photo #4 Looking southeast. Note: wells near light plant. Frac tanks inside temporary secondary containment. Tank headspace is piped to Large Combustor. It did not appear that the combustor was lit at the time of inspection.

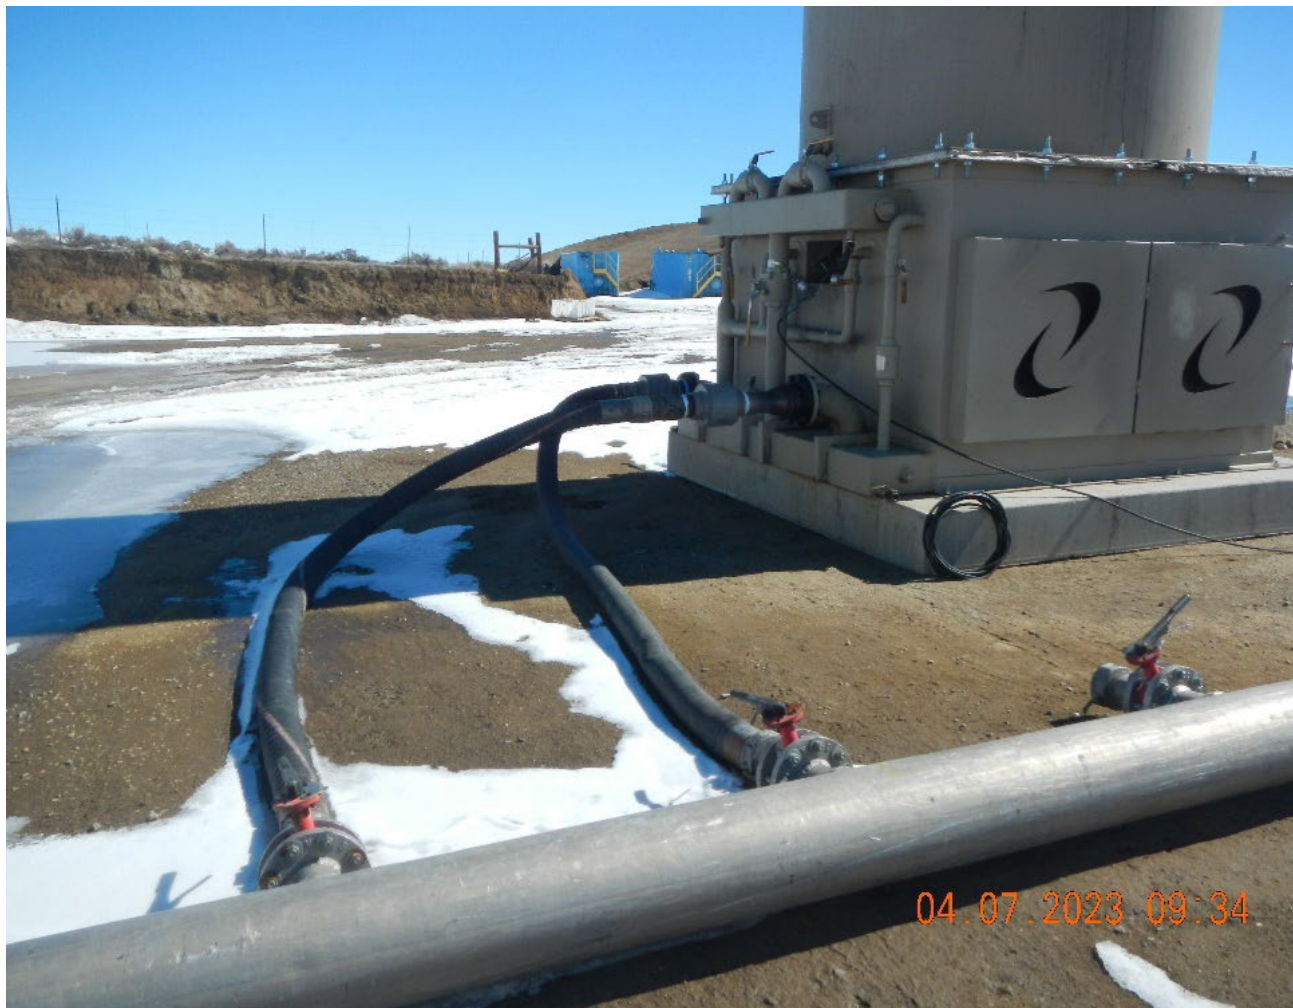
Photo #5 piping to combustor. Valves to the combustor were open from the manifold (at bottom of photo).

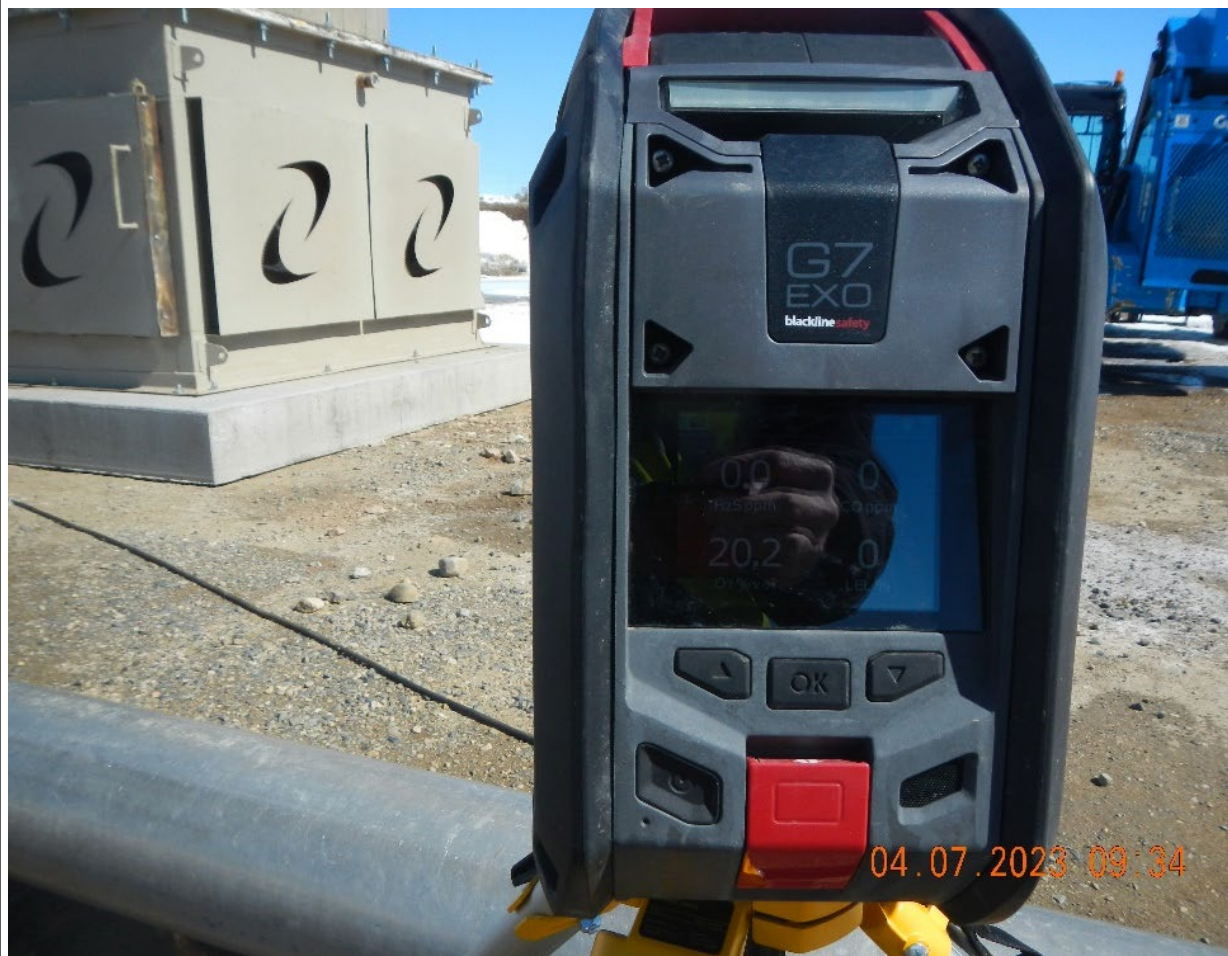
Photo #6 This device appeared to be a stationary gas monitor. The display read: H2S 0.0ppm, CO 0ppm, O2 20.2%, LEL 0%. Note: combustor on left of photo.

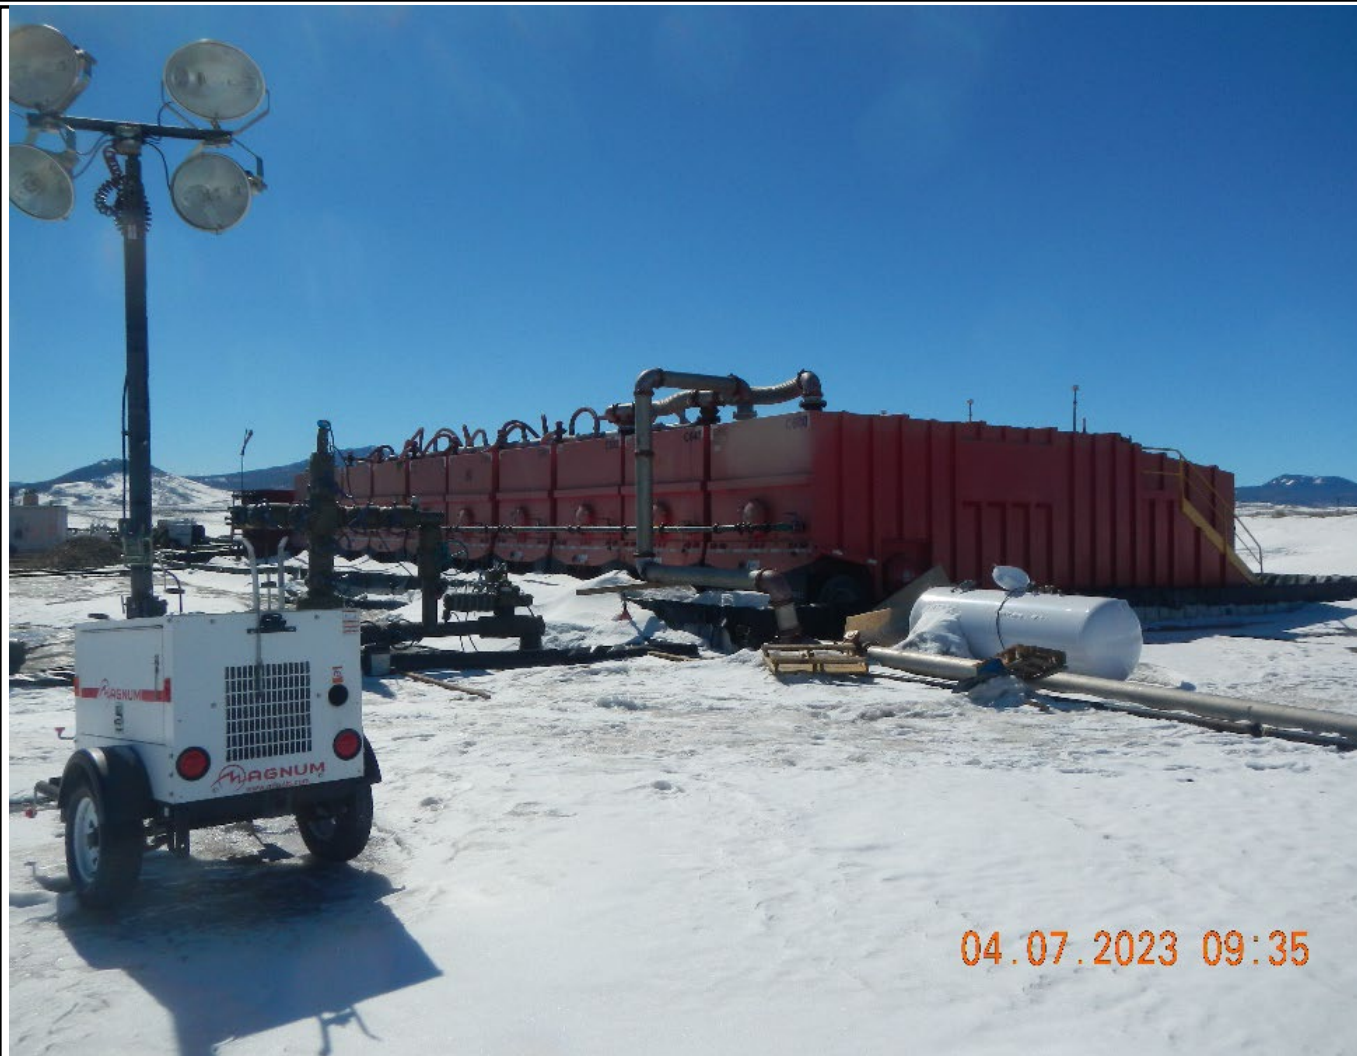
Photo #7 Recent drilled wells center left of photo. Looking ~southeast

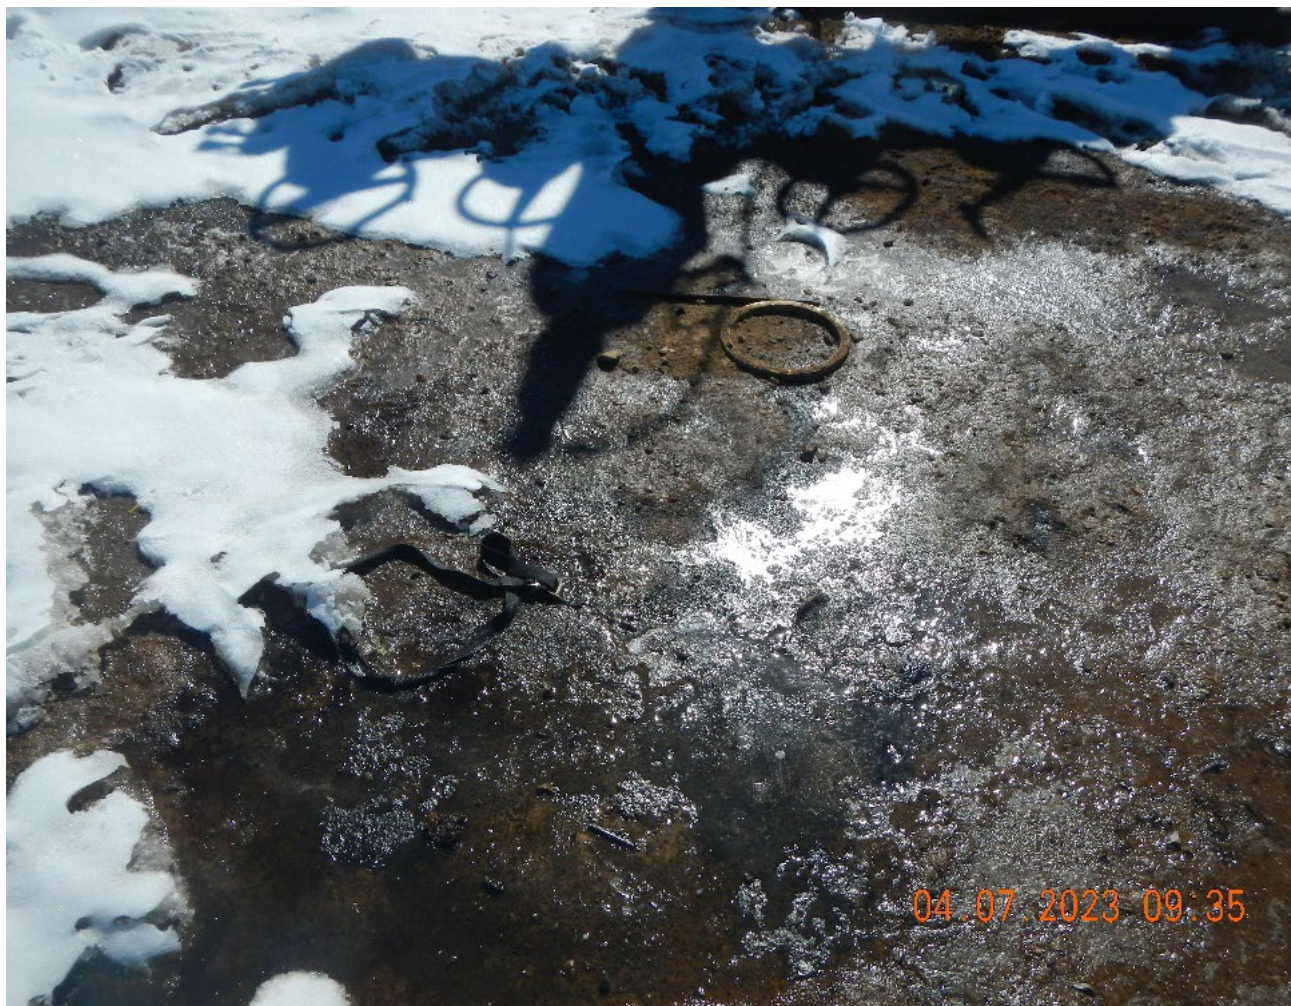
Photo #8 Stained soil near new drills. Corrective Action; This area shall be documented on a Remediation workplan (Form 27).

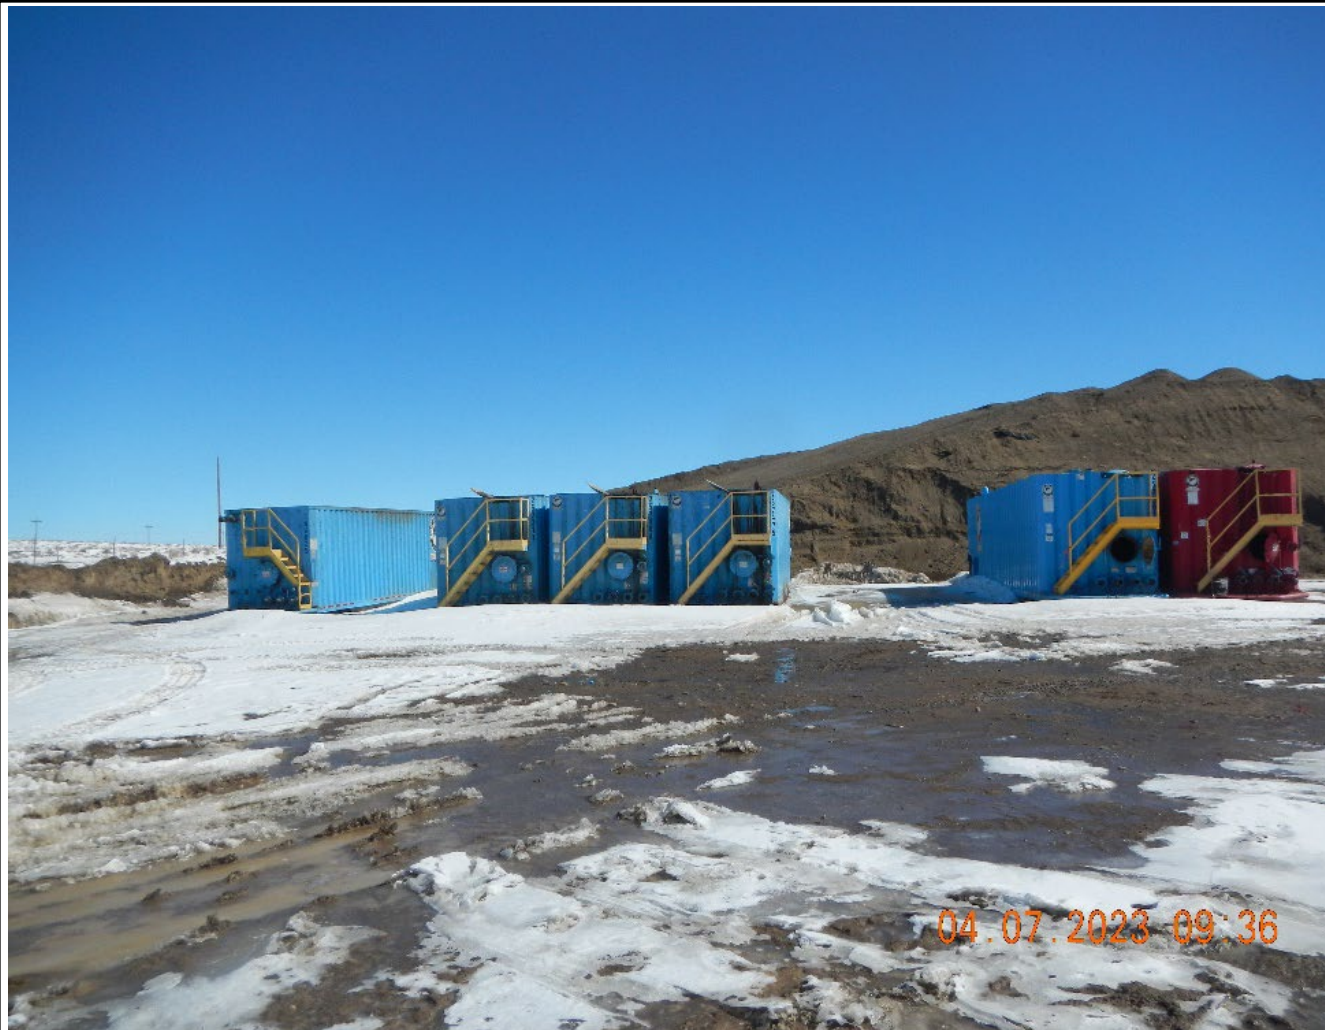
Photo #9 Frac tanks on North side of location. Appeared not plumbed. Note: cleanout hatch open on some tanks.

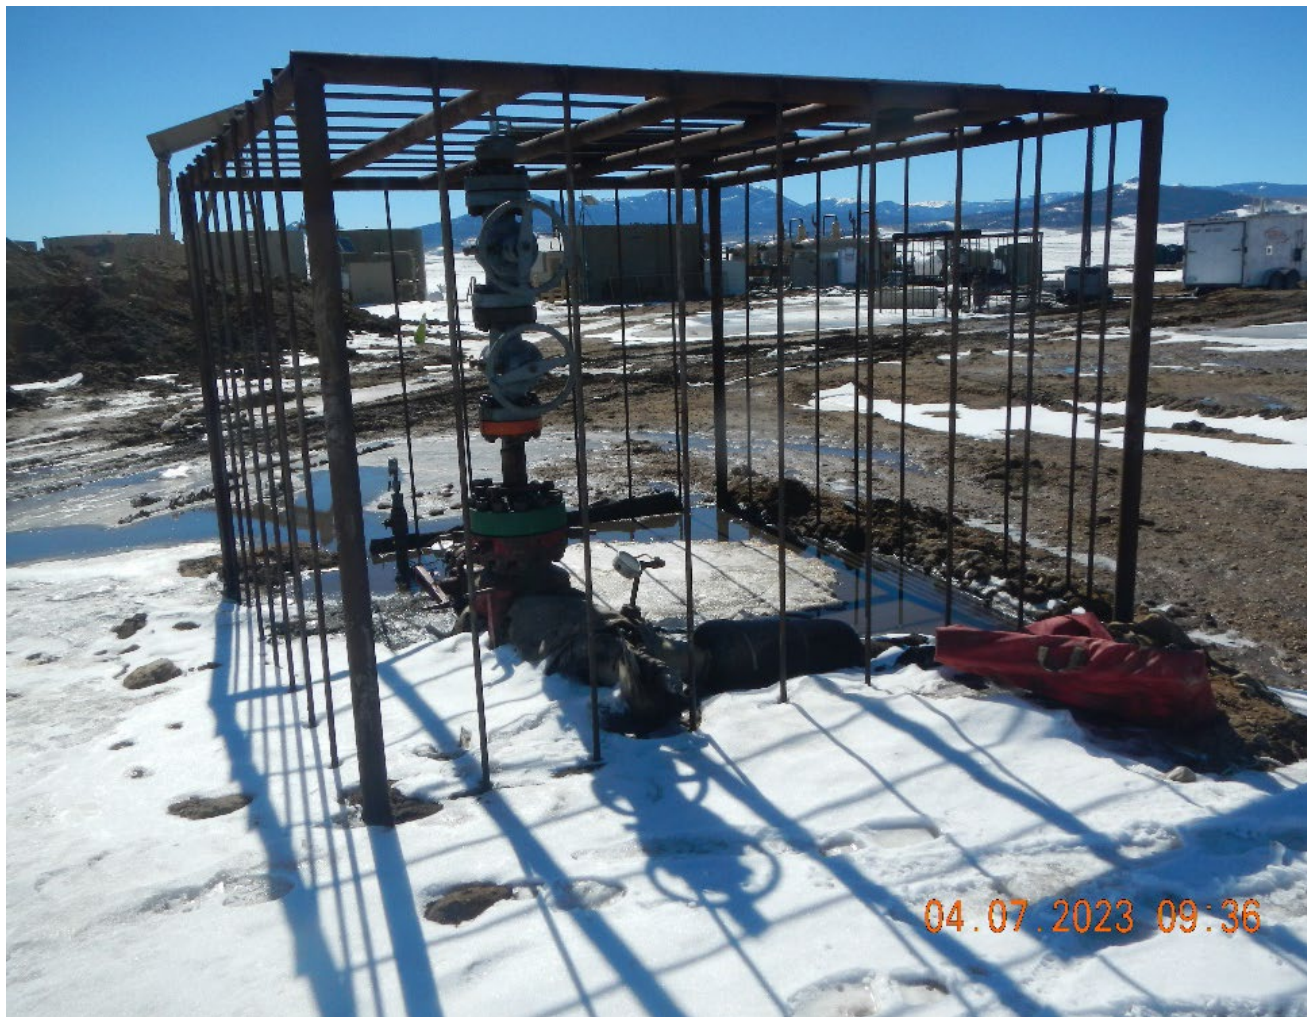
Photo #10 wellhead in cage. Oil on ground around wellhead. Well sign not present. Corrective Action; This area shall be documented on a Remediation workplan (Form 27).

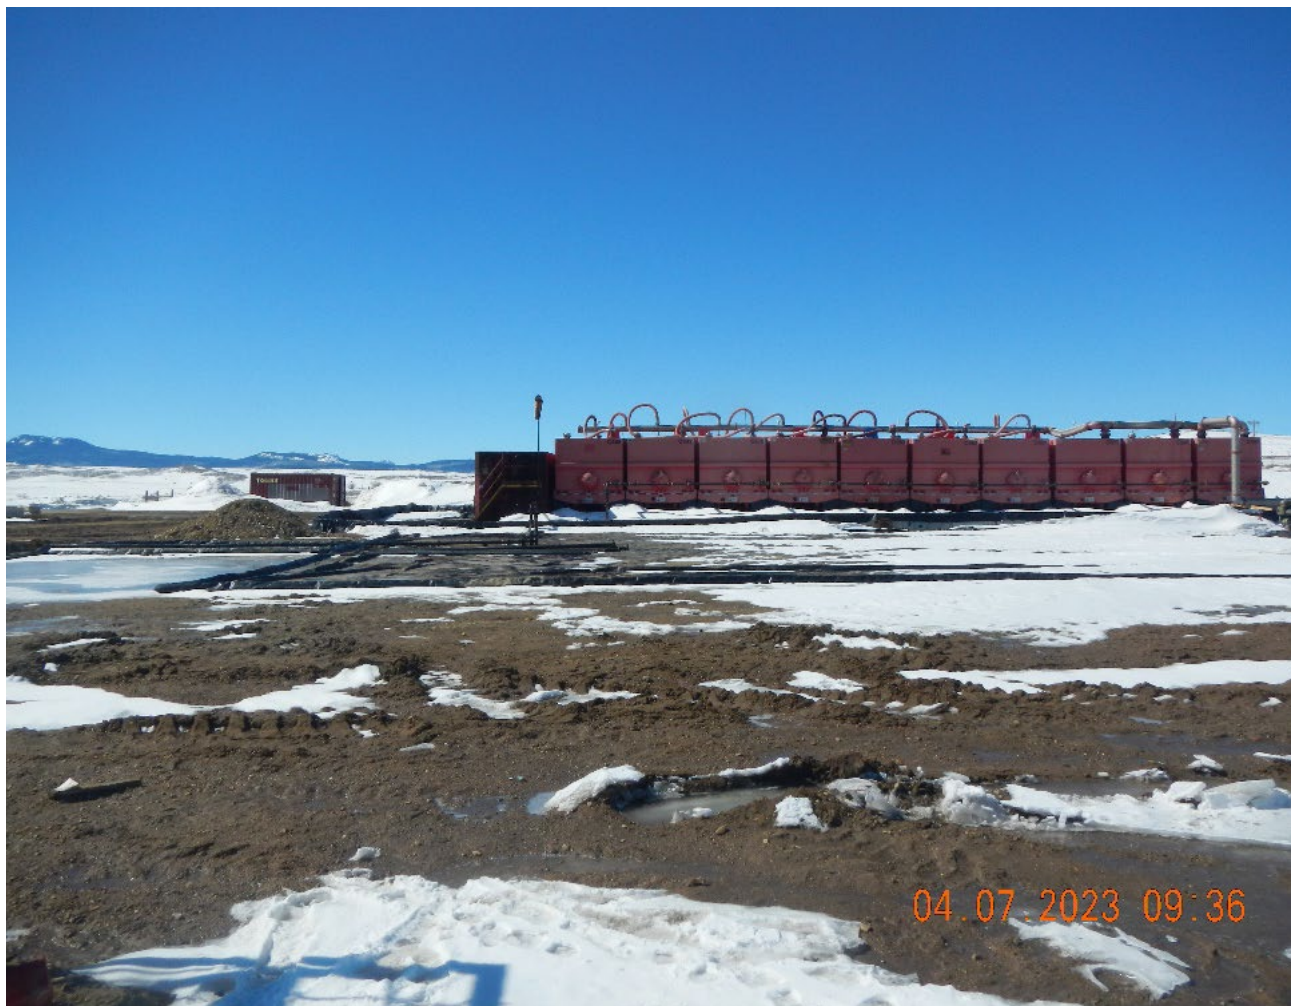
Photo #11 looking west, northwest.

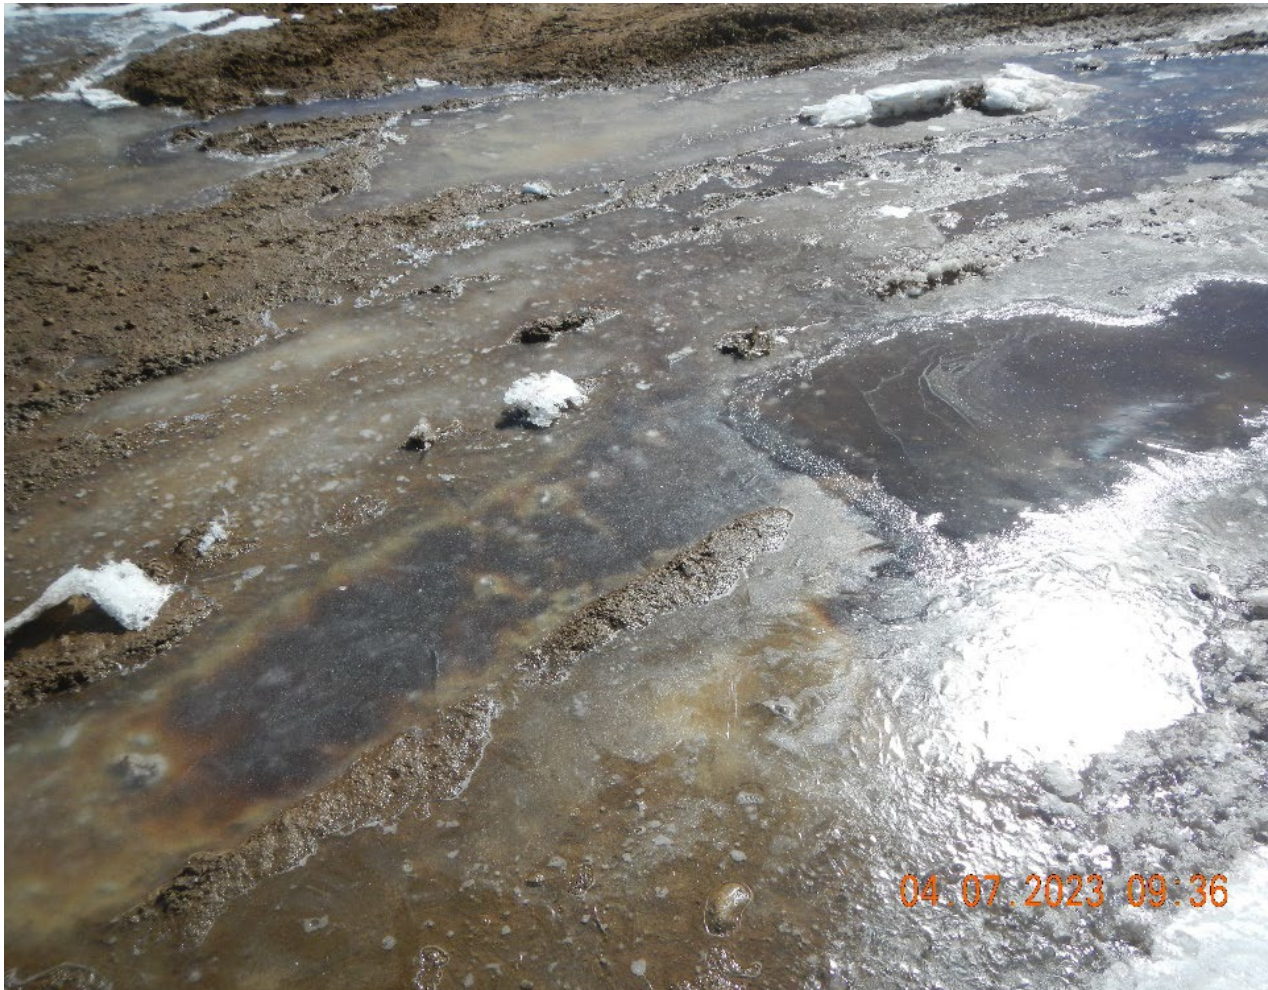
Photo #12 oil on ground near caged wellheads. Oil was on water below ice. Corrective Action; This area shall be documented on a Remediation workplan (Form 27).

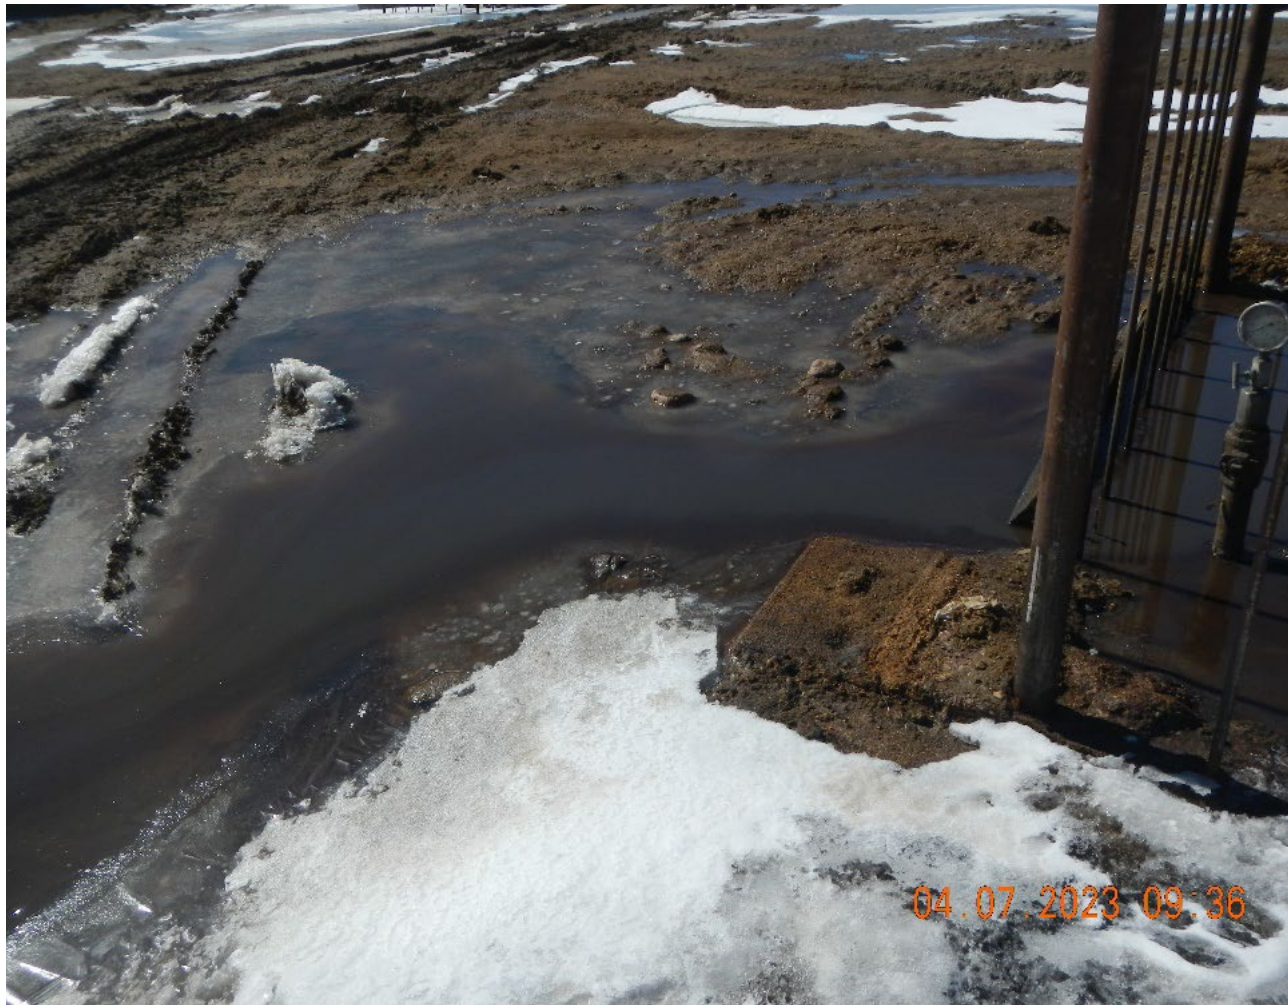
Photo #13 oil on water near caged wellhead. This is the eastern more caged well.

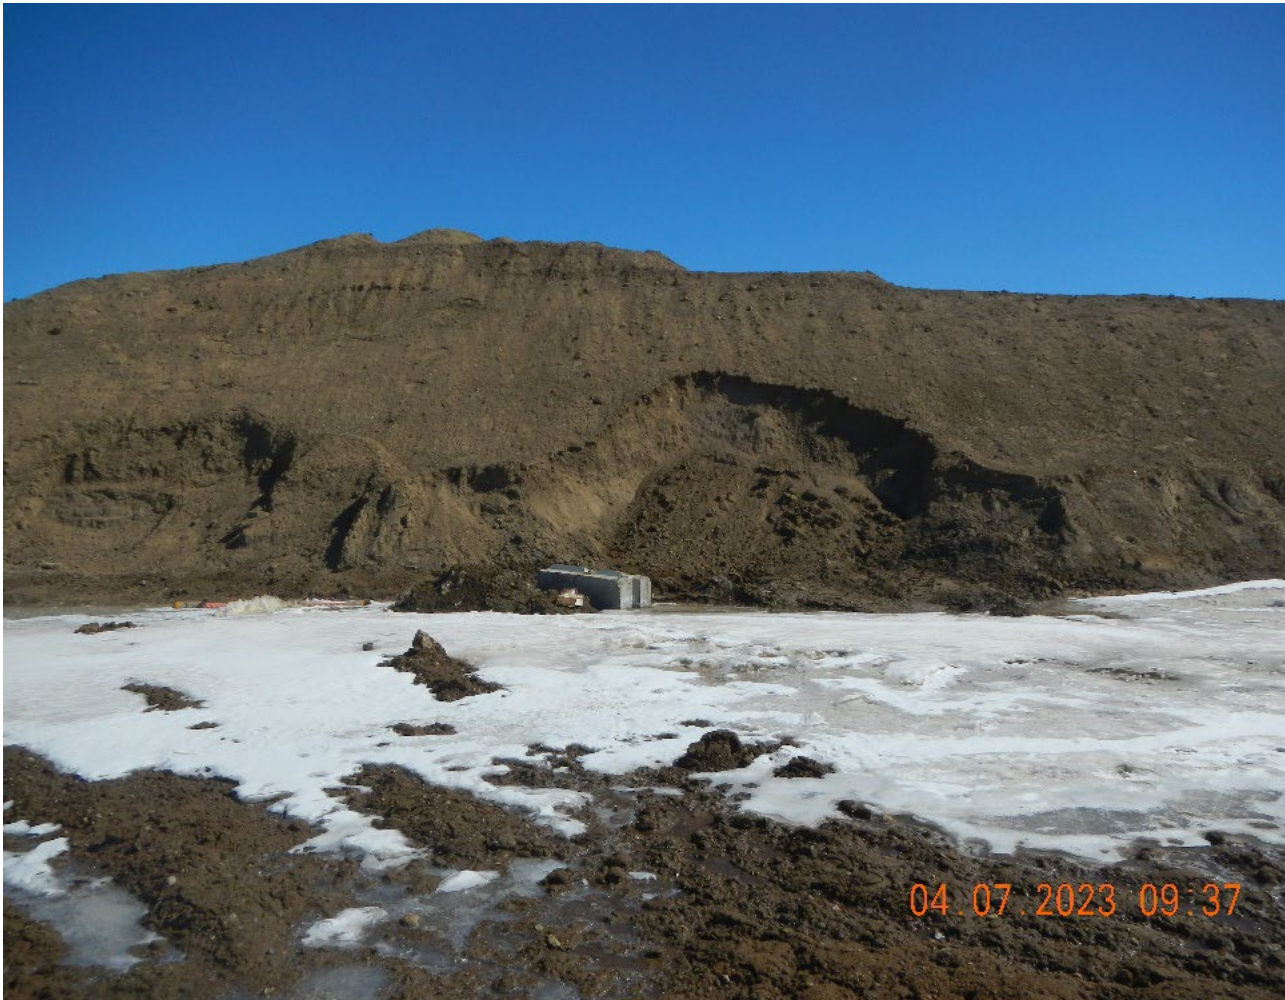
Photo #14 Overburden pile from pad construction. It appears that some of the stockpiled soil has been removed or sluffed off. This pile should be maintained properly to prevent soil migration, erosion or slope failure. This is potentially dangerous to personal on location.

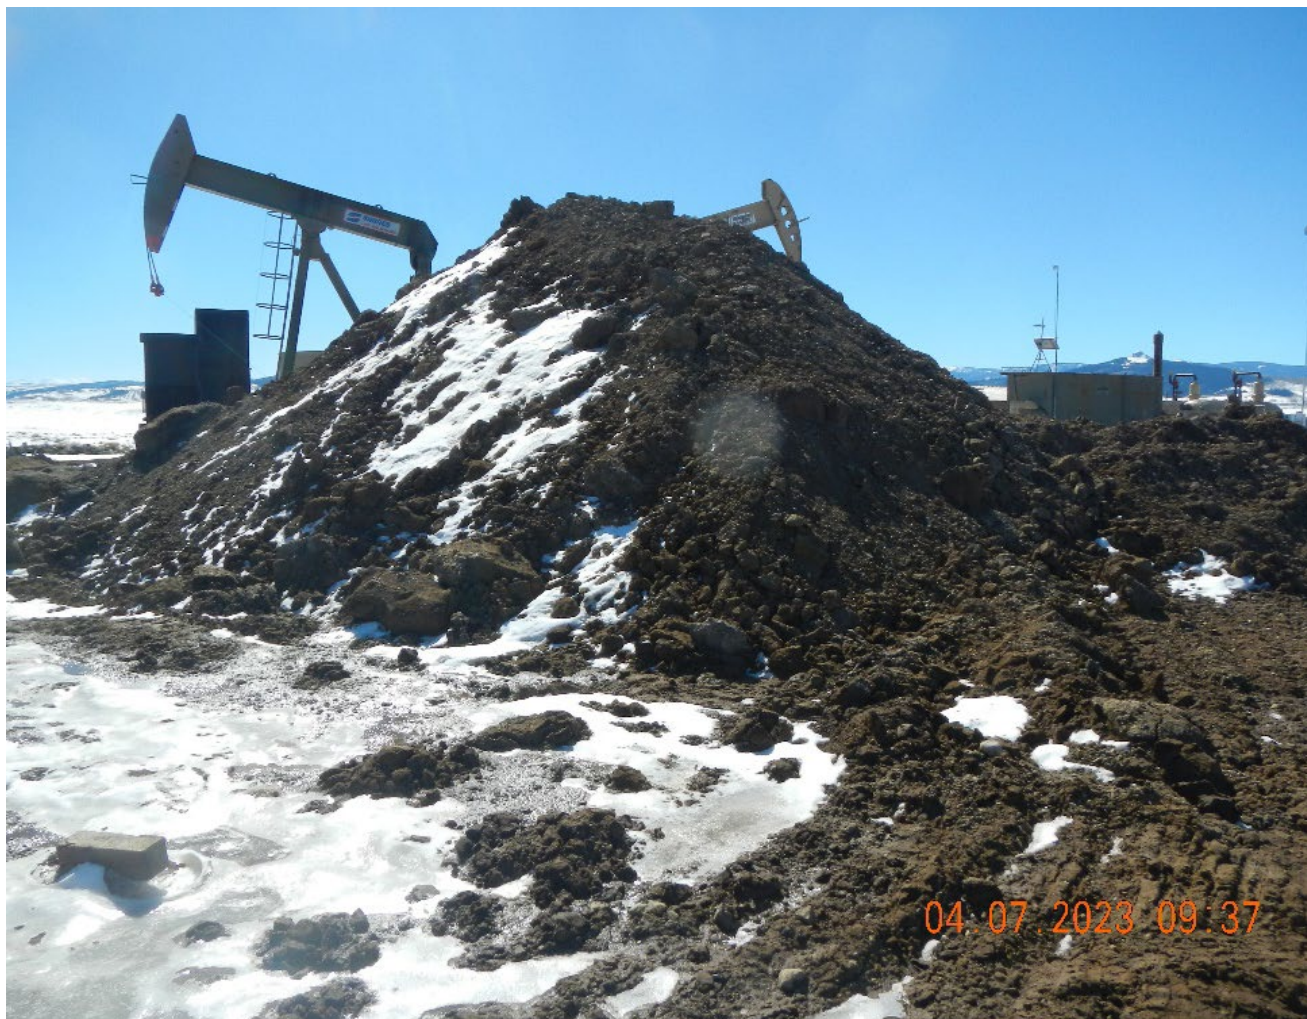
Photo #15 Stockpiled soil and stored equipment. This pile has surface water comingled. The surface water sediment controls on location appear to have been bermed off. Corrective Action; This area shall be documented on a Remediation workplan (Form 27). So

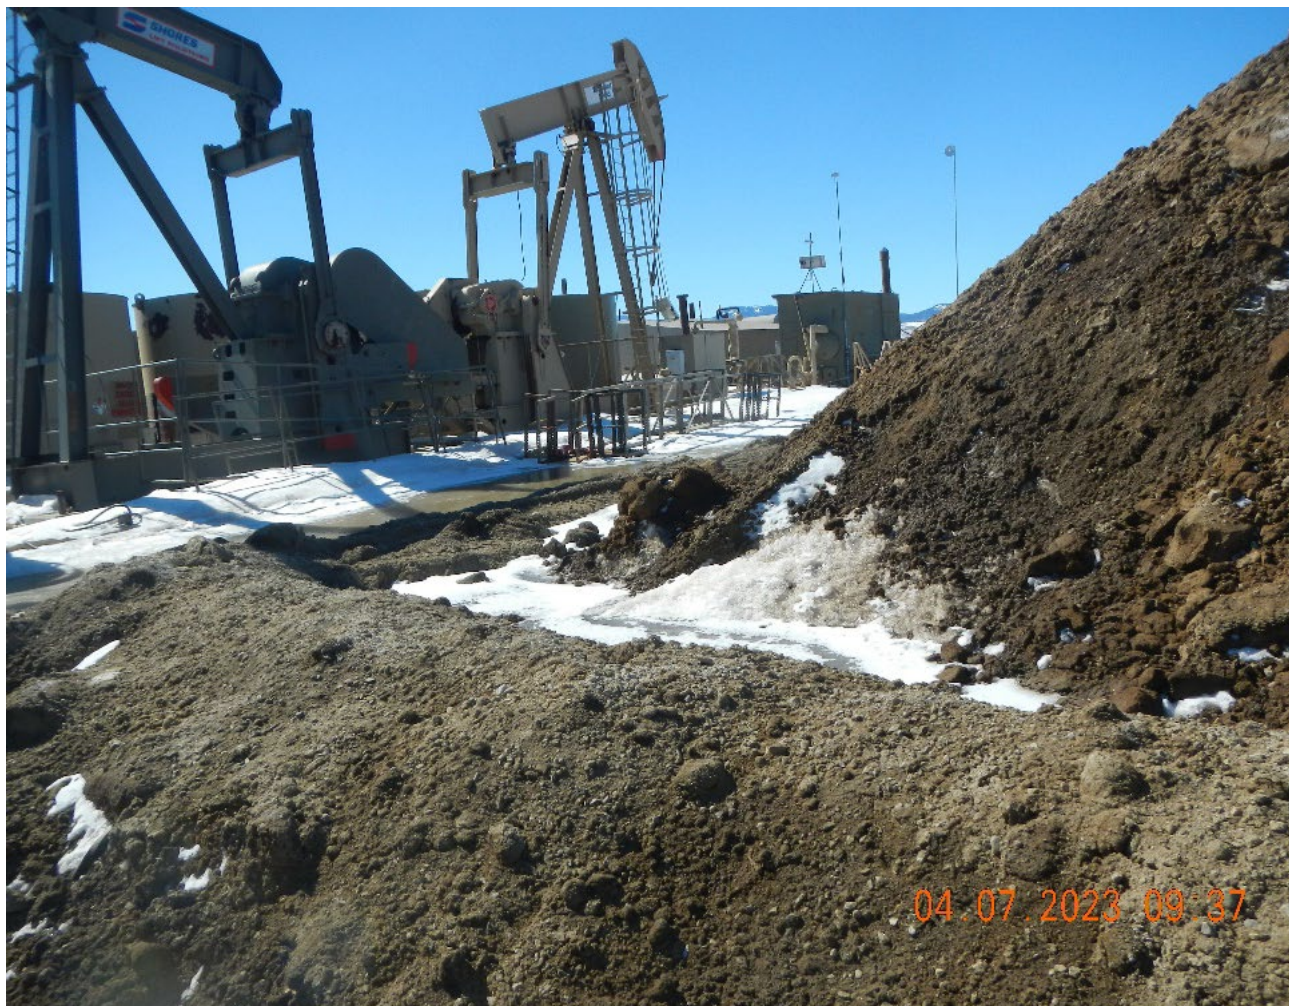
Photo #16 berm around stock piled soil. The berm material appears to be a gray color (drill cuttings?). Production equipment in background is currently stored on this northeast side of pad. Stockpiling of soils in exceedance of Table 915-1 is a violation of Rule 905.a. Soil shall be disposed of as E&Pw waste, pad below delineated, as a part of the forthcoming Remediation Project.

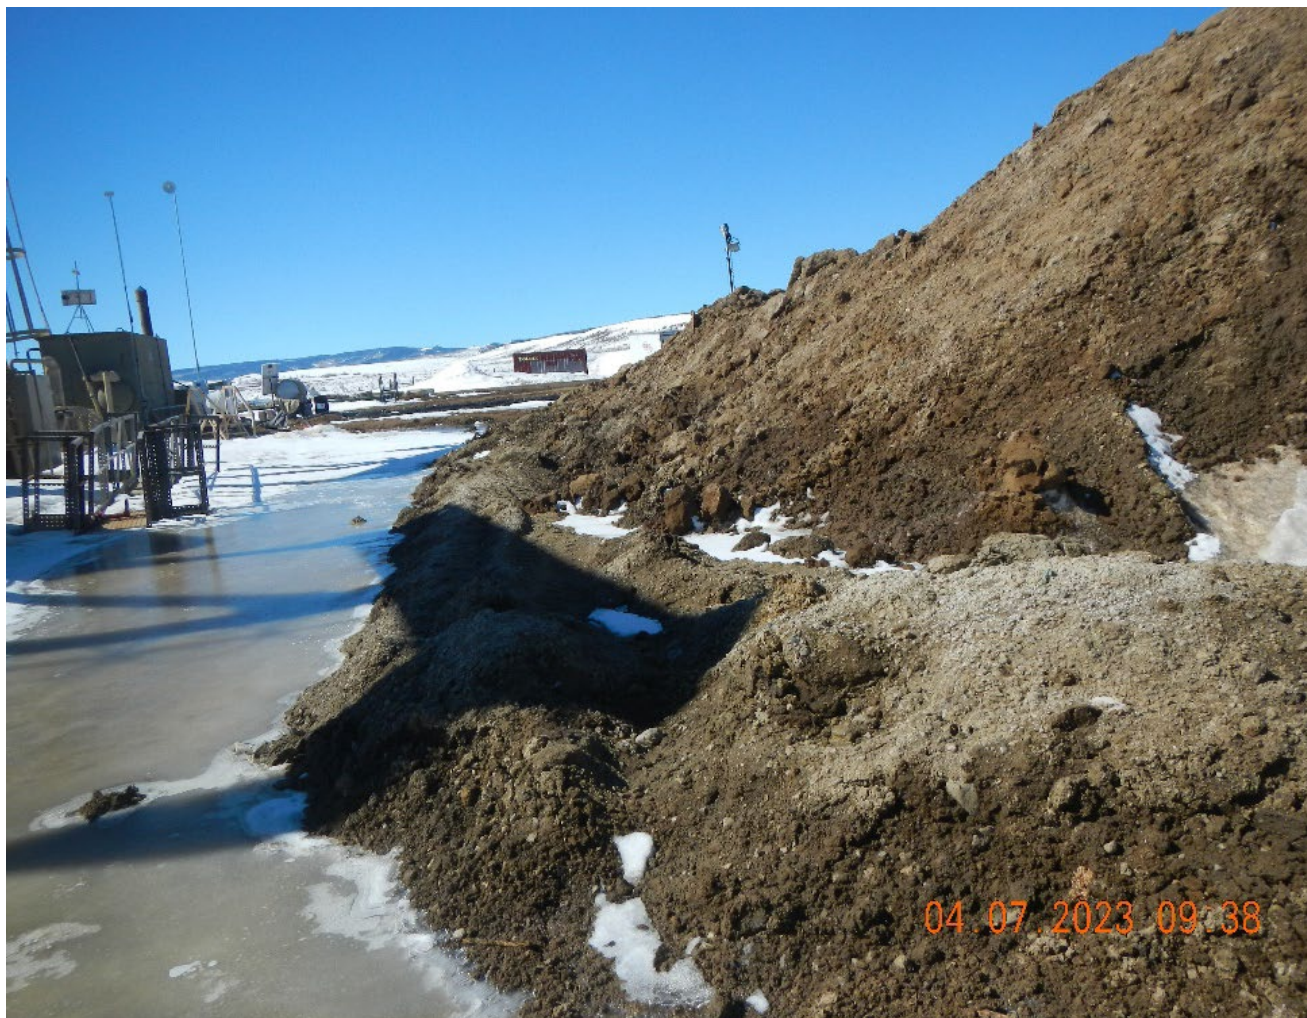
Photo #17 looking south-southwest. Water is pooling on left of photo. It appears that the stormwater sediment trap it bermed off. Fulcrum staff has told this inspector that they plan on removing stormwater via vac truck rather than discharge to the surface.
