Inspection Photos
location: 416625
Inspection
Date:4/7/2023

COLORADO
Oil & Gas Conservation
Commission
Department of Natural Resources

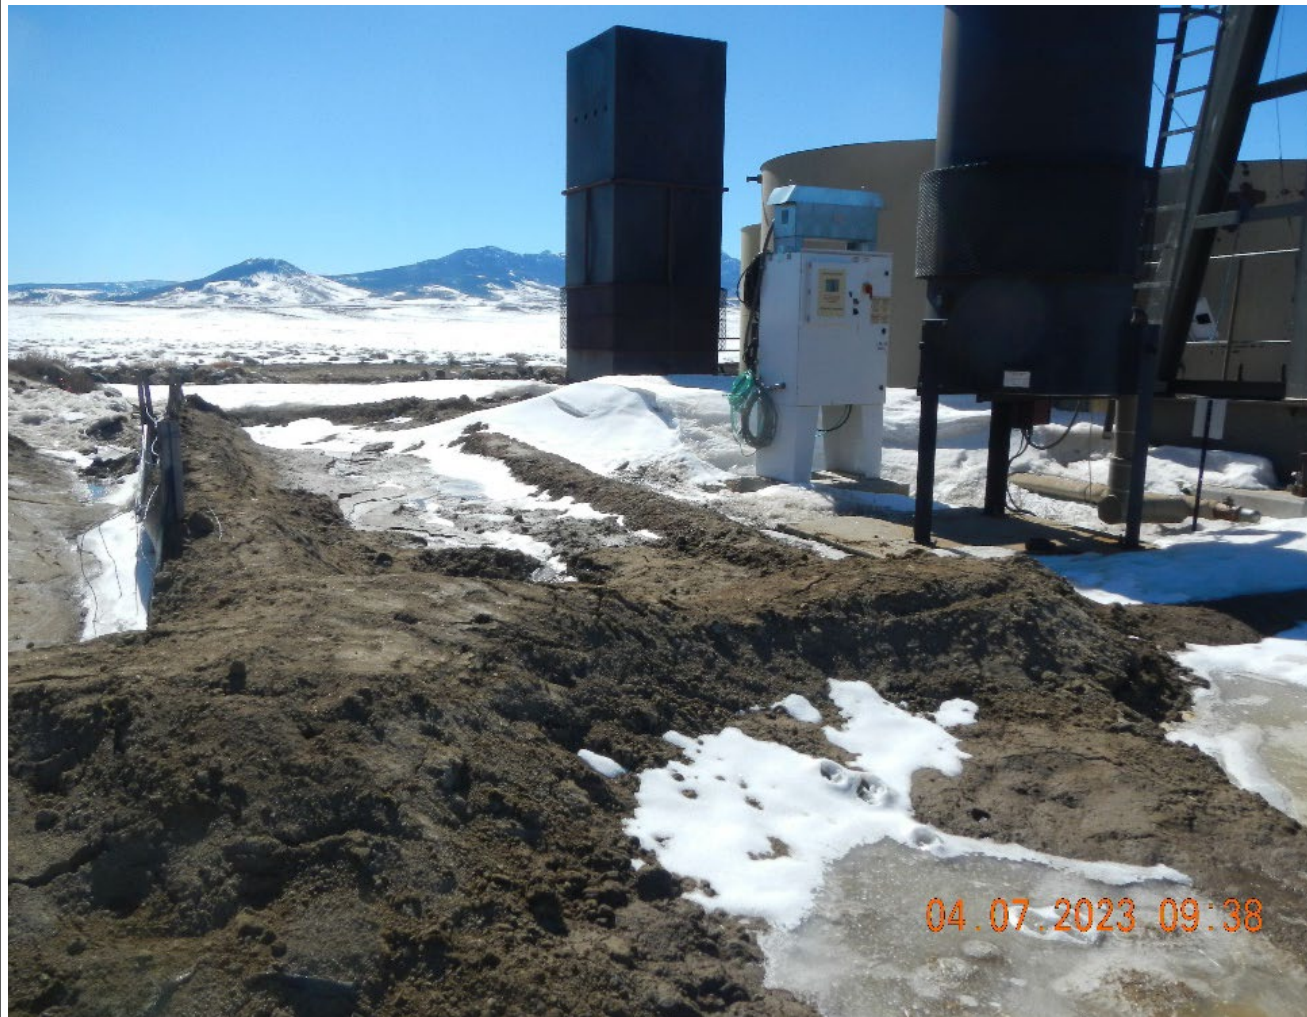
Photo #18 berm at front of photo is preventing pad water from entering discharge sediment trap.

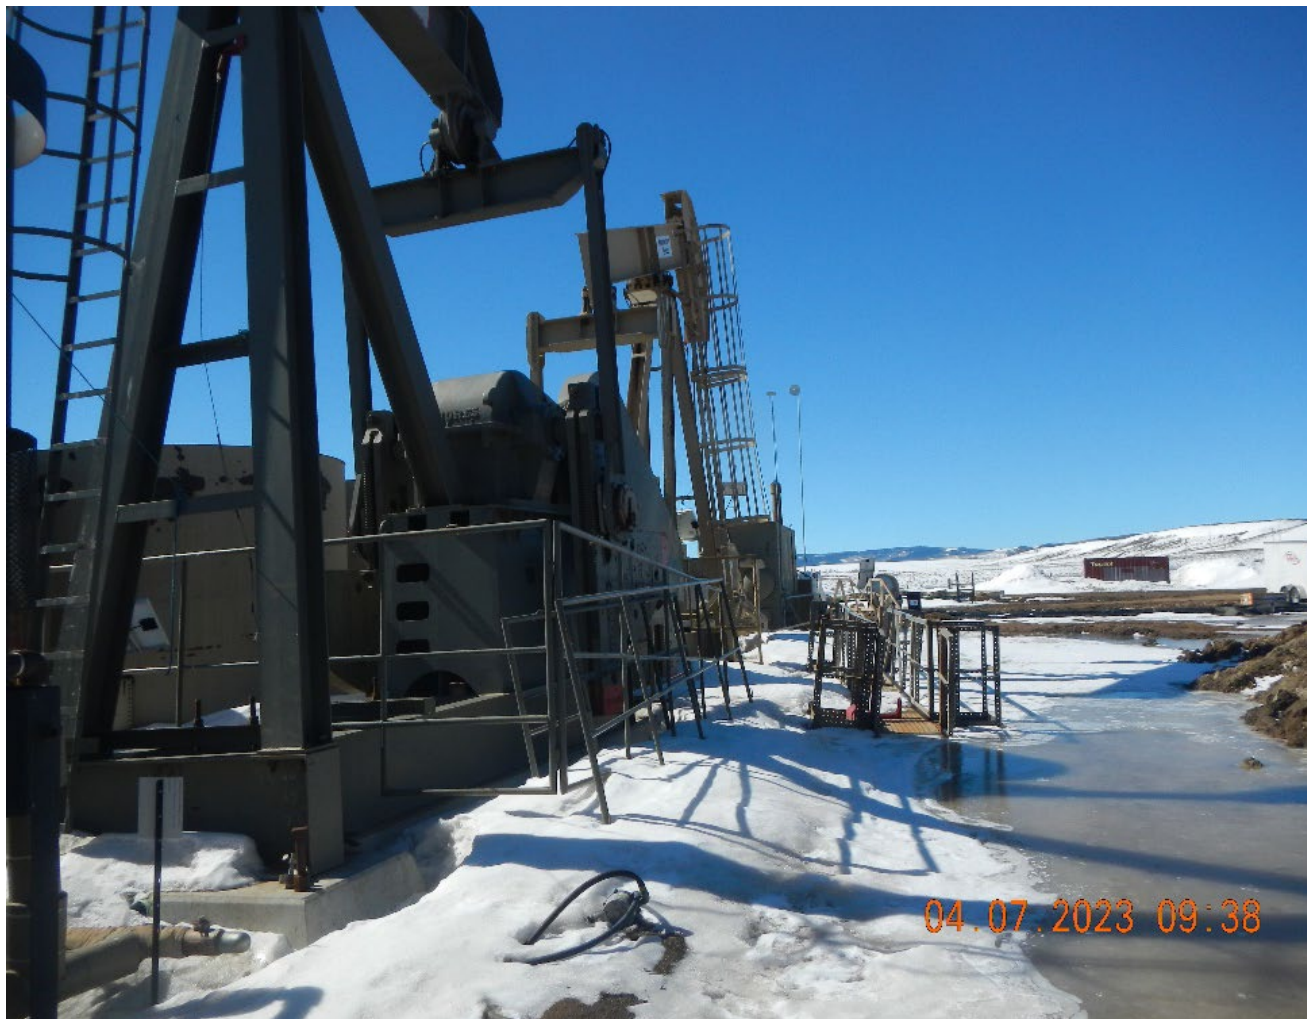
Photo #19 similar photo to #17.

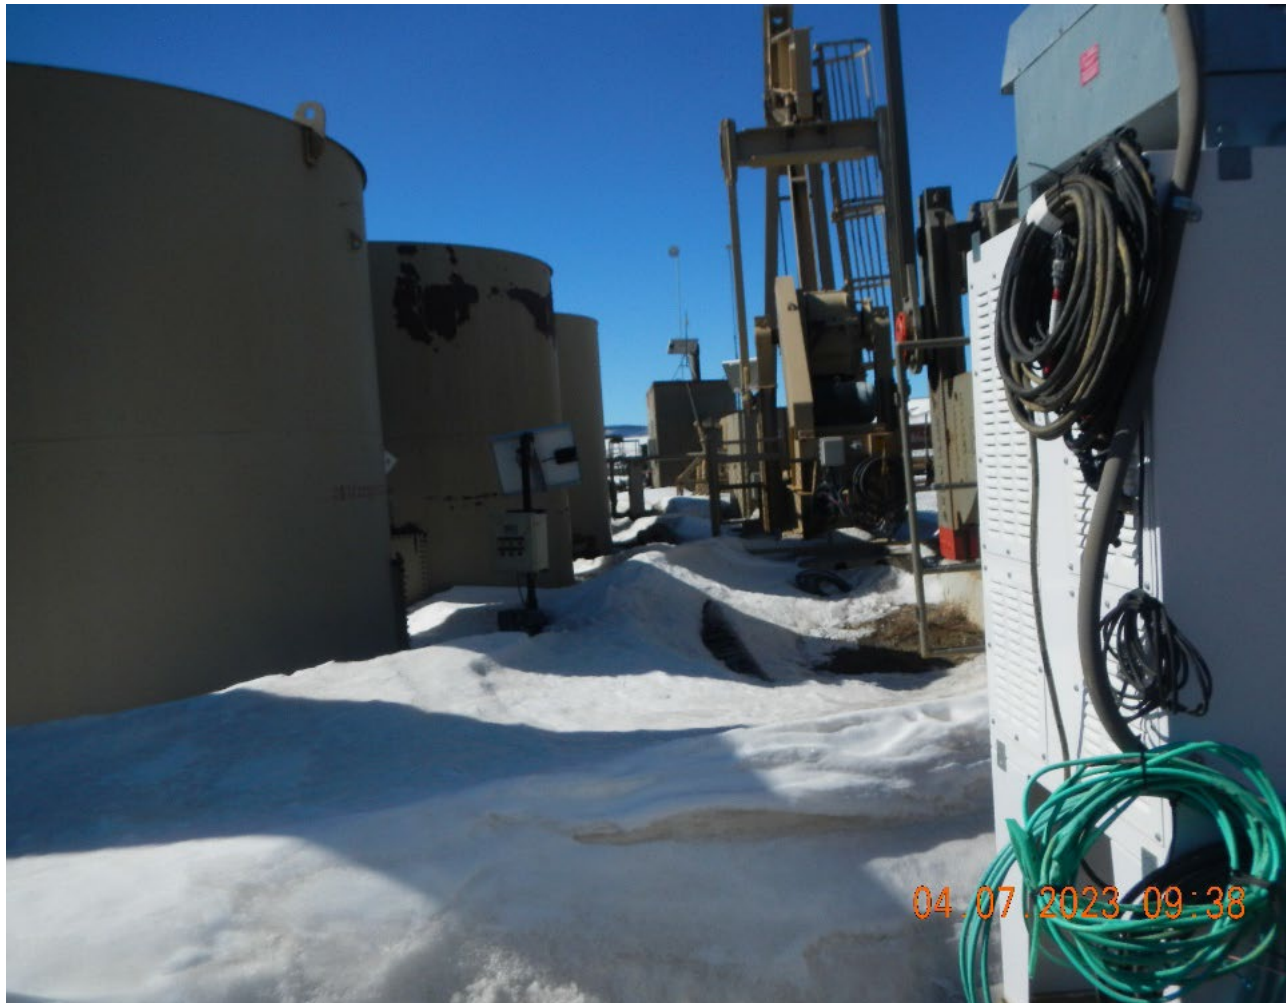
Photo #20 Old production tanks. These tanks are not in service. Stored on pad.

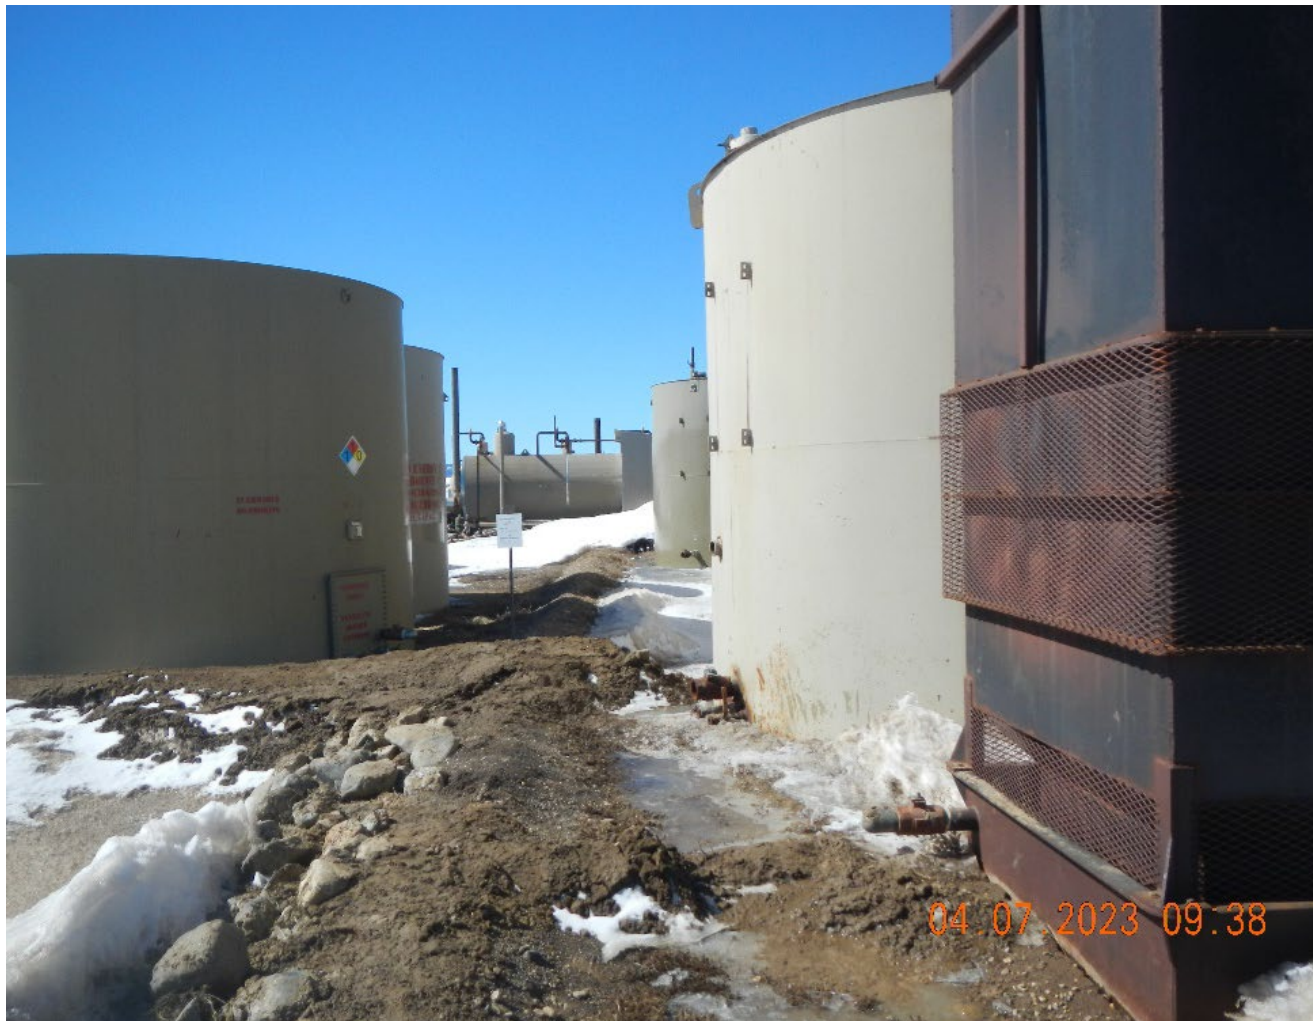
Photo #21 mostly out of service equipment.

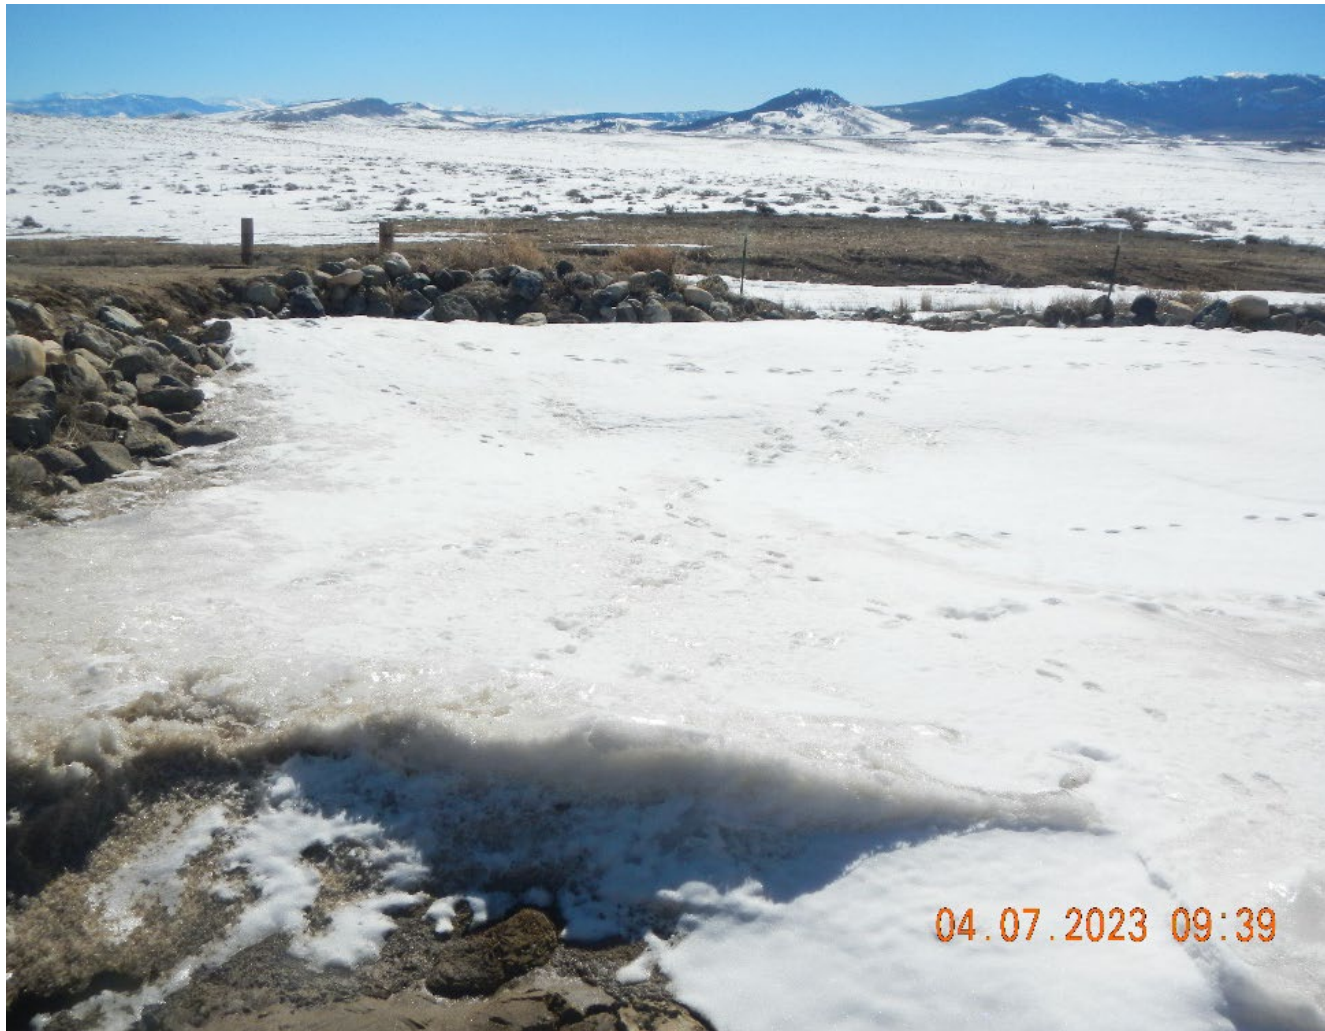
Photo #22 sediment trap on north east corner of location. Corrective Action: Stormwater feature shall be monitored as a part of normal operations.

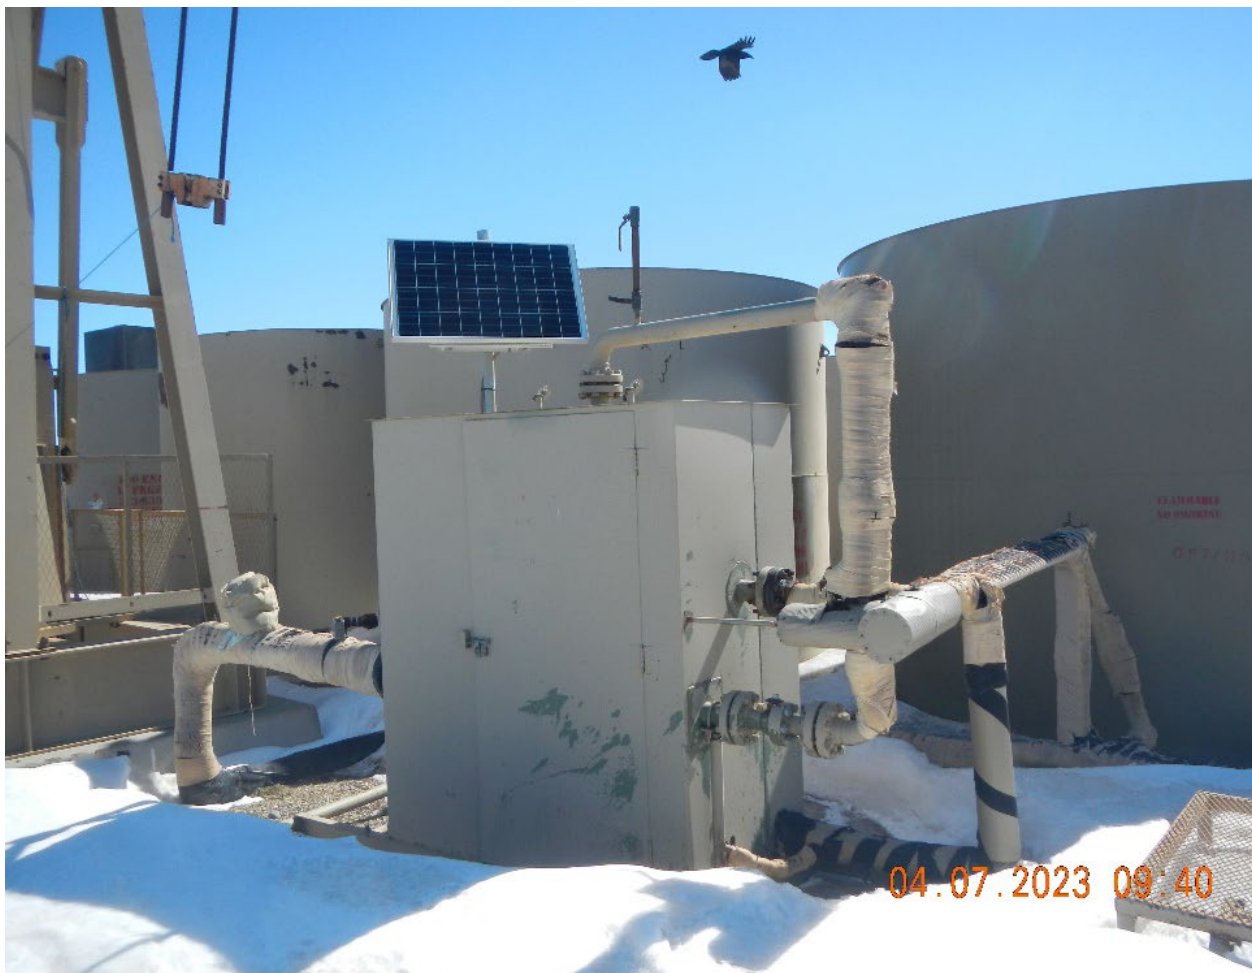
Photo #23 Birds are beginning to nest in equipment.

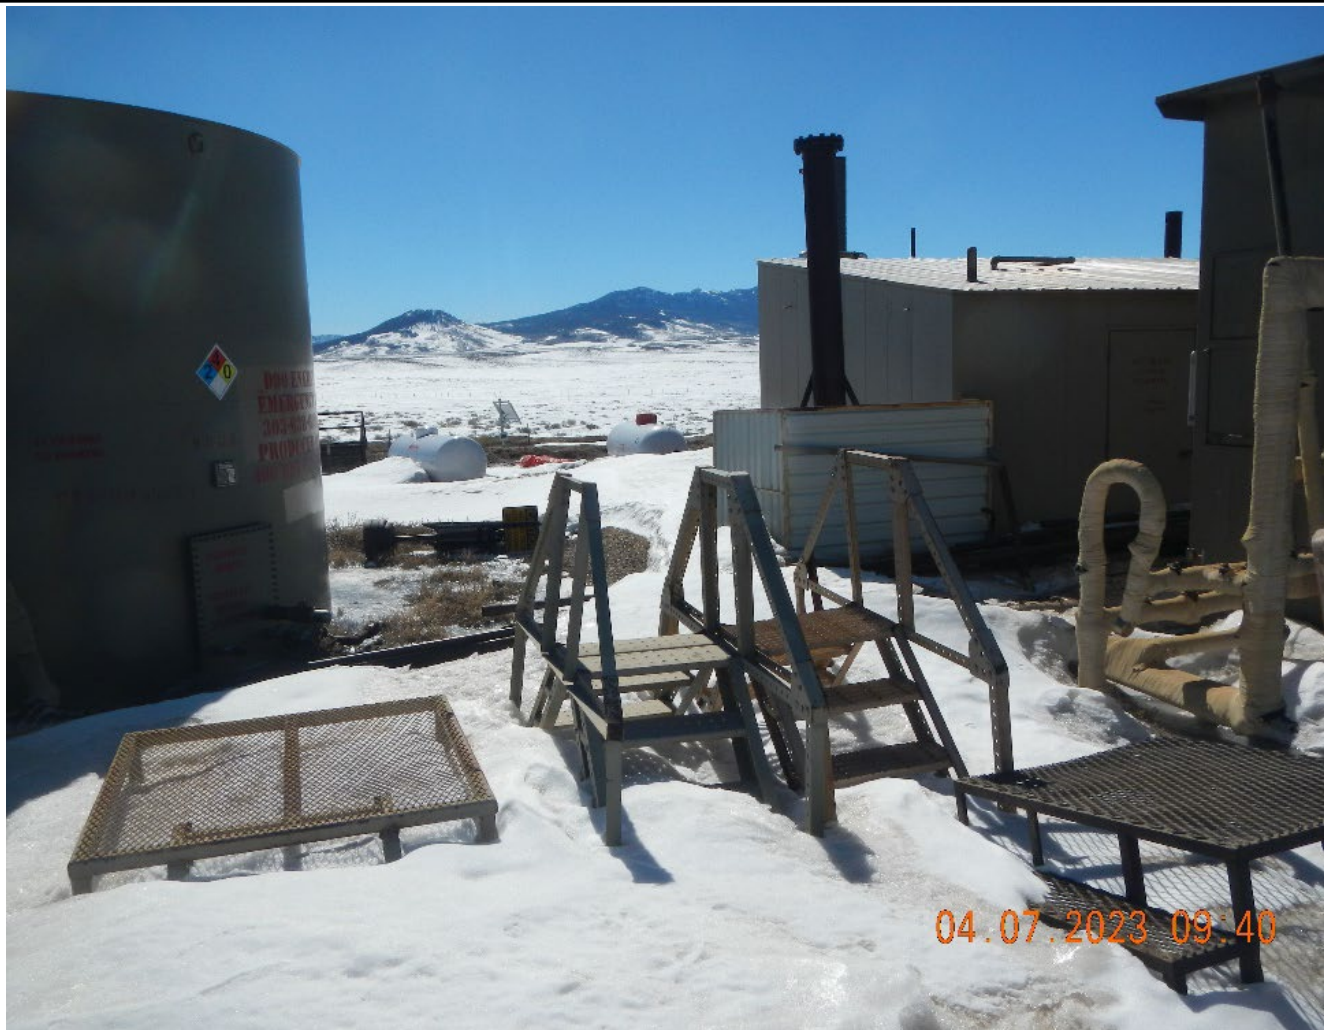
Photo #24 equipment on northeast side of location, not in use.

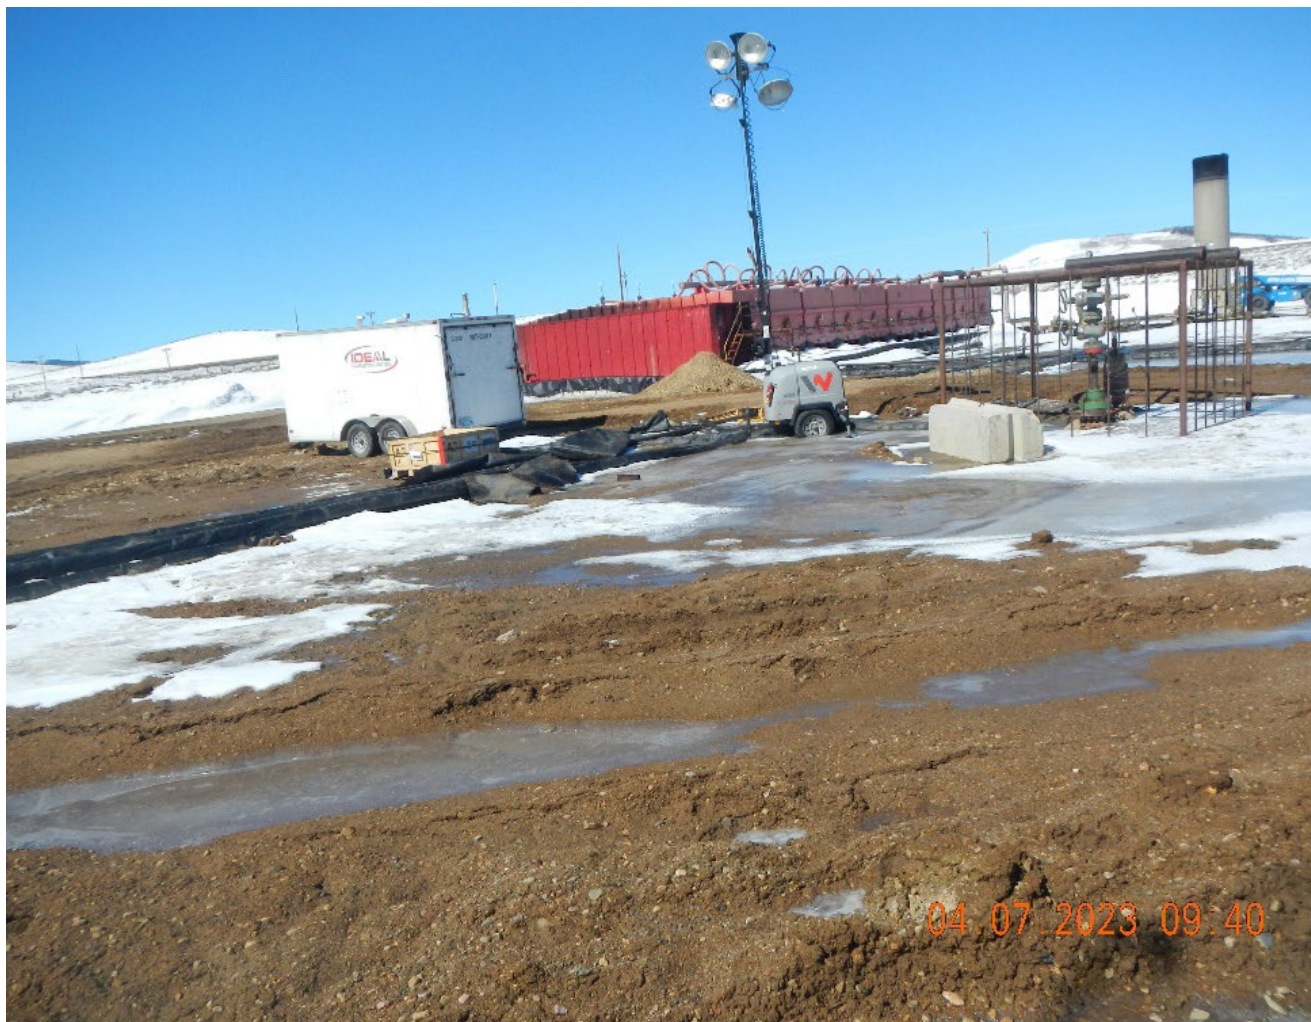
Photo #25 Wellhead inside cage is the Surprise 4-06. Note the location of the Lite plant.

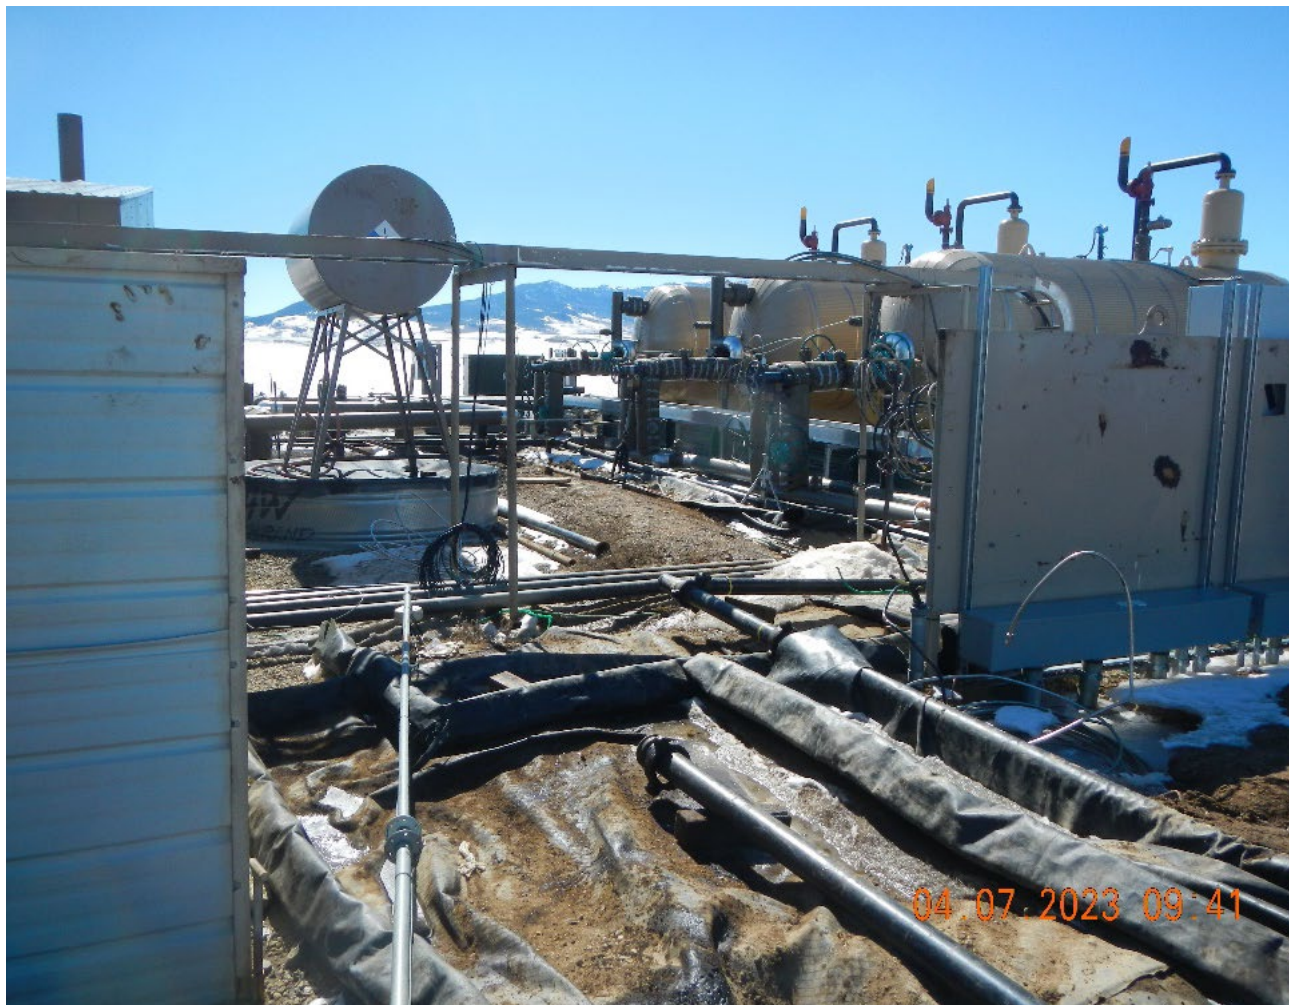
Photo #26 equipment in use on southeast side of pad. In the area of the old tank battery.

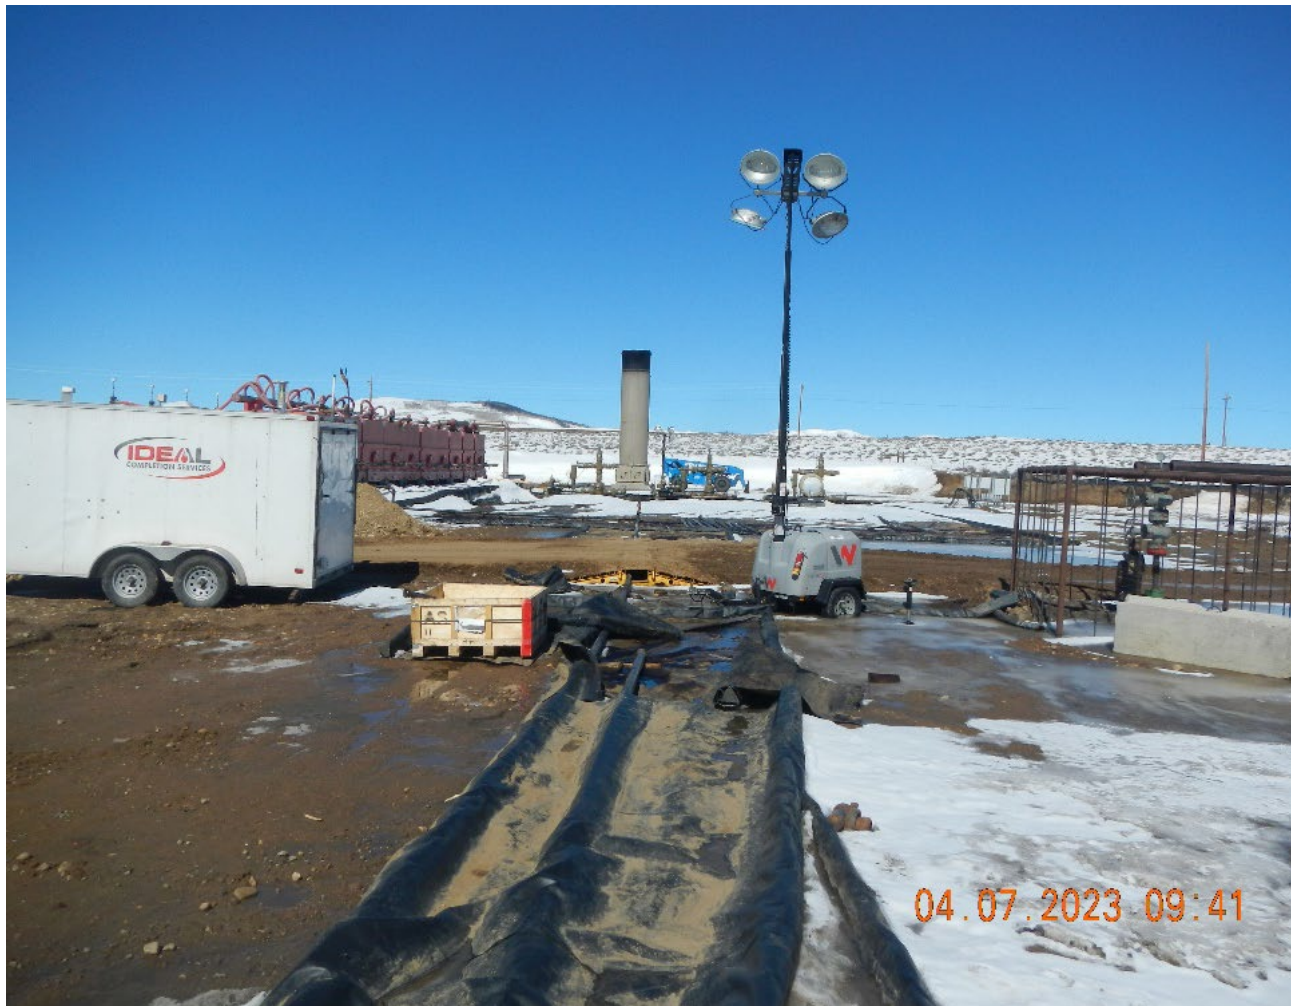
Photo #27 Surprise well.

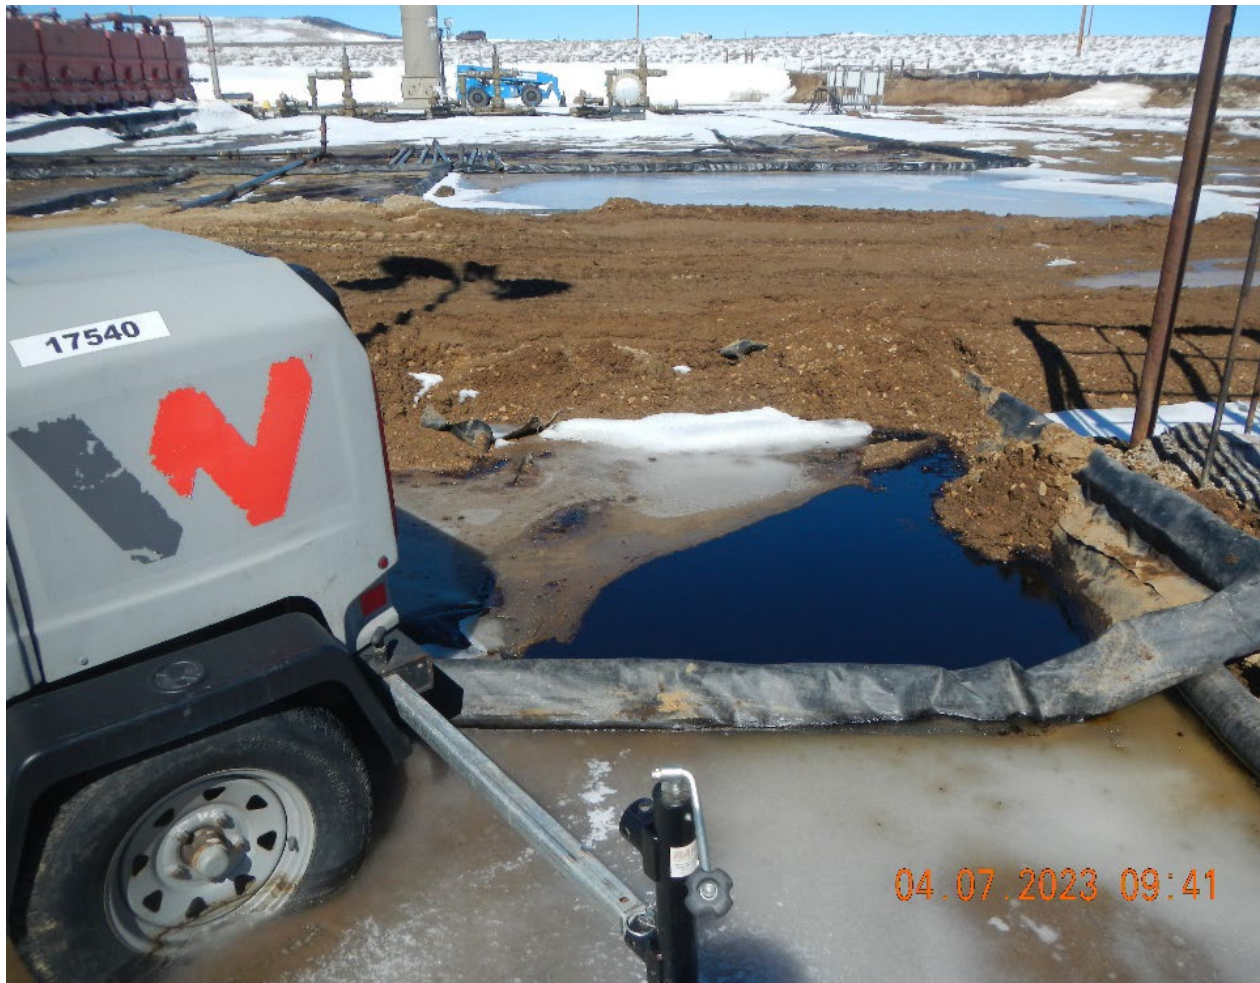
Photo #28 light plant and surprise well cage on right. Note spilled fluid. Corrective Action; This area shall be documented on a Remediation workplan (Form 27).

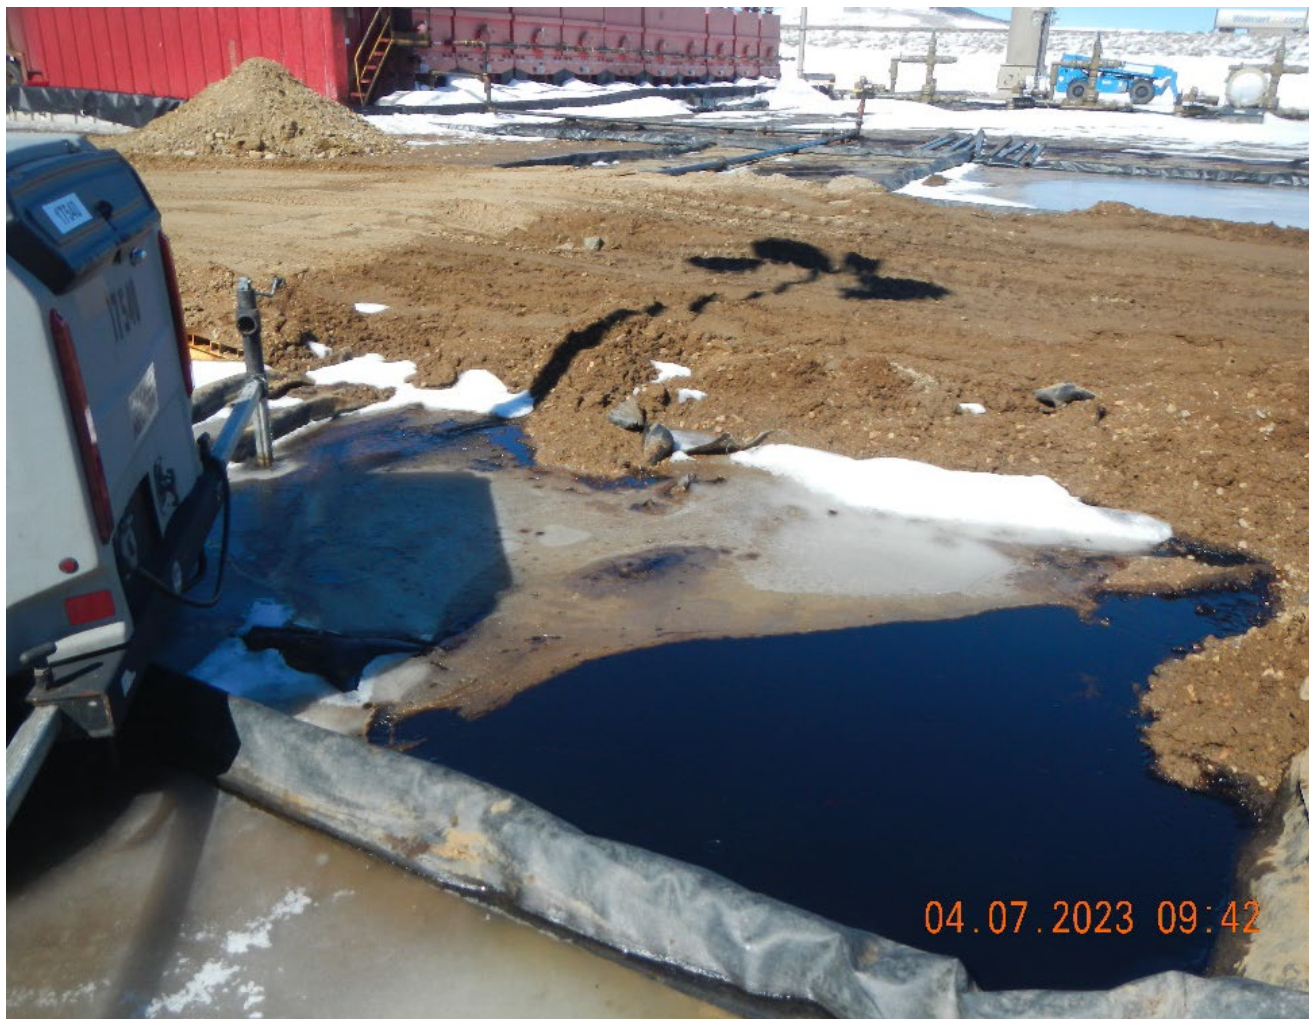
Photo #29 another view of #28 , This spill is adjacent to the Surprise wellhead. Corrective Action; This area shall be documented on a Remediation workplan (Form 27).

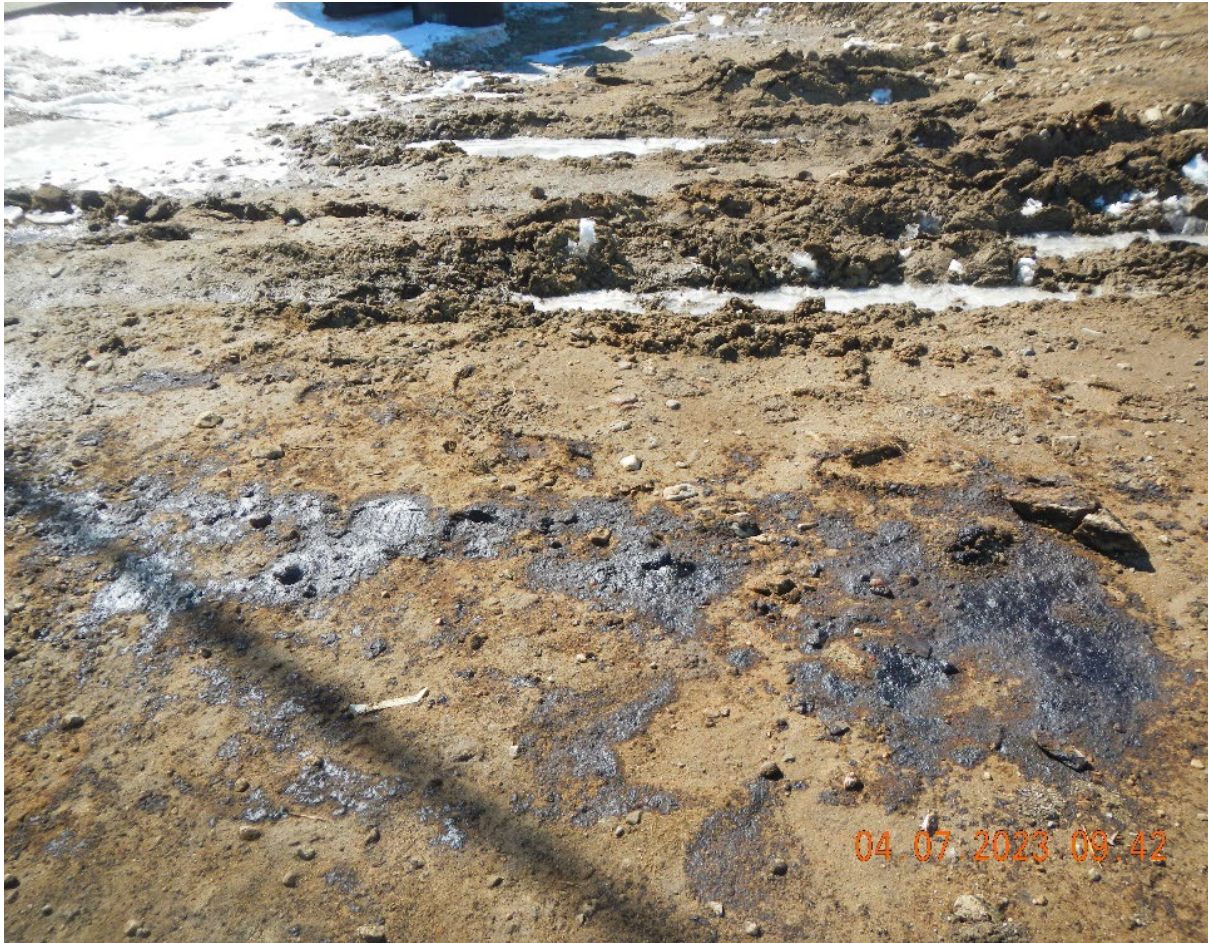
Photo #30 spill on ground. Corrective Action; This area shall be documented on a Remediation workplan (Form 27).

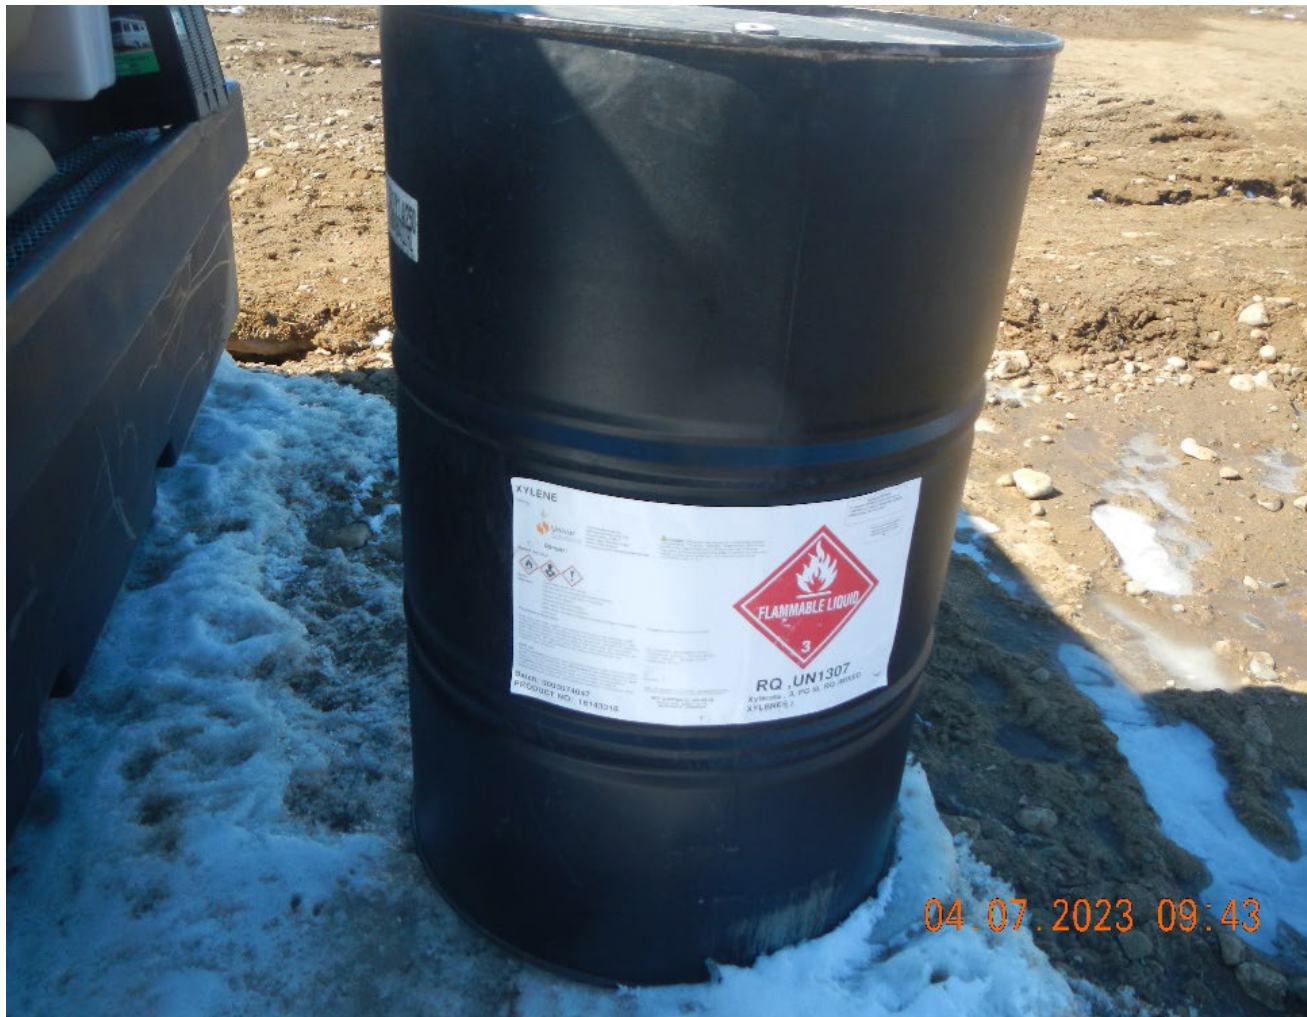
Photo #31 drum of Xylene. Appeared to have fluid inside drum. Sitting on pad. The operator shall provide COGCC staff internal SOP's regarding the handling and storage of this material.

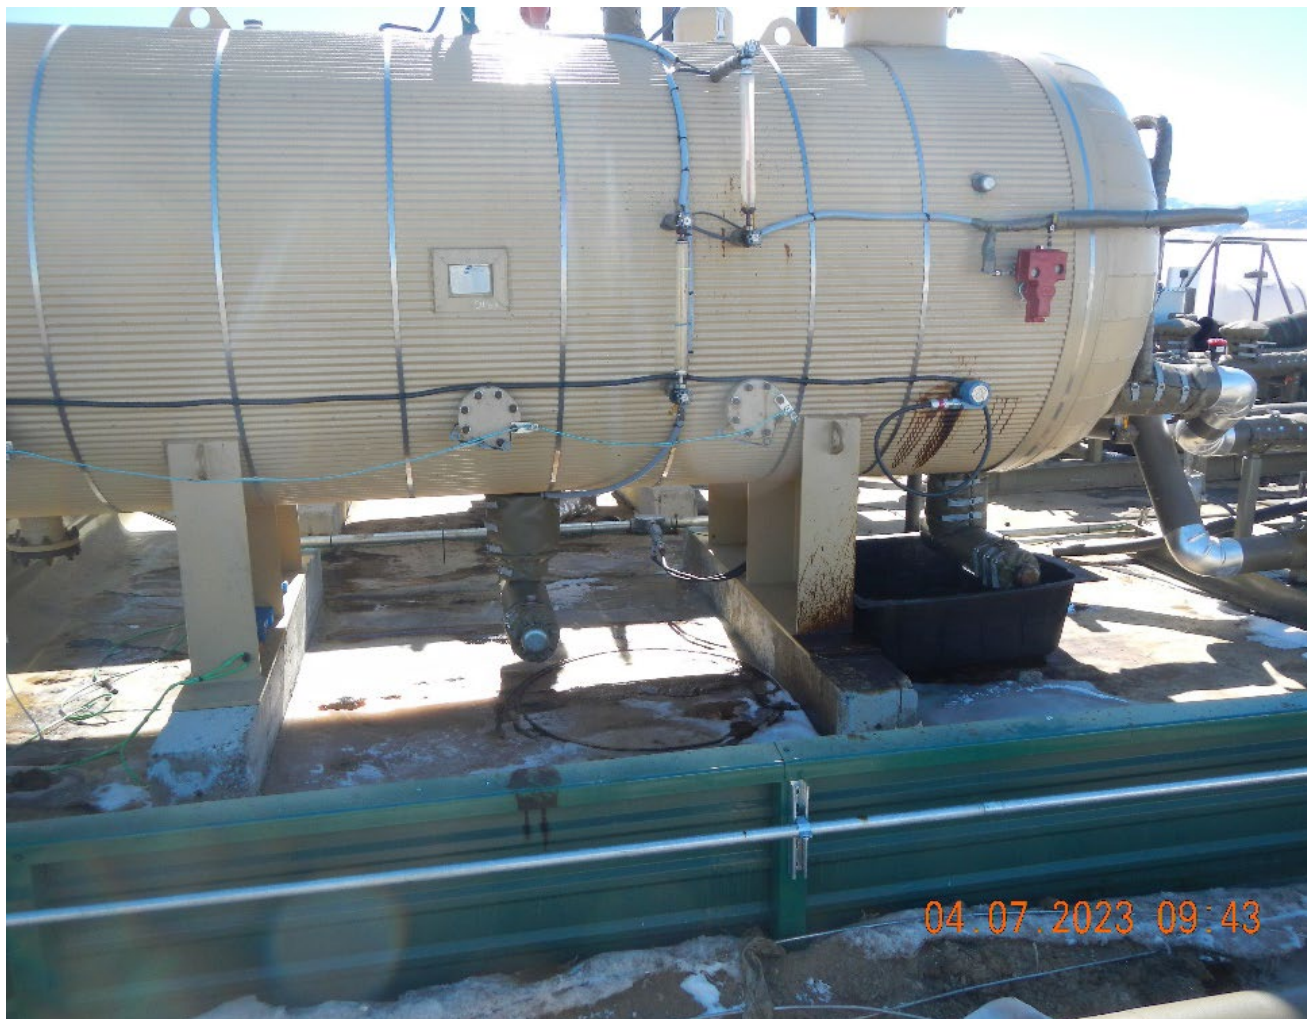
Photo #32 production equipment.

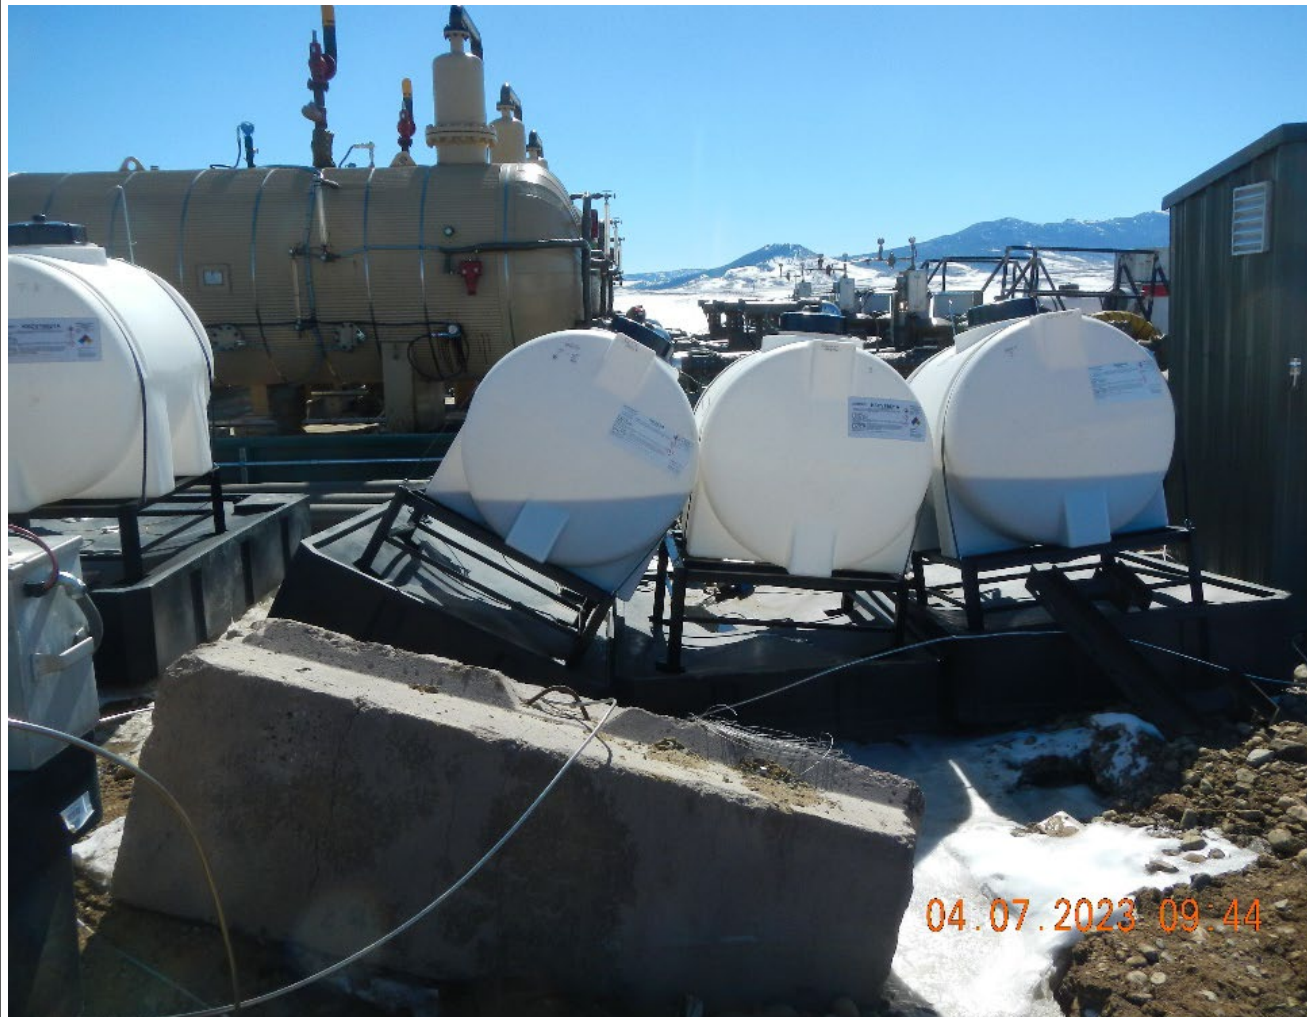
Photo #33 injection pumps. It sounded like the pumps were injecting. It does not appear that the secondary containment of these tanks will work as designed. Corrective Action: Restore secondary containment to injection pumps.

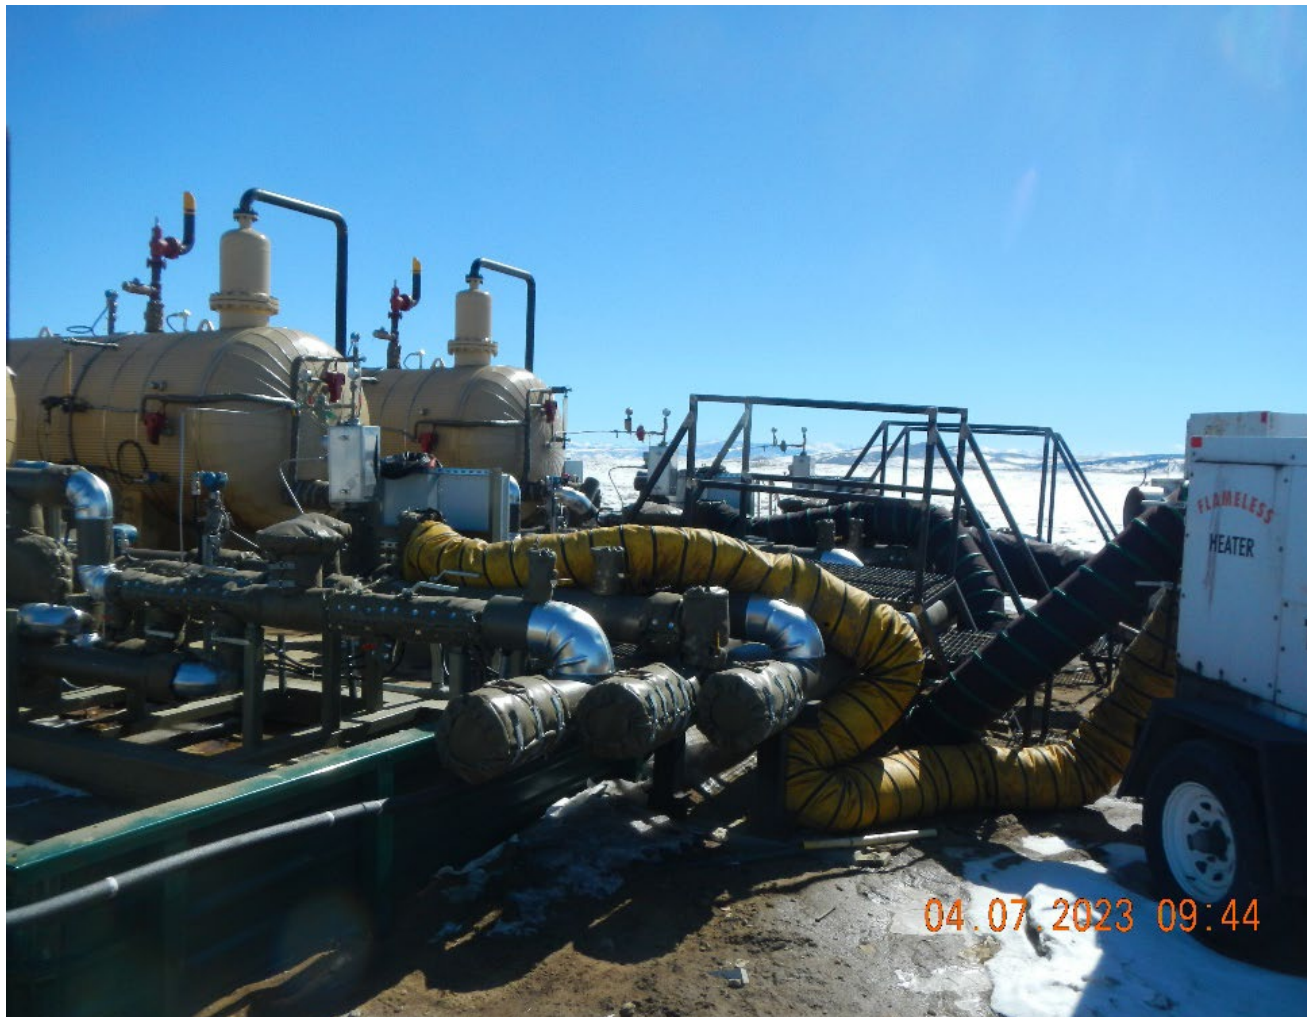
Photo #34 separation equipment with external heaters blowing.
