Inspection Photos
location: 416625
Inspection
Date:4/7/2023

COLORADO
Oil & Gas Conservation
Commission
Department of Natural Resources

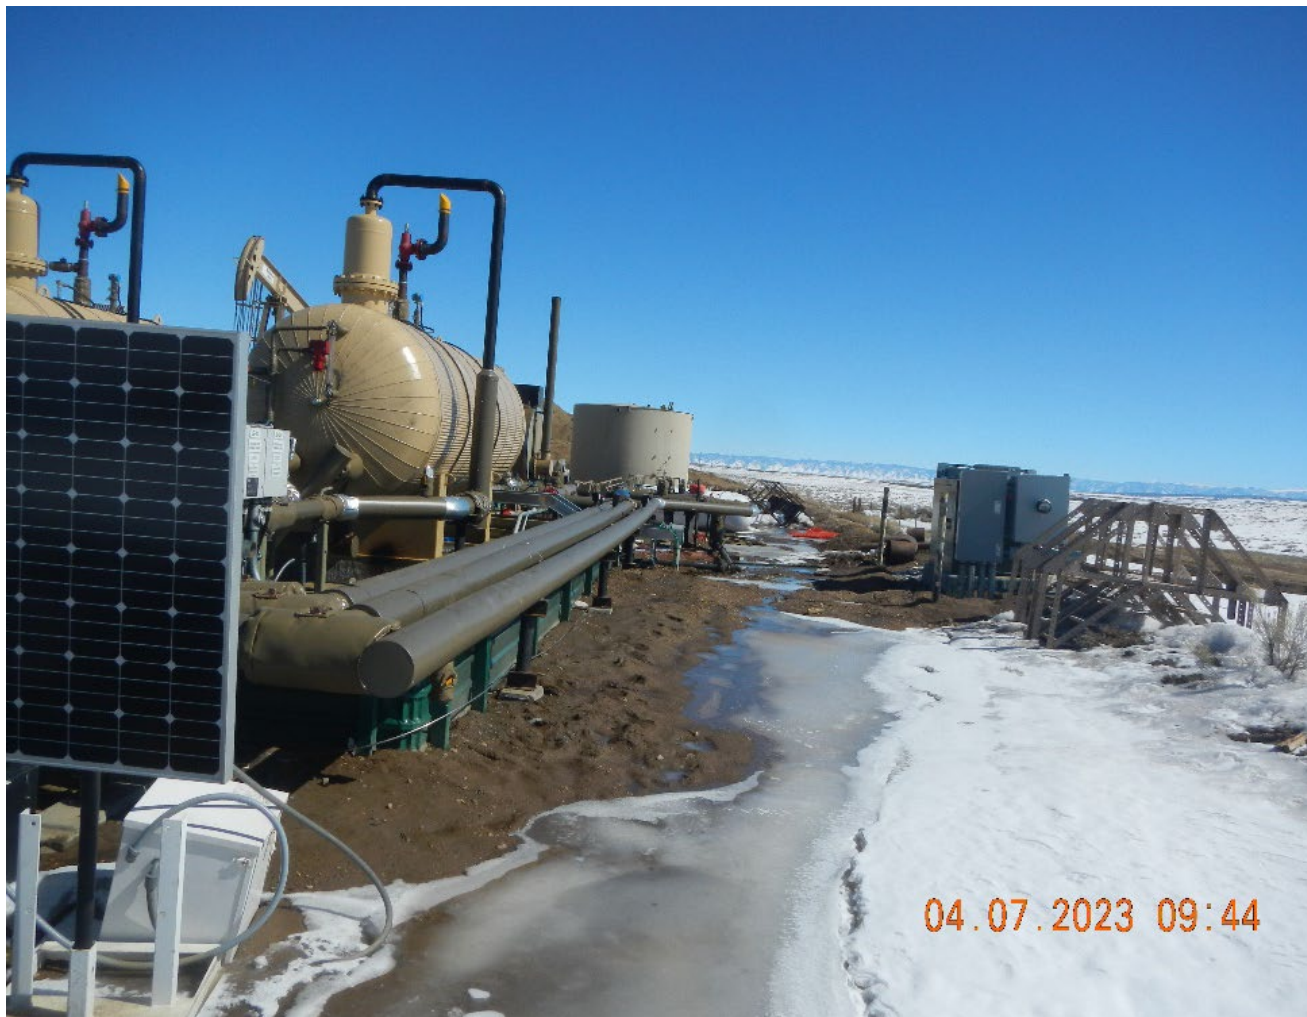
Photo #35 eastern most border of location, looking north.

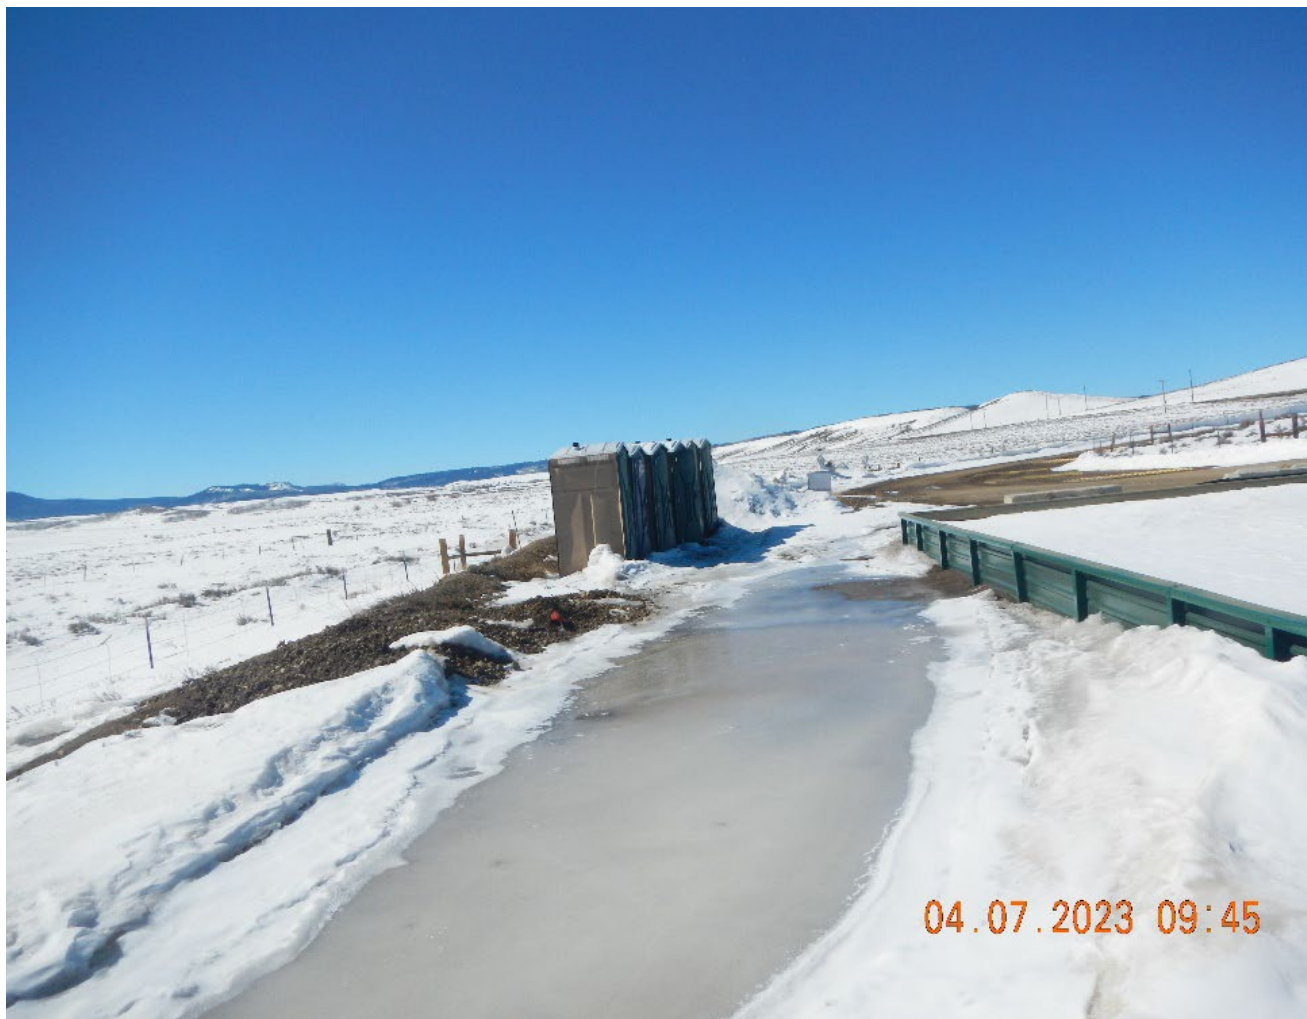
Photo #36 eastern most side of location, looking south. Pony wall on right is newly installed secondary containment for what appears to be a tank battery.

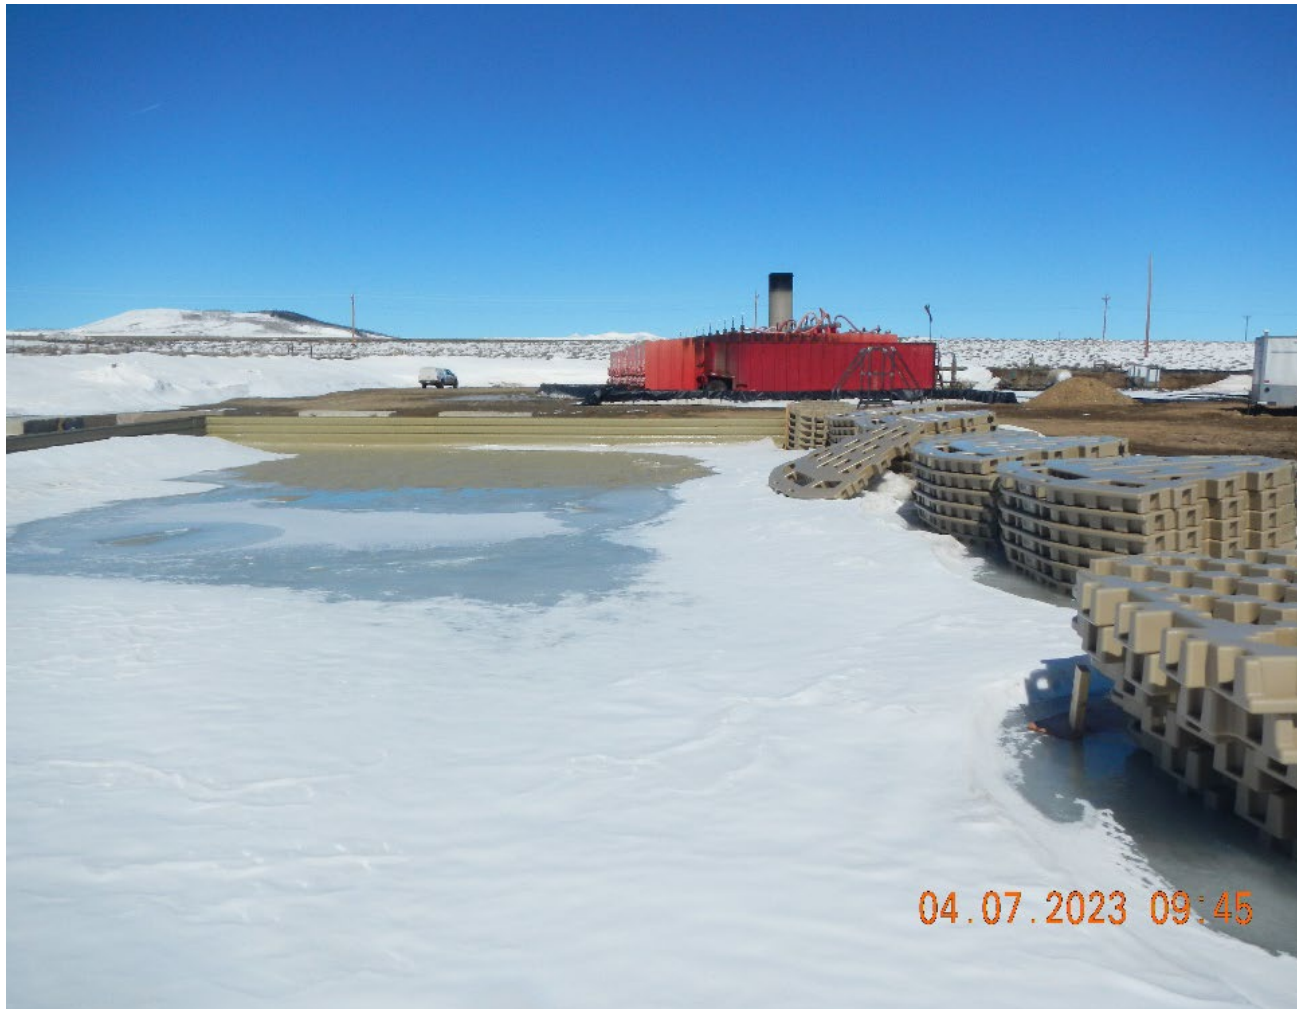
Photo #37 Inside new secondary containment area.

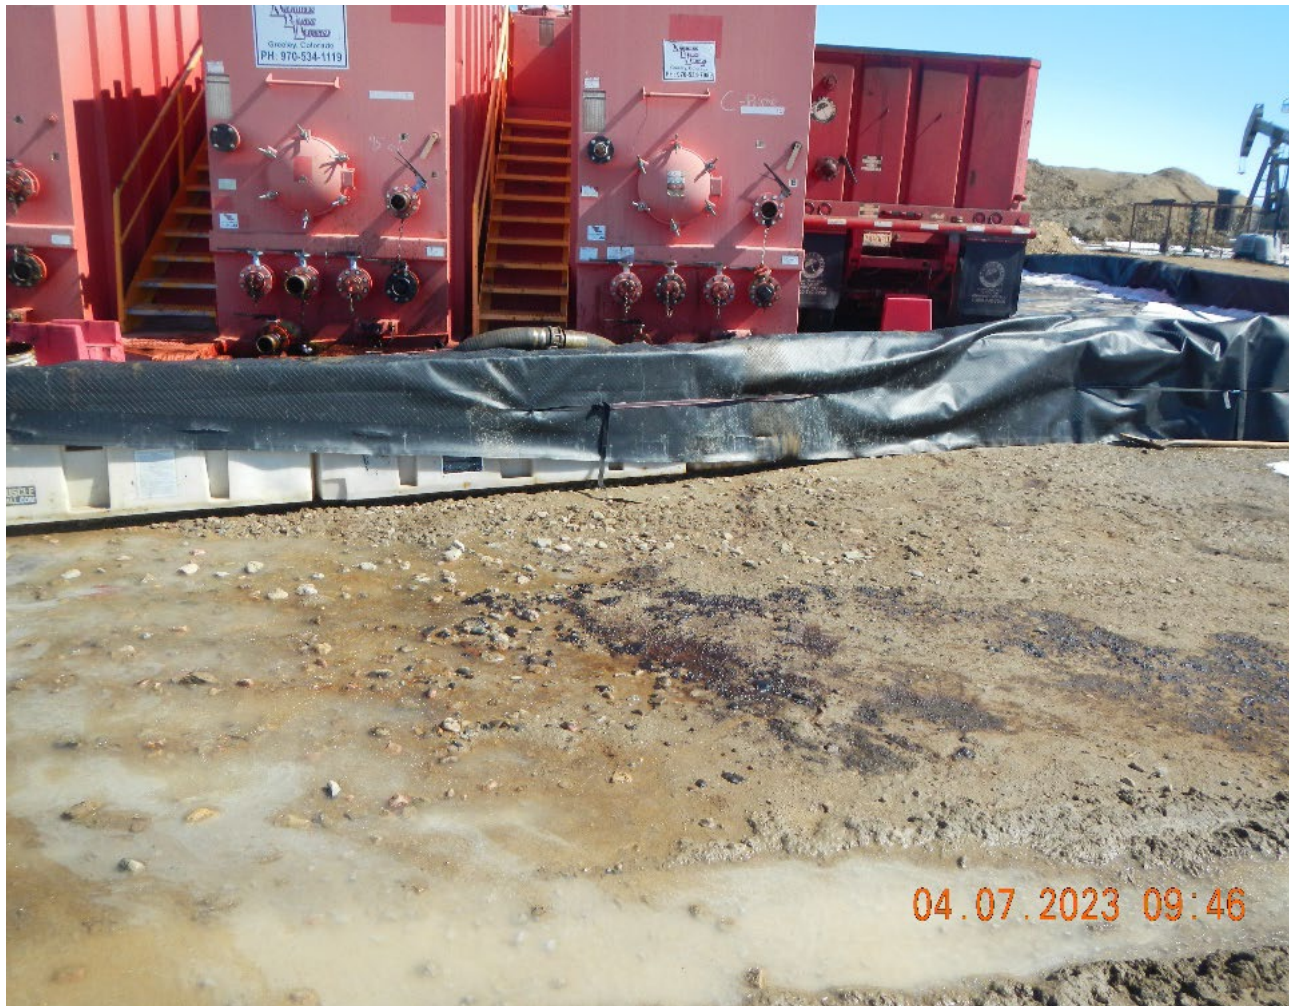
Photo #38 staining on ground near frac tanks. Corrective Action; This area shall be documented on a Remediation workplan (Form 27).

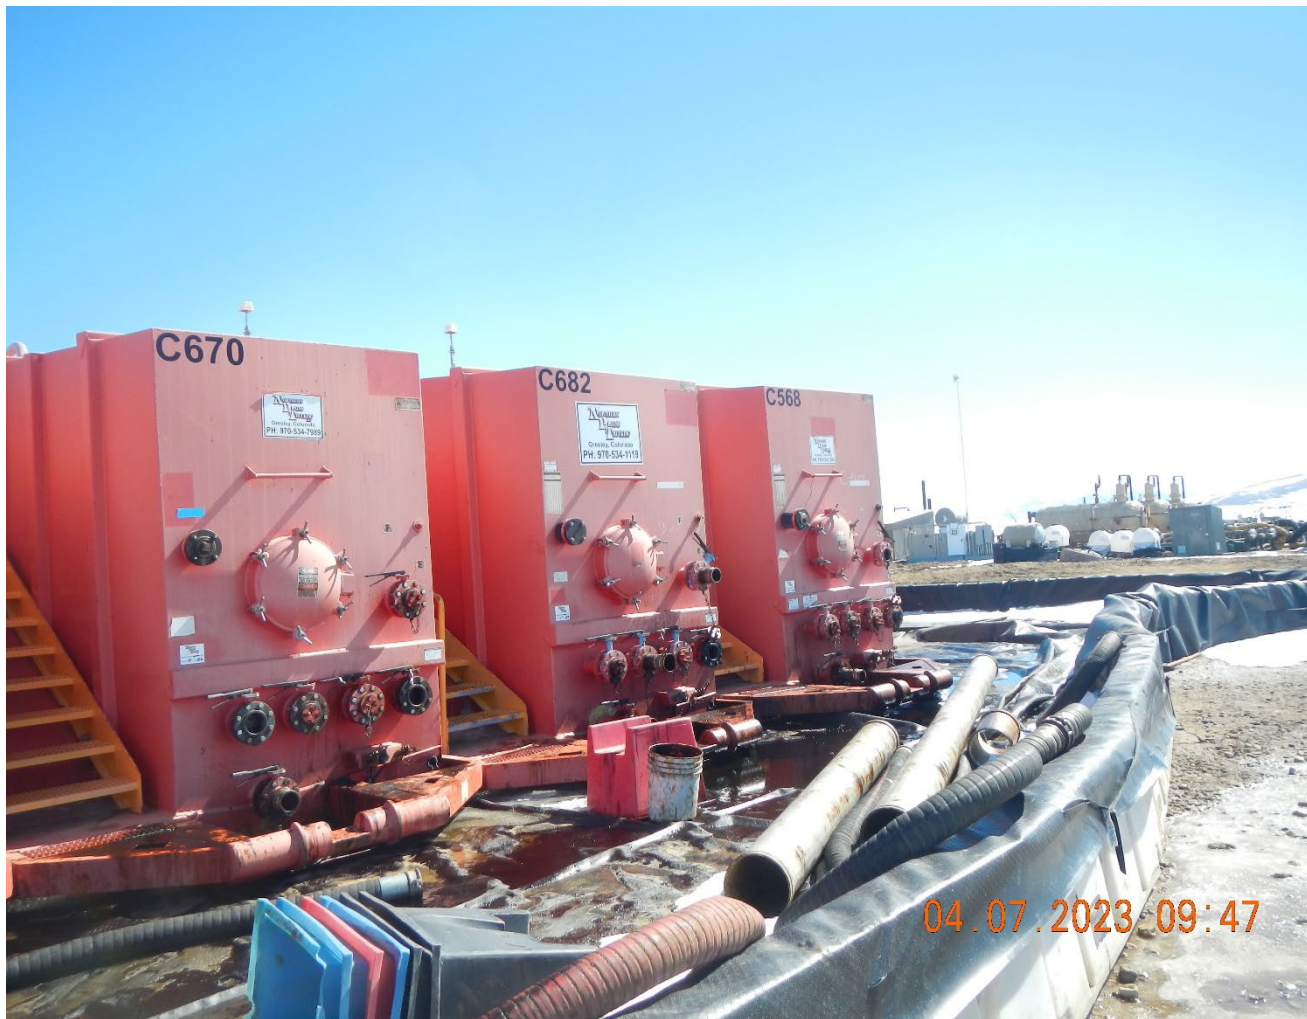
Photo #39 view inside secondary containment of frac tanks.

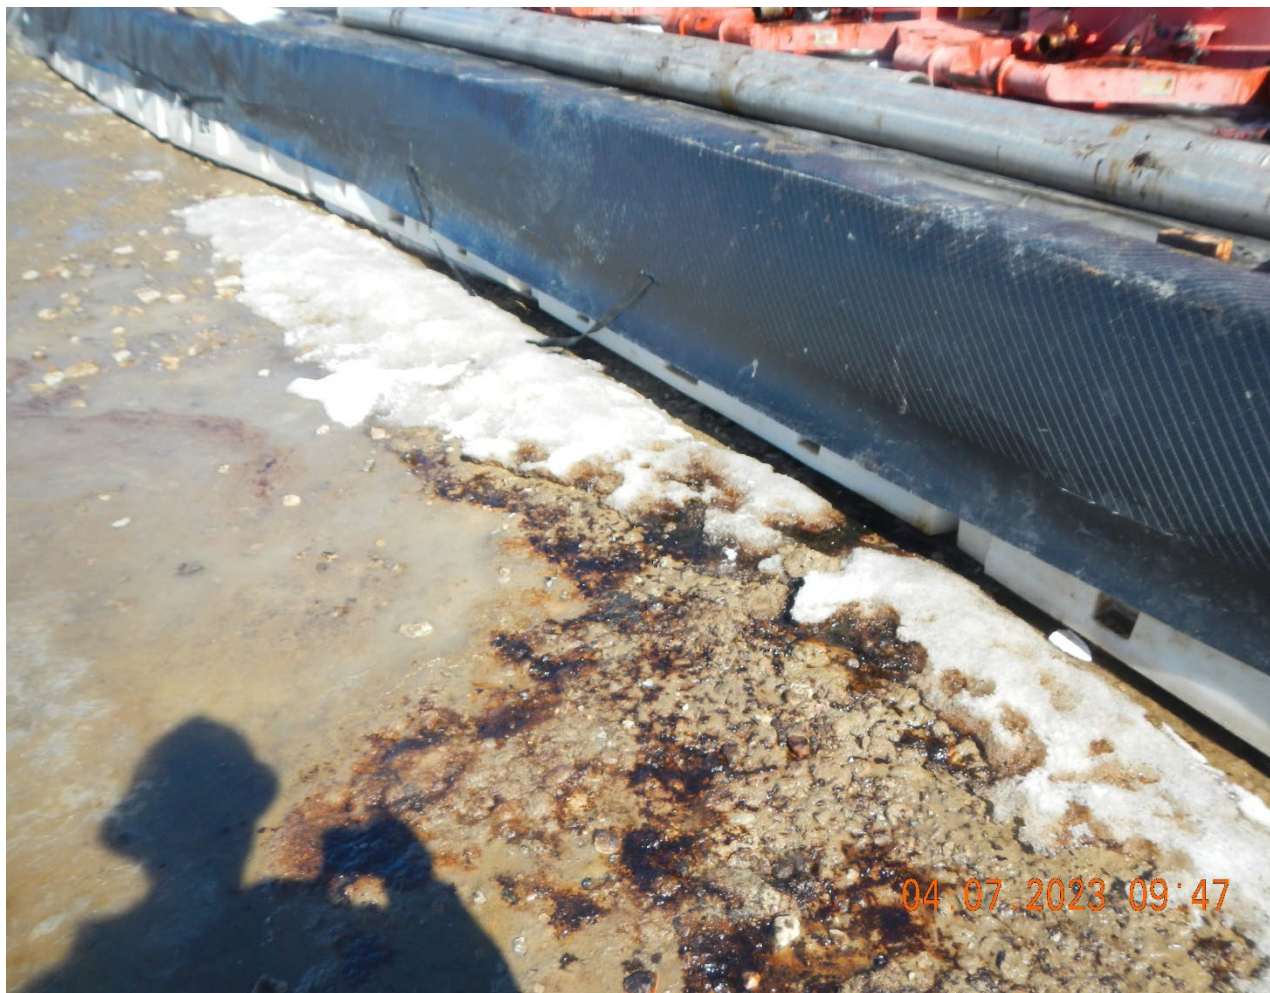
Photo #40 staining on pad outside of frac secondary containment, on south side. Corrective Action; This area shall be documented on a Remediation workplan (Form 27).
