Inspection Photos

API: 055-06102

Operator: OXY USA INC

Inspection Date: 4/10/2023

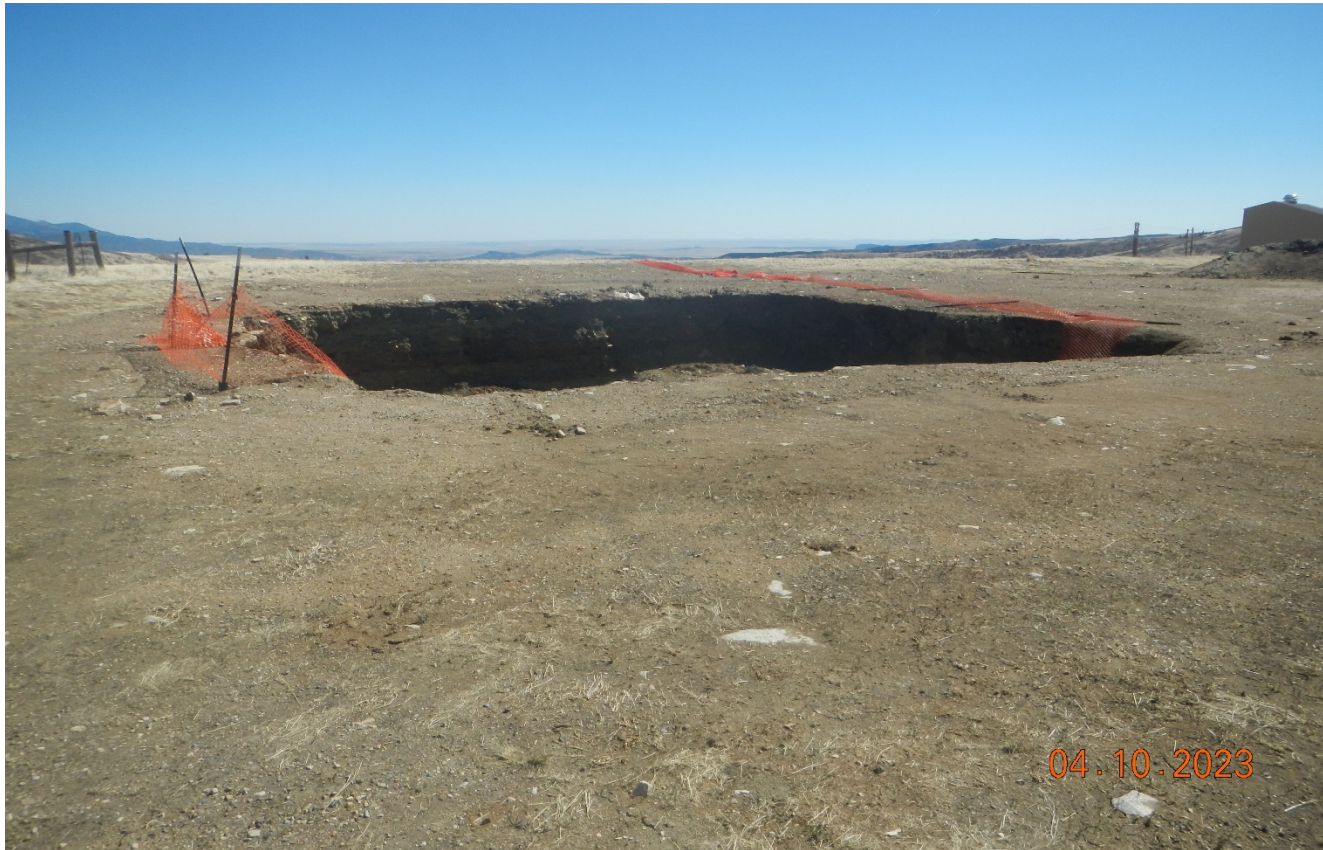
Photo 1. Facing northeast toward the wellsite. There is a large excavation around the wellhead approx. 10ft deep by 15'w. The excavation has vertical sides that wildlife could easily fall into and the safety fence is in disrepair.

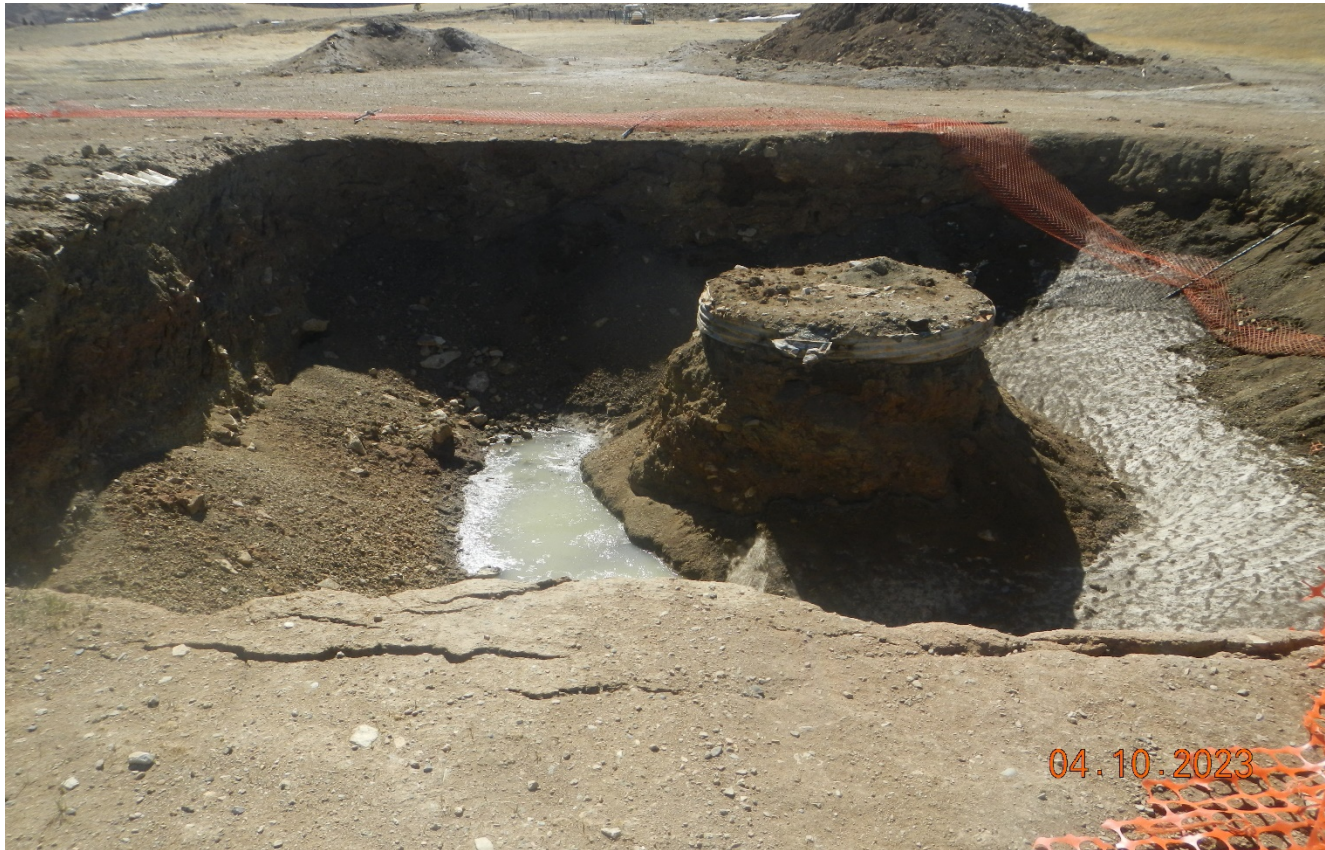
Photo 2. There is a large excavation around the wellhead approx. 10ft deep by 15'w. The excavation has vertical sides that wildlife could easily fall into and the safety fence is in disrepair.

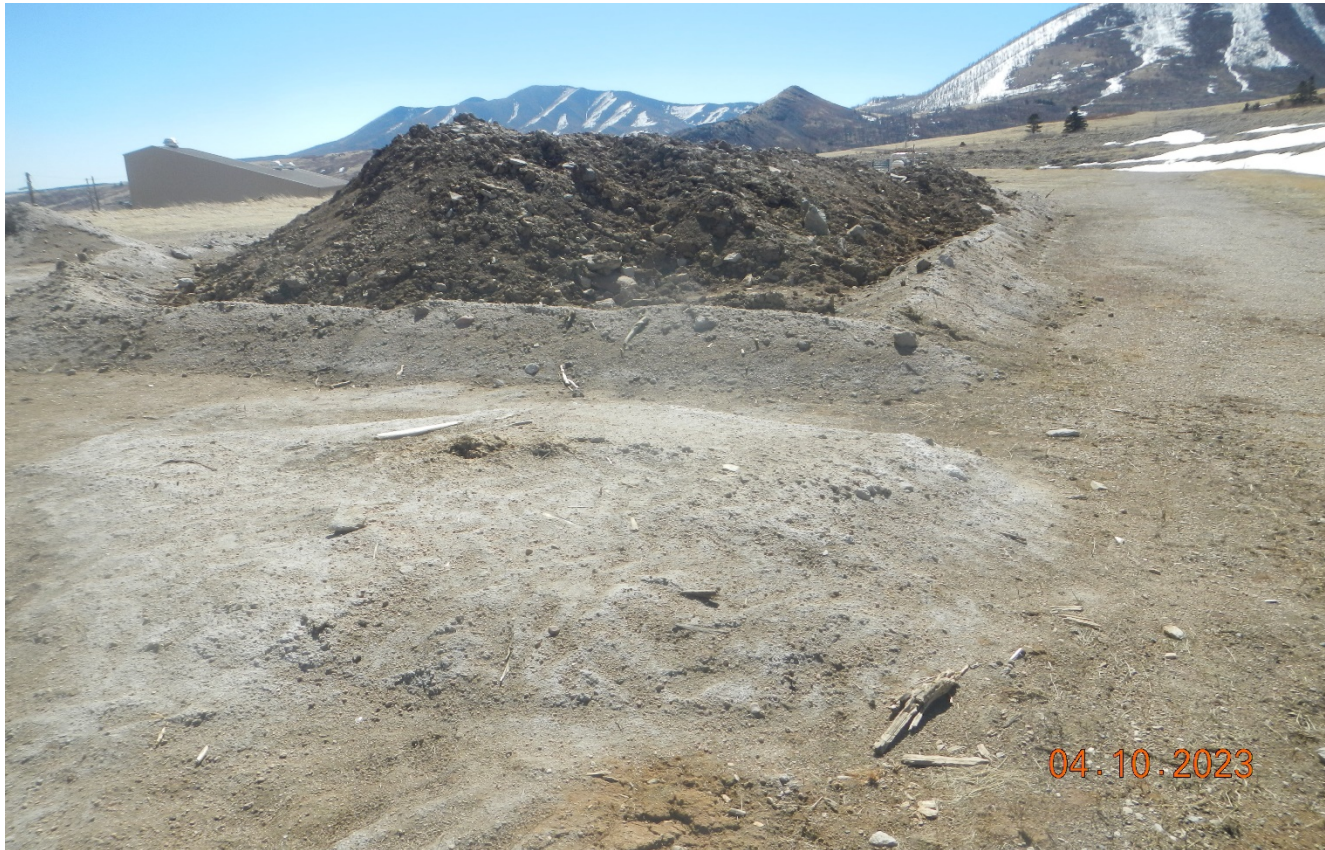
Photo 4. Facing east. The excavated material is being improperly stored on location.

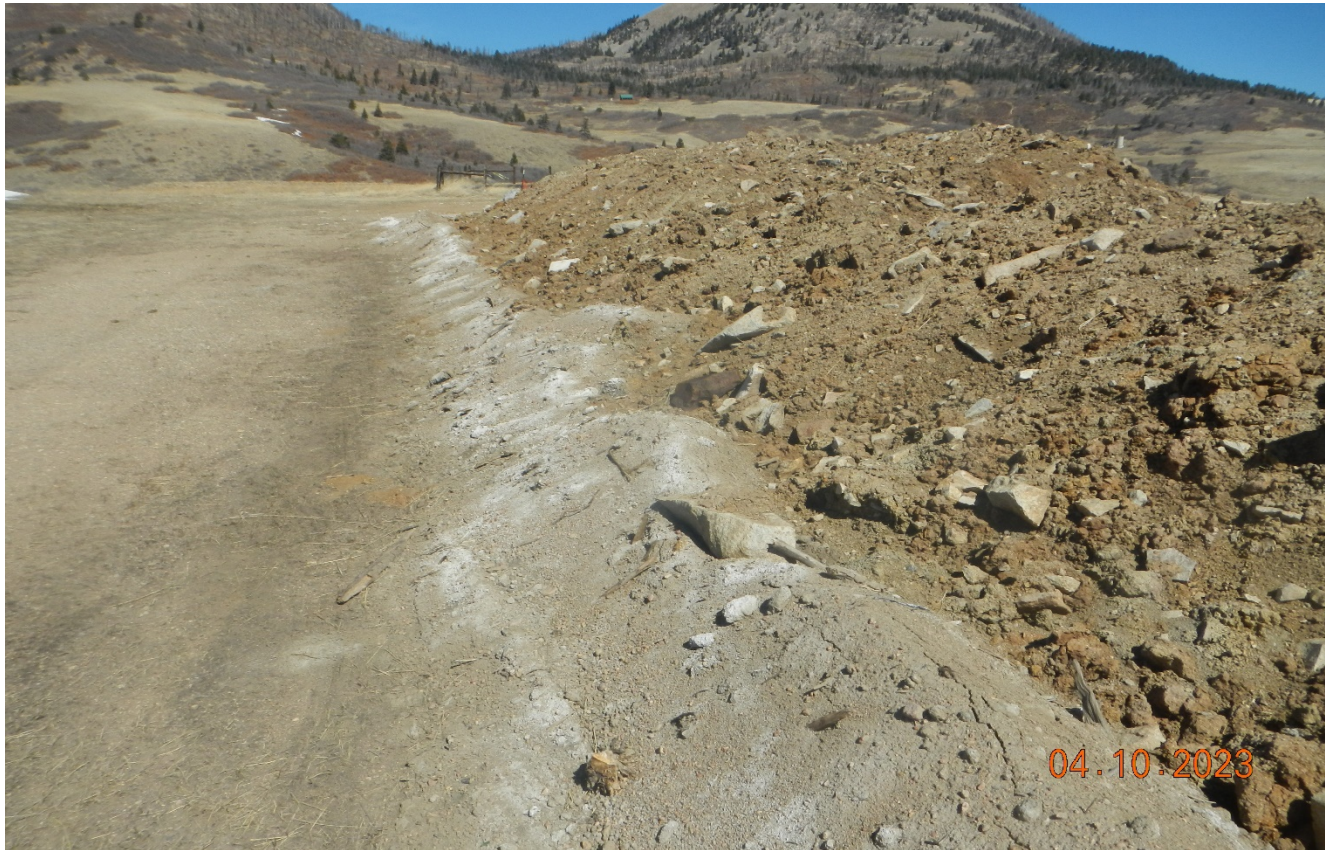
Photo 4. The excavated material is not properly stored with liner and sufficiently sized berms. Material is overtopping the berm in this area.

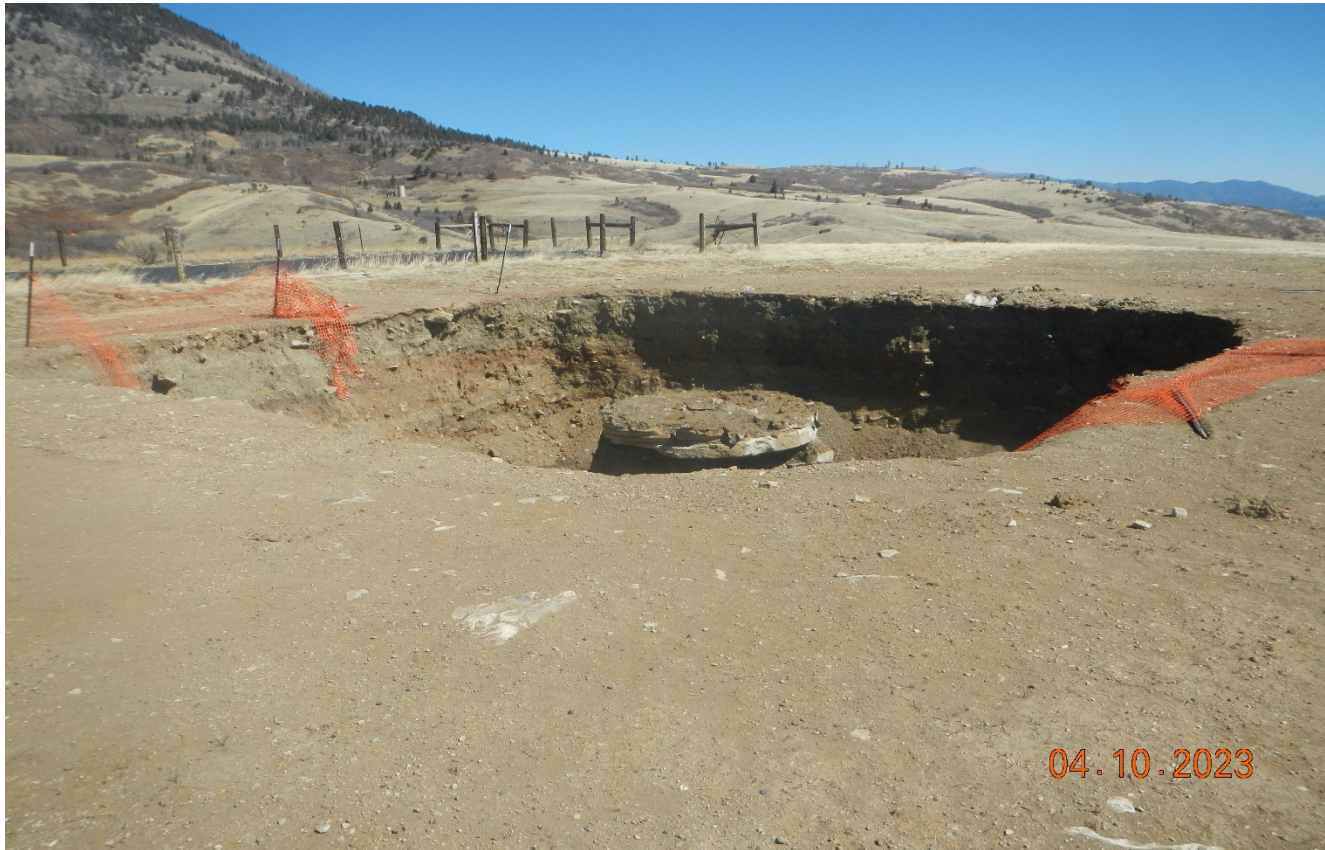
Photo 5. Facing north toward the excavated area at the wellhead. The wellhead will need to be cut an capped far enough below grade to allow proper recontouring.
