Inspection Photos

API: 055-06037

Operator: OXY USA INC

Inspection Date: 4/10/2023

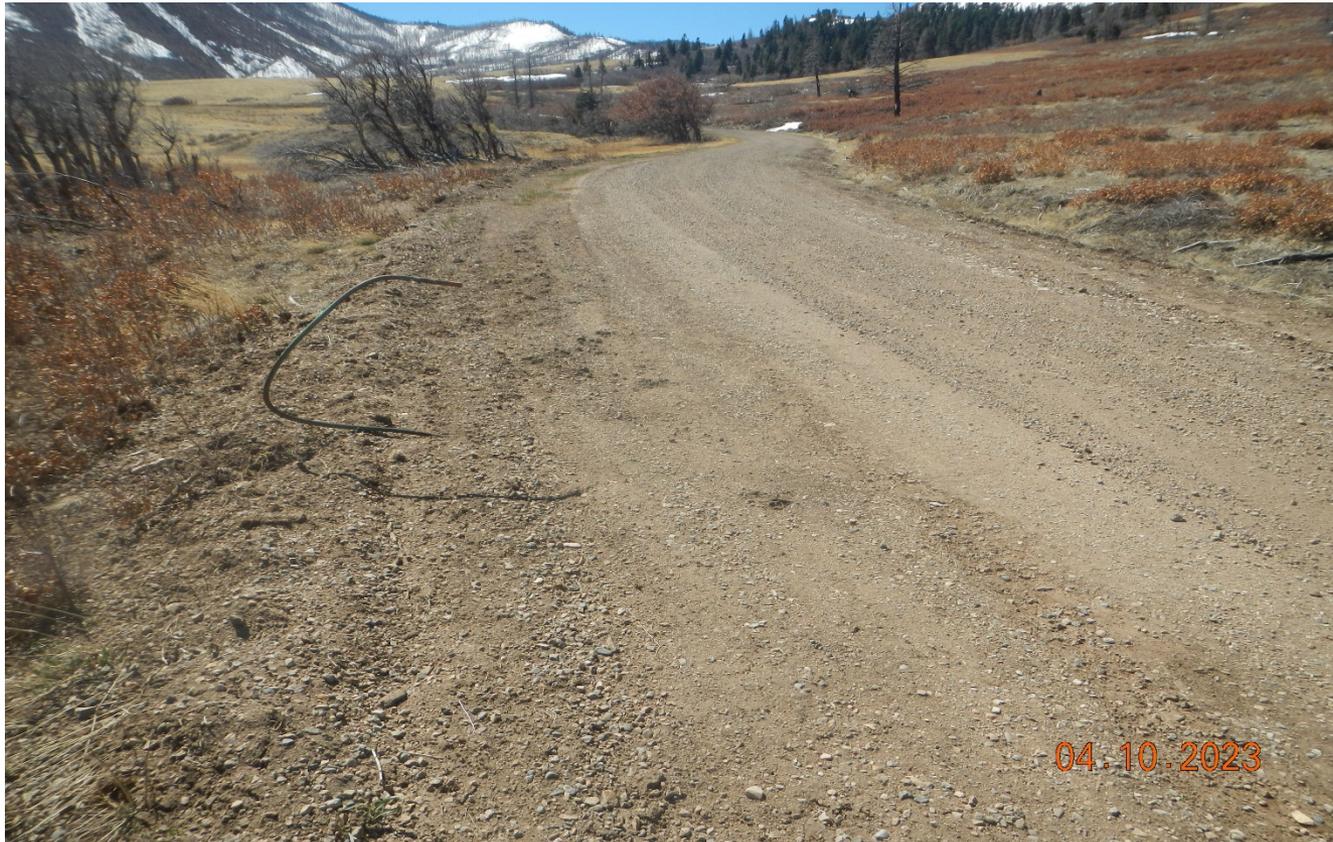
Photo 1. Facing south along the main road. Grading of the road has pushed up the metal rebar and has pushed material and gravel off the roadway. There were a few other bent rebar observed along the road as well.

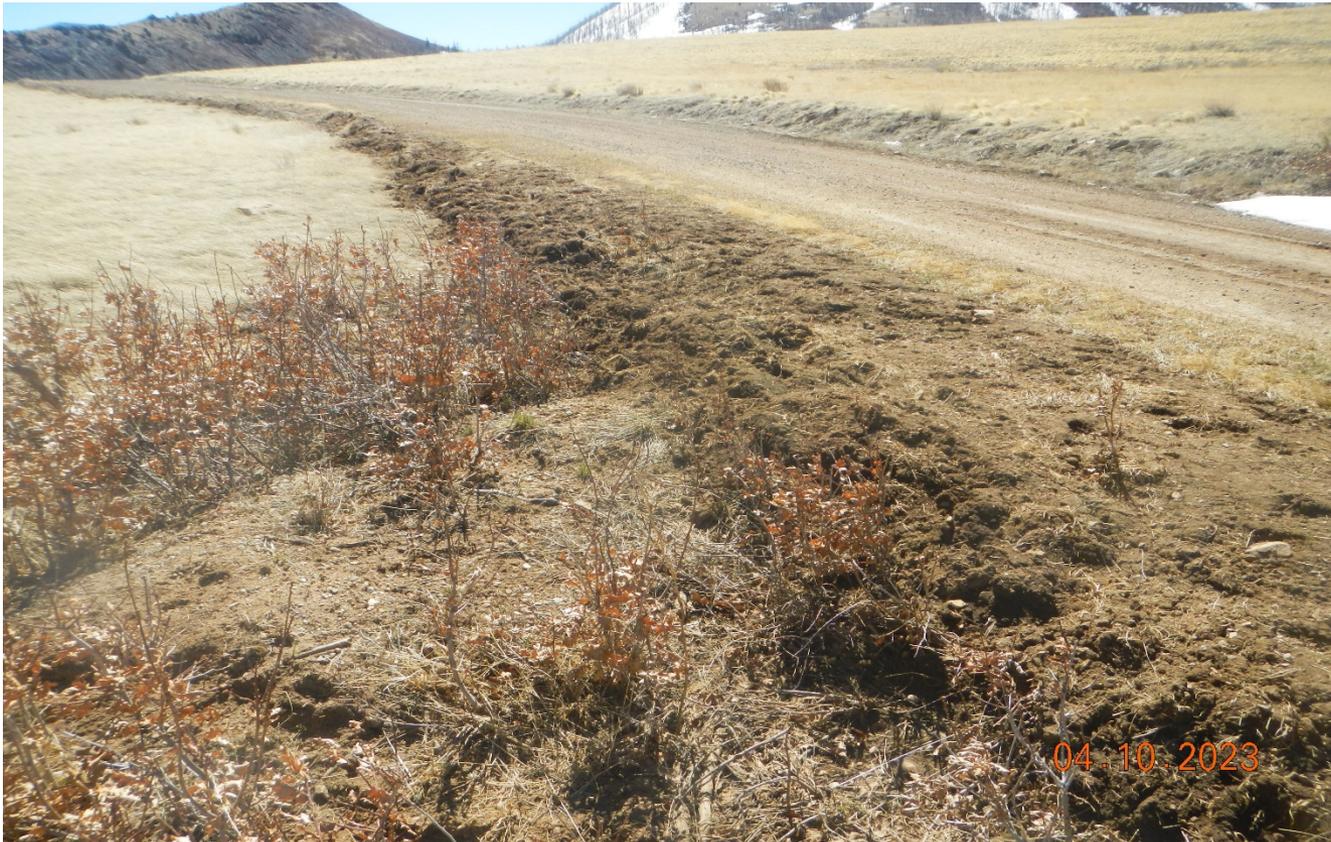
Photo 2. There has been grading performed along the road however, gravel material has been pushed off the road causing additional disturbance. This material needs to be removed.

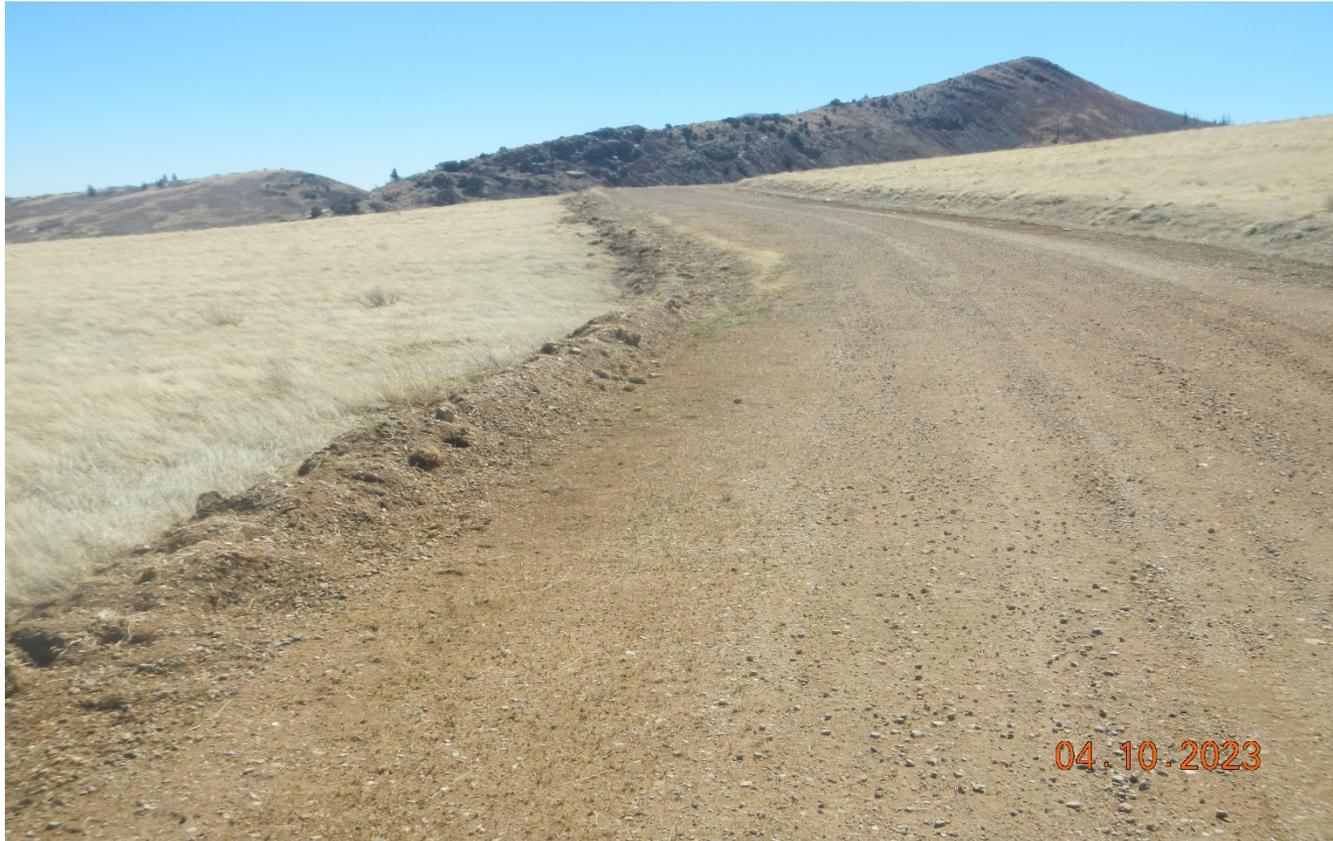
Photo 3. There has been grading performed along the road however, gravel material has been pushed off the road causing additional disturbance This material needs to be removed.

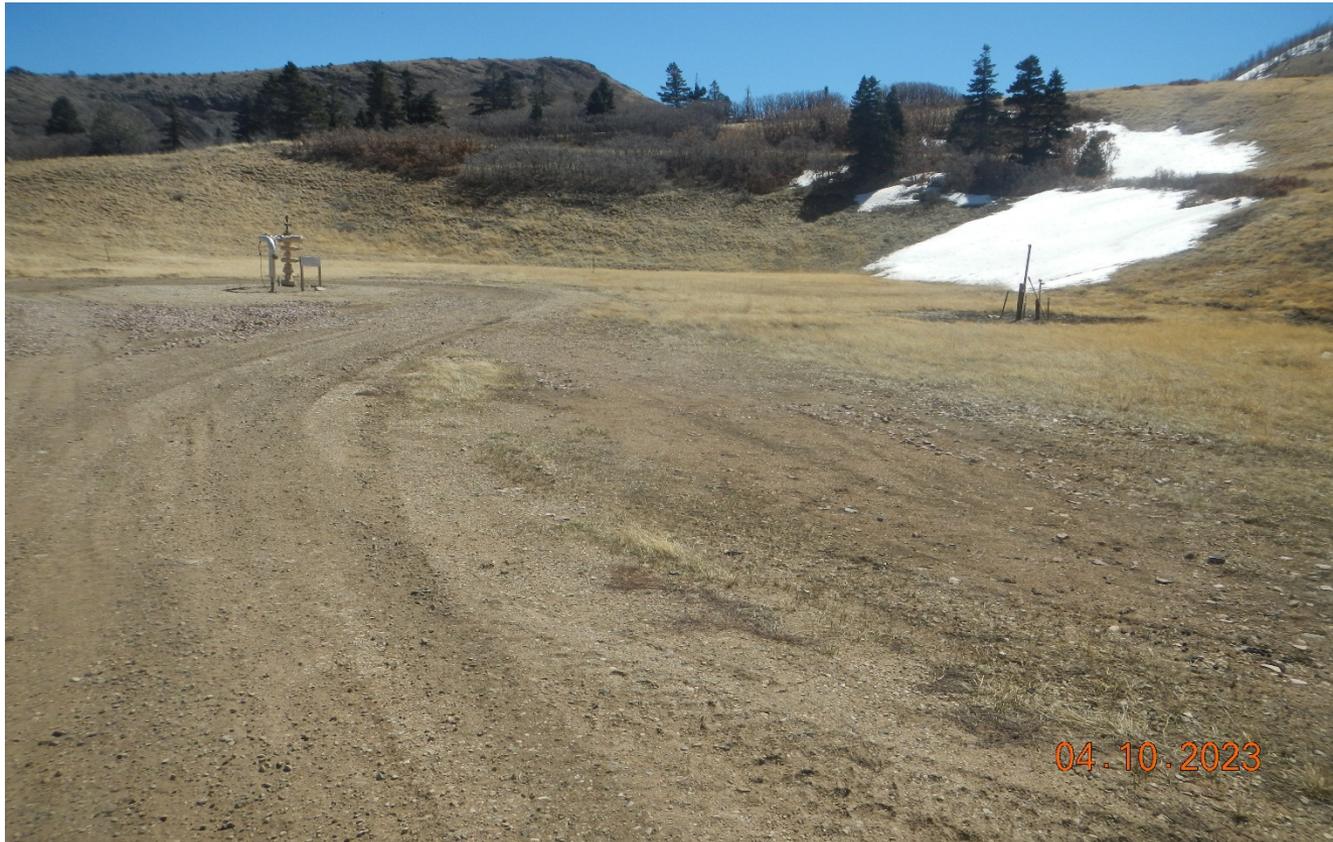
Photo 4. Facing southeast toward the well site. The gravel debris has mostly been removed.
