Inspection Photos

API: 055-06012

Operator: OXY USA INC

Inspection Date: 4/10/2023

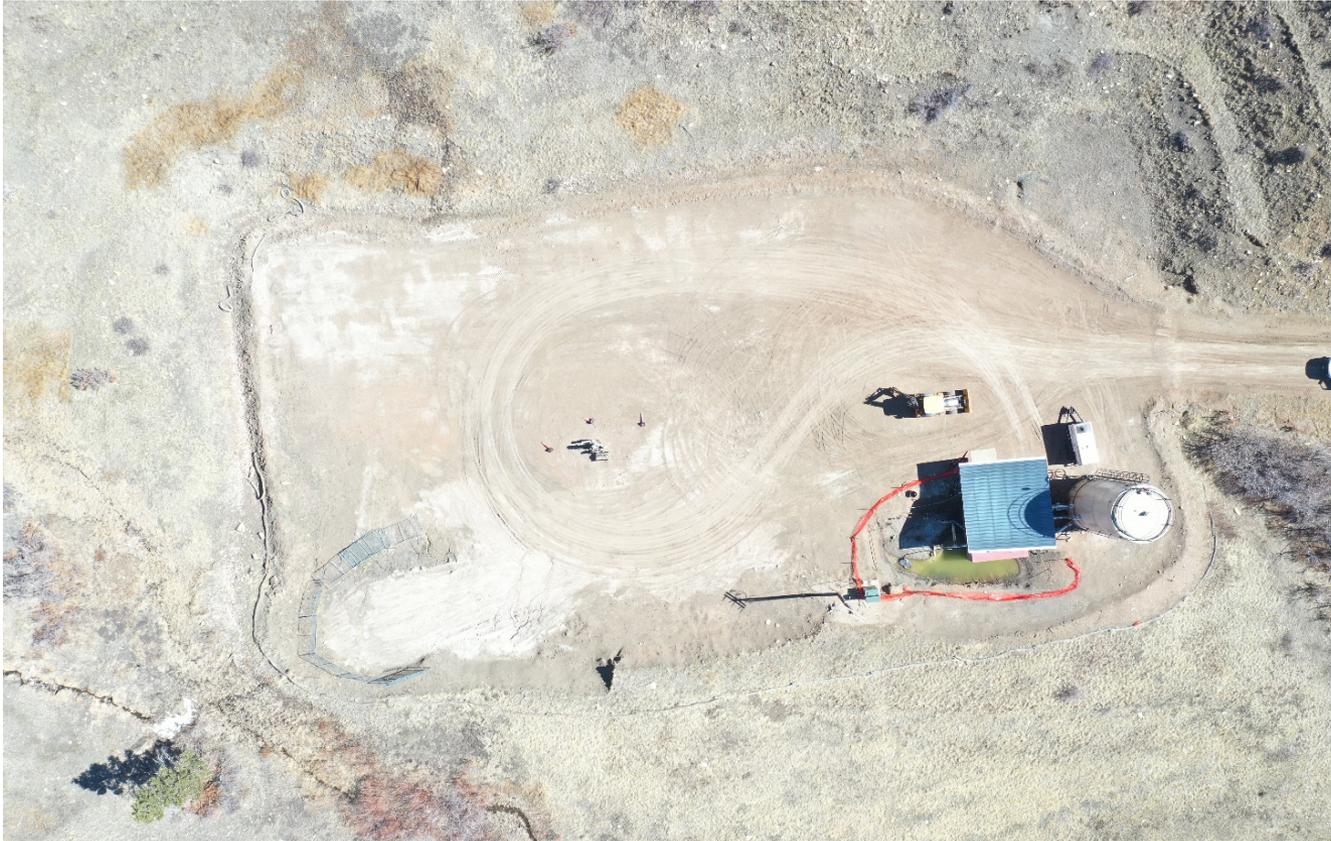
Photo 1. Drone aerial photo of the location showing the excavated areas of the remediation project.

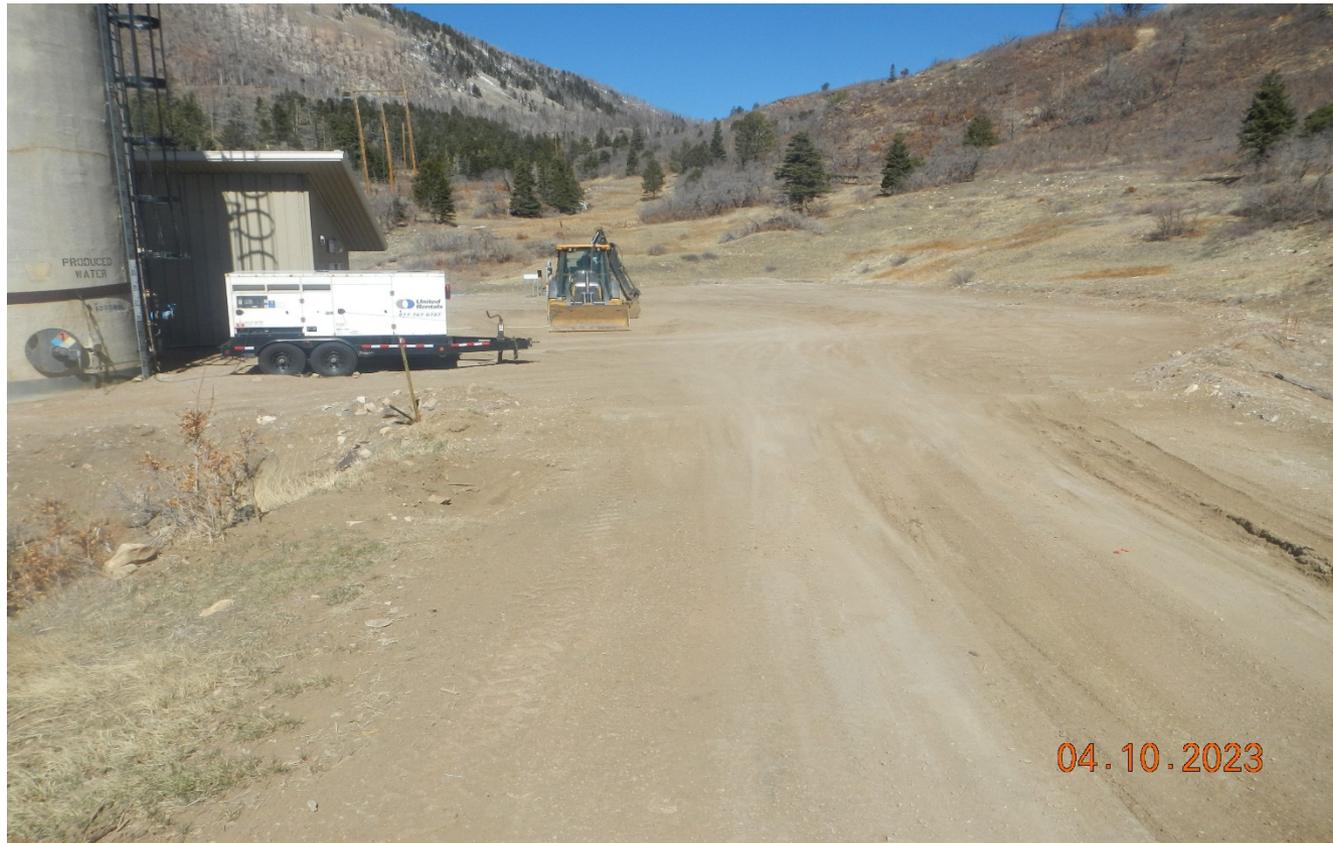
Photo 2. Facing northwest toward the location.

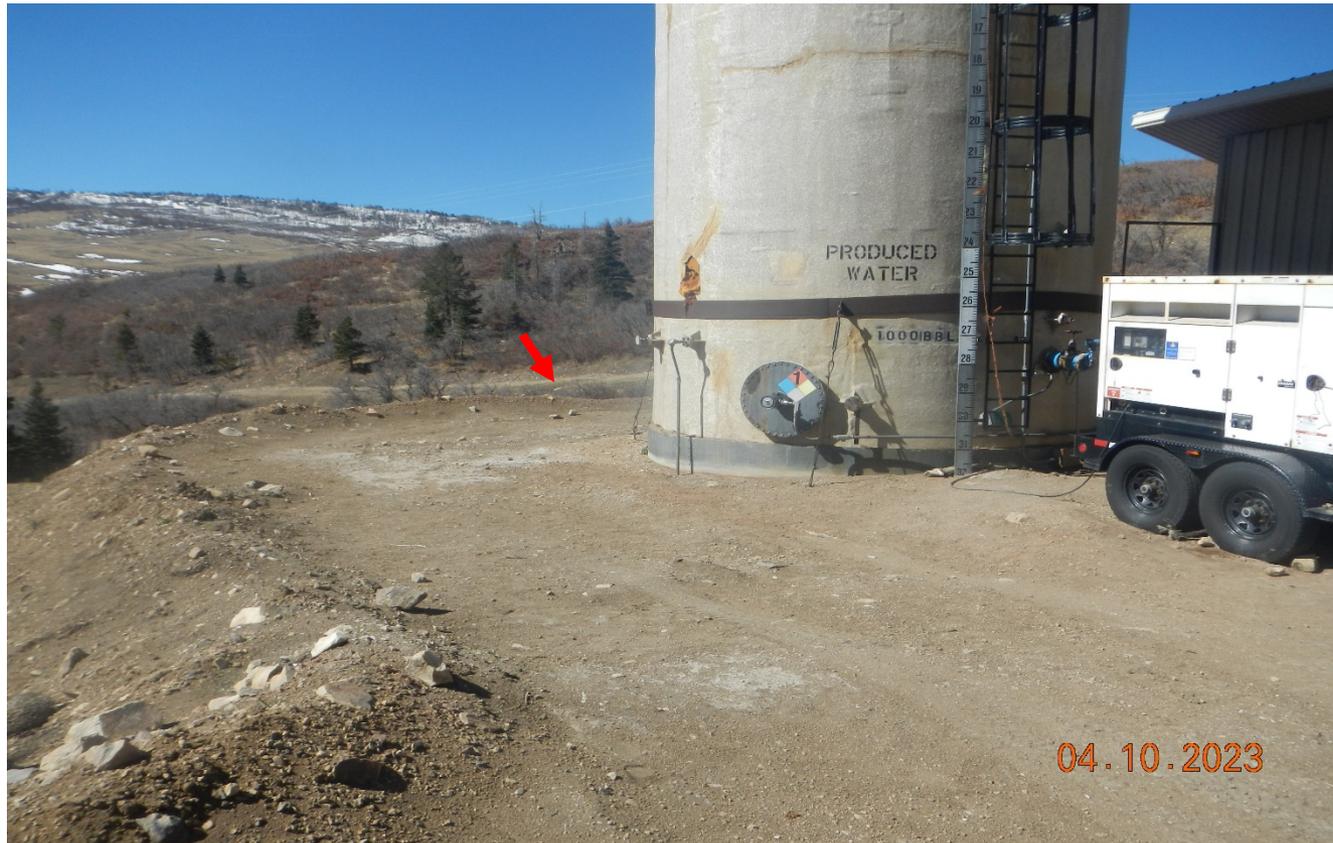
Photo 3. Facing toward the produced water tank. The secondary berm around the tank is insufficient to contain a spill. Red arrow points to small berm which could easily be overtopped by a leak.

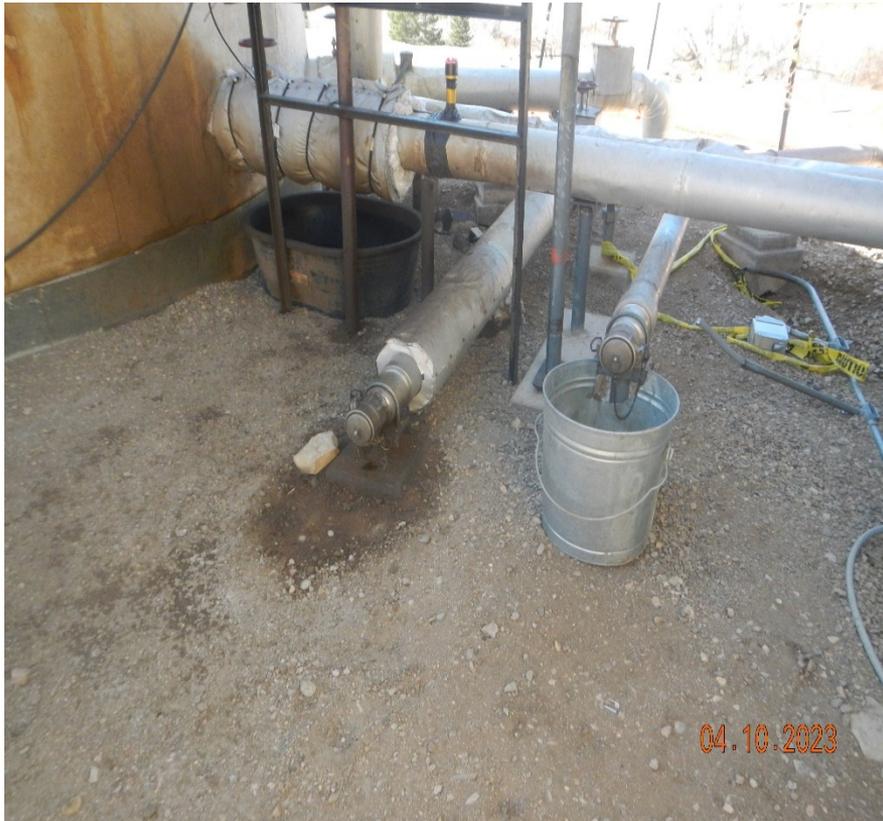
Photo 4. There is oily fluid and stained soil at the pipe outlets of the tank.

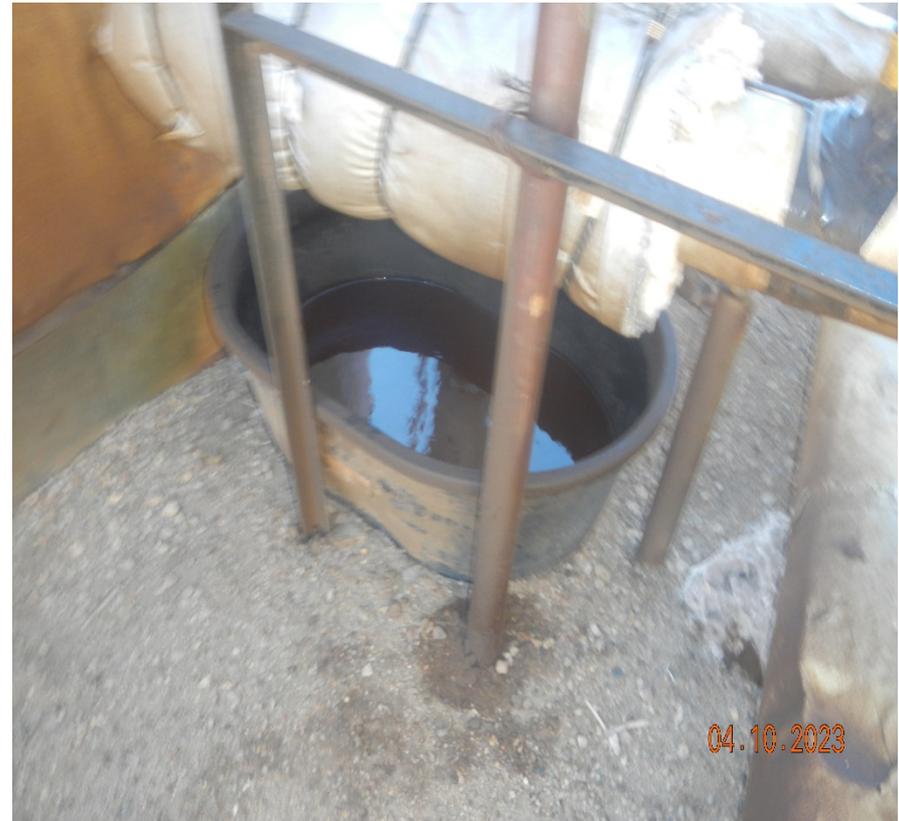
Photo 5. There is oily fluid inside this container used for containment. This needs to be cleaned up and should be netted to prevent wildlife entry.

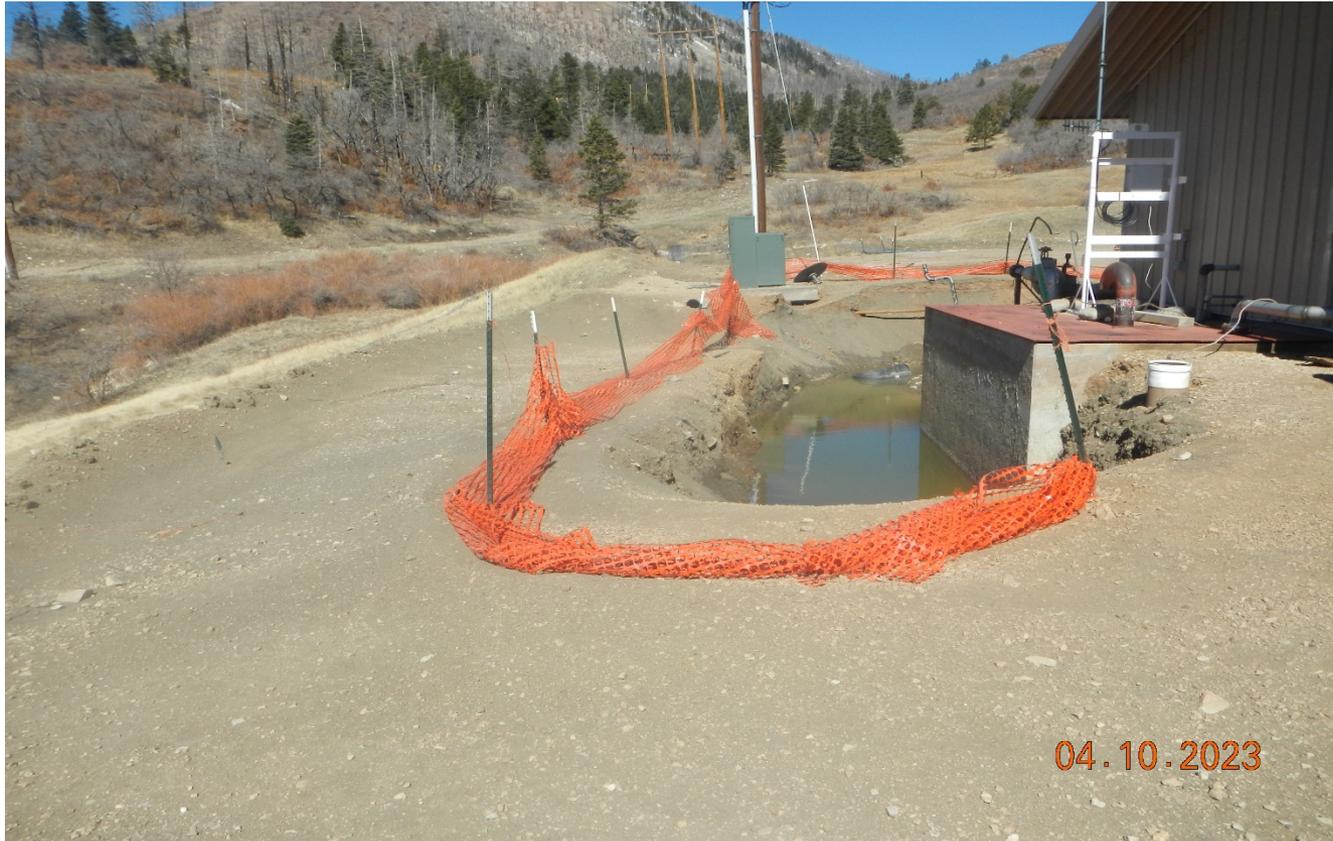
Photo 6. Facing northwest at the location. The remediation area where tank was located remains open and the safety fence is in disrepair.

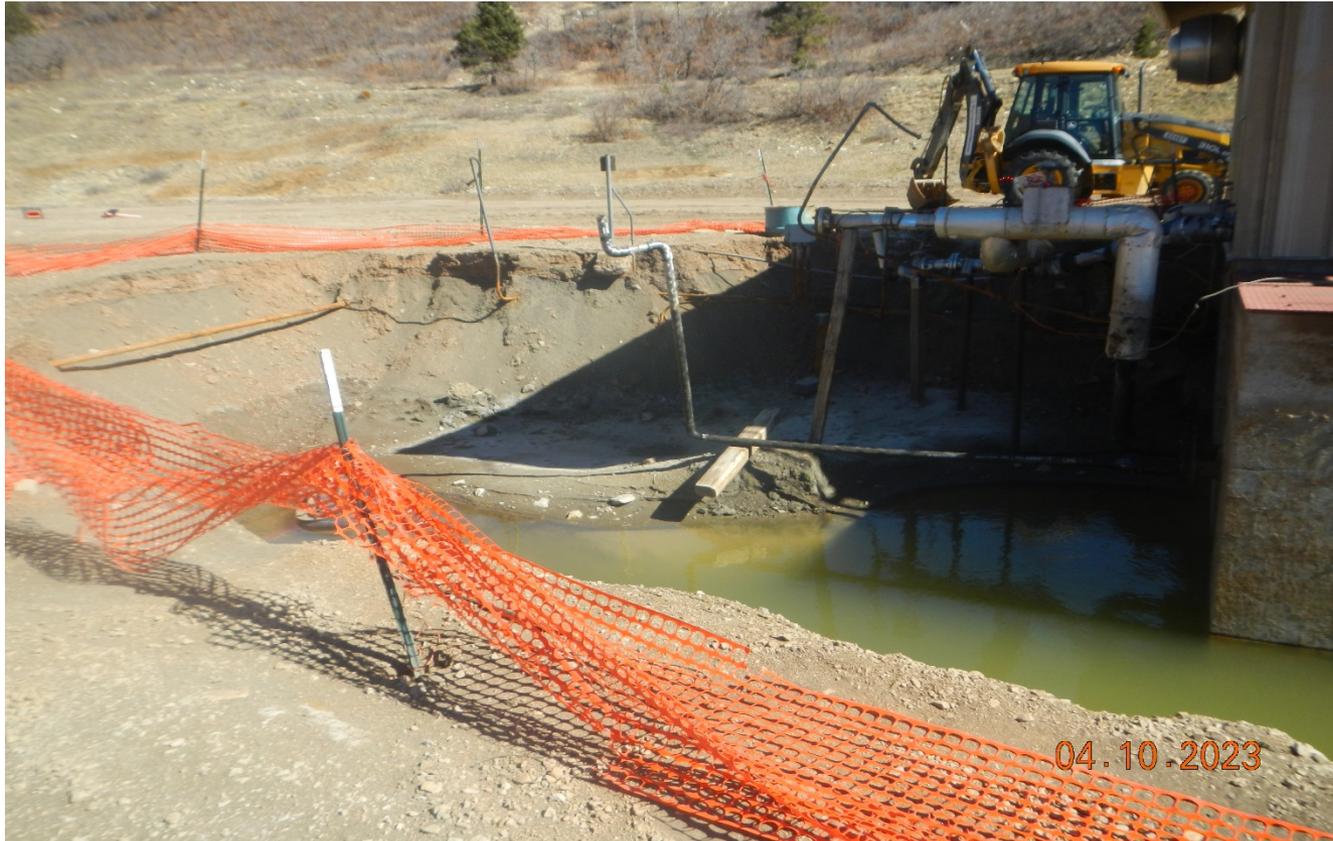
Photo 7. Facing where tank was located which remains an open excavation due to active remediation.

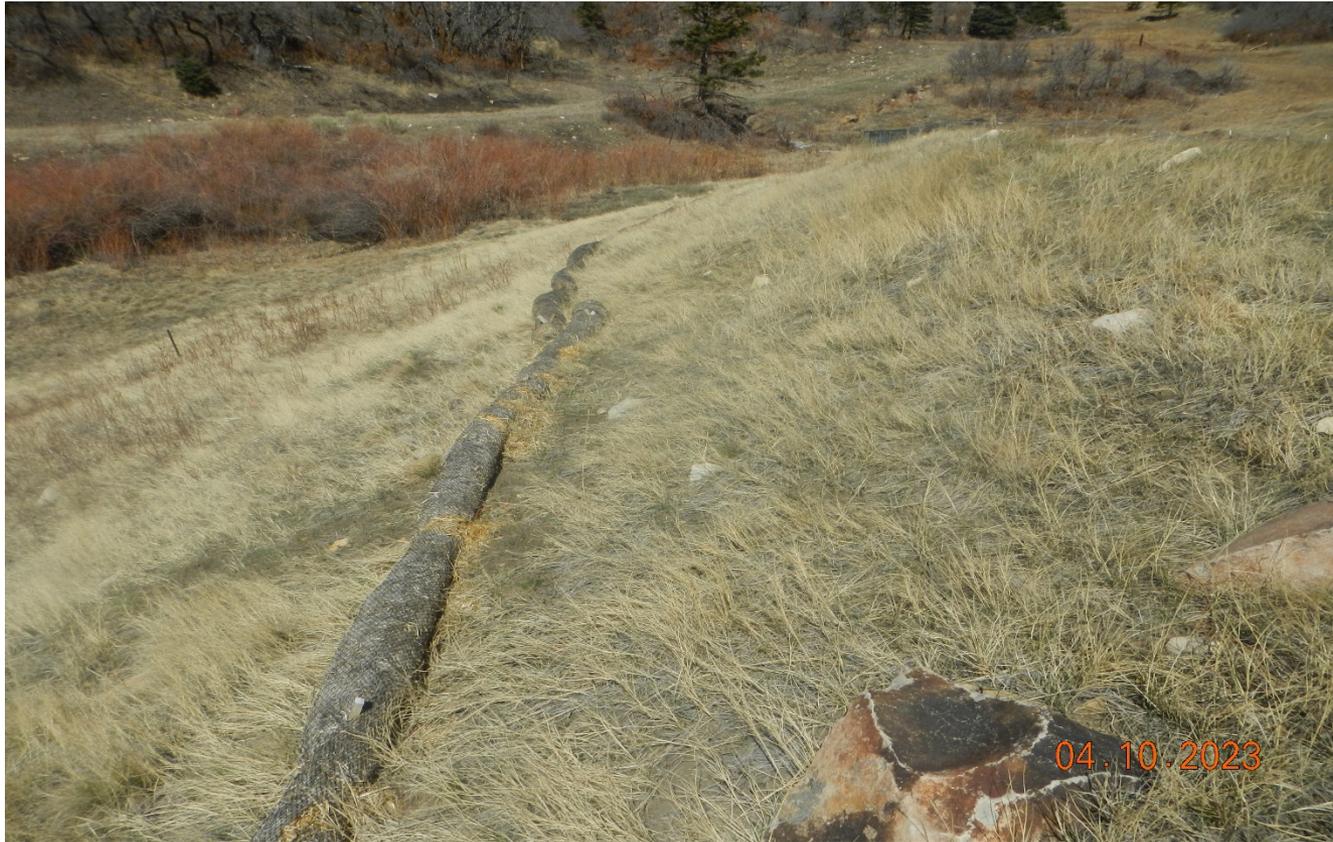
Photo 8. The perimeter wattles are degraded and need to be replaced and maintained.

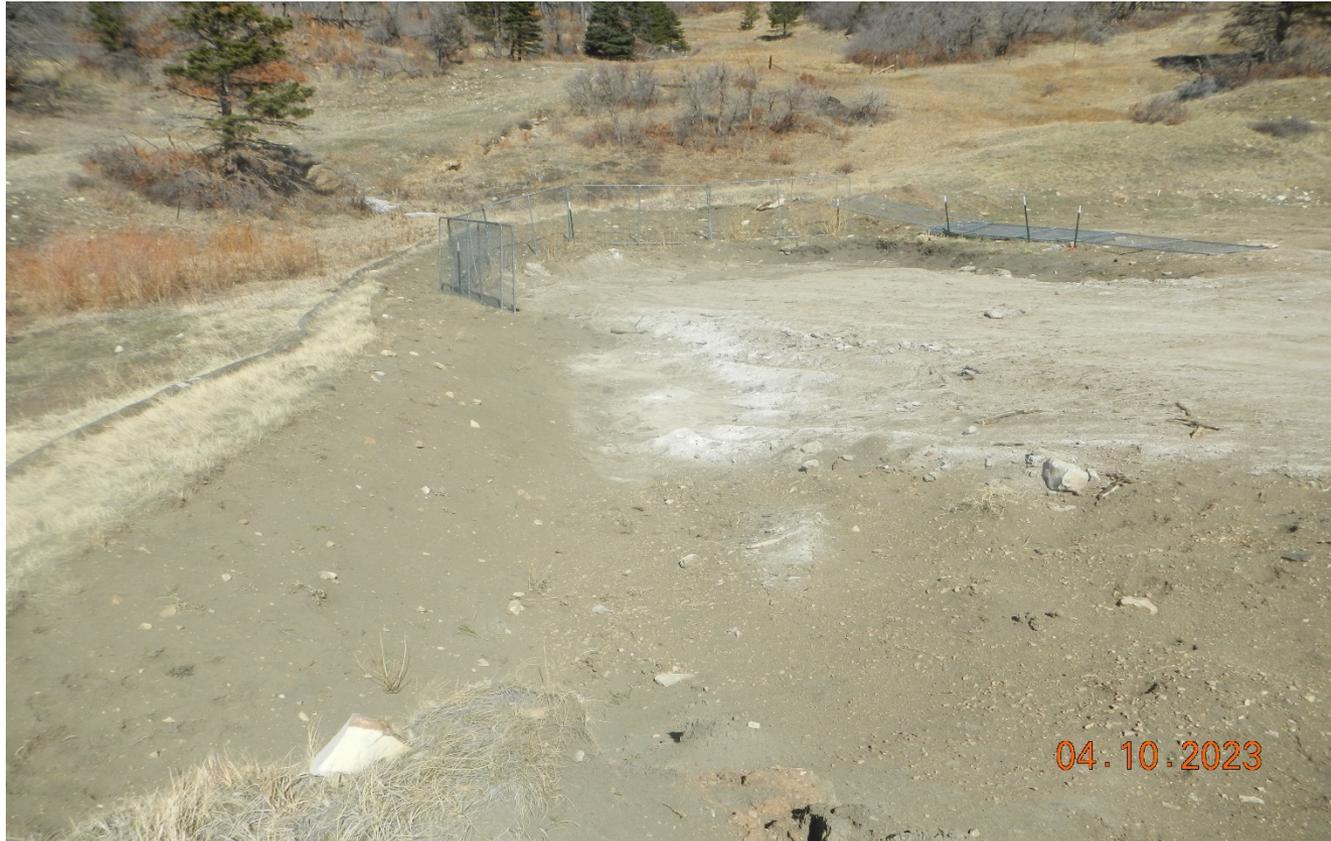
Photo 9. Facing northwest toward the excavated area which has been back. There was chalky colored soil material used to backfill the area.

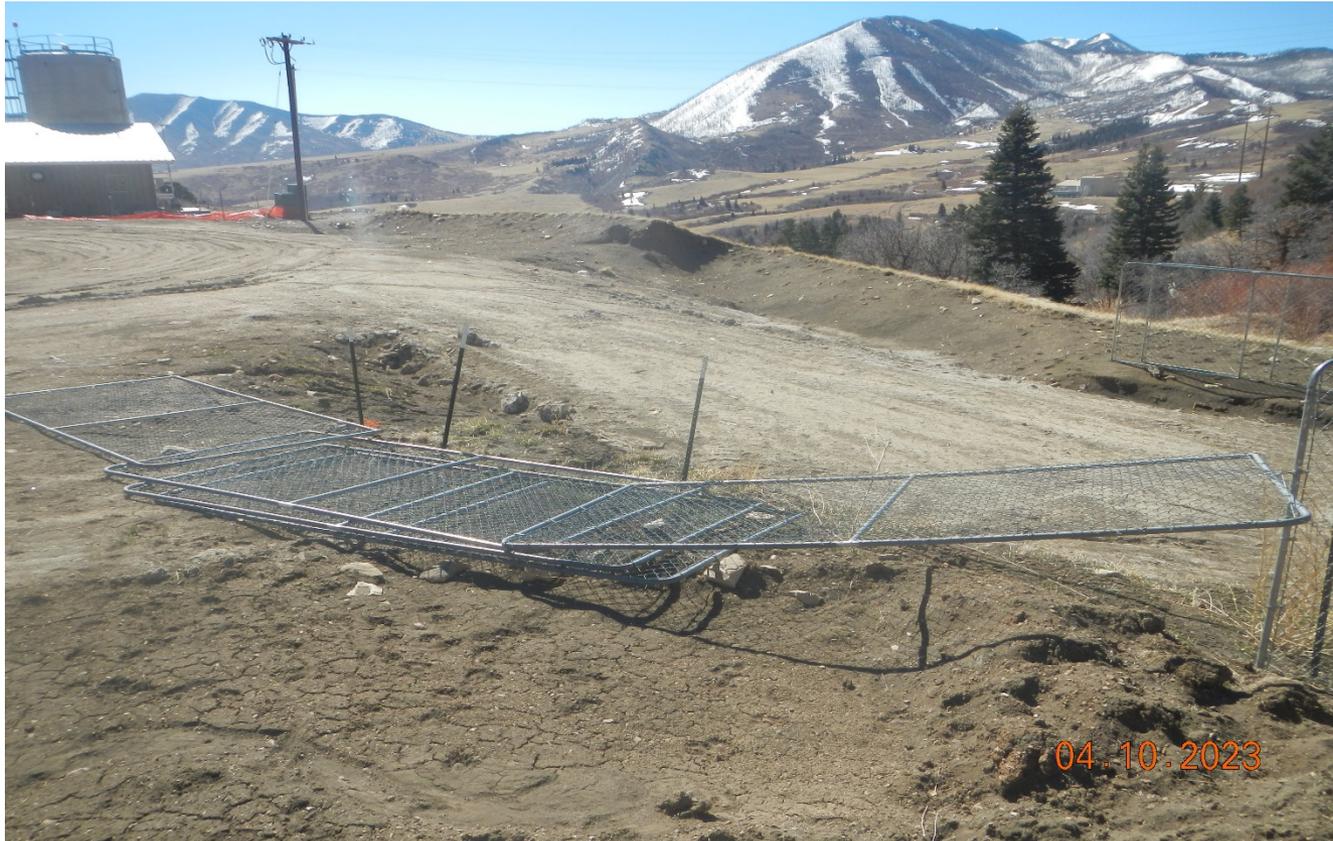
Photo 10. The panels which were around the excavation have fallen over and need to be removed or placed at the other open excavation.

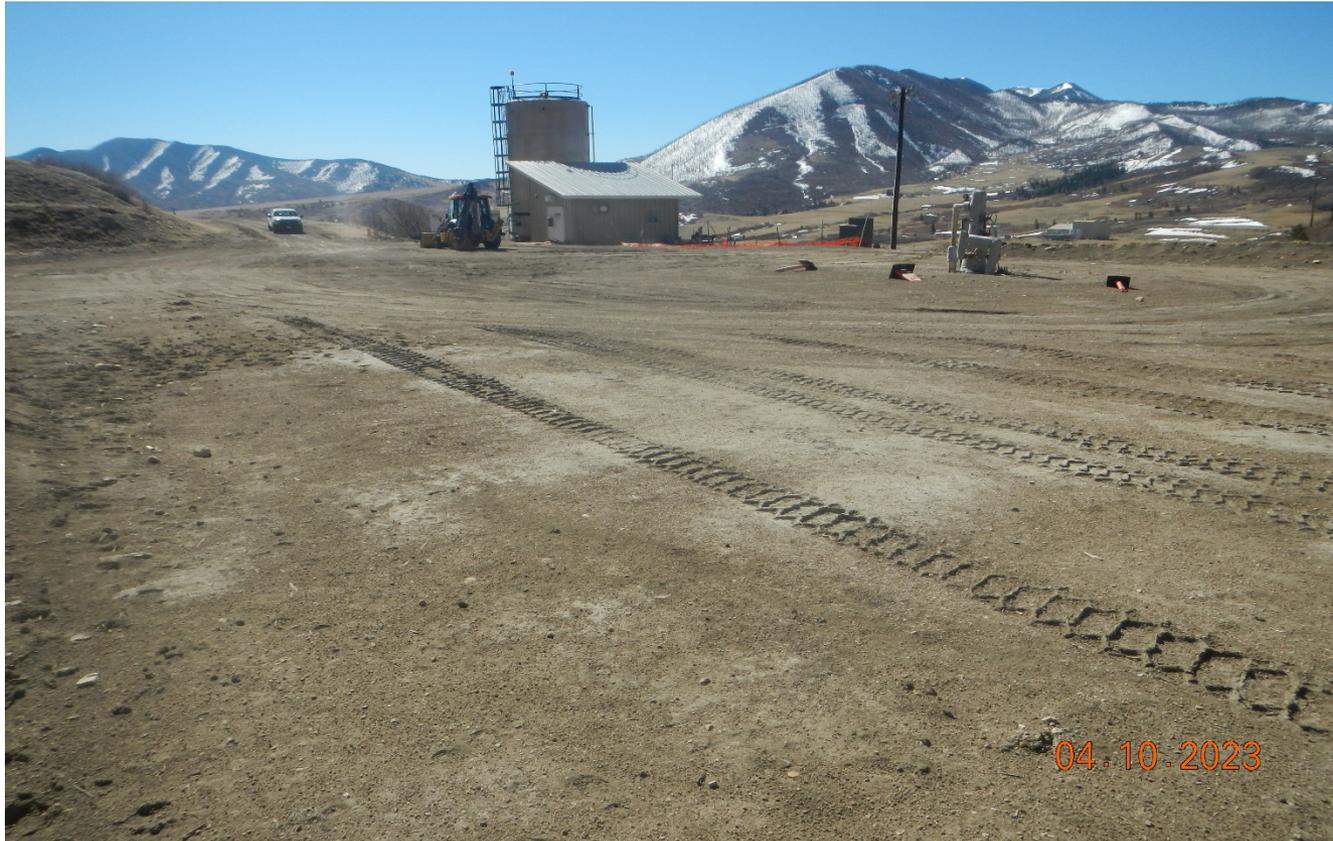
Photo 11. Facing southeast at the location. The stored impacted soils have been removed since previous inspection.

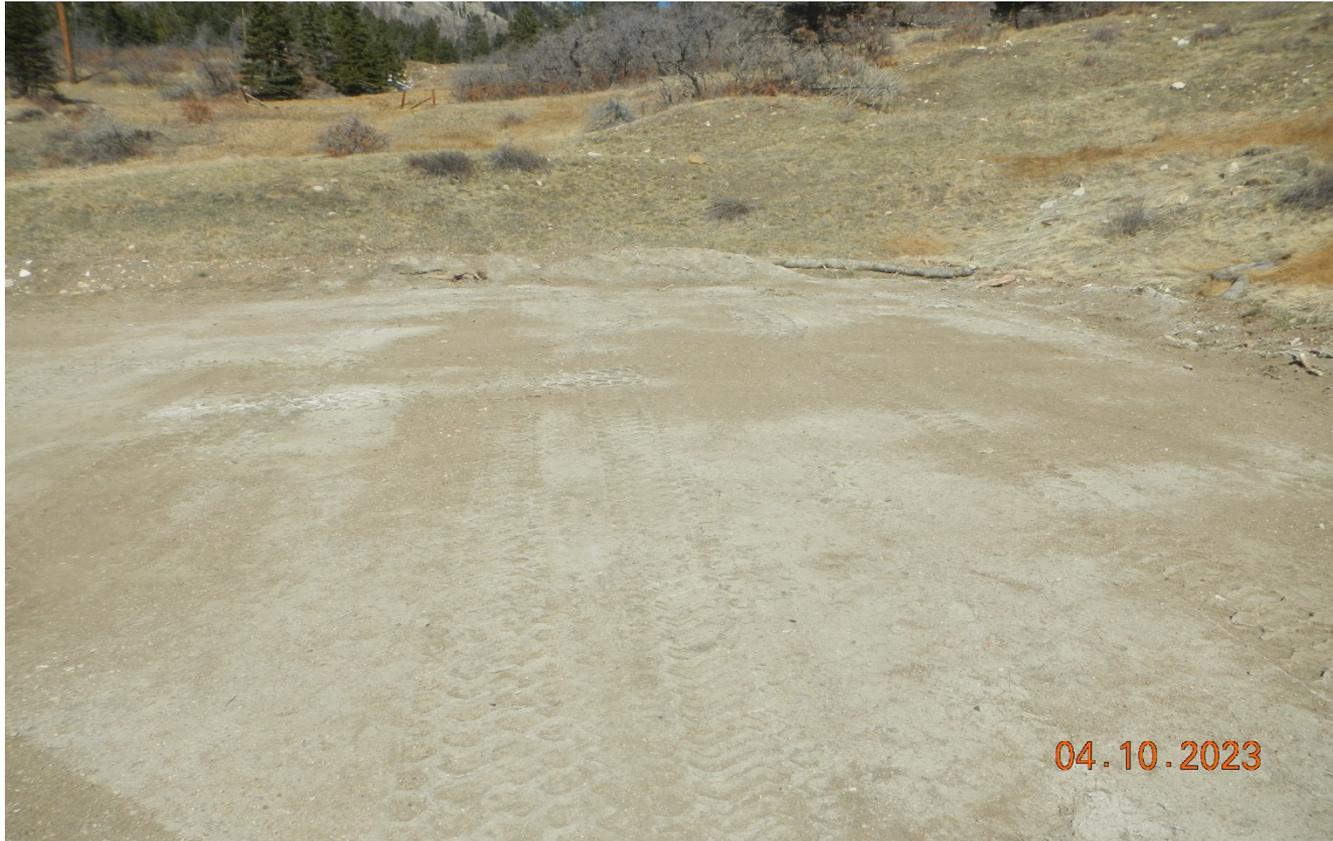
Photo 12. Facing toward the northwest side of the location. It appears the chaulky white soils were pushed out in this area. All unneeded disturbed areas will need to be reclaimed per 1003 rules.
