Inspection Photos

Location Name: TEP ROCKY MOUNTAIN LLC RMV 3-20 Pad

Location ID: 323886

COLORADO
Oil & Gas Conservation
Commission
Department of Natural Resources

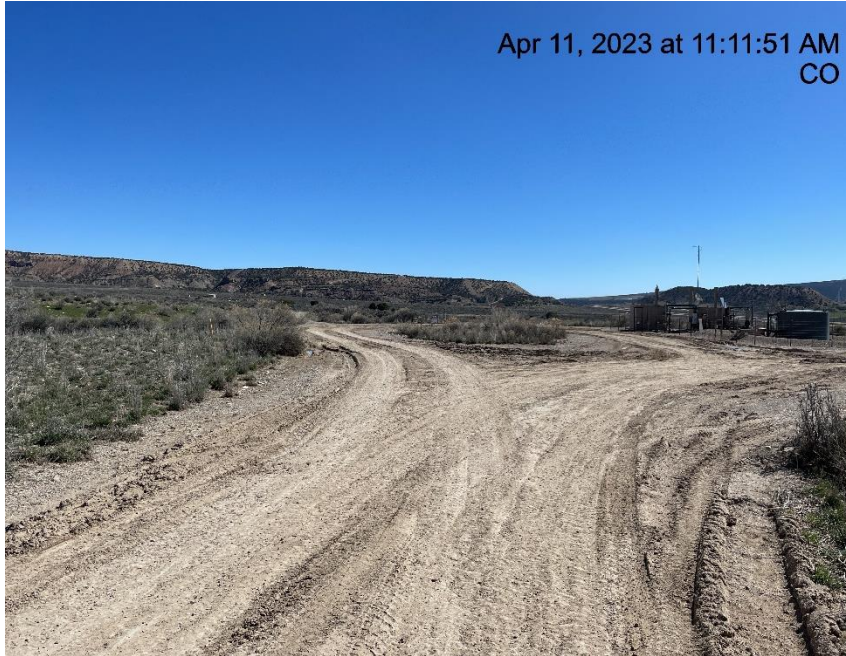
Photo # 5006 From entrance to location

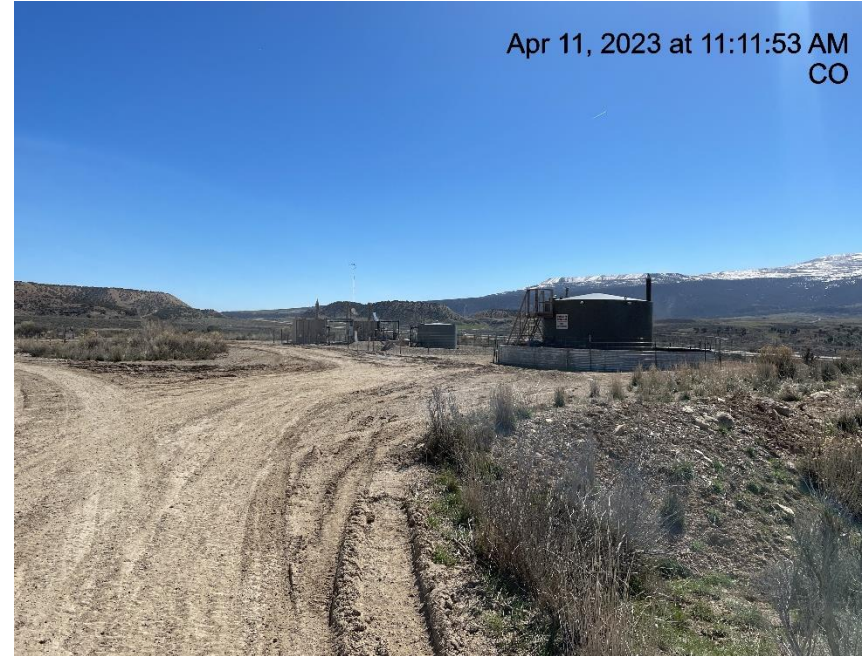
Photo # 5007 From entrance to location

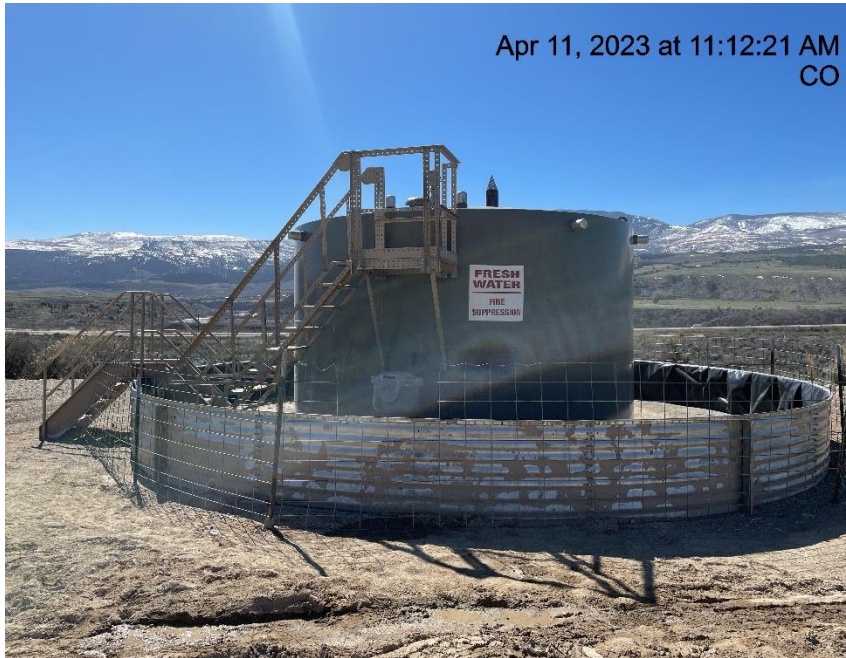
Photo # 5008 Location

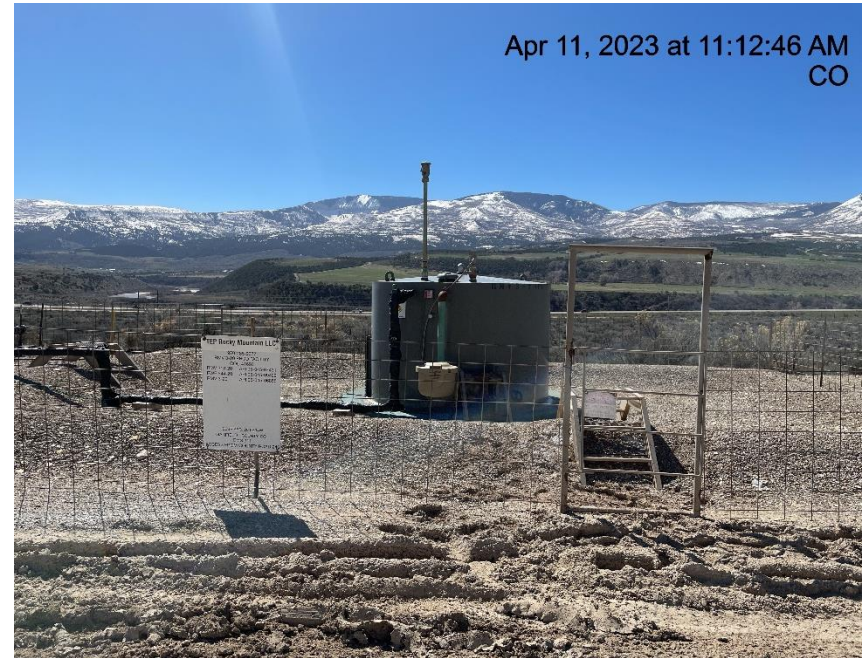
Photo # 5009 Location

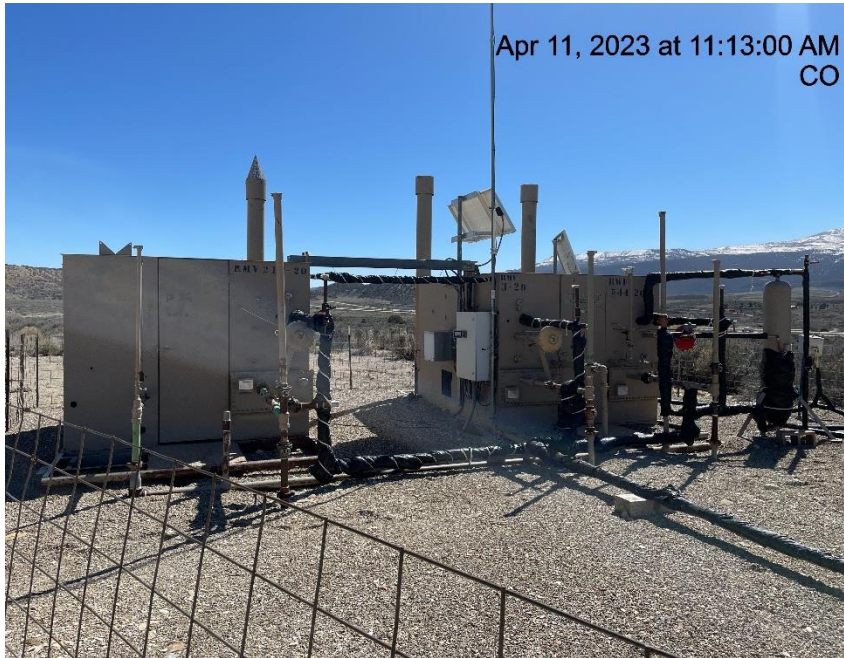
Photo # 5010 Location

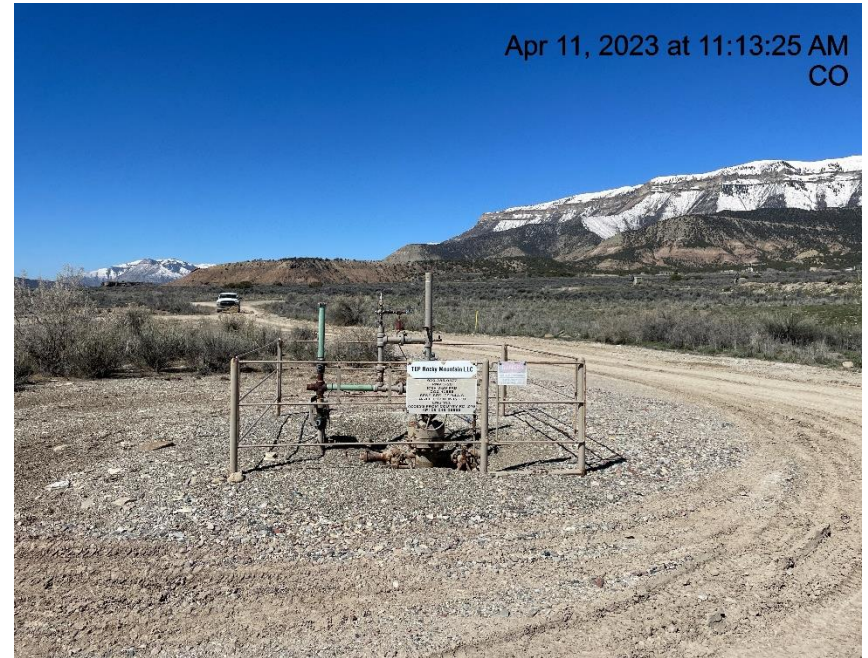
Photo # 5011 Location

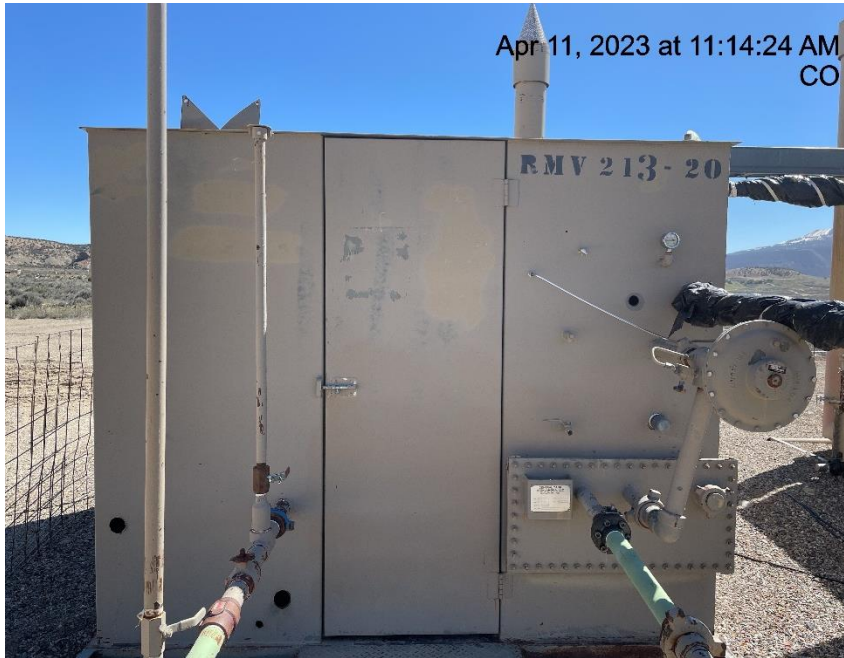
Photo # 5014 Meter calibration info not conspicuously posted

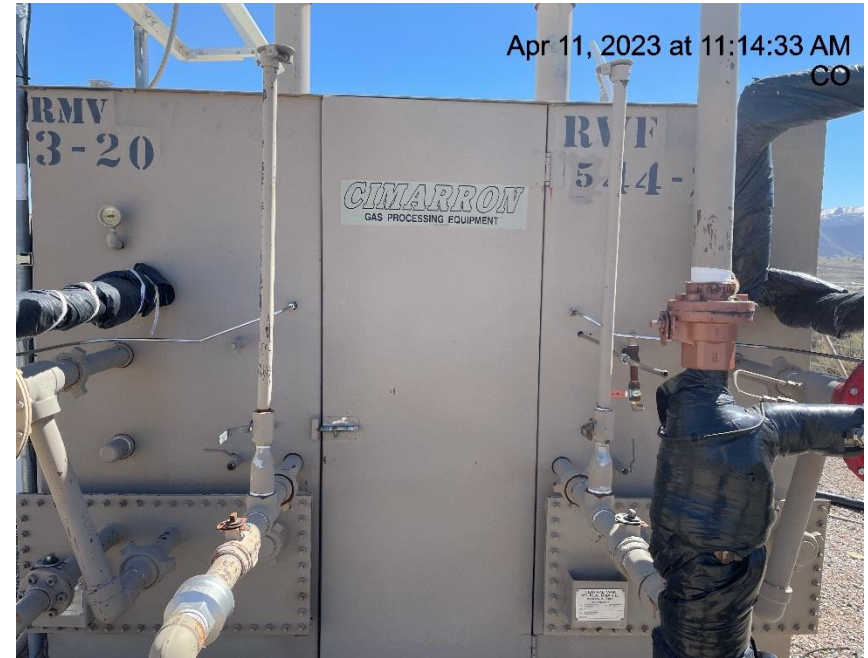
Photo # 5015 Meter calibration info not conspicuously posted

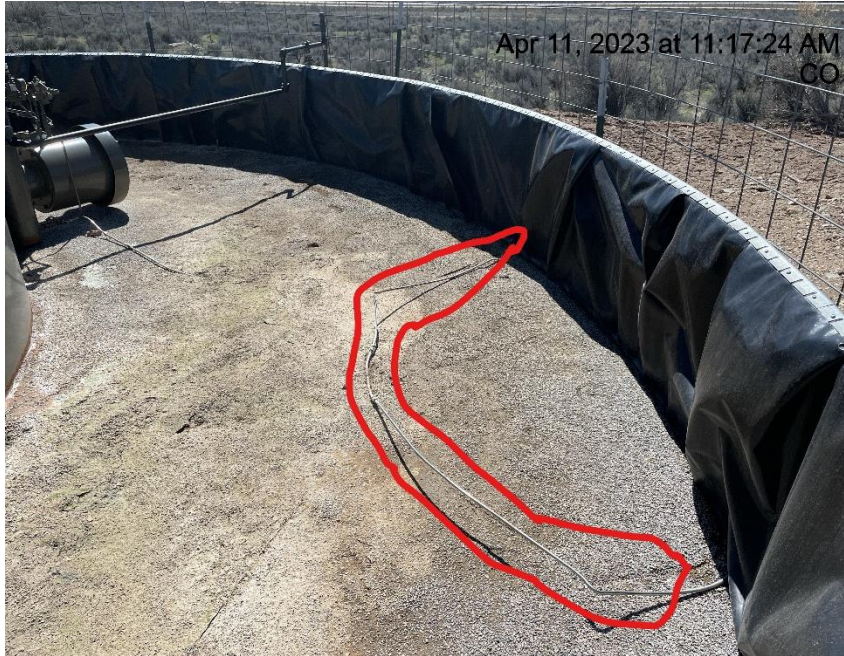
Photo # 5016 Debris

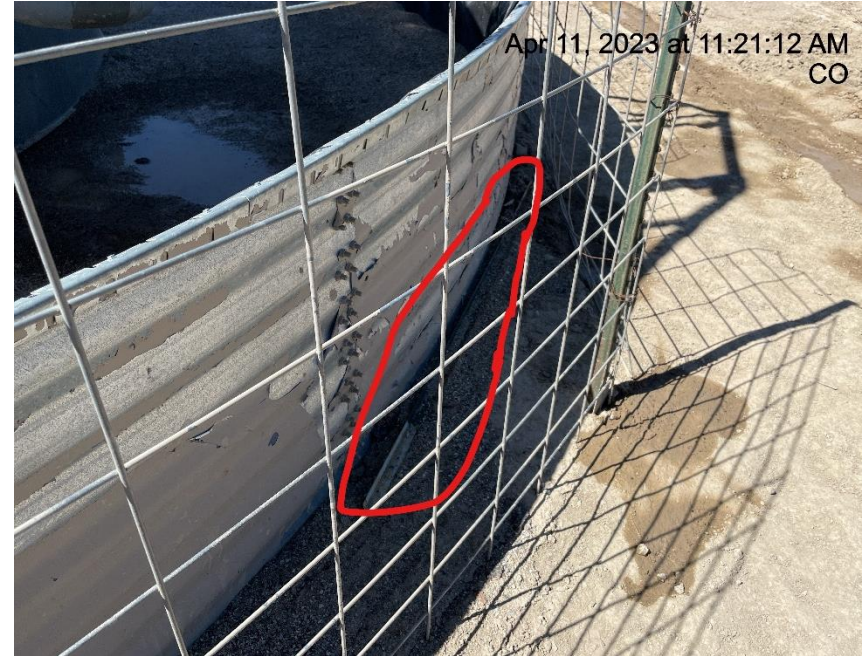
Photo # 5027 Debris

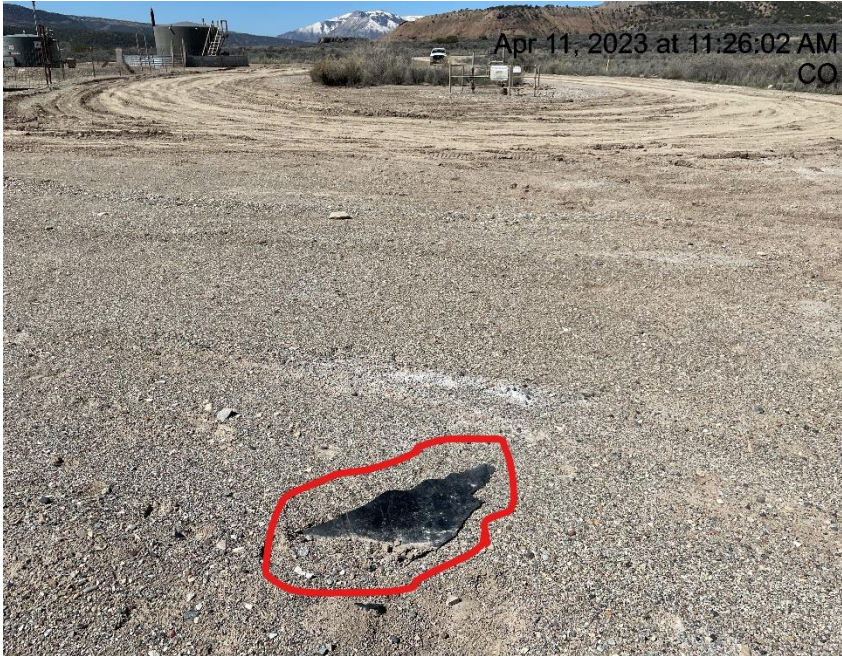
Photo # 5041 Debris

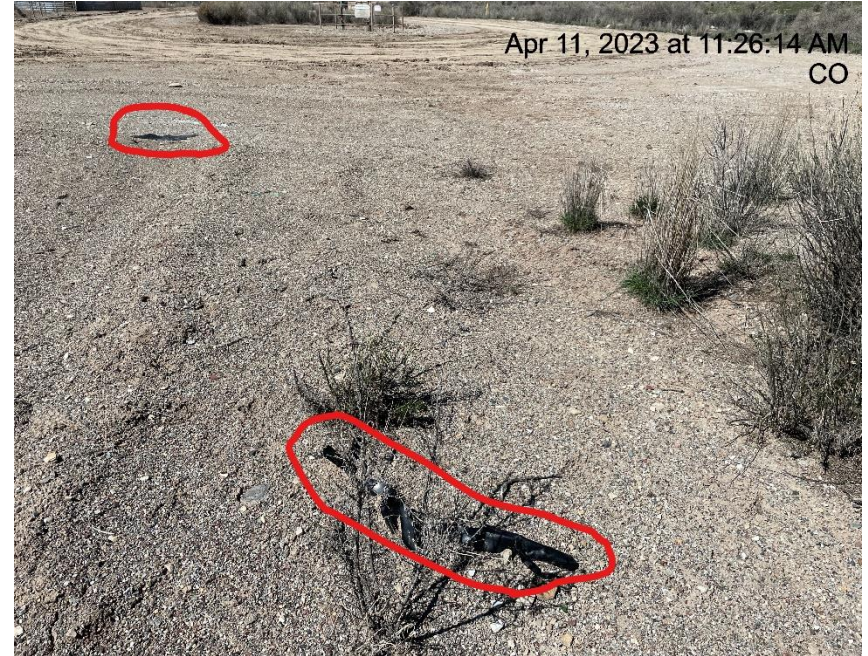
Photo # 5042 Debris

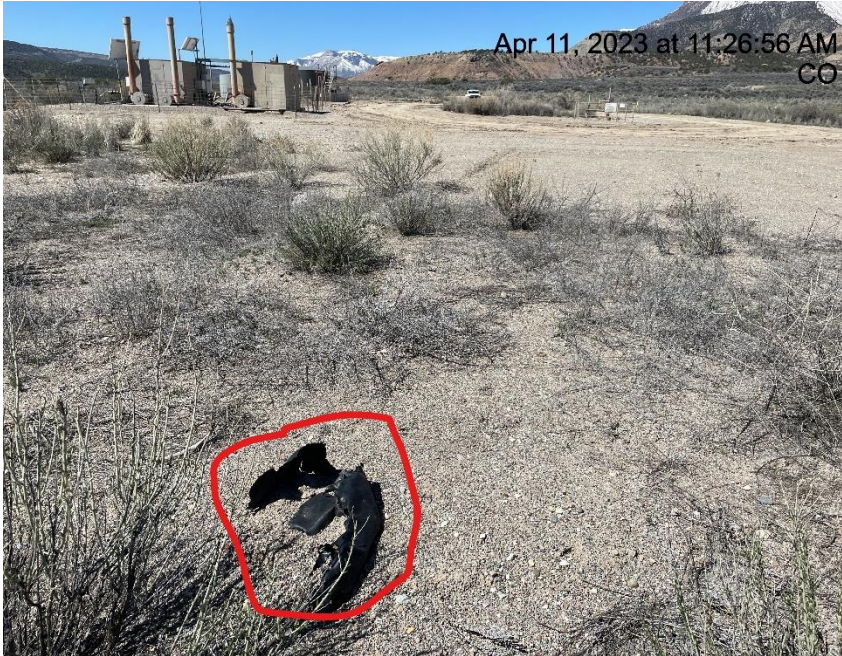
Photo # 5043 Debris

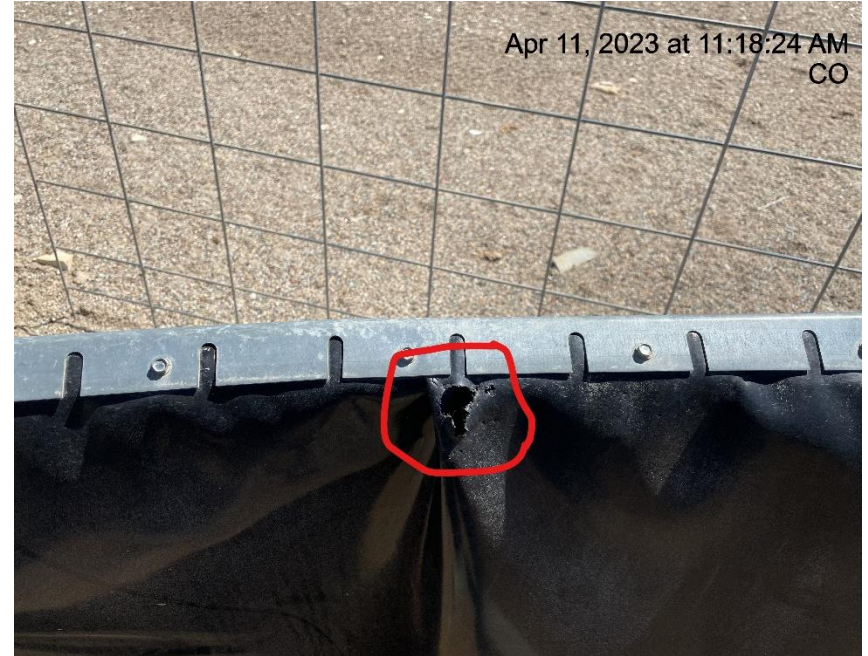
Photo # 5020 Containment liner needs maintenance

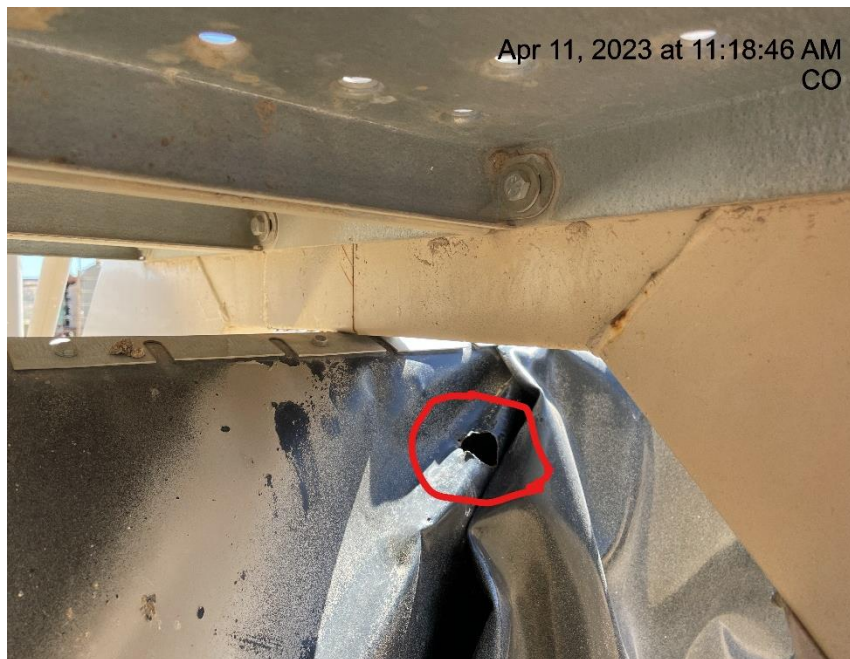
Photo # 5021 Containment liner needs maintenance

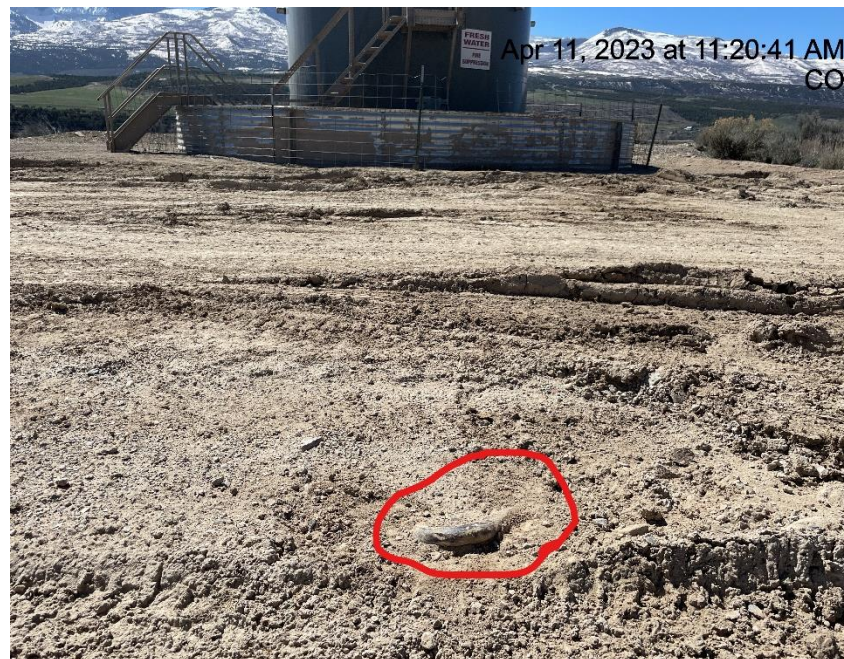
Photo # 5025 Unmarked deadman

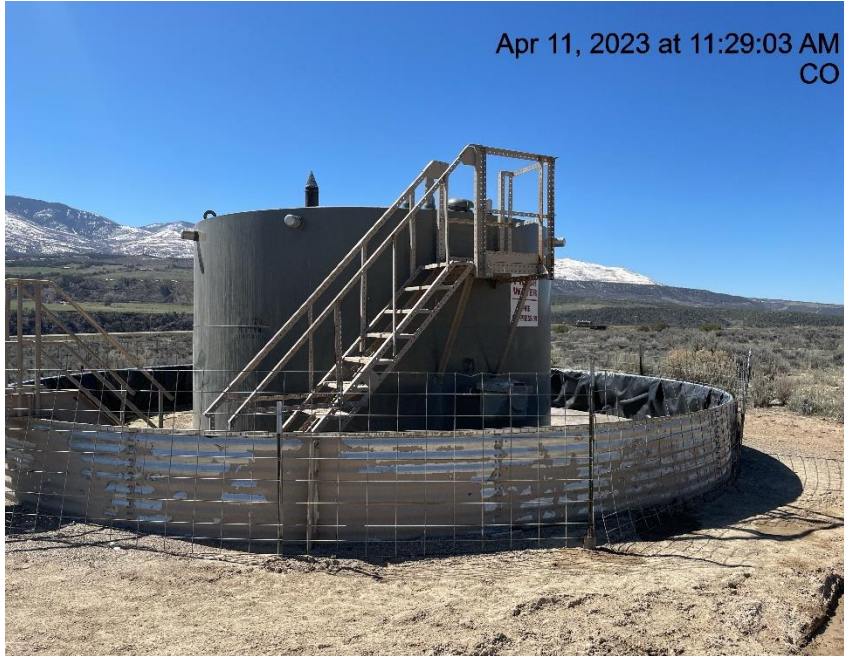
Photo # 5047 Tank missing required information

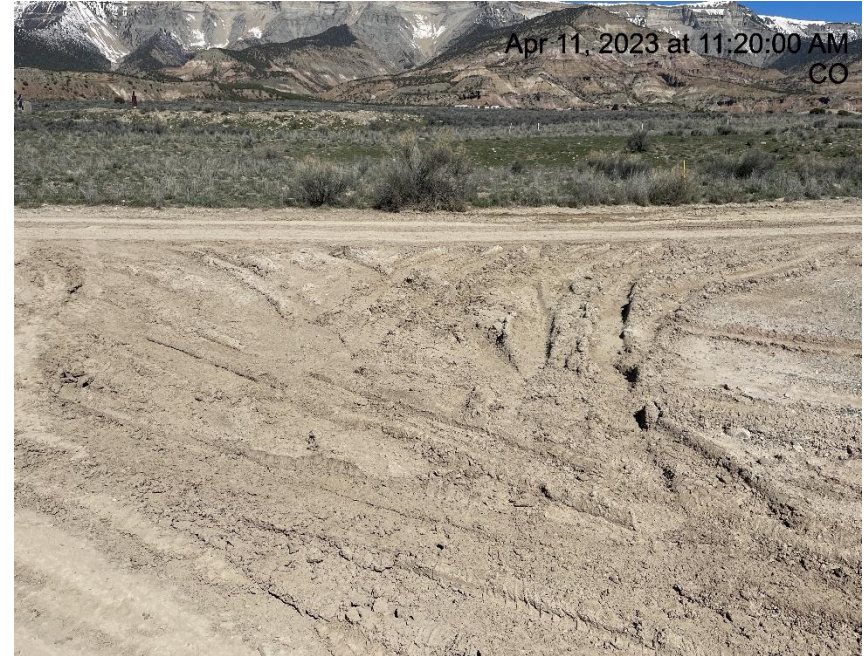
Photo # 5024 Lack of stabilization/compaction

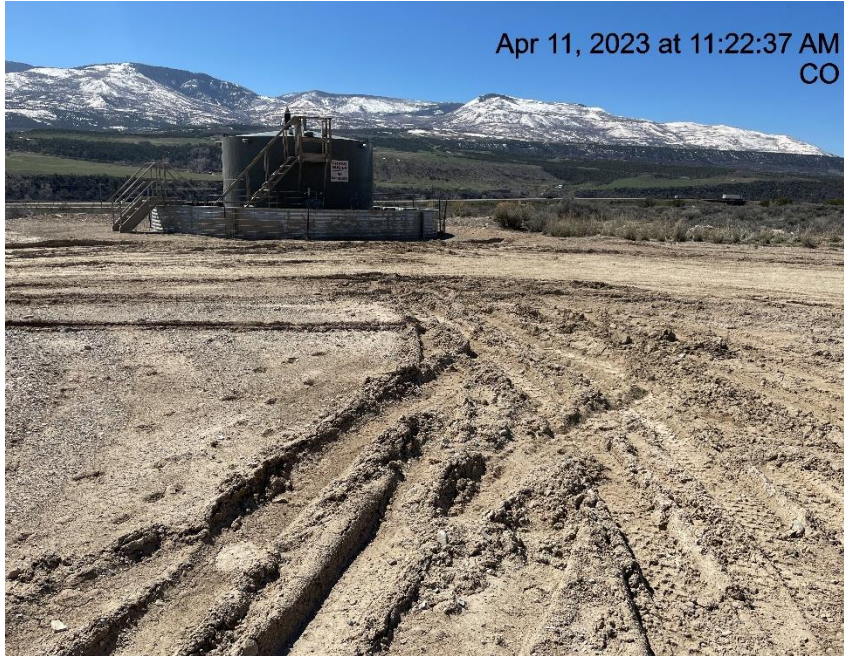
Photo # 5029 Lack of stabilization/compaction

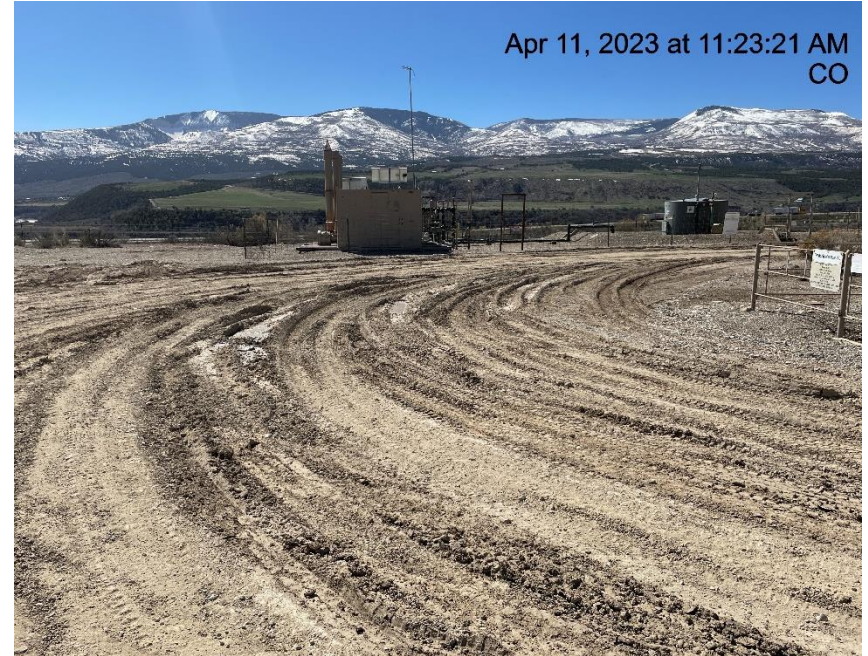
Photo # 5031 Lack of stabilization/compaction

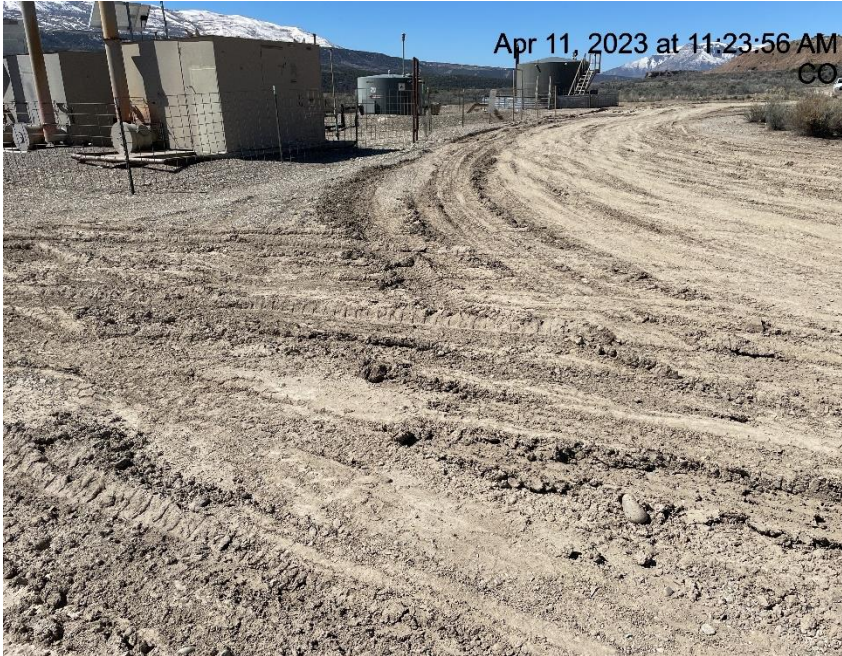
Photo # 5034 Lack of stabilization/compaction

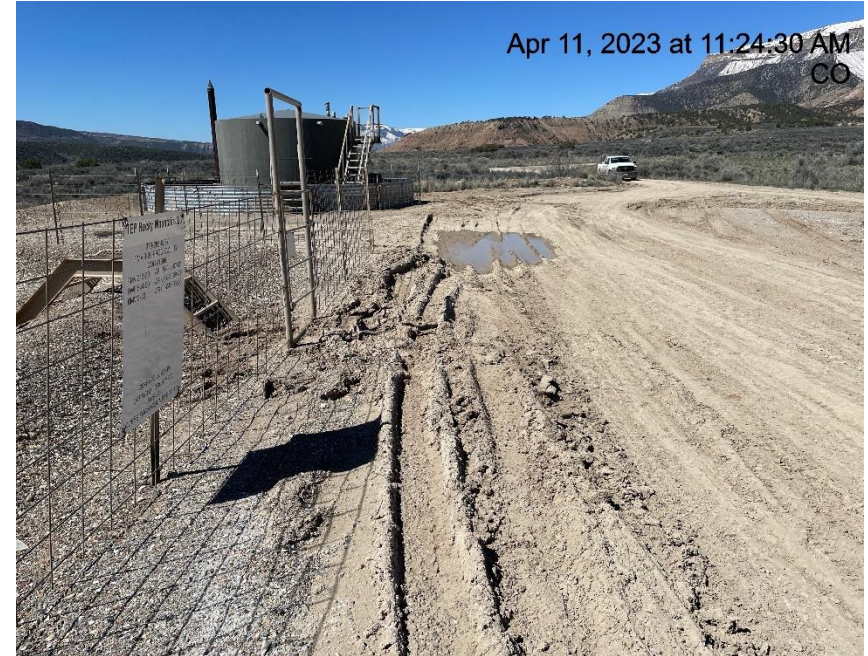
Photo # 5036 Lack of stabilization/compaction

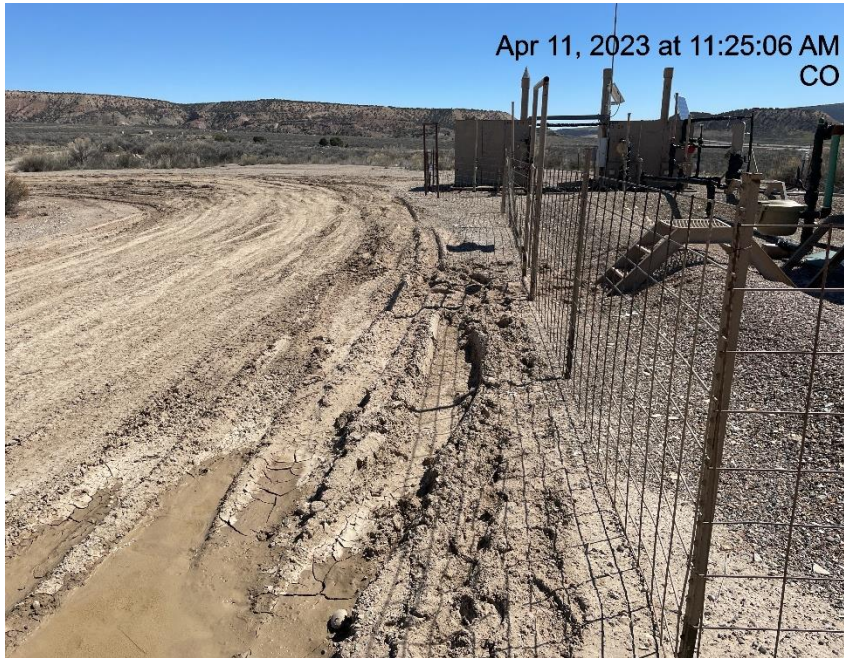
Photo # 5039 Lack of stabilization/compaction

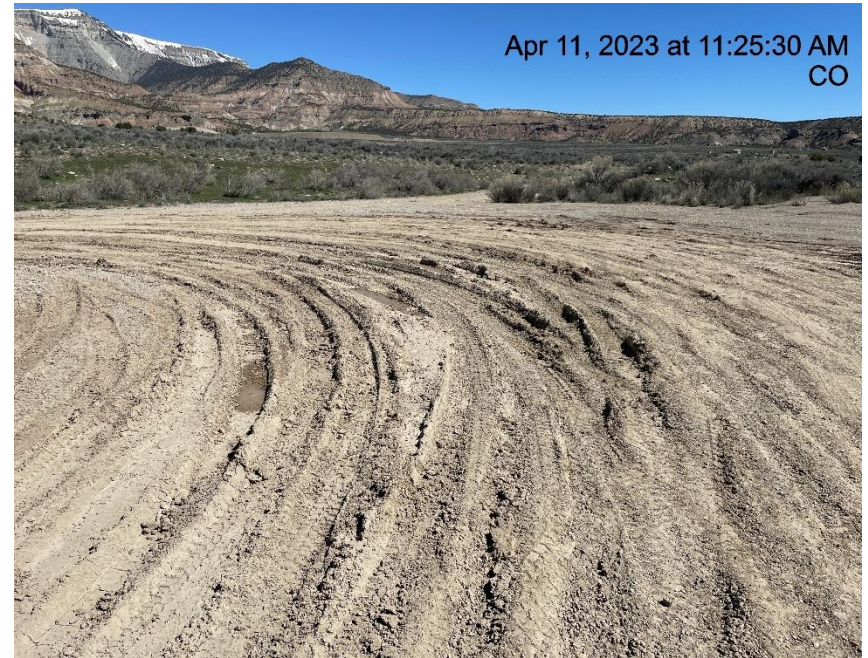
Photo # 5040 Lack of stabilization/compaction

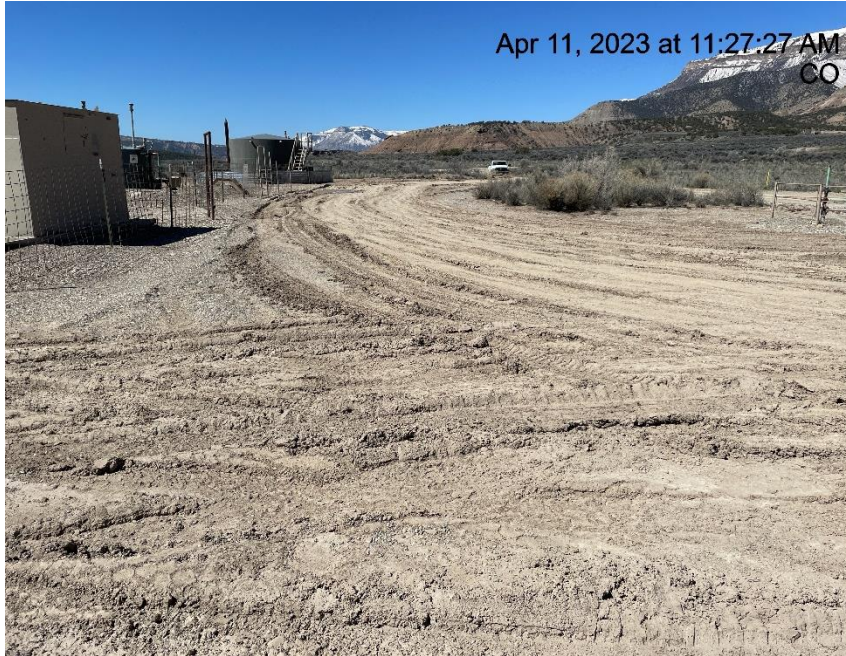
Photo # 5044 Lack of stabilization/compaction
