**Operator: EXTRACTION OIL & GAS INC**  
**Location Name: SIMPSON MD-61S69W2NENE**  
**Loc ID: 321379**  
**Inspection: 709400023**

**Exhibit A**

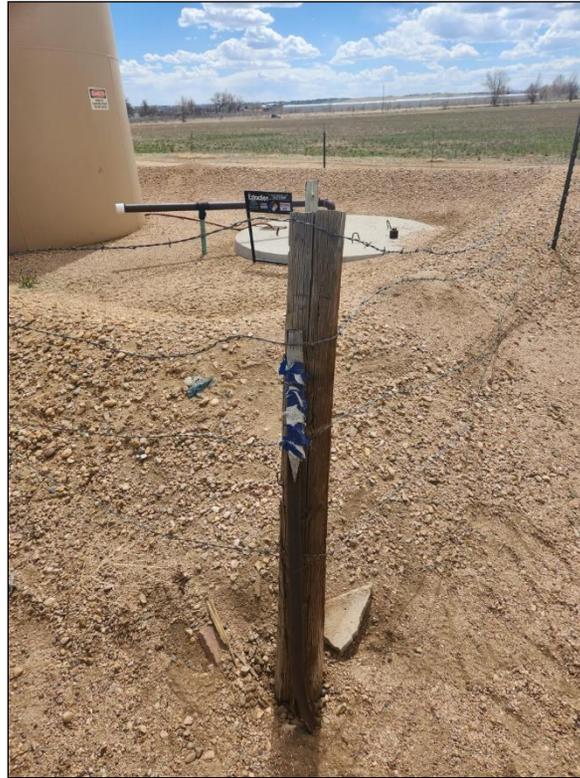
**CA:** Corner post on tank battery perimeter fence has been knocked down, barbed wire fence laying on the ground. See inspection photos. Weeds along access road and north side of location. See inspection photos. Comply with Rule 606 to remove weed debris.

**CA Resolution:** Corner Post has been straightened, and a crew has been scheduled to mow the vegetation along the access road so the location complies with Rule 606.
