Inspection Photos

Location Name: TEP ROCKY MOUNTAIN LLC RMV 138-21 Pad

Location ID: 324136

COLORADO
Oil & Gas Conservation
Commission
Department of Natural Resources

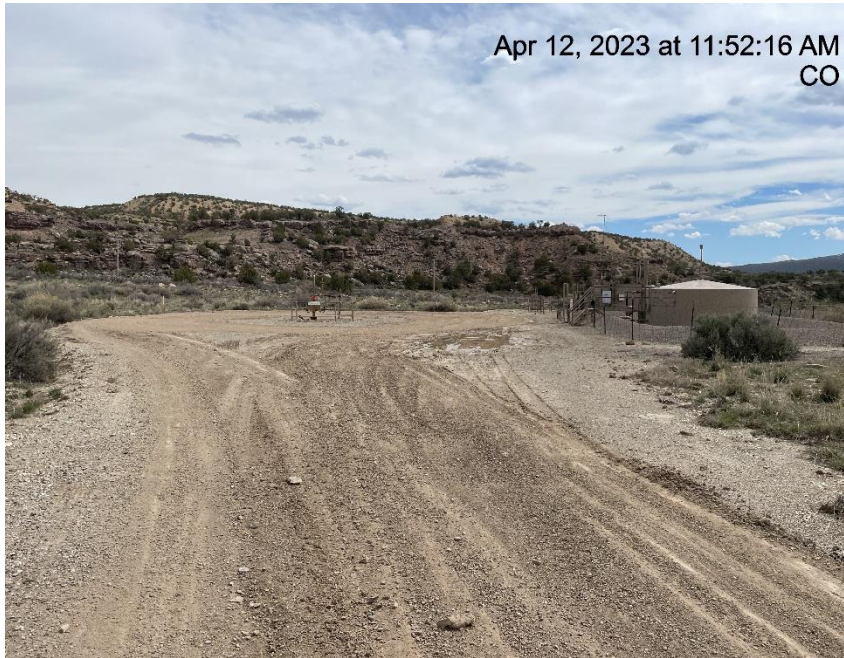
Photo # 5122 From entrance to location

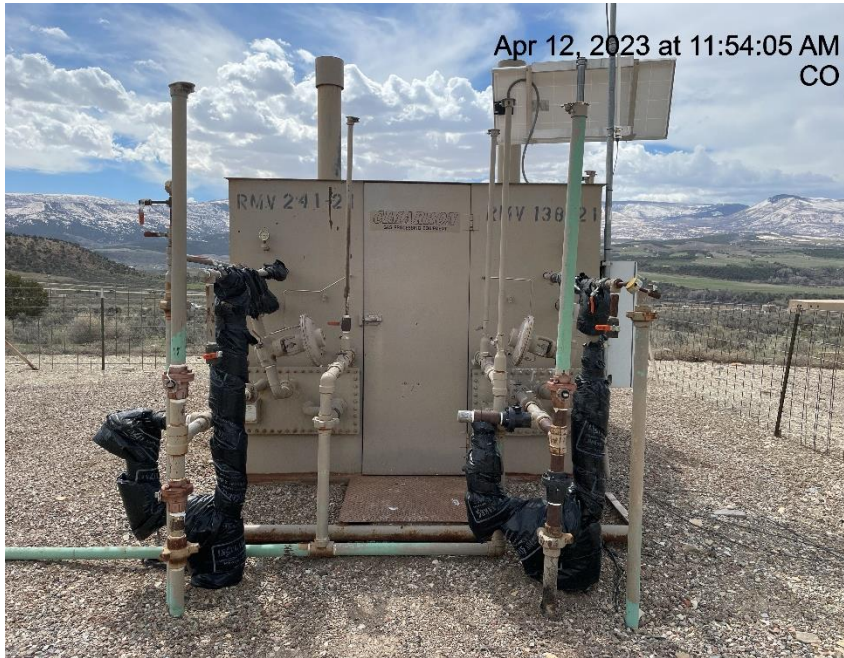
Photo # 5126 Meter calibration info not conspicuously posted

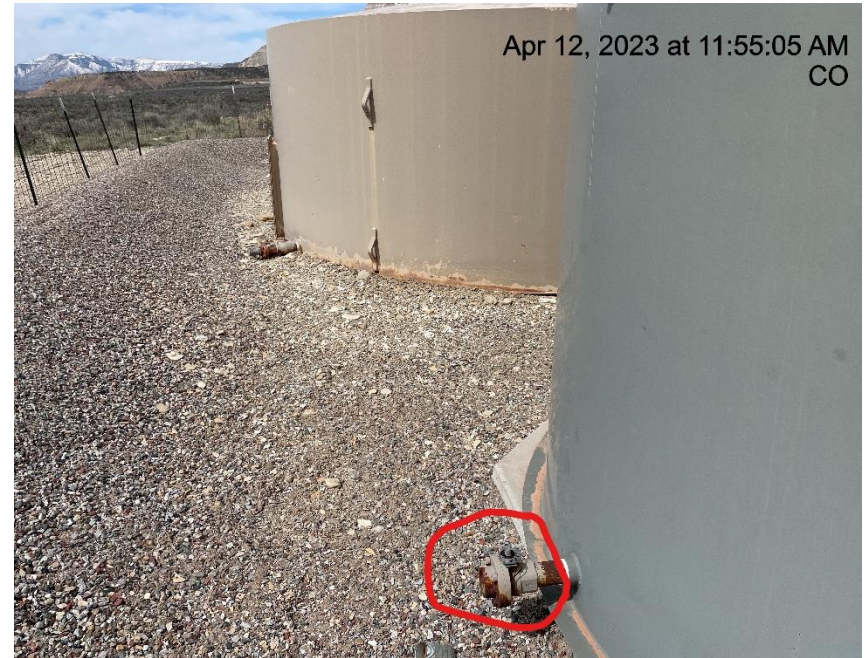
Photo # 5127 Open ended load line

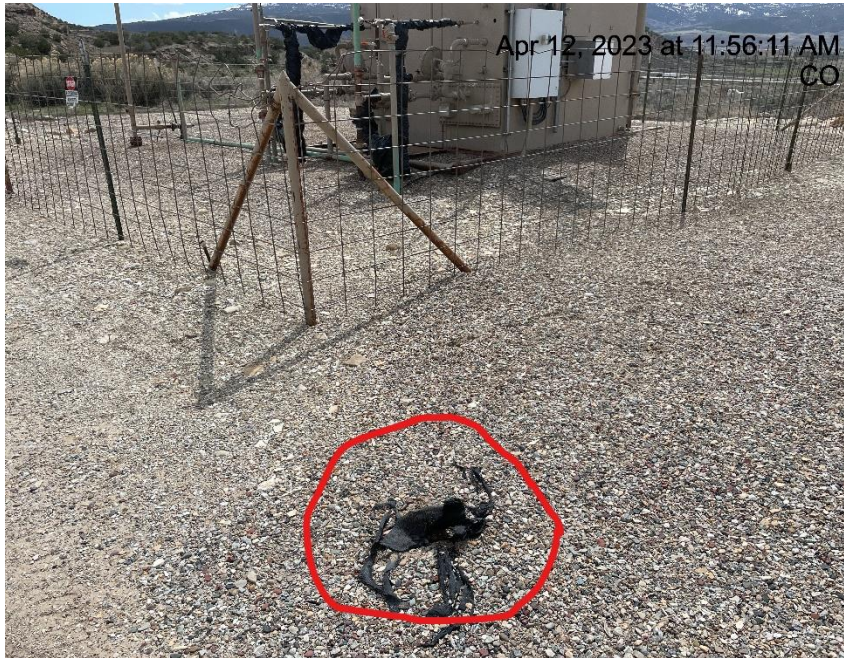
Photo # 5128 Debris

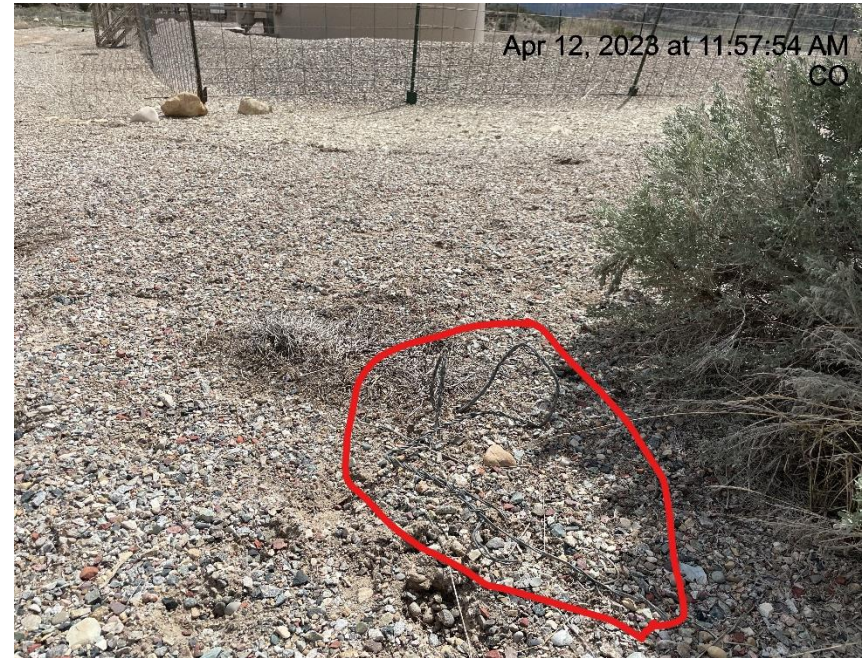
Photo # 5129 Debris – barbed wire

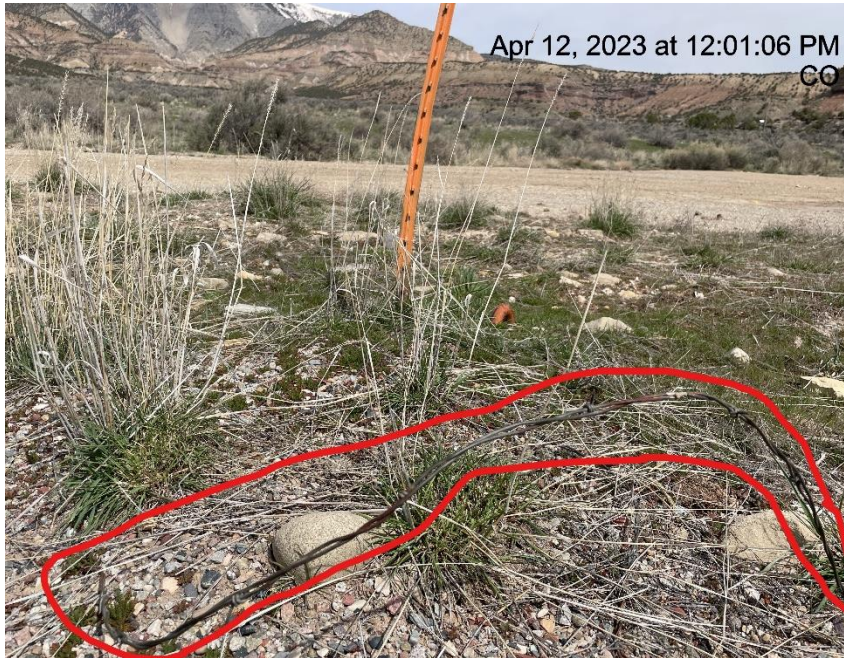
Photo # 5140 Debris – barbed wire

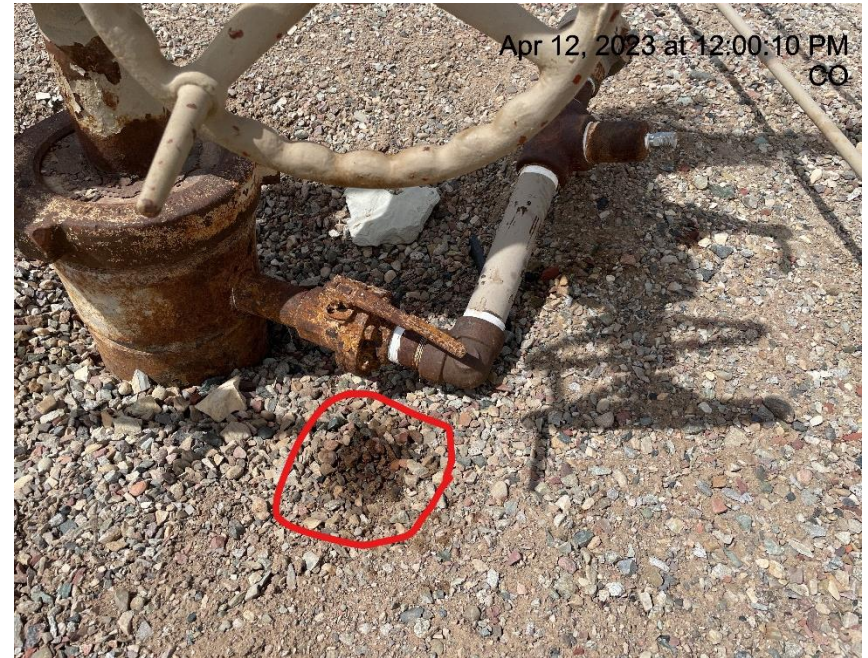
Photo # 5135 Stained soil & gravel

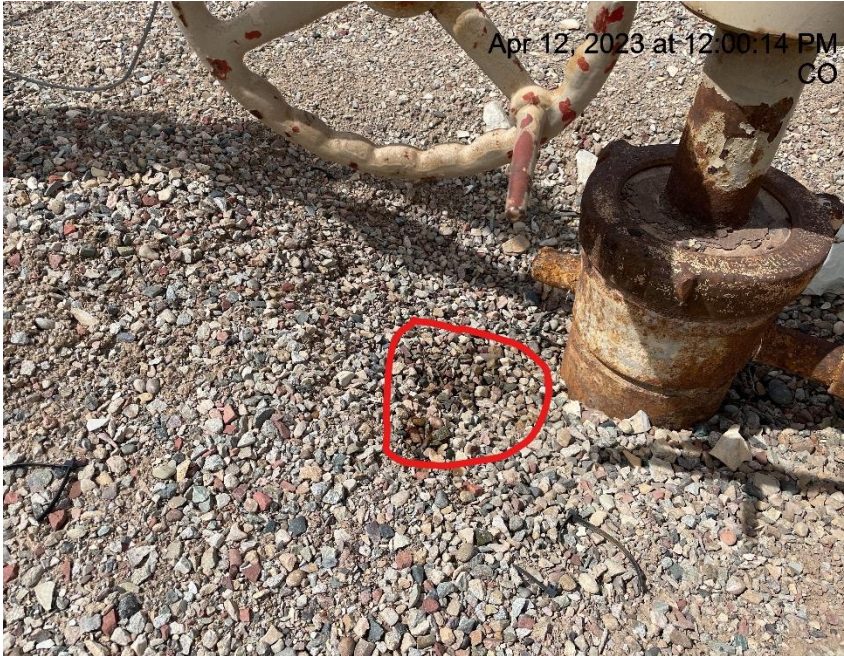
Photo # 5136 Stained soil & gravel
