Caerus Piceance LLC  
PCU 296-6B  
Location # 413466

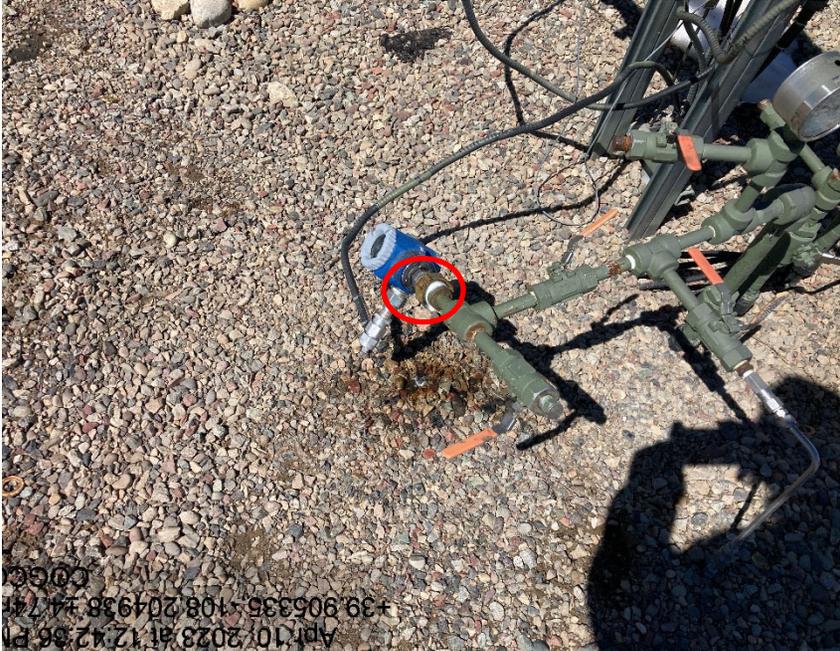
Leaking fitting and stained soil

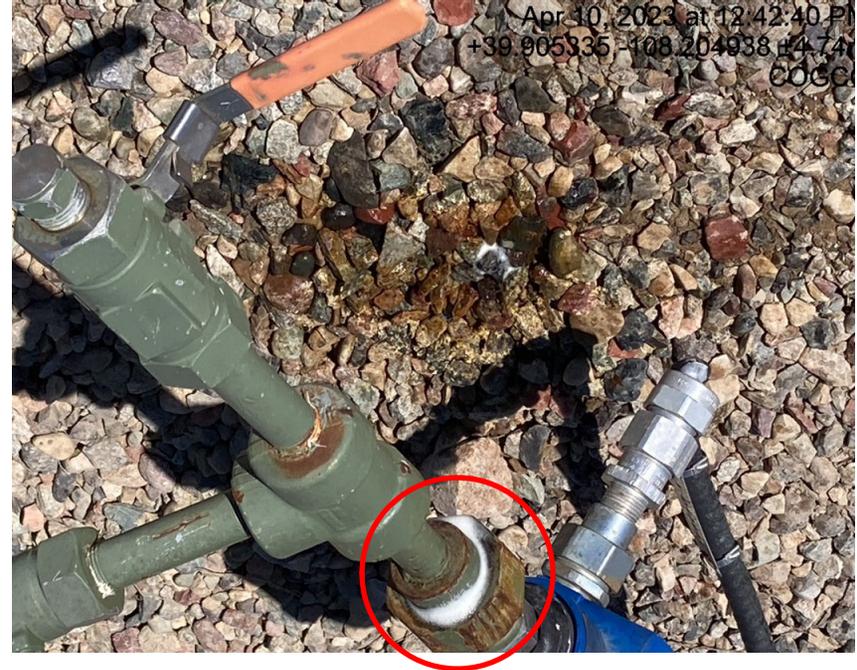
Leaking fitting and stained soil

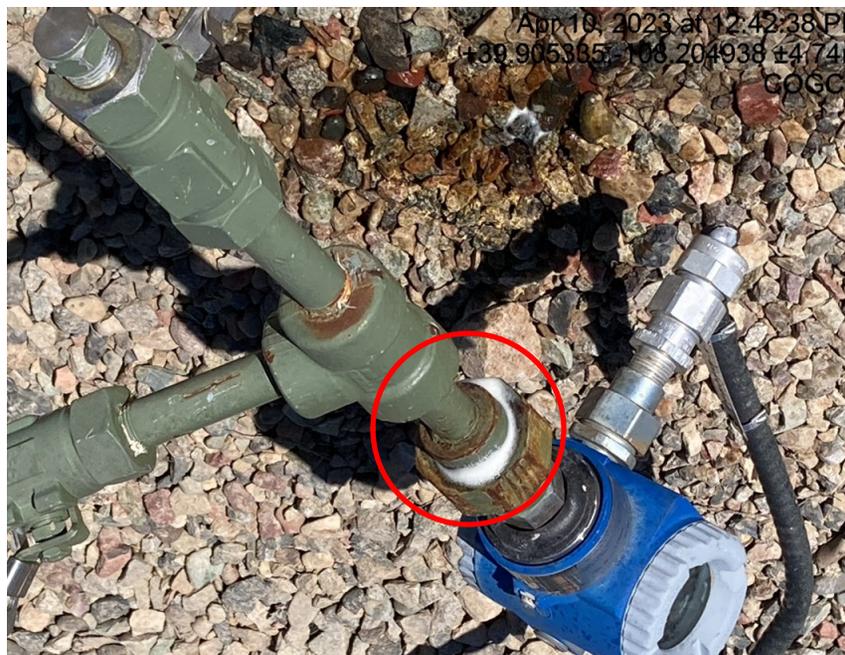
Leaking fitting

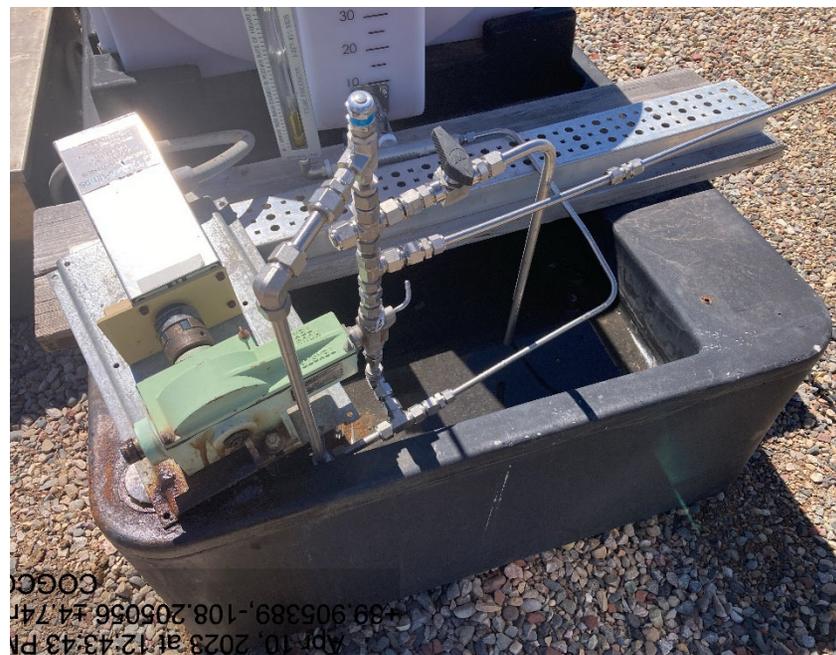
Chemical containment is full of fluid

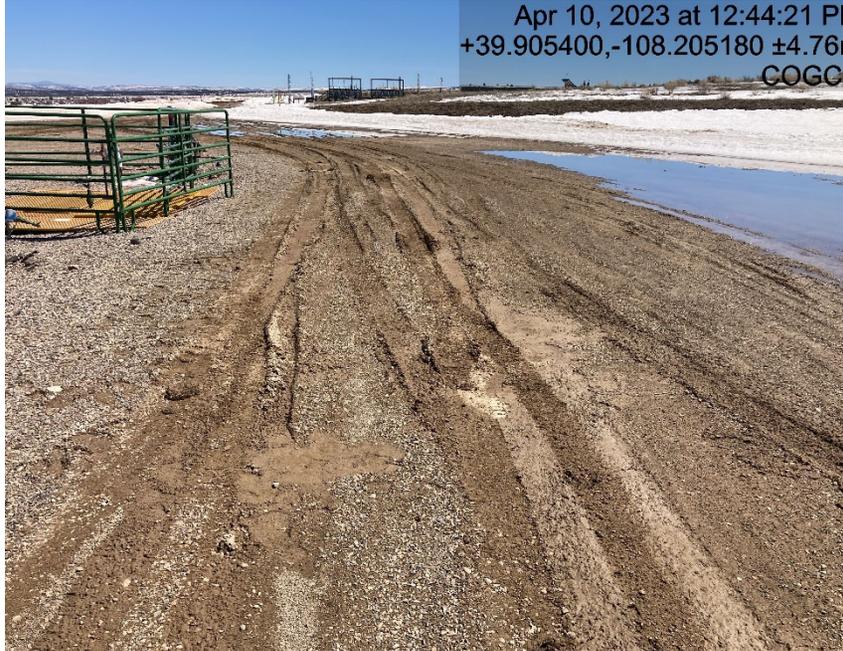
Lack of stabilization/ compaction

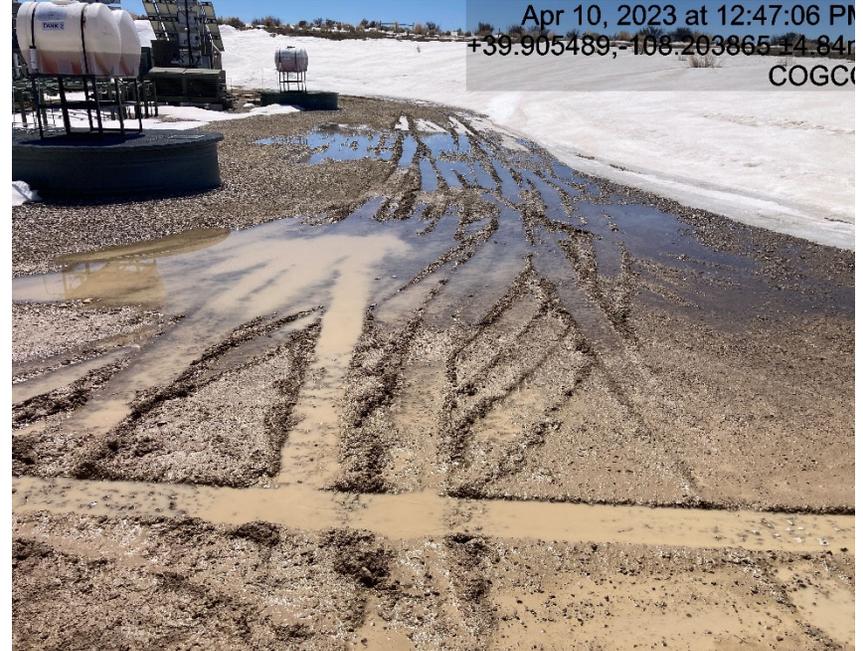
Lack of stabilization/ compaction

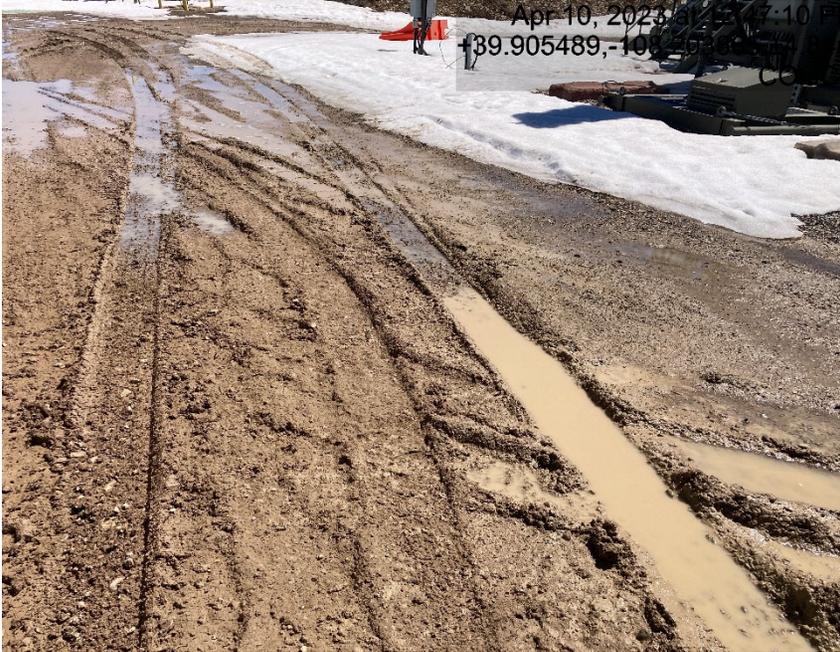
Lack of stabilization/ compaction

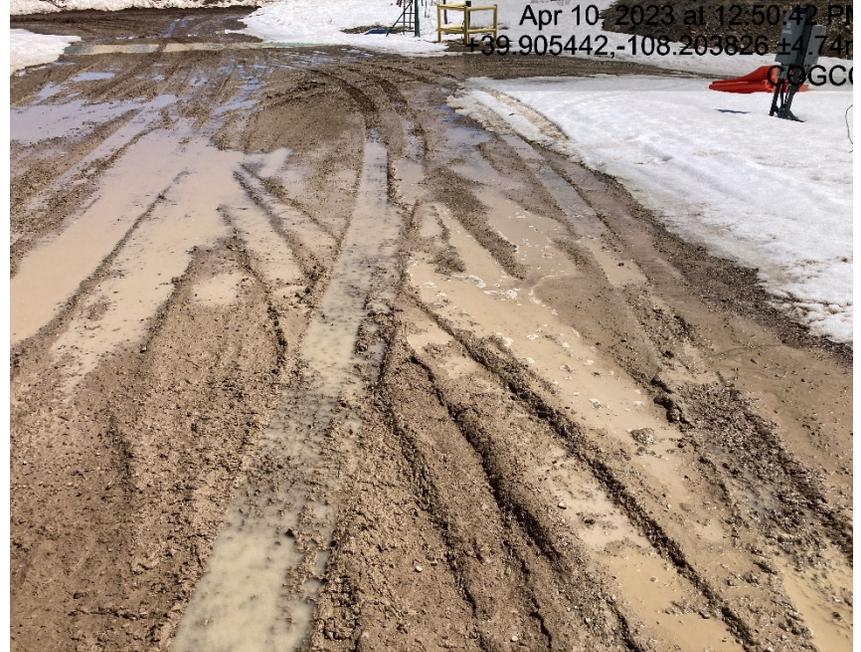
Lack of stabilization/ compaction

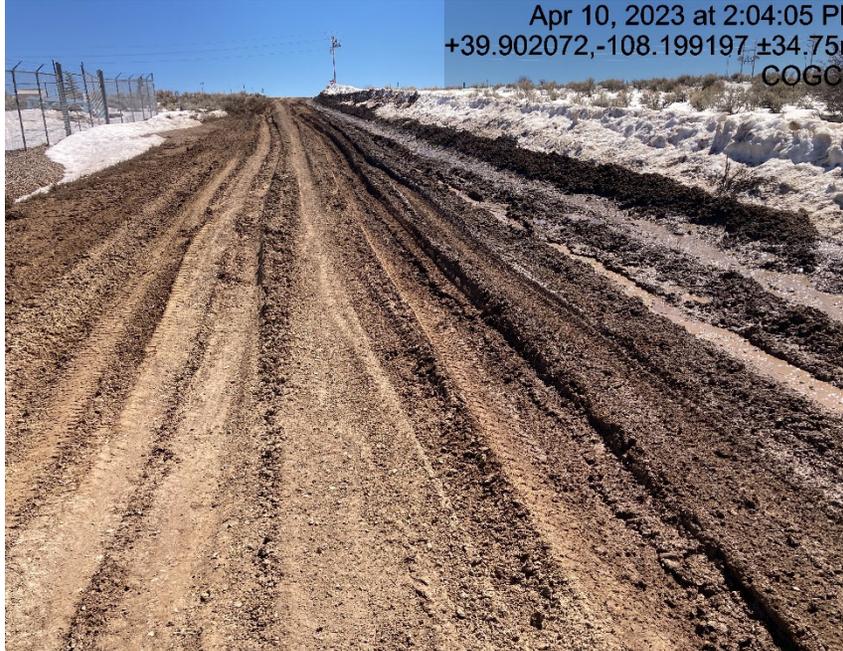
Lease road lacks compaction/ stabilization

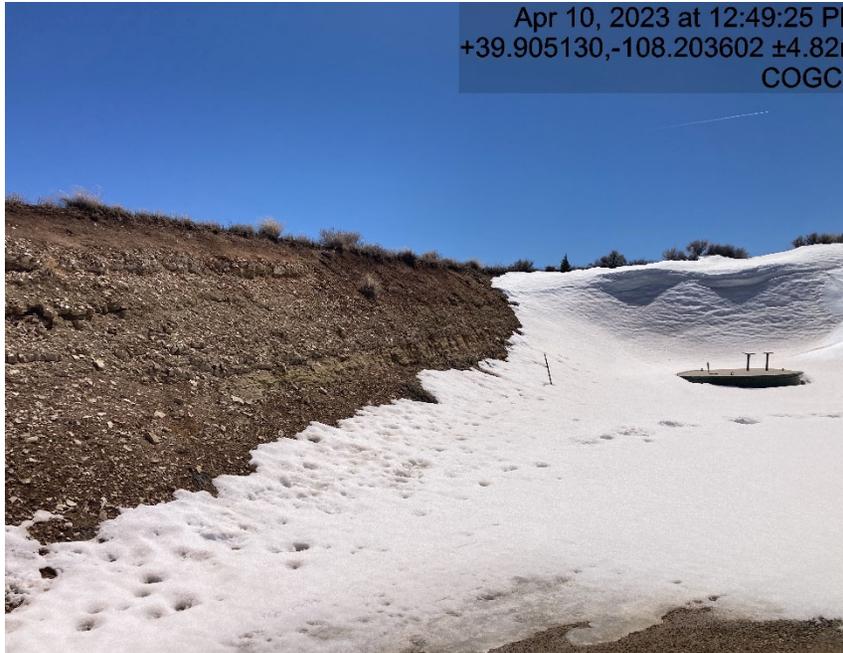
**Cut slope lacks stabilization/ erosion some still snow covered**

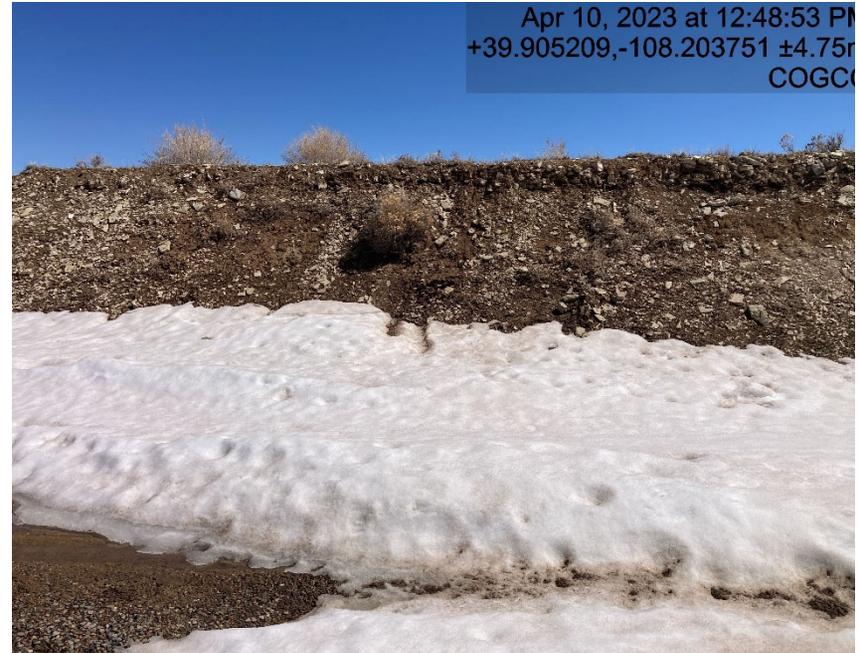
**Cut slope lacks stabilization/ erosion**

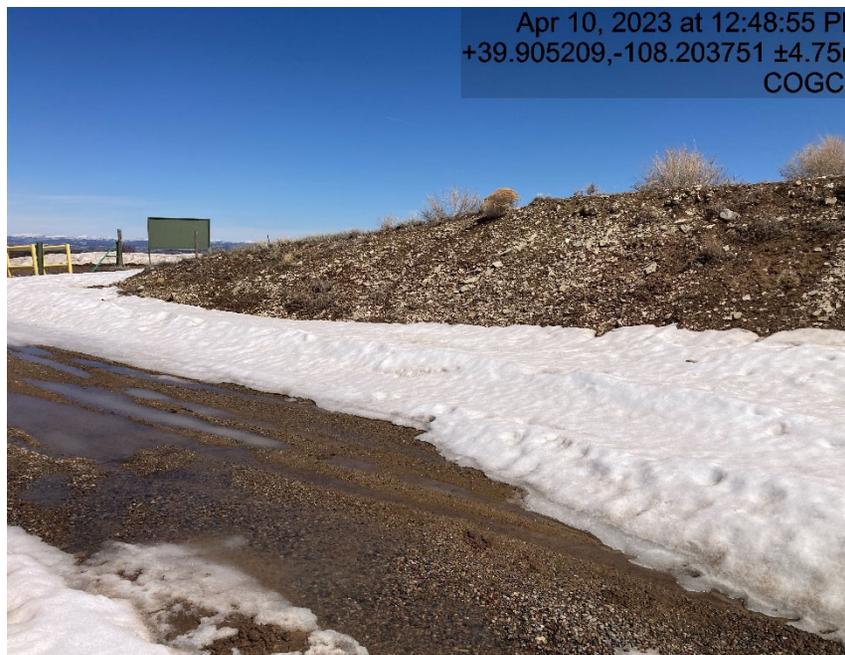
Cut slope lacks stabilization/ erosion

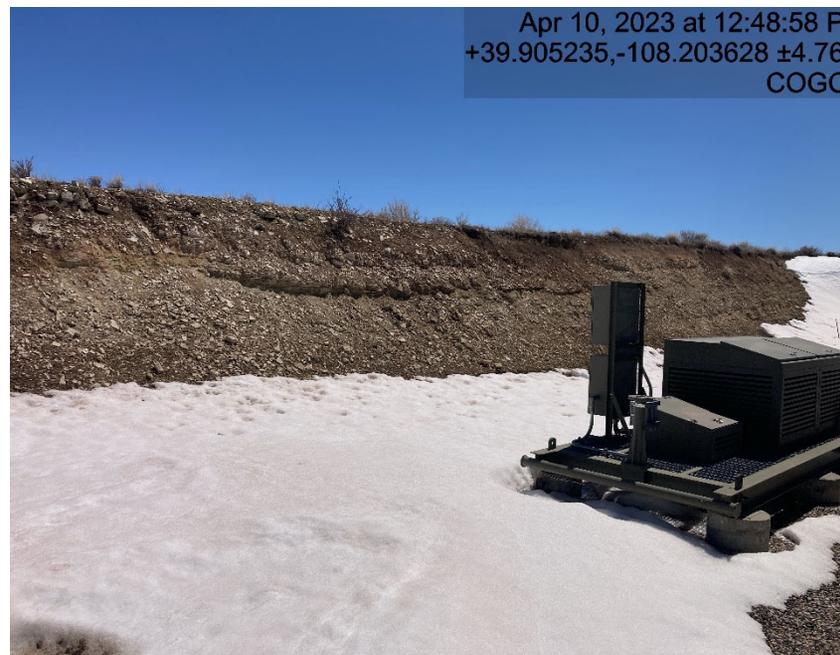
Cut slope lacks stabilization/ erosion
