Inspection Photos

Location Name: TEP ROCKY MOUNTAIN LLC CLOUGH 134 Pad

Location ID: 322440

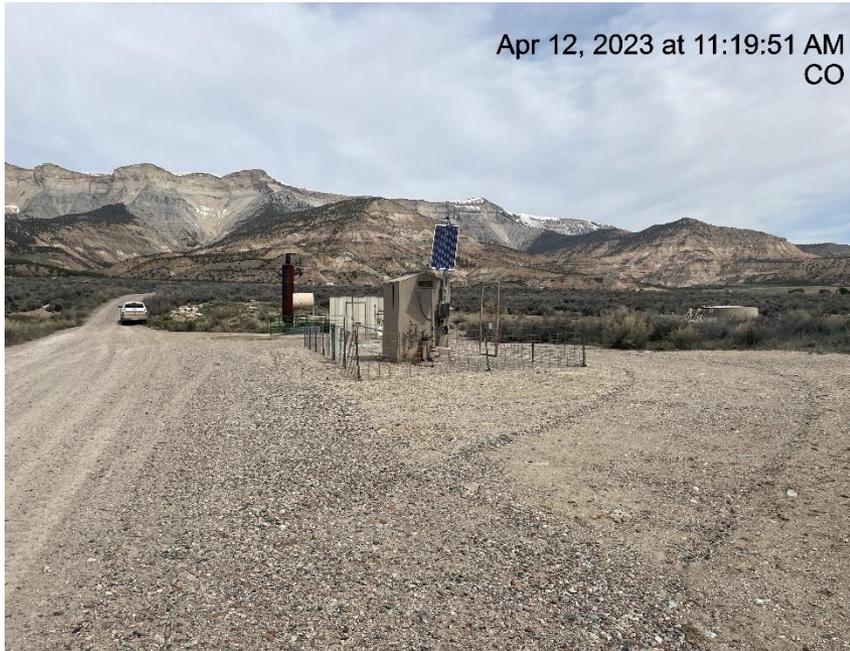
Photo # 5057 From entrance to location

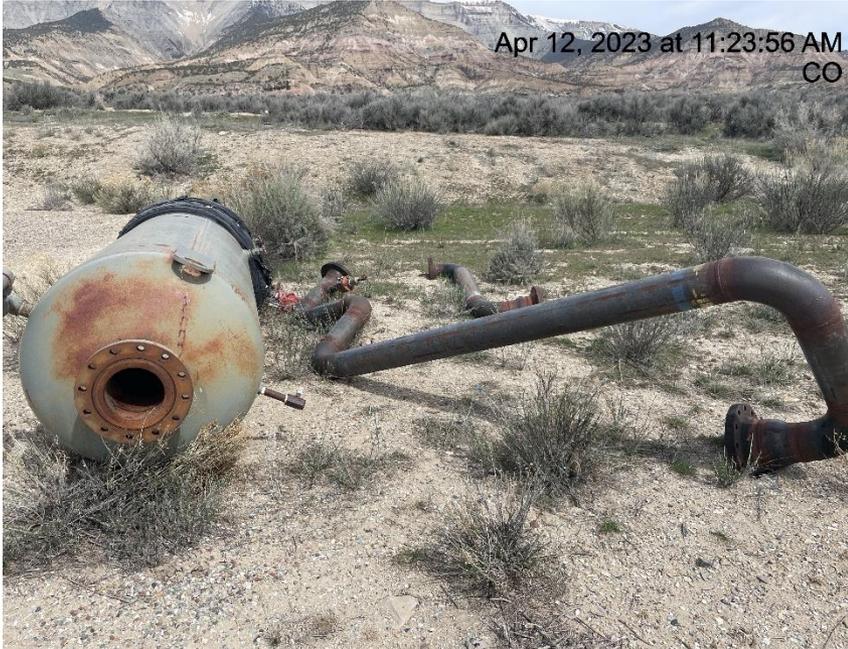
Photo # 5062 Debris/Unused equipment

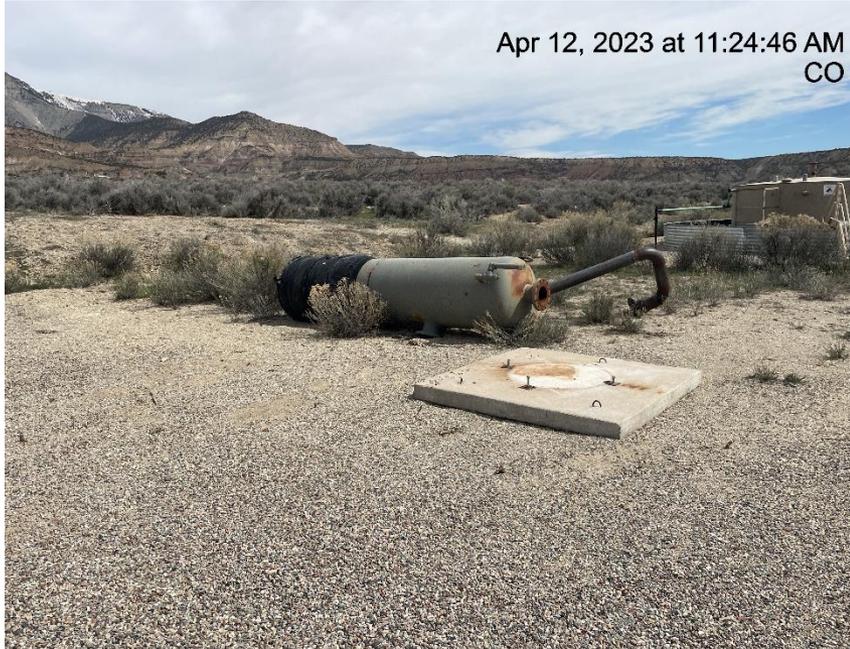
Photo # 5064 Debris/Unused equipment

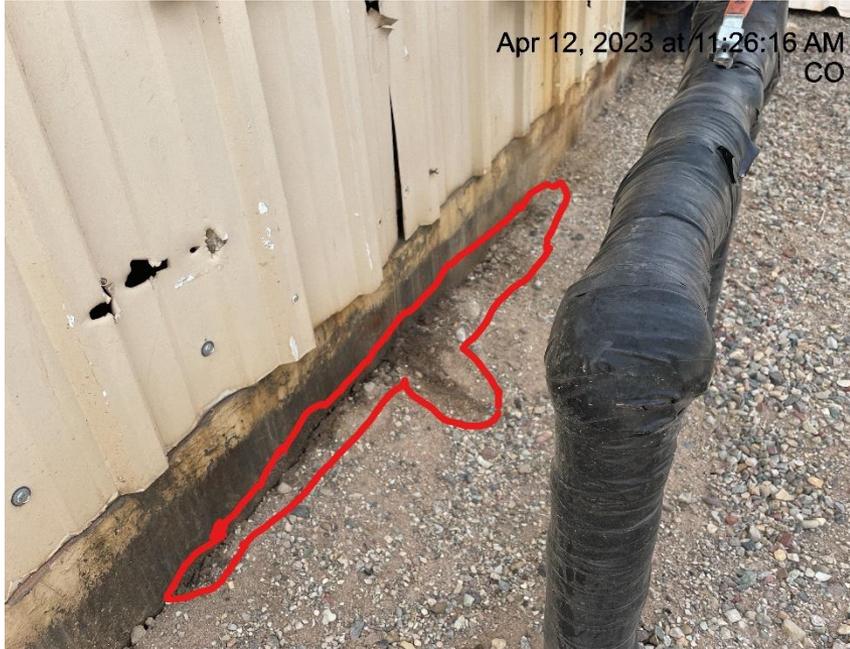
Photo # 5069 Stained soils & gravel

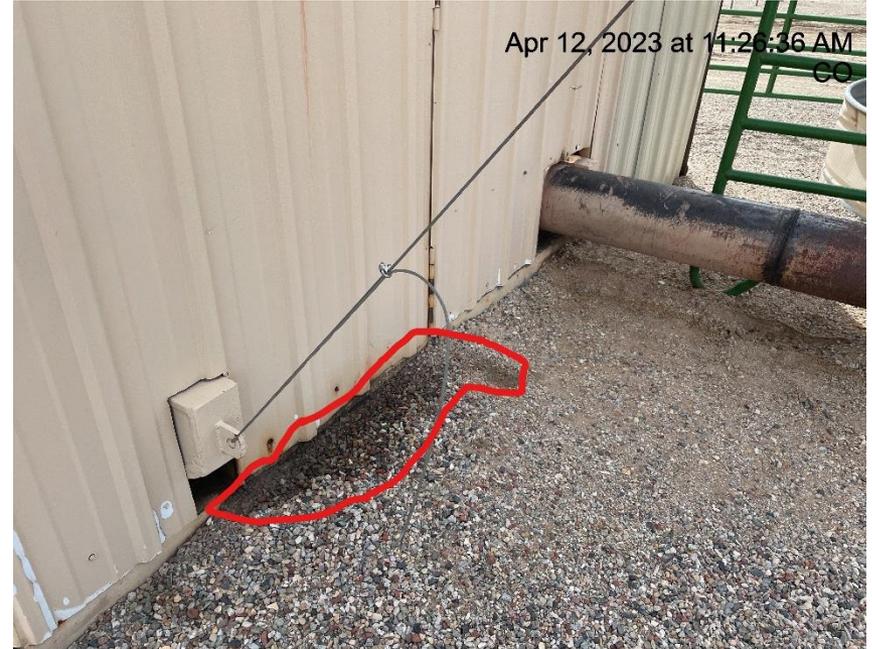
Photo # 5070 Stained soils & gravel

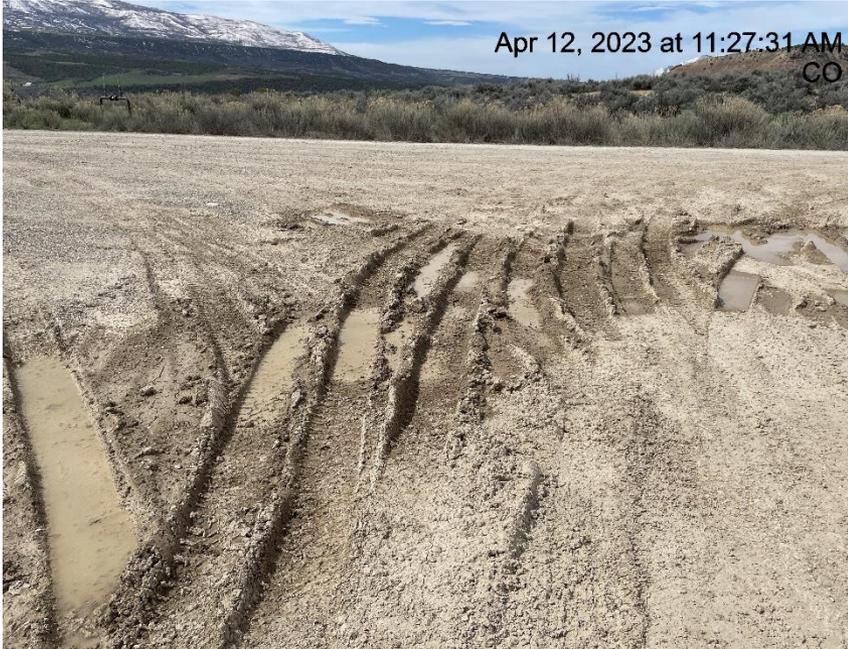
Photo # 5072 Lack of stabilization/compaction

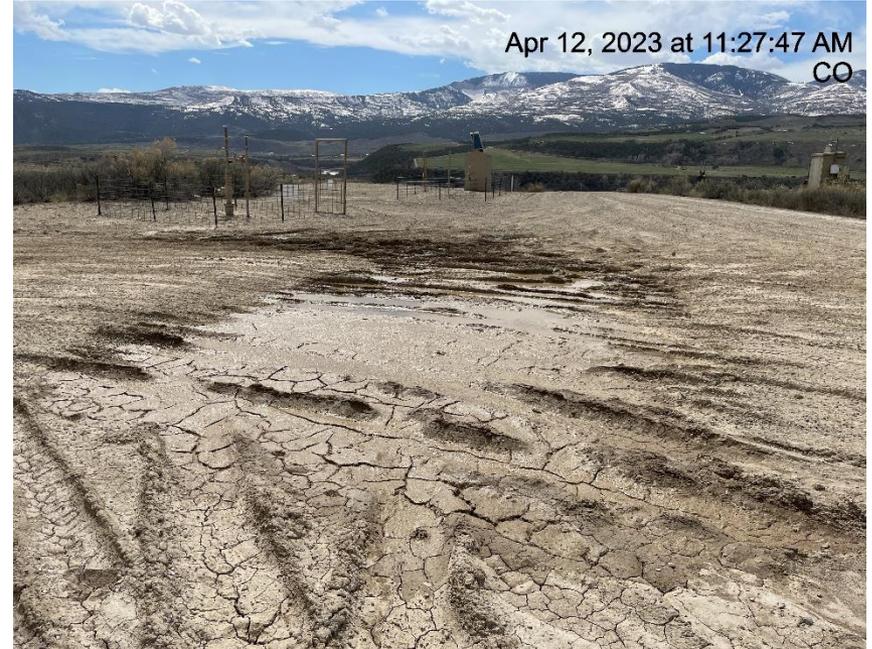
Photo # 5073 Lack of stabilization/compaction

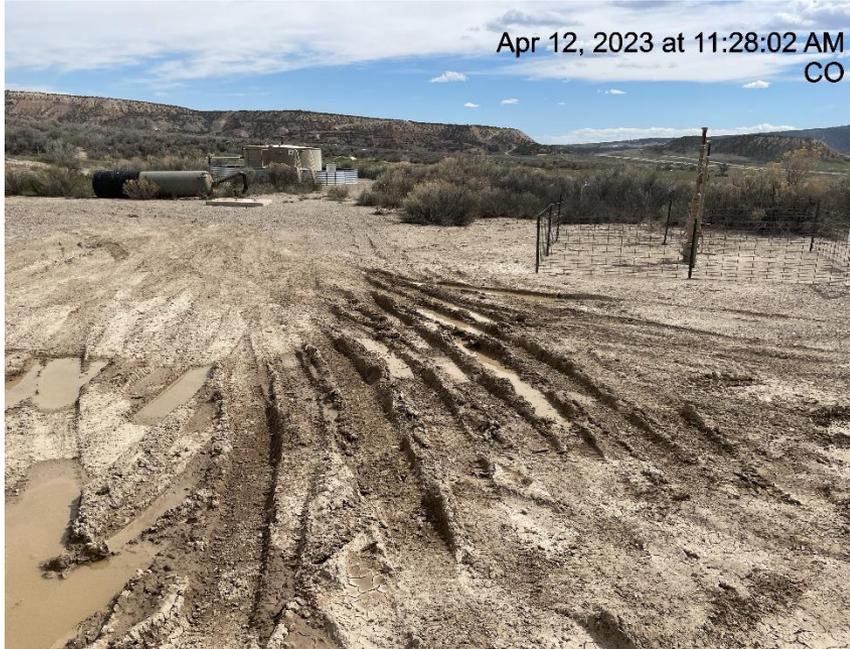
Photo # 5074 Lack of stabilization/compaction

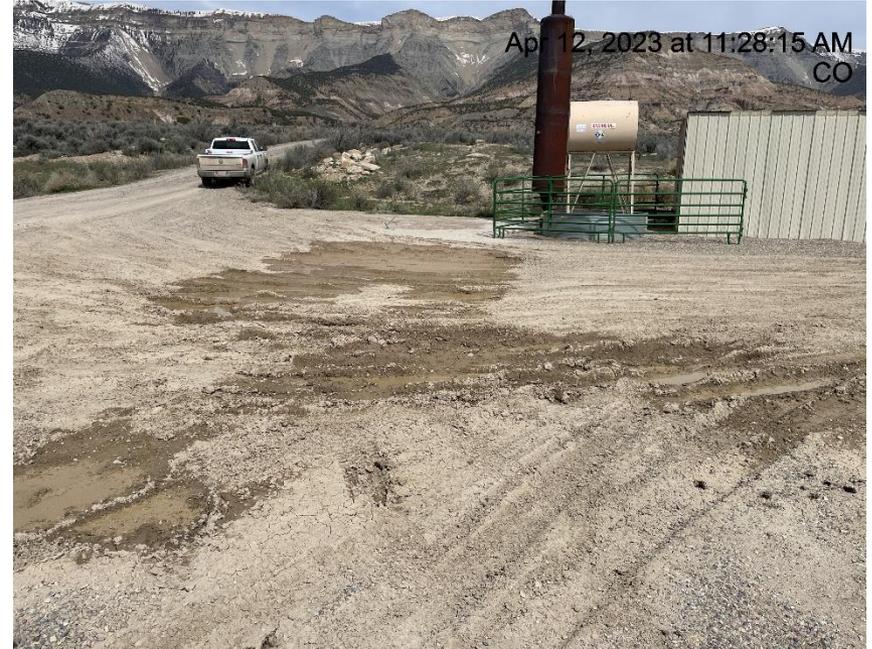
Photo # 5075 Lack of stabilization/compaction

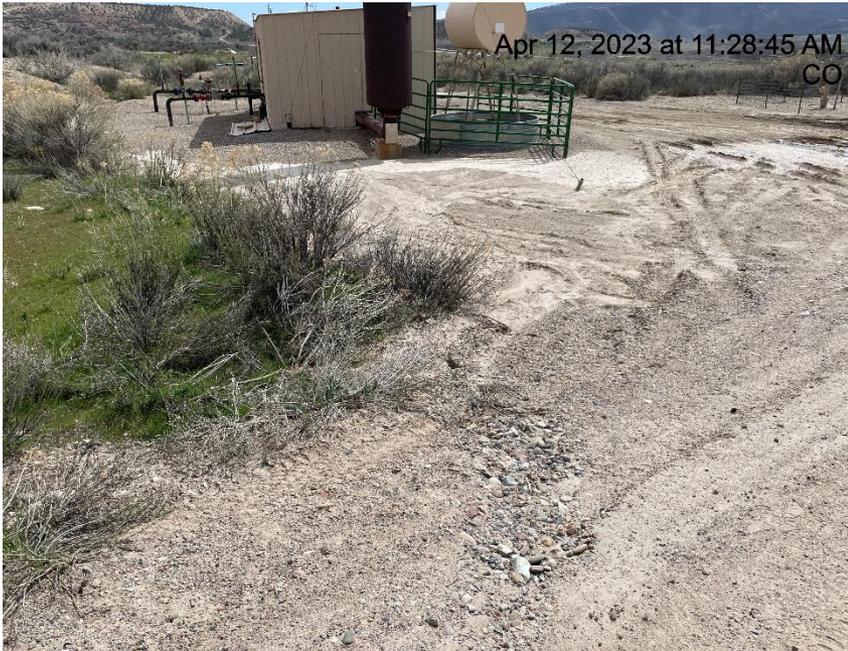
Photo # 5076 Erosion & transport of sediment onto location

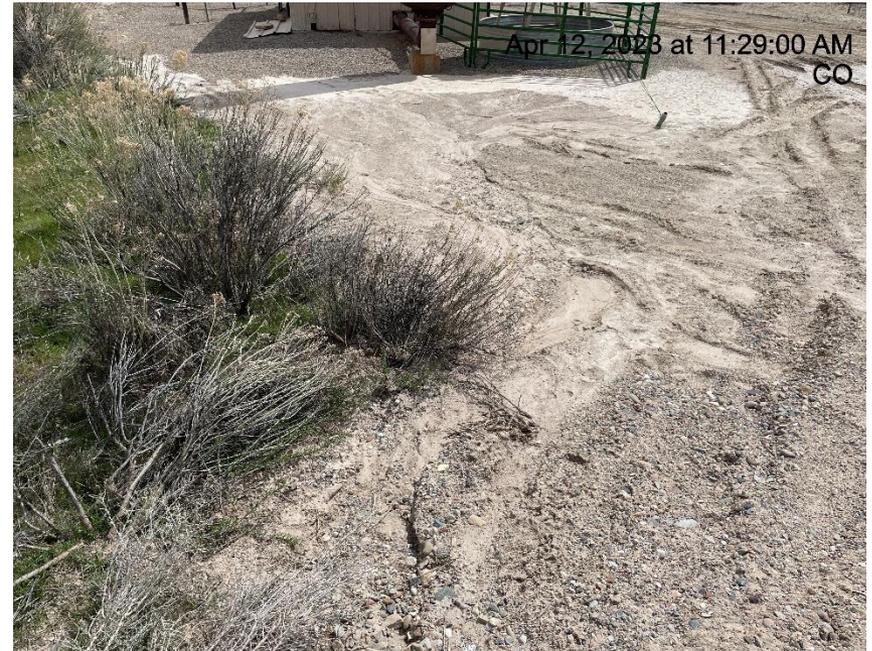
Photo # 5078 Erosion & transport of sediment onto location

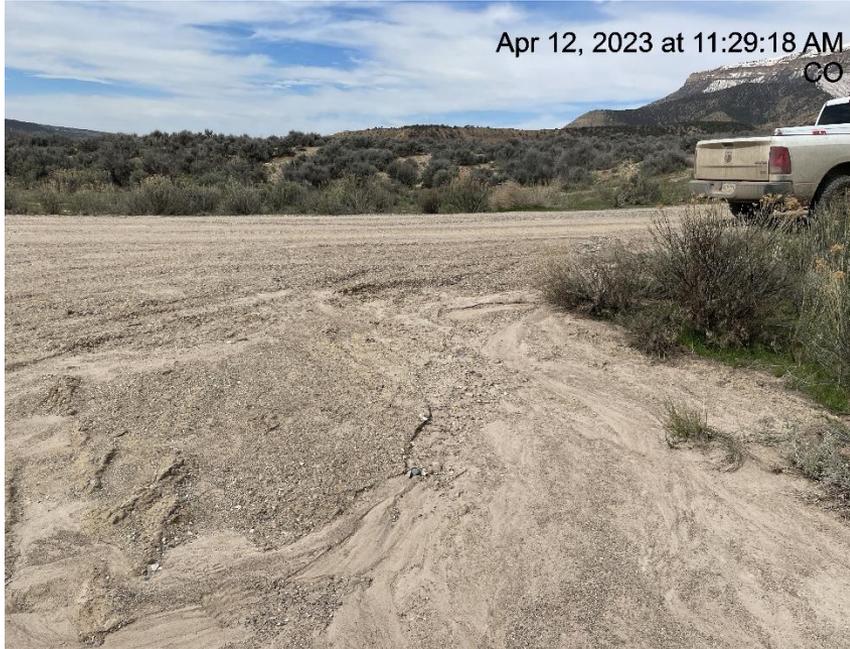
Photo # 5079 Erosion & transport of sediment onto location

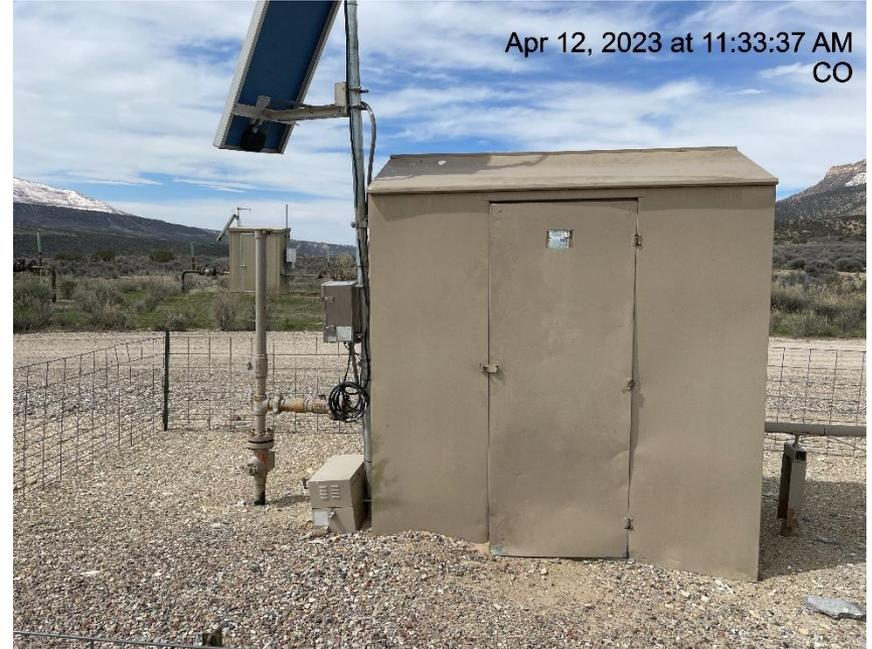
Photo # 5094 Meter calibration info not conspicuously posted
