# Inspection Photos

Operator: TEP Rocky Mountain- #96850

Location Name: JOLLEY-66S91W/16NWSW

Inspection Document #: 702801460

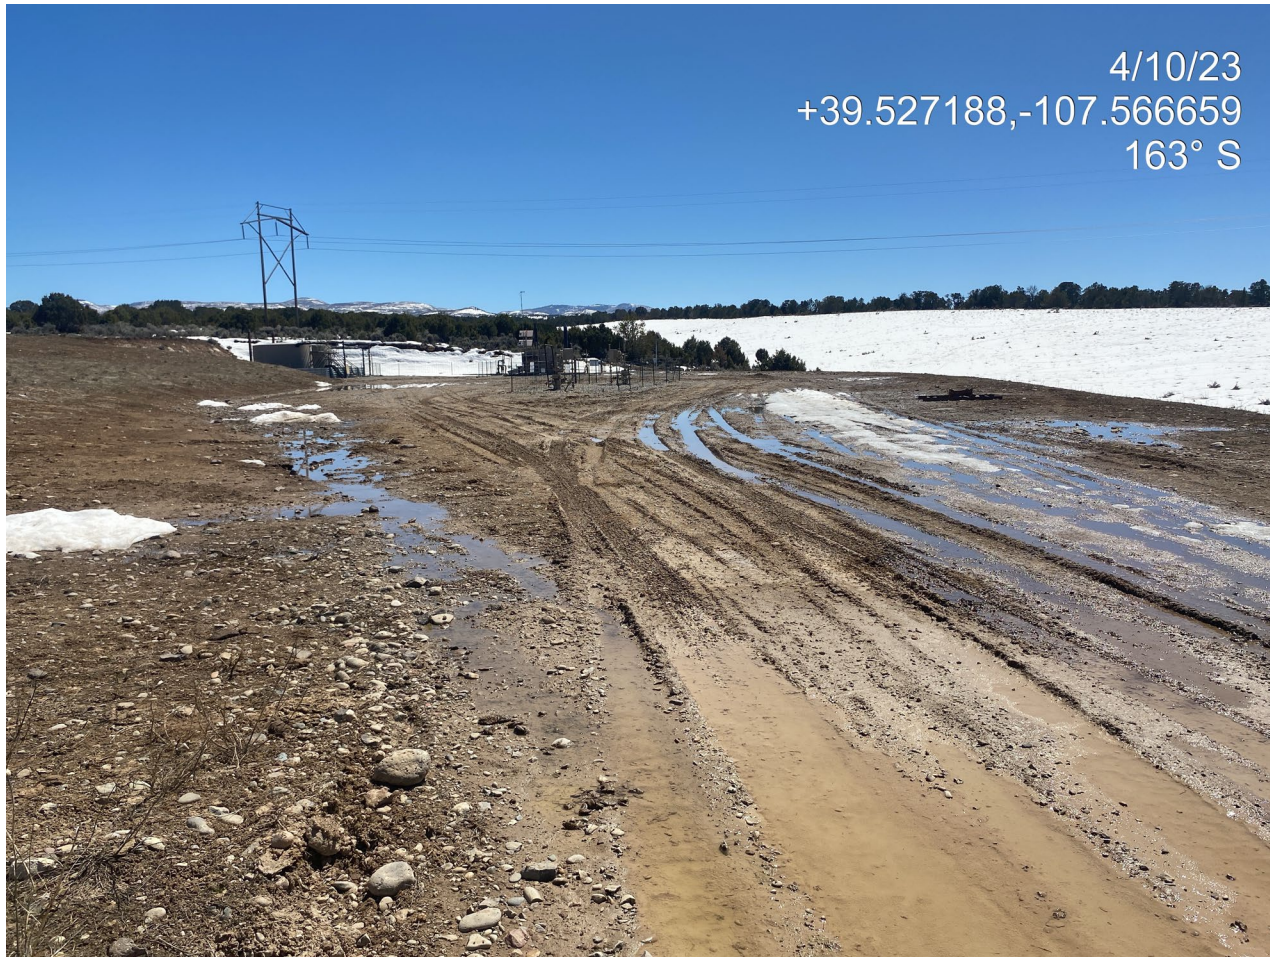
**Photo 1.** Photo taken from the entrance shows an overview of the location.

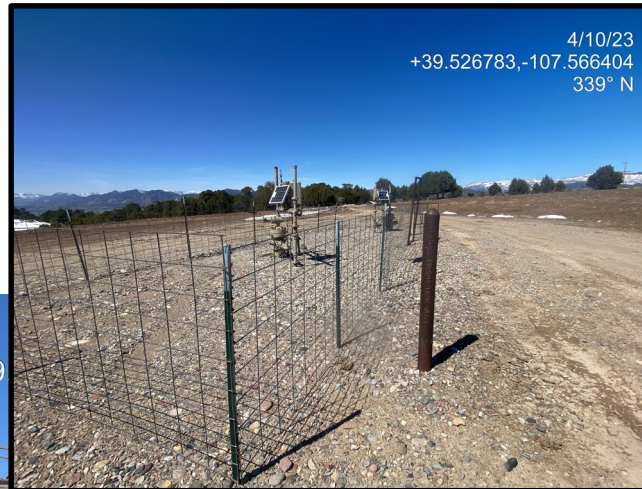
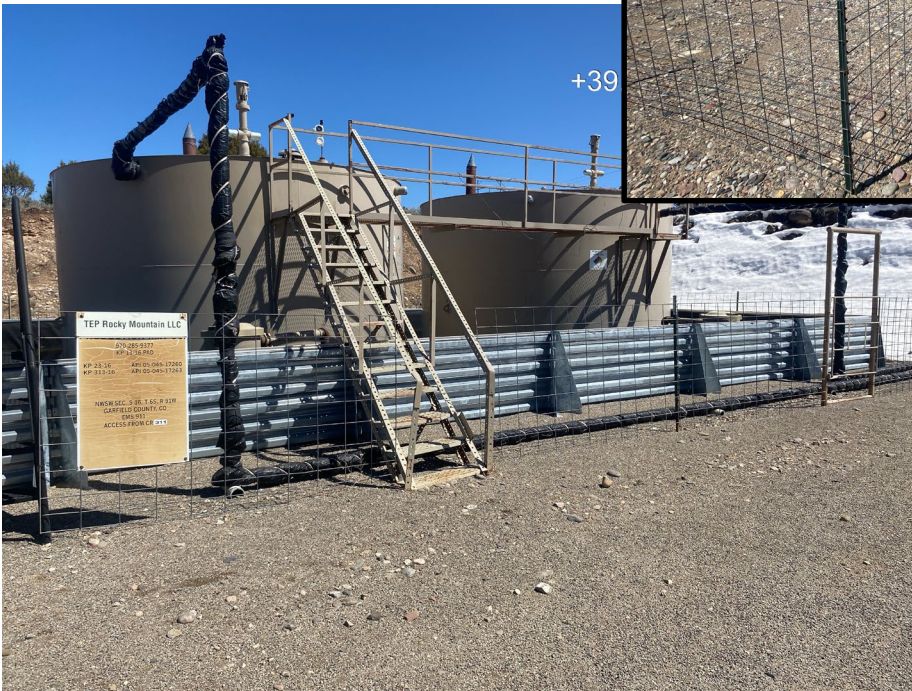
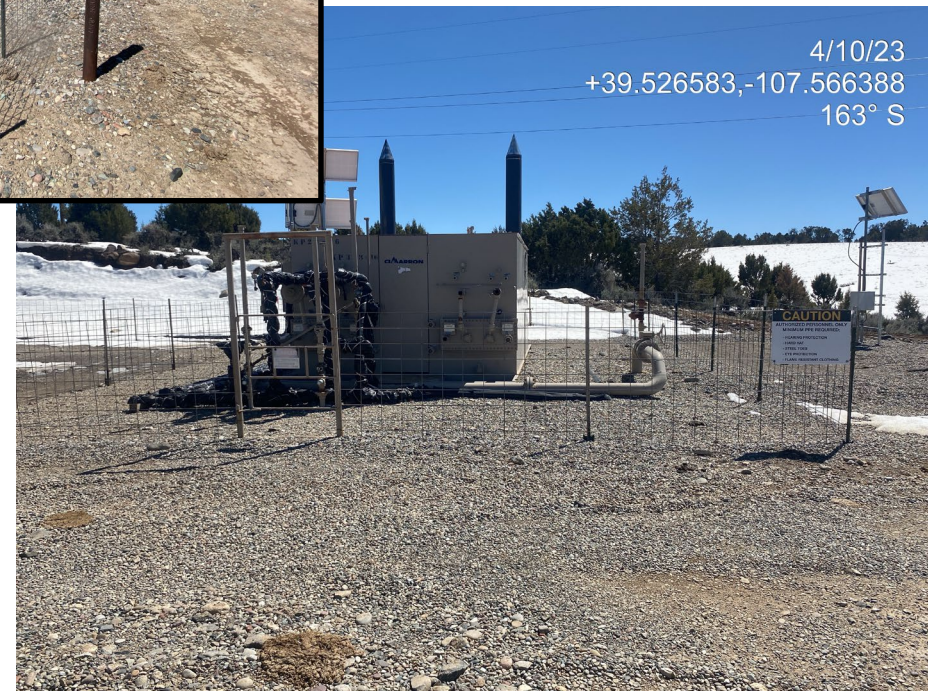
Photo 2. Photos show production areas.

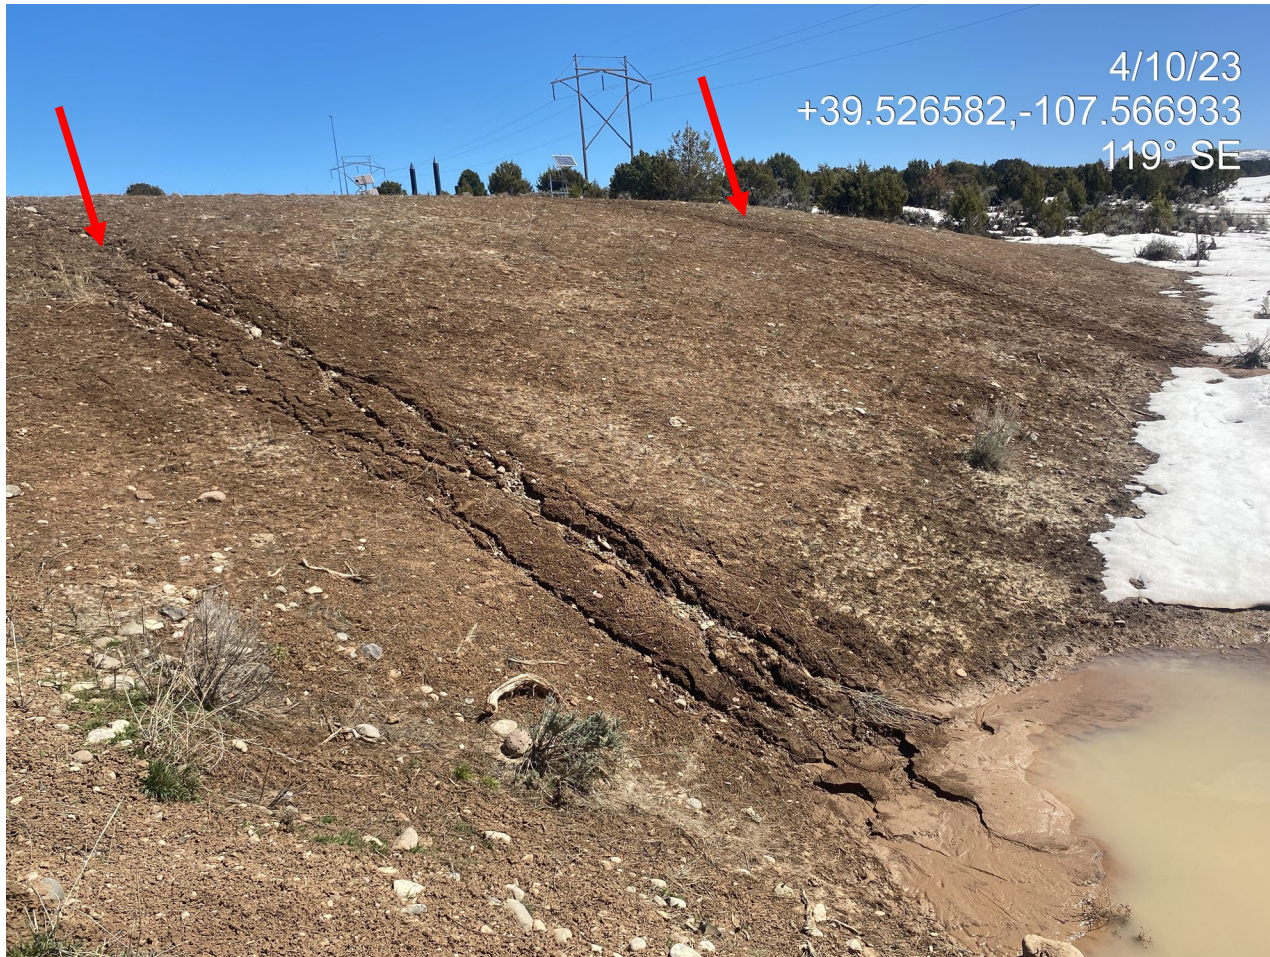
**Photo 3.** Photos show erosion in the western interim area.

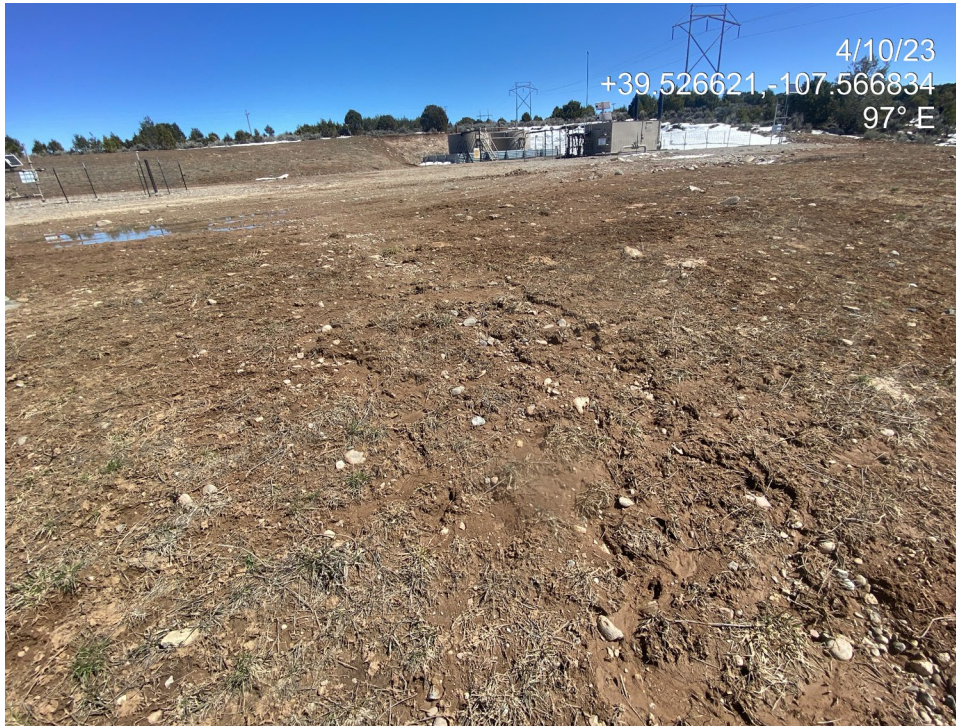
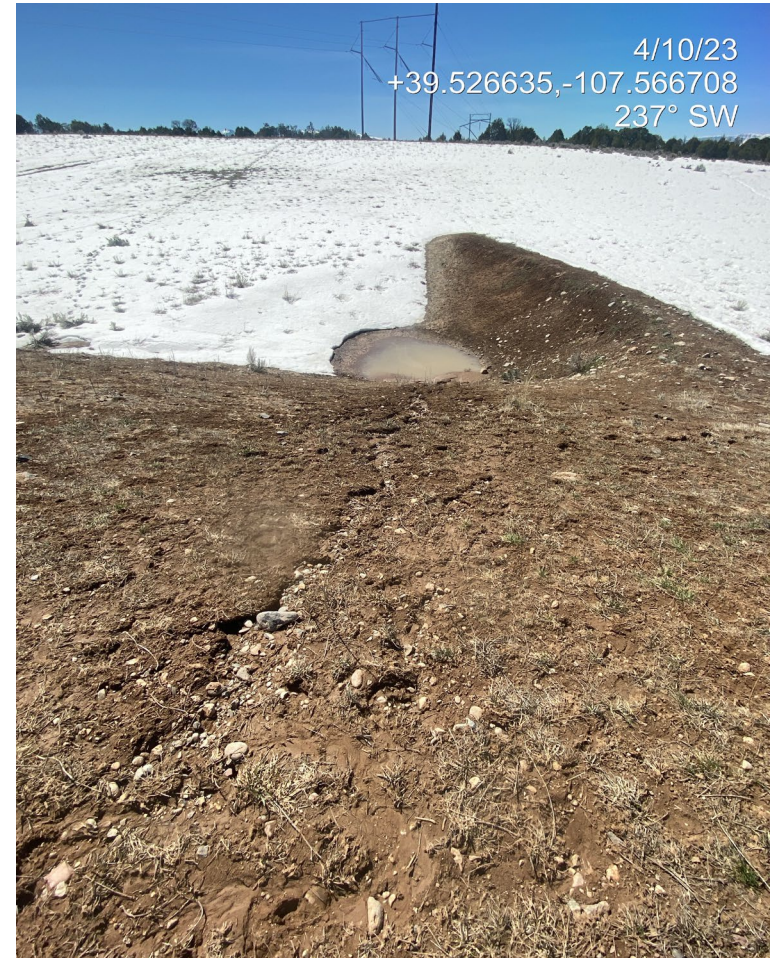
**Photo 4.** Photos show erosion starting at the western edge of the pad (left) and continuing into the interim area towards a retention pond (right).

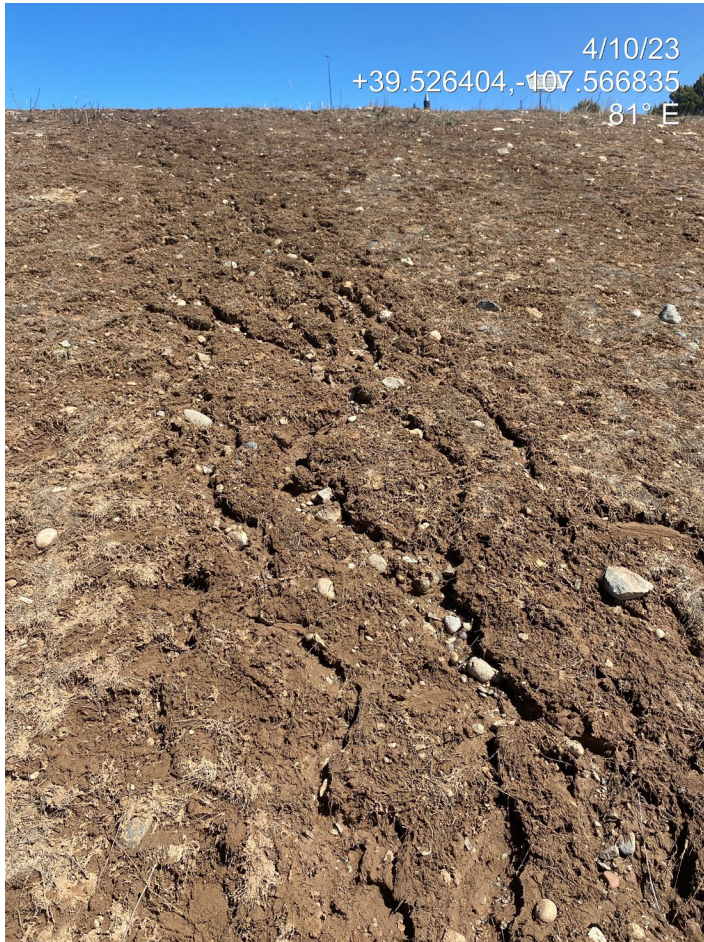
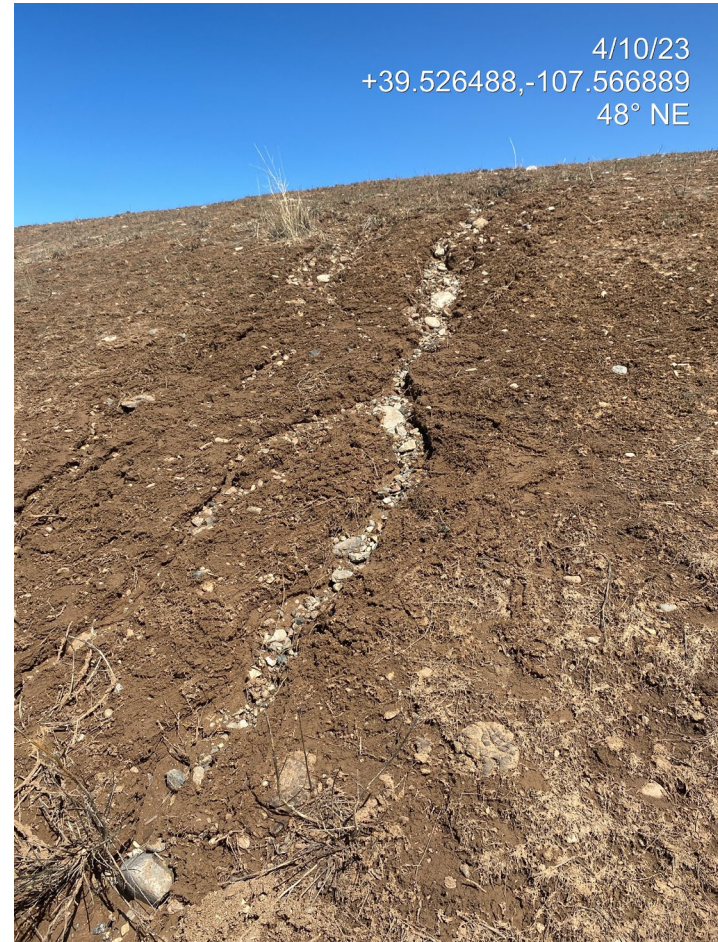
**Photo 5.** Photos show erosion in the western interim area.

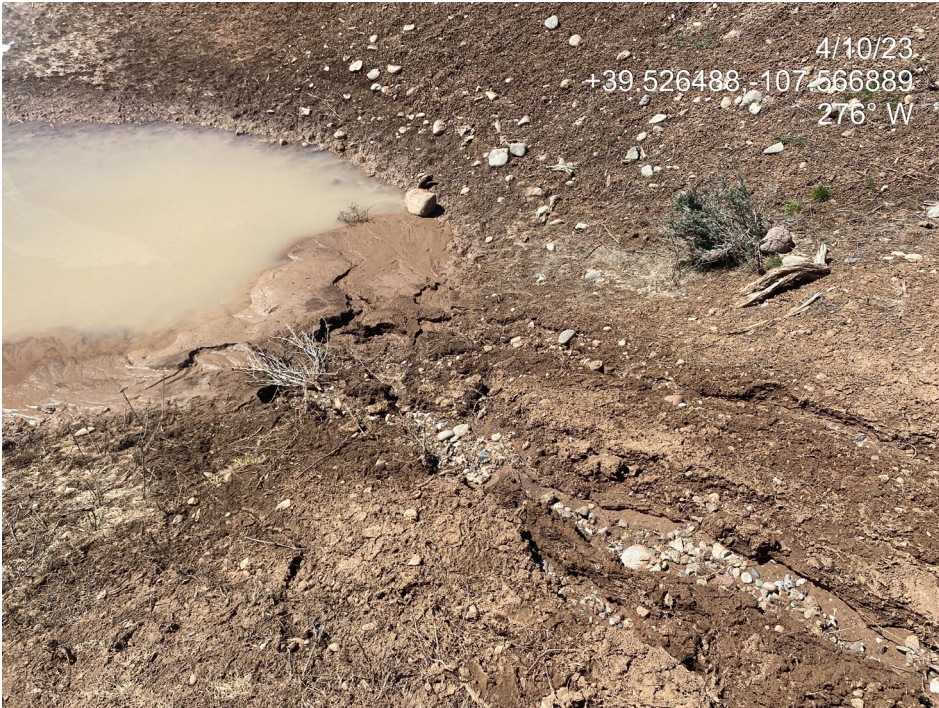
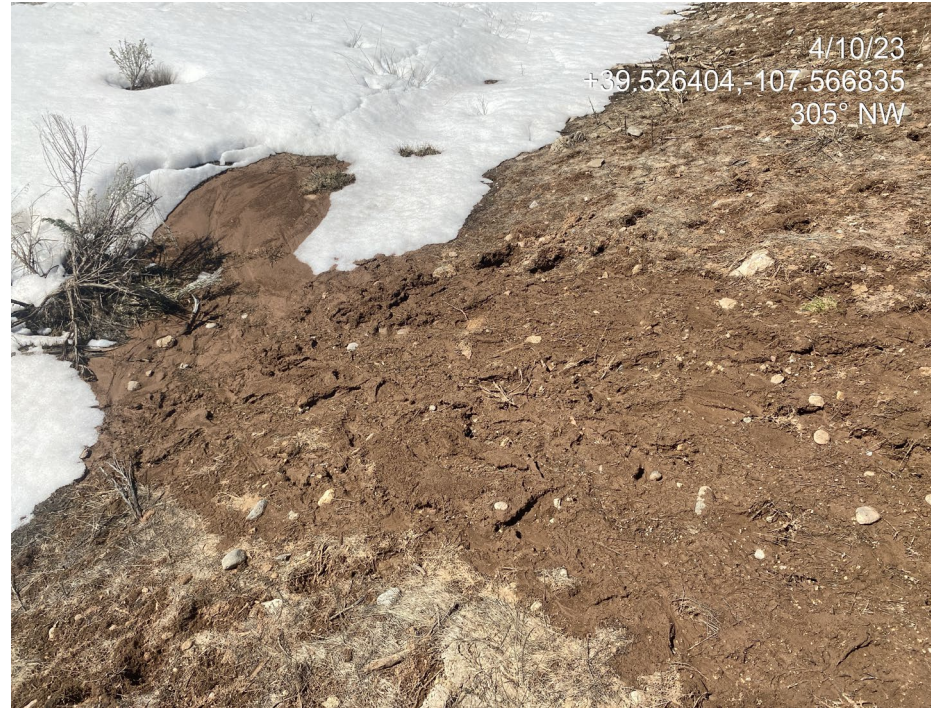
**Photo 6.** Photos show erosion in the western interim area.

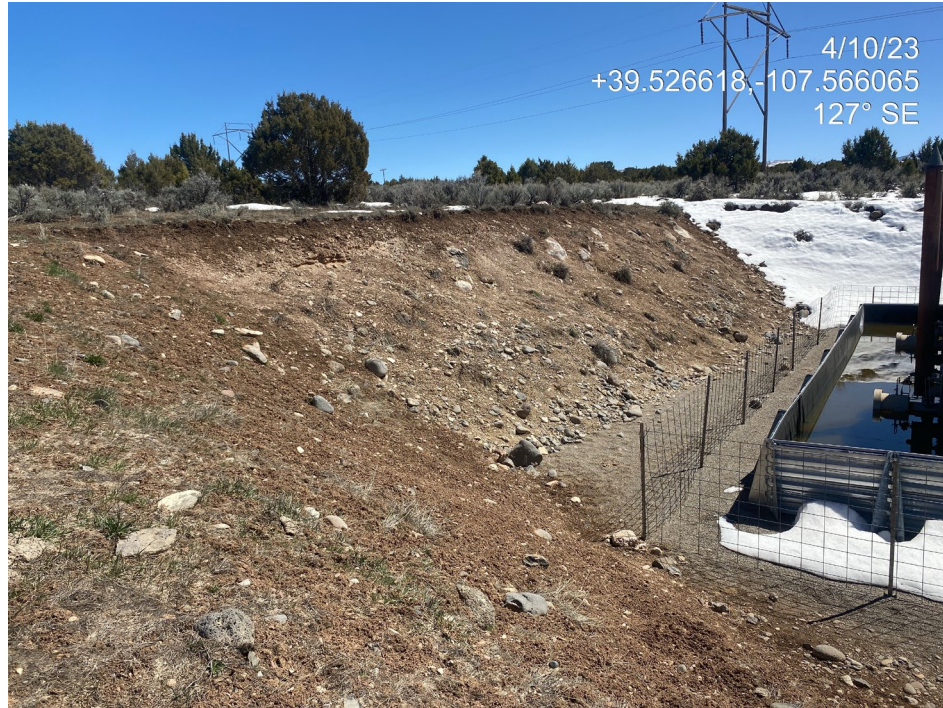
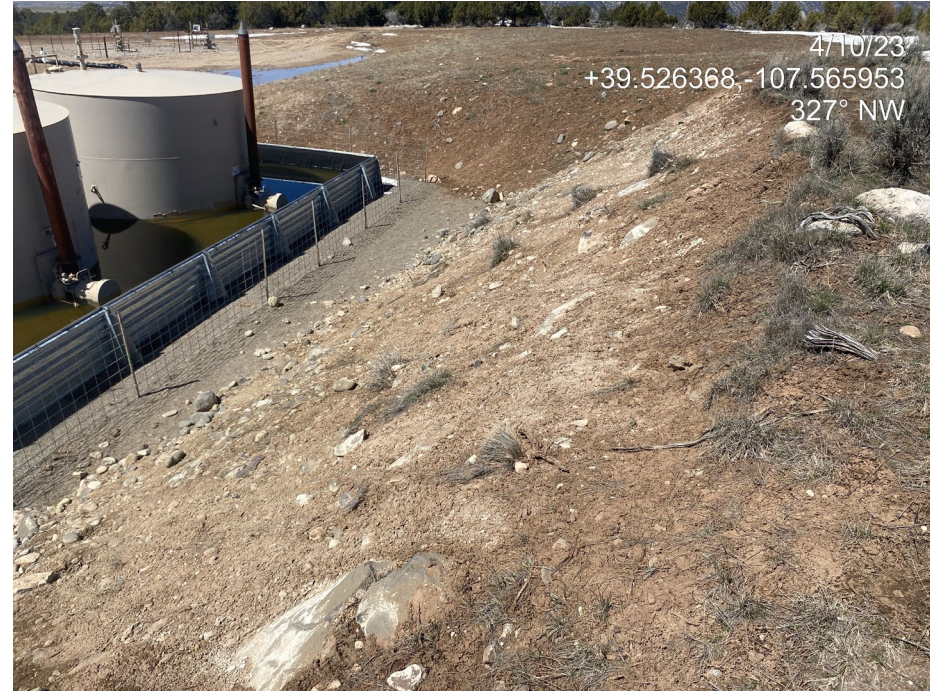
**Photo 7.** Photos the cut slope at the southeast is not stabilized.

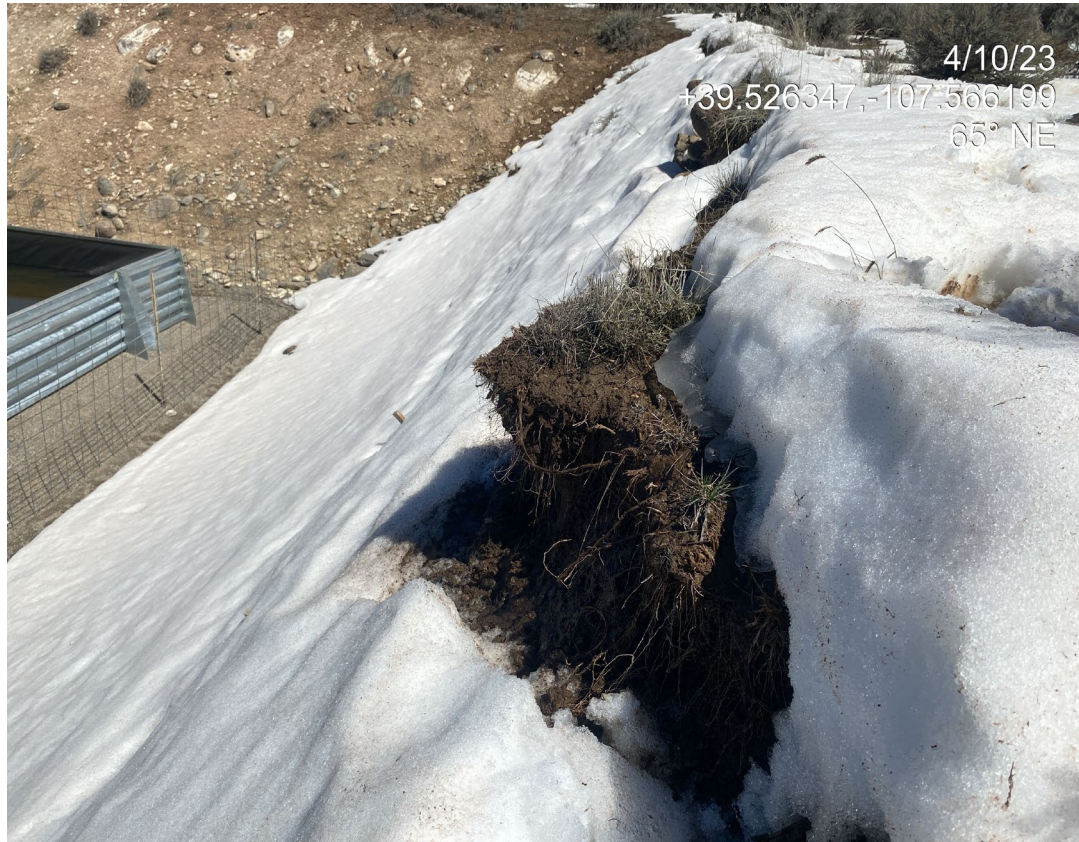
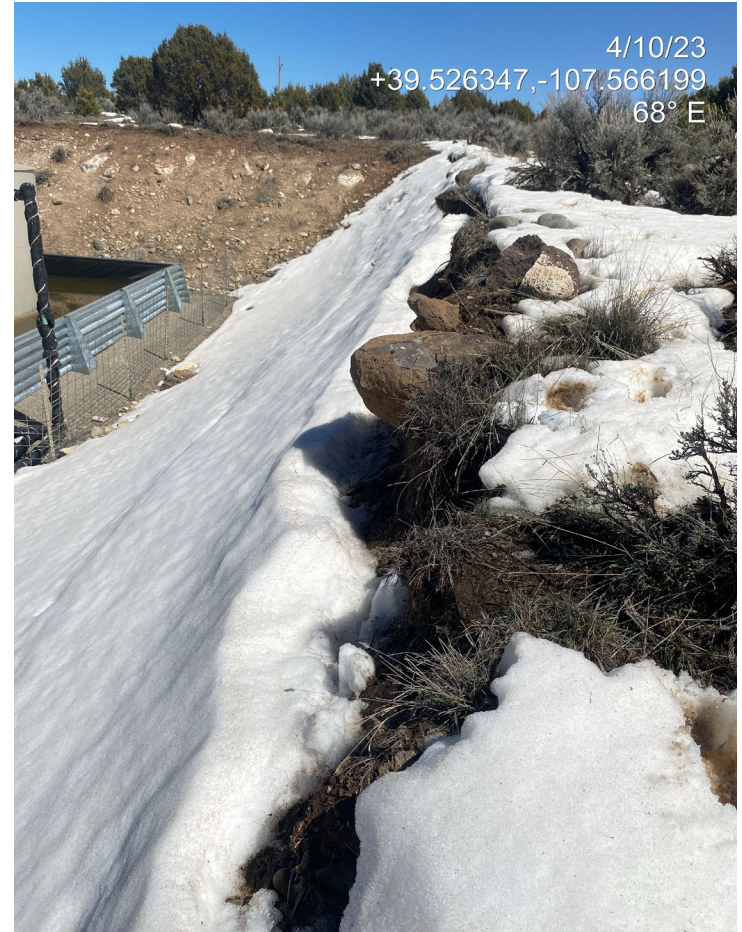
**Photo 8.** Photos show the cut slope at the south is not stabilized. The lack of stabilization appears to be impacting vegetation areas above and migrating backwards/upslope as is evidenced by eroded/pedestaled vegetation at the top of the slope.

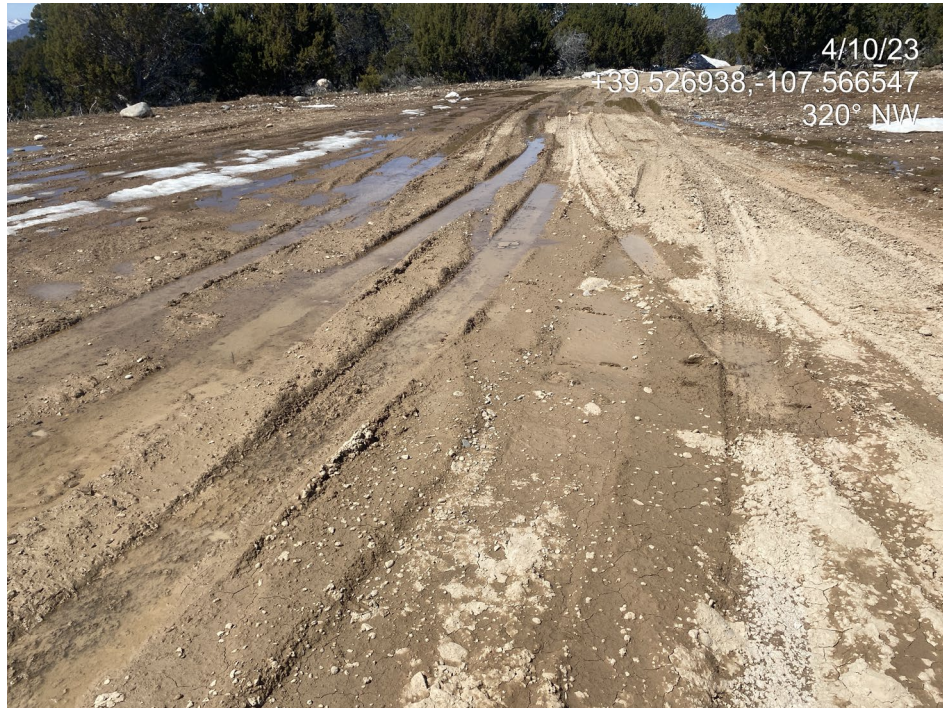
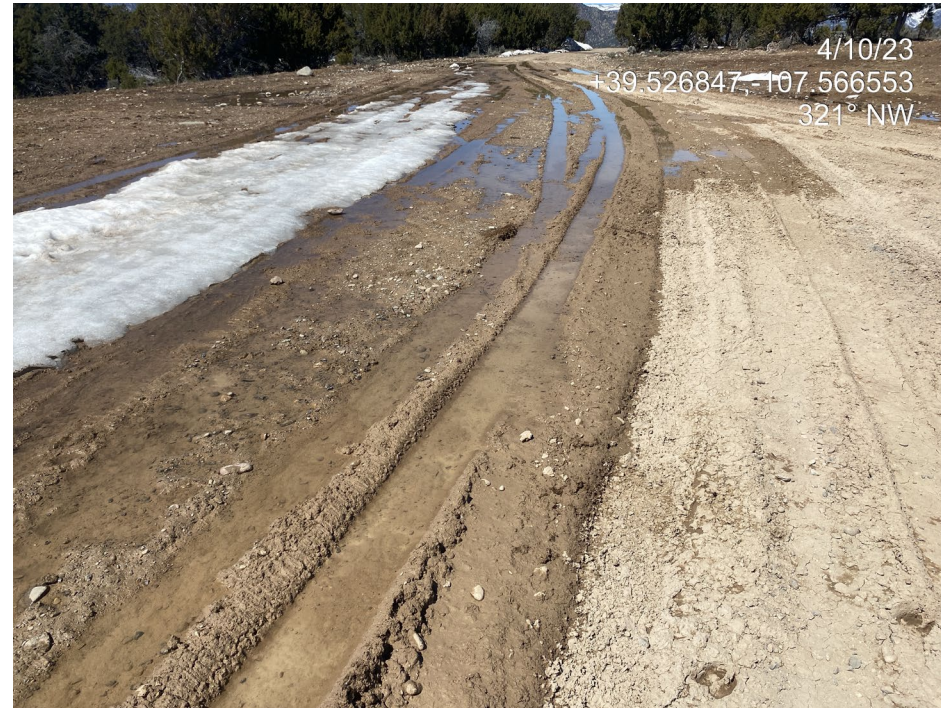
**Photo 9.** Photos show lack of stabilization of the working pad surface leading towards the access road.

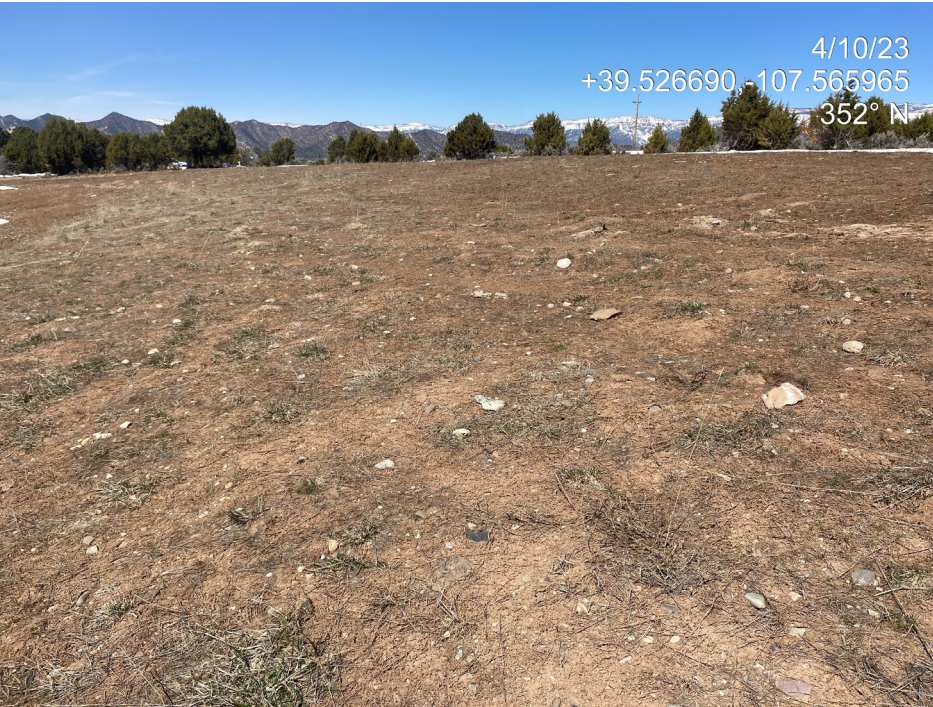
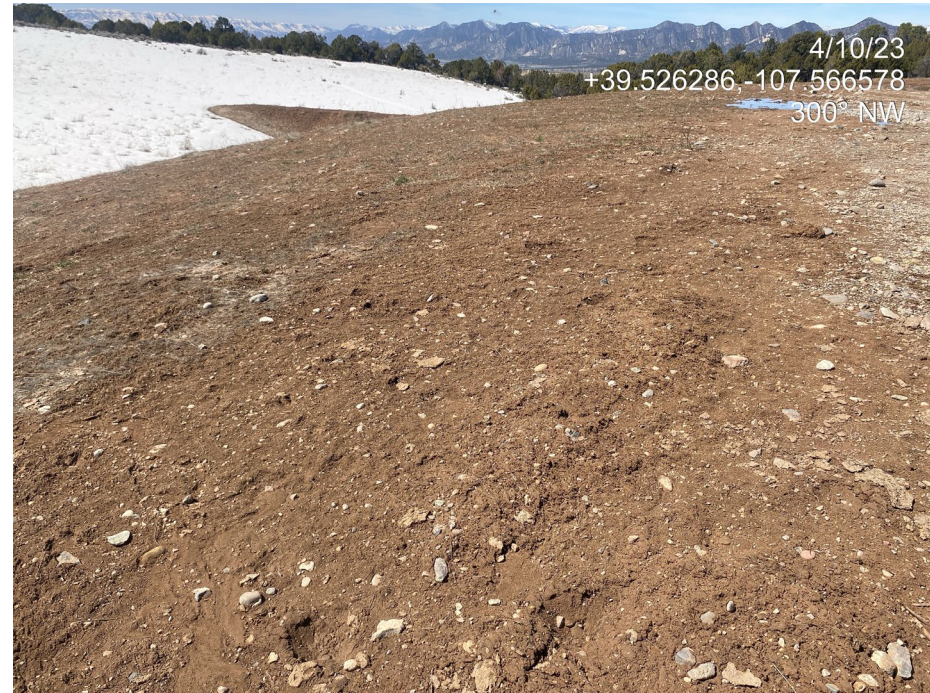
**Photo 10.** Photos show an example of interim areas to the east (left) and west (right).
