Inspection Photos
Location Name: Foster 1
API: 05-061-06010

Insp #701006844 performed in accordance with Complaint Doc #403372601

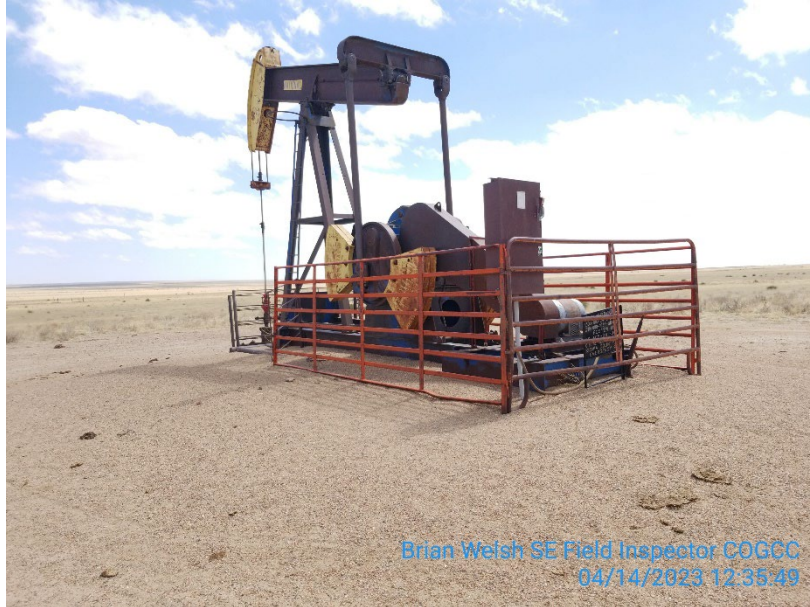
1. Pumping unit with panels installed

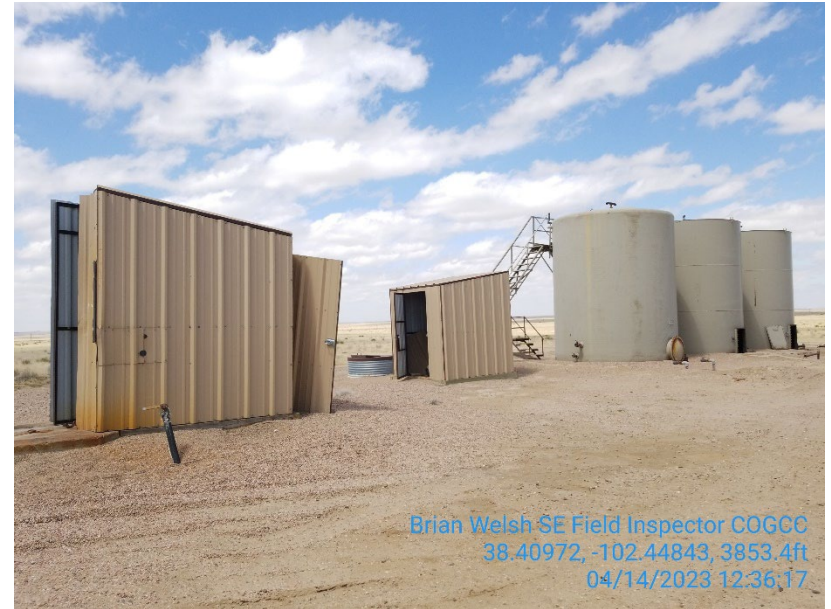
2. SE corner of tank battery looking northwest. No visible oil on the ground

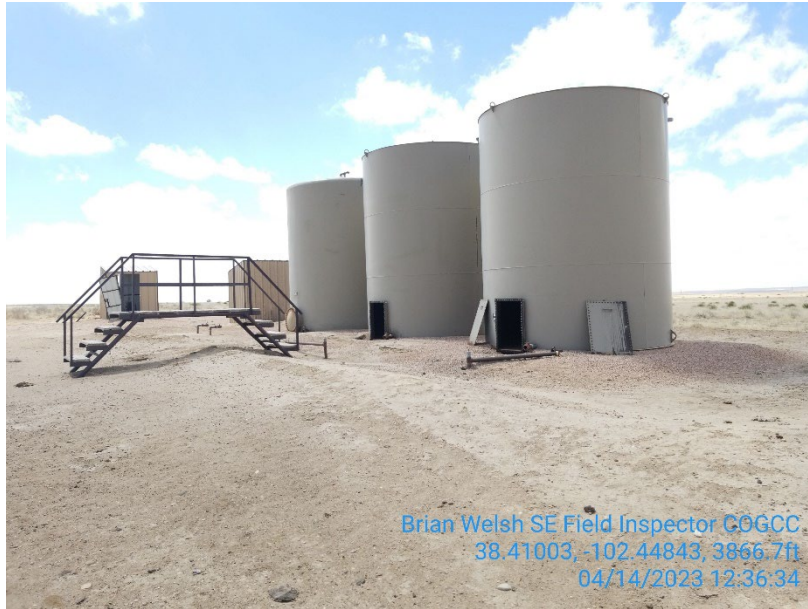
1. NE corner of tank battery location looking southwest at tank hatches. No visible oil noted on the ground

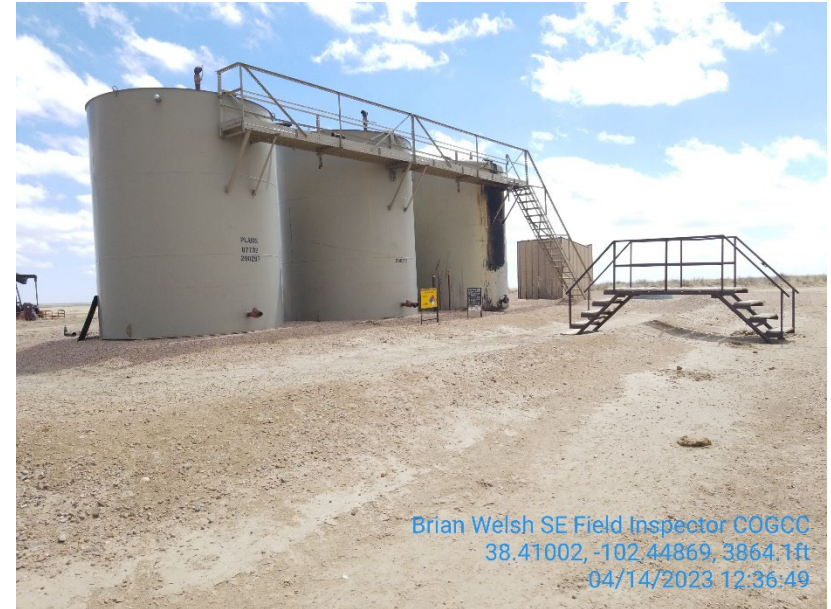
2. NW corner of tank battery location looking southeast. No oil was on the ground

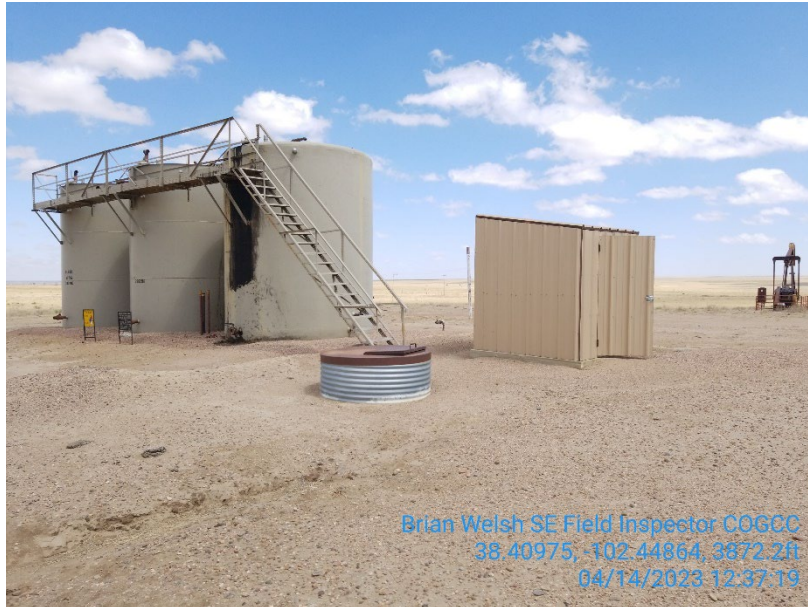
**1. SE corner of tank battery location looking northeast.
No visible oil noted on the ground**

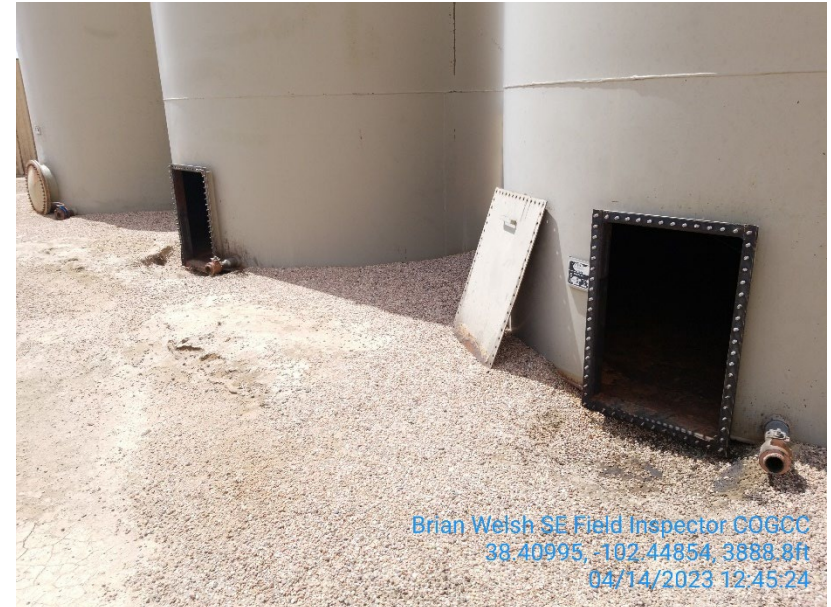
**2. East side of oil and water tanks looking at tank hatches.
No visible oil noted on the ground and no freestanding
fluid was observed**
