## Inspection Photos

Location Name: TEP ROCKY MOUNTAIN LLC CLOUGH 113 Pad

Location ID: 311536

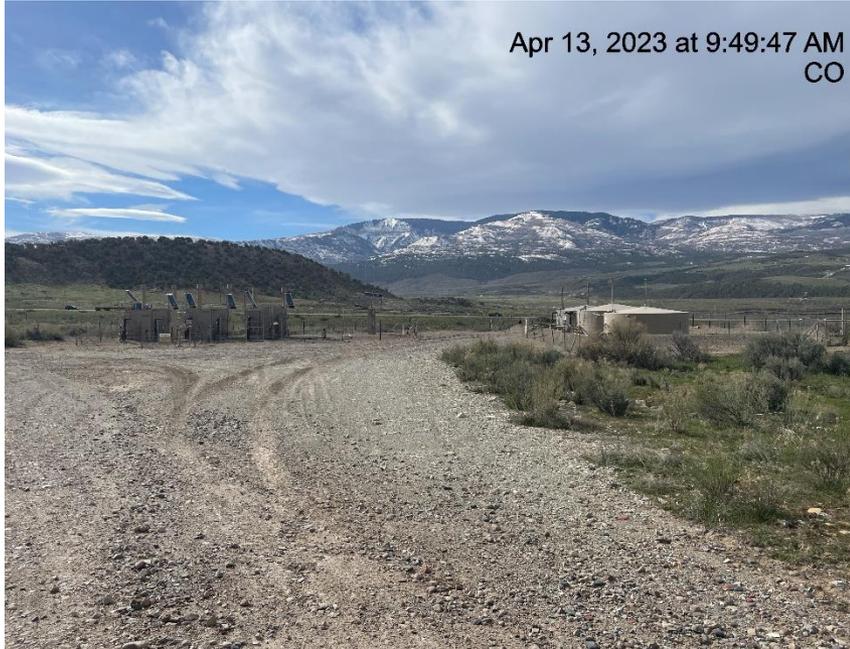
Photo # 5339 From entrance to location

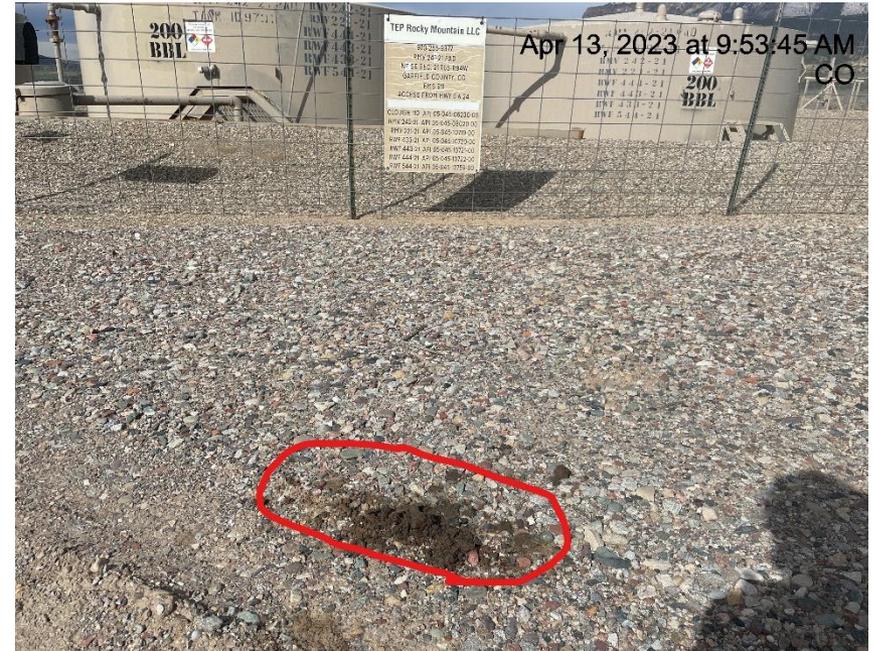
Photo # 5344 Stained soils & gravel

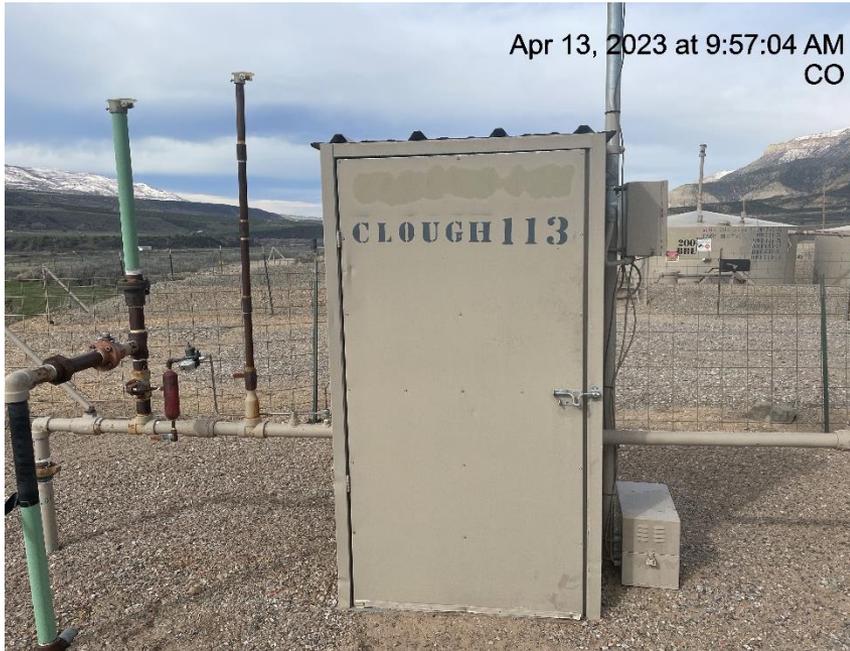
Photo # 5346 Meter calibration info not conspicuously posted

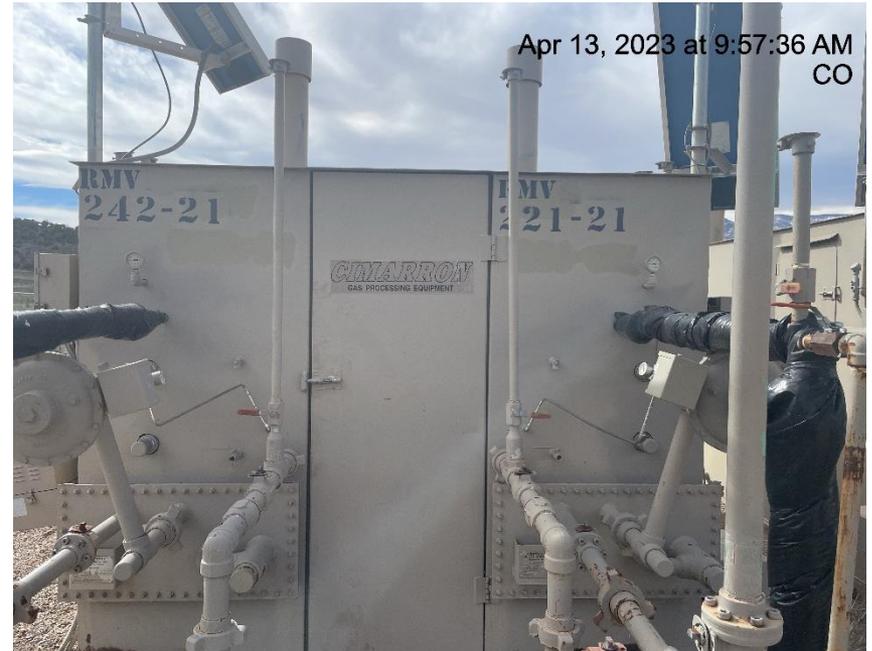
Photo # 5347 Meter calibration info not conspicuously posted

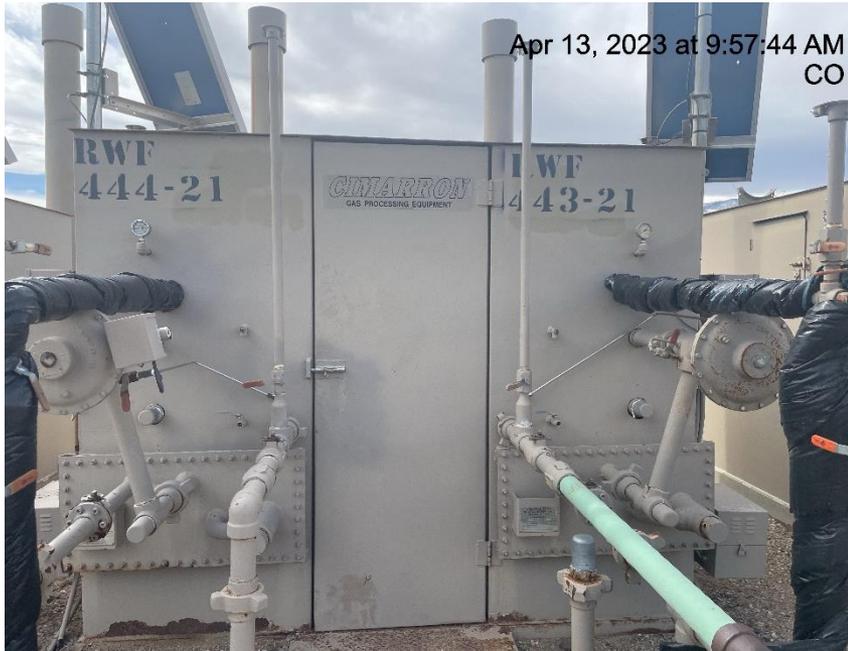
**Photo # 5348 Meter calibration info not conspicuously posted**

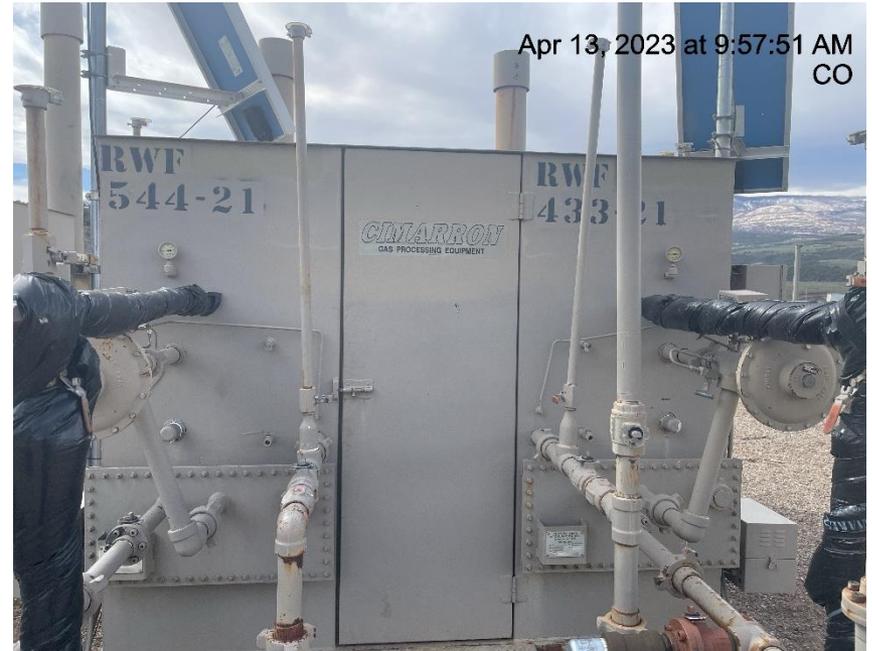
**Photo # 5349 Meter calibration info not conspicuously posted**

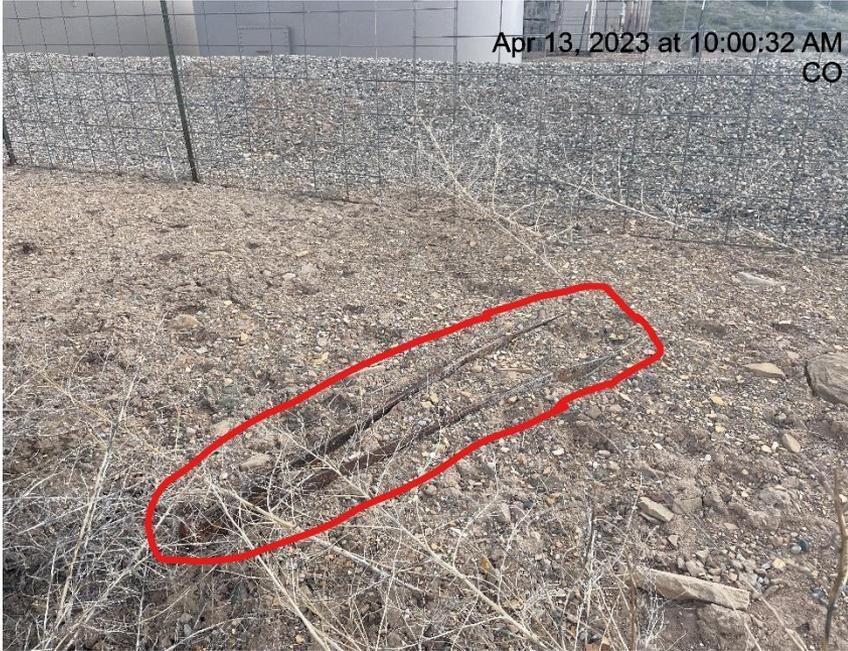
Photo # 5353 Debris

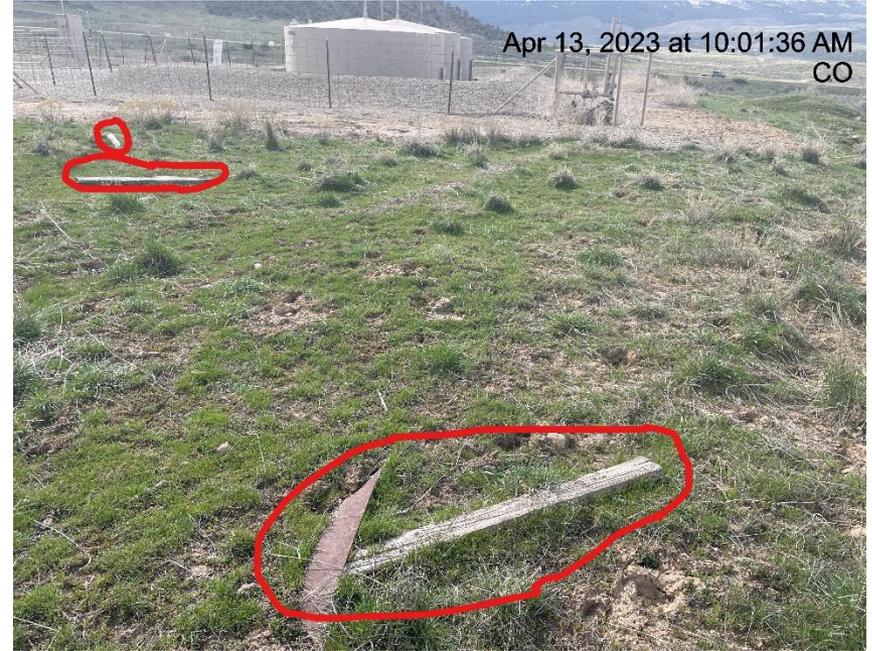
Photo # 5354 Debris

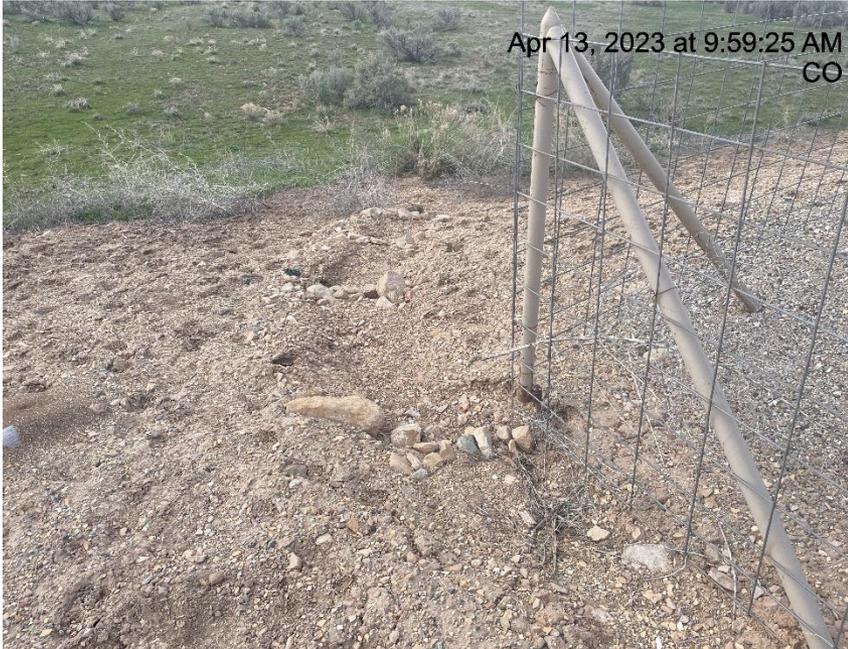
**Photo # 5351 Check dams need maintenance**
