Interim Reclamation and Stormwater Inspection

Operator: CIVITAS NORTH LLC - 10661

Location ID: 476815

Inspection Photos
Location Name: Allred 8-59-30
Location ID: 476815

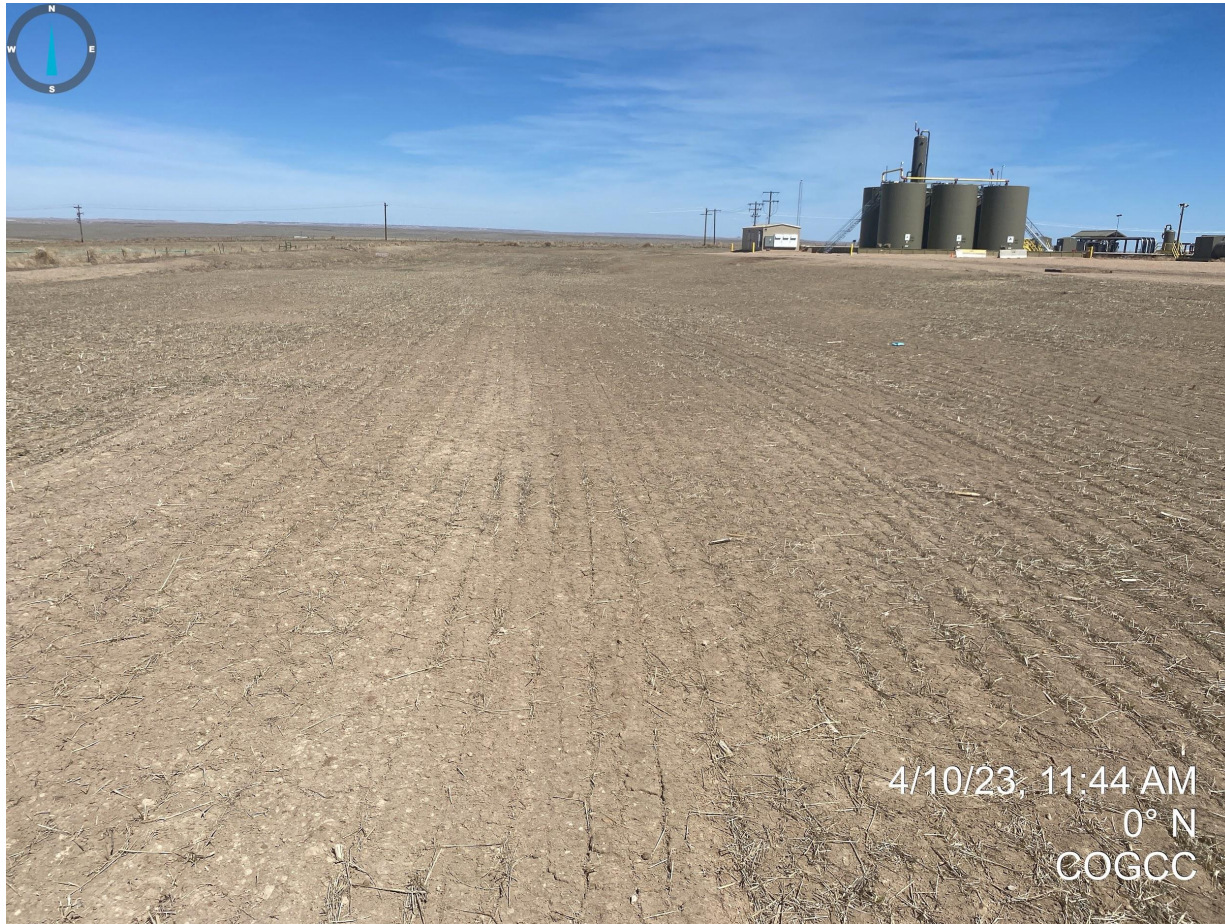
Photo 1. Facing north from the western portion of the location. It appears the operator has performed interim reclamation activities with the evidence of drill rows and mulch, and germination present at the time of this inspection. Staff will conduct a follow-up inspection at a future date to verify vegetation establishment in accordance with Rule 1003.

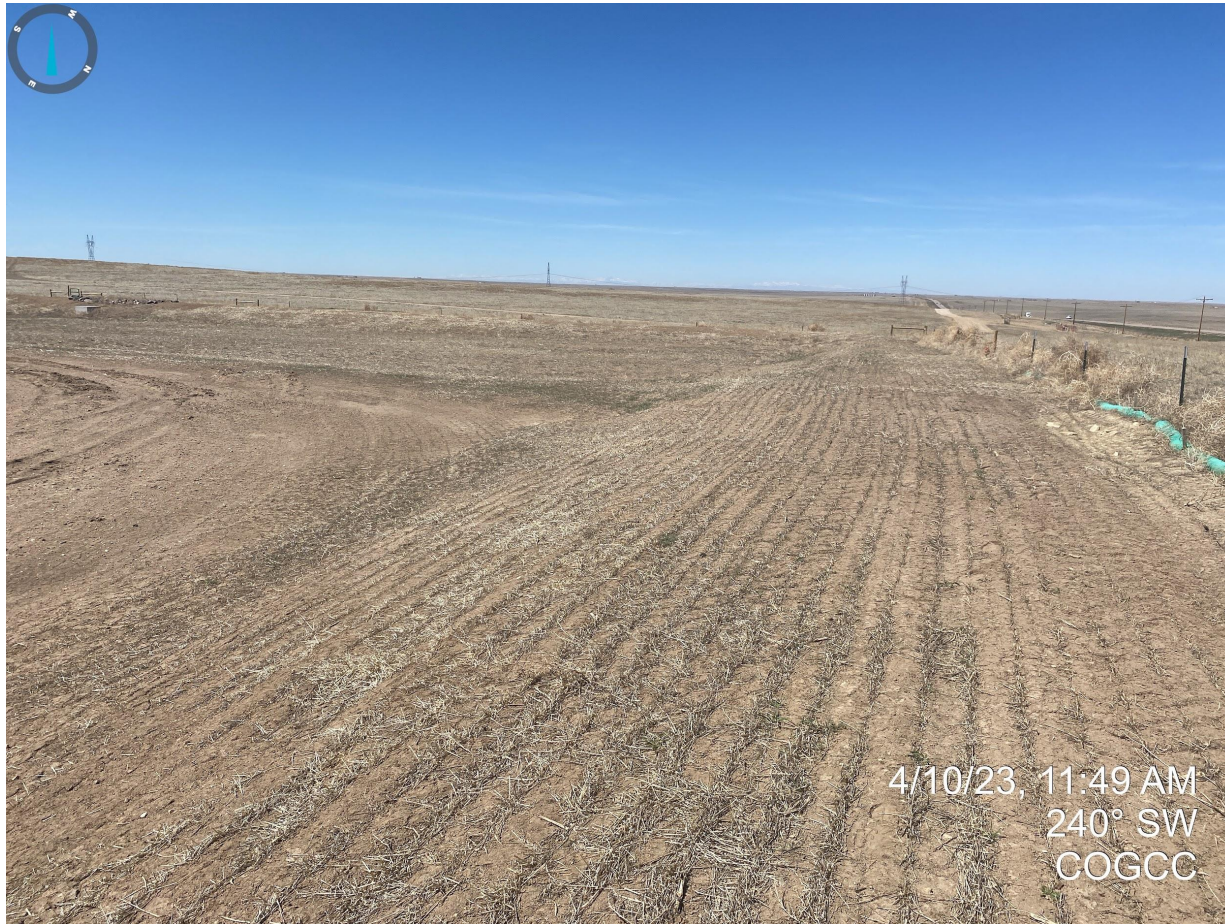
Photo 2. Facing southwest from the northern portion of the location. See comments in Photo 1.

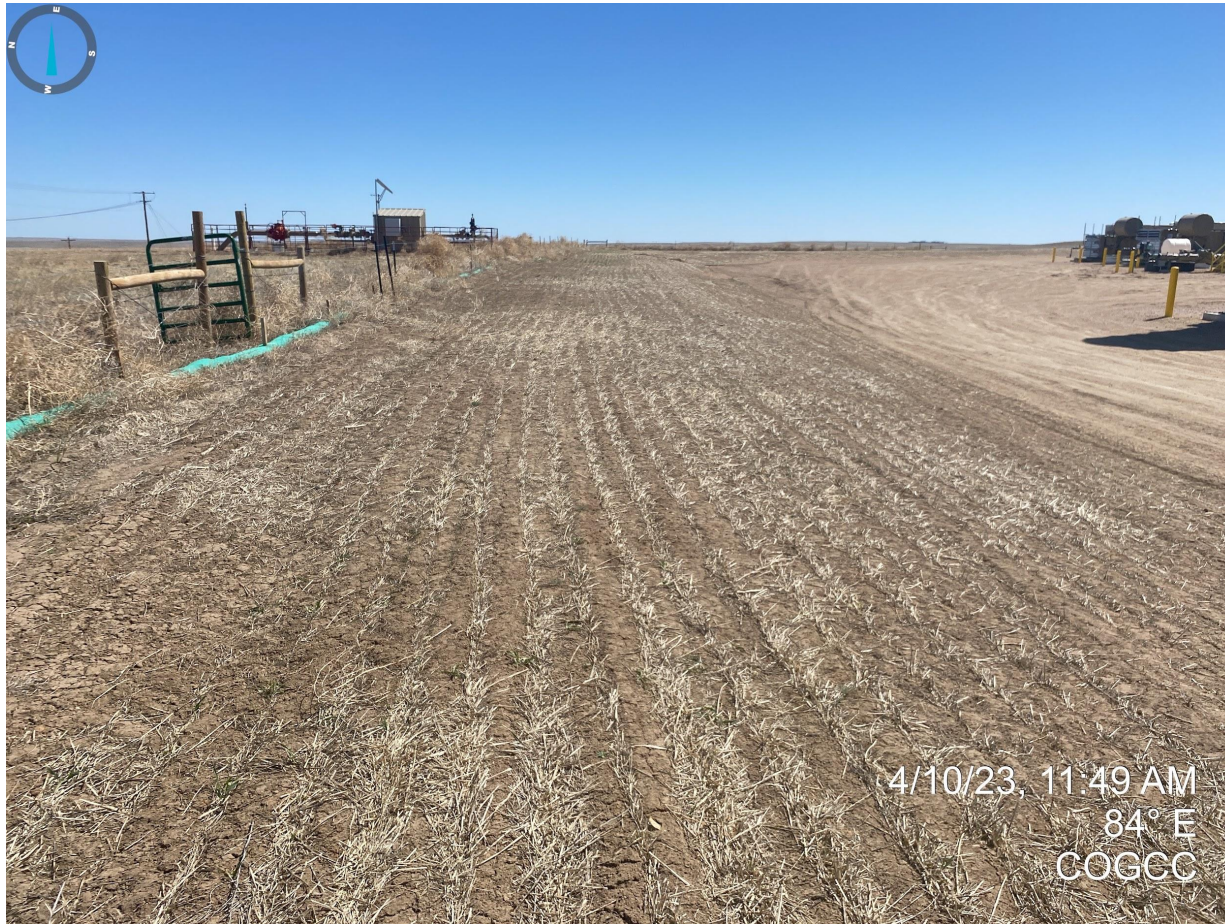
Photo 3. Facing east from the northern portion of the location; see comments in Photo 1.

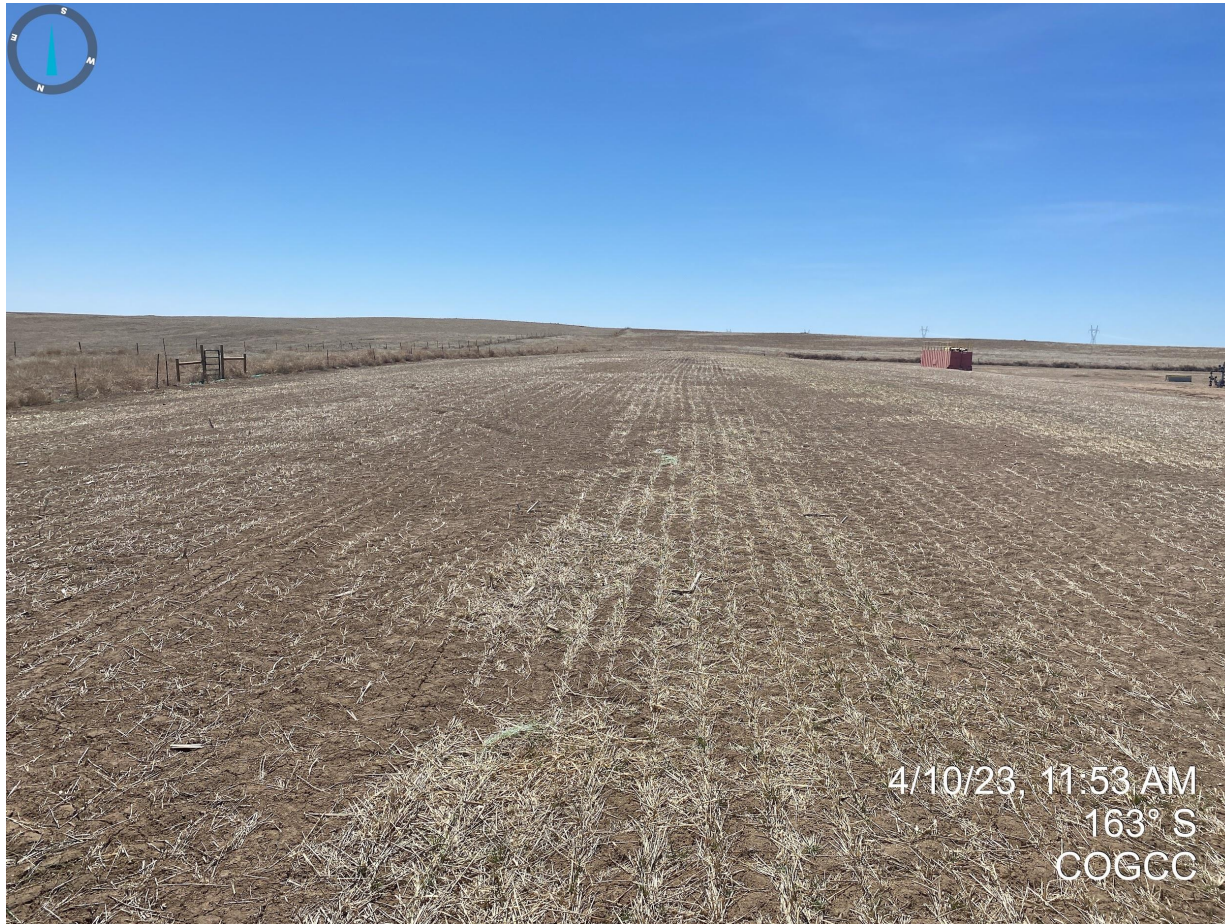
Photo 4. Facing south from the eastern portion of the location. See comments in Photo 1.

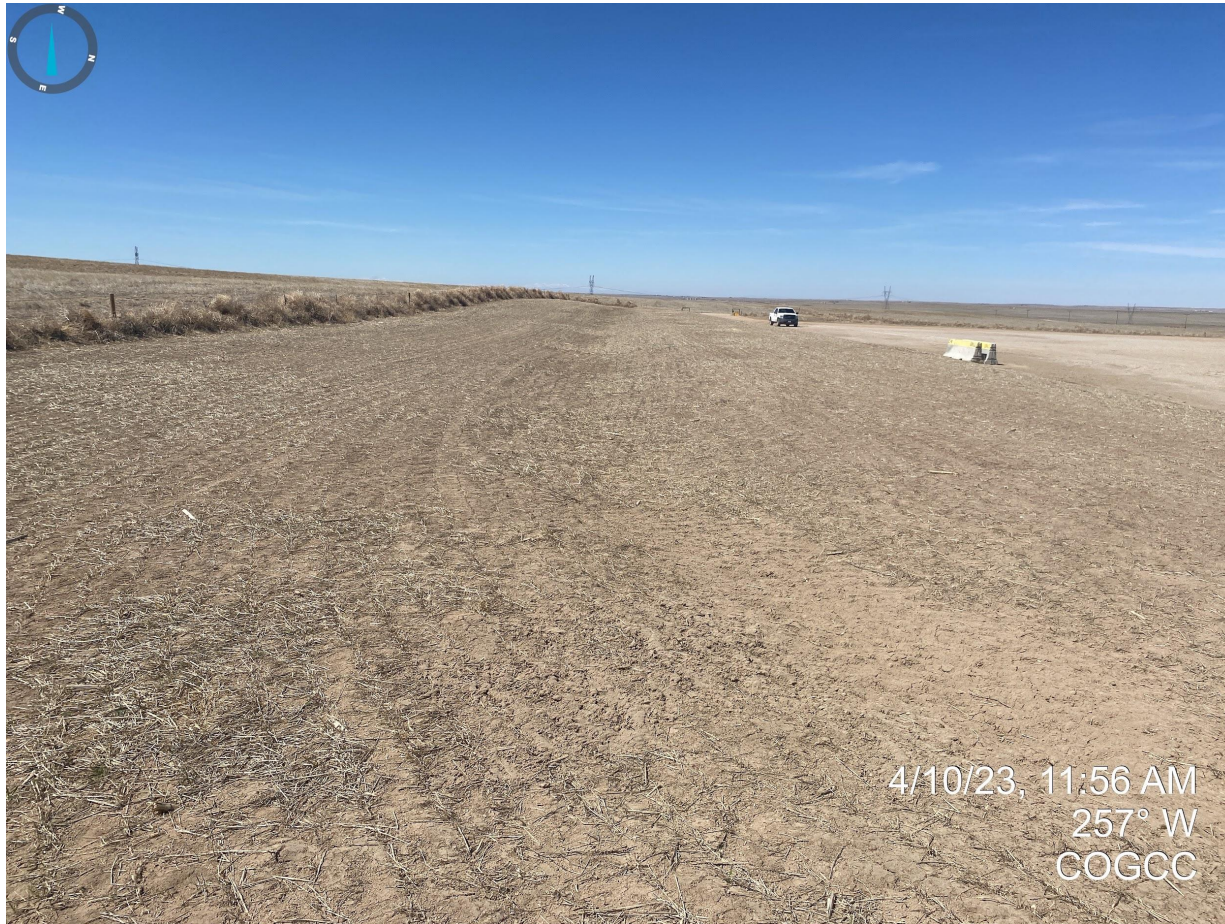
Photo 5. Facing west from the southern portion of the location. See comments in Photo 1.

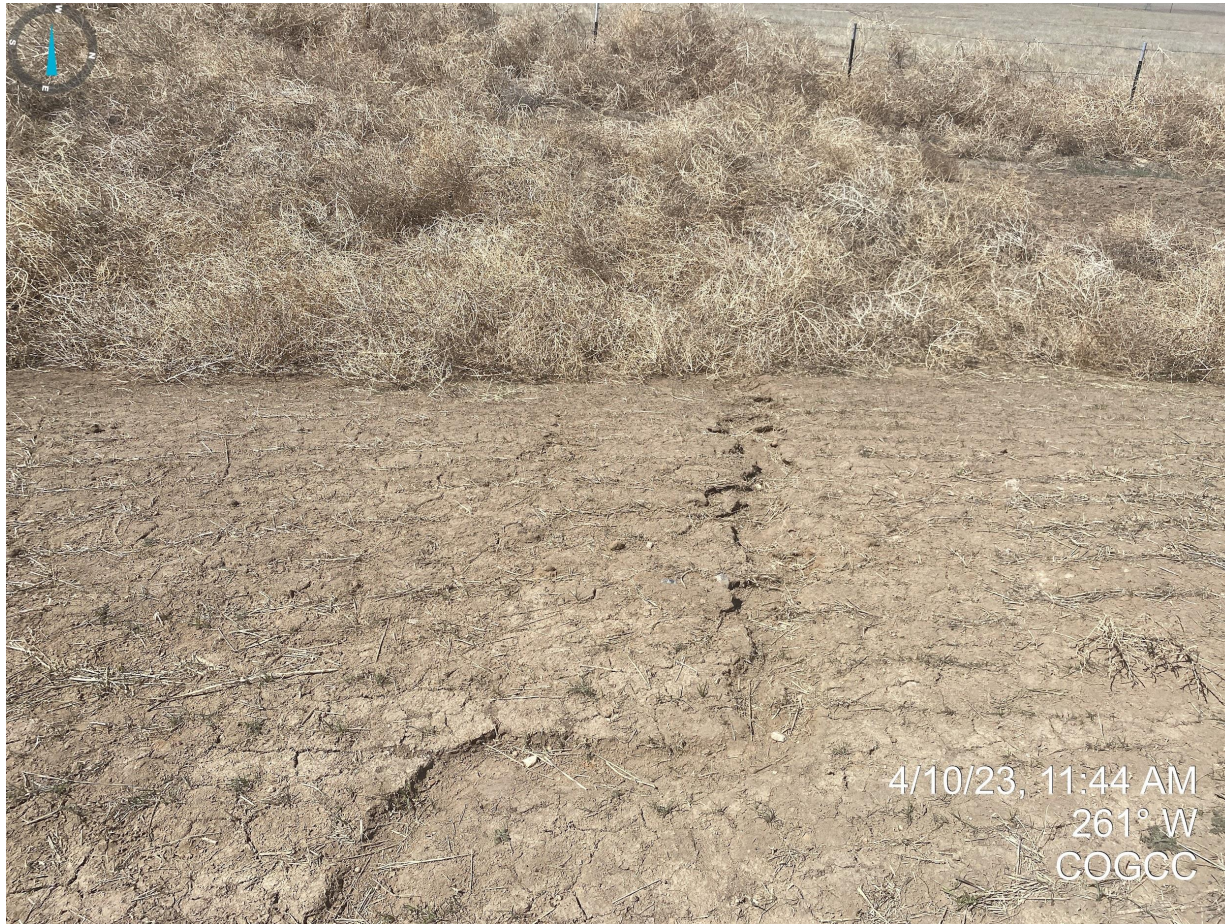
Photo 6. Close up photo taken near the location's entrance, illustrating evidence of rill erosion. While germination was detected in the interim areas, additional soil stabilization techniques will need to be implemented prevent further site degradation and erosion from occurring.

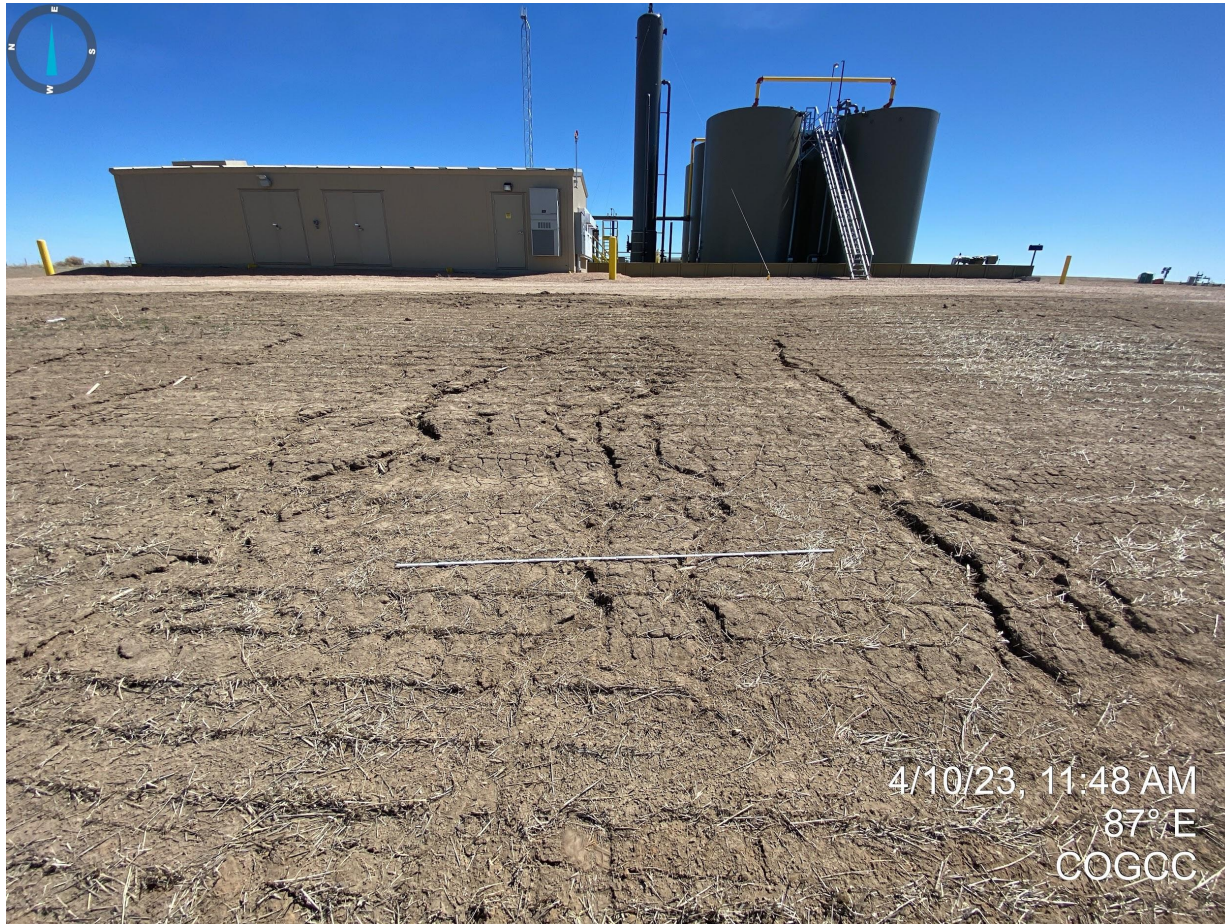
Photo 7. Facing east from the western portion of the location. See comments in Photo 6.

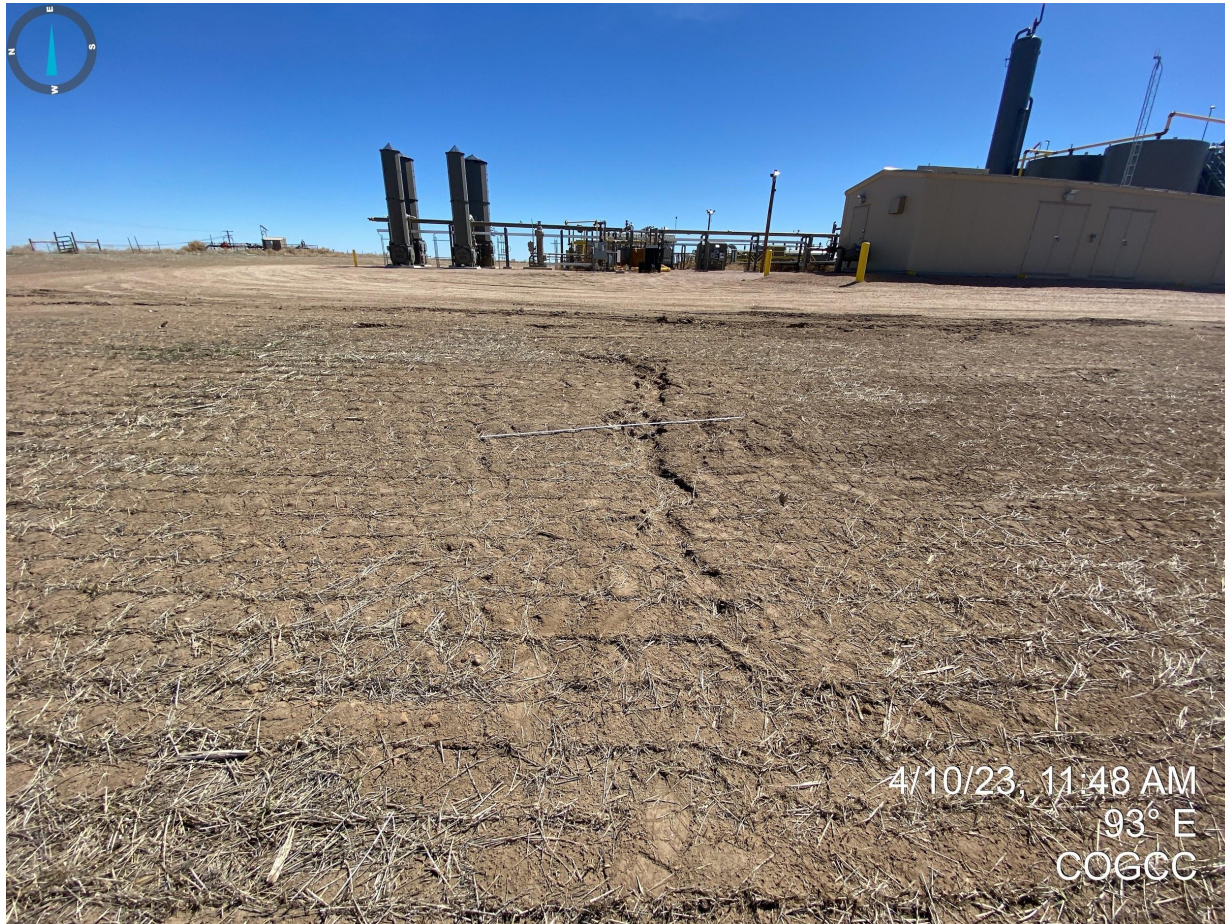
Photo 8. Facing east from the northwestern portion of the location. See comments in Photo 6.

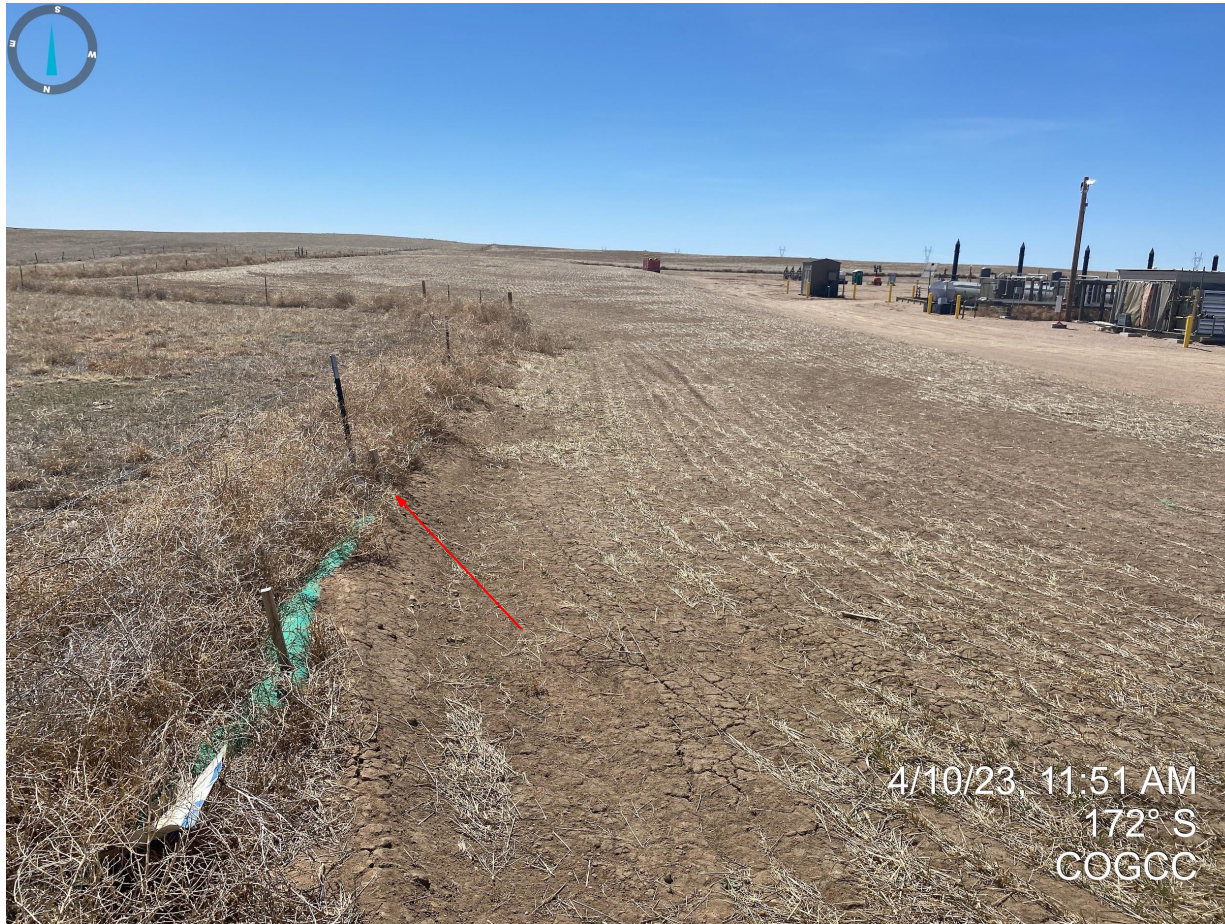
Photo 9. Facing south from the northeastern corner of the location. During this inspection it was observed that the fil-trexx wattles installed on the perimeter of the location have become buried in sediment and show signs of deterioration. These BMPs require maintenance and or replacement to be adequate in controlling stormwater run on and run off.

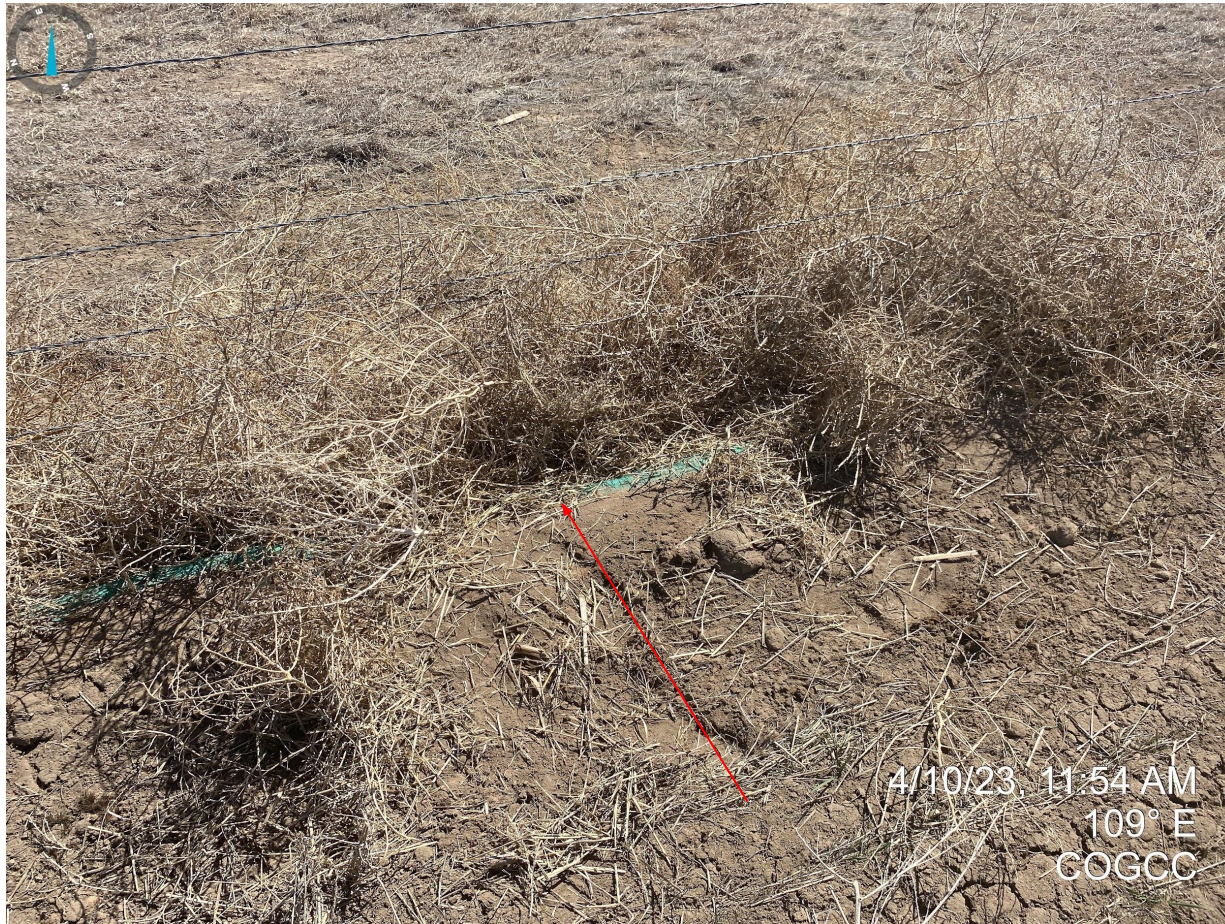
Photo 10. Taken from the eastern side of the location. See comments in Photo 9.

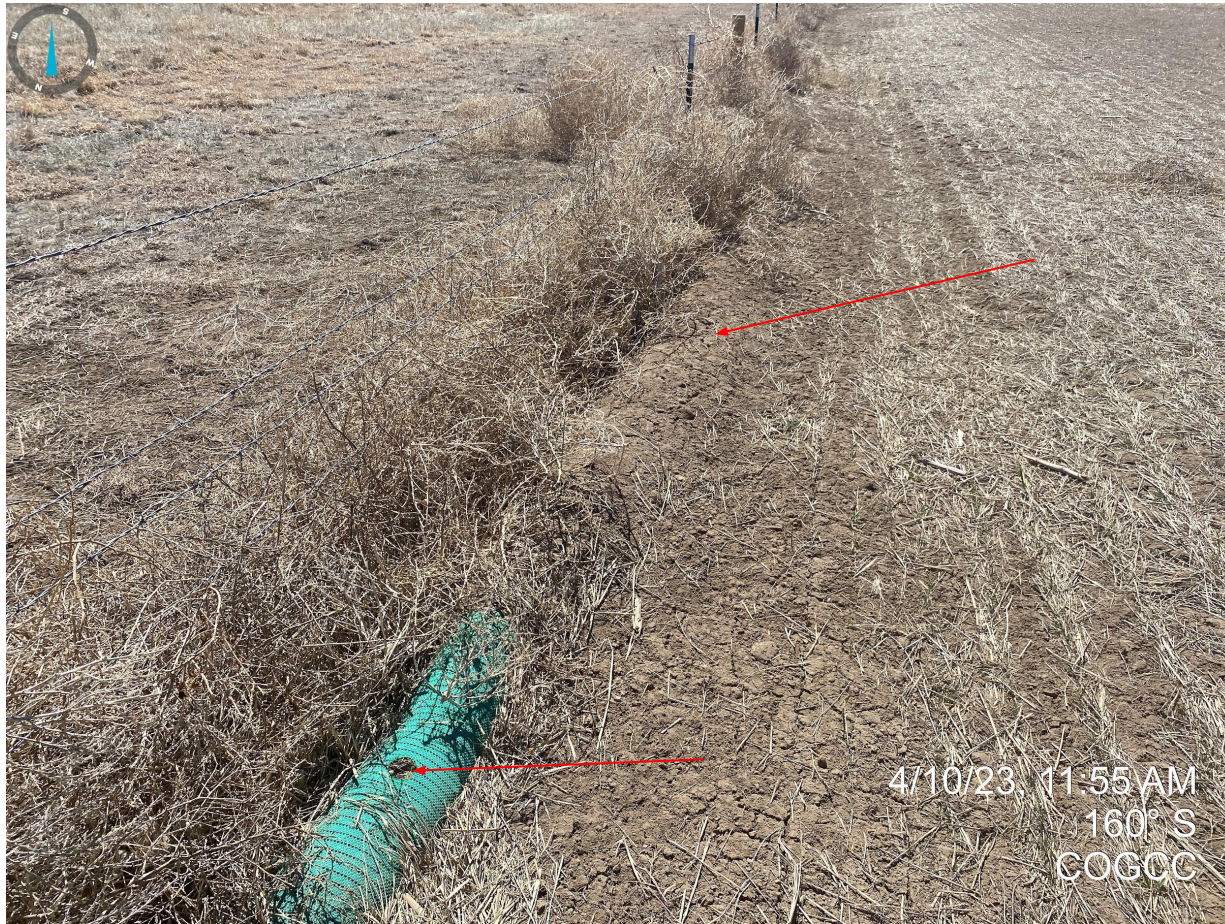
Photo 11. See comments in Photos 9 & 10.

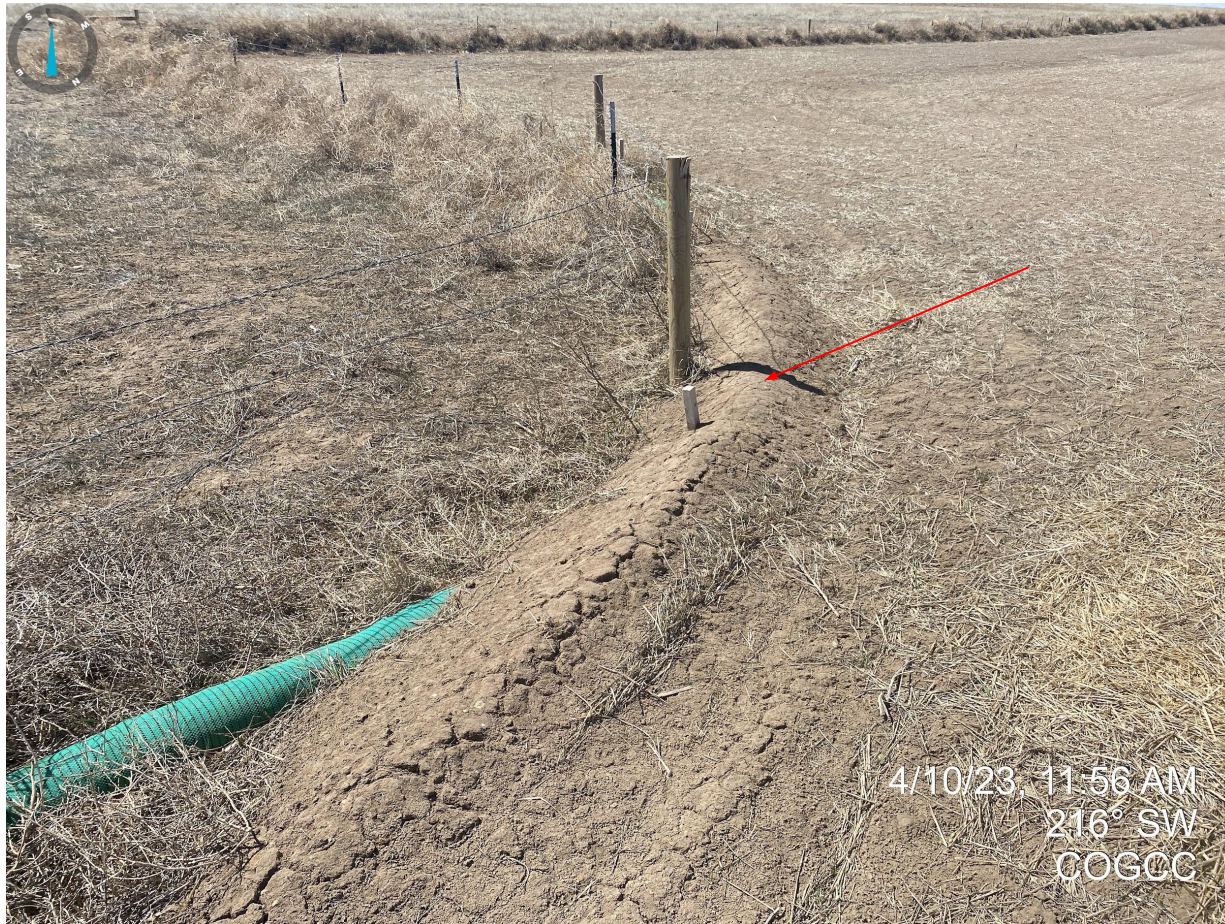
Photo 12. Taken from the southeastern corner of the location. See comments in Photo 9.

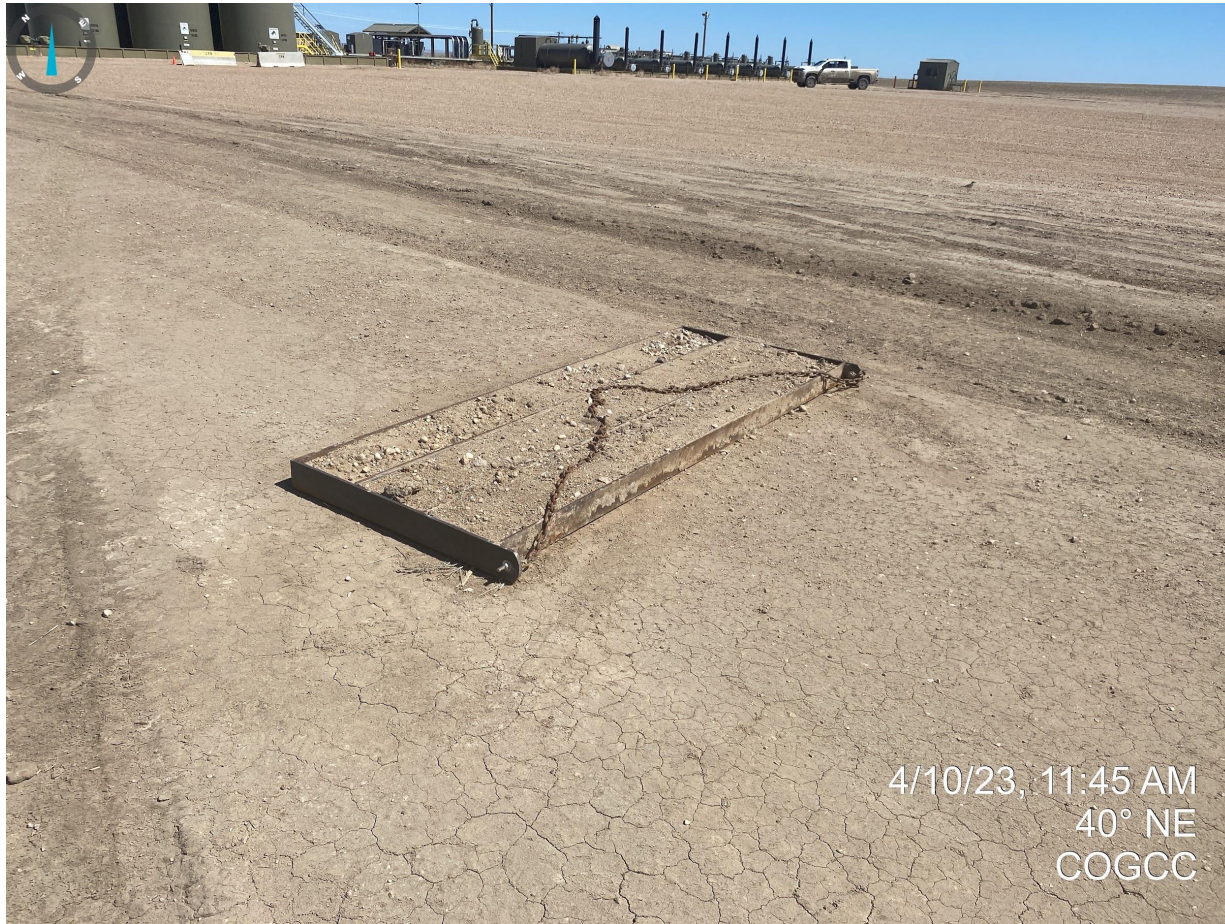
Photo 13. Road maintainer/drag observed on location. Storage of equipment on location is prohibited.

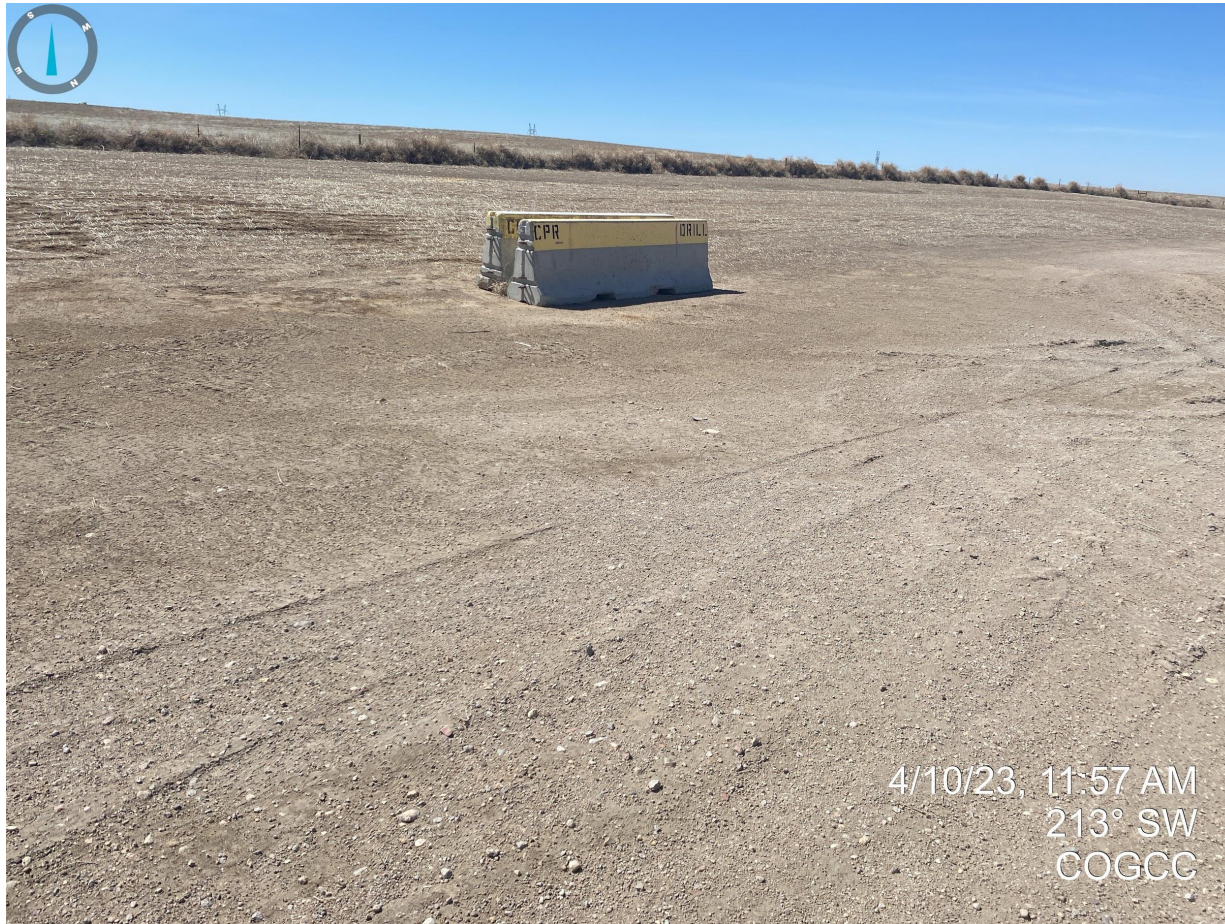
Photo 14. Jersey barriers observed on the southern edge of production area; see comments in Photo 13.

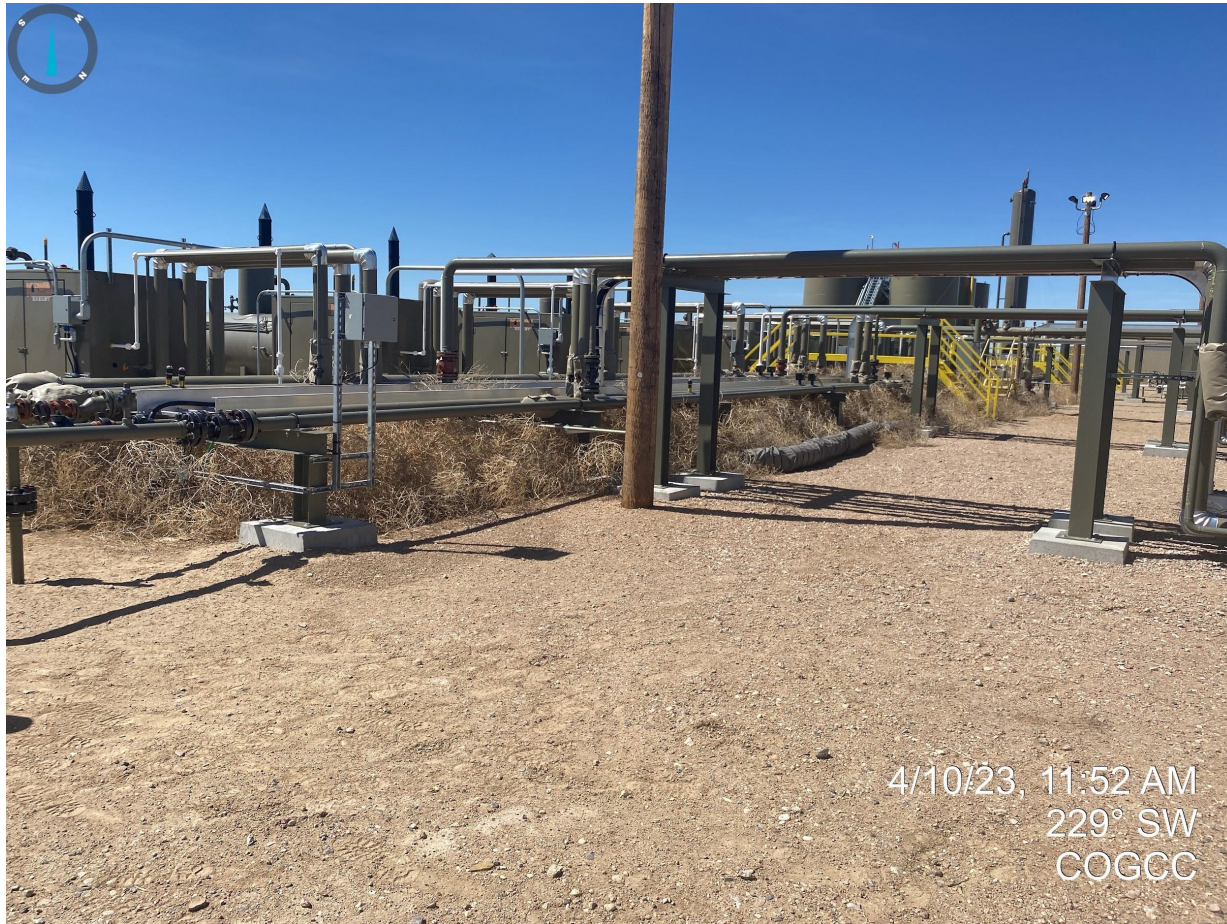
Photo 15. Tumbleweed accumulations observed in and around equipment will need to be removed as it presents a fire hazard.

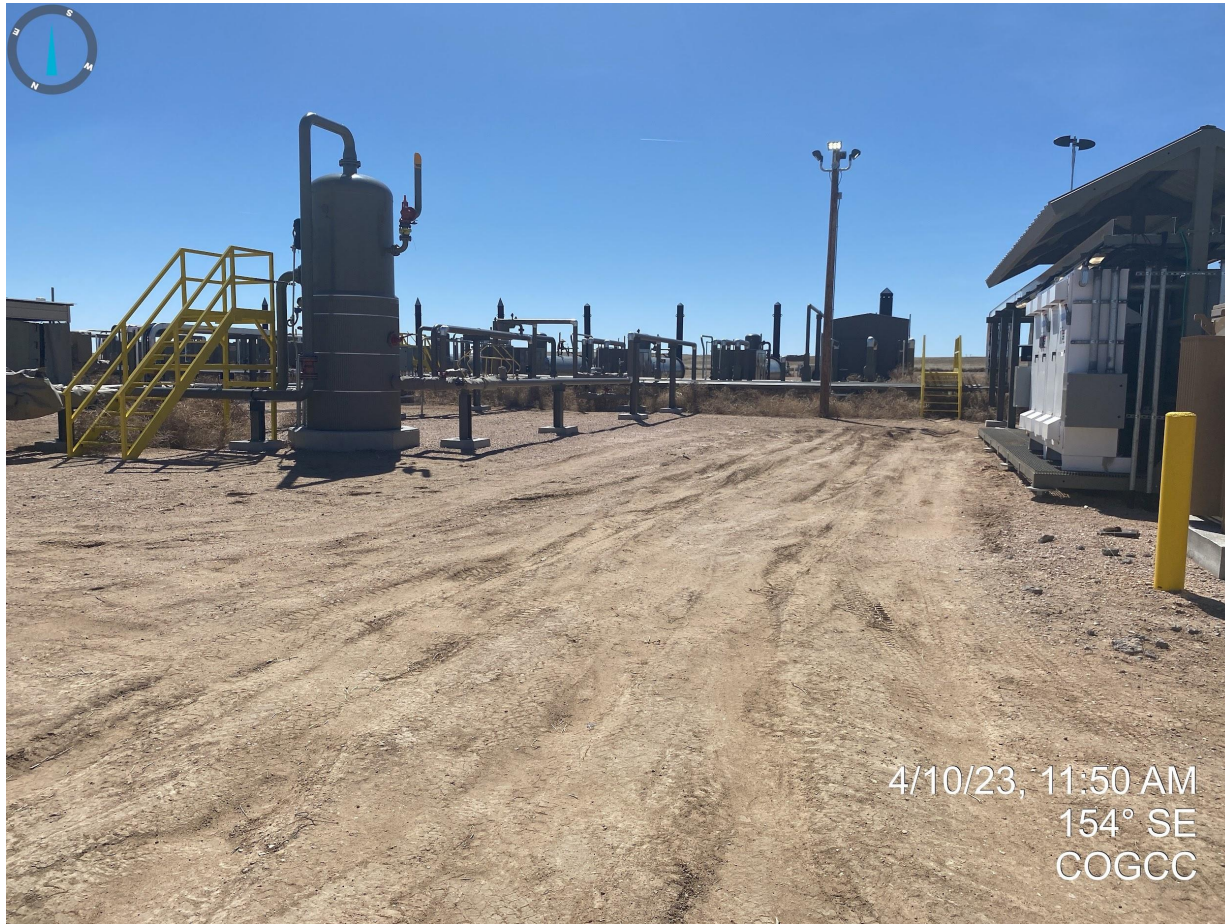
Photo 16. See comments in Photo 15.

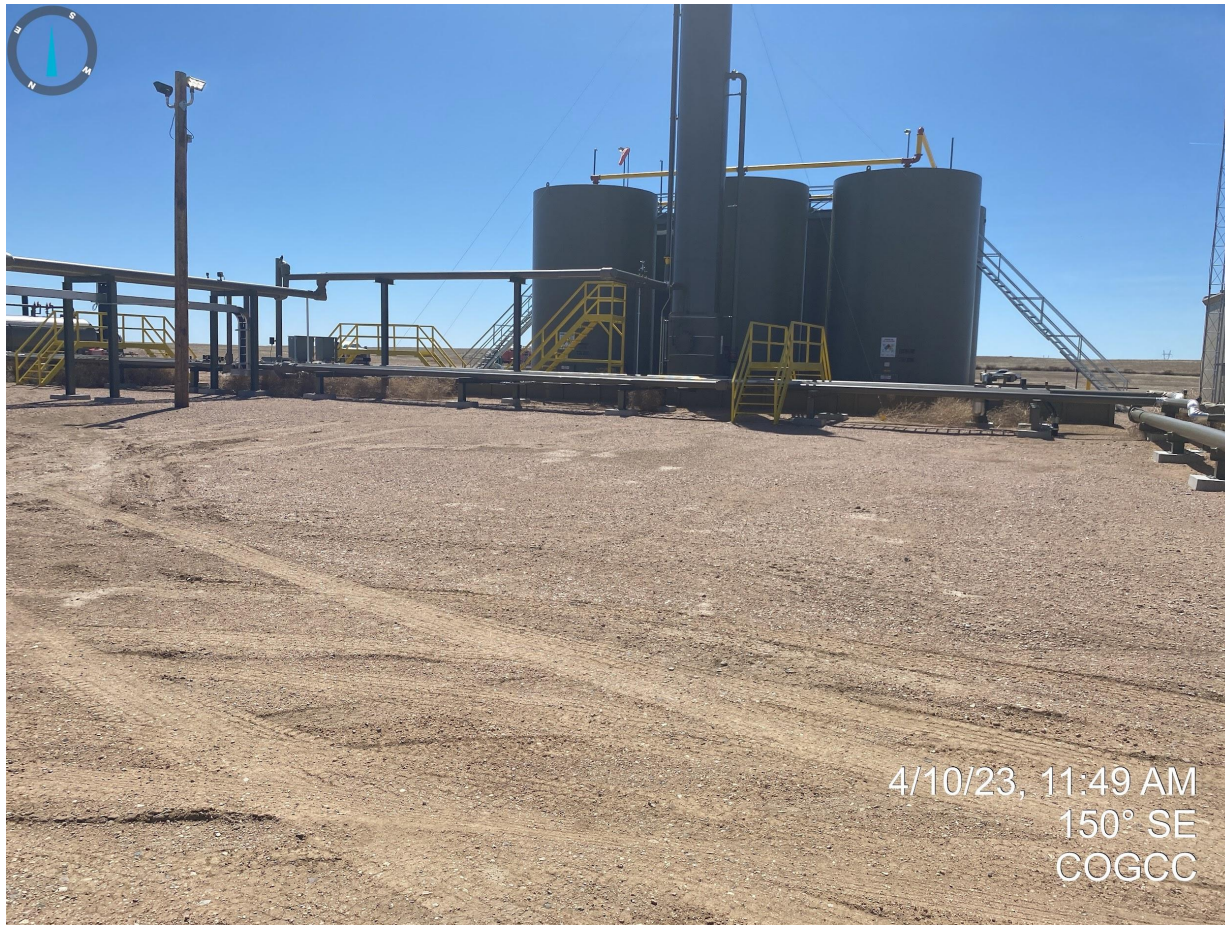
Photo 17. See comments in Photo 15.

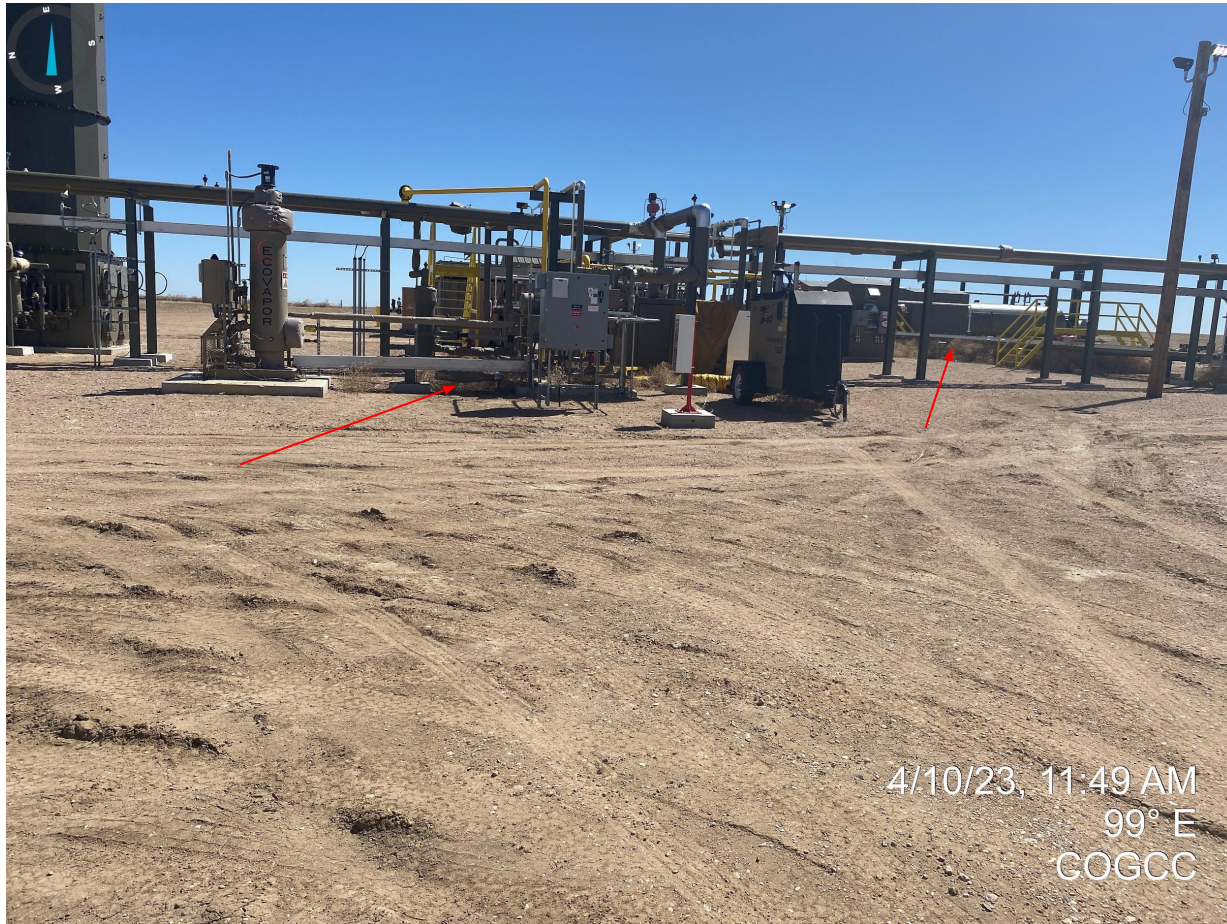
Photo 18. See comments in Photo 15.

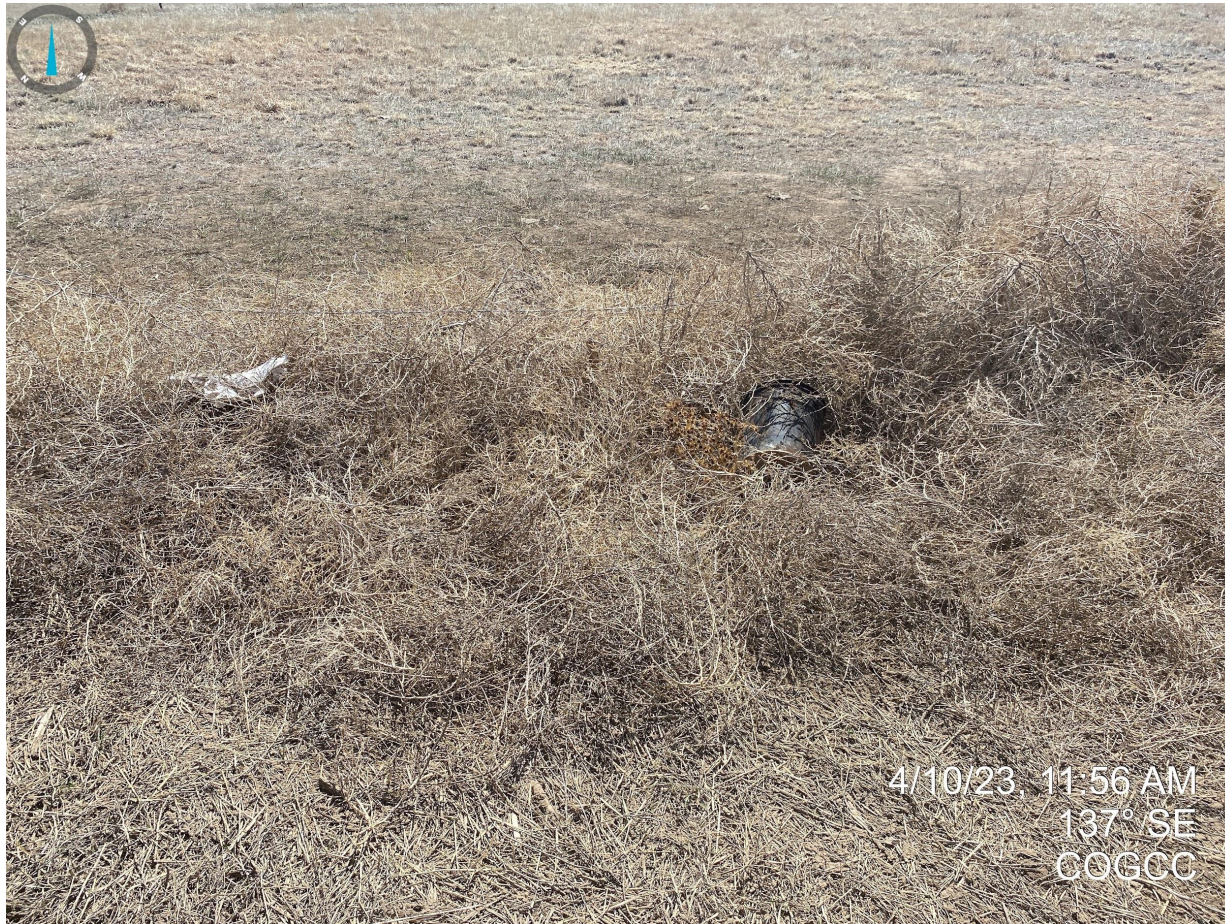
Photo 19. Trash and debris observed throughout the location. The operator shall self inspect the entire location to ensure it is kept free from all trash and debris, at all times.

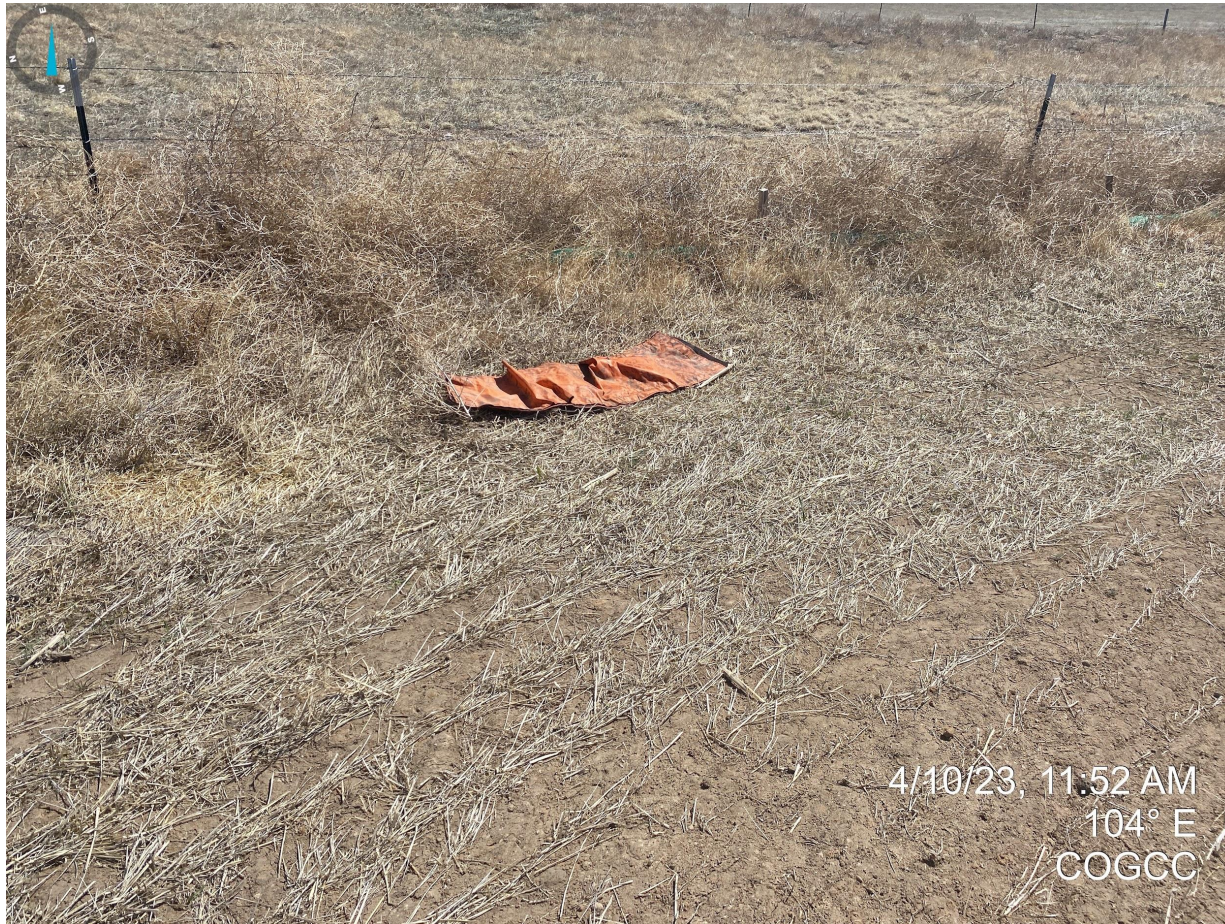
Photo 20. See comments in Photo 19.
