Inspection Photos

Location Name: TEP ROCKY MOUNTAIN LLC RMV 136-21 Pad

Location ID: 324180

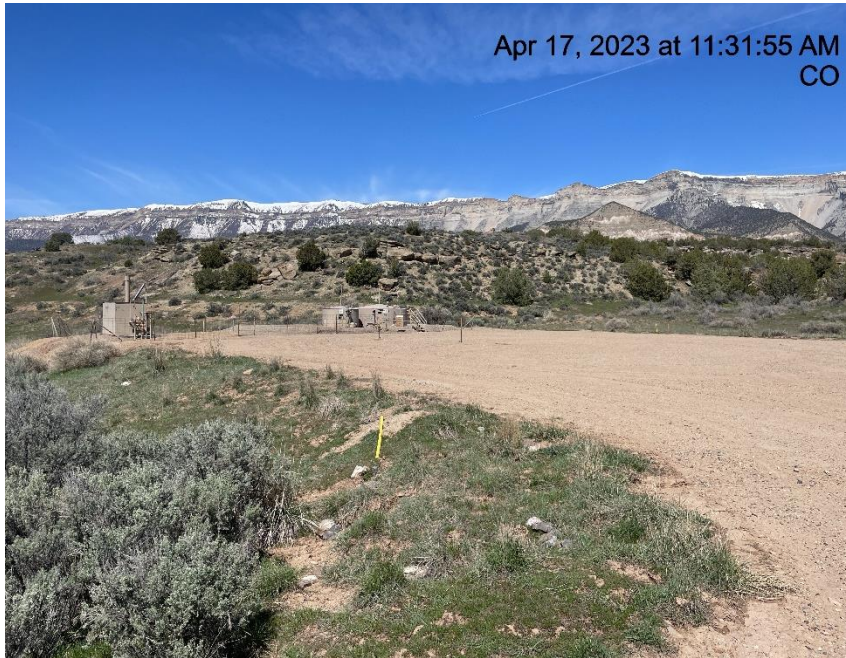
Photo # 5453 From entrance to location

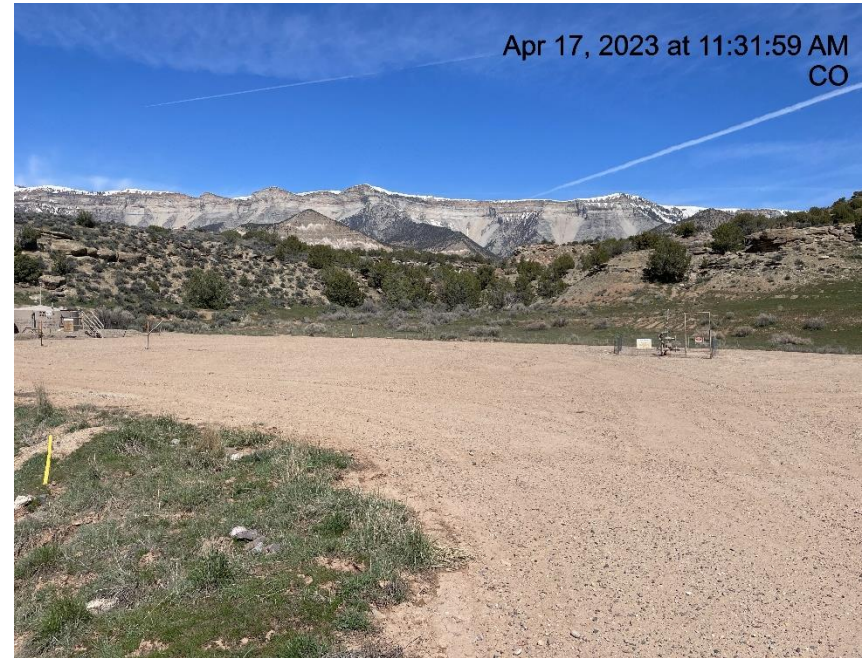
Photo # 5454 From entrance to location

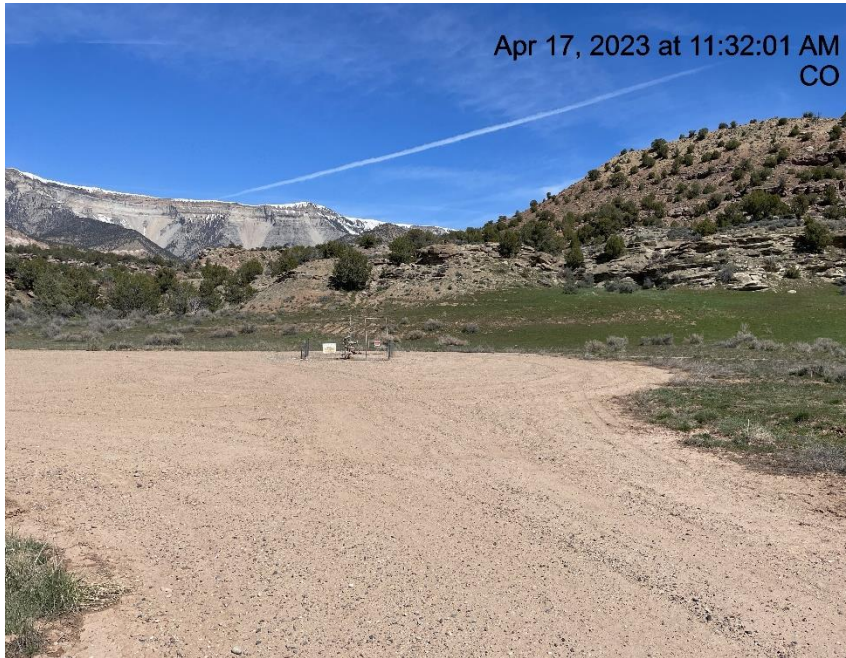
Photo # 5455 From entrance to location

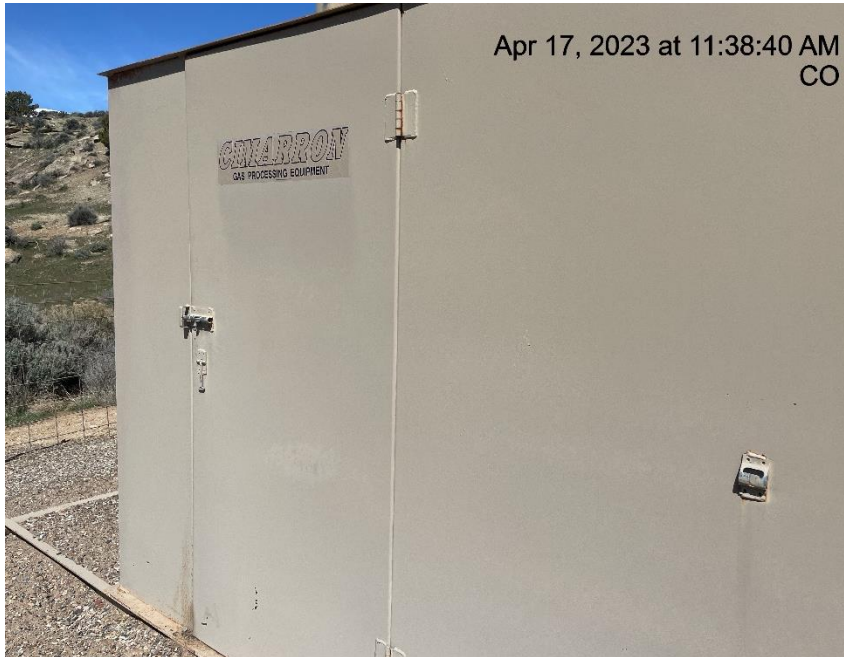
Photo # 5465 Meter calibration info not conspicuously posted

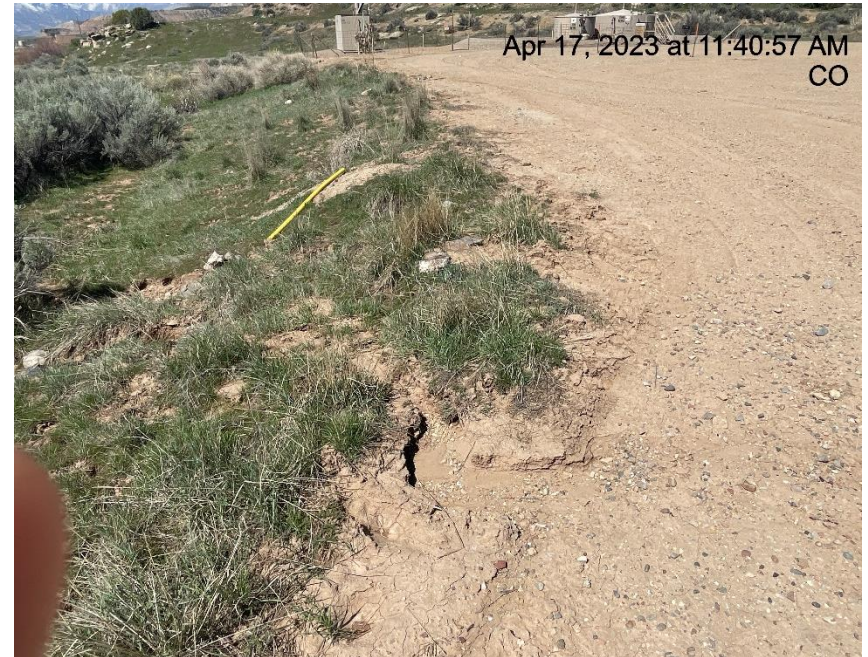
Photo # 5466 Erosion & transport of sediment off location (SE area of location, near entrance to location)

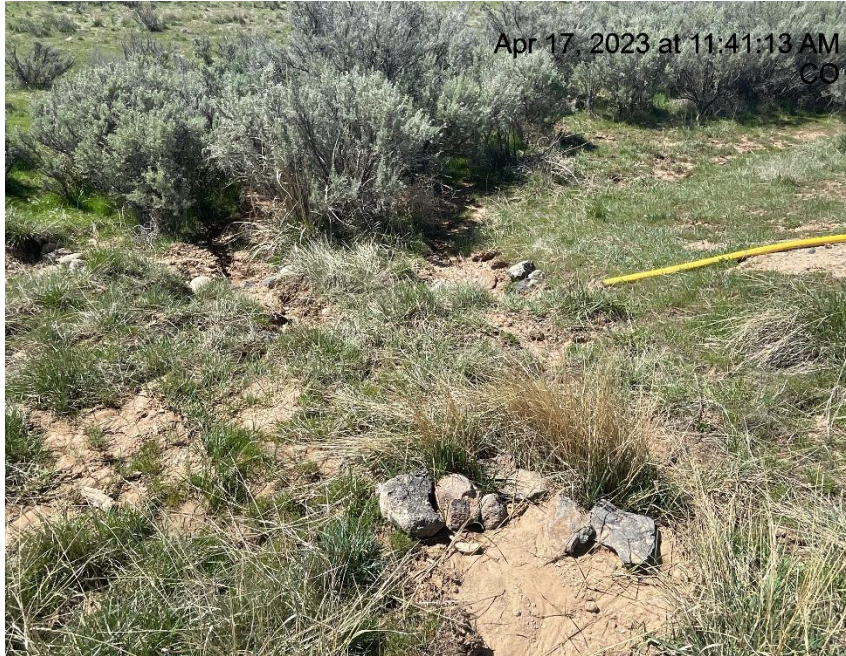
Photo # 5467 Erosion & transport of sediment off location/insufficient BMP's (SE area of location, near entrance to location)

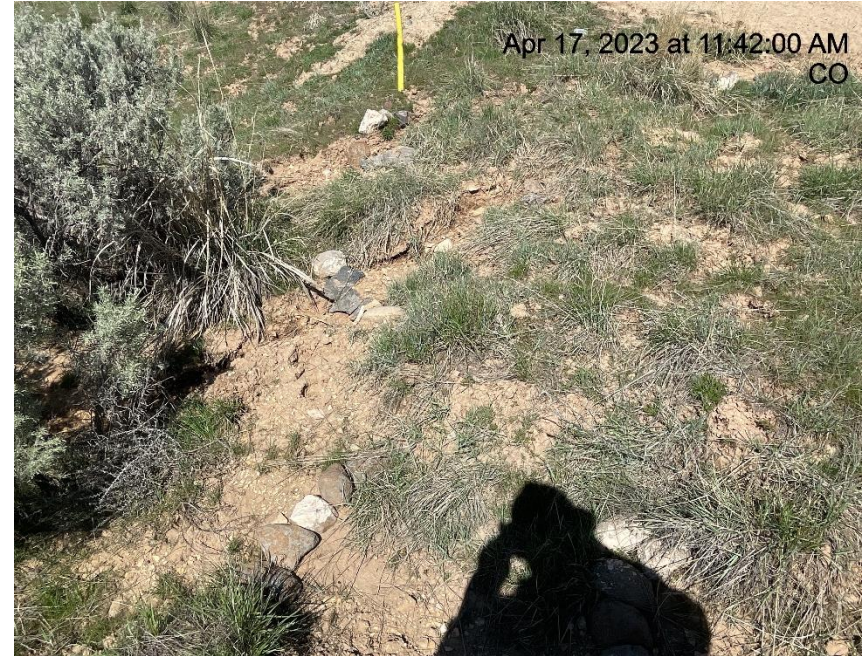
Photo # 5469 Erosion & transport of sediment off location/insufficient BMP's (SE area of location, near entrance to location)

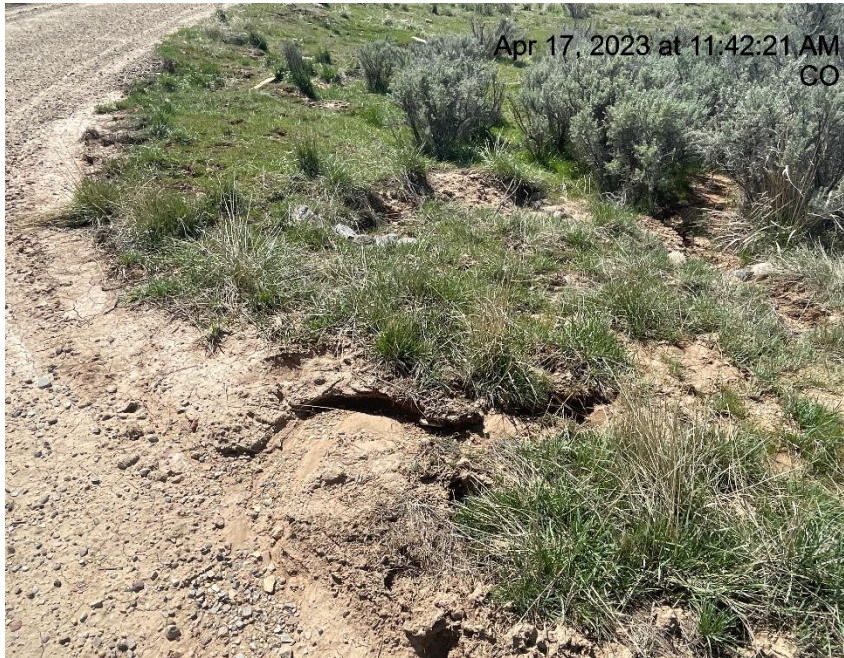
**Photo # 5471 Erosion & transport of sediment off location
(SE area of location, near entrance to location)**

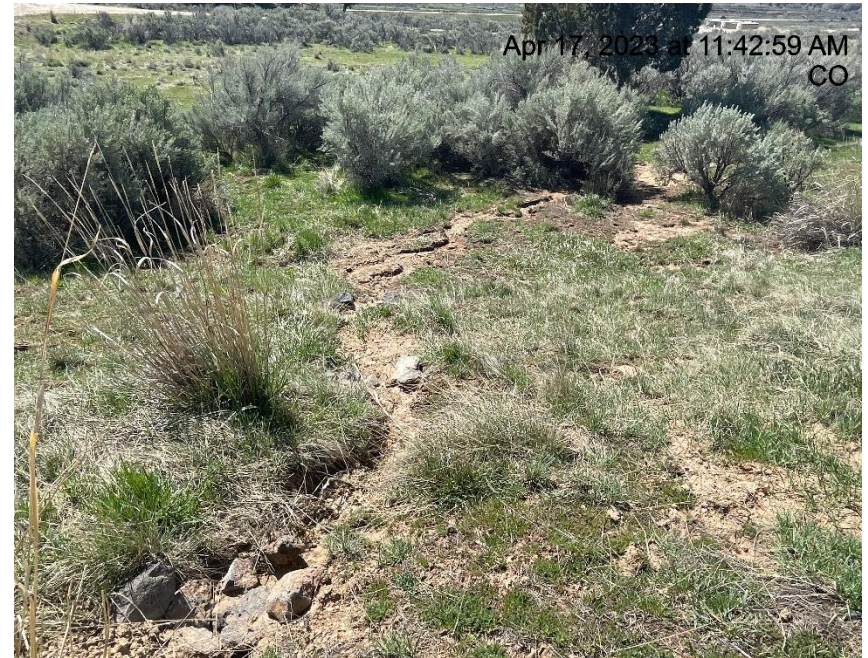
**Photo # 5474 Transport of sediment off location/choking off
vegetation/insufficient BMP's (SE area of location, near entrance
to location)**

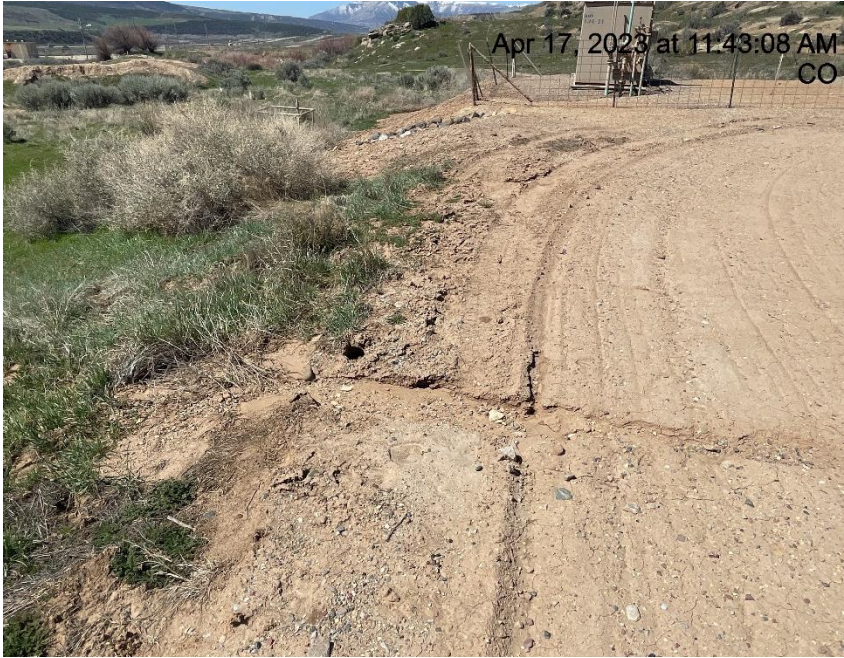
Photo # 5475 Erosion & transport of sediment off location

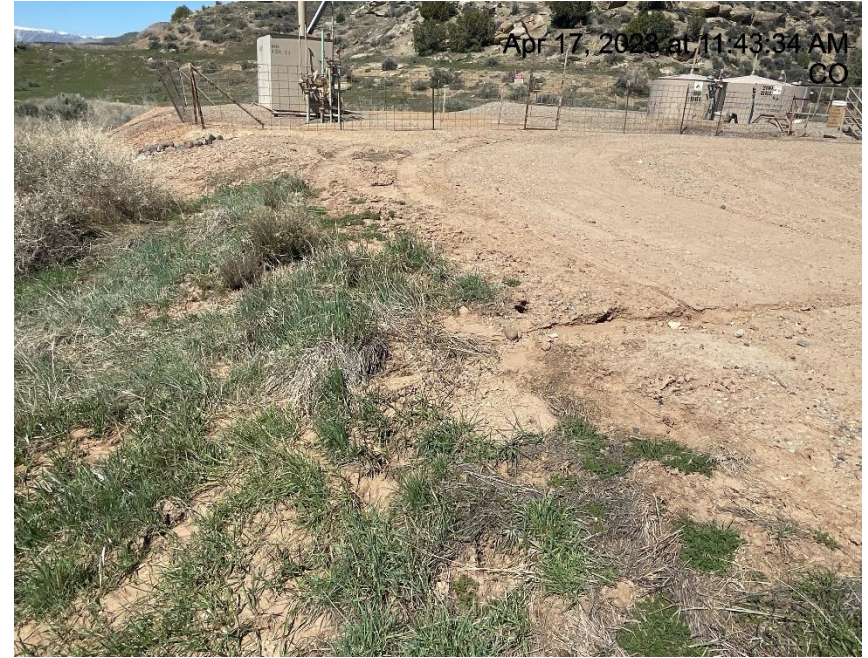
Photo # 5478 Erosion & transport of sediment off location

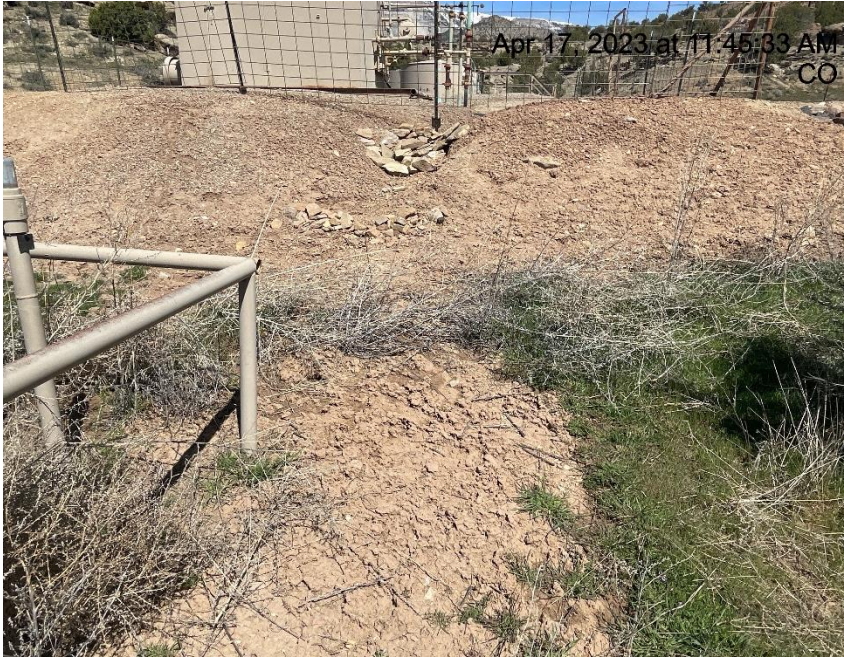
Photo # 5482 Erosion & transport of sediment off location/insufficient BMP's

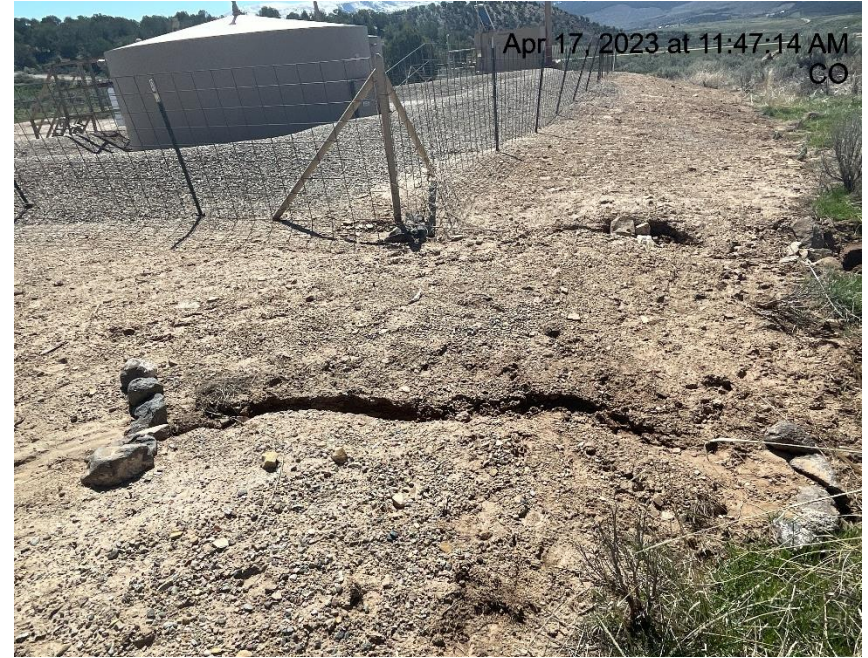
Photo # 5484 Check dams need maintenance

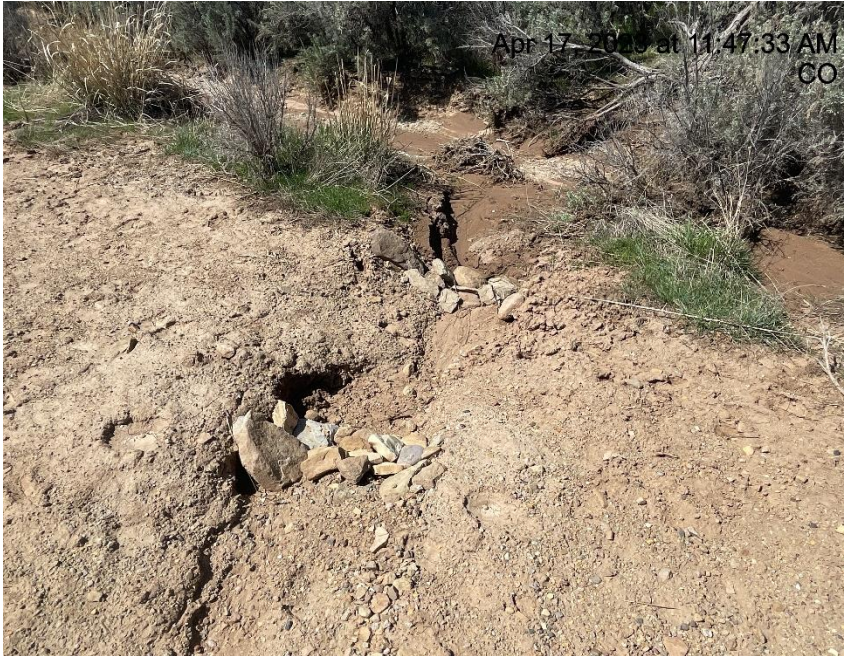
Photo # 5486 Check dams need maintenance

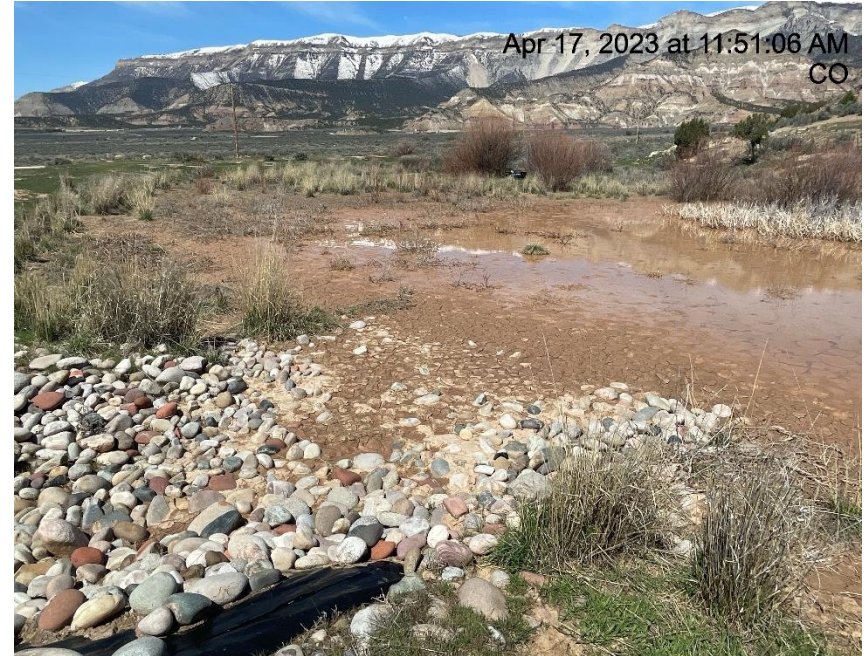
Photo # 5493 Retention Pond/BMP's need maintenance (on north side of lease road approximately 1/10th of a mile from location)

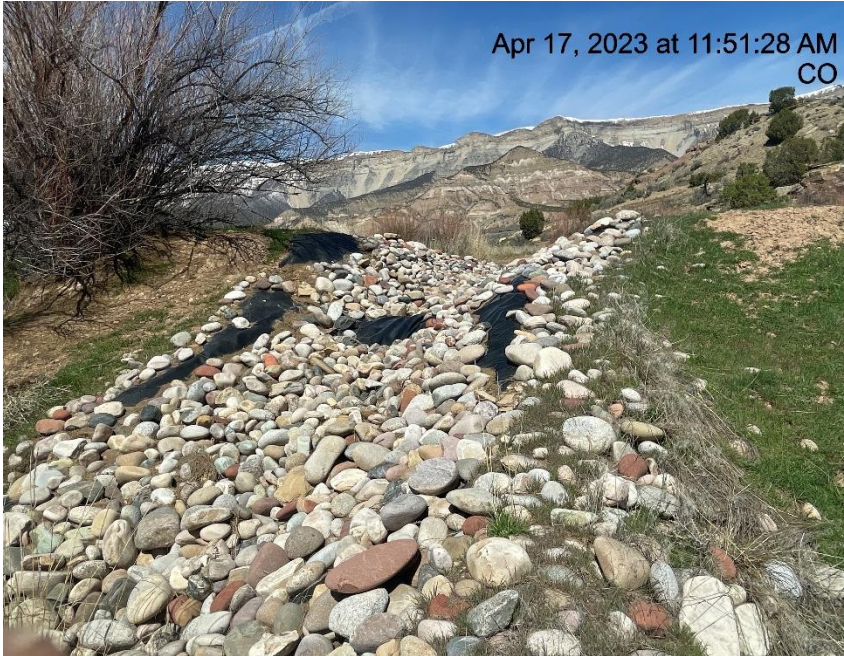
Photo # 5494 Rip Rap run needs maintenance (on north side of lease road approximately 1/10th of a mile from location)

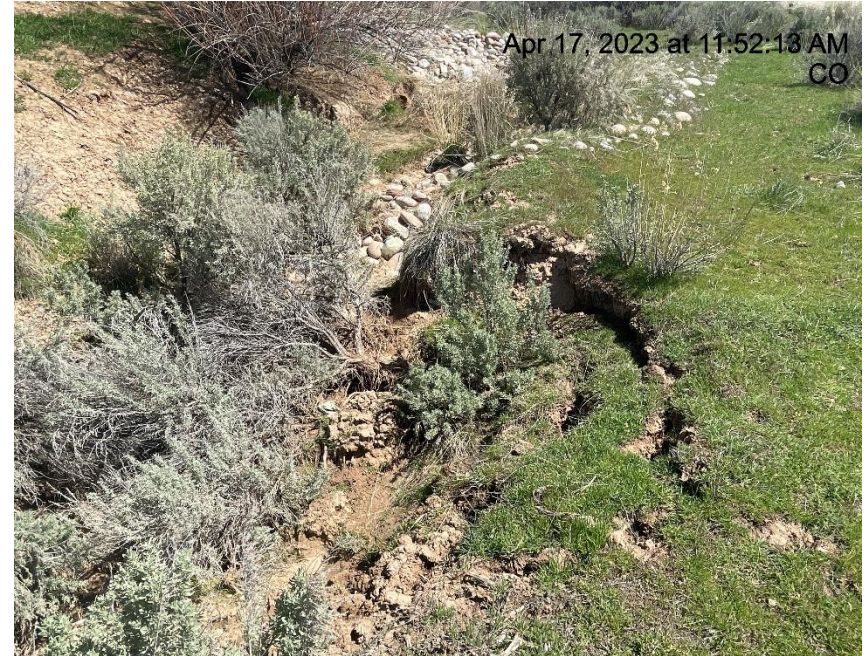
Photo # 5497 Ditch needs maintenance/insufficient BMP's/erosion of habitat (on north side of lease road approximately 1/10th of a mile from location)

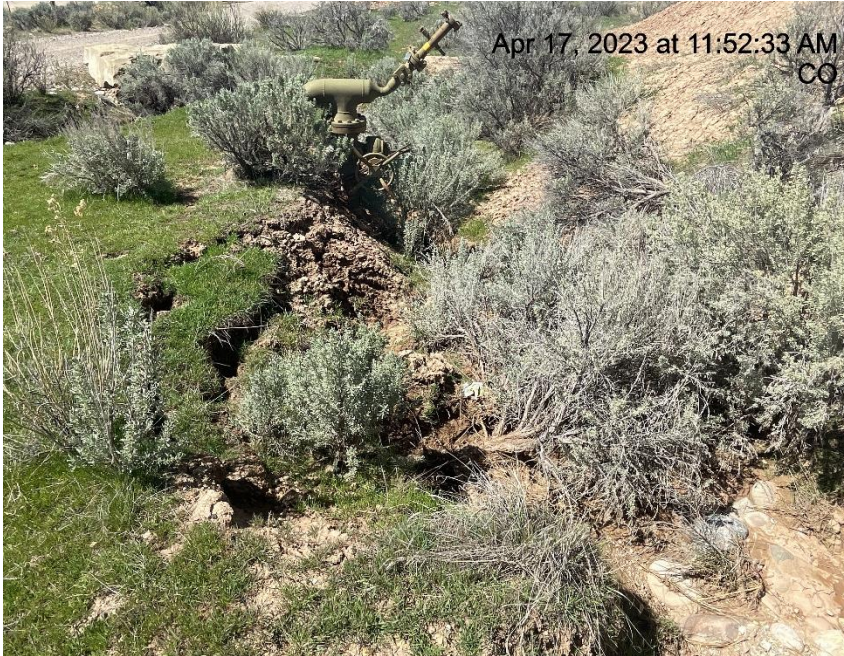
Photo # 5499 Ditch needs maintenance/insufficient BMP's/erosion of habitat (on north side of lease road approximately 1/10th of a mile from location)

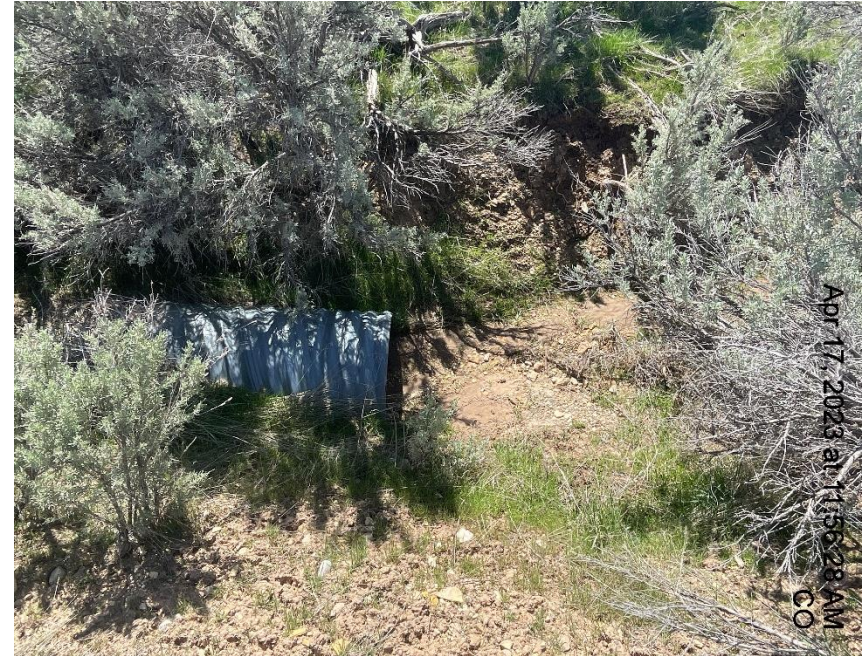
Photo # 5505 Culvert needs maintenance (on spur road into location, approximately 50-75 feet from entrance to location)

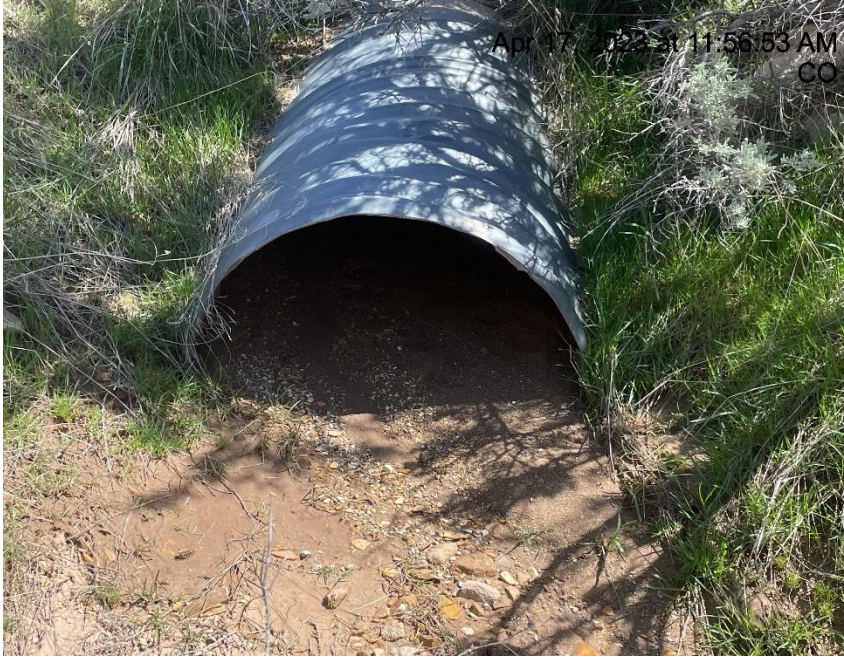
Photo # 5506 Culvert needs maintenance (on spur road into location, approximately 50-75 feet from entrance to location)
