Inspection Photos

Location Name: TEP ROCKY MOUNTAIN LLC RWF 332-21 Pad

Location ID: 335340

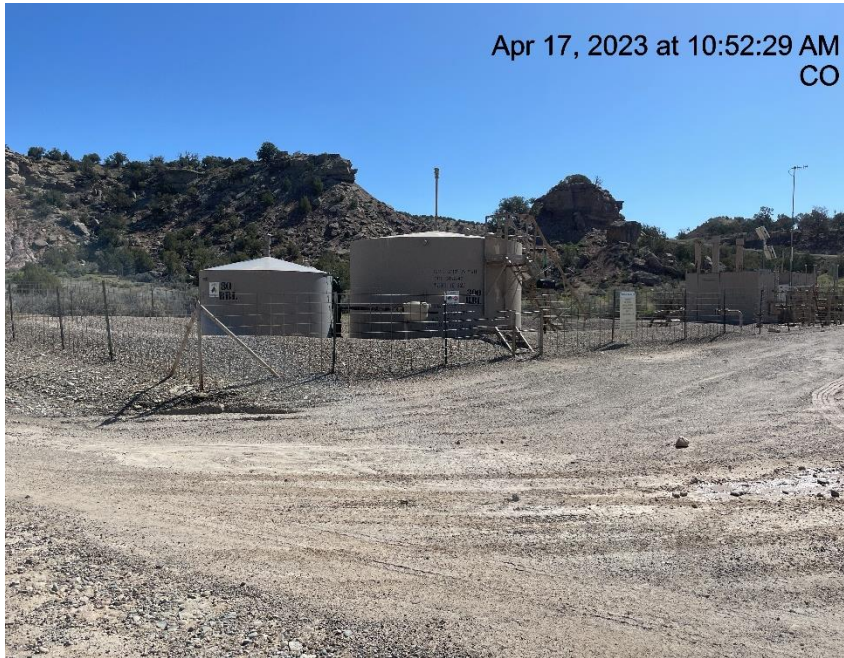
Photo # 5397 From entrance to location

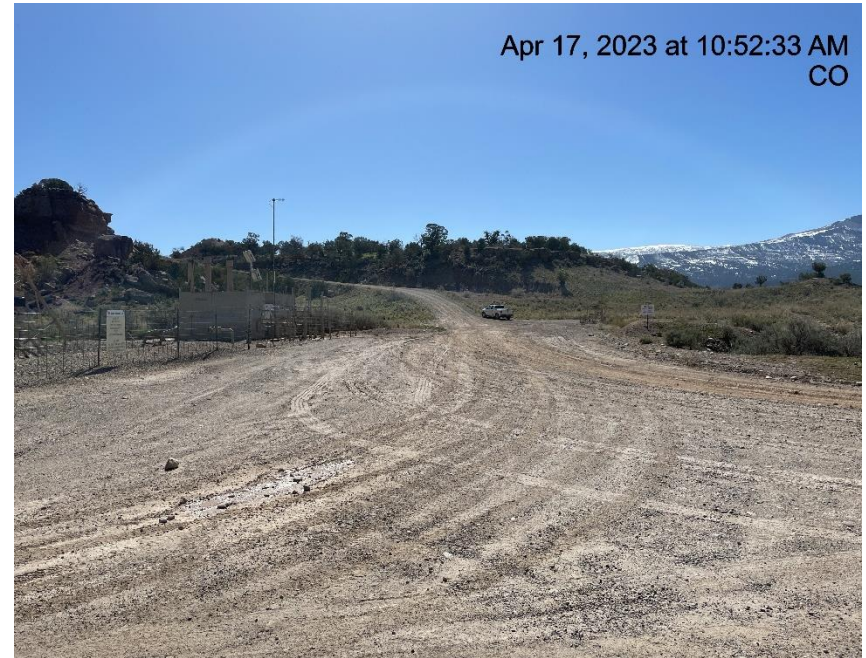
Photo # 5398 From entrance to location

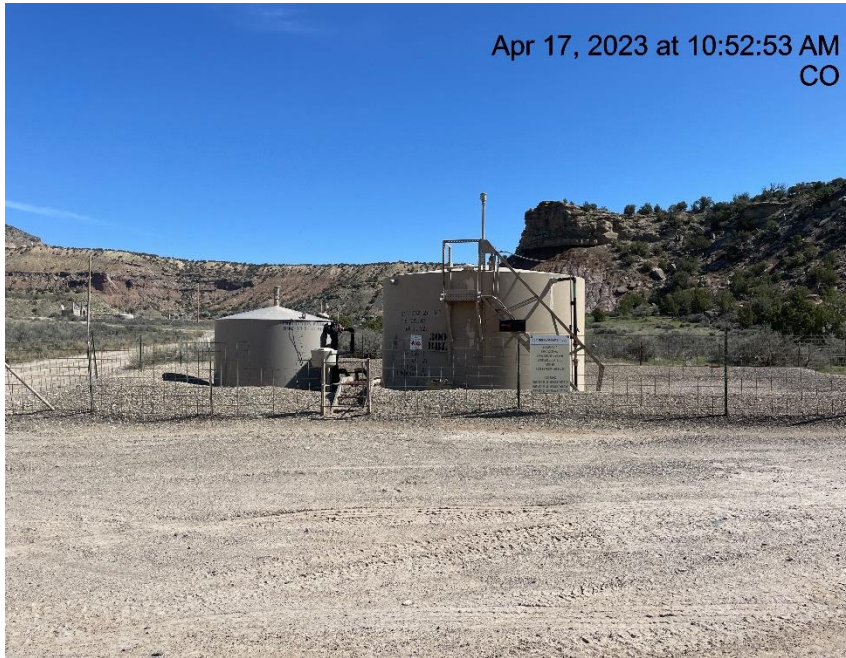
Photo # 5399 Location

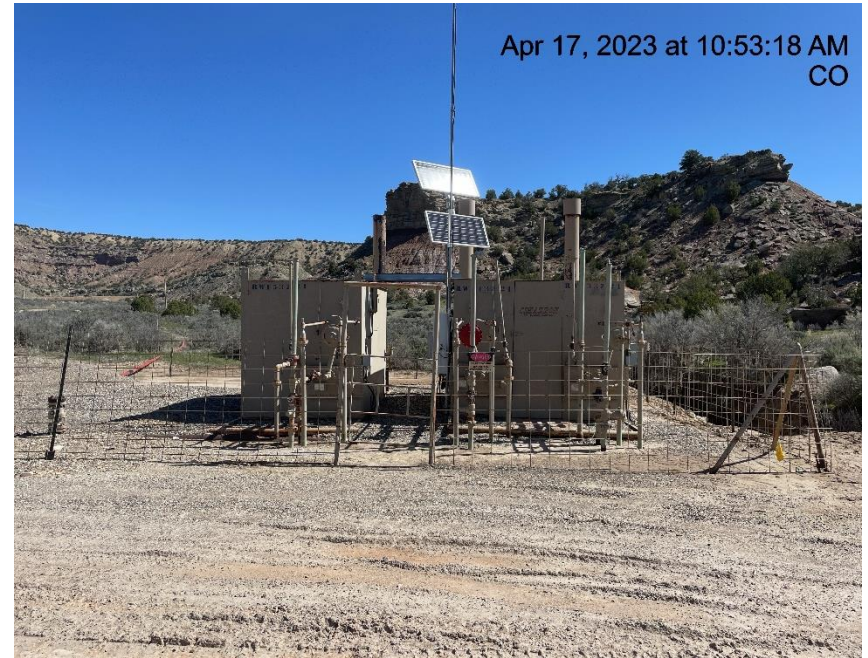
Photo # 5400 Location

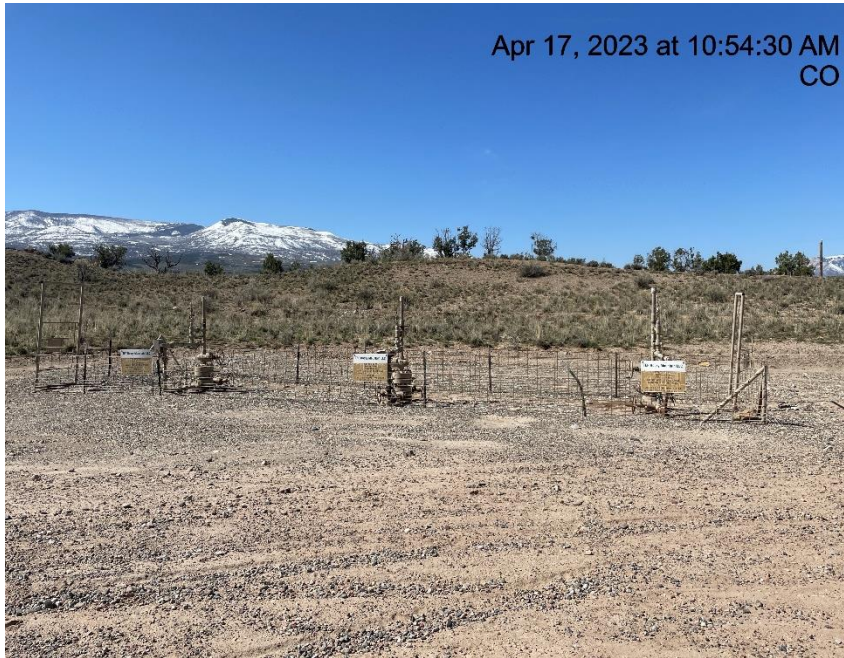
Photo # 5401 Location

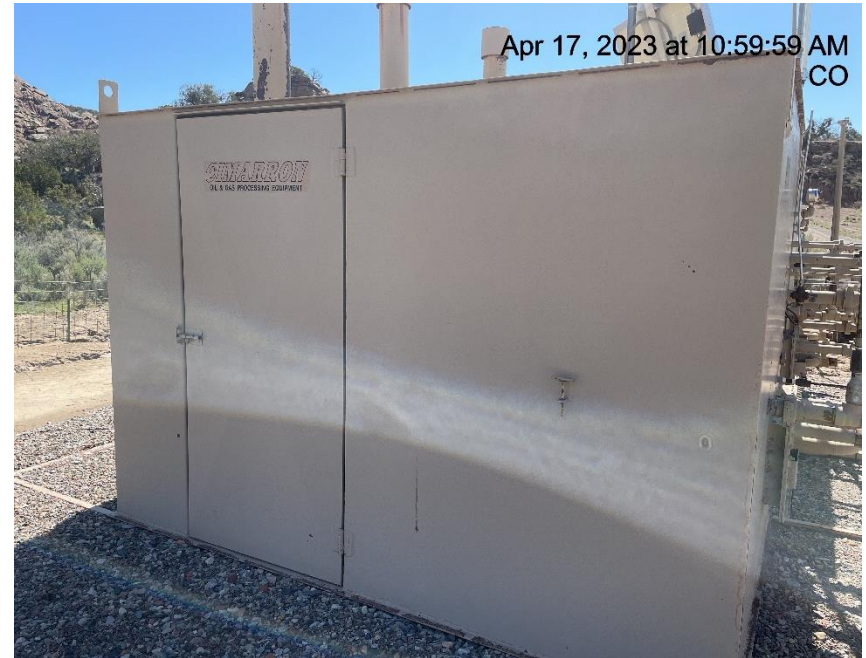
Photo # 5402 Meter calibration info not conspicuously posted

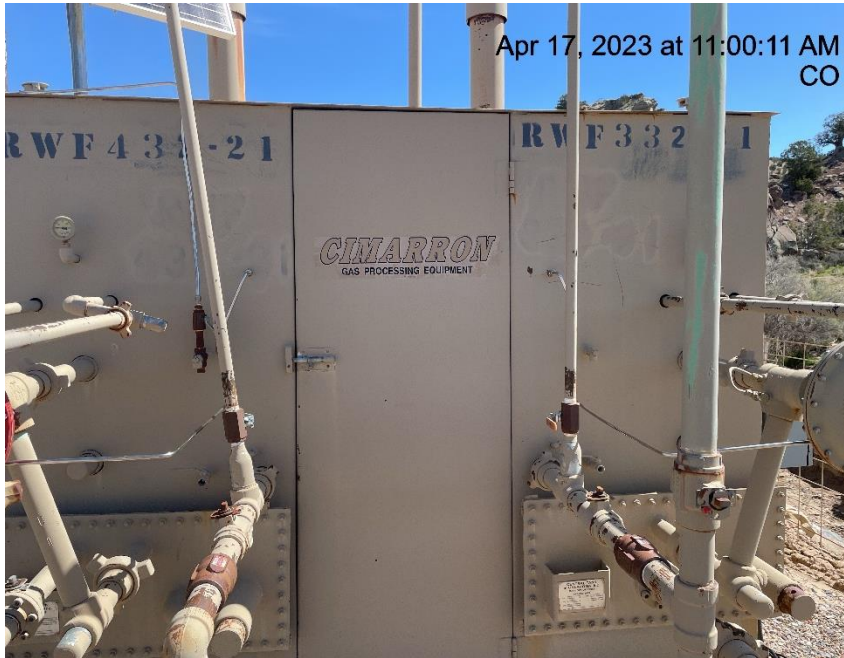
Photo # 5403 Meter calibration info not conspicuously posted

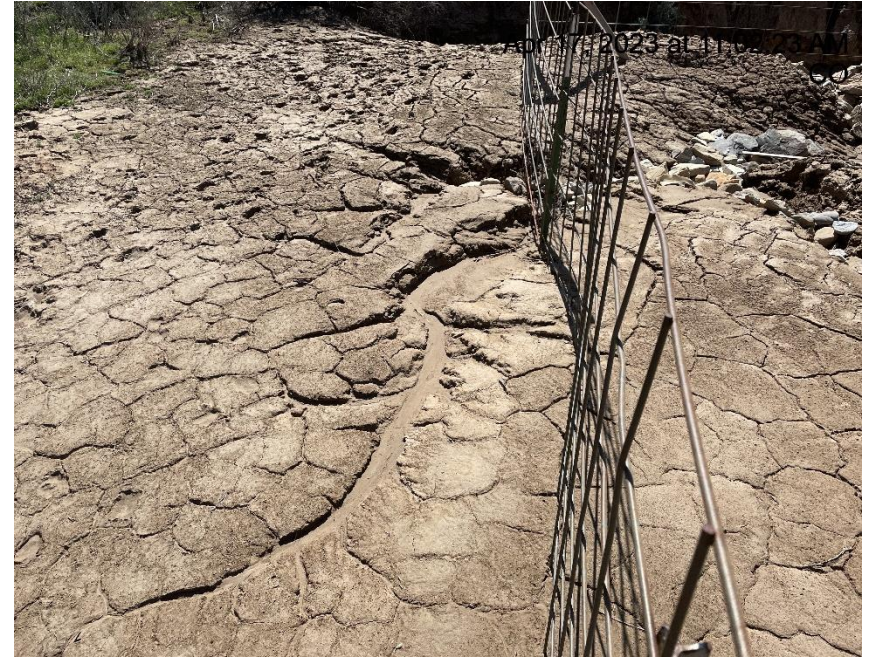
Photo # 5411 Rill erosion (back side of separator units)

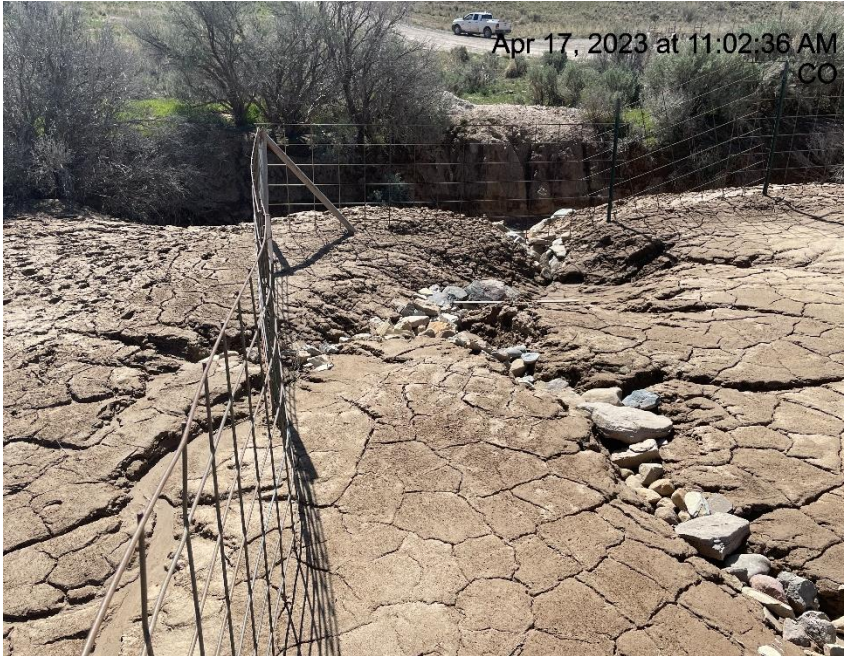
Photo # 5412 Erosion/insufficient BMP's

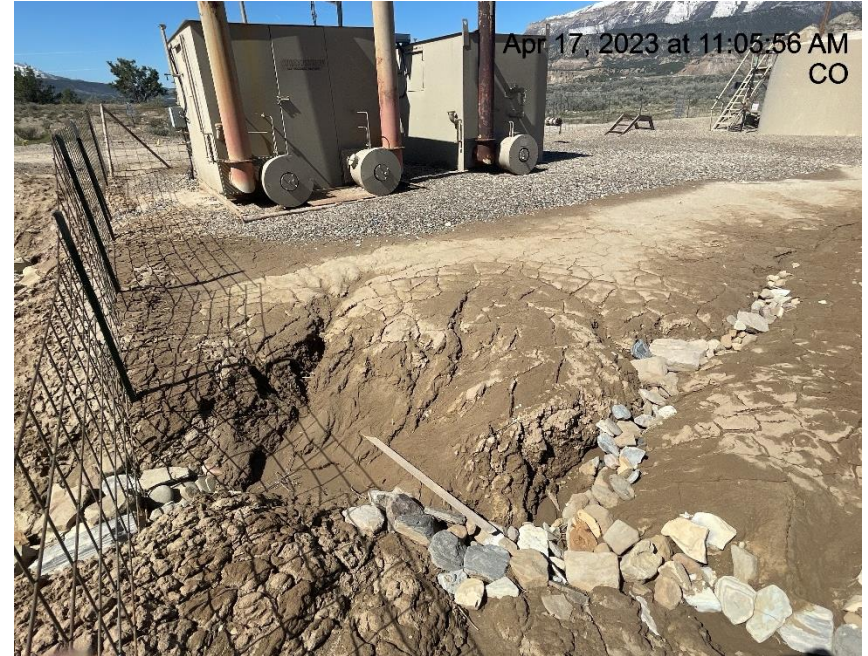
Photo # 5420 Erosion/insufficient BMP's

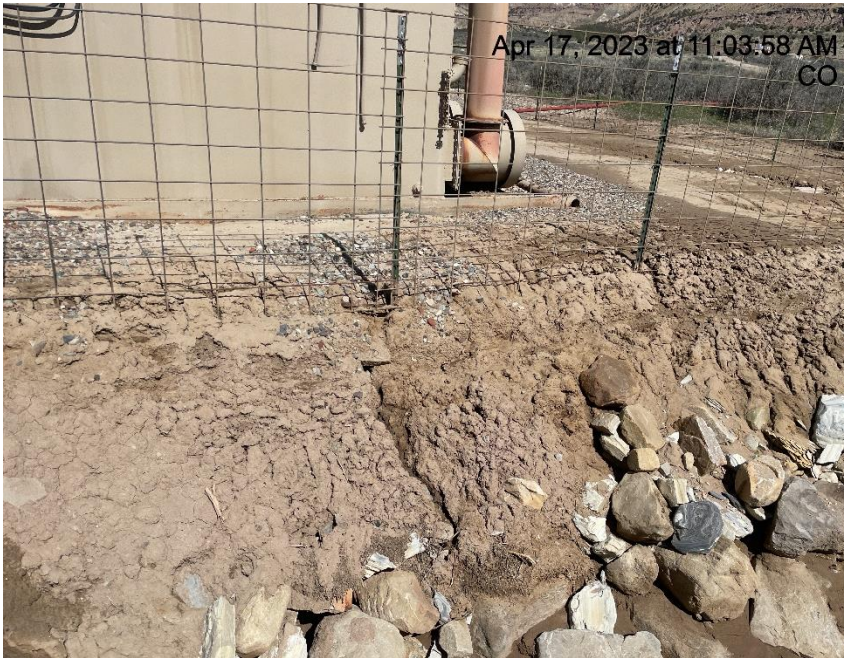
Photo # 5416 Erosion on slope going into ditch

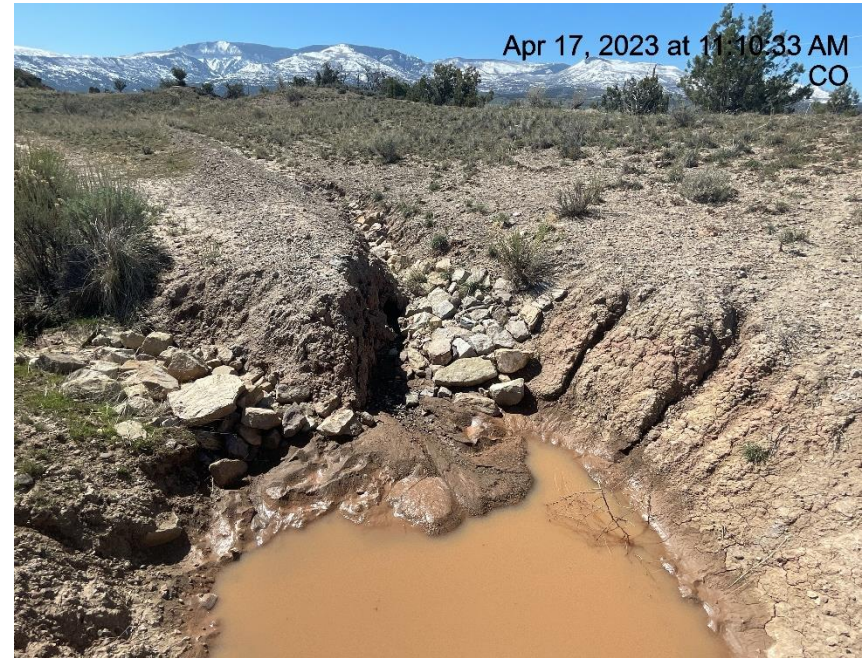
Photo # 5426 Sediment trap needs maintenance (SW side of location)

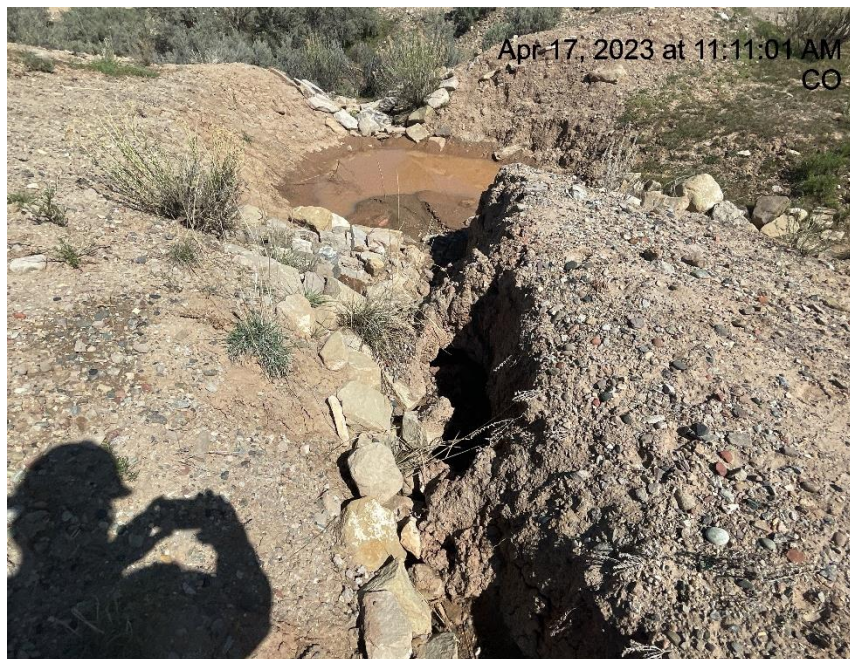
Photo # 5427 Sediment trap needs maintenance (SW side of location)

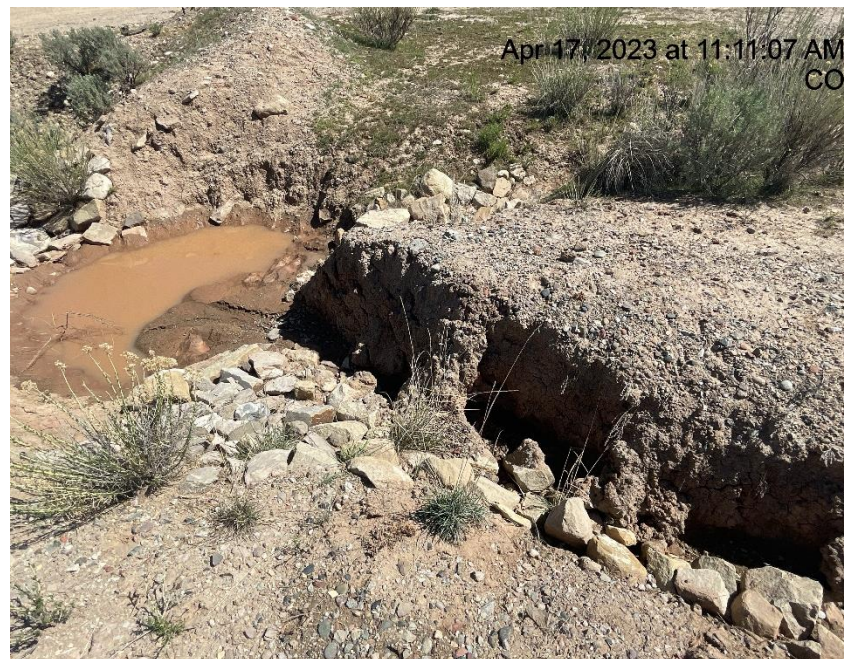
Photo # 5428 Sediment trap needs maintenance (SW side of location)

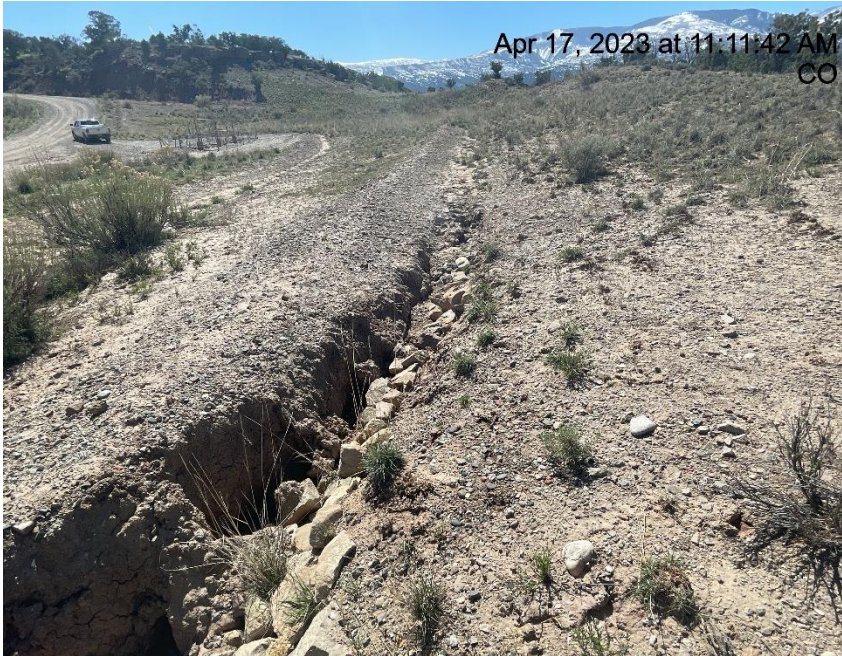
Photo # 5430 Ditch going into sediment trap needs maintenance (SW side of location)

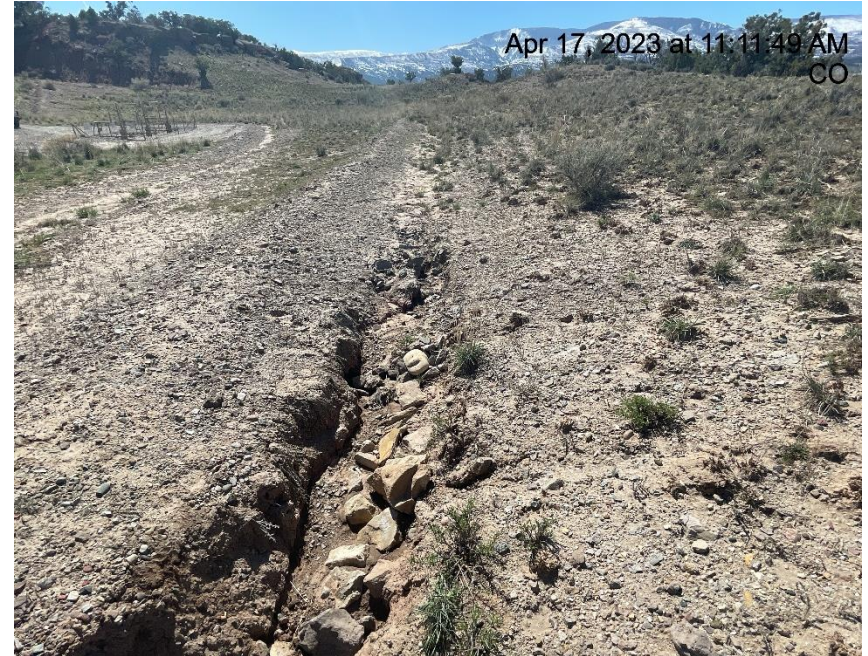
Photo # 5431 Ditch going into sediment trap needs maintenance (SW side of location)

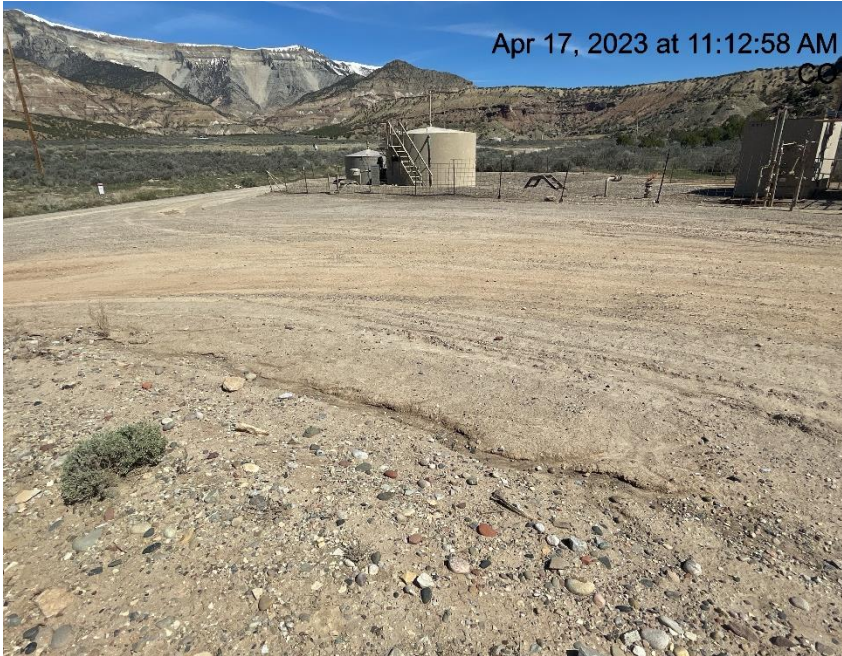
Photo # 5435 Rill erosion on location

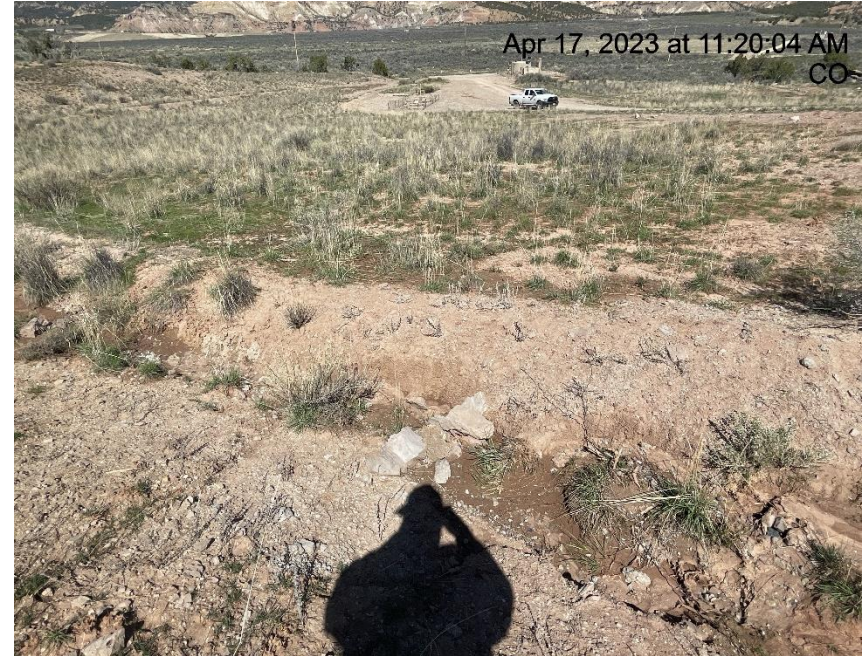
Photo # 5441 Check dams on slope need maintenance (SE side of location)

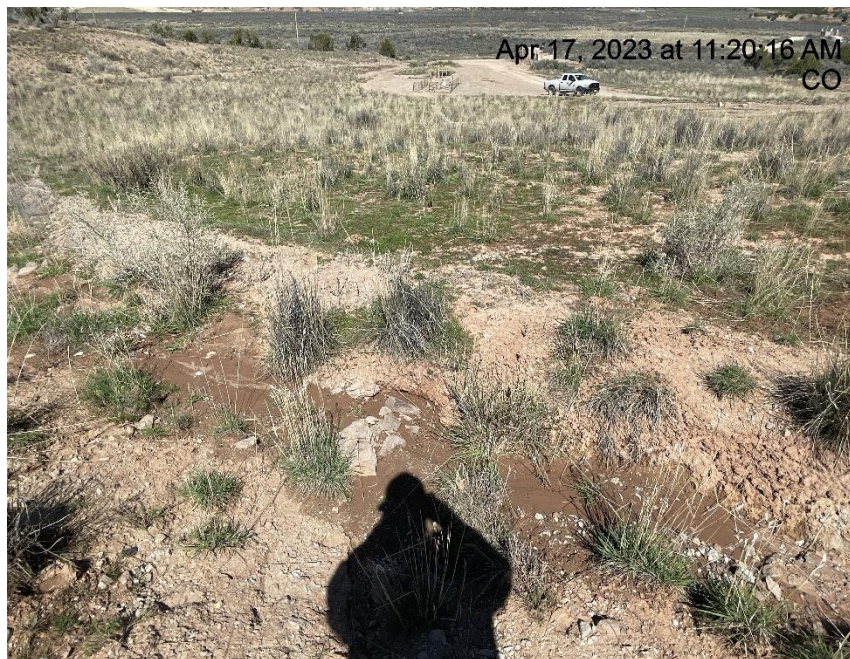
Photo # 5442 Check dams on slope need maintenance (SE side of location)

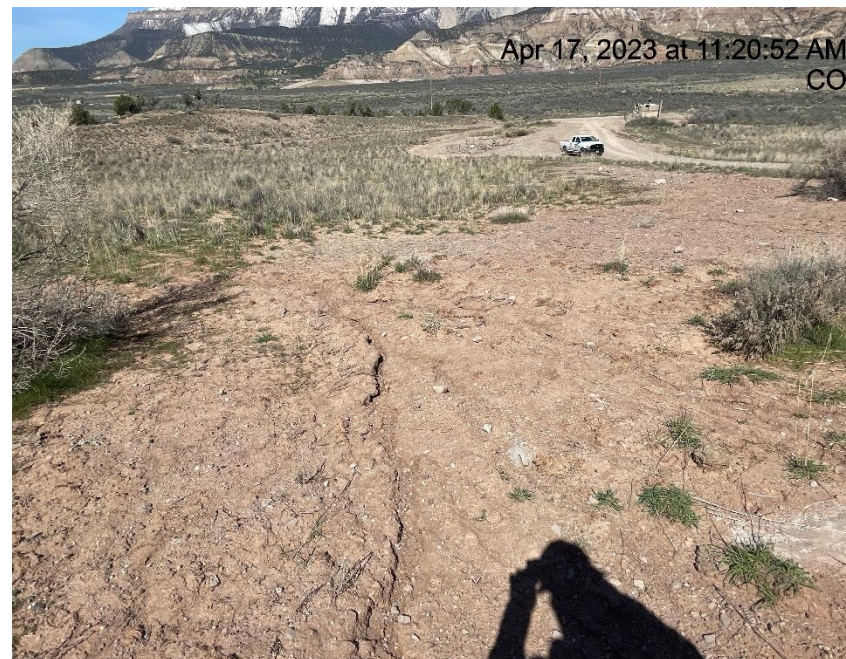
Photo # 5443 Rill erosion/transport of sediment on slope (SE side of location)

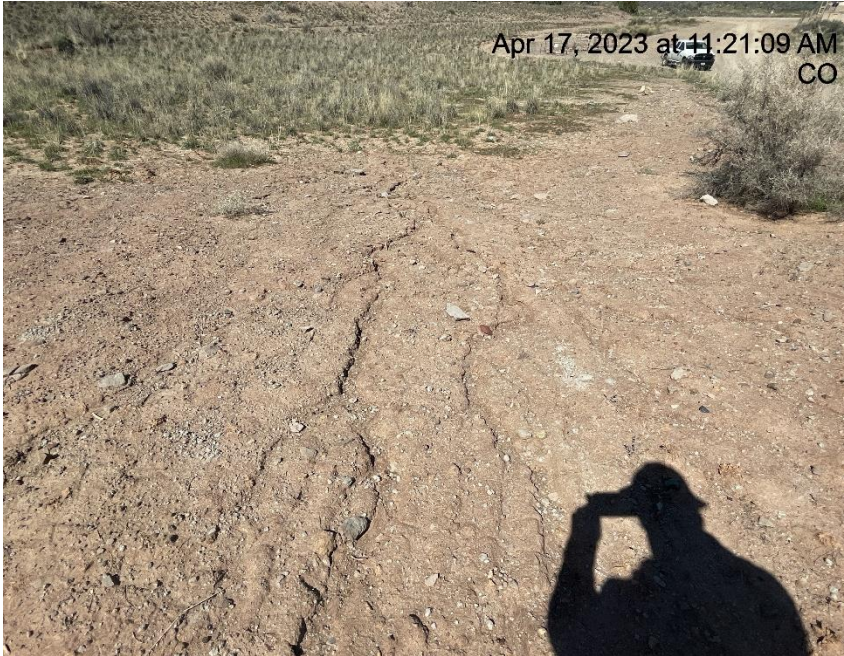
Photo # 5444 Rill erosion/transport of sediment on slope (SE side of location)

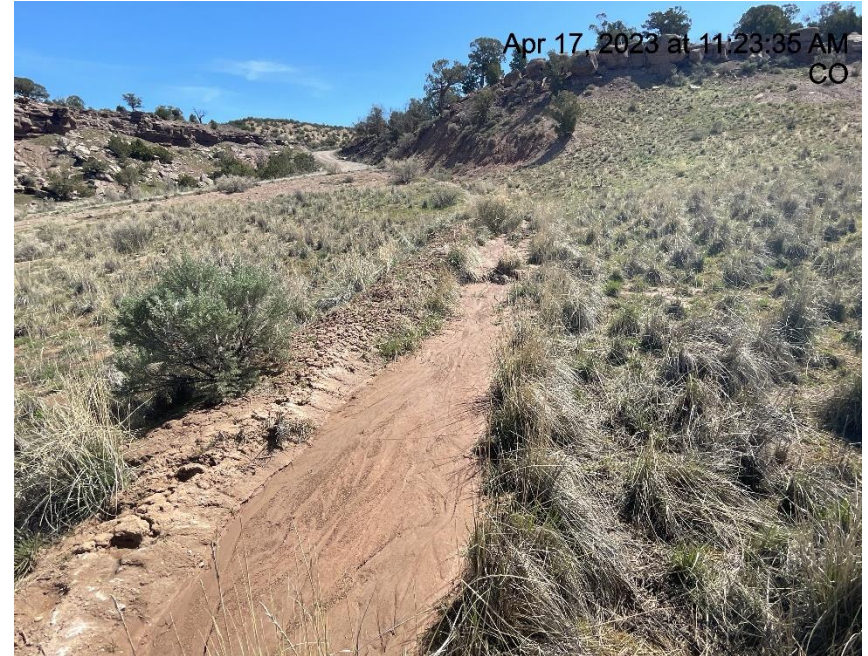
Photo # 5448 Ditch & check dams need maintenance (Southern side of location on slope, ditch runs from the SE side of location to the SW side of location)

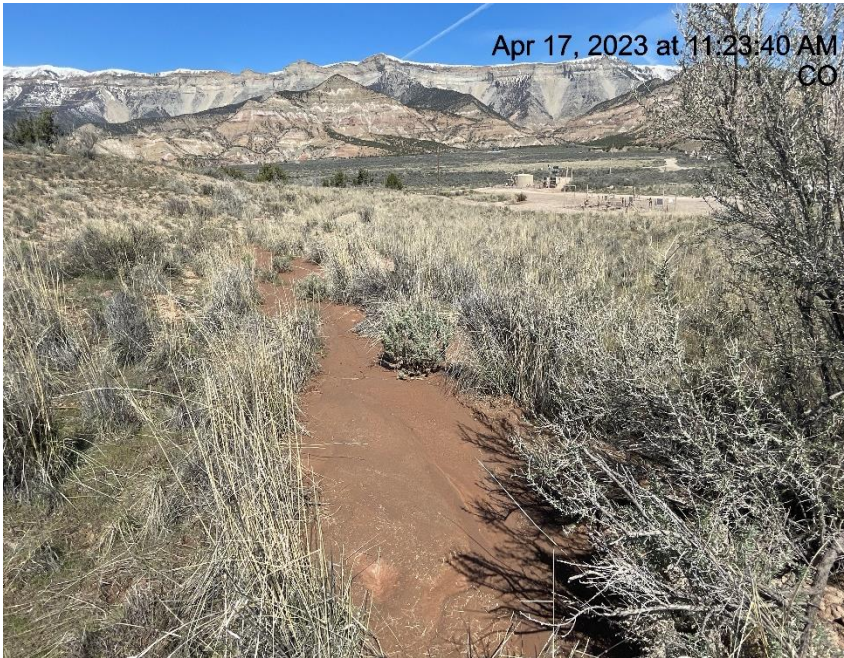
Photo # 5449 Ditch needs maintenance (Southern side of location on slope, ditch runs from the SE side of location to the SW side of location)
