**KT Resources LLC
Ant Hill Unit 36-11 & 36-11BD
Location #336462**

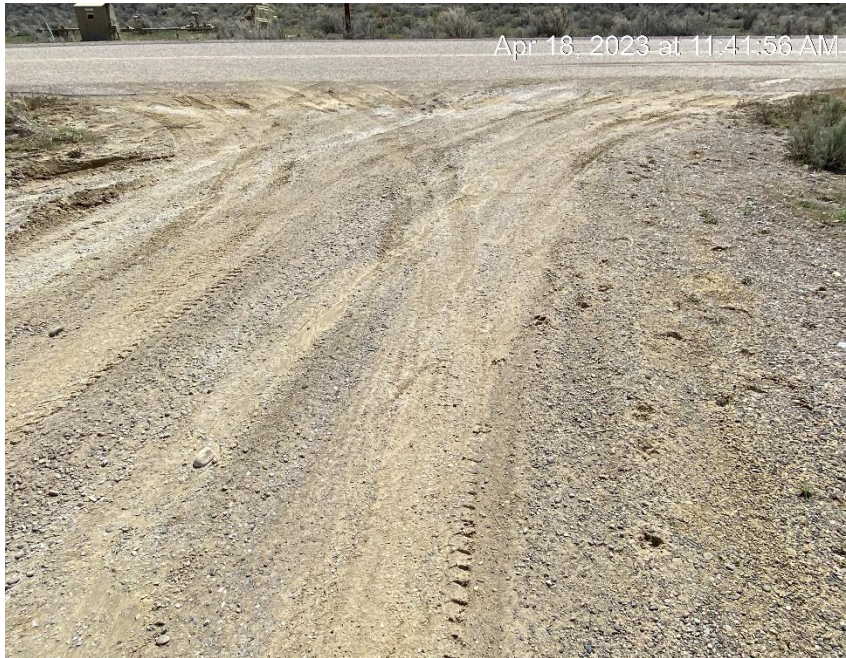
Access road and county road 72

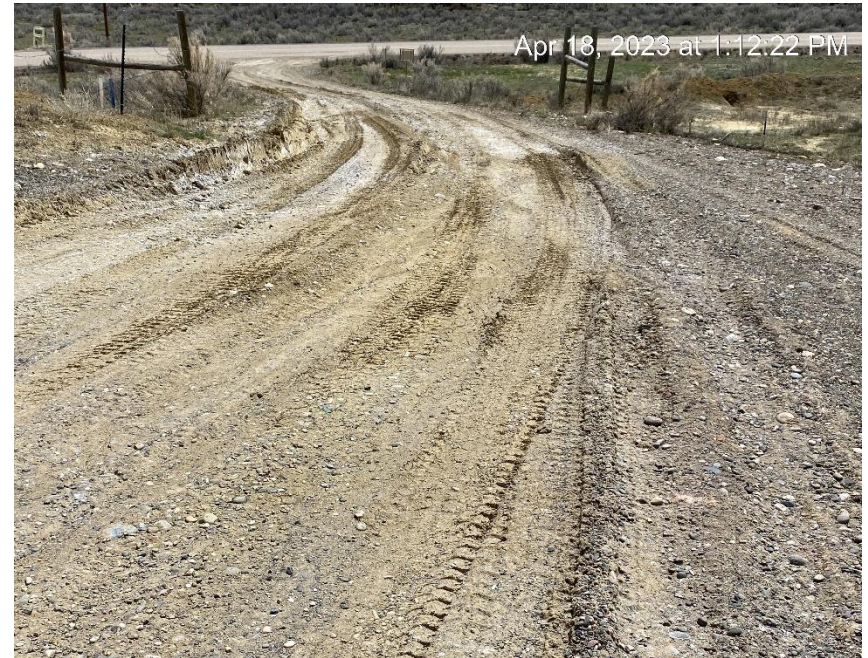
Access road to location

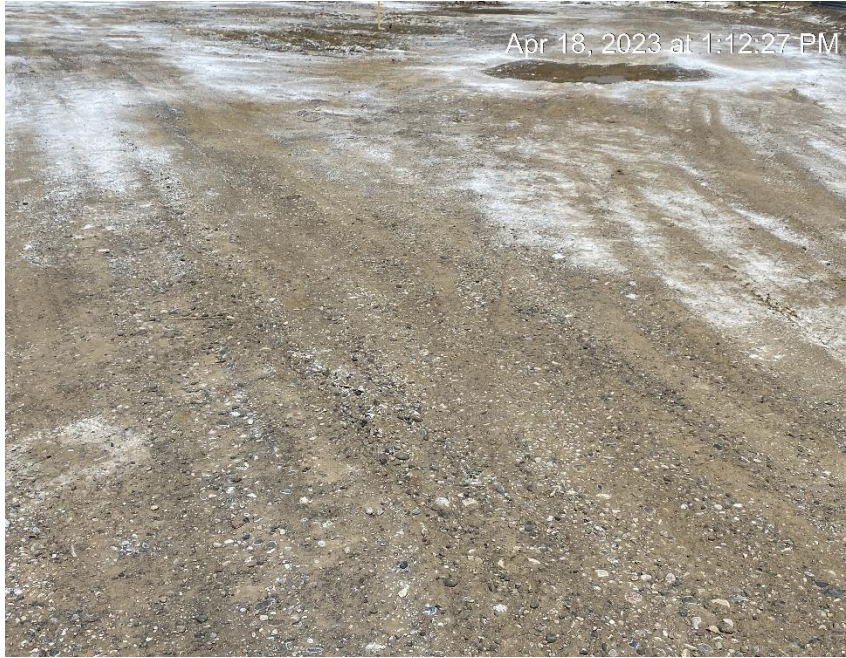
Location entrance

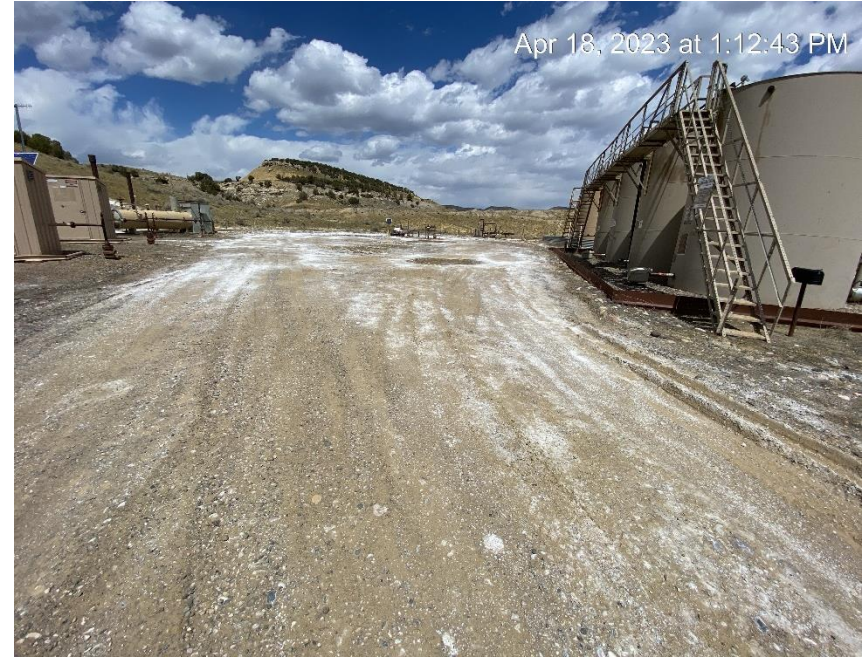
Entrance to location view

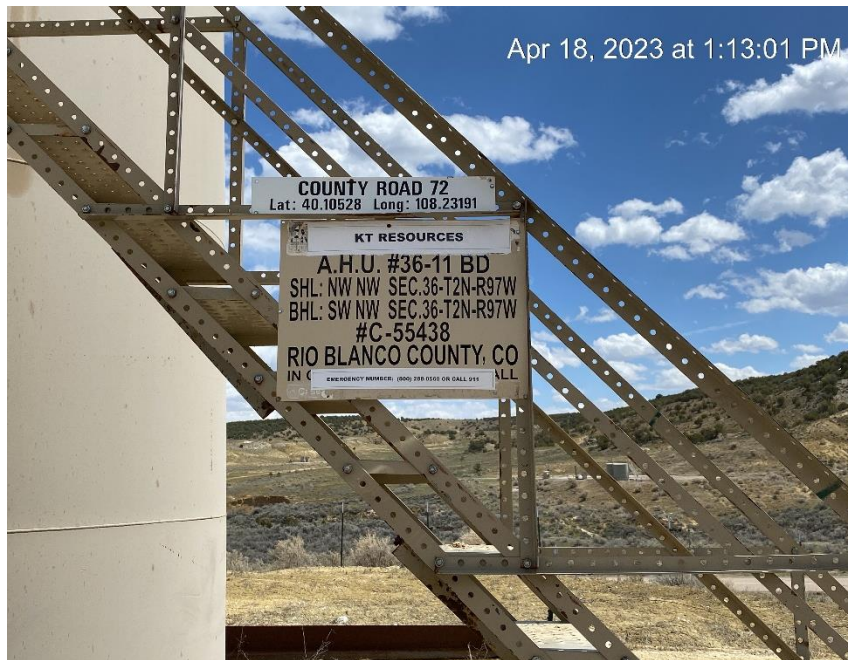
API Number missing from tank battery sign

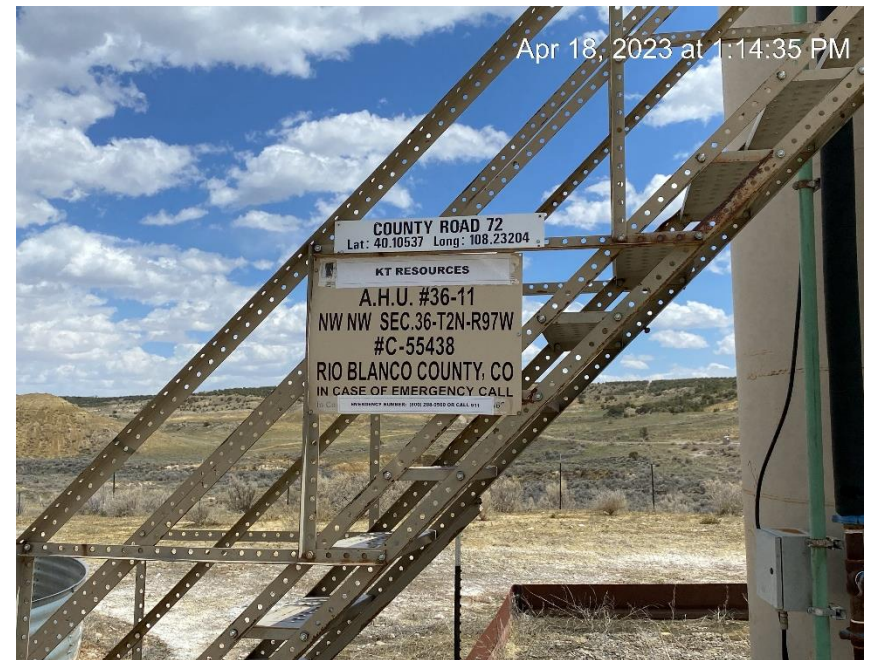
API Number missing from tank battery sign

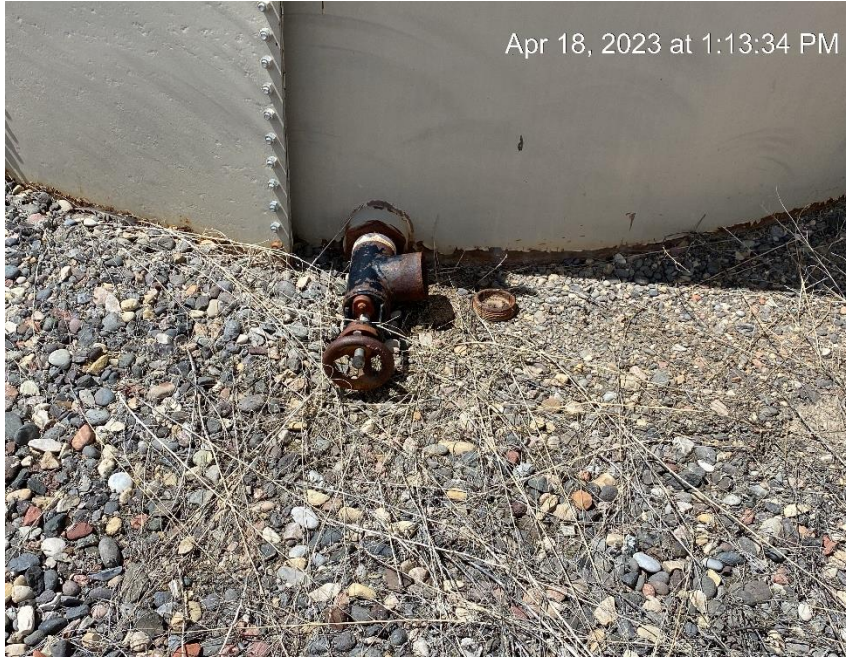
Open end tank valve

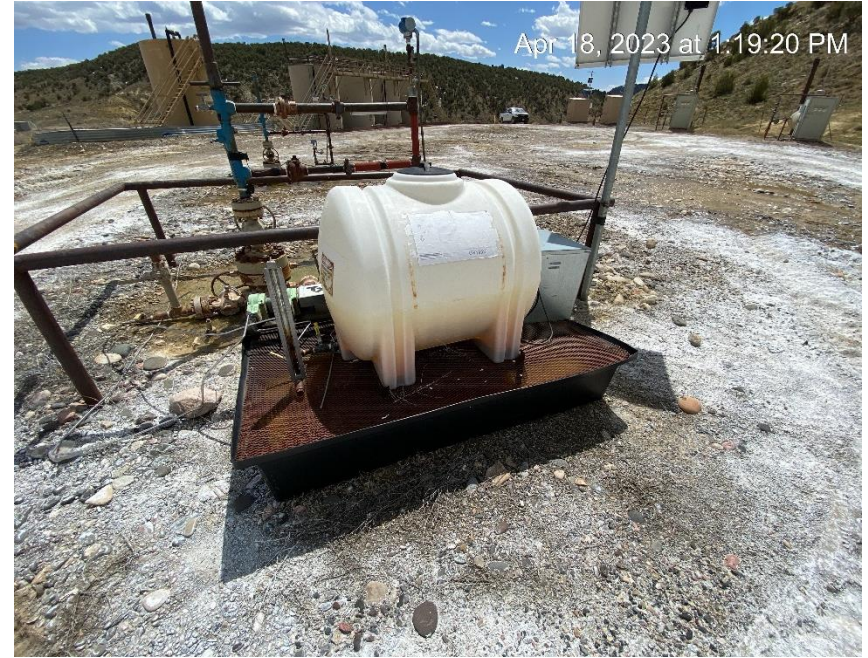
Label fading and illegible

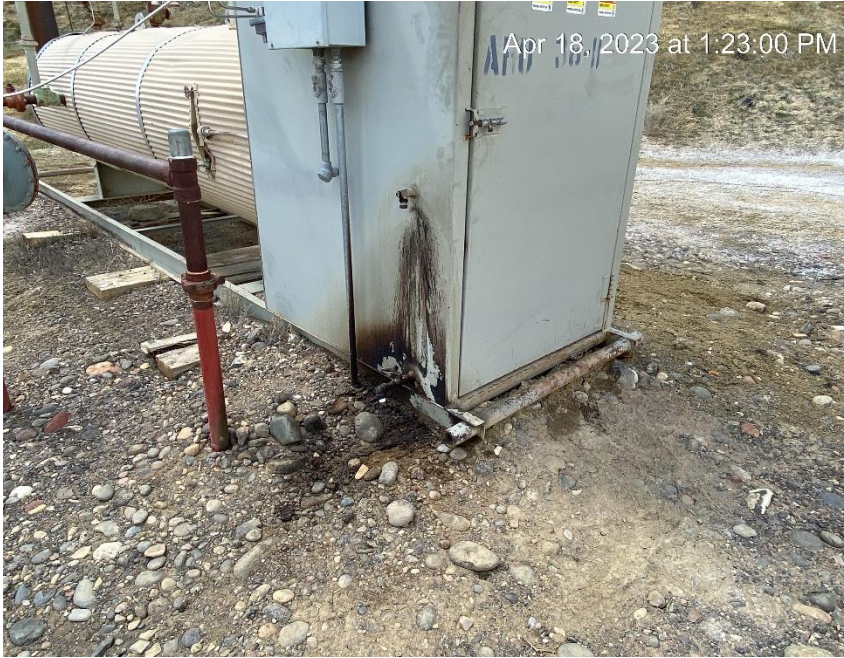
Equipment and soil staining

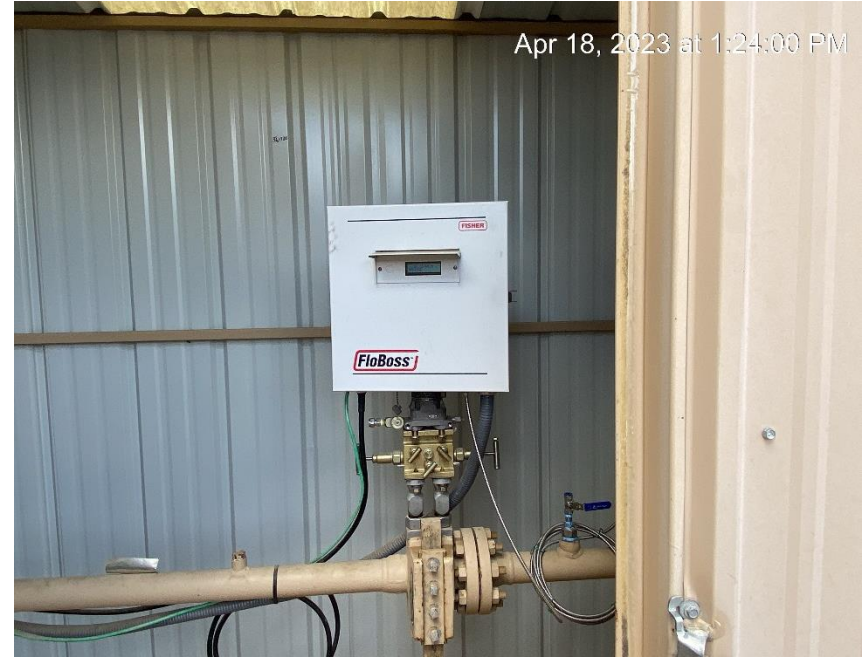
Gas meter calibration cards not visibly displayed

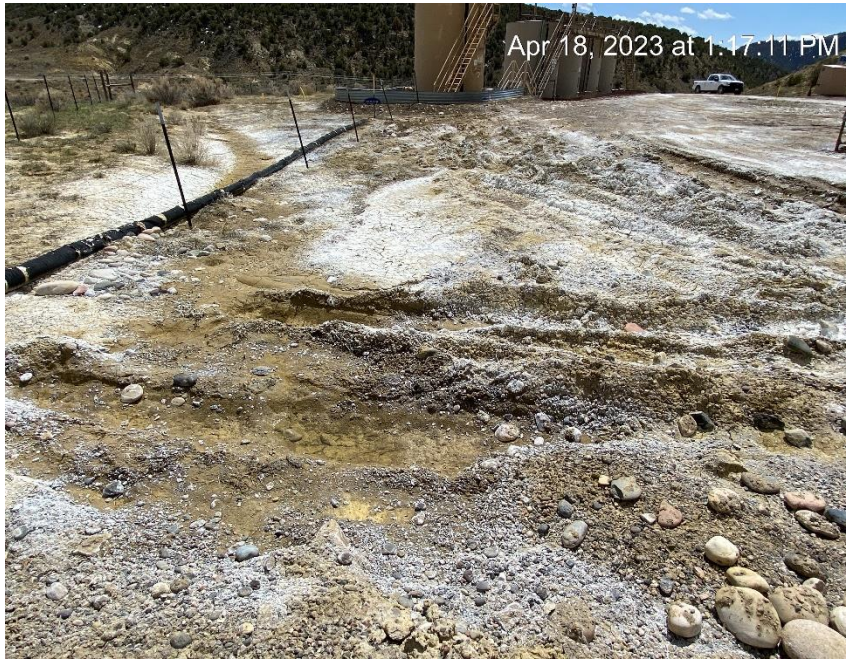
Lack of stabilization and sediment migration

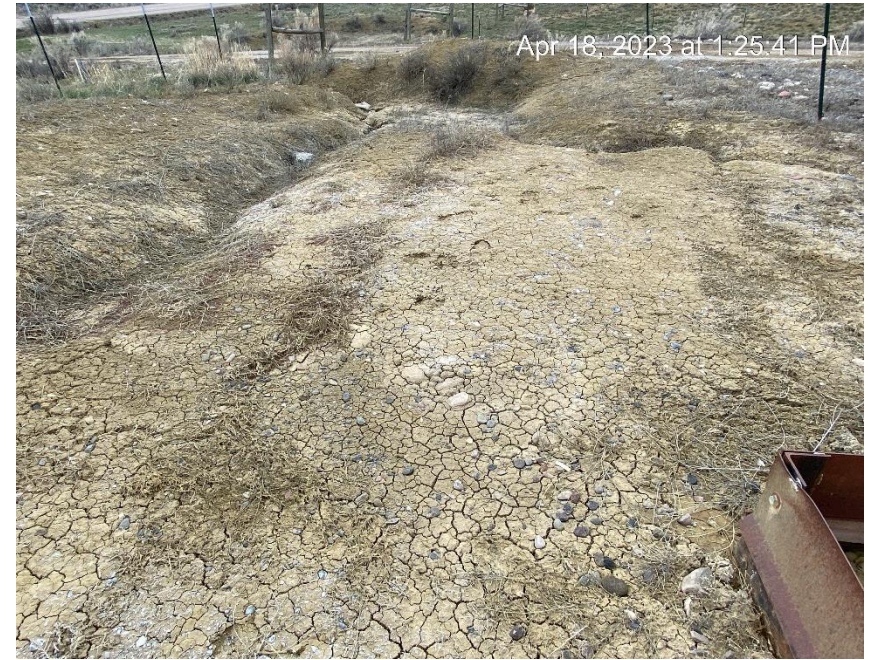
Erosion and sediment migration

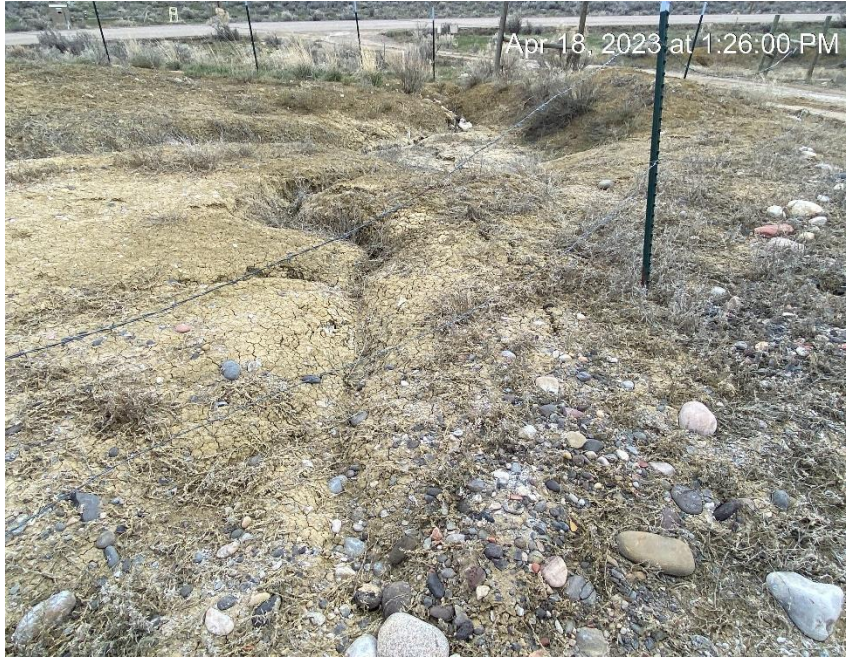
Erosion and sediment migration

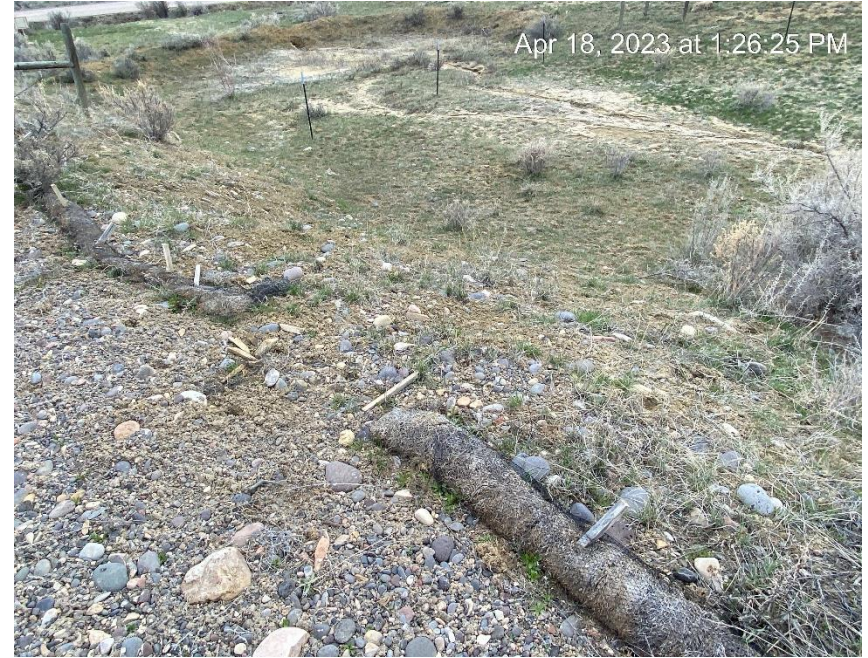
Lack of BMP maintenance
