Inspection Photos

Location Name: TEP ROCKY MOUNTAIN LLC RMV 160-22 Pad

Location ID: 335069

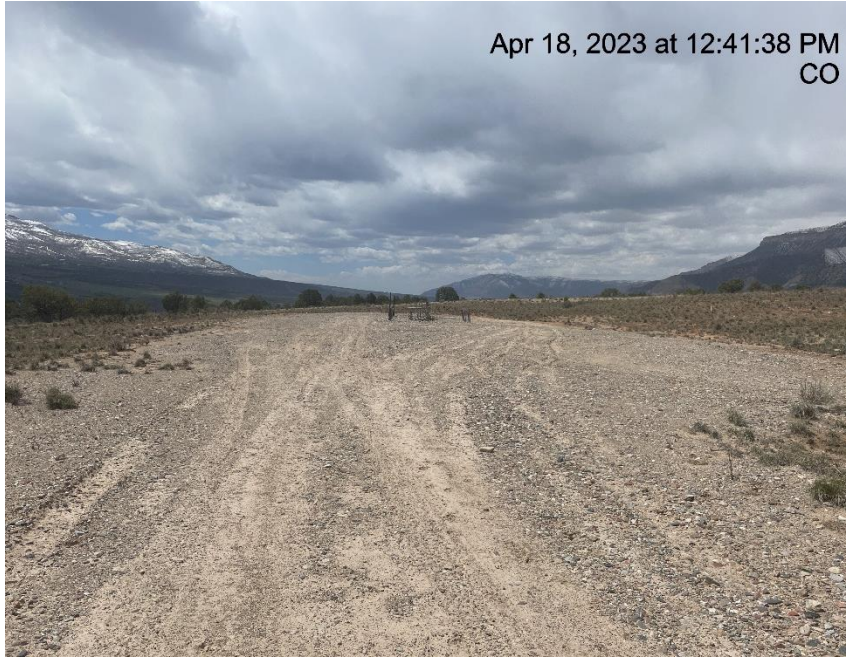
Photo # 5615 From entrance to location

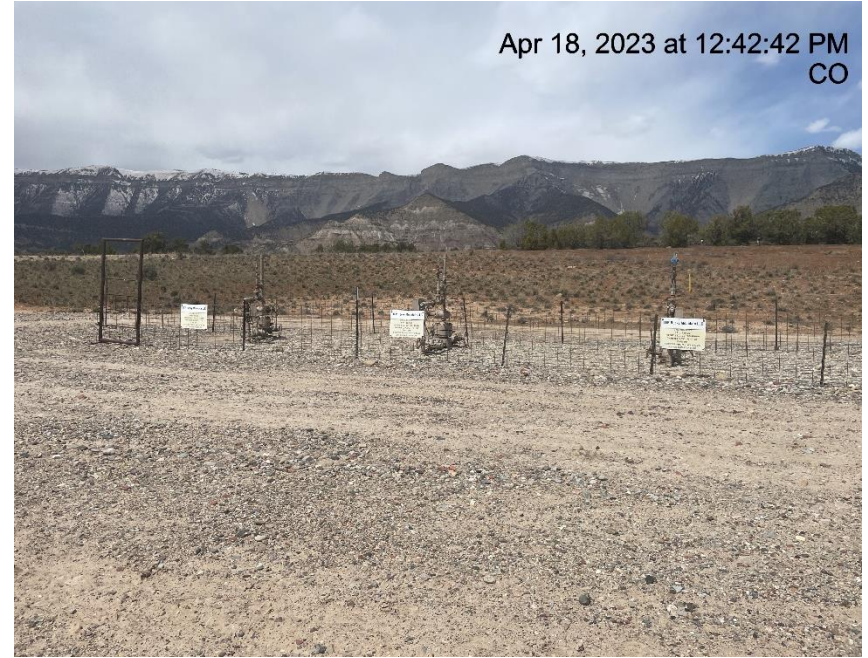
Photo # 5616 Location

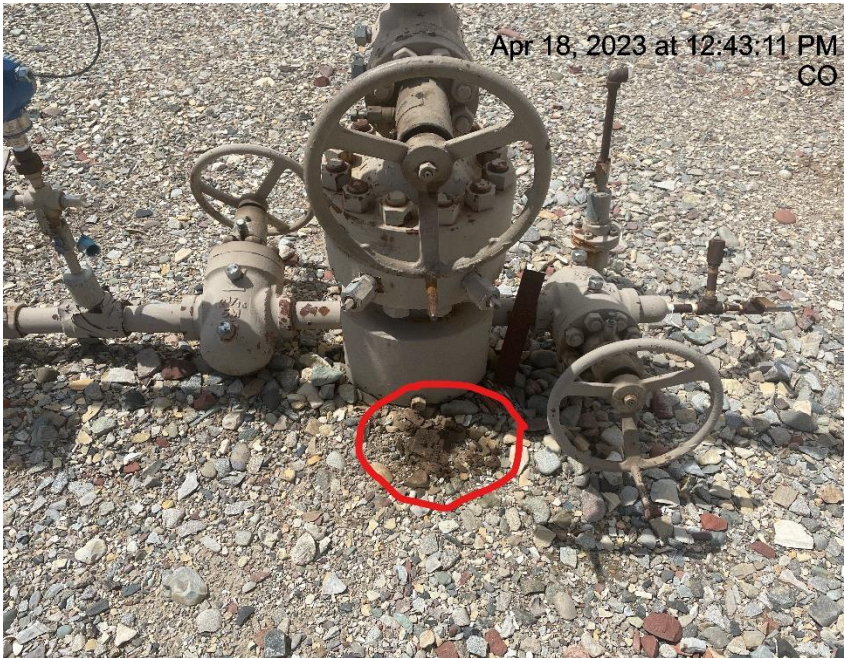
Photo # 5617 Stained soils & gravel

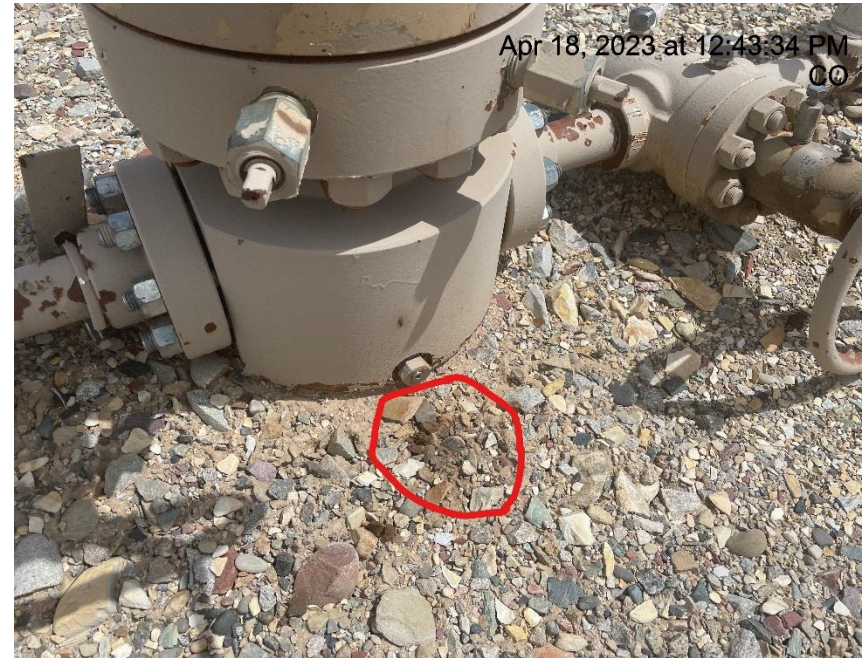
Photo # 5618 Stained soils & gravel

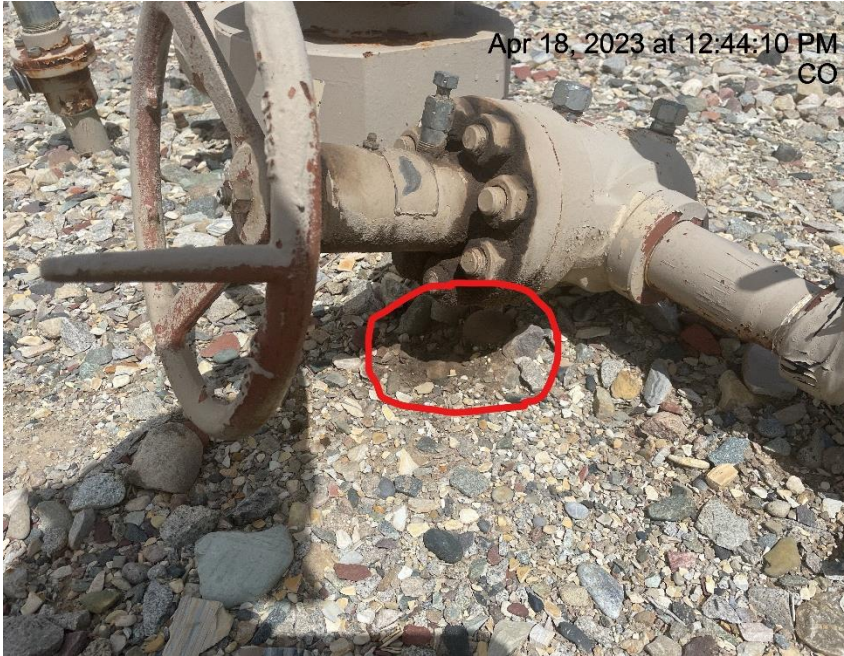
Photo # 5620 Stained soils & gravel

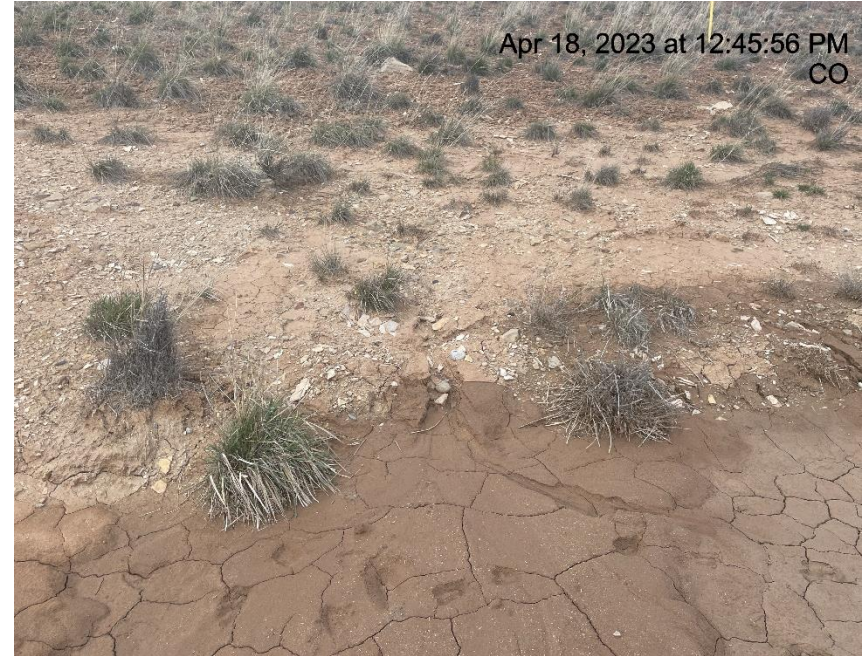
Photo # 5623 Rill erosion & transport of sediment onto location (north side of pad)

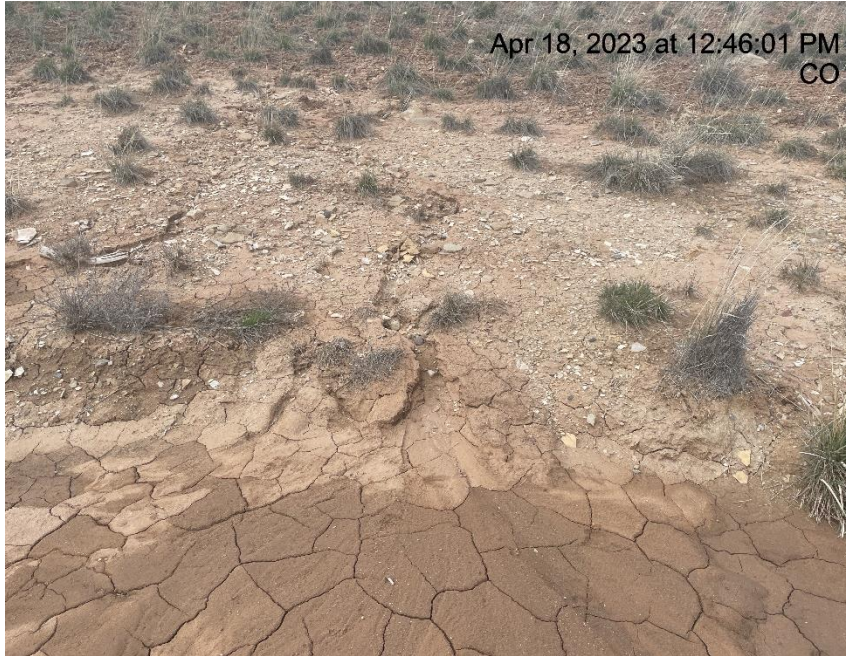
Photo # 5624 Rill erosion & transport of sediment onto location (north side of pad)

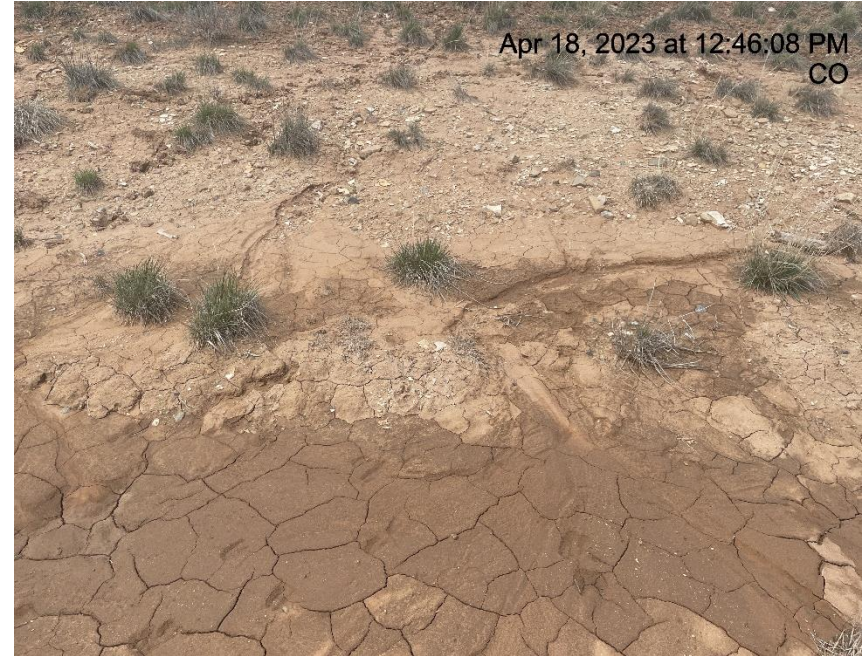
Photo # 5625 Rill erosion & transport of sediment onto location (north side of pad)

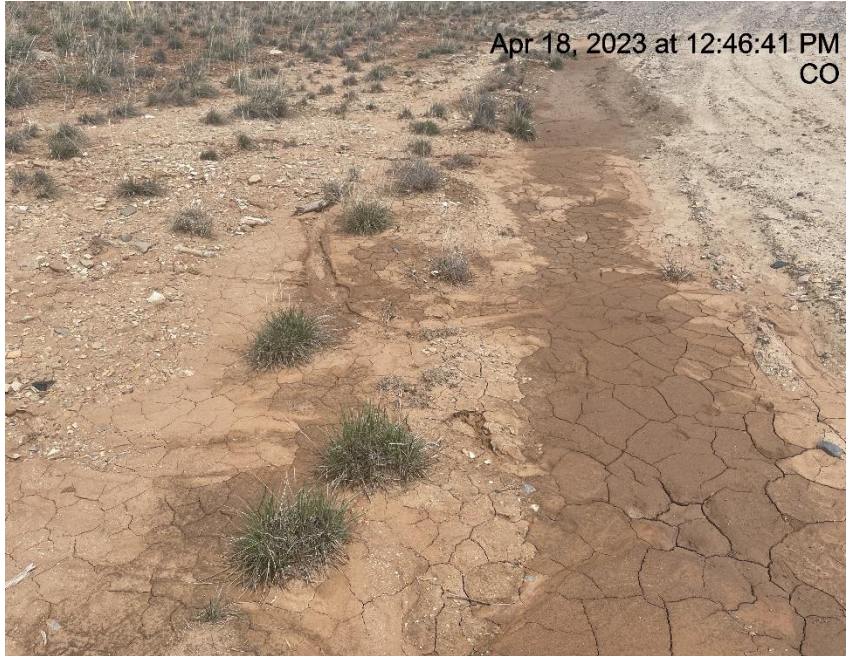
Photo # 5627 Rill erosion & transport of sediment onto location (north side of pad)

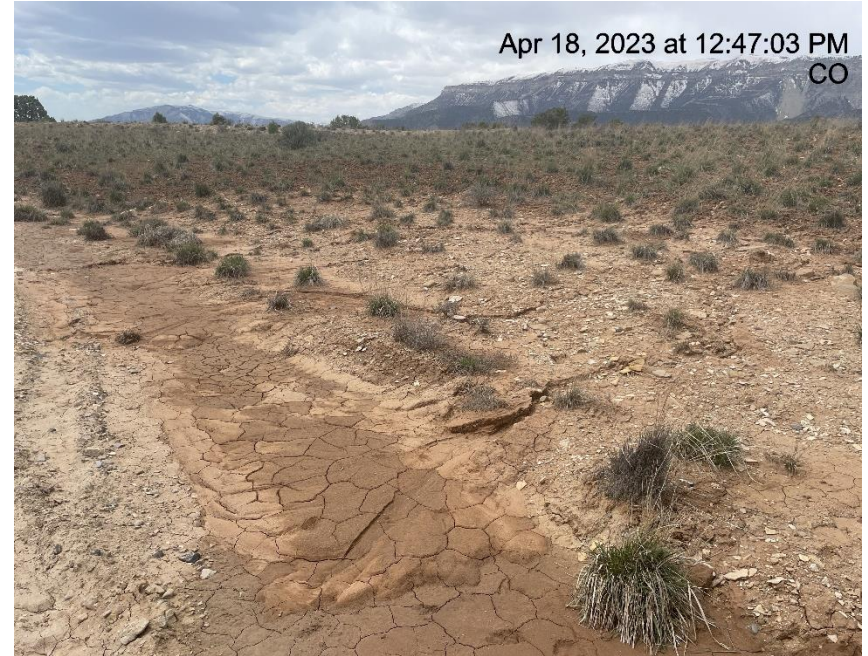
Photo # 5629 Rill erosion & transport of sediment onto location (north side of pad)

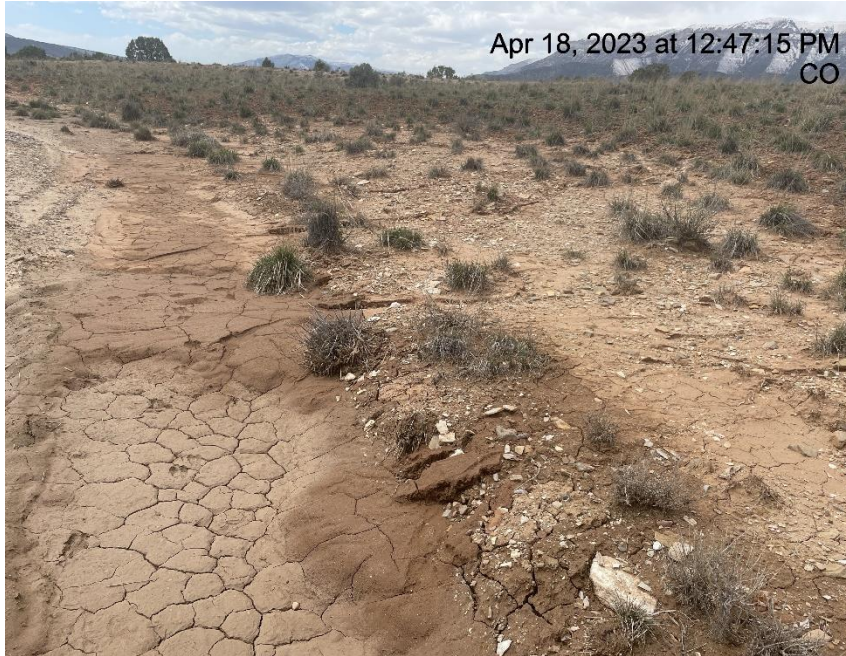
Photo # 5630 Rill erosion & transport of sediment onto location (north side of pad)

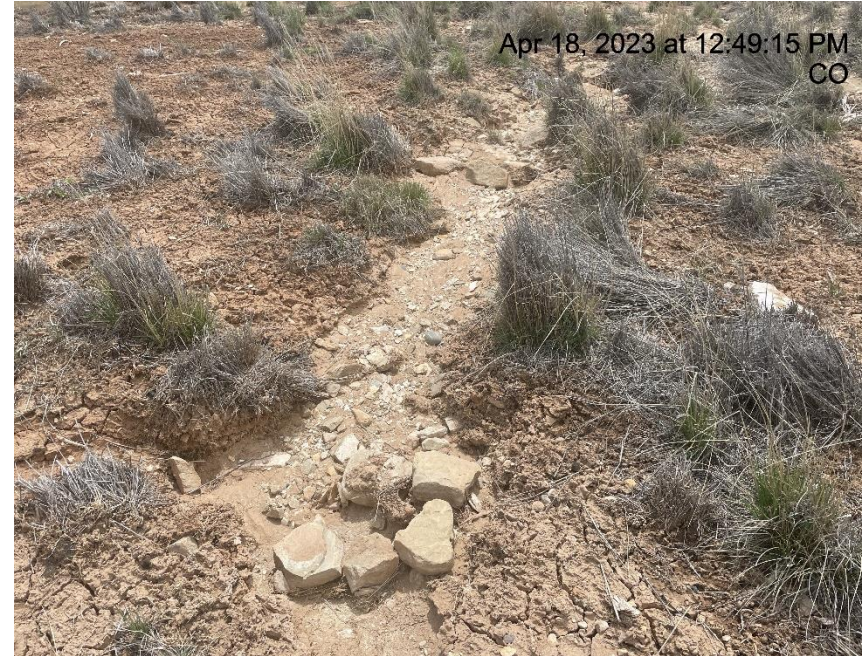
Photo # 5631 Check dams need maintenance (SW area of pad)

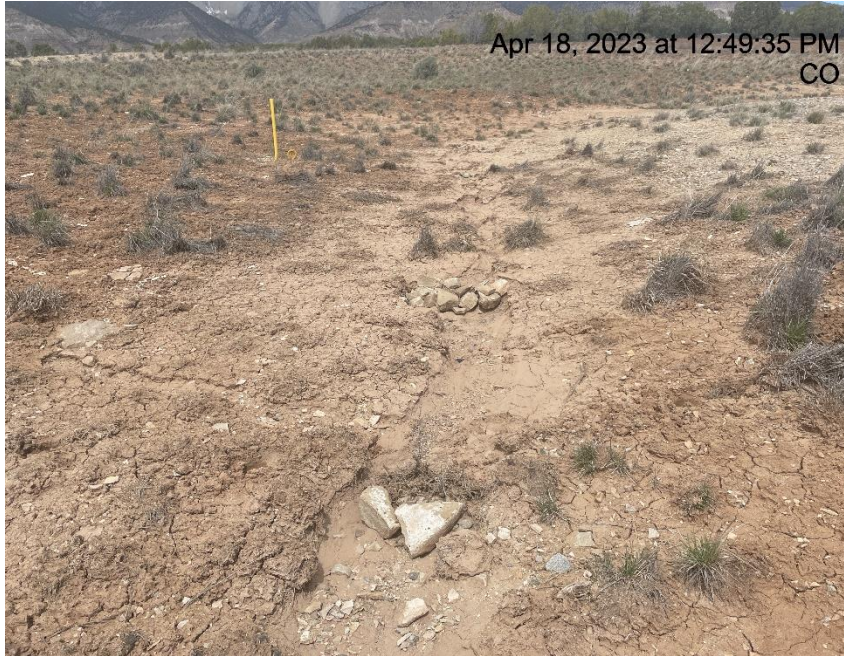
Photo # 5632 Check dams need maintenance (SW area of pad)

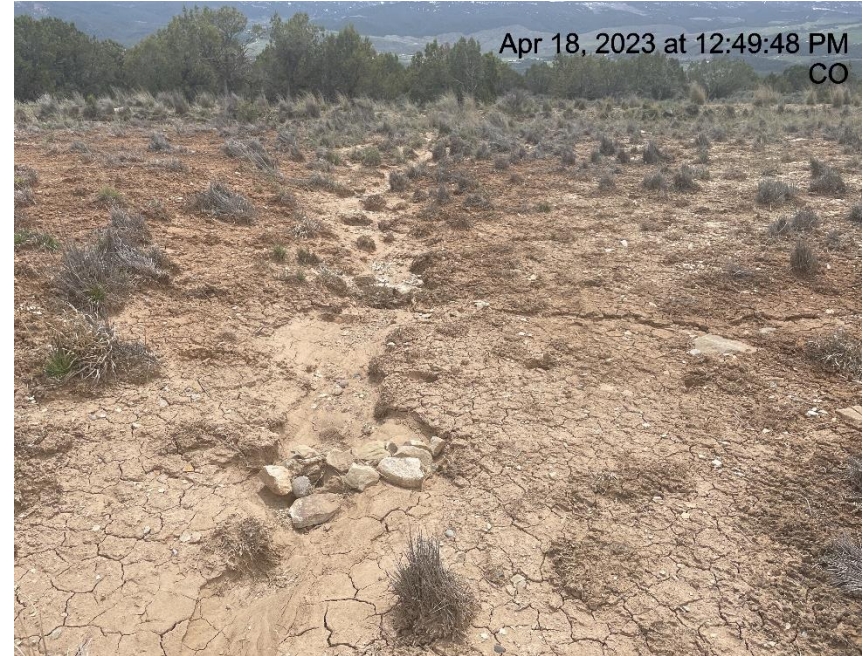
Photo # 5633 Check dams need maintenance (SW area of pad)

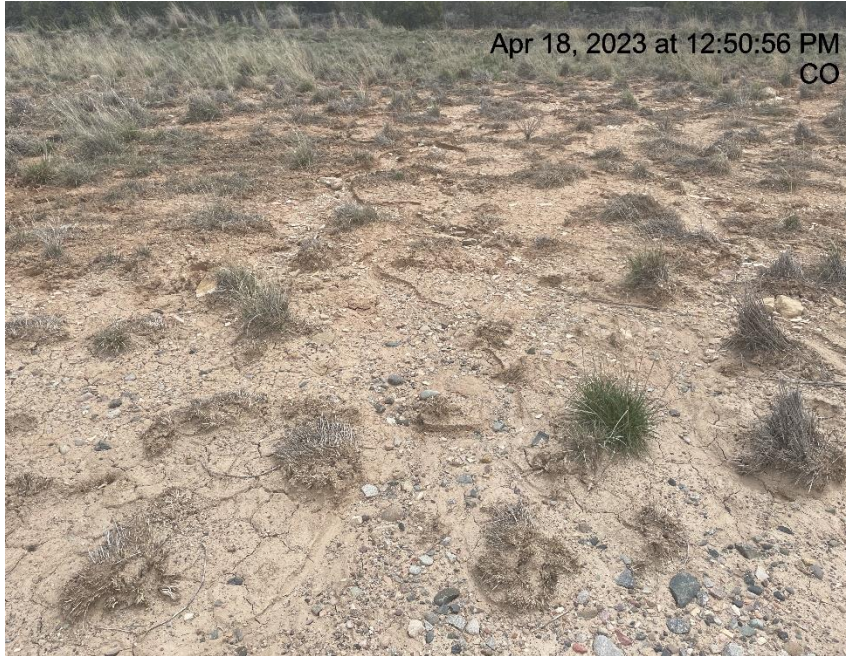
Photo # 5634 Rill erosion on the edge of the pad going into the interim area (south side of pad)

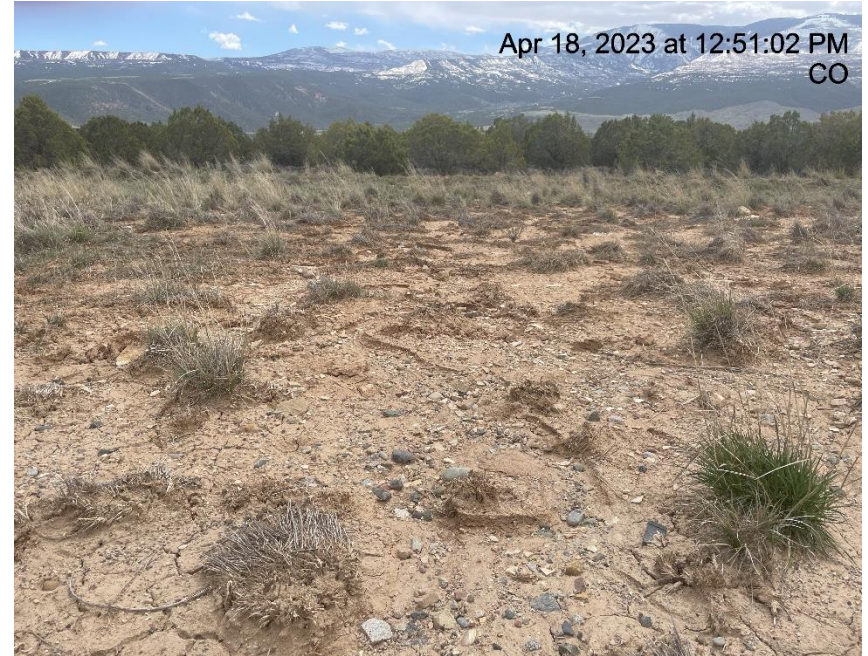
Photo # 5635 Rill erosion on the edge of the pad going into the interim area (south side of pad)

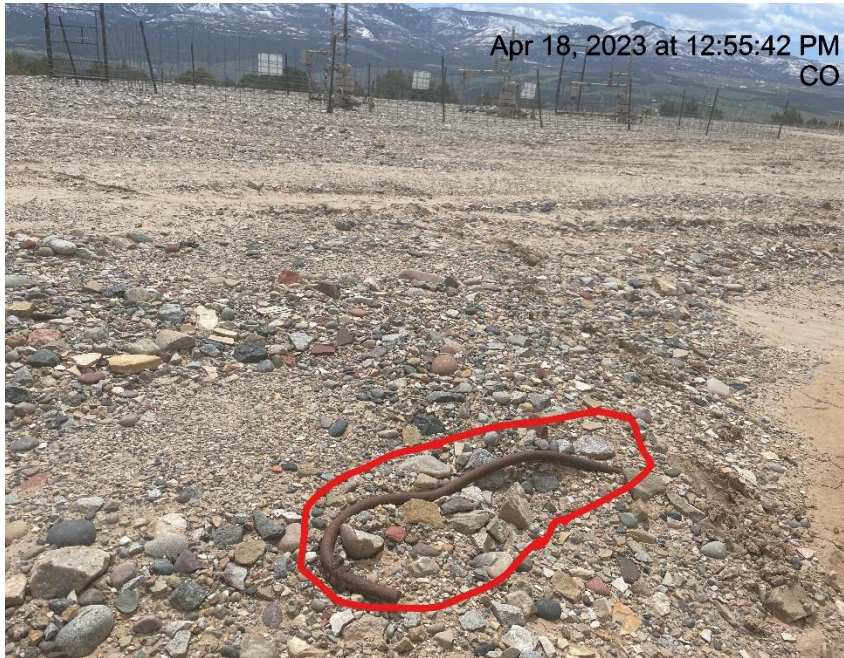
Photo # 5648 Debris
