Inspection Photos

Location Name: TEP ROCKY MOUNTAIN LLC RMV 10-22 Pad

Location ID: 335175

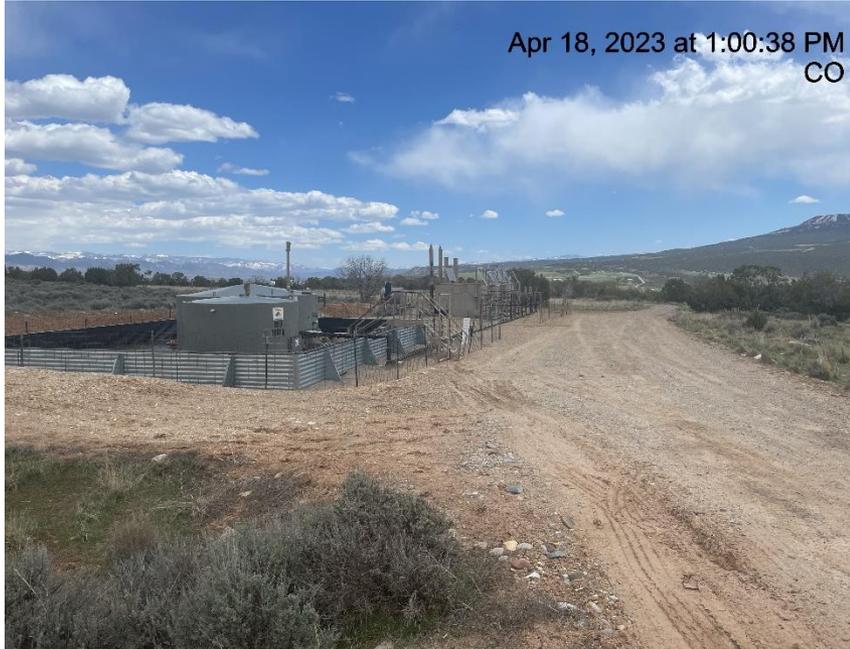
Photo # 5655 From entrance to location

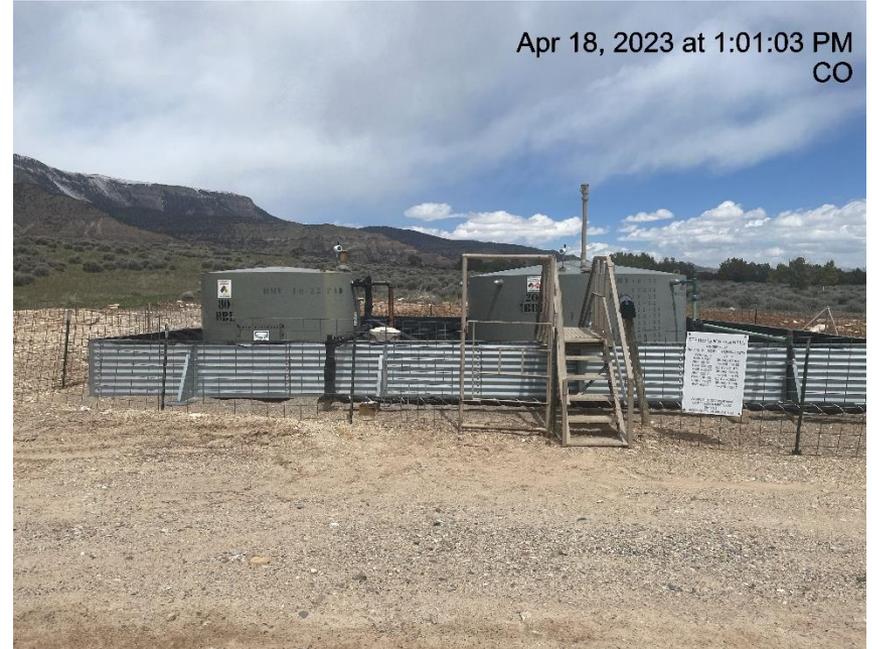
Photo # 5656 Location

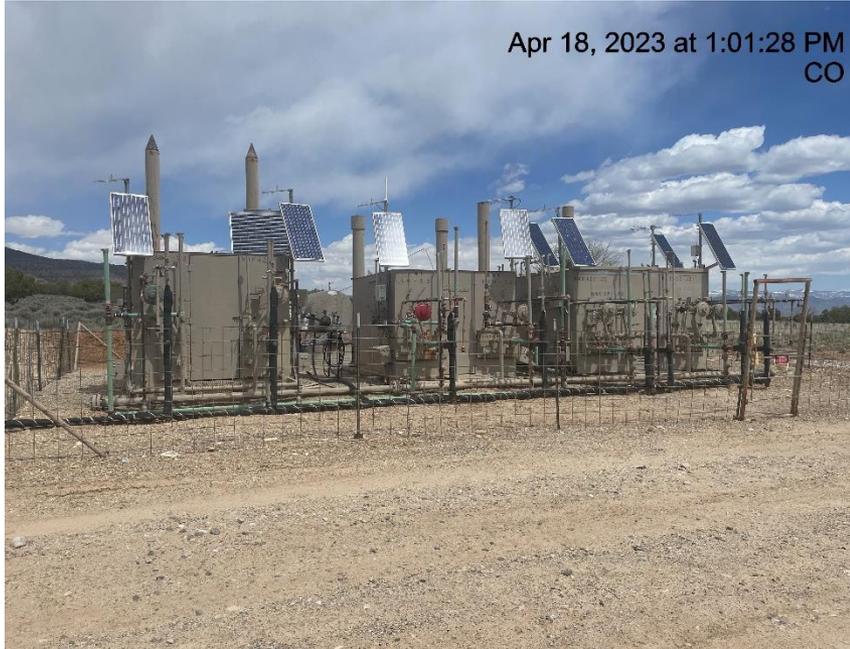
Photo # 5657 Location

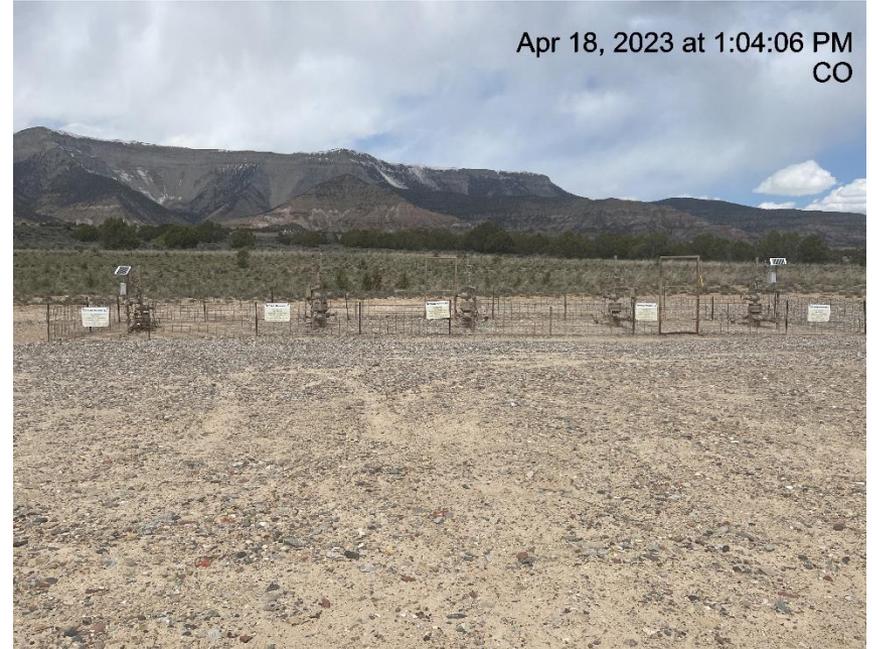
Photo # 5658 Location

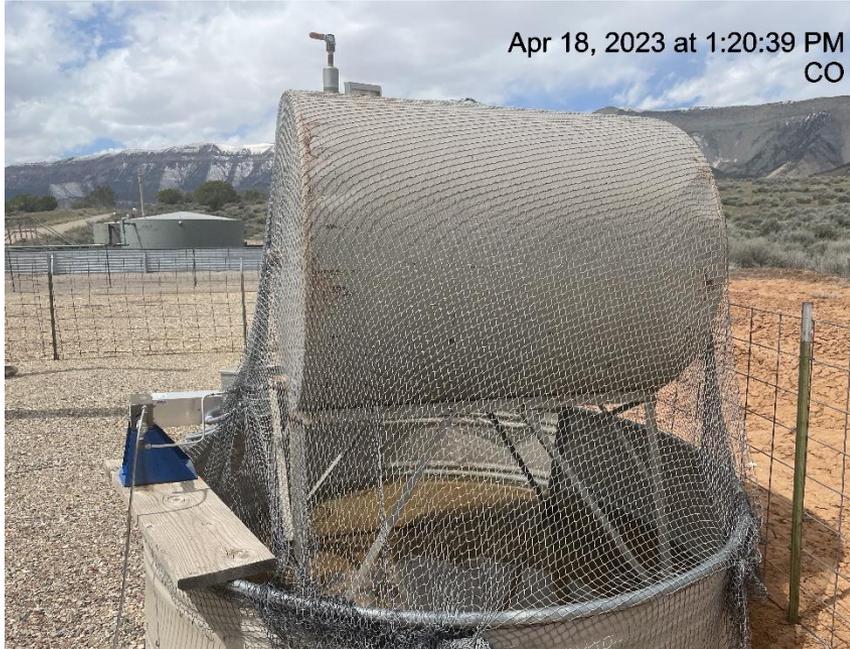
Photo # 5681 Location

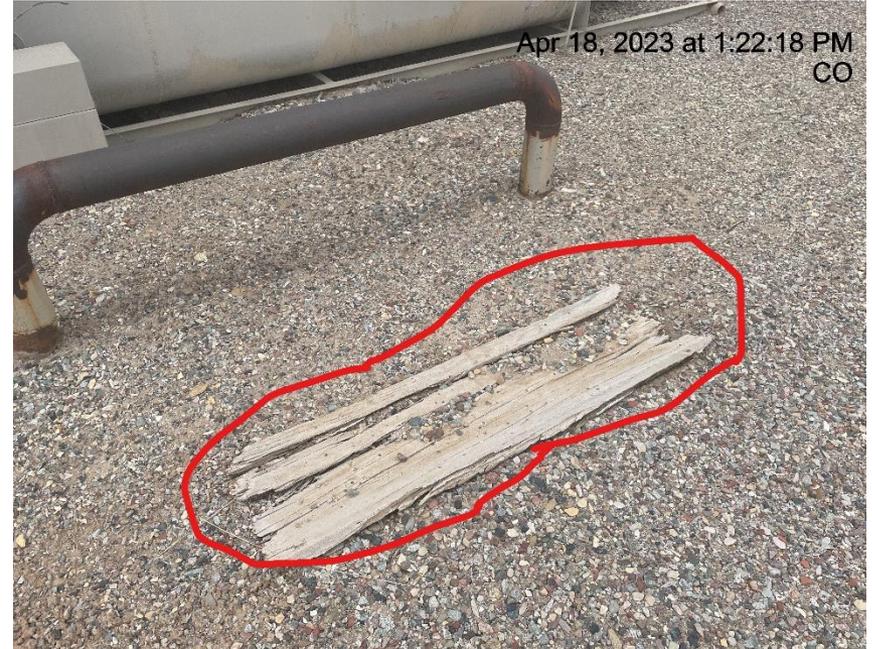
Photo # 5684 Debris

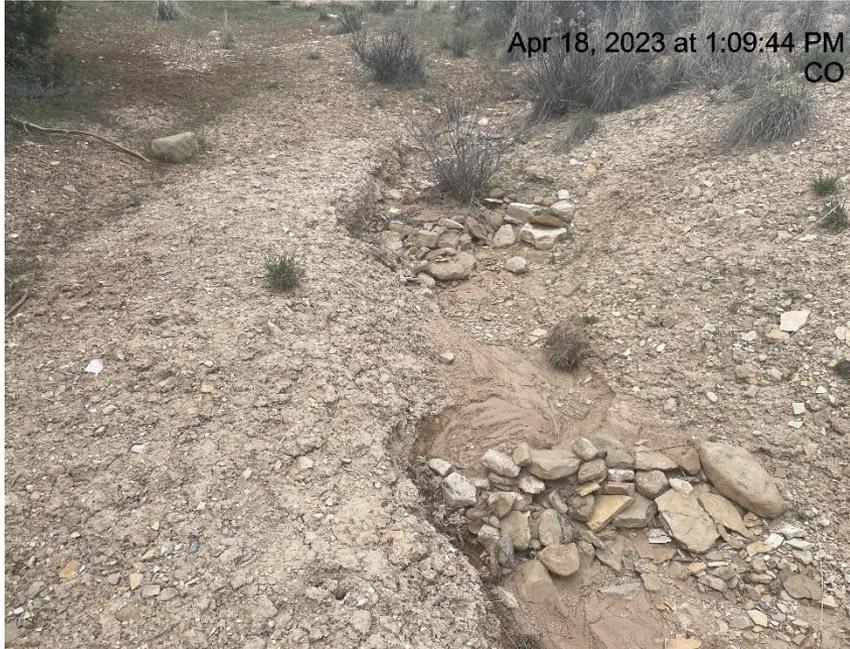
Photo # 5668 Check dams need maintenance (SW corner of lower pad that wellheads are located on)

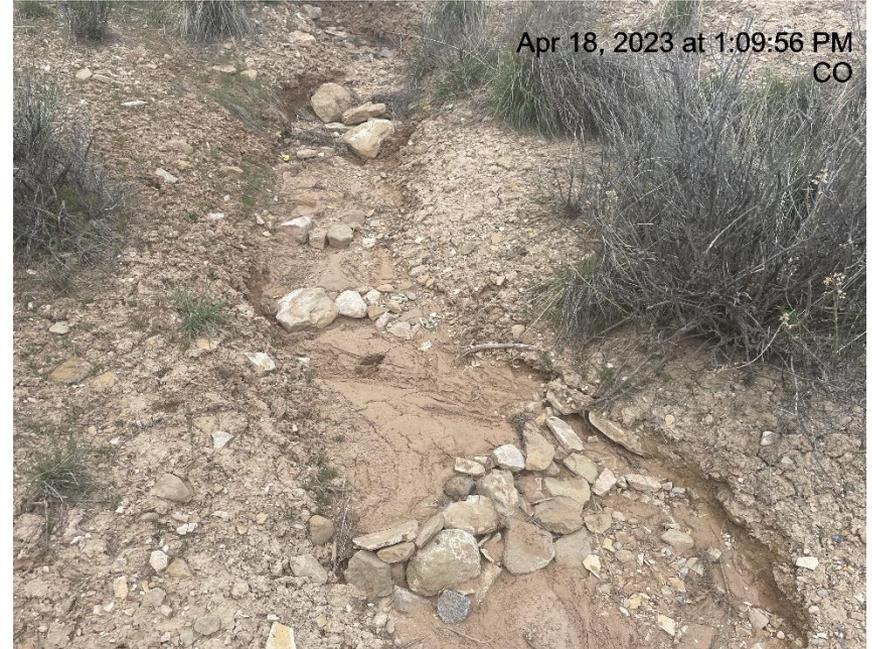
Photo # 5669 Check dams need maintenance (SW corner of lower pad that wellheads are located on)

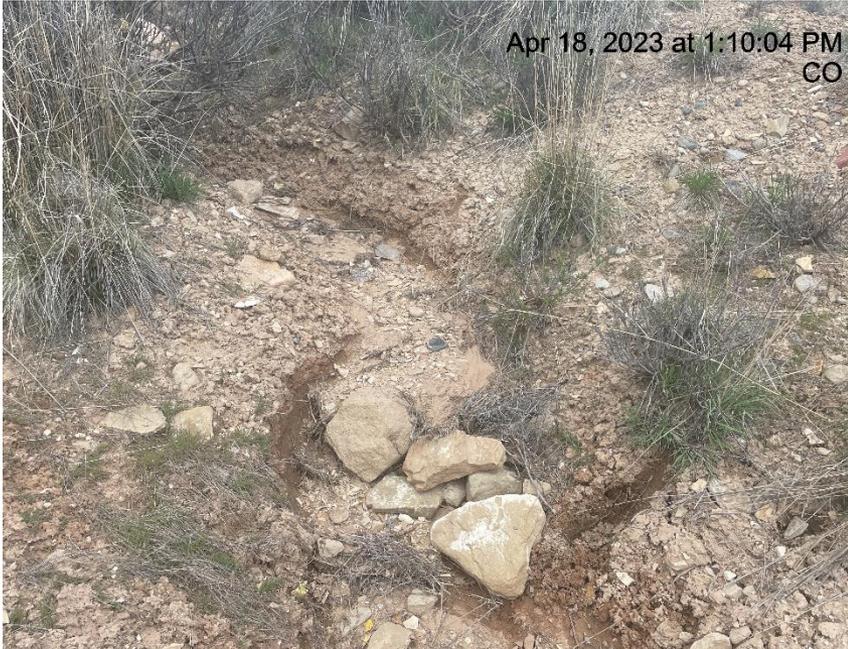
Photo # 5670 Check dam needs maintenance (SW corner of lower pad that wellheads are located on)

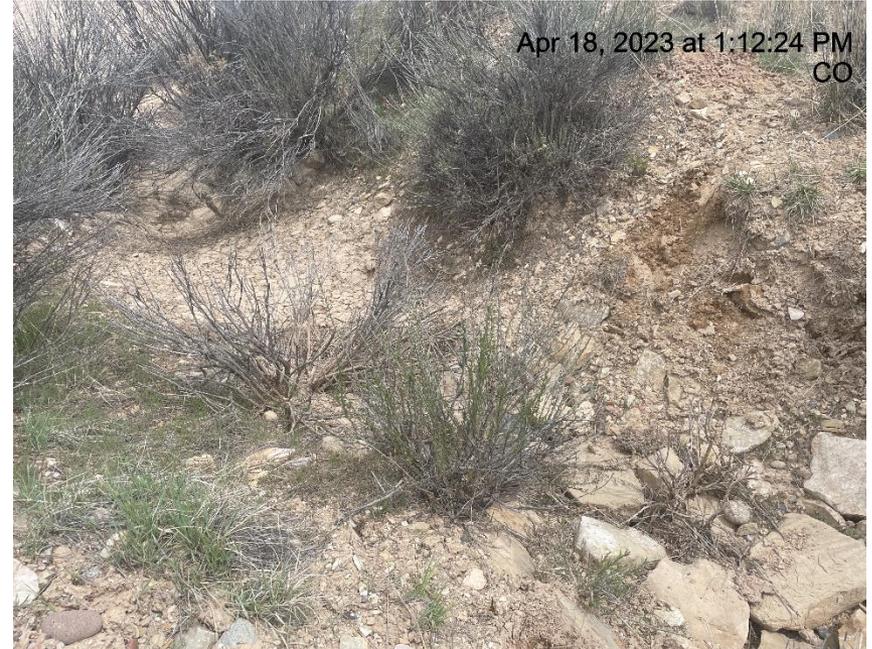
Photo # 5671 Sediment Trap needs maintenance (SW corner of lower pad that wellheads are located on)

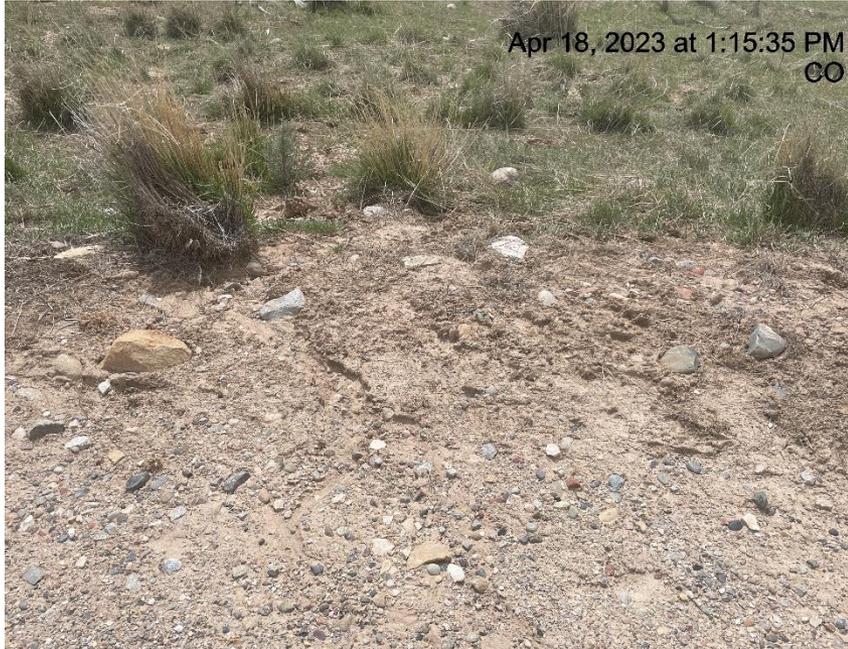
Photo # 5673 Rill erosion & transport of sediment off location (south side of pad)

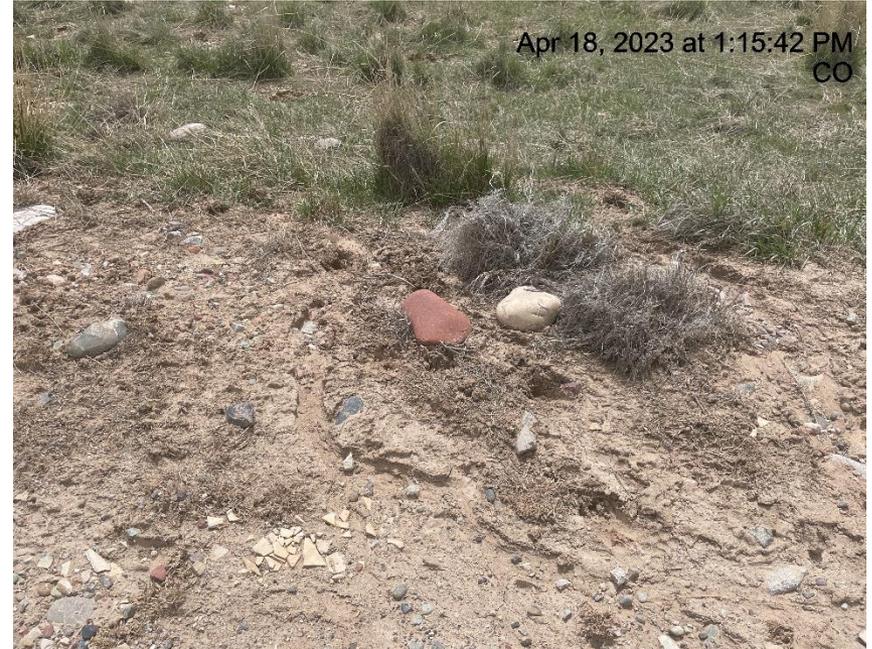
Photo # 5674 Rill erosion & transport of sediment off location (south side of pad)

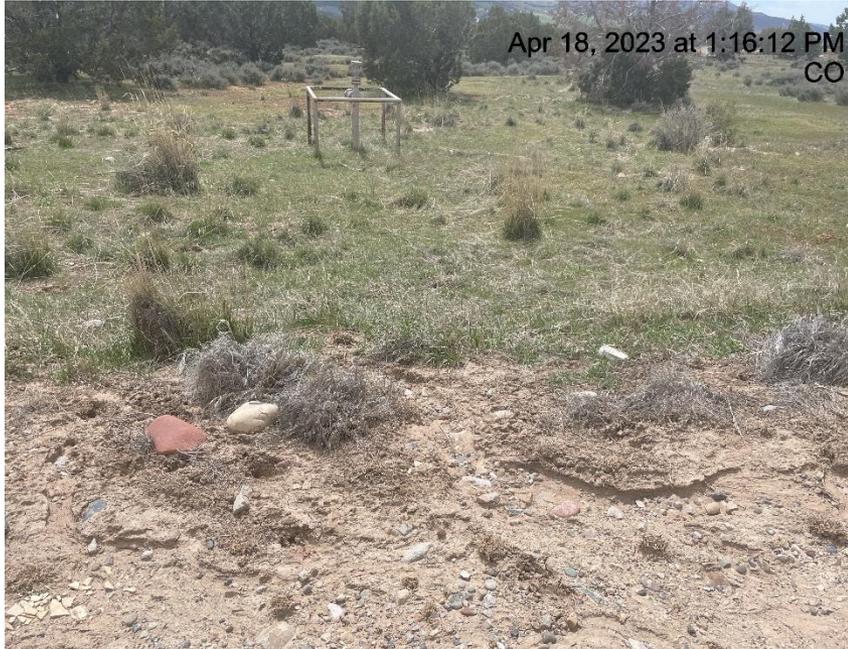
Photo # 5676 Rill erosion & transport of sediment off location (south side of pad)

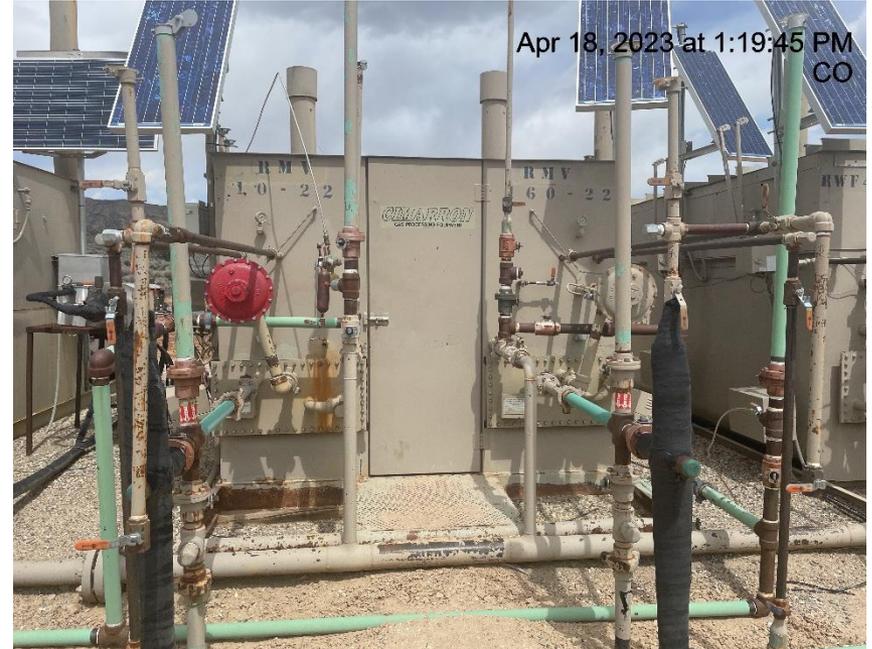
Photo # 5679 Meter calibration info not conspicuously posted

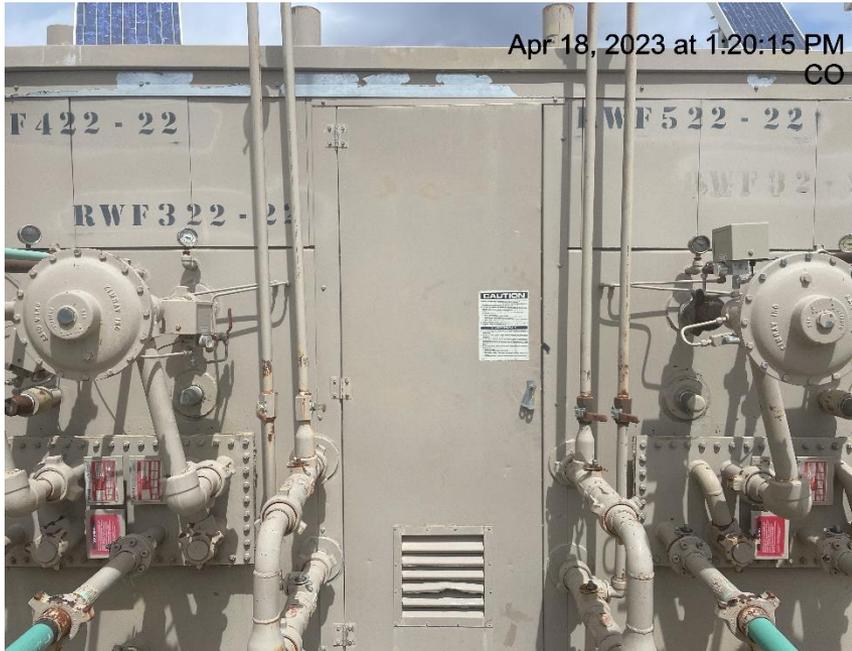
Photo # 5680 Meter calibration info not conspicuously posted

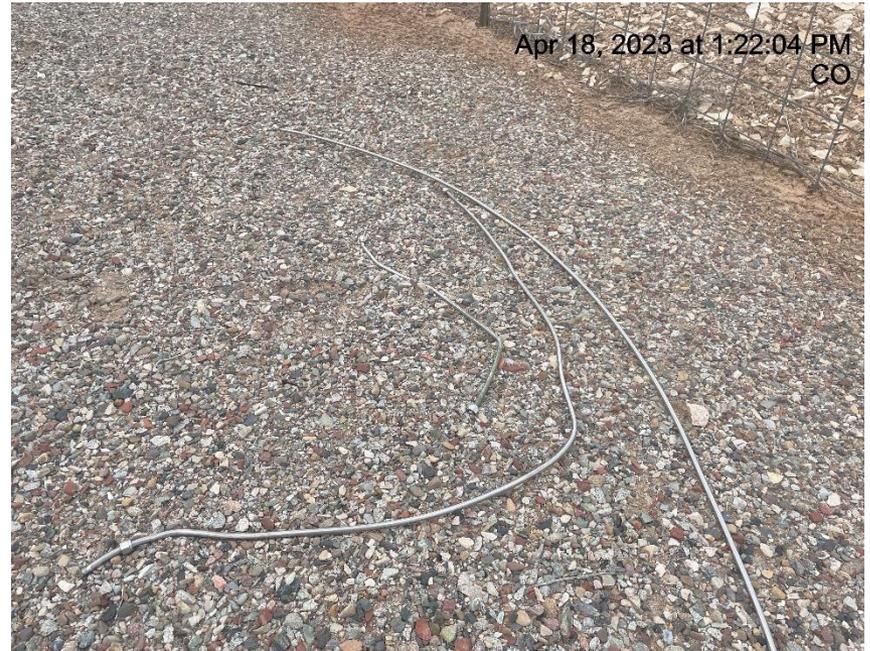
Photo # 5683 Debris
