ESME 24-19

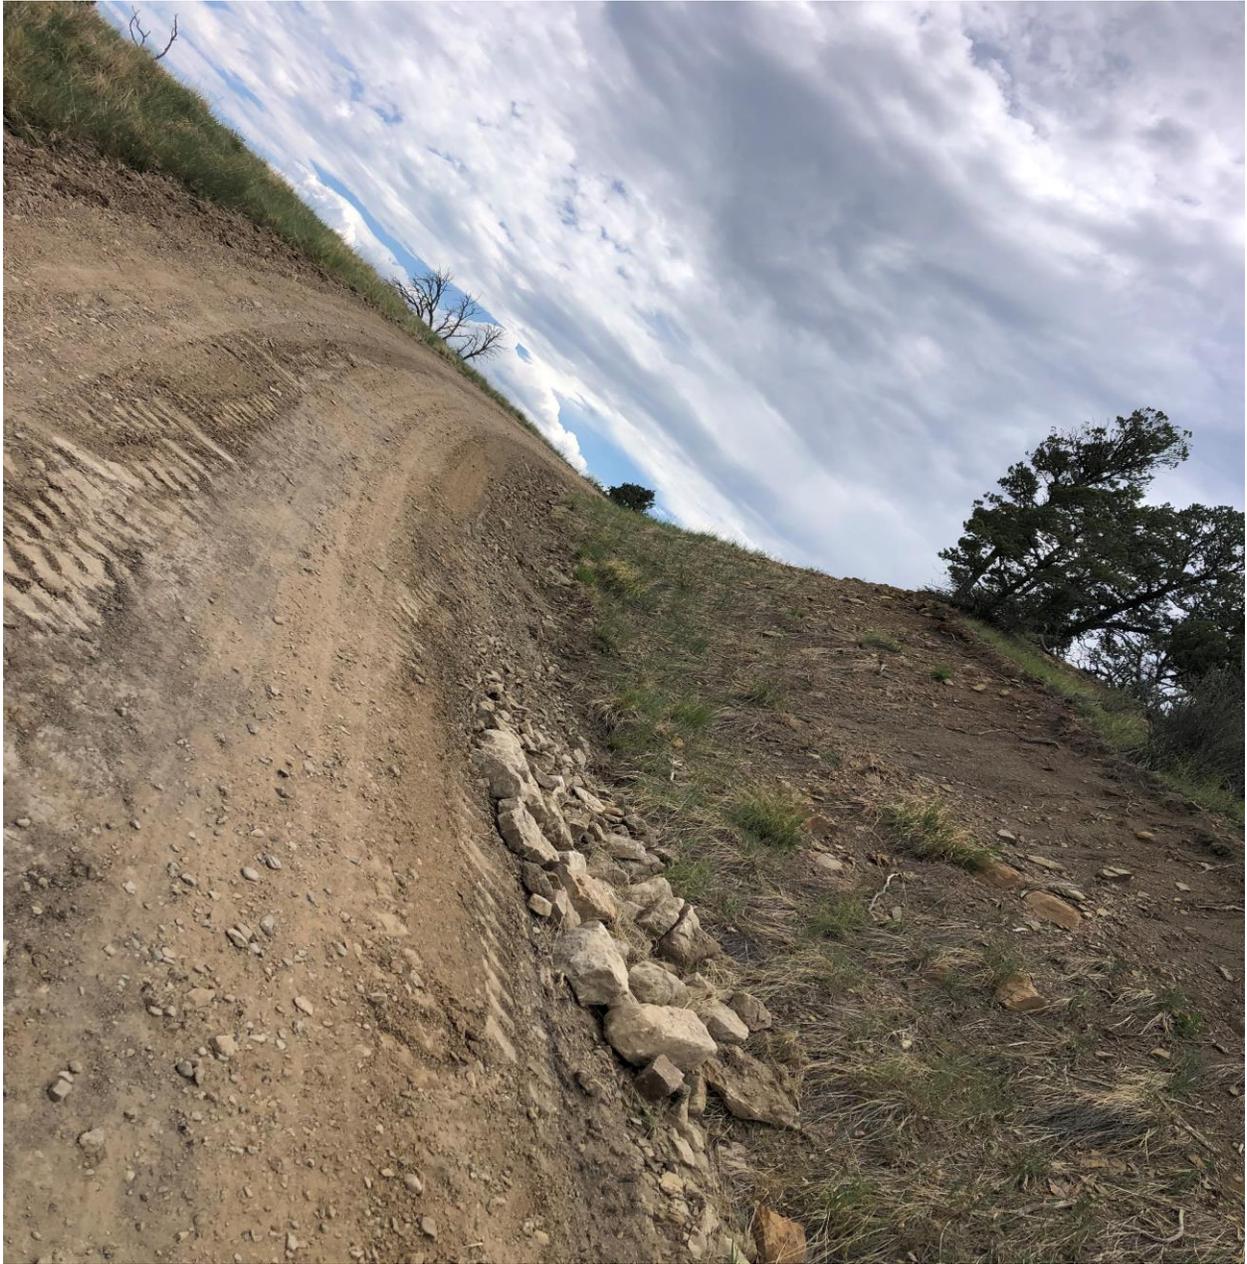
Access road have been recontoured and reclaimed to Comply with 1004 Rules

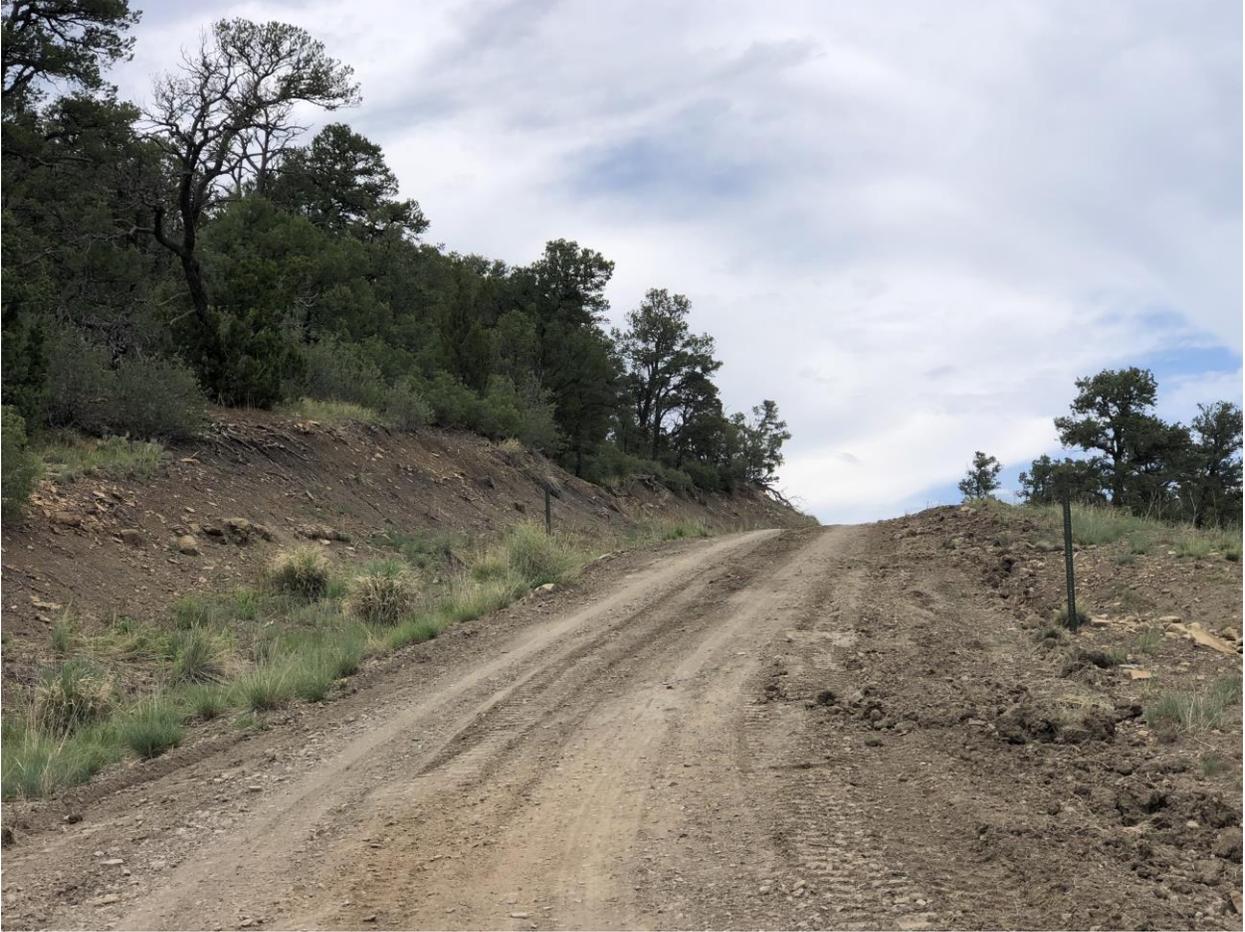
Access road have been recontoured and reclaimed to Comply with 1004 Rules Installed and repaired BMP's per Rule 1002.f.(2)C

Electrical unit doesn't belong to us it belongs to San Isabell

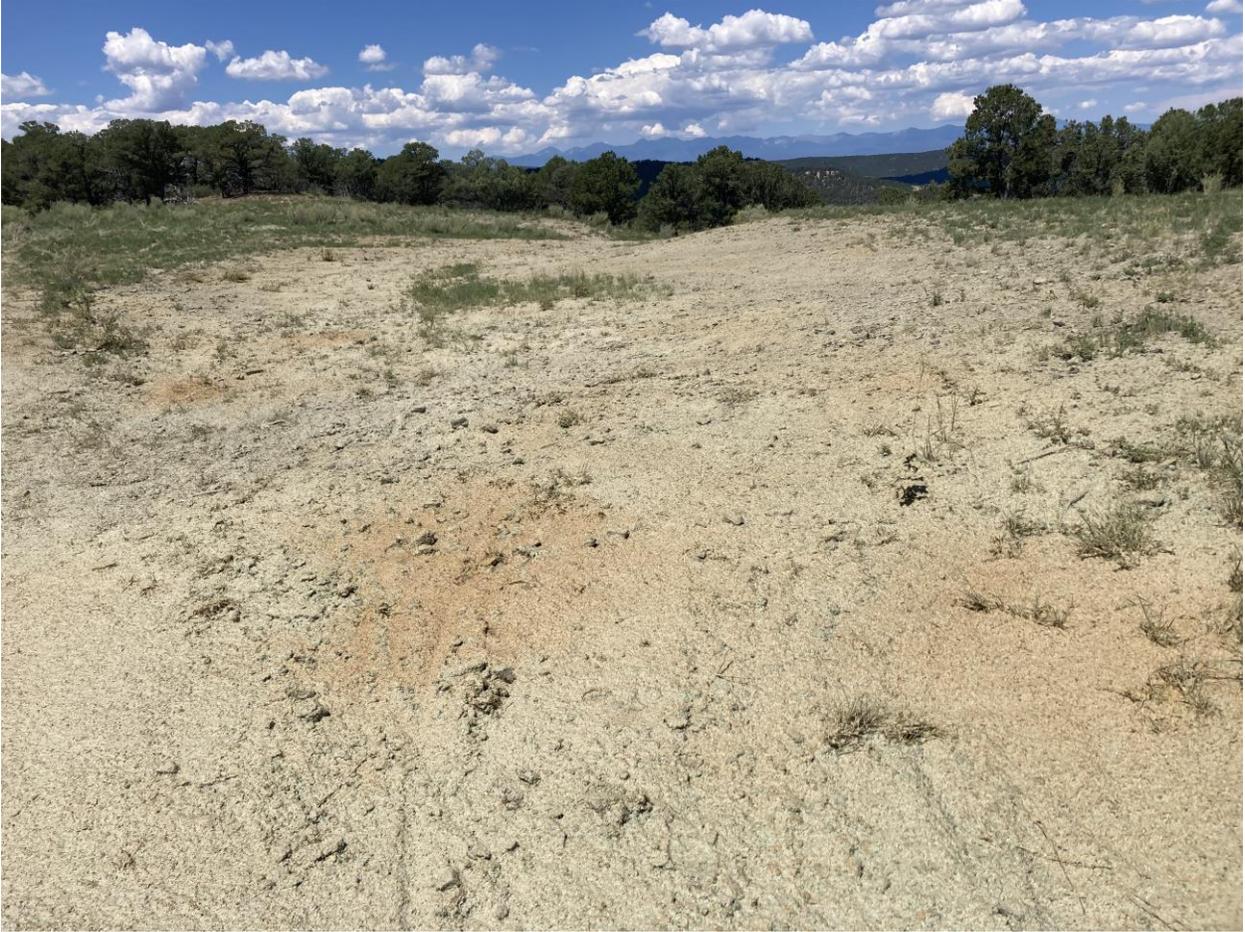
Access road have been recontoured and reclaimed to Comply with 1004 Rules Installed and repaired BMP's per Rule 1002.f.(2)C

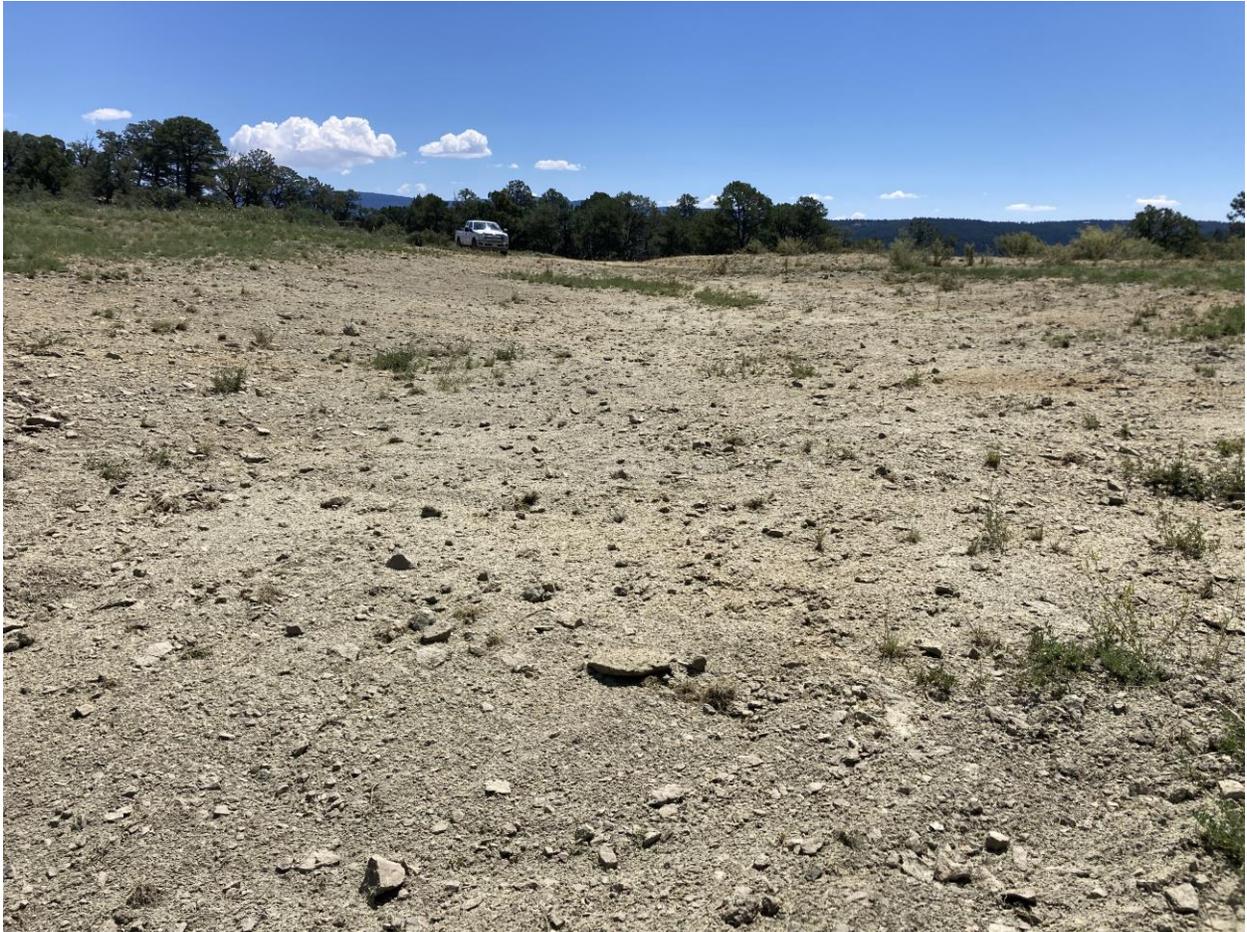
Access road have been recontoured and reclaimed to Comply with 1004 Rules Installed and repaired BMP's per Rule 1002.f.(2)C
