Inspection Photos
Location Name: Kell C35 Pad
Location ID: #335359
Inspection Date: April 18, 2023

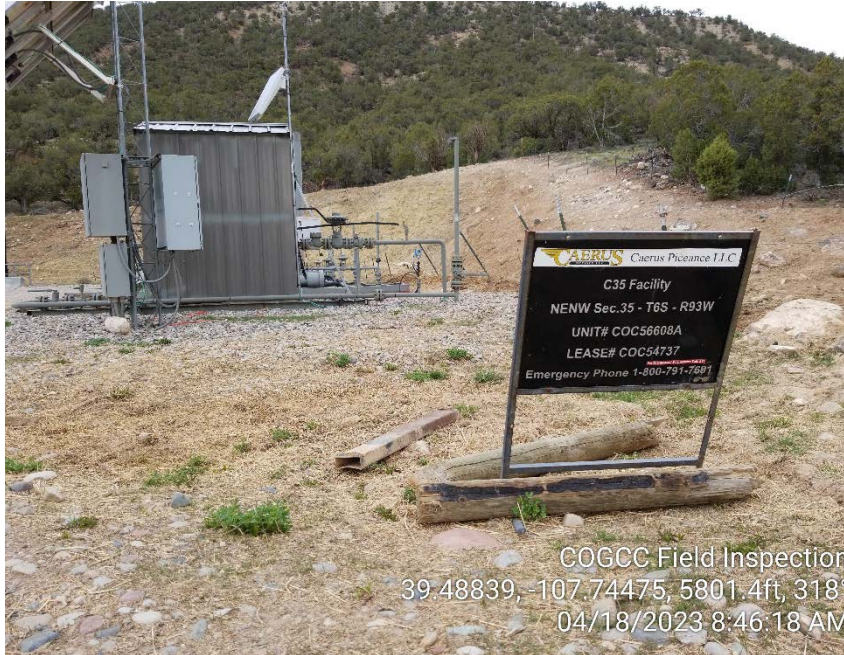
Photo #1 – Sign at entrance to pad. Note debris below sign.

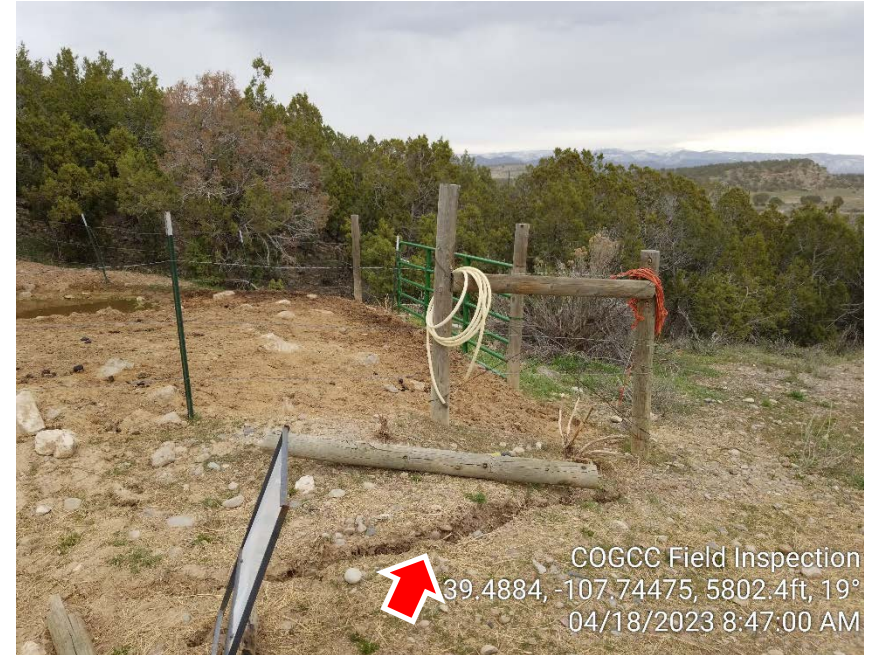
Photo #2 – Additional debris (fence post and rope) at entrance to pad. Note erosion rill located between sign and fence (red arrow).

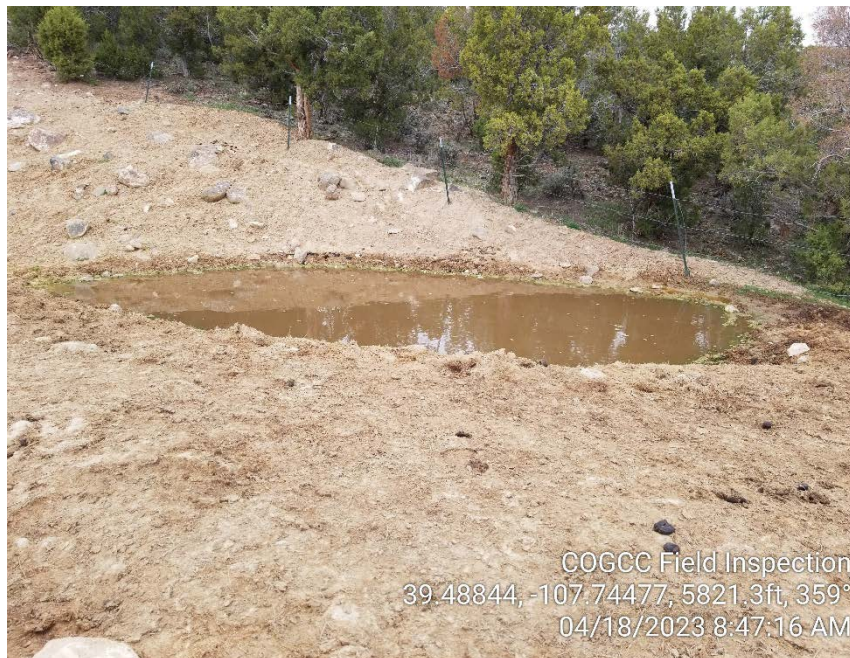
Photo #3 – Stormwater pond in NE corner of pad.

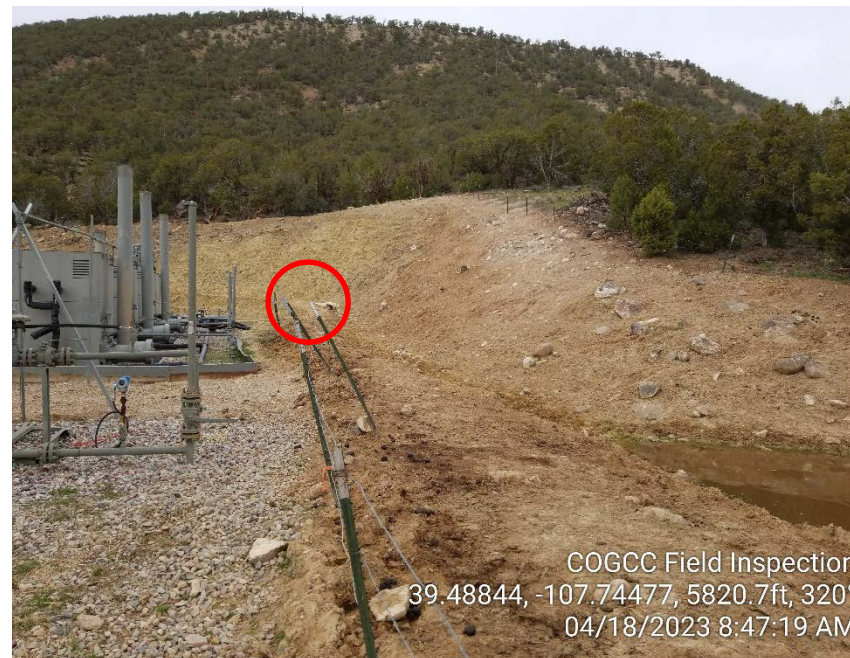
Photo #4 – View of separators and stormwater ditch. Note red circle indicates position of a dead horse that was observed during inspection.

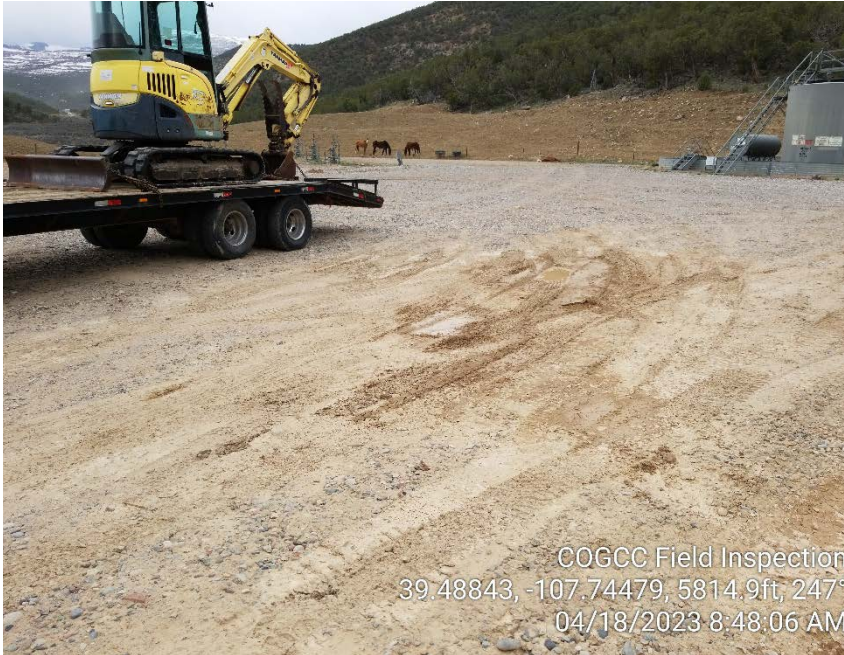
Photo #5 – Ruts, erosion, and sediment transport were observed throughout the pad surface on inspection date.

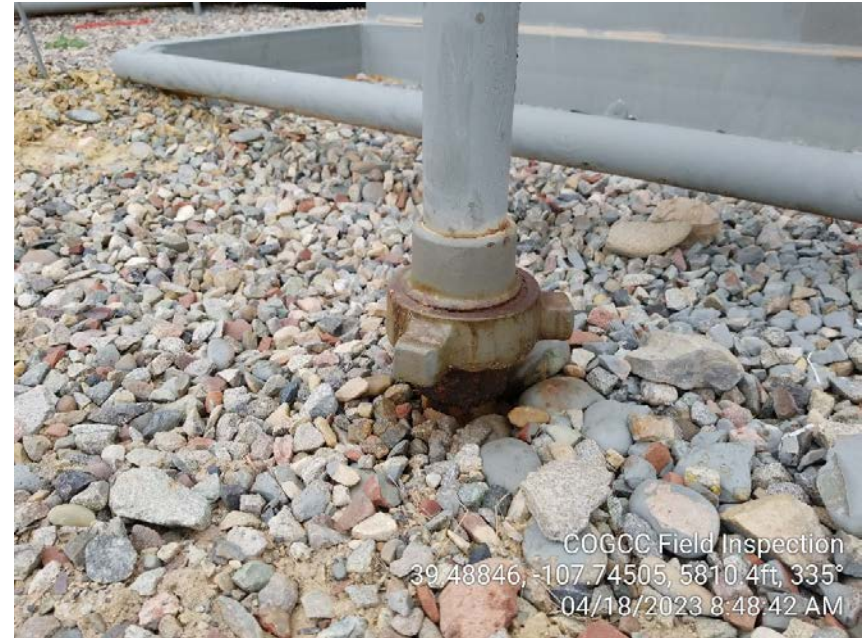
Photo #6 – Staining and discoloration observed at hammer union on Kell 35-3 Separator.

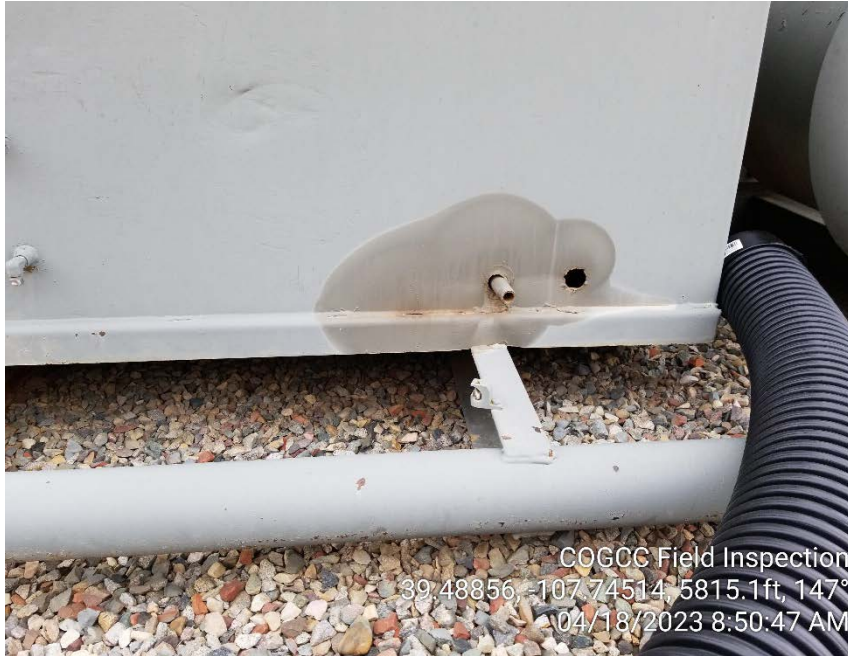
Photo #7 – Fluid staining observed on west side of vertical separator for Craig 35-5A C35 well.

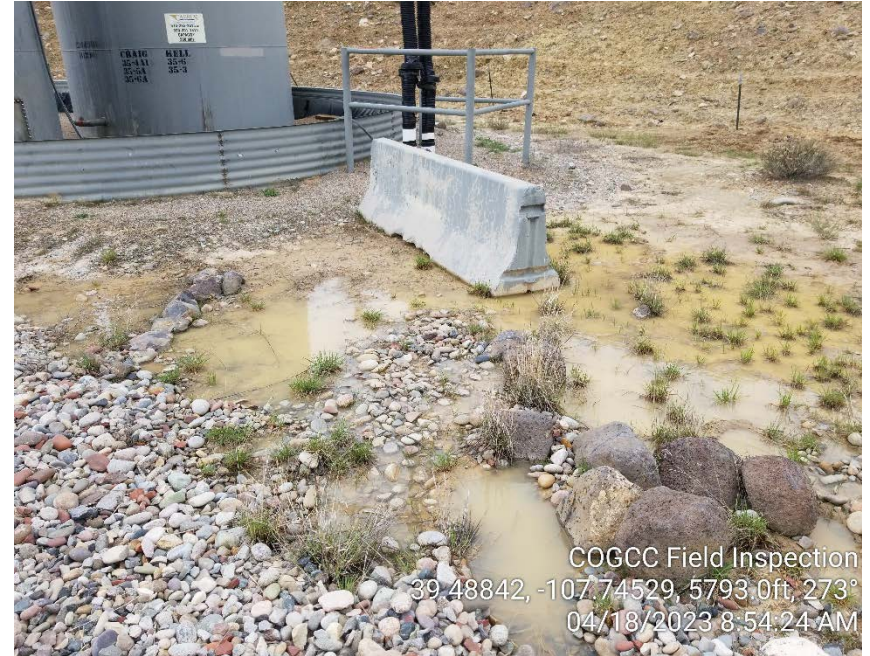
Photo #8 - Stormwater pooling on north side of tank battery.

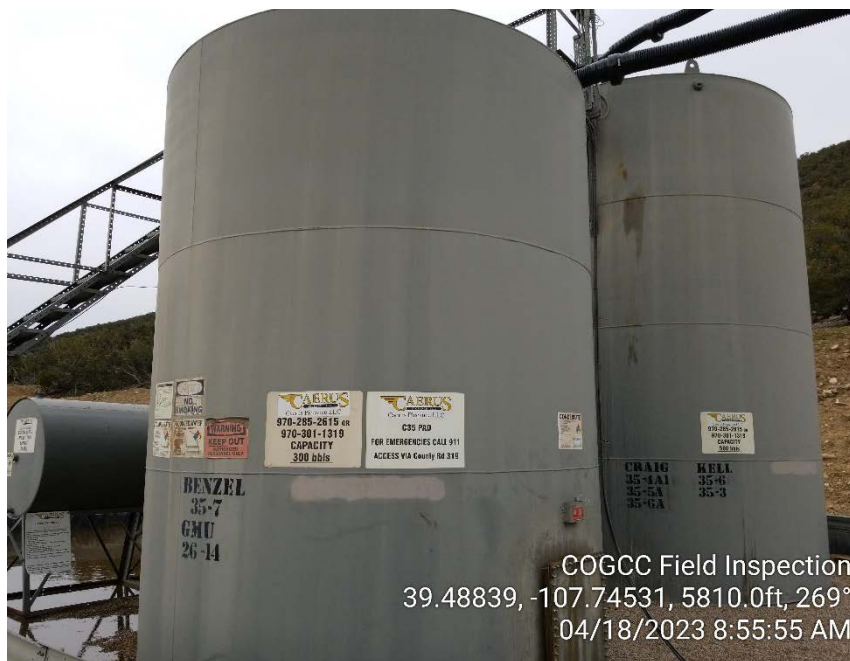
Photo #9 – Tank battery consists of one 300 bbl steel AST and one 500 bbl steel AST, both labeled to contain Produced Water and Condensate, and one 24 bbl methanol tank inside of a lined metal berm.

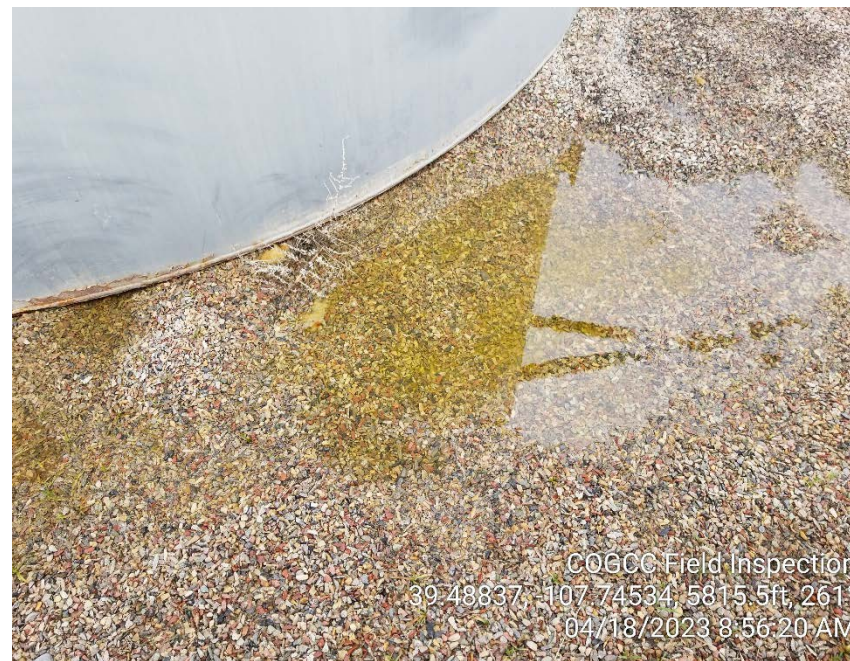
Photo #10 – Tank battery secondary containment contained unknown fluids on inspection date. Discoloration of fluids in close proximity to 300 bbl steel AST indicate potential hydrocarbon impacts.

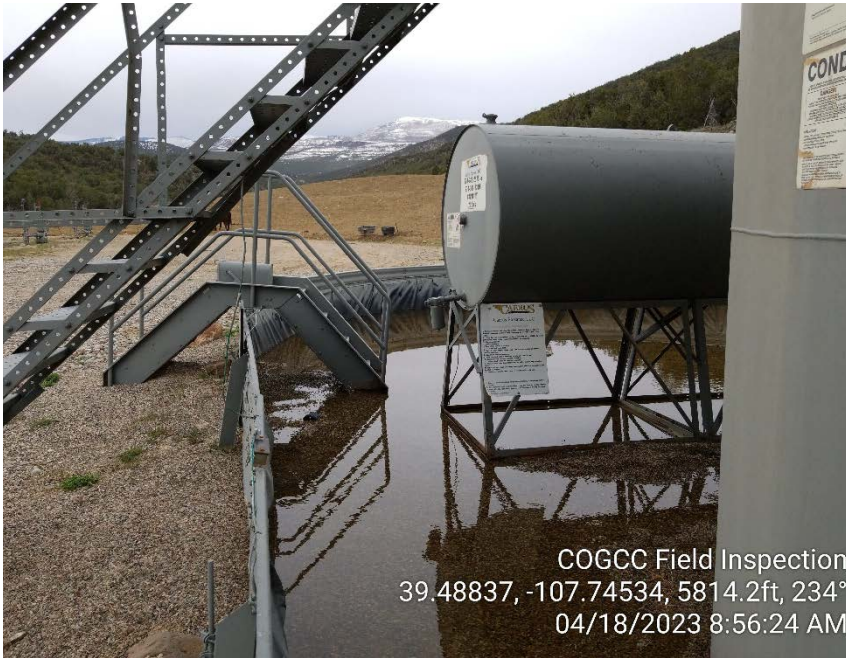
Photo #11 – South half of tank battery secondary containment contained hydrocarbon-impacted fluids on inspection date.

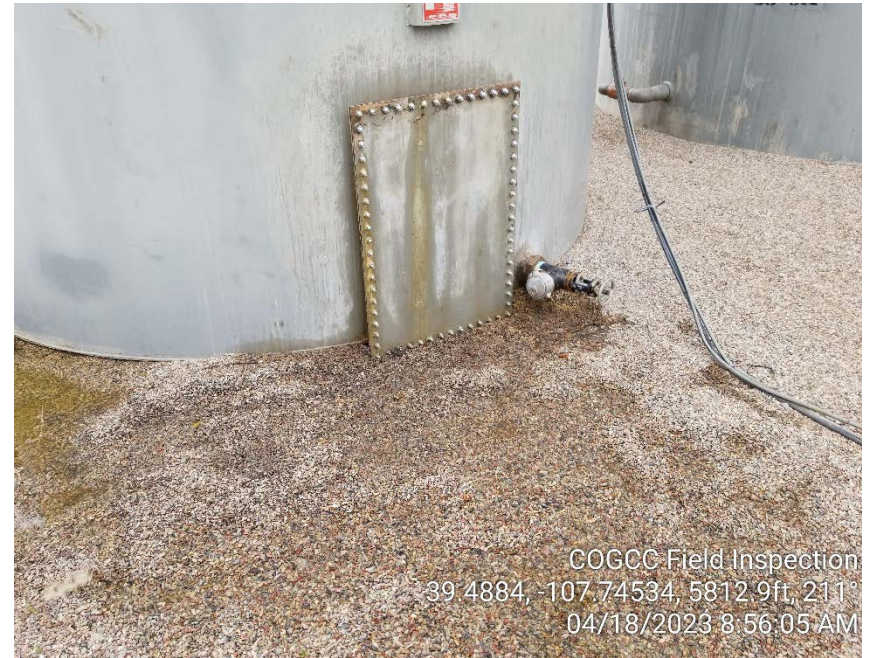
Photo #12 - Localized accumulation of oily waste near manhole cover and bullplug attached to 300 bbl steel AST has the potential to impact stormwater accumulations.

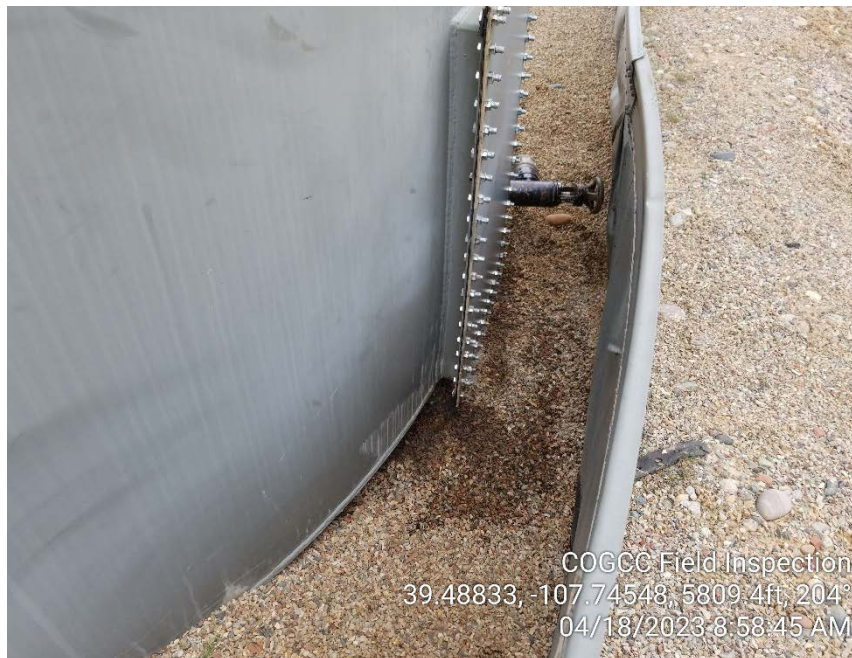
Photo #13 - Localized accumulation of oily waste near manhole cover and bullplug attached to 500 bbl steel AST has the potential to impact stormwater accumulations.

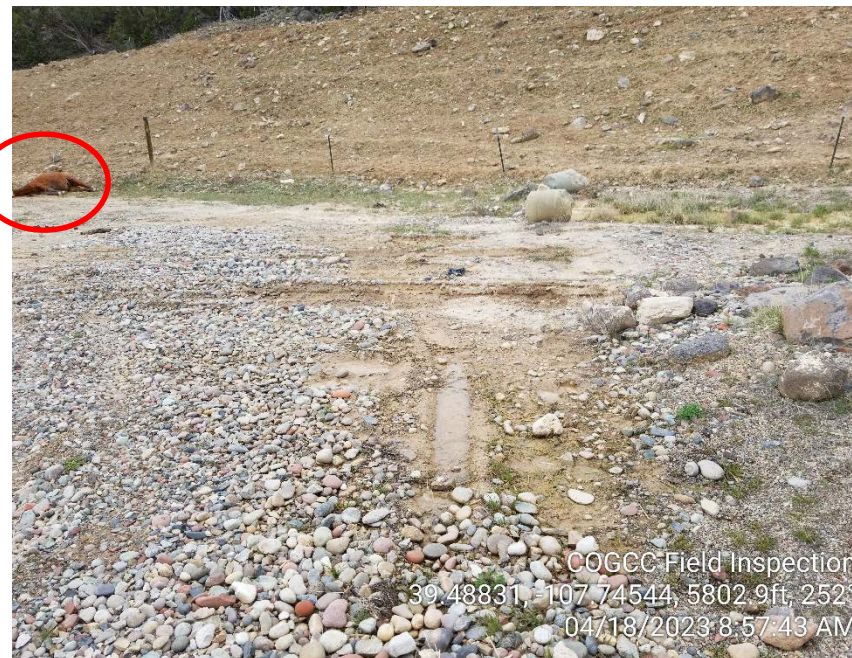
Photo #14 – Ruts, stormwater, and vegetation growth on pad, located south of tank battery. Note red circle indicates position of a second dead horse that was observed during inspection.

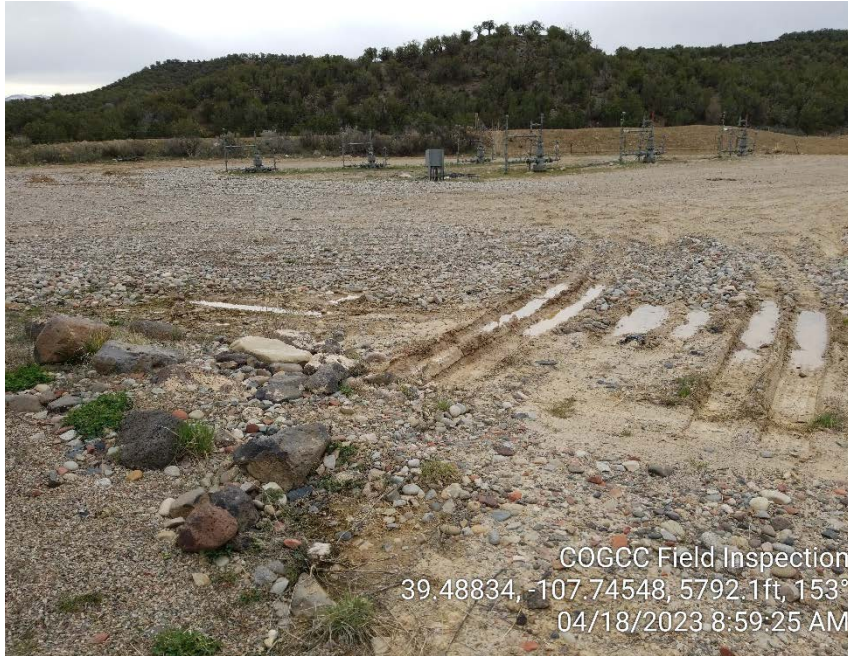
Photo #15 – Ruts and stormwater accumulation on pad.

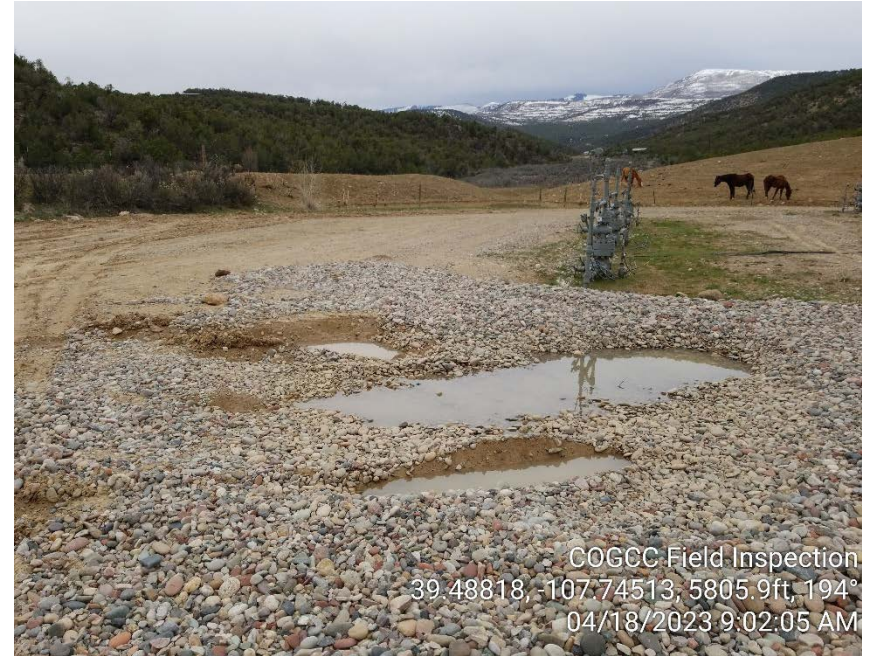
Photo #16 – Stormwater accumulation and ruts on pad.

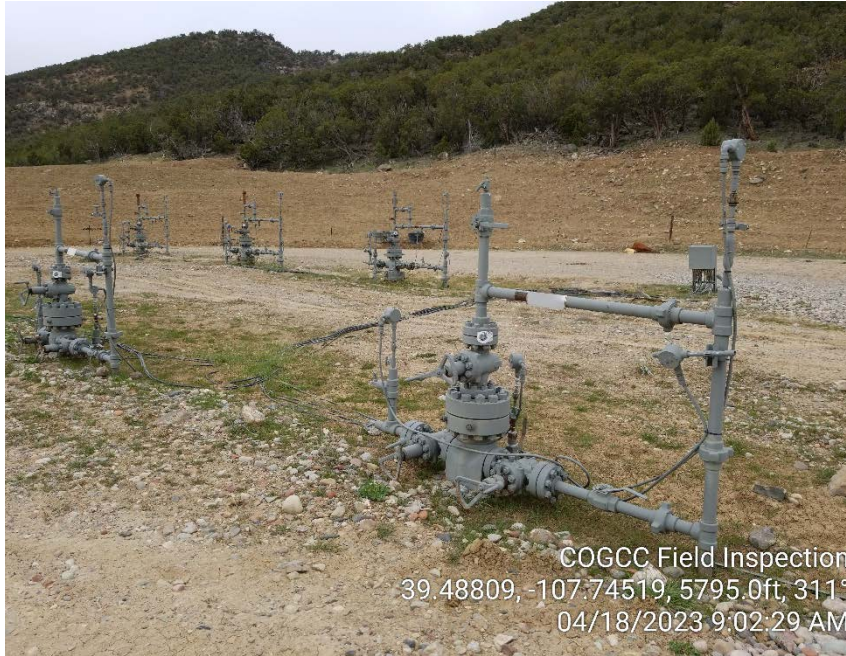
Photo #17 – Uncontrolled vegetation growth in wellhead area.

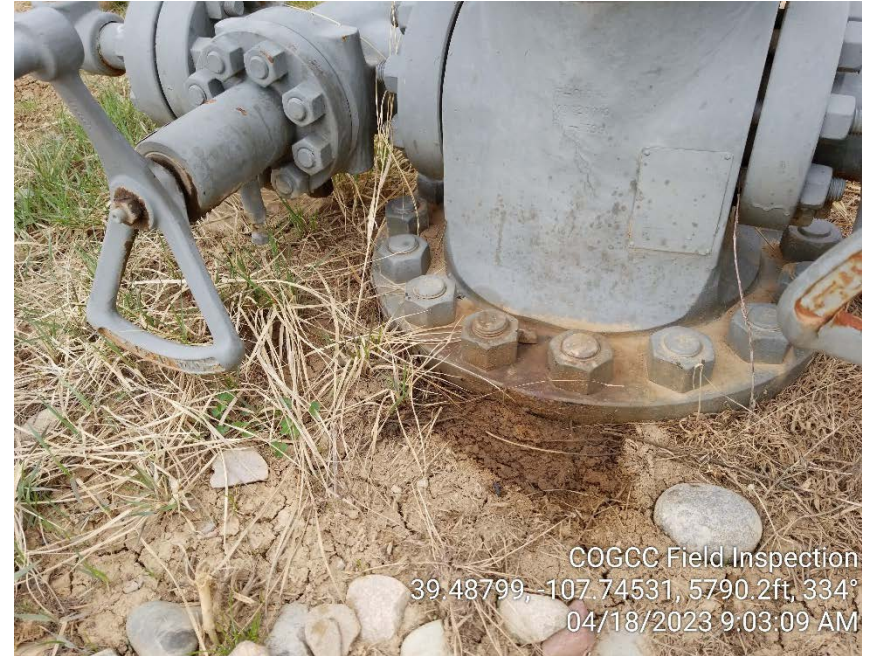
Photo #18 – Localized accumulation of oily waste observed at C35 Kell 35-3 wellhead.

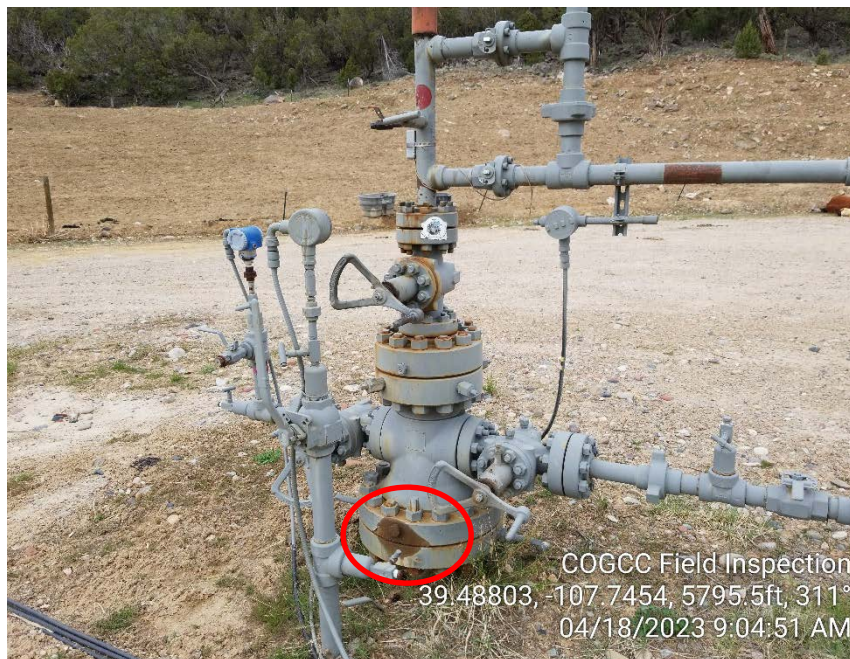
Photo #19 – Localized accumulation of oily waste observed at C35 Craig 35-6A wellhead (red circle).

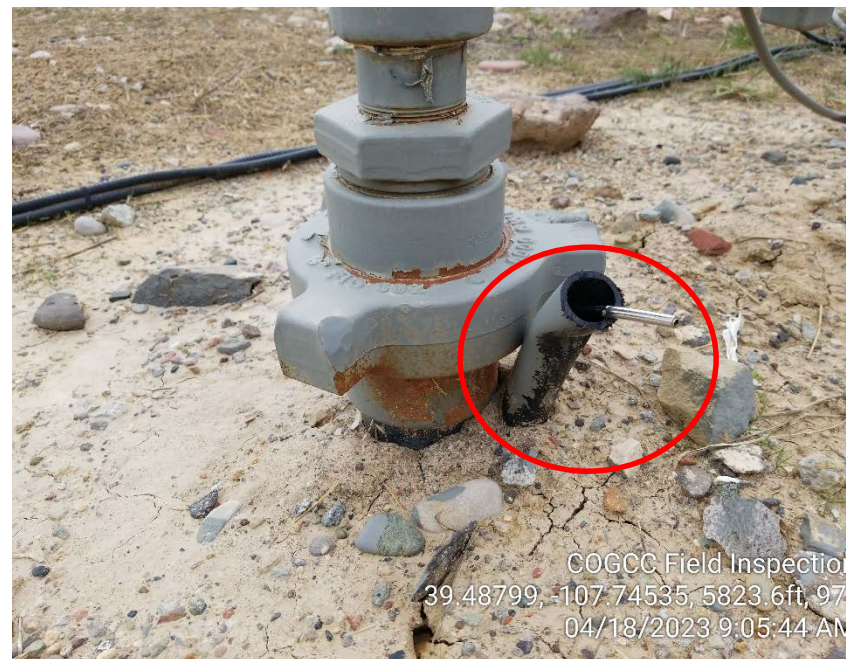
Photo #20 – Multiple wellheads (GMU 35-4A1, Craig 35-6A, and Craig 35-5A) have associated flowline risers configured with an uncapped 1/4" process pipe.

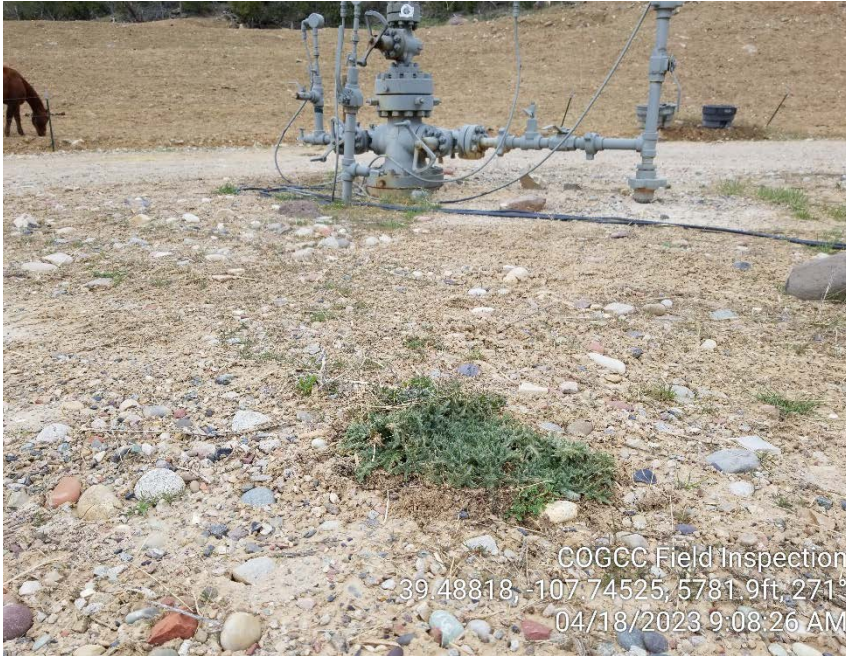
Photo #21 – Noxious weeds observed in wellhead area.

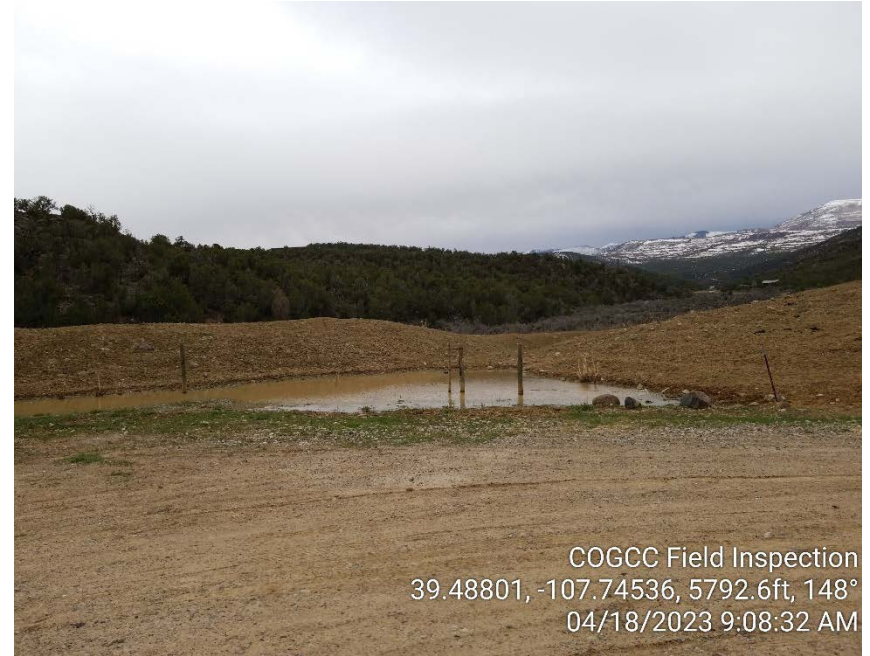
Photo #22 – Stormwater containment pond on south end of pad.

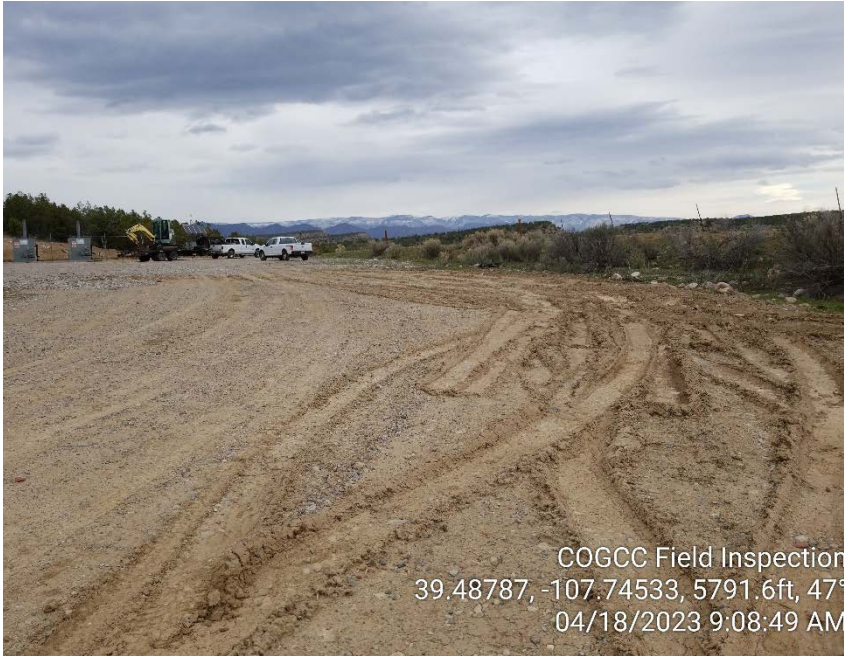
Photo #23 – Rutted area along east side of pad.

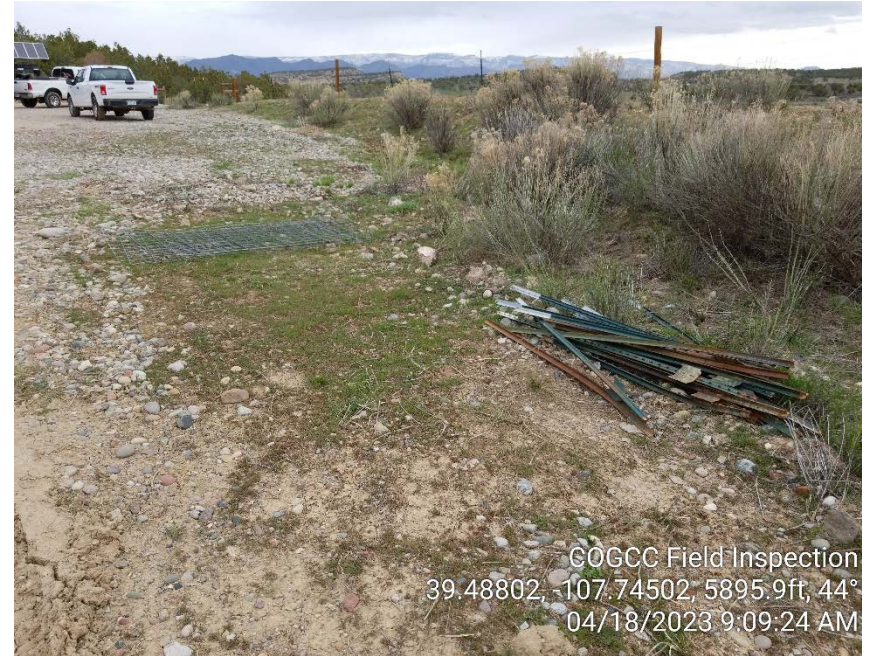
Photo #24 – Unused equipment stored on east side of pad.

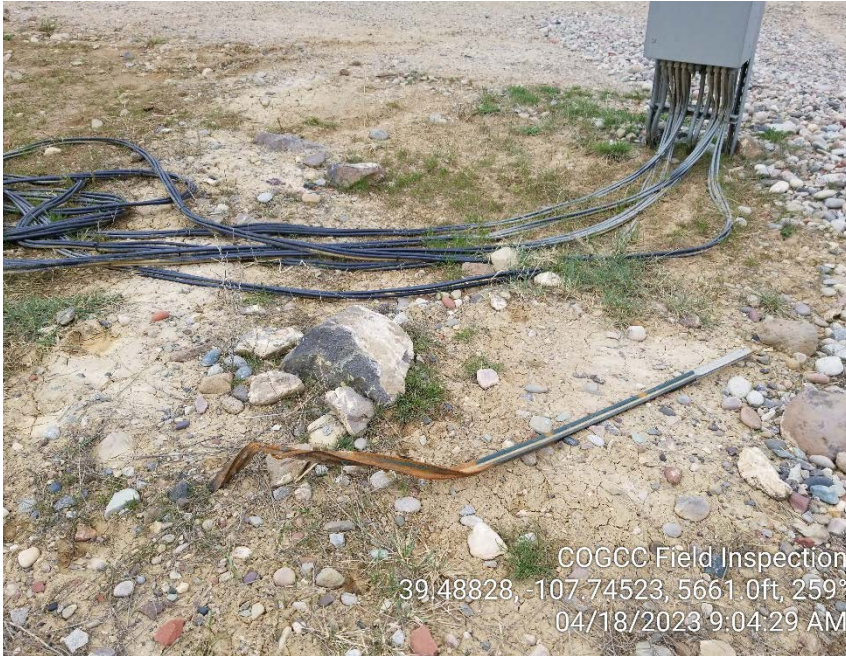
Photo #25 – Junk and debris (damaged t-post) located in wellhead area.
