Inspection Photos

Operator: TEP Rocky Mountain LLC - #96850

Location Name: RU/13-6

Inspection Document #: 702801477

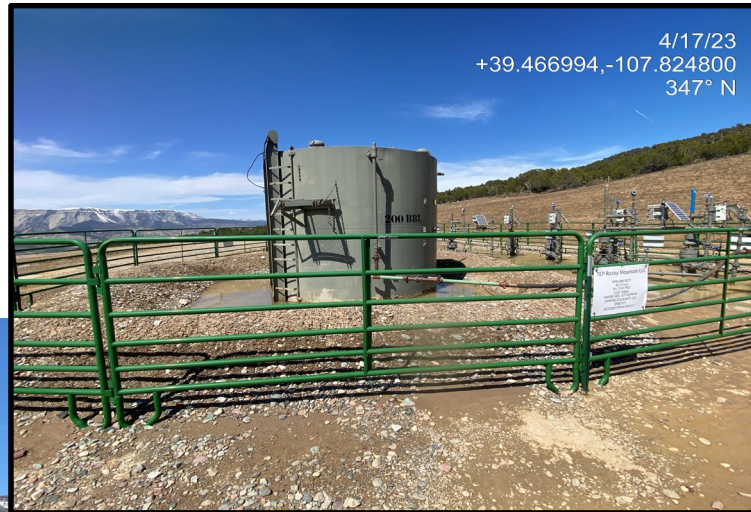
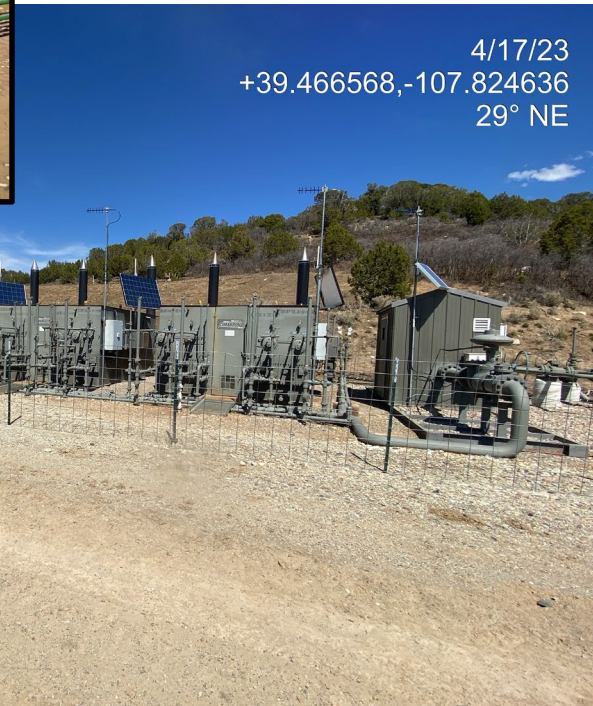
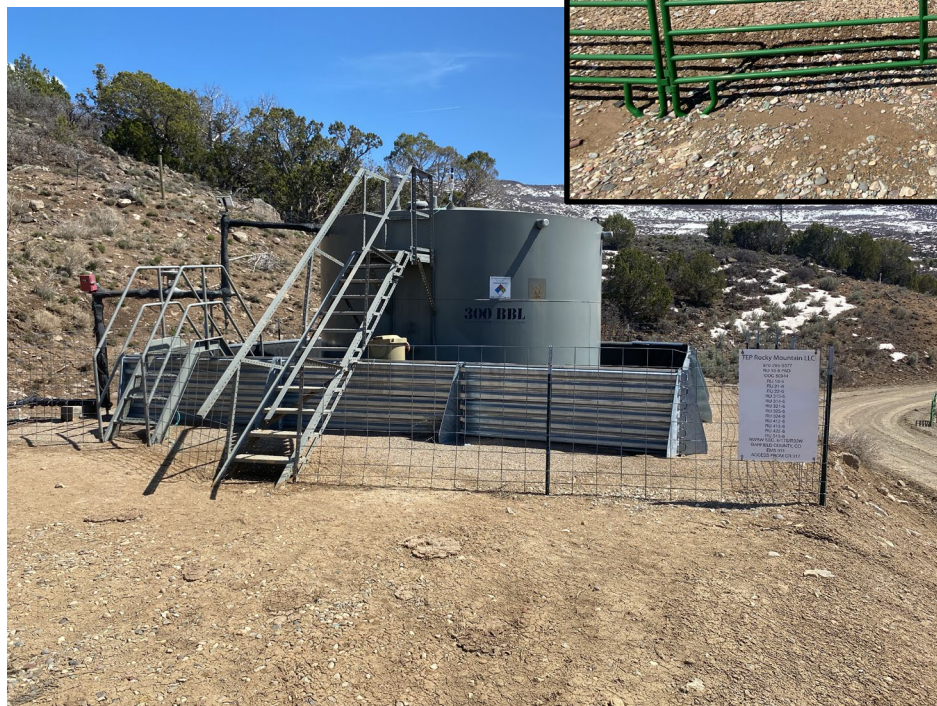
Photo 1. Photos show production areas.

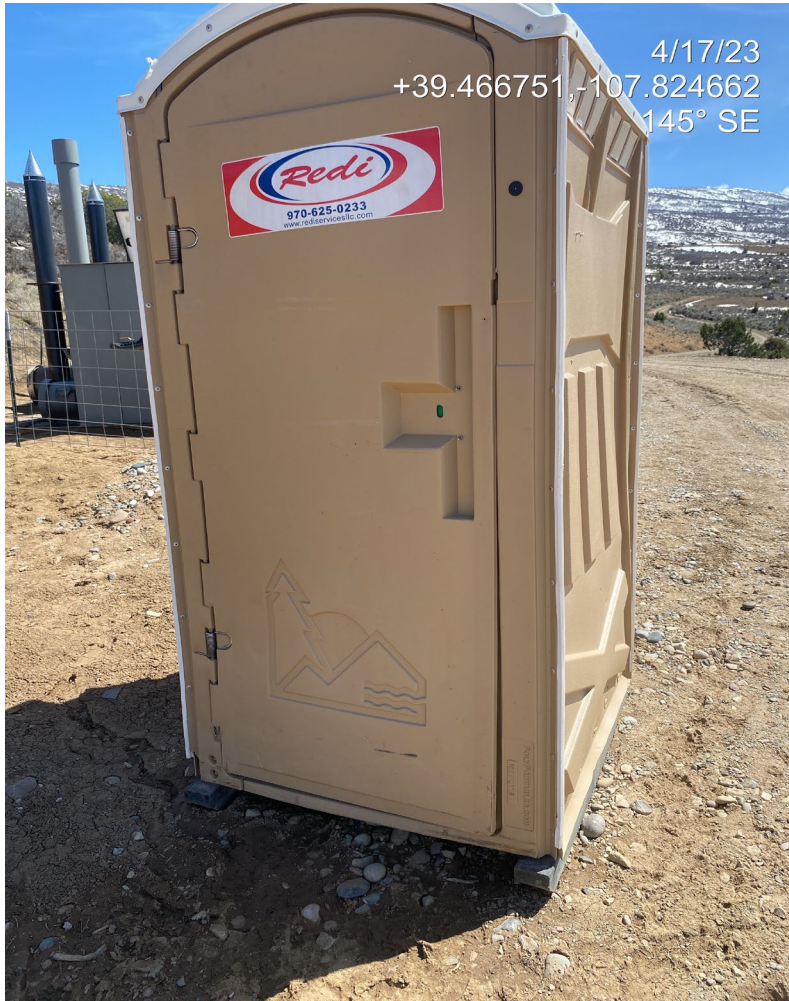
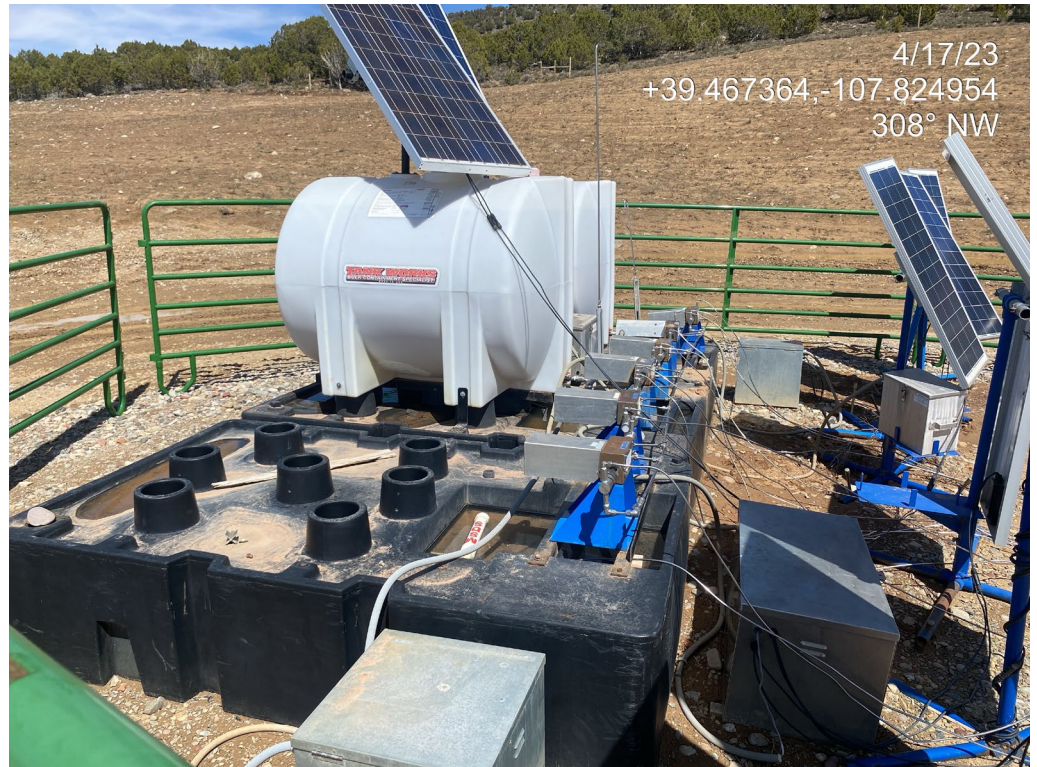
Photo 2. Photos show a portable toilet not secured to prevent a spill (left) and unused secondary containment equipment (right).

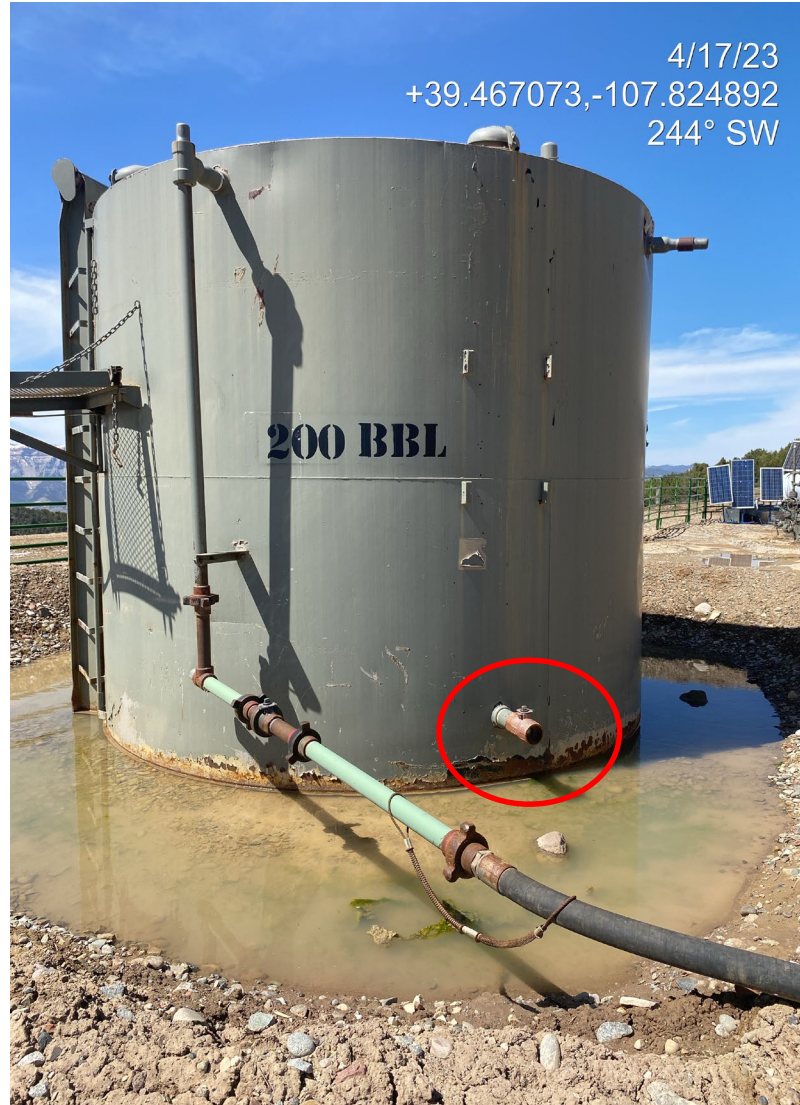
Photo 3. Photo shows a bull plug not installed on a tank drain.

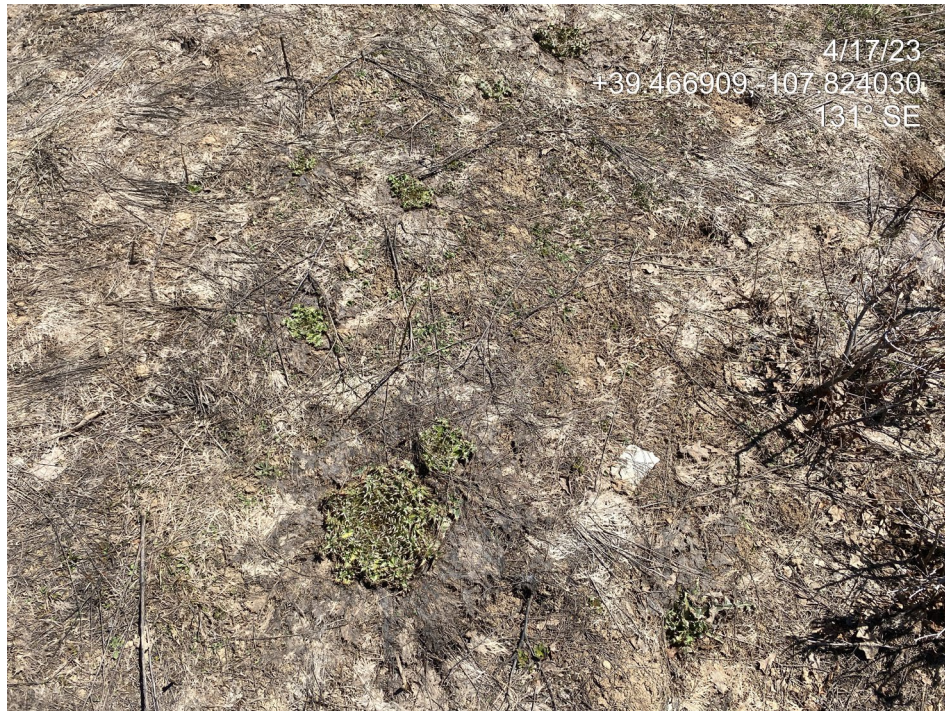
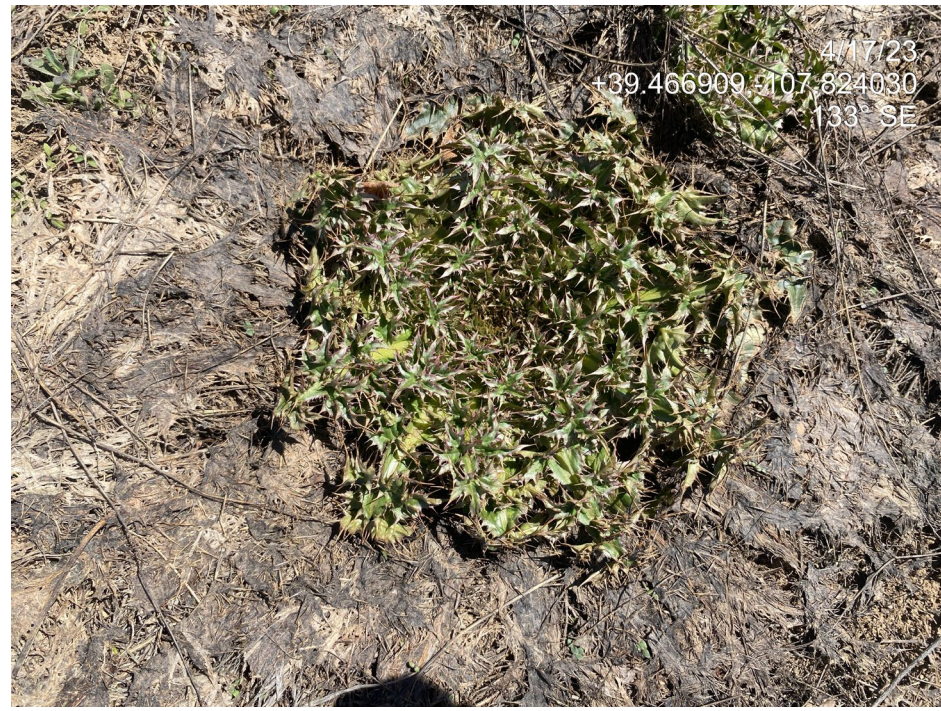
Photo 4. Photos show musk thistle rosettes

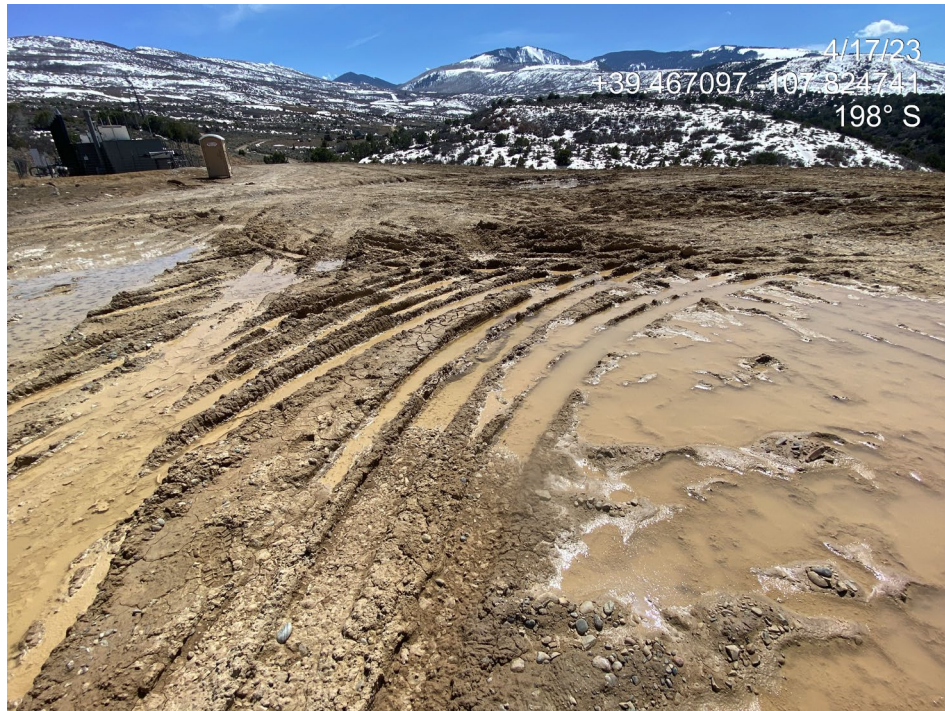
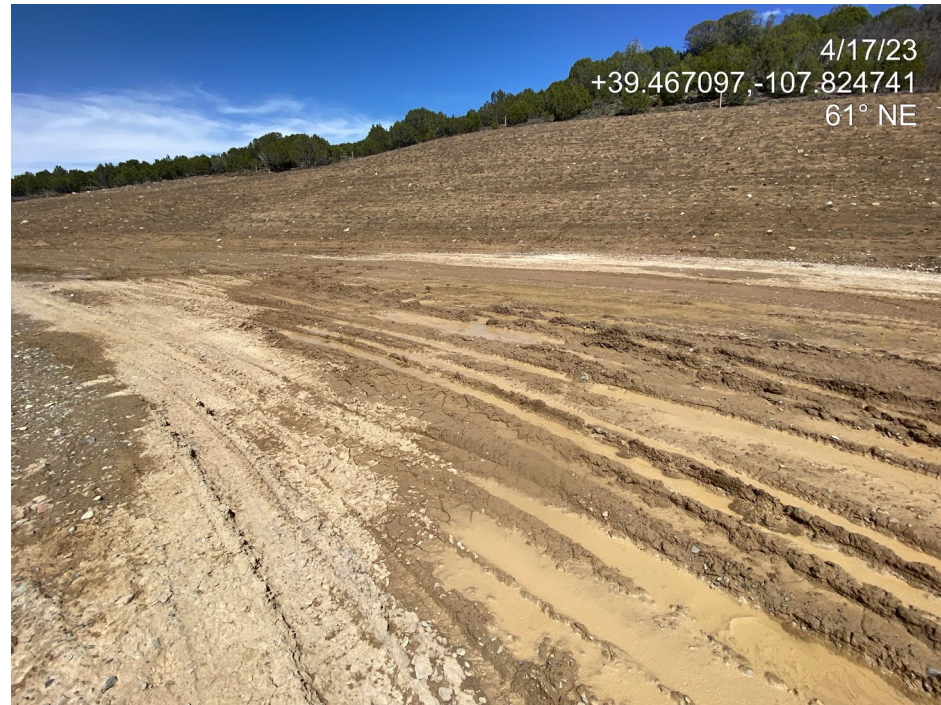
Photo 5. Photos show lack of stabilization of the pad surface.

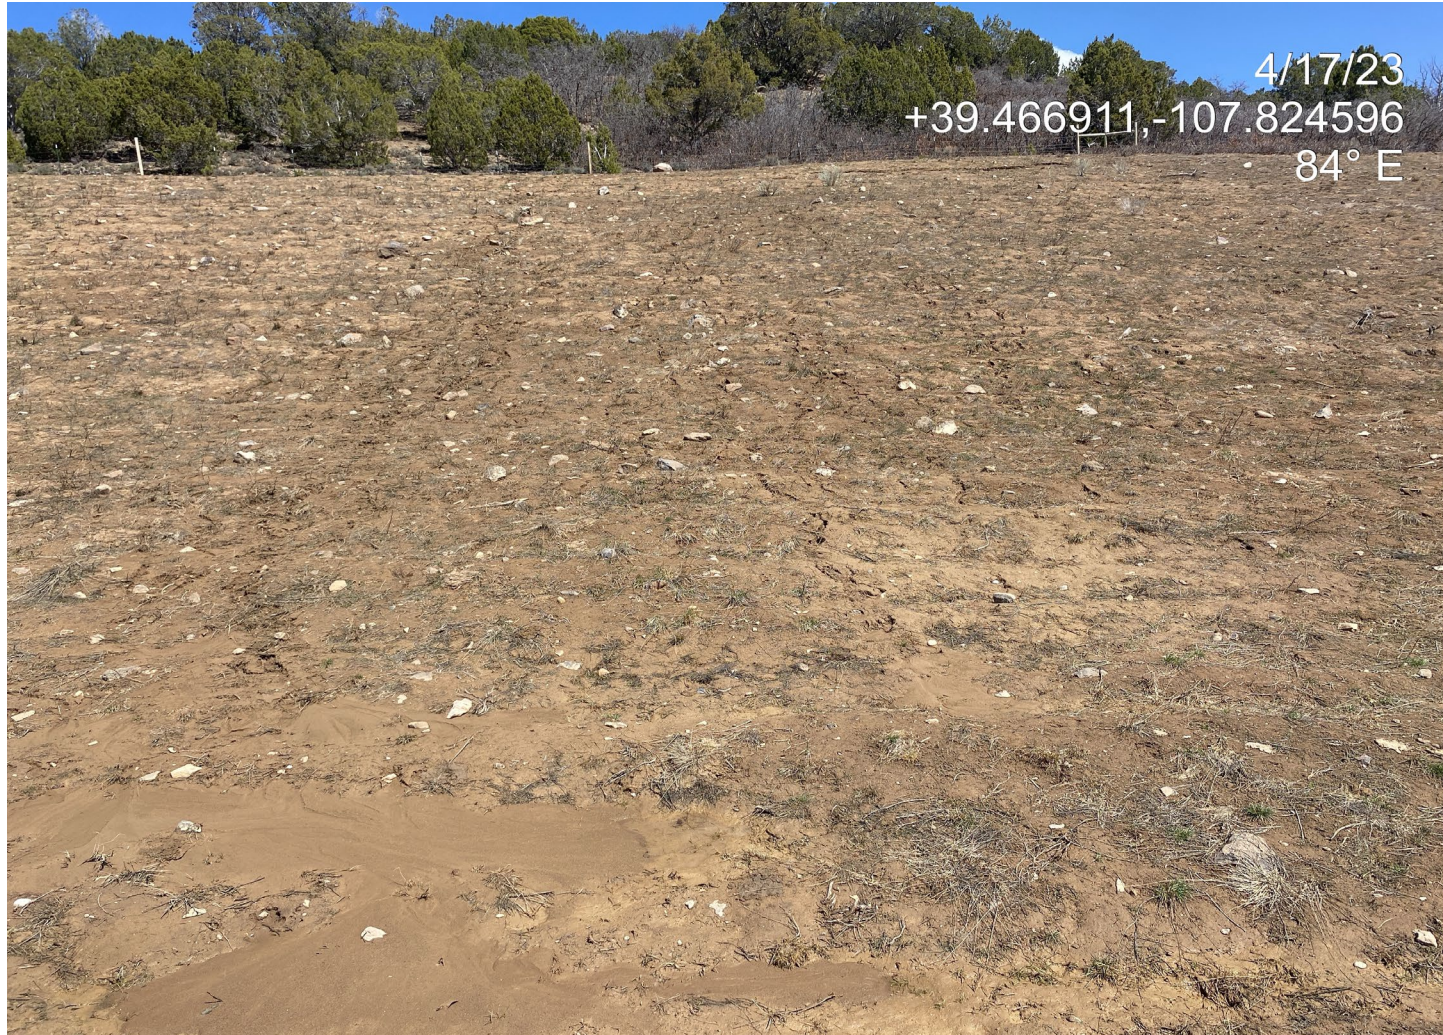
Photo 6. Photos show interim area slopes at the east are unstabilized.

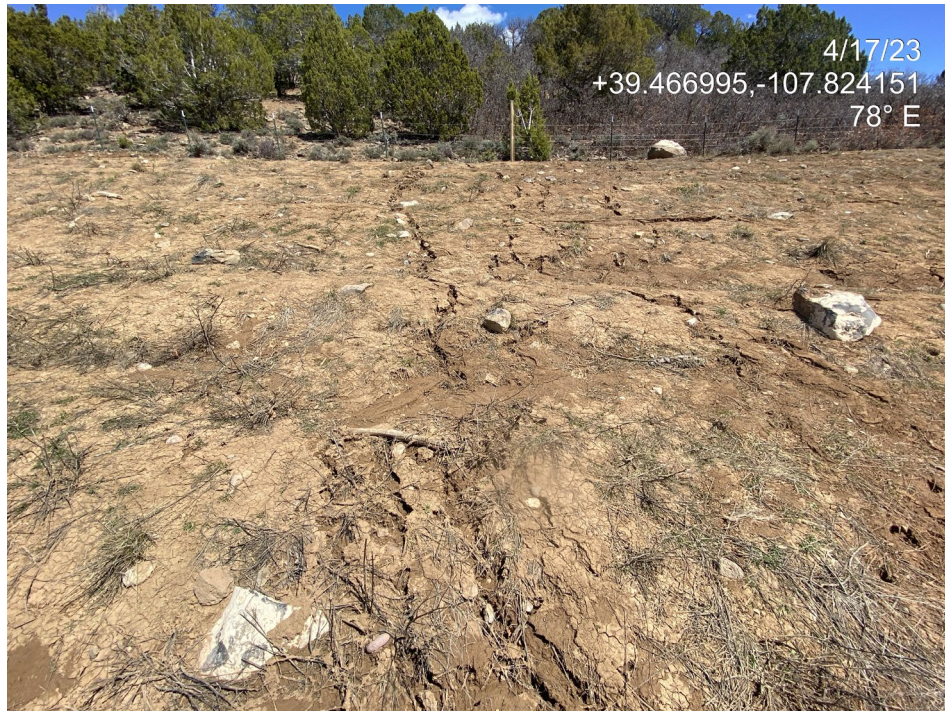
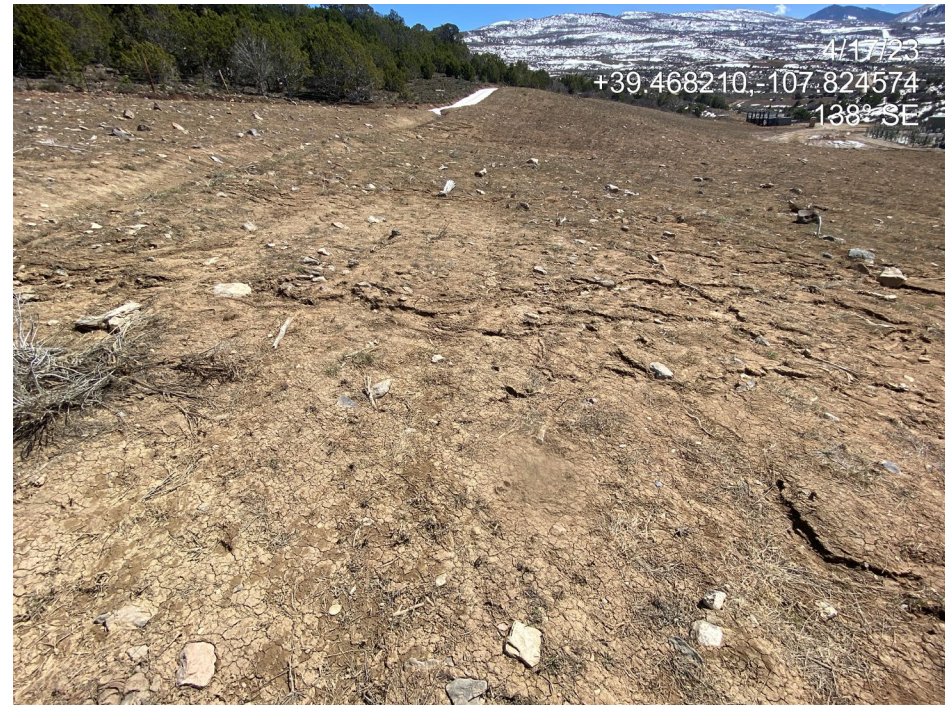
Photo 7. Photos show interim area slopes at the east are unstabilized.

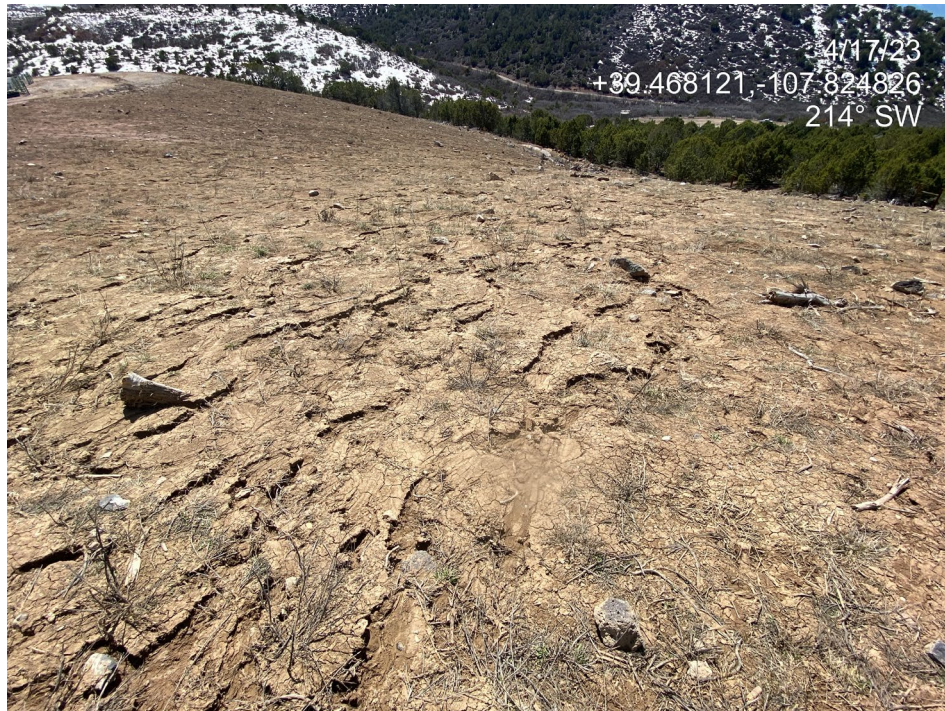
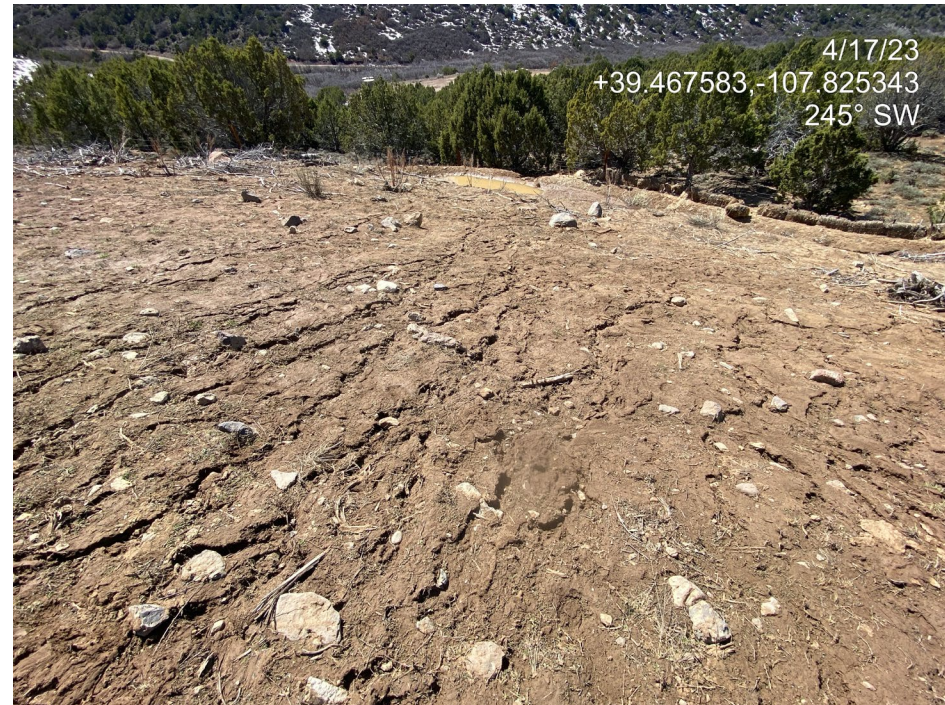
Photo 8. Photos show interim area slopes at the north are unstabilized.

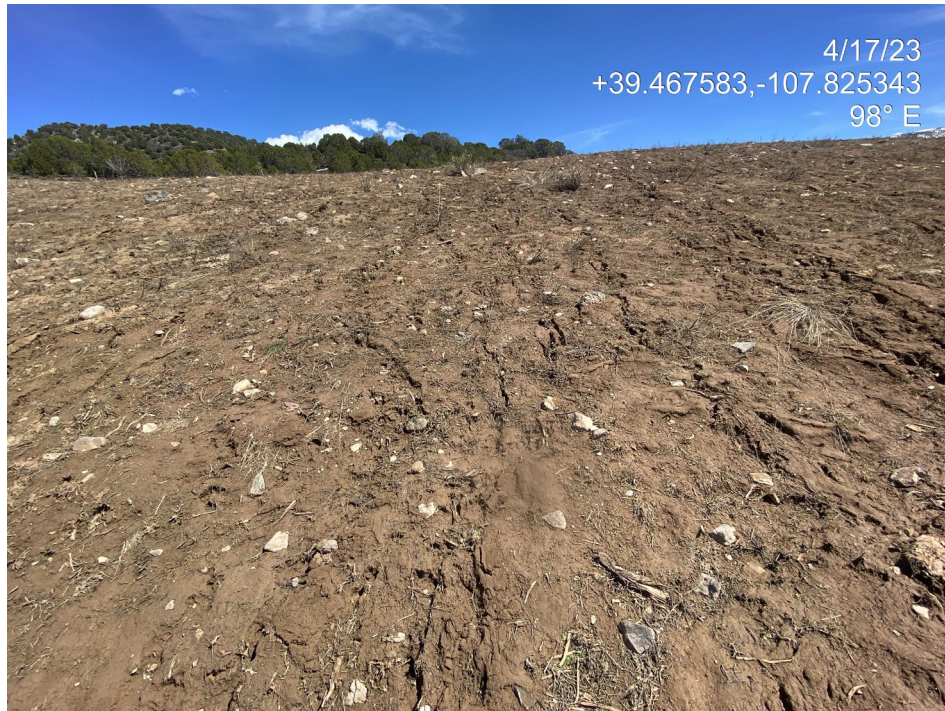
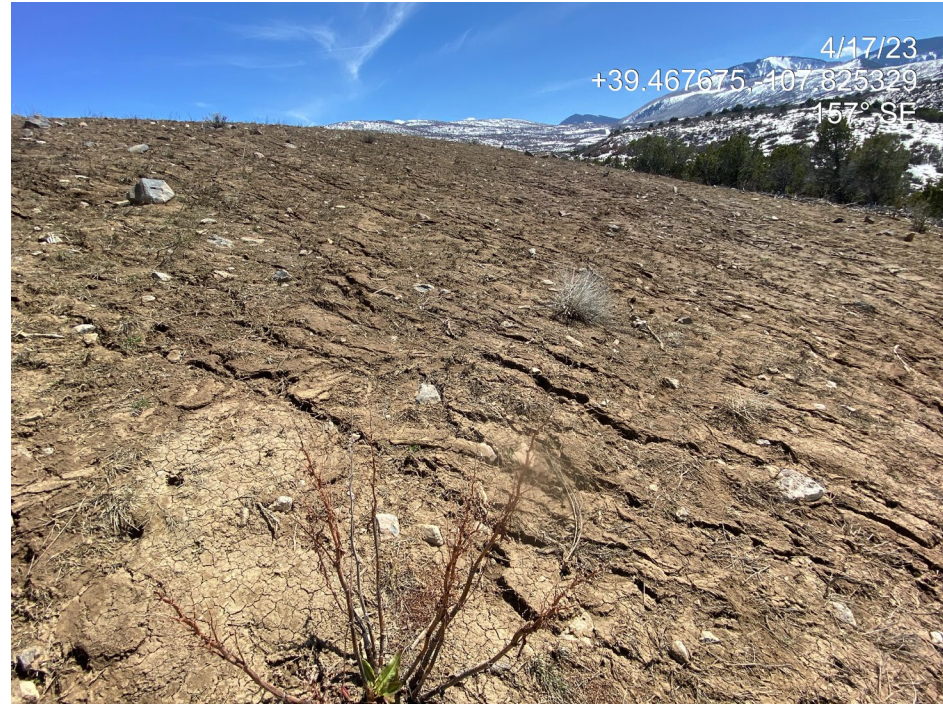
Photo 9. Photos show interim area slopes at the west are unstabilized.

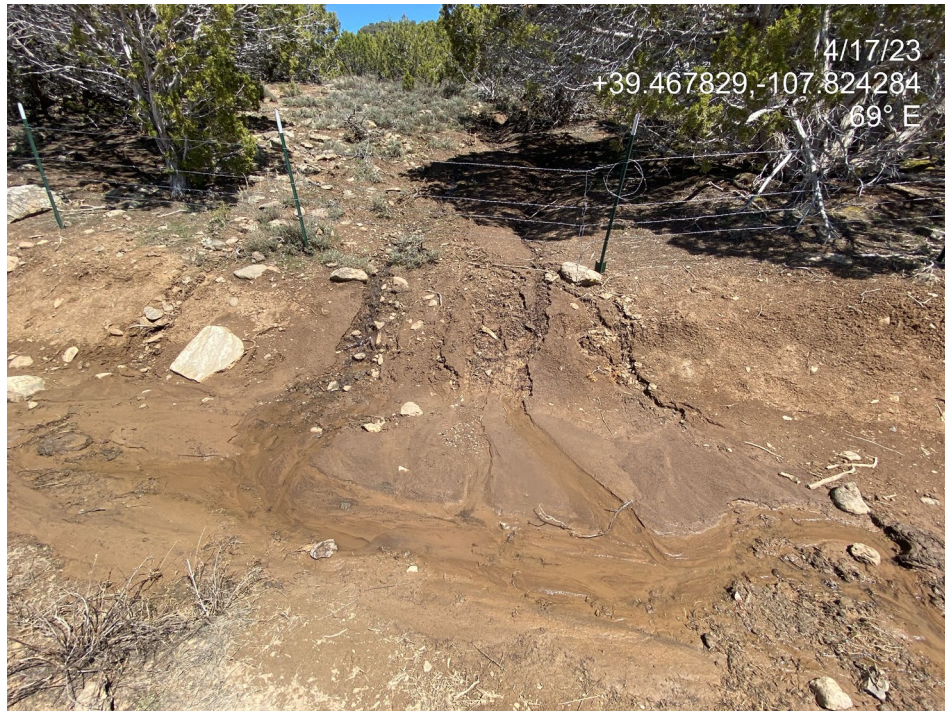
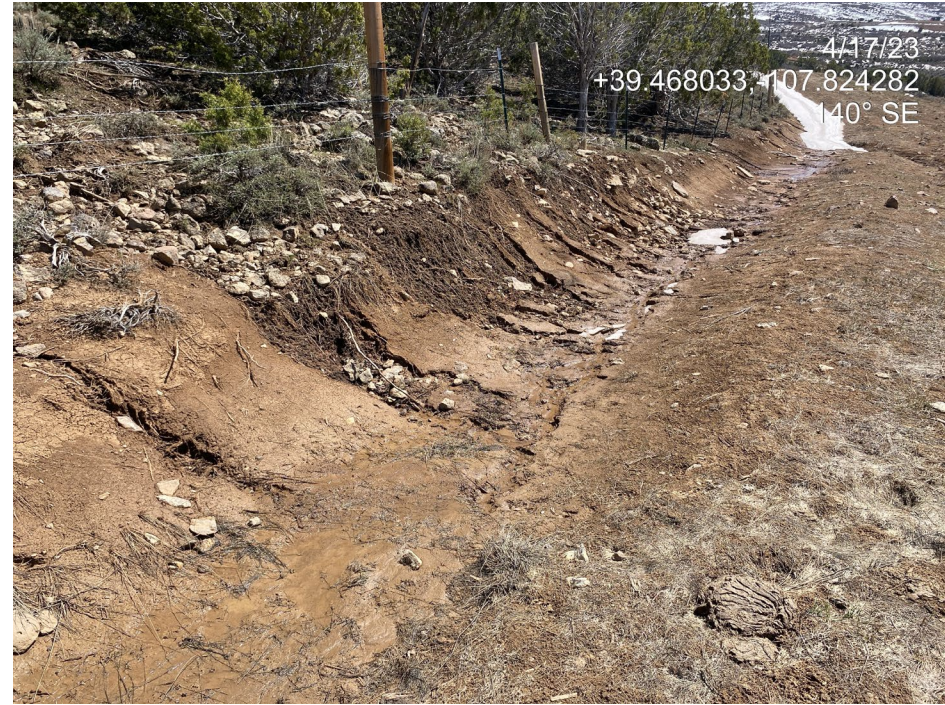
Photo 10. Photos show a small portion of the cut at the northeast of the location which leads into a stormwater ditch is unstabilized.

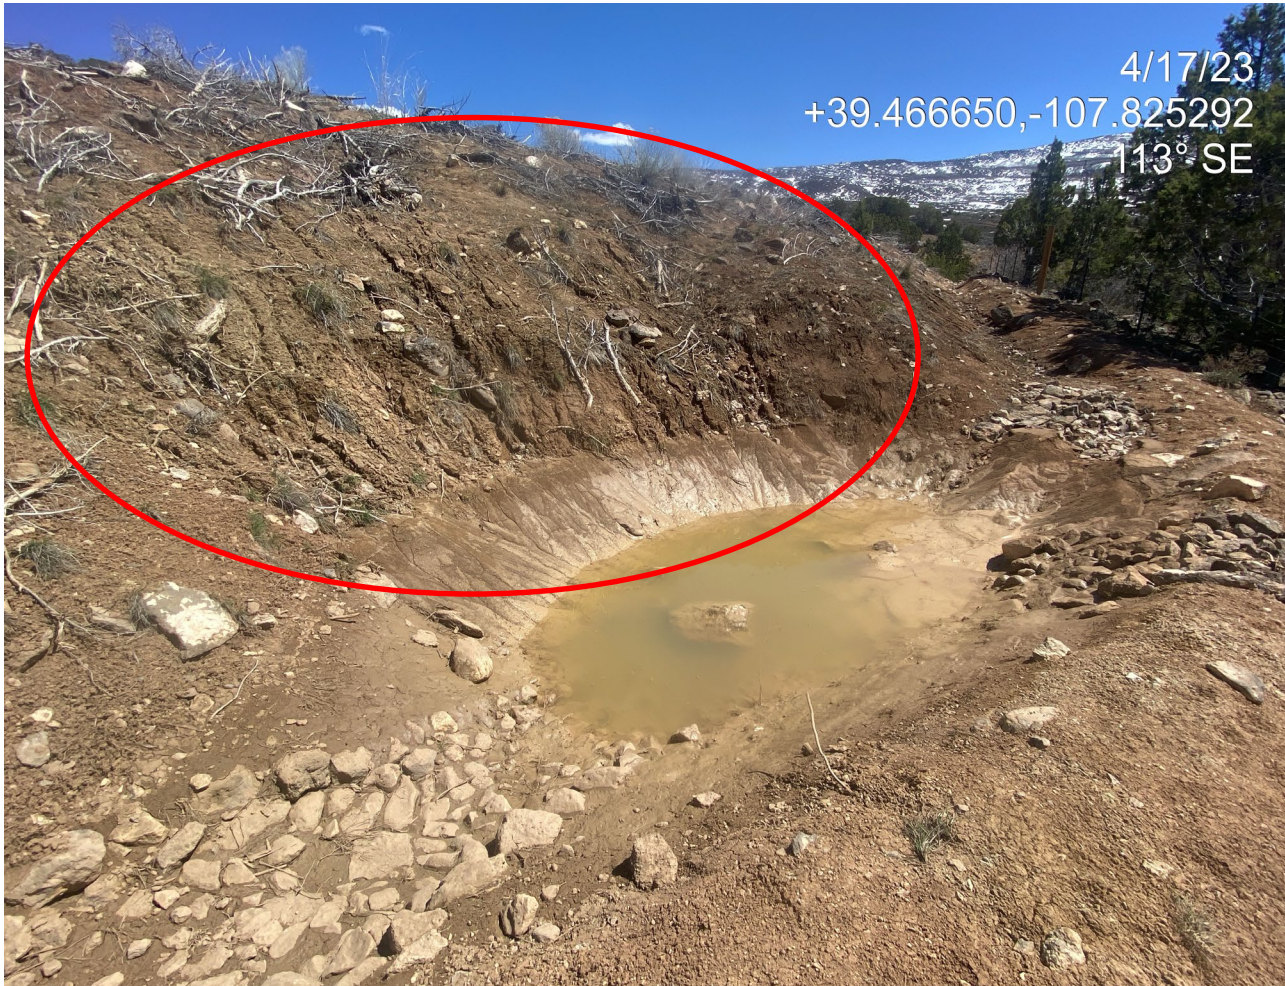
Photo 11. Photo shows a sediment trap at the southwest of the location. The interim area above and the side of the trap are not stabilized.

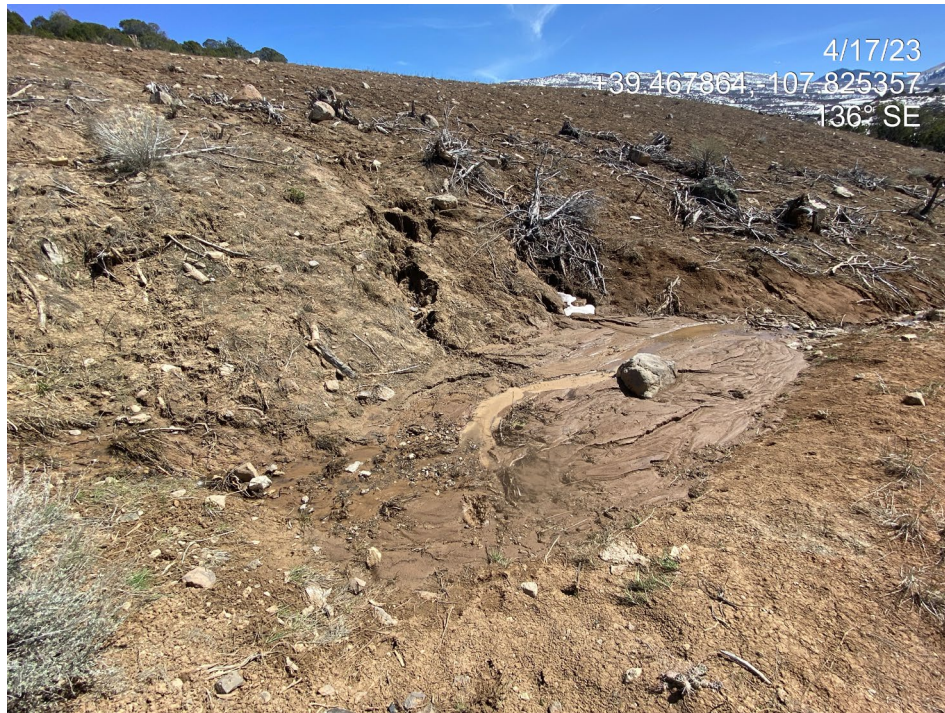
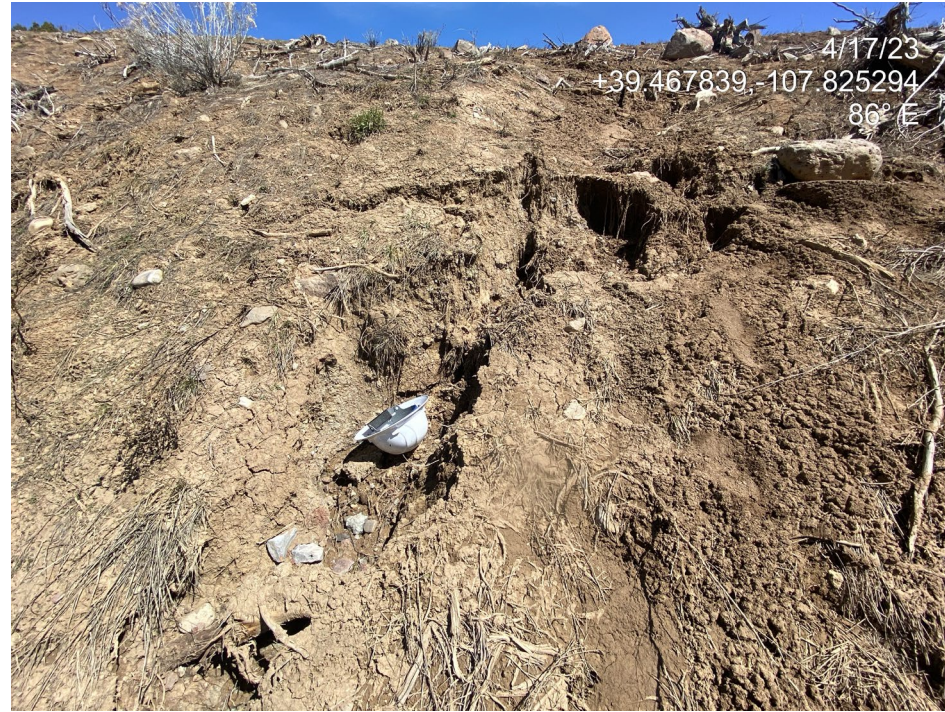
Photo 12. Photos show a sediment trap at the northwest of the location. The interim area above and side of the trap is not stabilized.

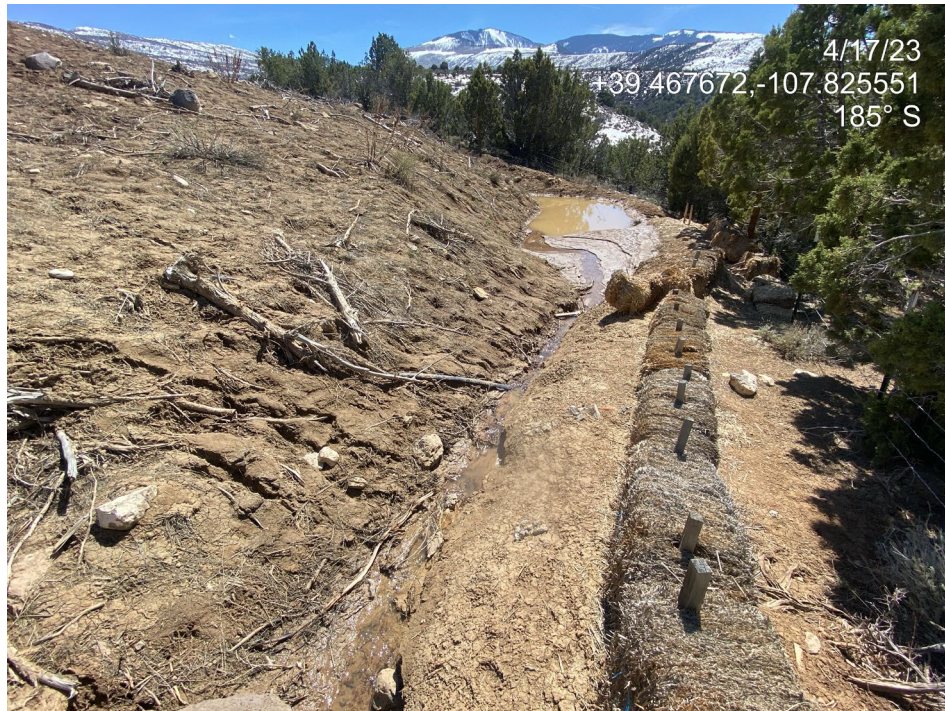
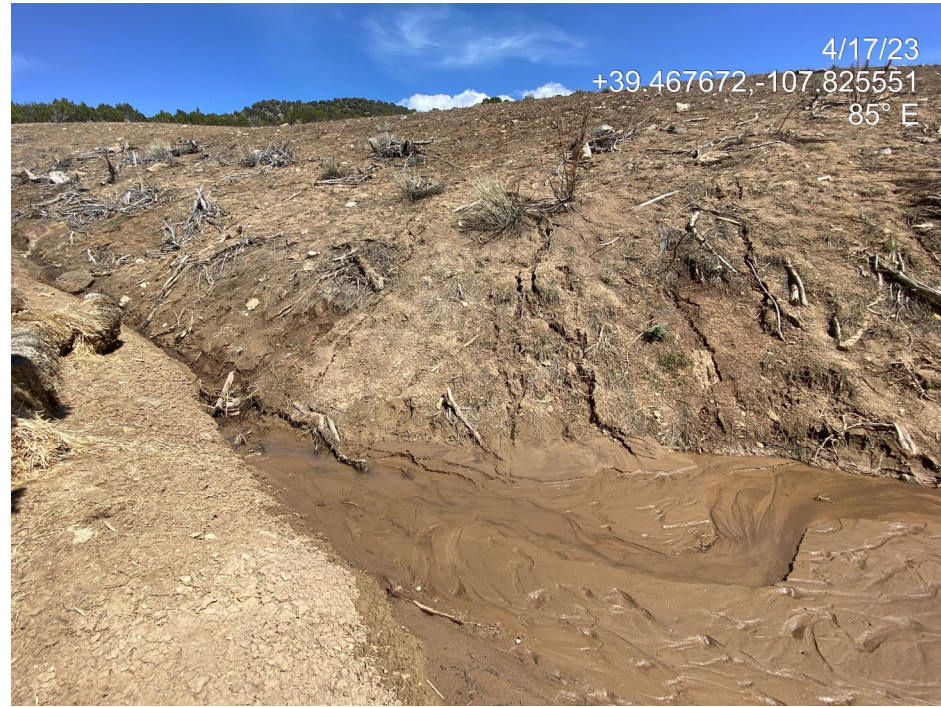
Photo 13. Photos show BMPs at the west of the location including erosion of the sediment trap walls.

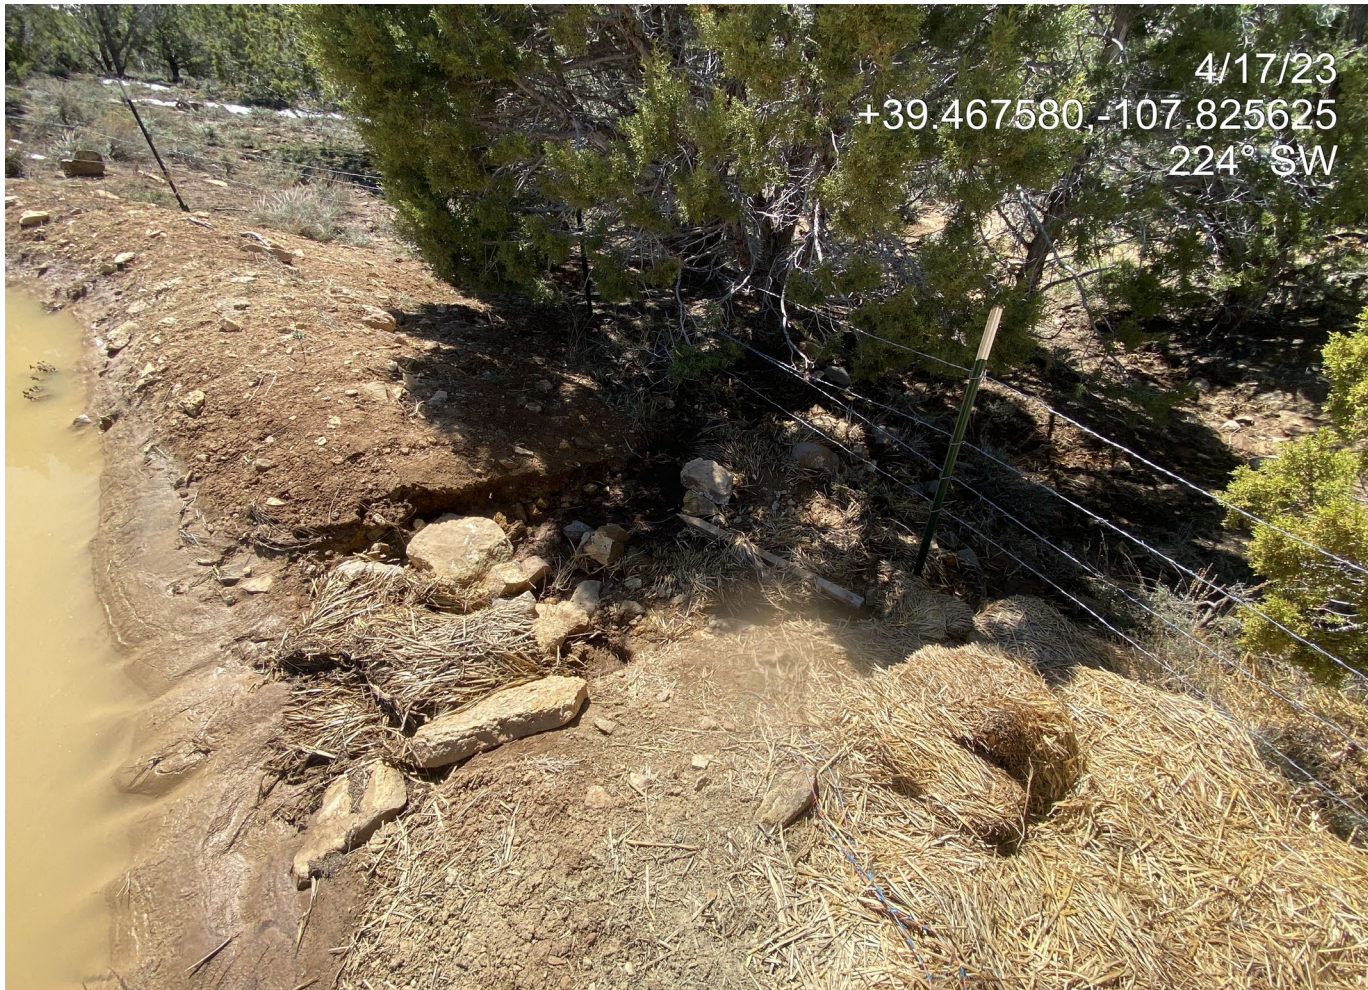
Photo 14. Photos show insufficient sediment trap outlet protections/degraded BMPs.

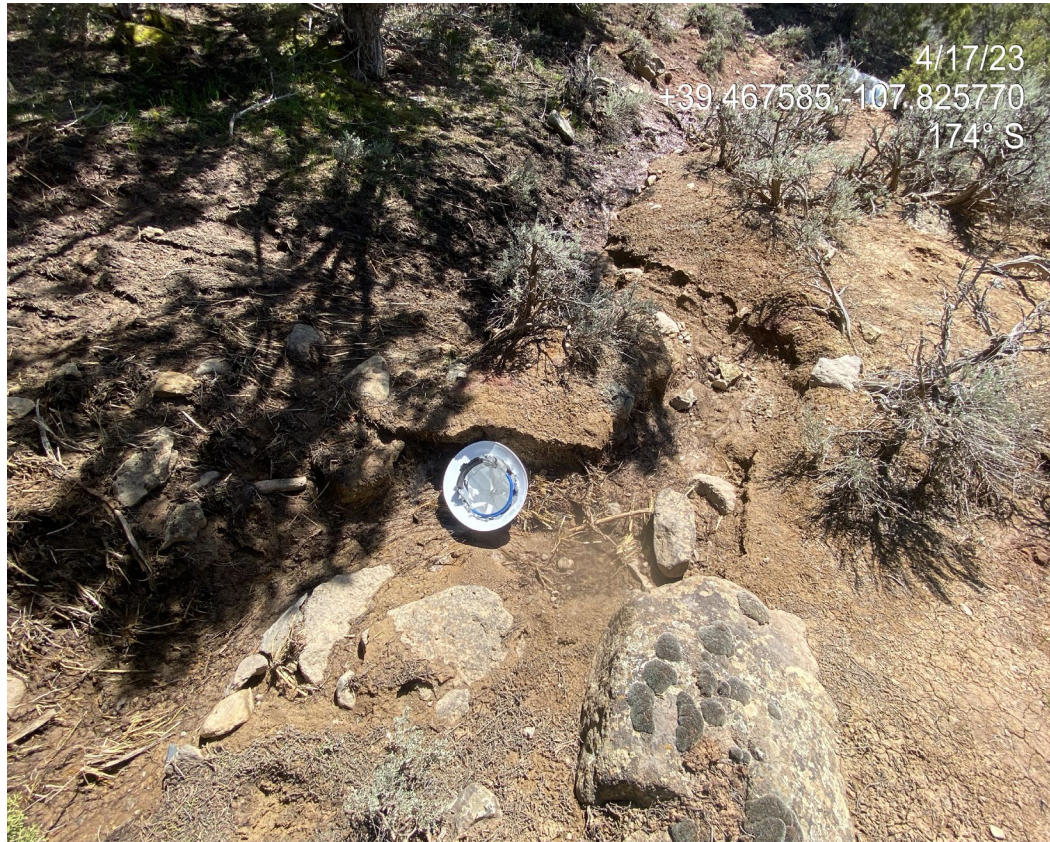
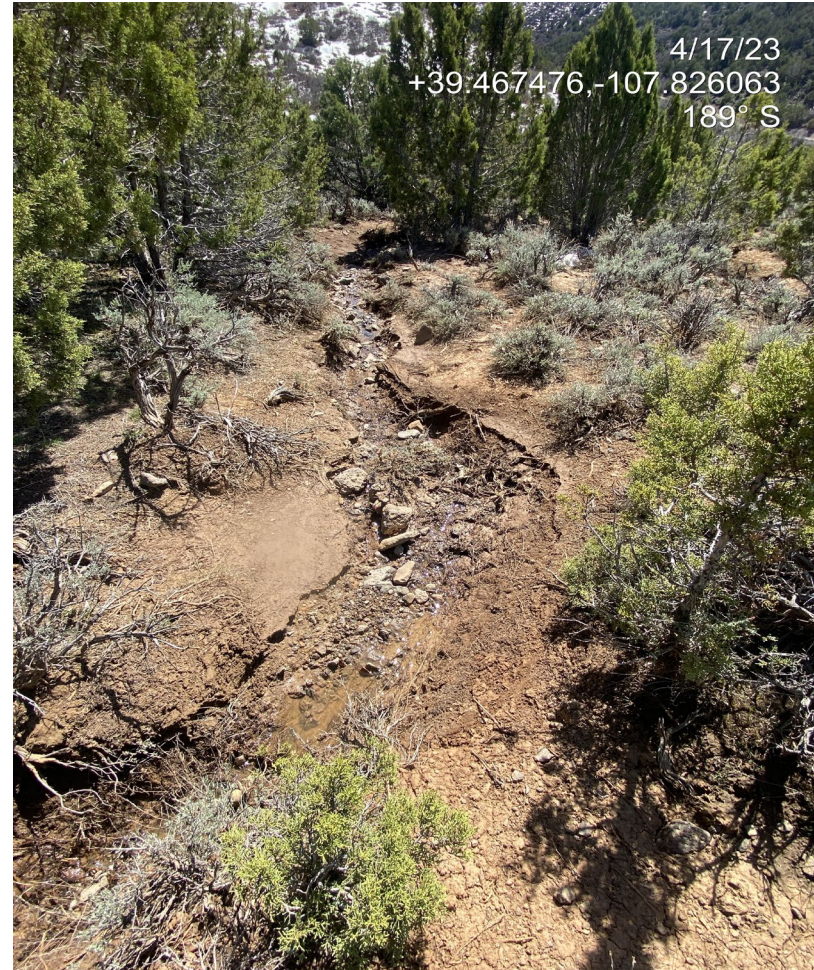
Photo 15. Photos show offsite degradation downslope of the sediment trap outlet pictured in Photo 13.
