**KT Resources LLC  
Ant Hill Unit Wyatt 36-13  
Location #316347**

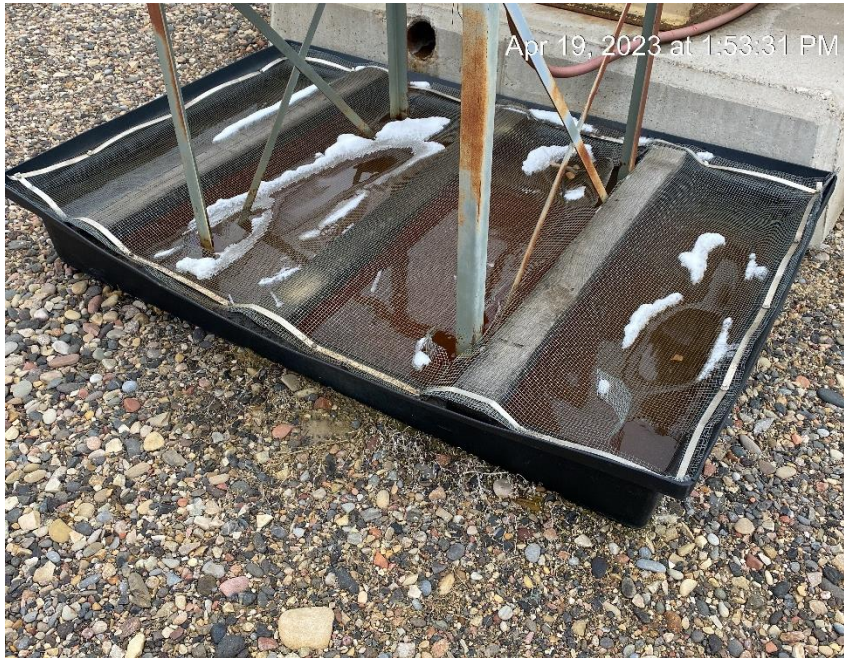
**Containment full of liquid**

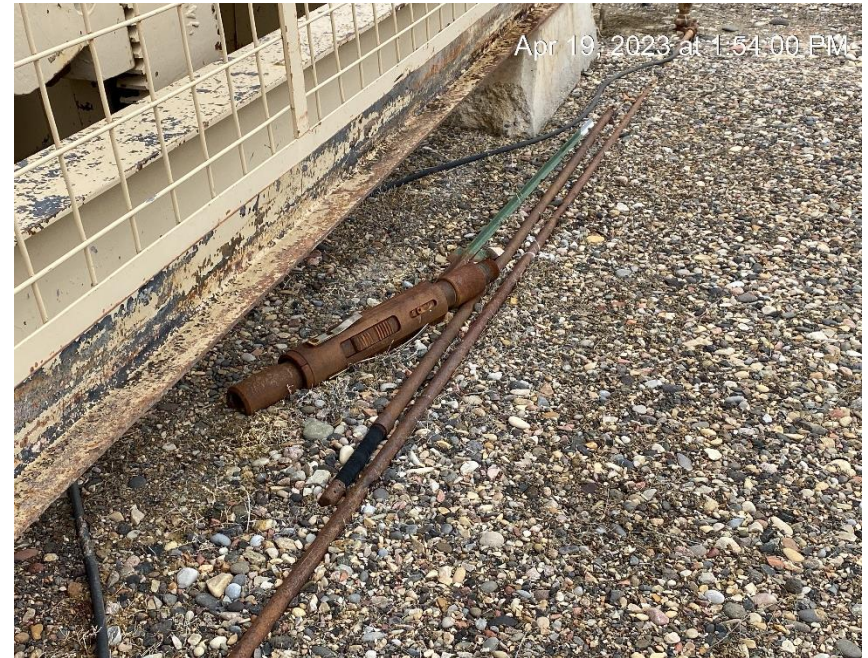
**Debris alongside pumping unit**

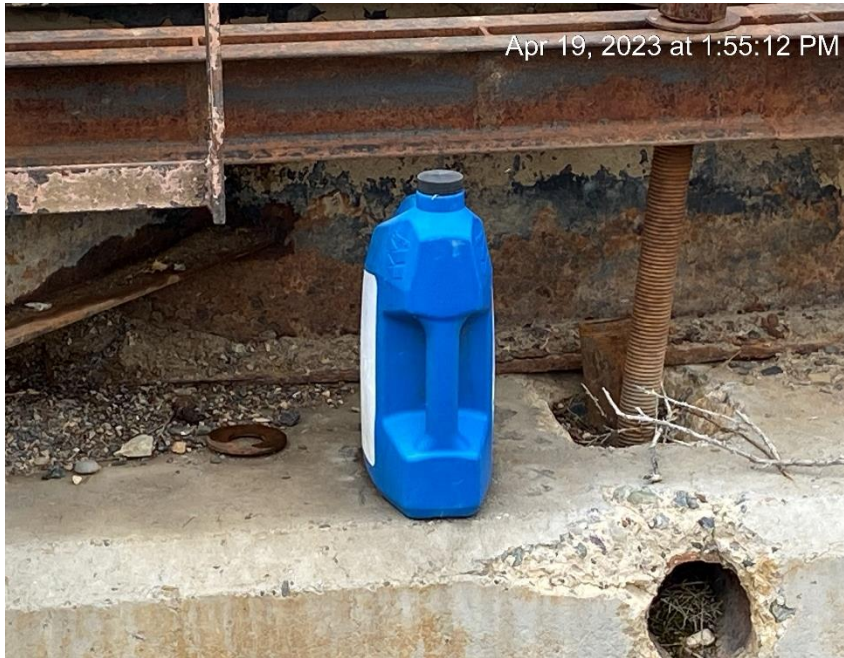
**Debris sitting on pumping unit base**

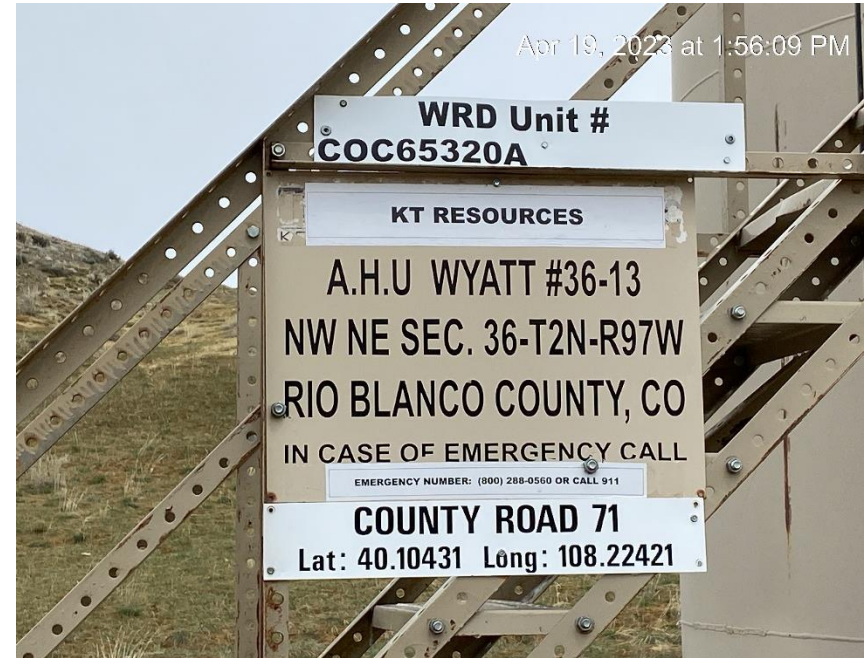
**API Number missing from tank battery sign**

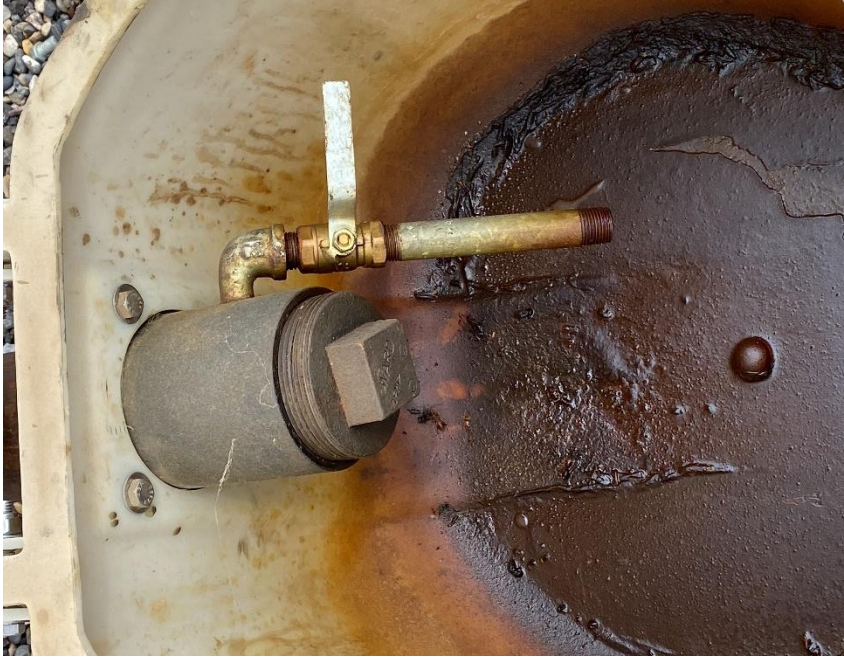
**Drain valve on loadline lacks cap or plug**

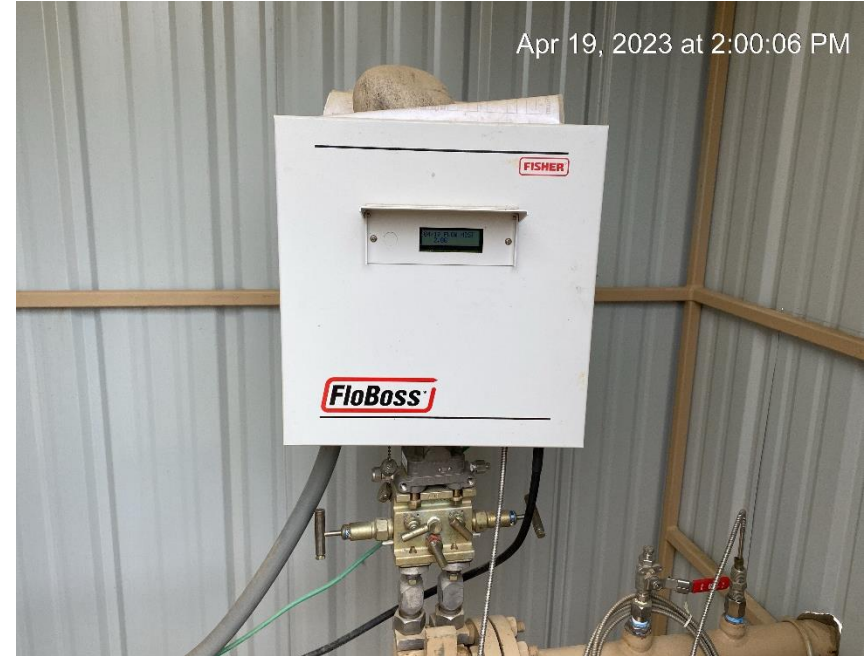
**Gas meter calibration card not visibly displayed**

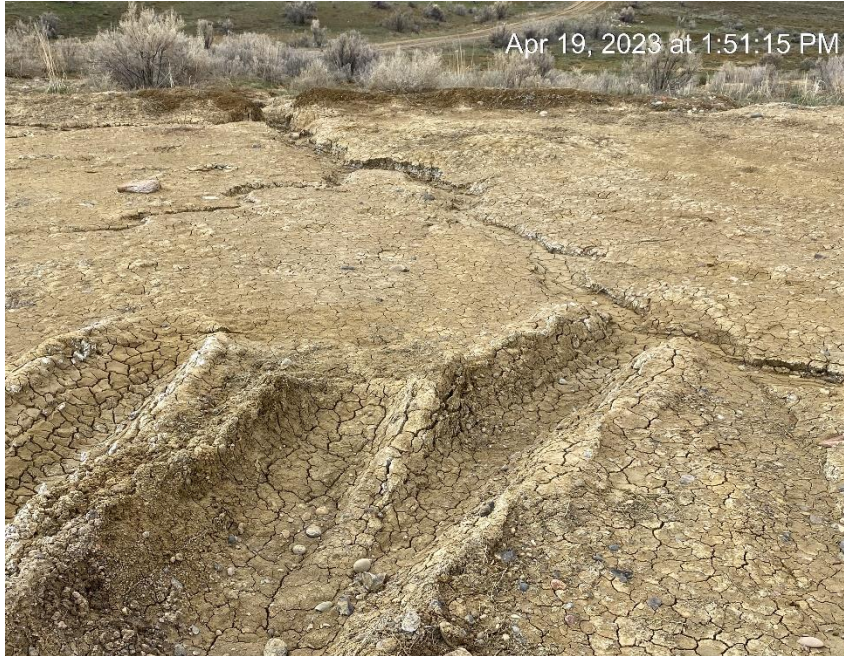
**Erosion and sediment migration exiting location**

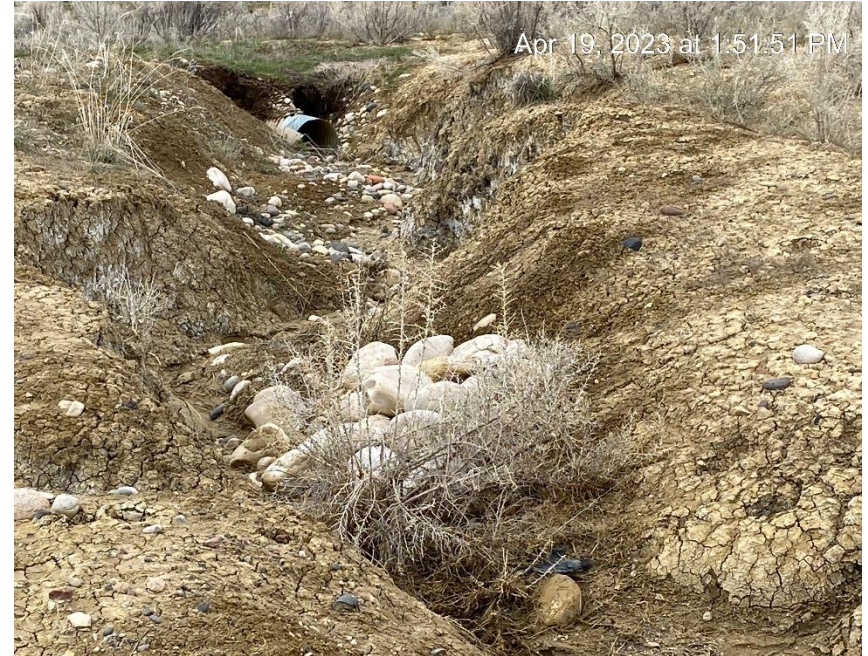
**Check dams and culvert erosion**

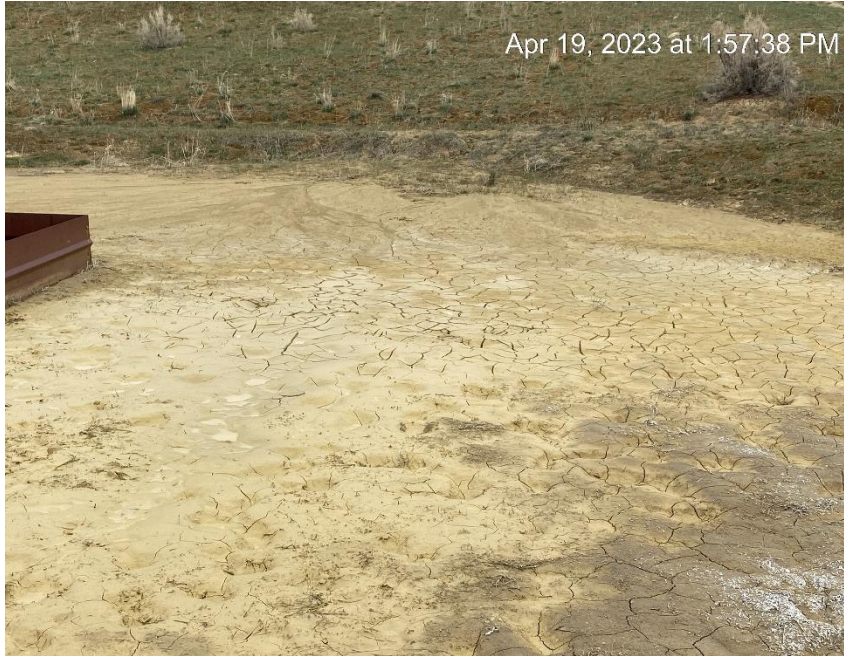
**Sediment migration onto location**

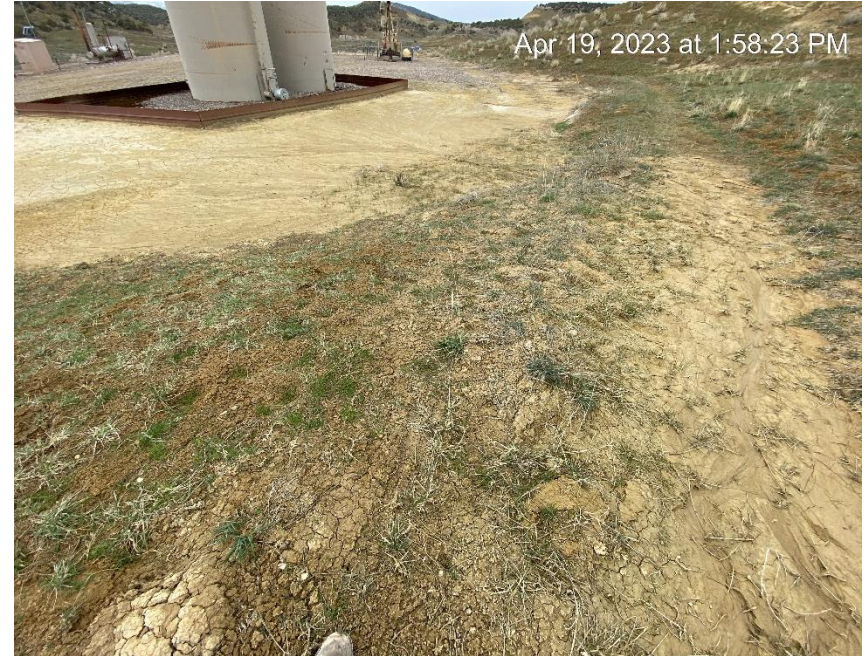
**Bypass ditch full of sediment, erosion and sediment migration entering location**

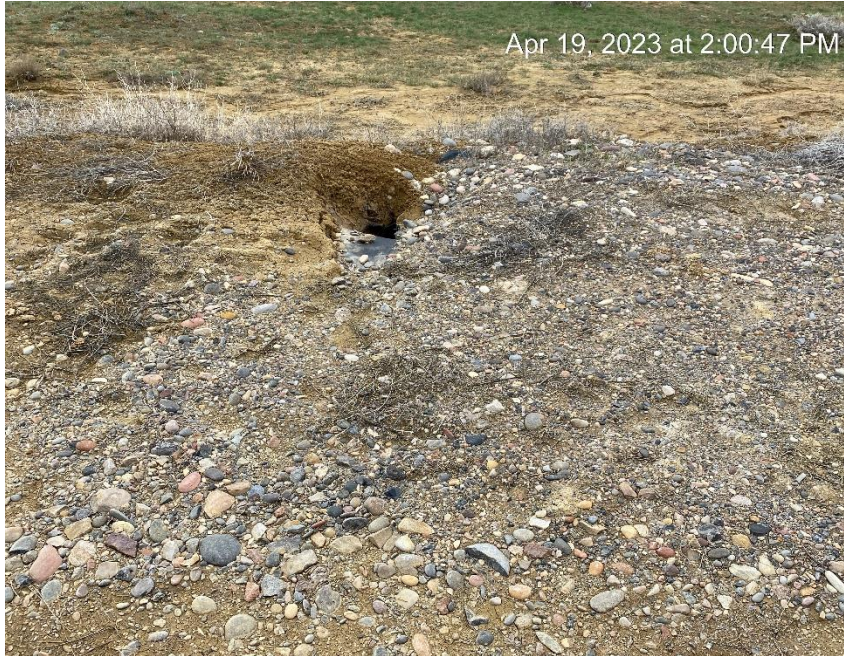
**Erosion and sediment migration leaving location**

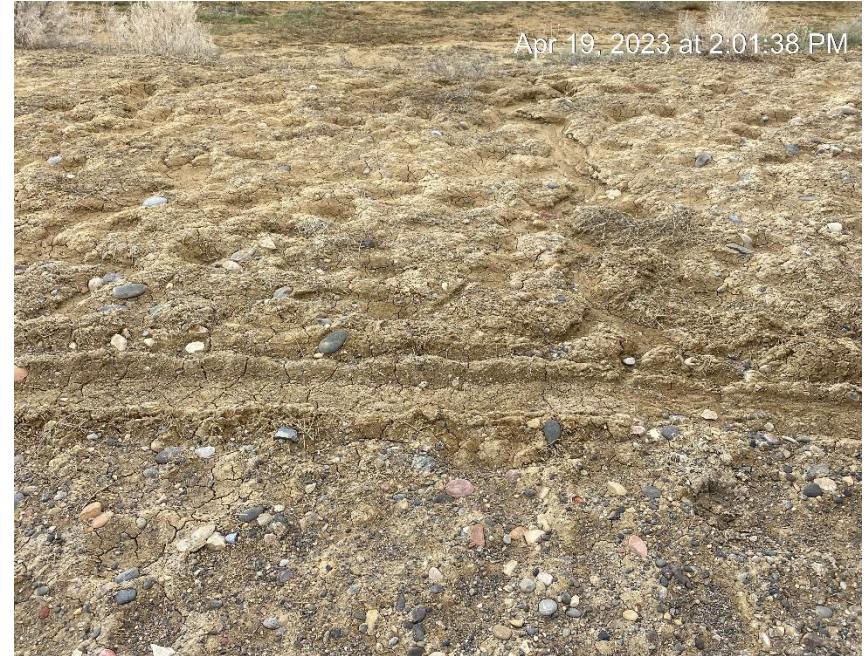
**Erosion and sediment migration leaving location**
