Inspection Photos

Location Name: TEP ROCKY MOUNTAIN LLC BOSELY SG 24-23 Pad

Location ID: 334579

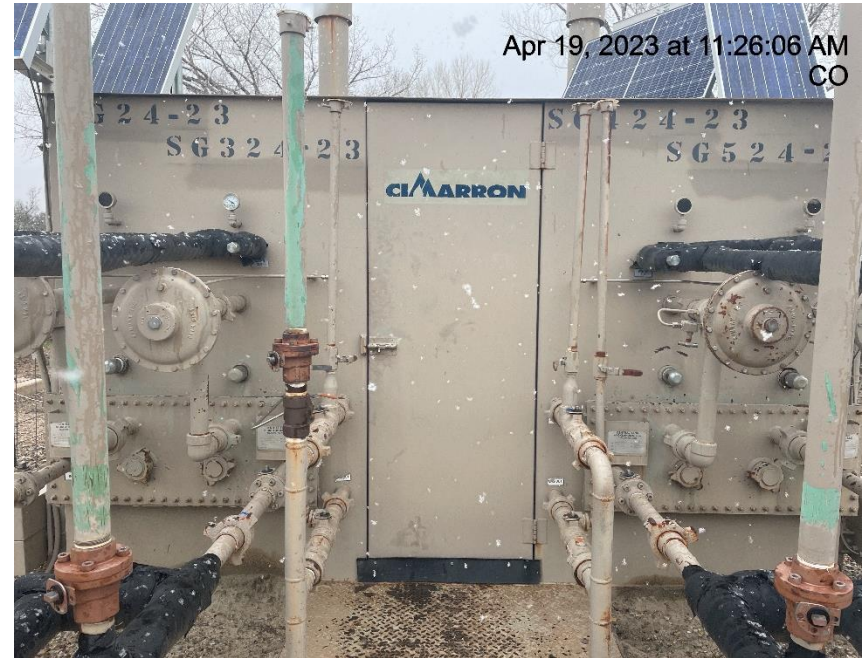
Photo # 5755 Meter calibration info not conspicuously posted

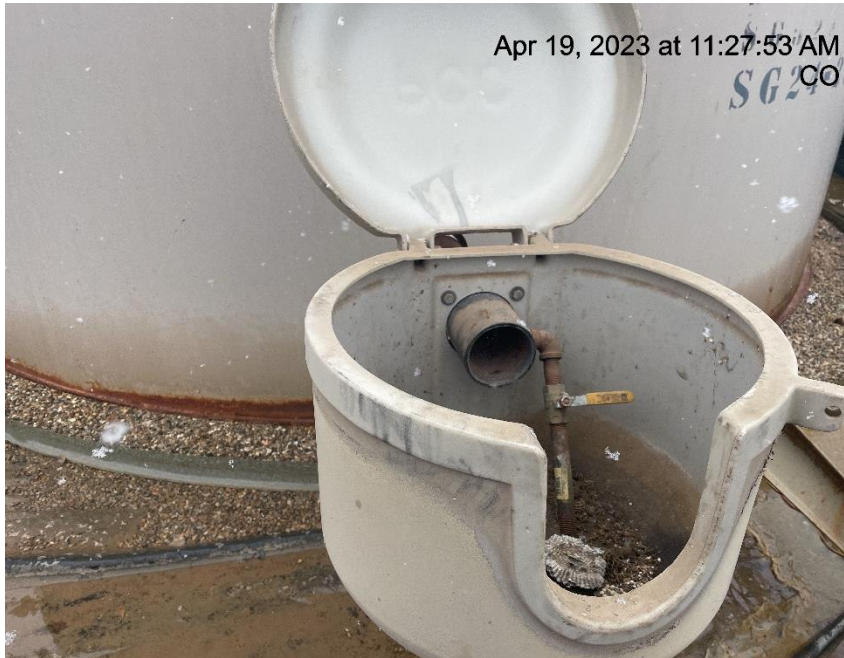
Photo # 5756 Open ended load line

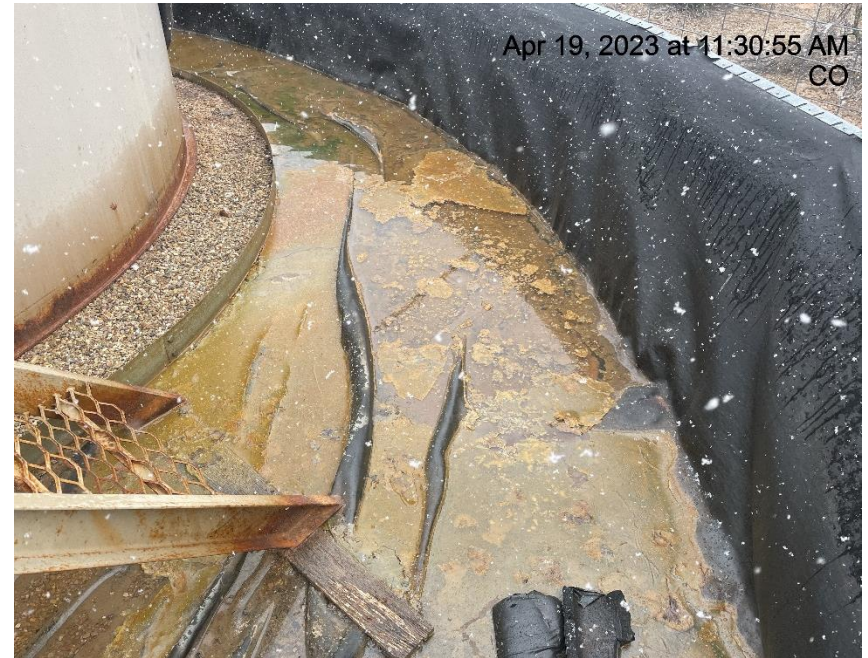
Photo # 5758 E & P waste is secondary containment

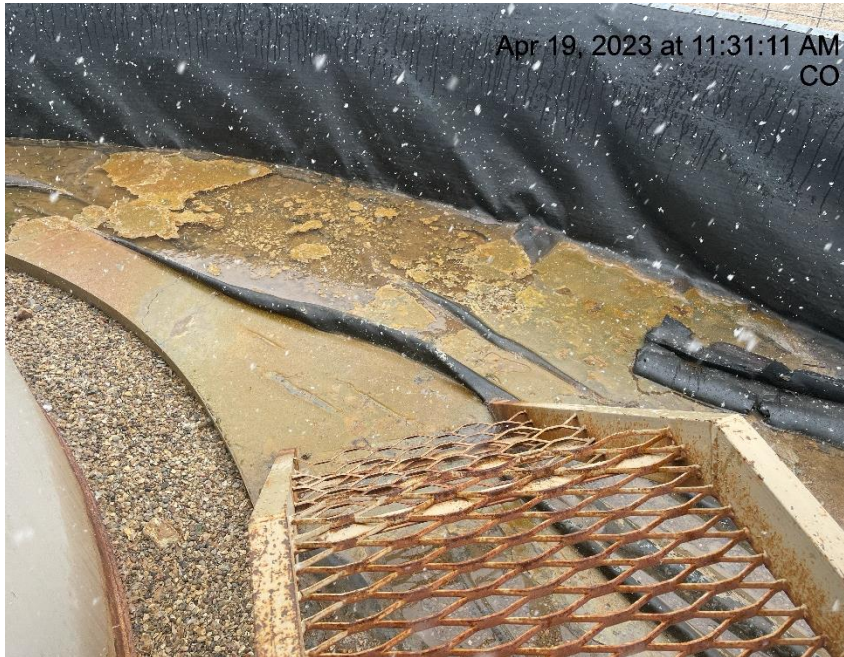
Photo # 5760 E & P waste is secondary containment

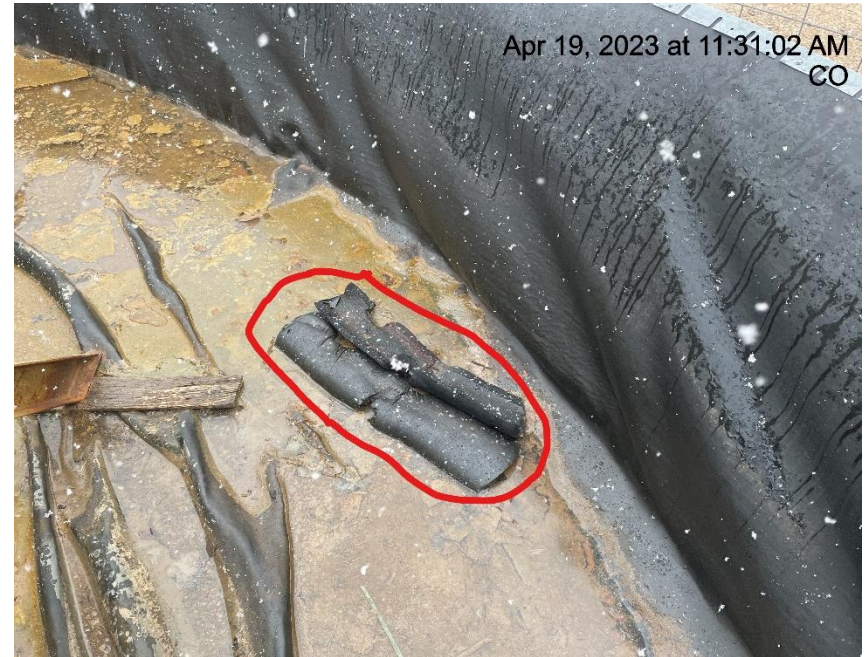
Photo # 5759 Debris

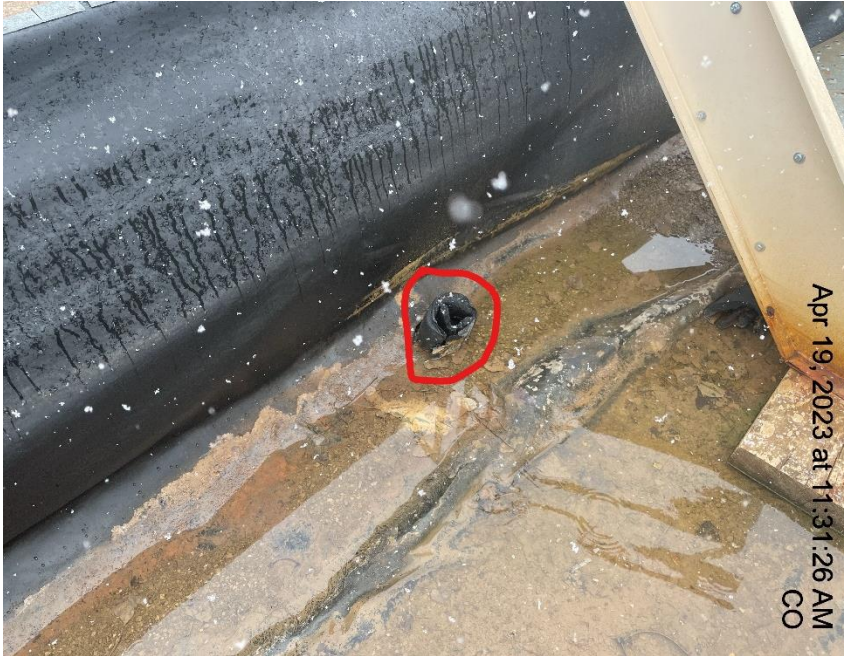
Photo # 5761 Debris

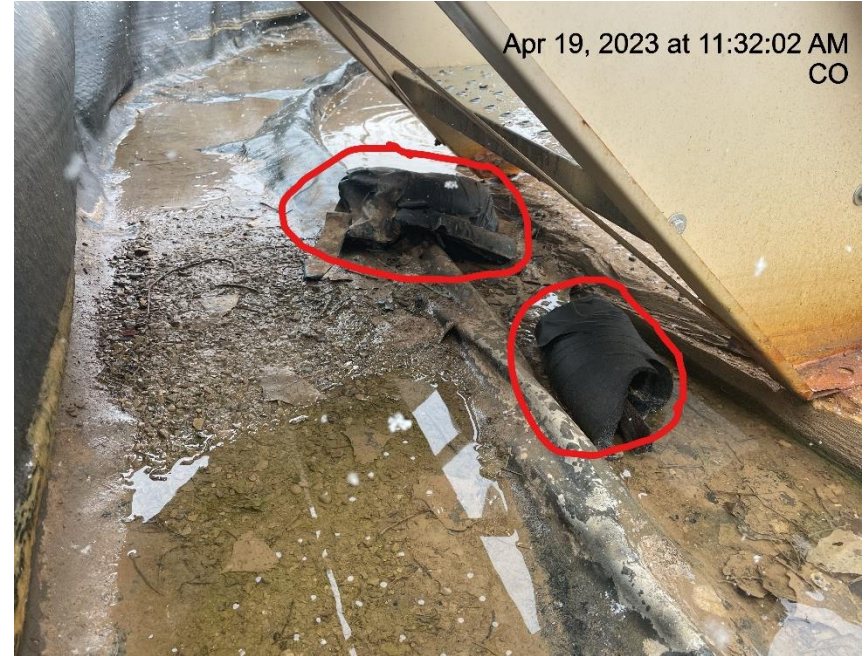
Photo # 5762 Debris

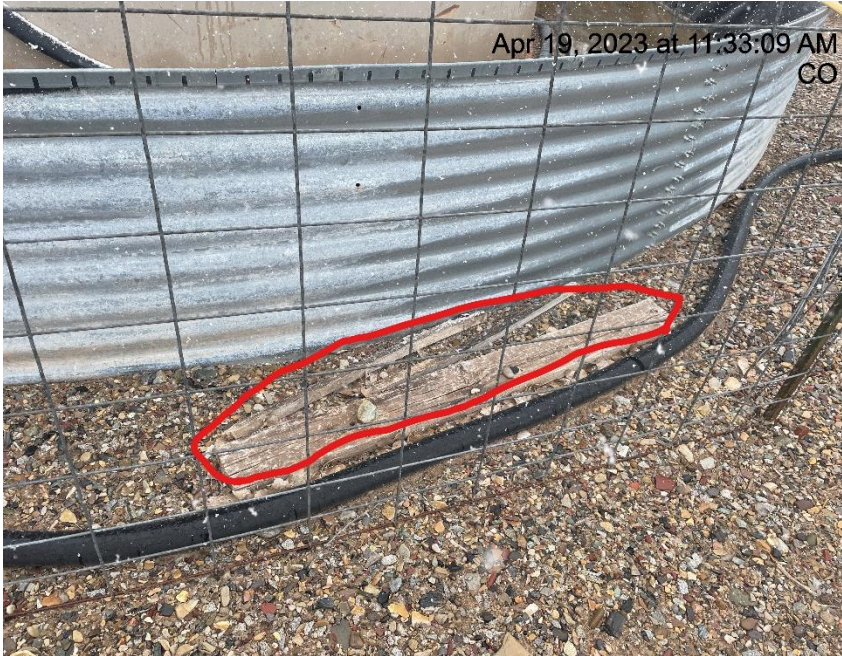
Photo # 5764 Debris

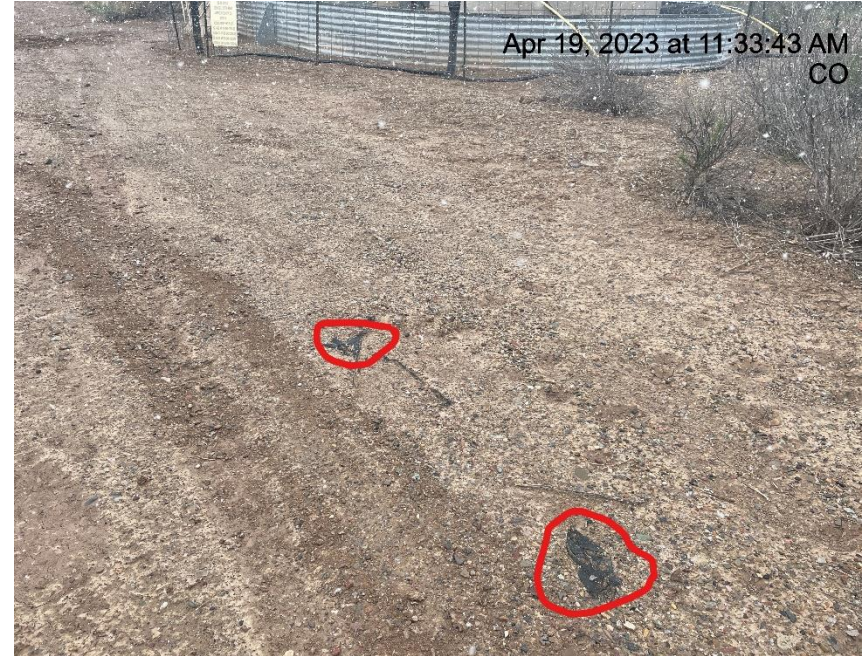
Photo # 5766 Debris

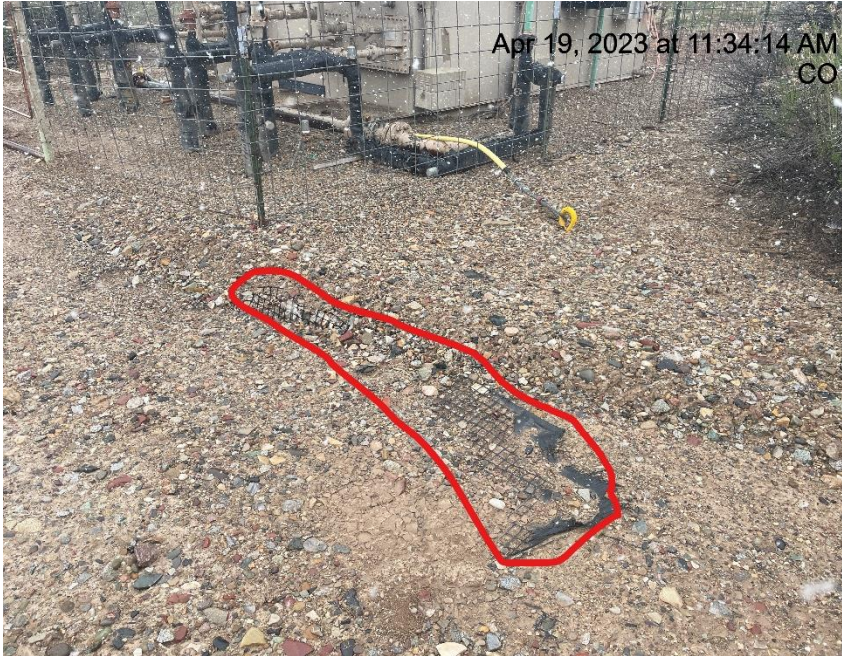
Photo # 5767 Debris

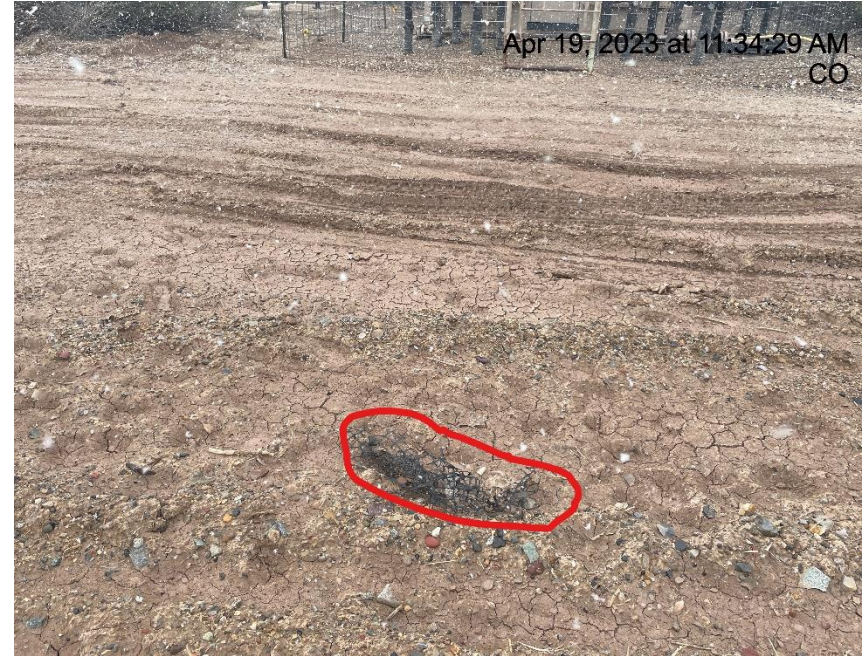
Photo # 5768 Debris

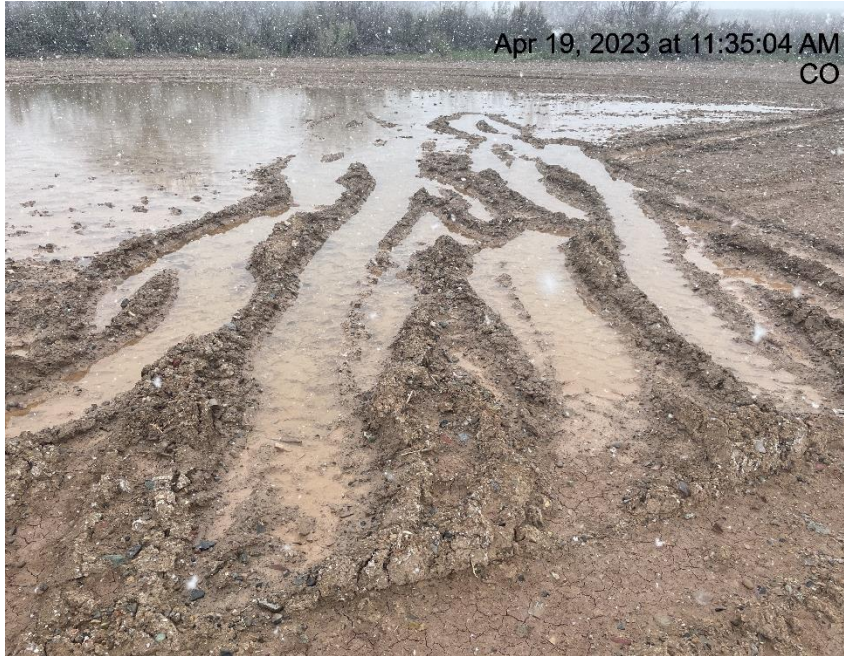
Photo # 5770 Lack of stabilization/compaction

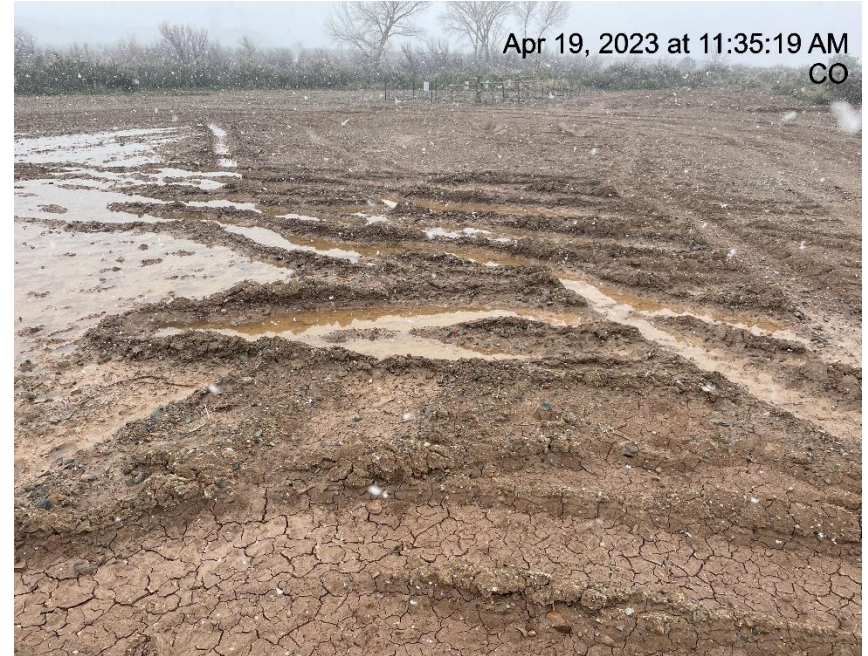
Photo # 5771 Lack of stabilization/compaction

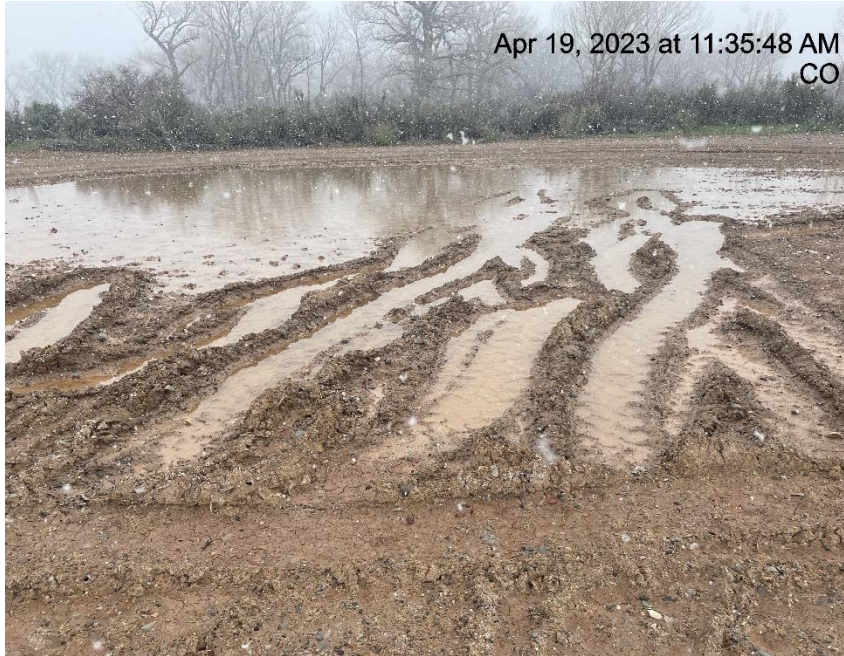
Photo # 5772 Lack of stabilization/compaction

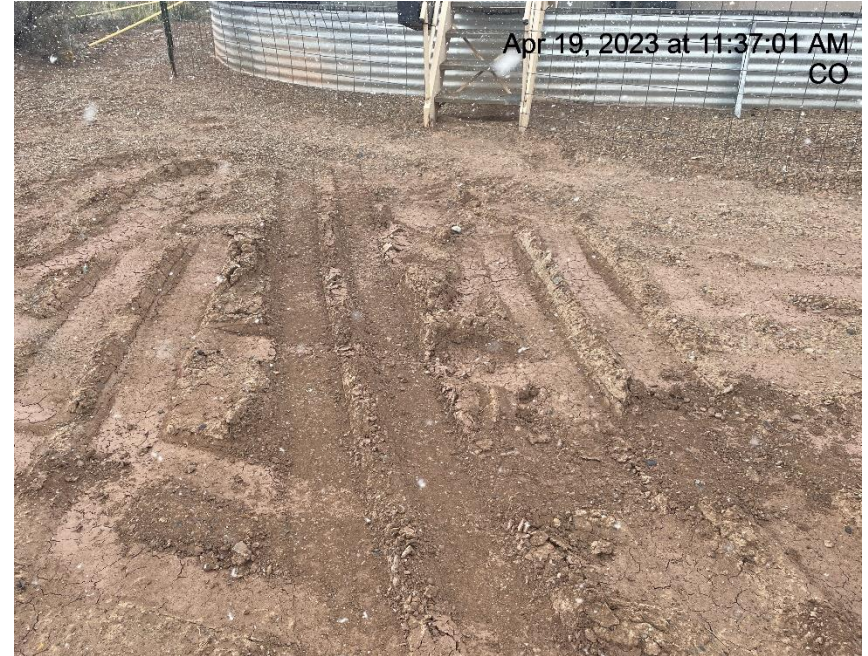
Photo # 5776 Lack of stabilization/compaction

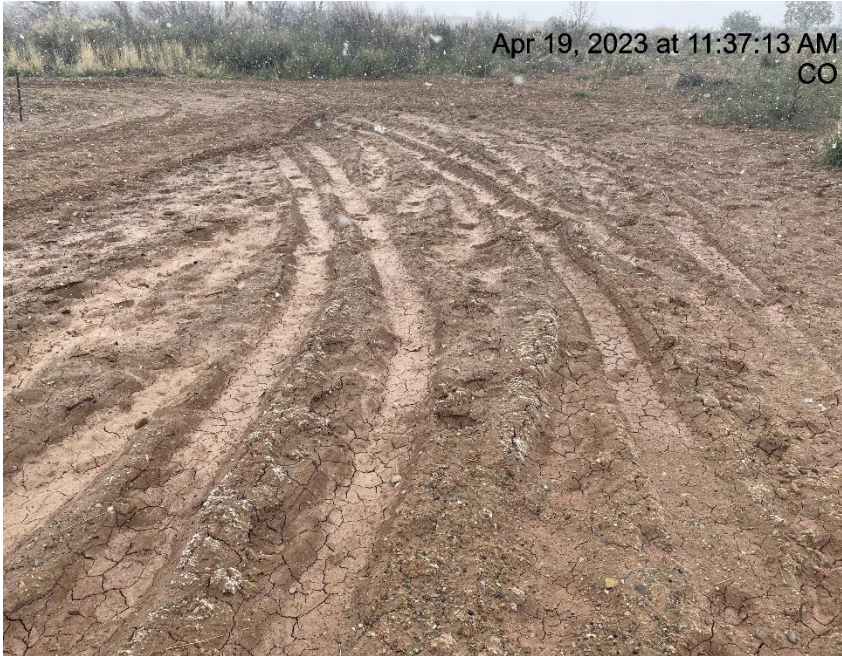
Photo # 5777 Lack of stabilization/compaction

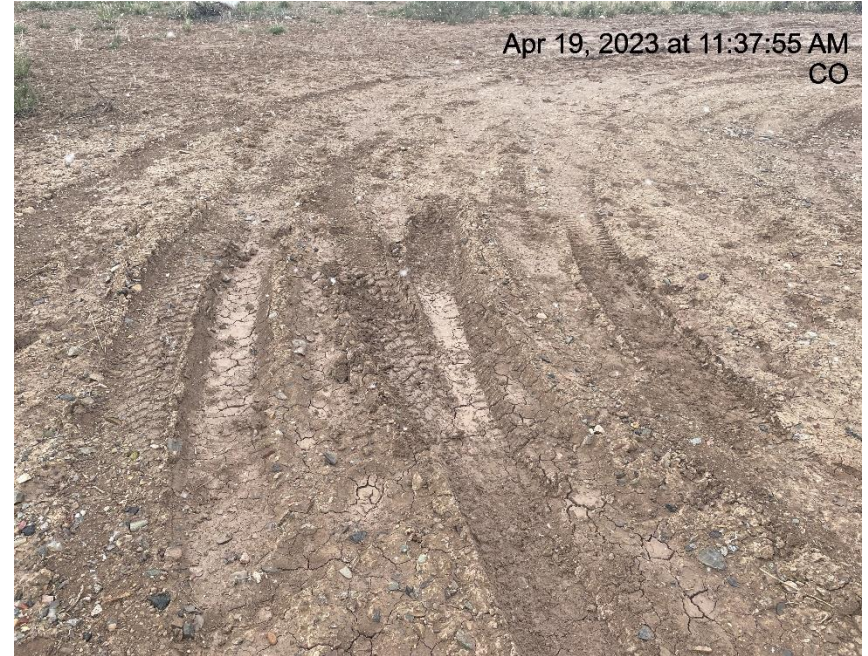
Photo # 5779 Lack of stabilization/compaction

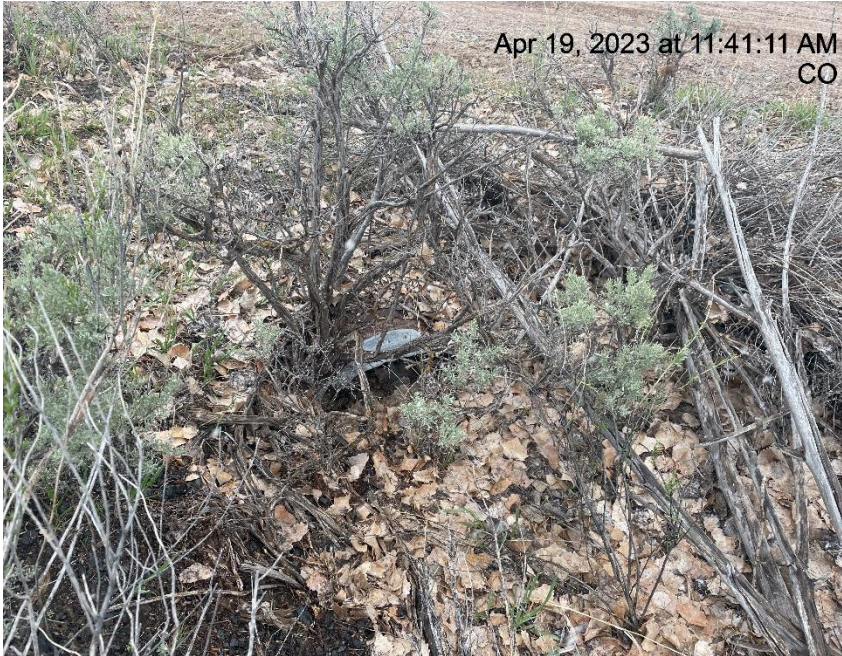
Photo # 5783 Culvert needs maintenance (on lease road near entrance to location)

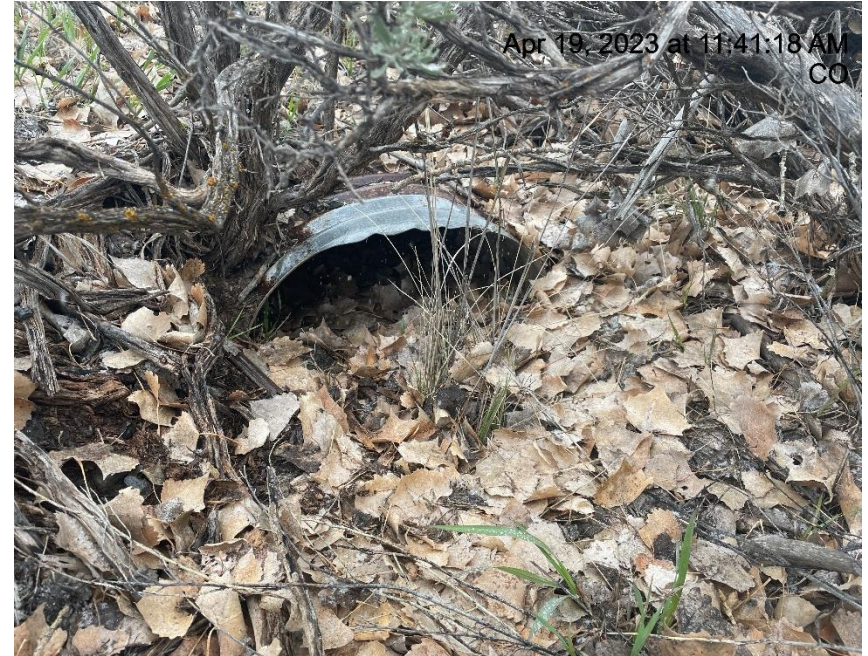
Photo # 5784 Culvert needs maintenance (on lease road near entrance to location)
