TEP ROCKY MOUNTAIN LLC, UNION-66S96W/33NWSE

Location # 335237

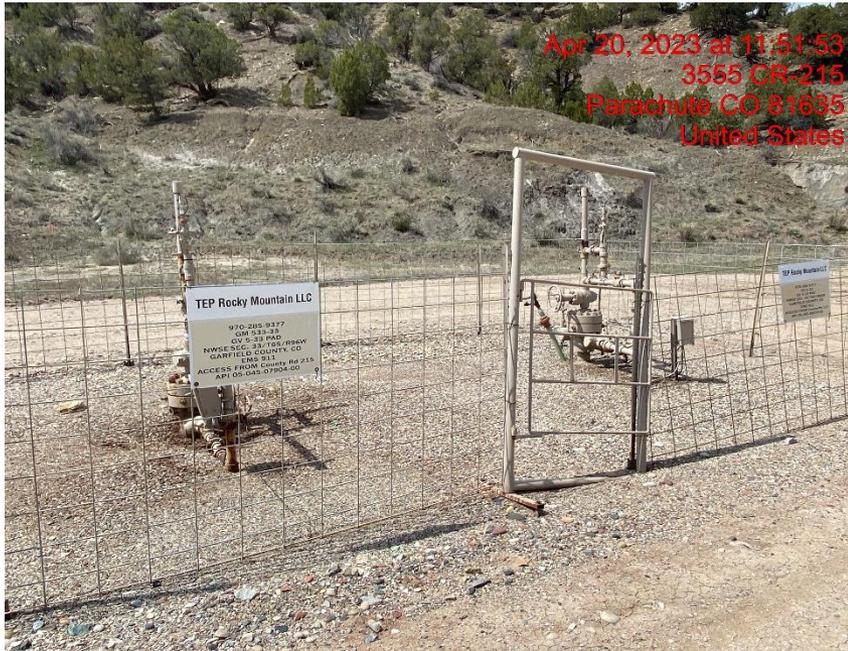
Wellheads – Photo #02397

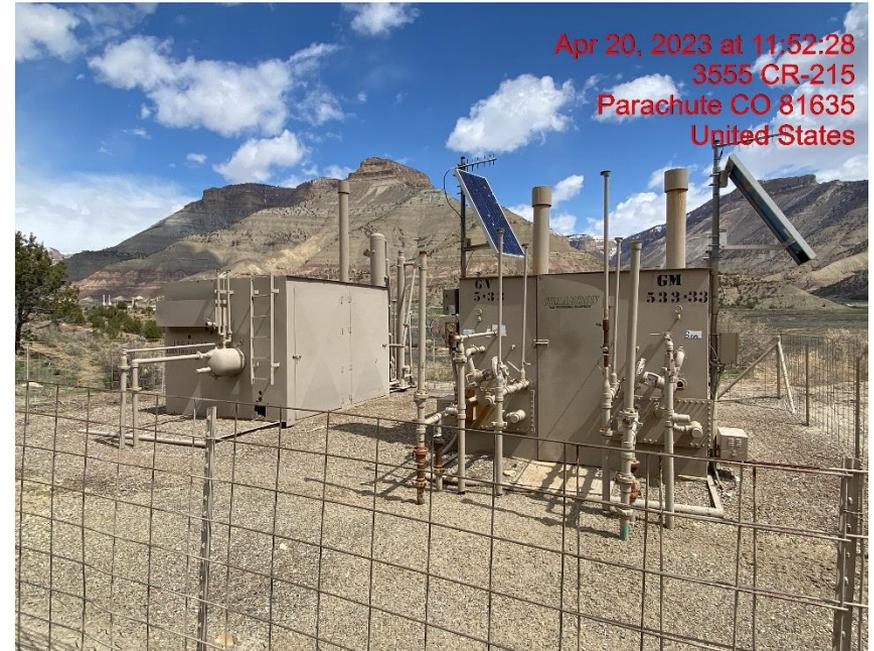
Separators – Photo #02399

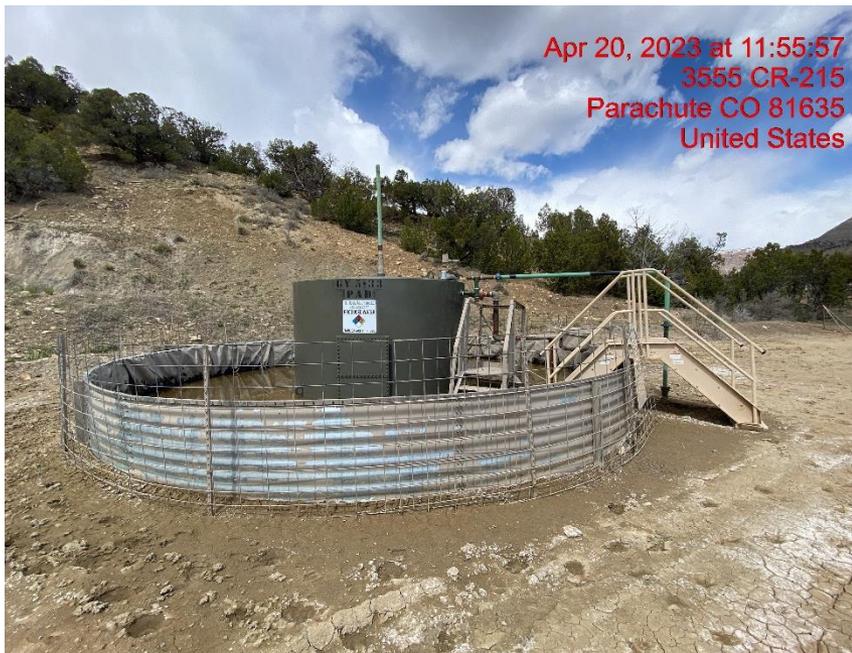
Tank Battery – Photo #02404

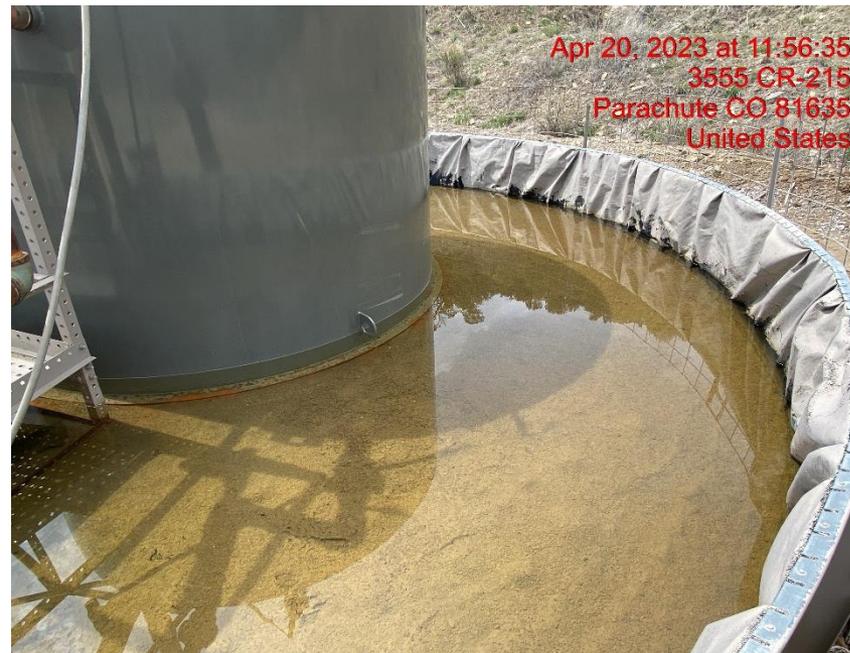
Inadequate Berm Capacity - Photo #02406

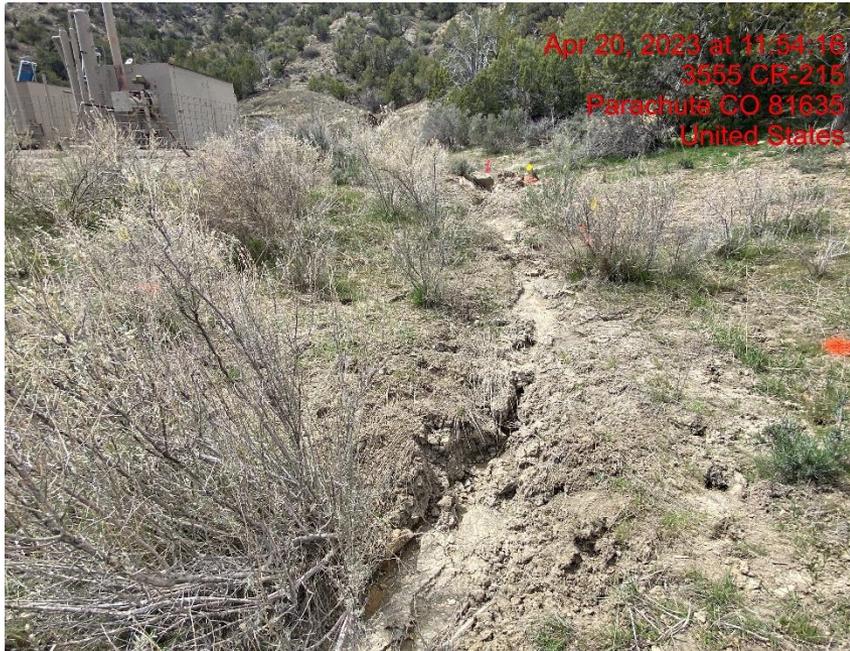
Rill Erosion/Transport of Sediment from Location – Photo #02401

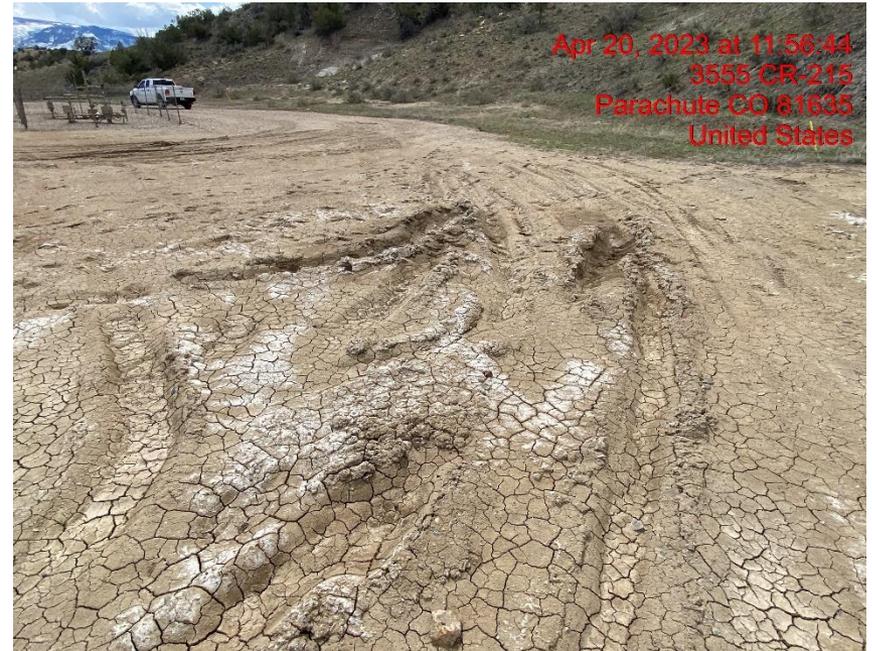
Lack of Stabilization – Photo #02407

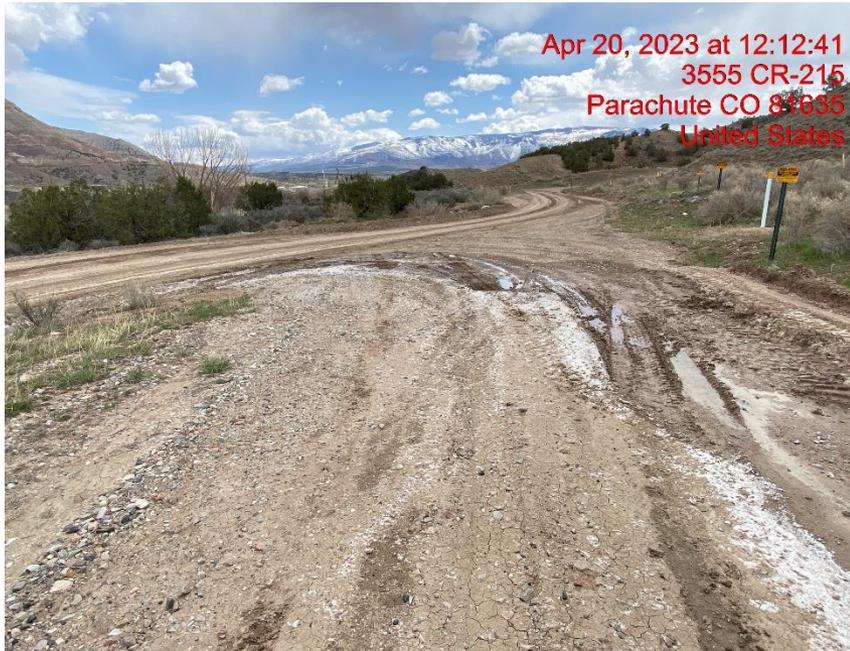
**Inadequate Vehicle Tracking BMPs at Location
Entrance/Exit – Photo #02409**

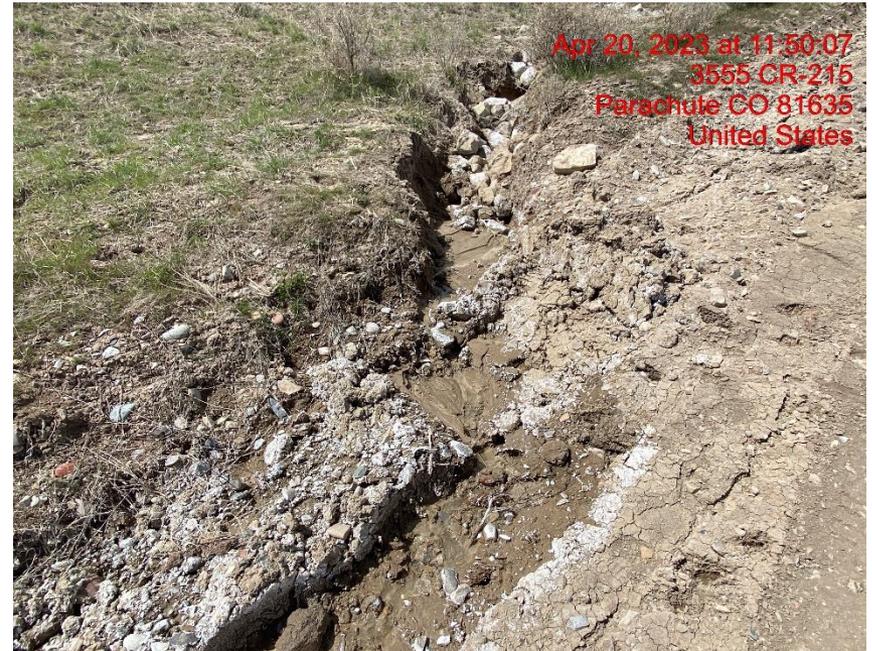
Access Road Ditch Erosion– Photo #02395
