Operator: CIVITAS NORTH
Location Name: Allred 8-59 30
Loc ID: 476815
Inspection: 708200130

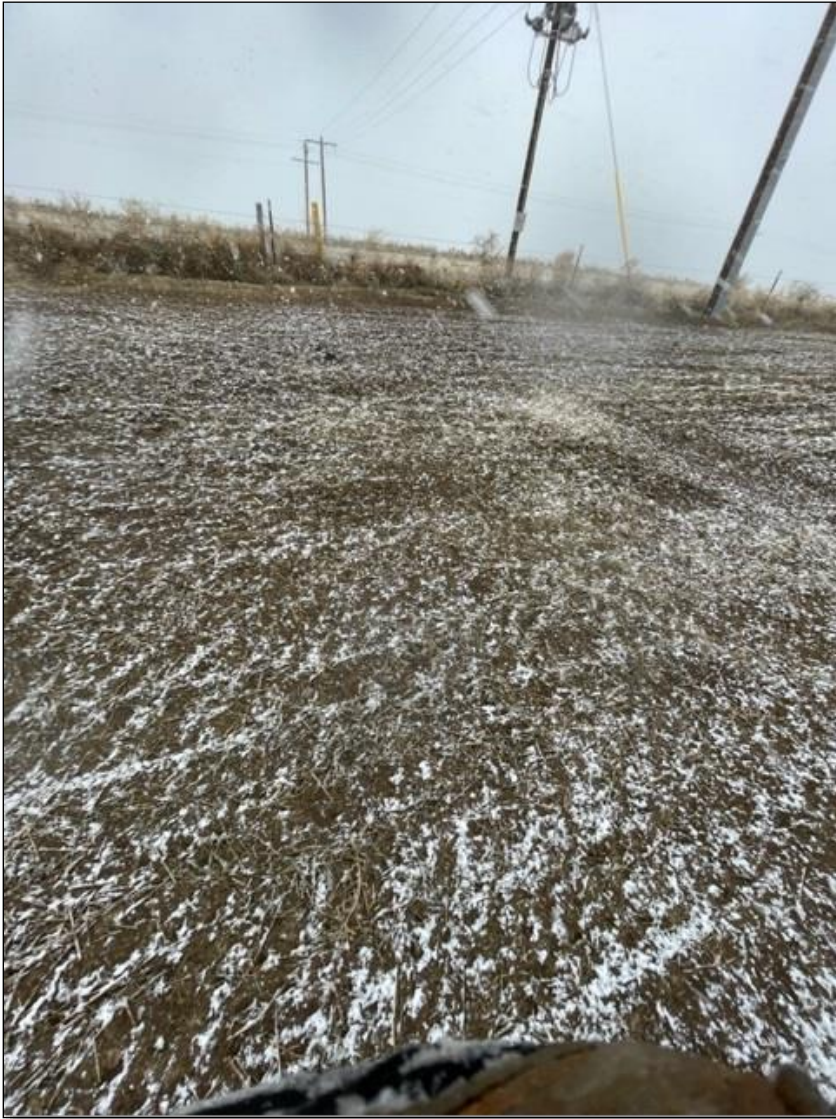
Exhibit A

CA: Tumbleweed accumulations were observed around equipment and present a fire hazard. Comply with Rule 606 and remove weedy debris from around equipment.

CA Resolution: Weeds were removed/mowed on 4/19/2023. The location now complies with Rule 606.

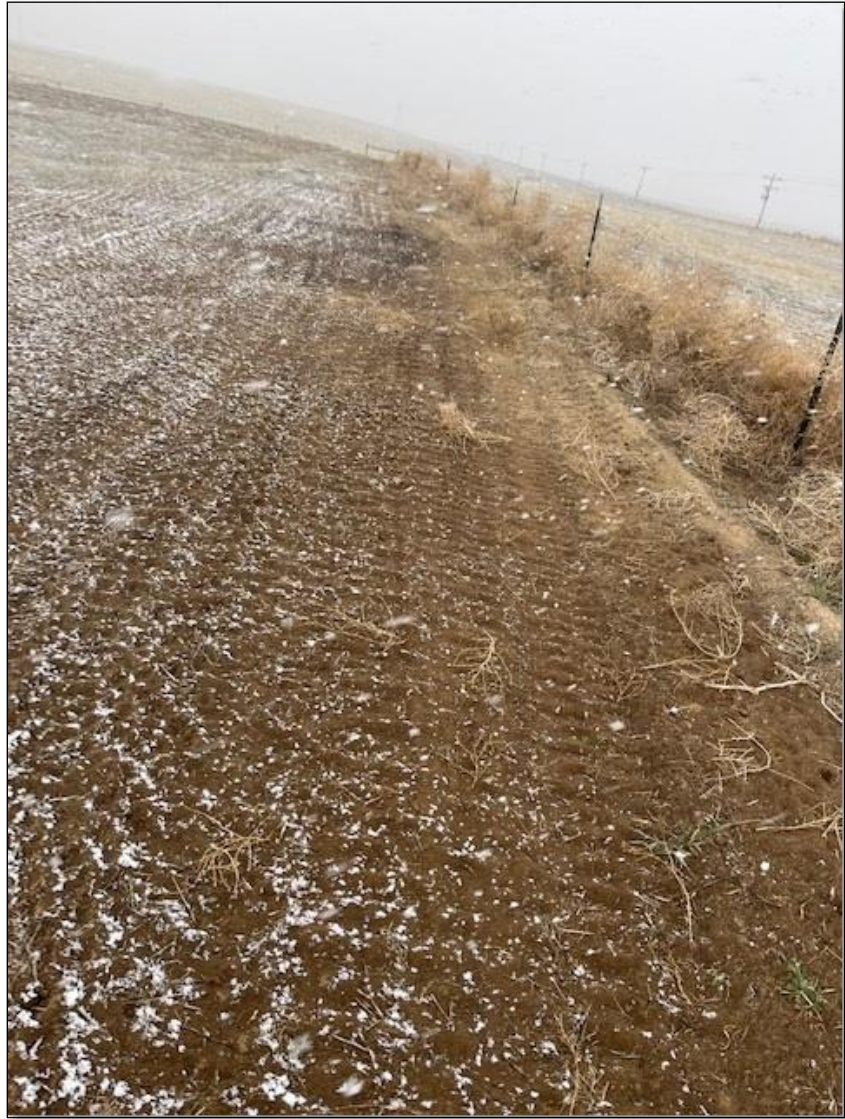
Exhibit B

CA: Trash observed accumulating on perimeter fences. Comply with Rule 606 and remove all trash from the location.

CA Resolution: Trash on perimeter fences has been cleaned-up and removed as of 4/19/2023 to comply with Rule 606.

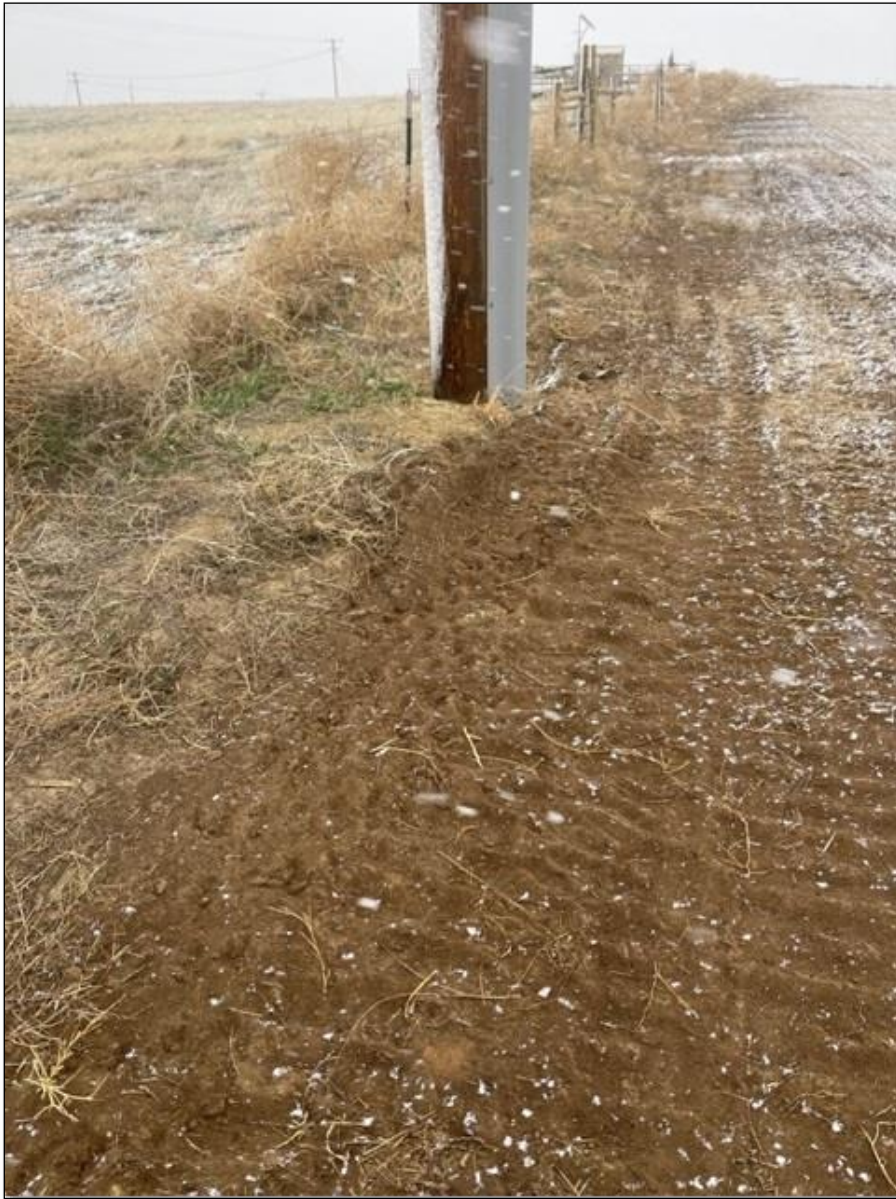
Exhibit C

CA: Road maintainer/drag, and concrete jersey barriers being stored on location. Comply with Rule 606 and remove equipment from the location.

CA Resolution: Equipment noted during inspection has been removed as of 4/19/2023 to comply with Rule 606.

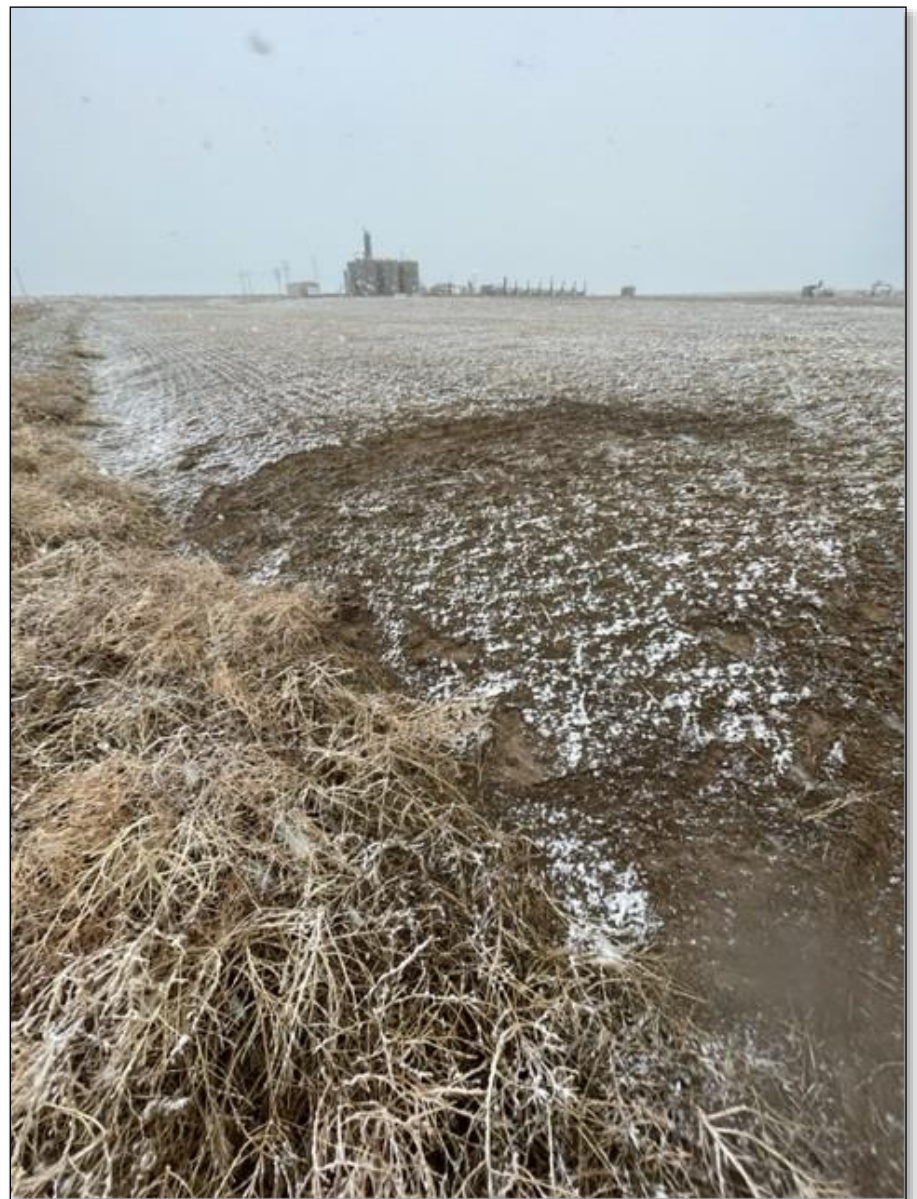
Exhibit D

CA: This location does not comply with Rule 1002.f. Rill erosion is occurring in the interim areas on the west side of the location and are not properly stabilized as vegetation has not established (germinated at time of this inspection). Additionally, the stormwater BMPs (e.g., fil-trexx wattles) placed on the eastside of the location are buried with sediment and are insufficient in preventing sediment laden stormwater from exiting off location and will require maintenance and/or replacement. Refer to attached inspection photos for documentation. Comply with Rule 1002.f.(2) to repair, maintain, and/or install BMPs in accordance with good engineering practices.

CA Resolution: As of 4/19/2023, Operator has removed filtrex wattles that were noted as deteriorating, and rill erosion has been raked in and the areas were over seeded. Operator will continue to maintain and/or install BMPs in accordance with good engineering practices to help minimize erosion and site degradation as outlined in Rule 1002.f.(2)
