**Caerus Piceance LLC
RNP 197-15A1
Location #441601**

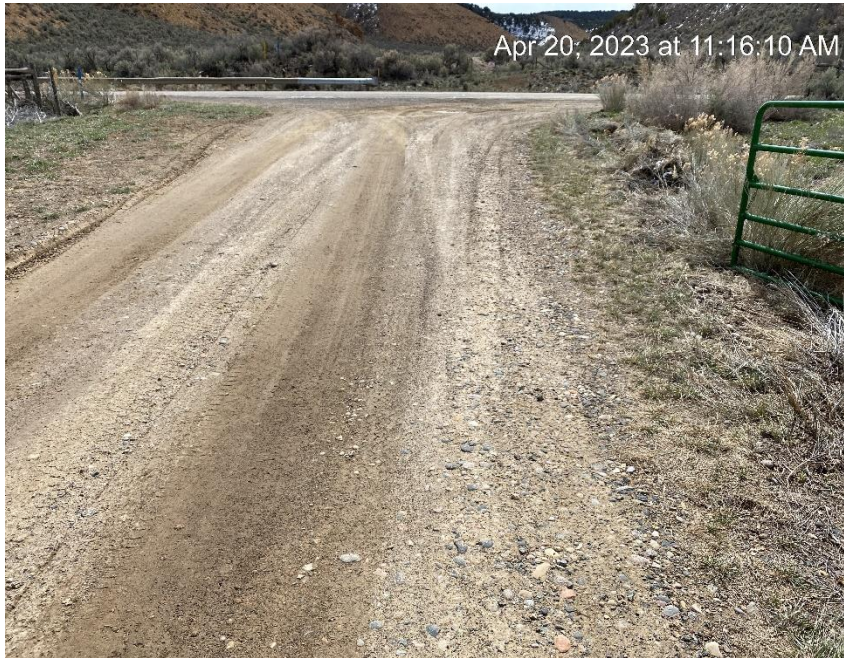
Access at county road

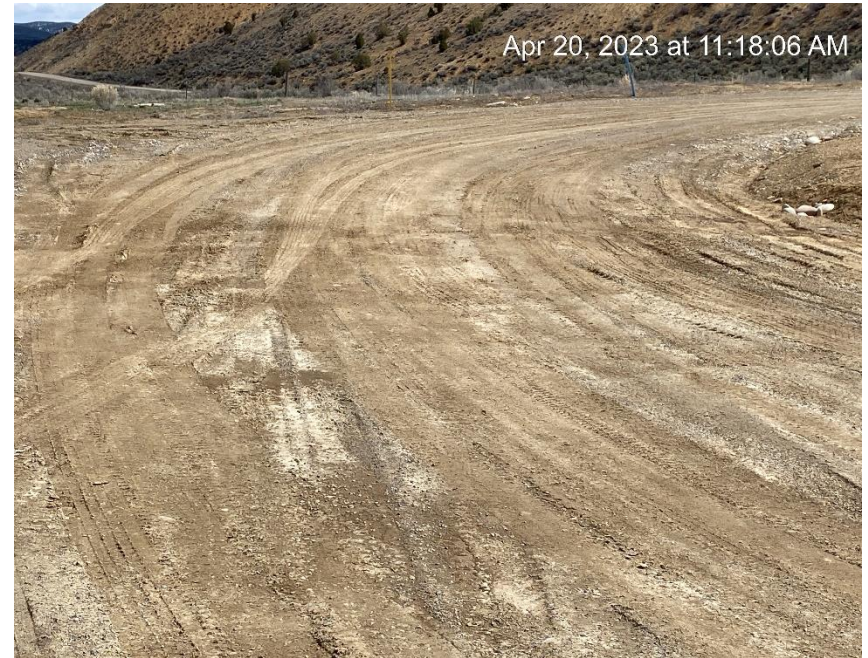
Access to location

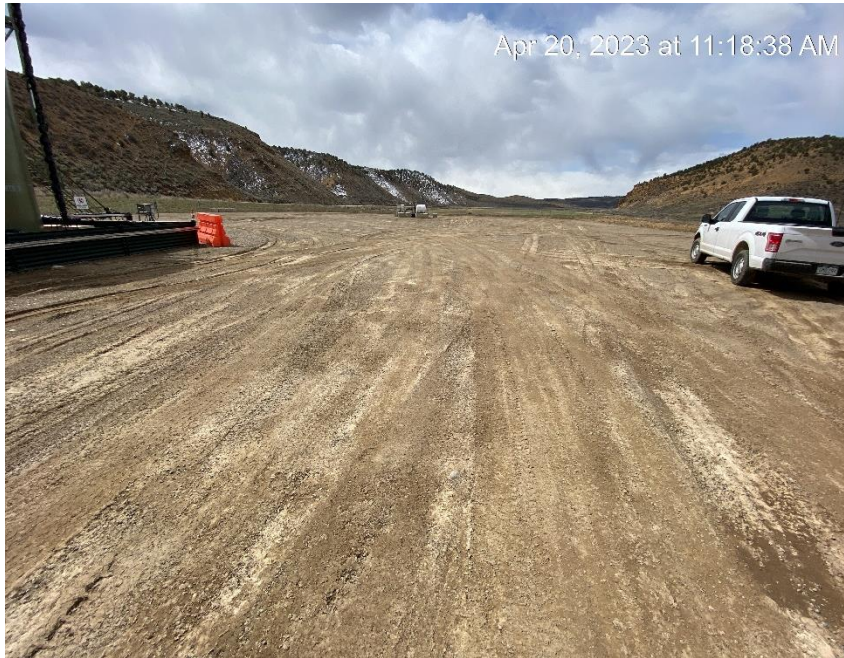
Entrance to location

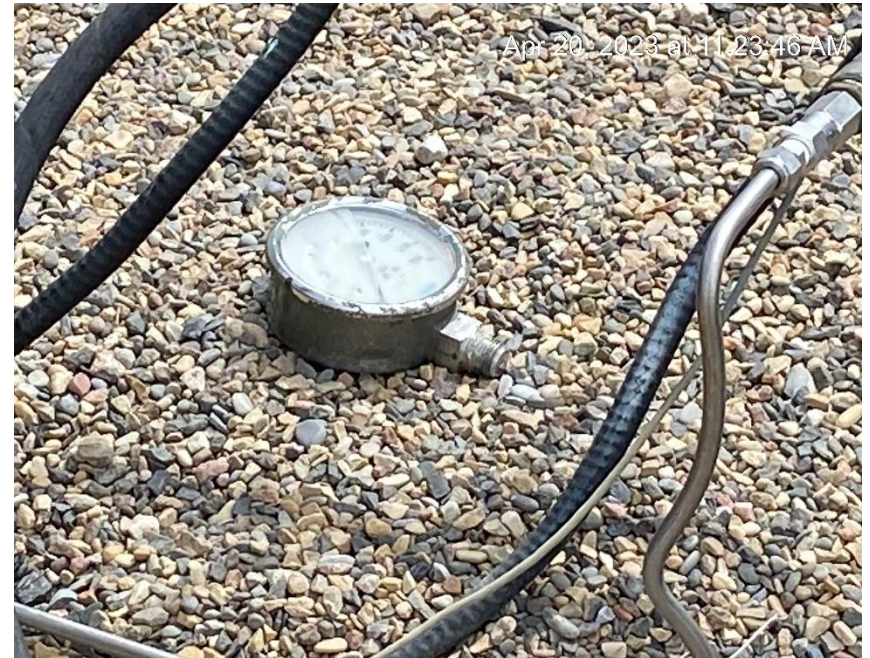
Debris

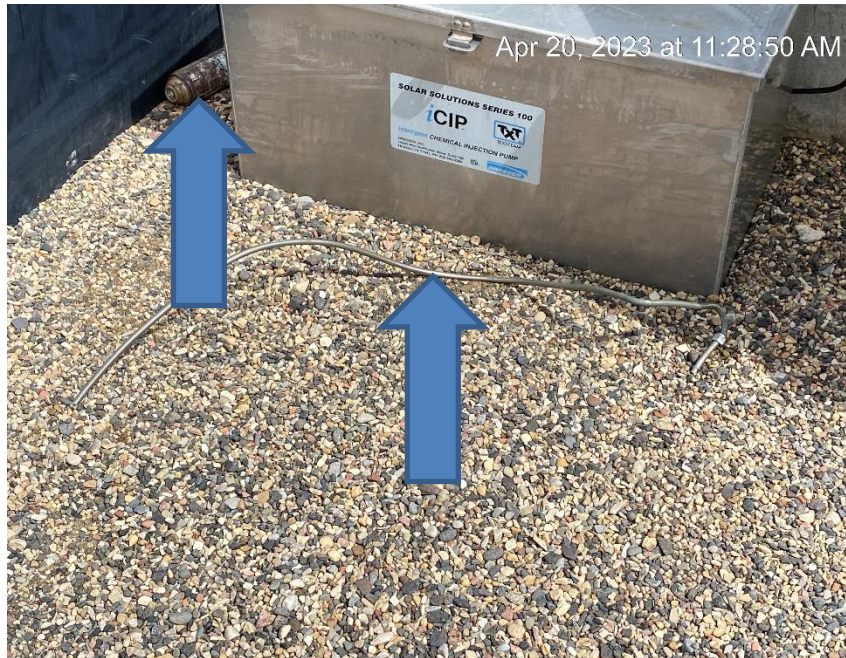
Random debris

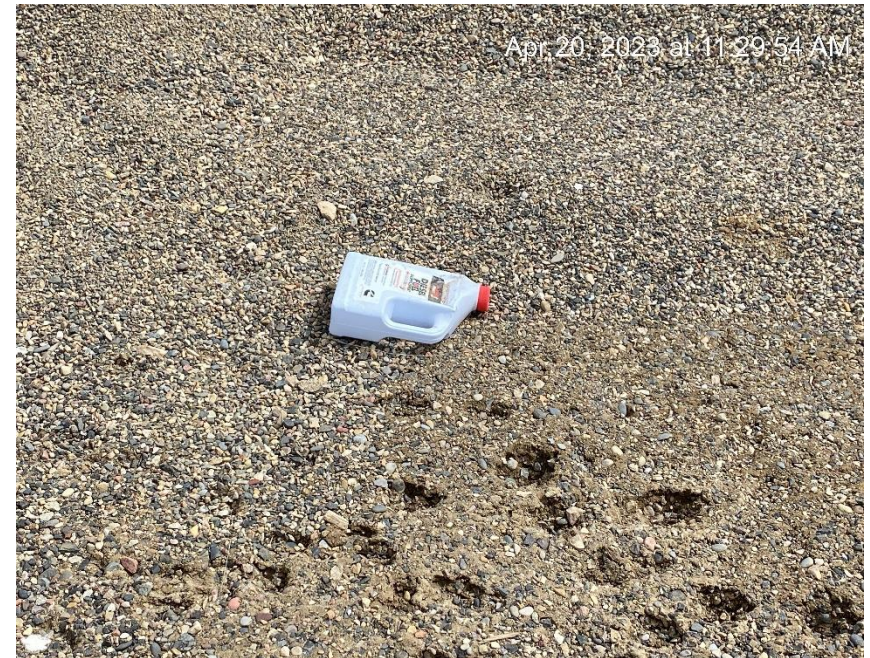
Trash

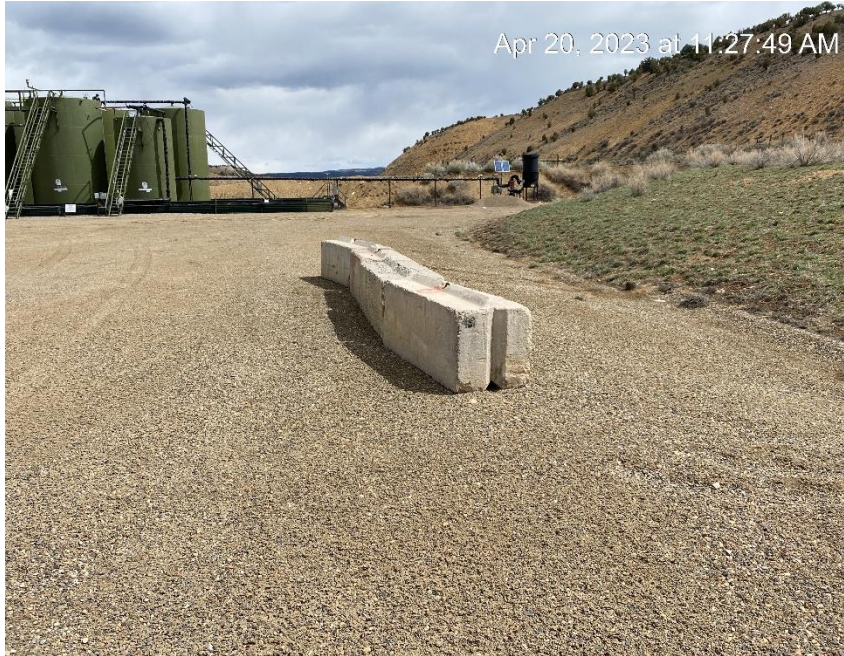
Unused equipment?

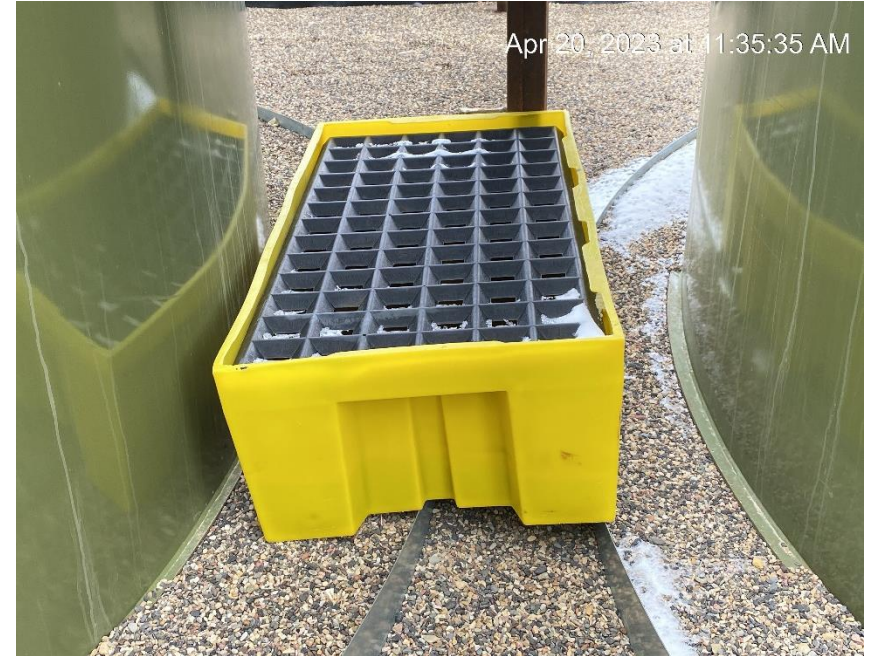
Unused equipment?

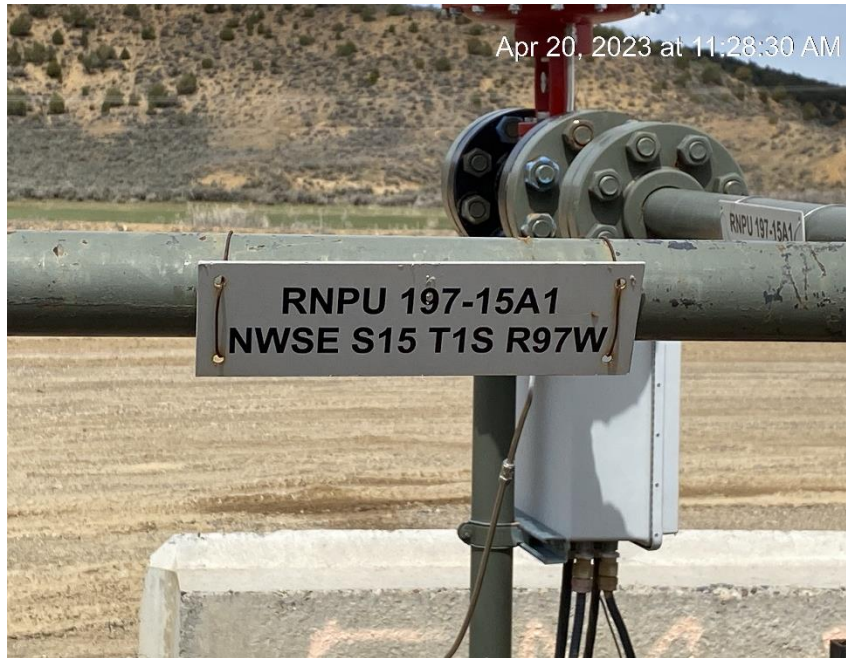
Section numbers do not match

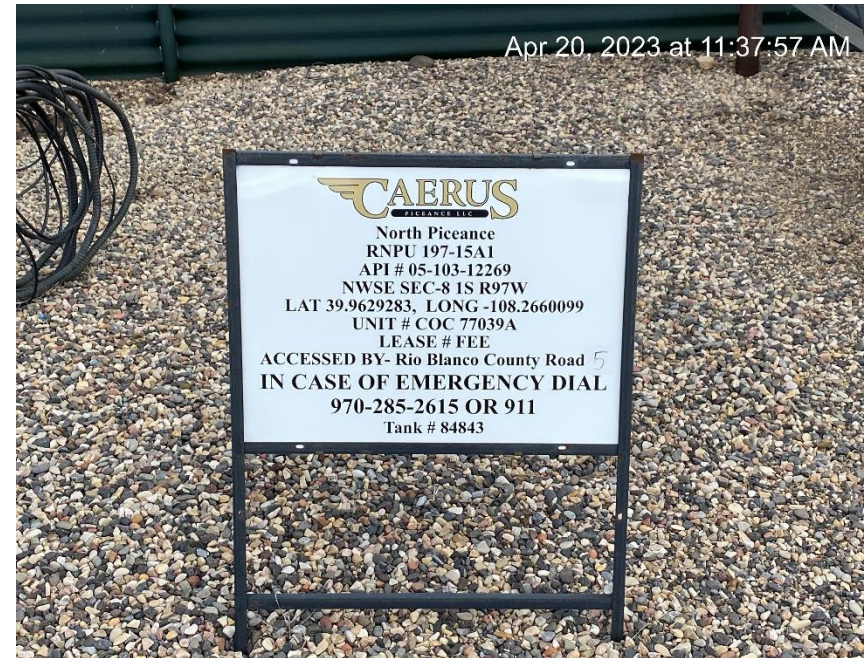
Section numbers do not match

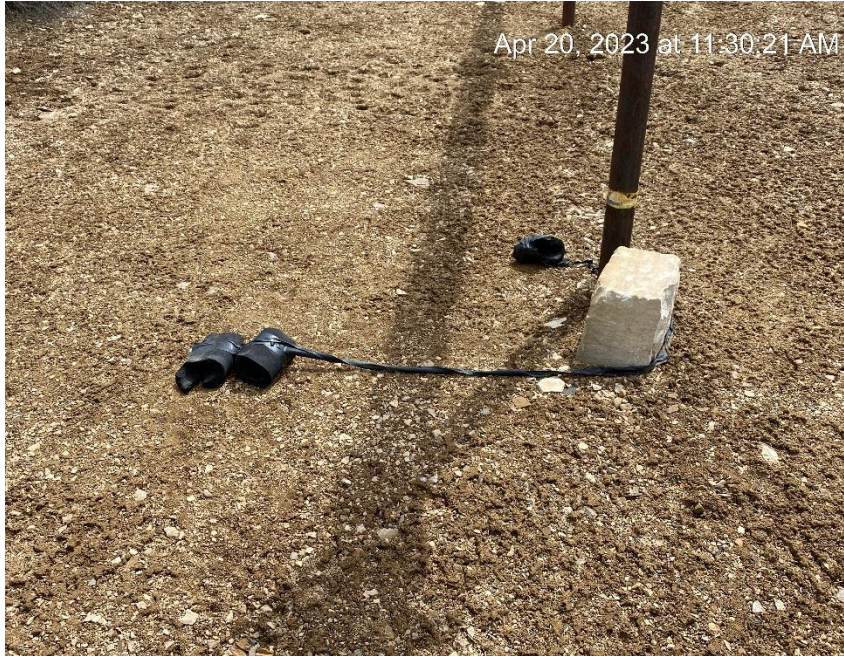
Debris

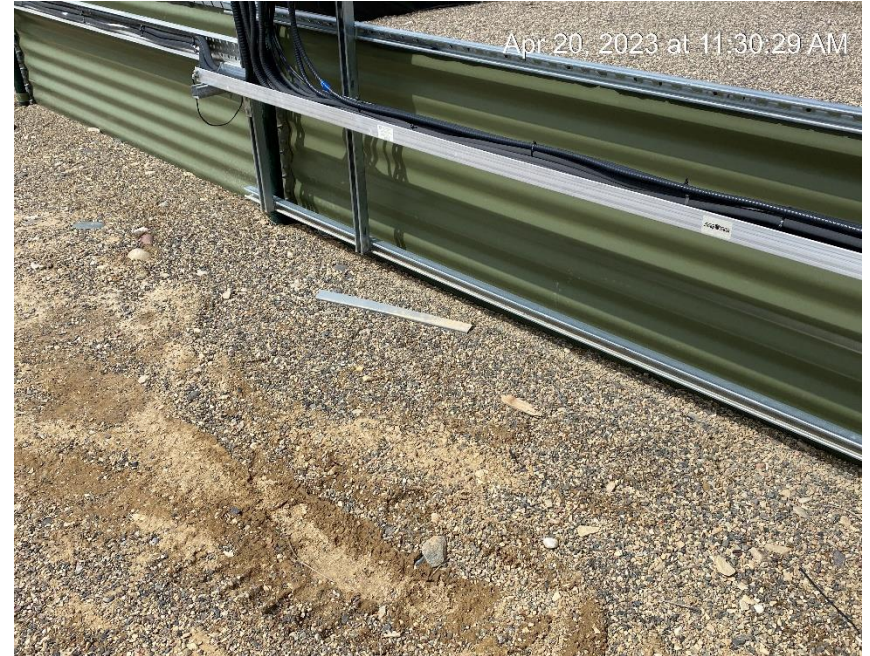
Debris

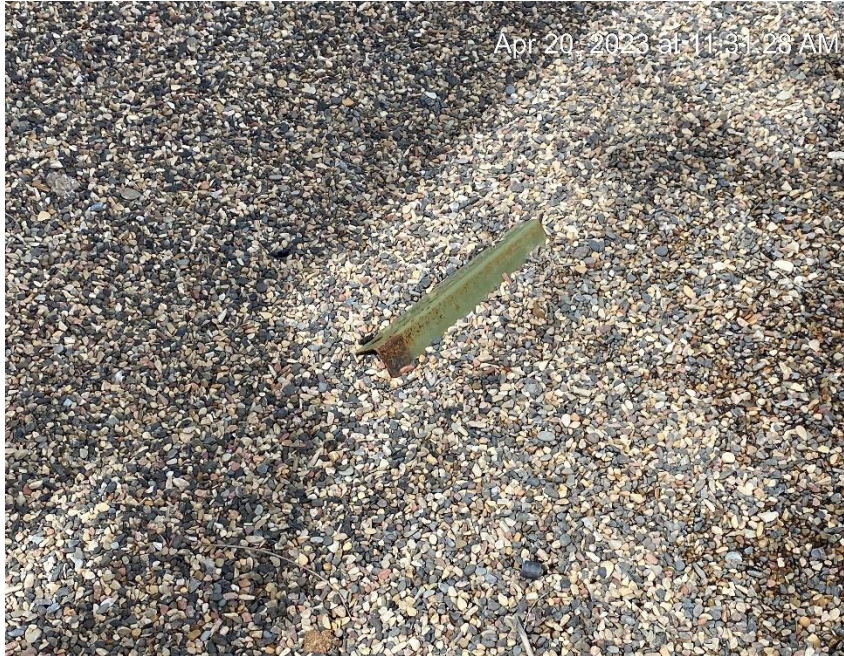
Debris

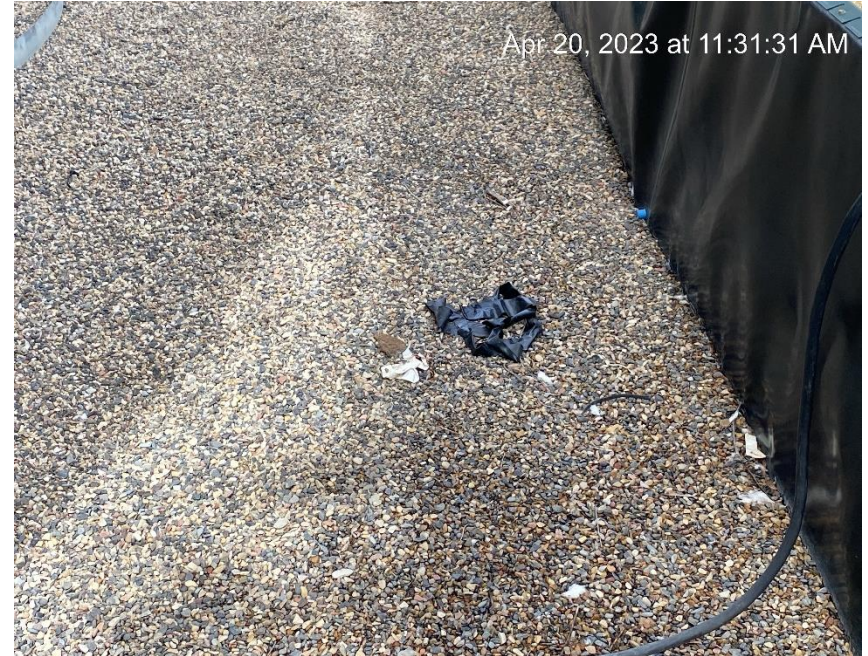
Debris

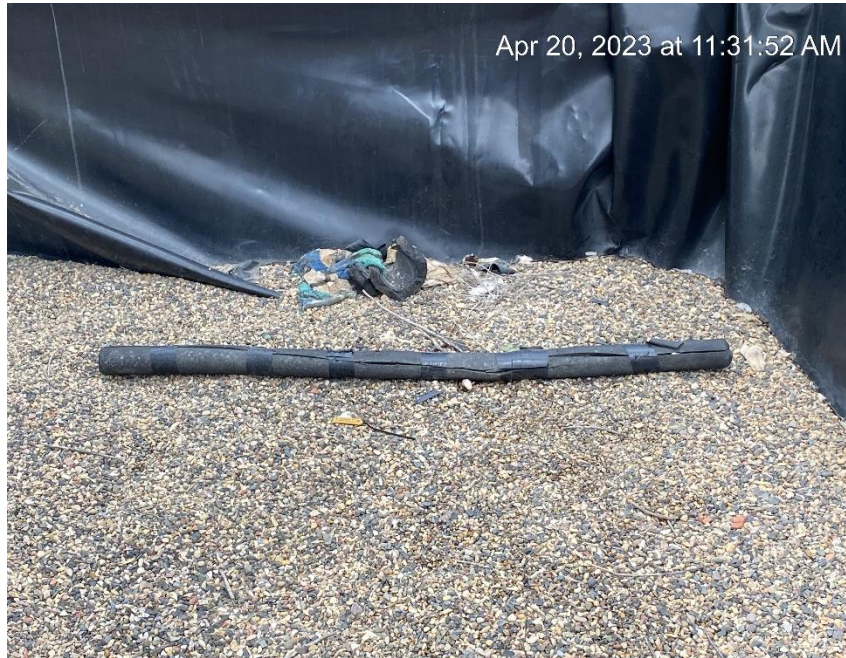
Debris

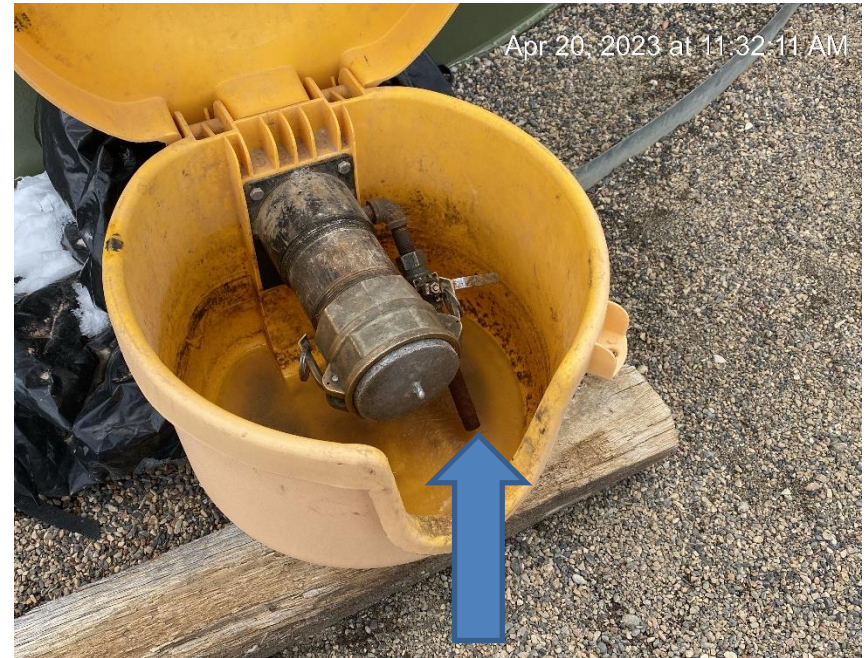
Open end valve on loadline

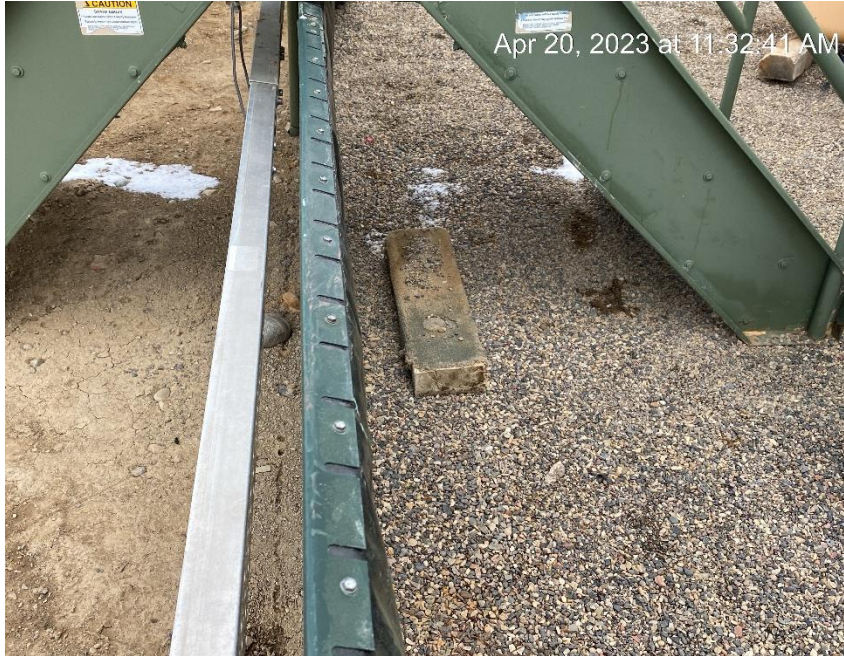
Debris

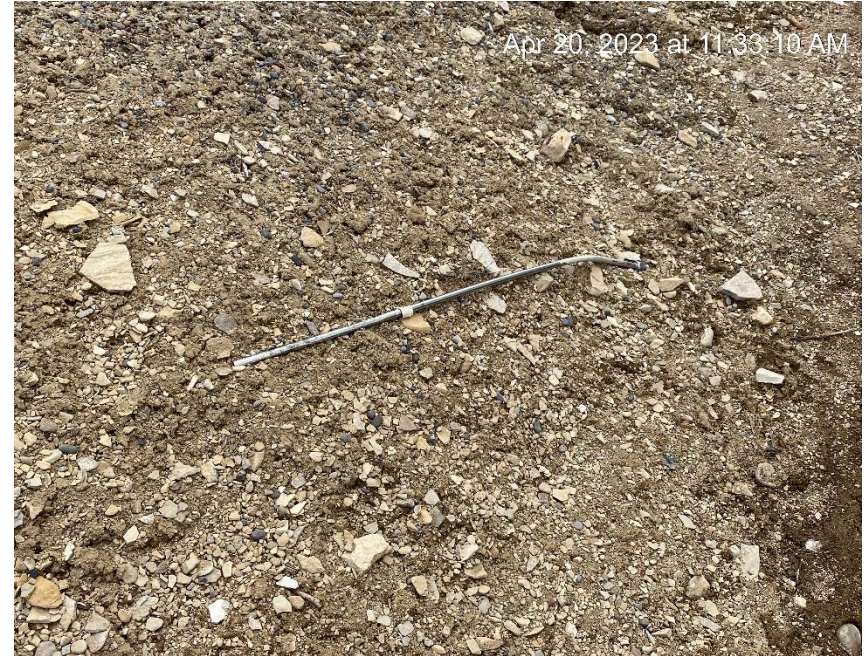
Debris

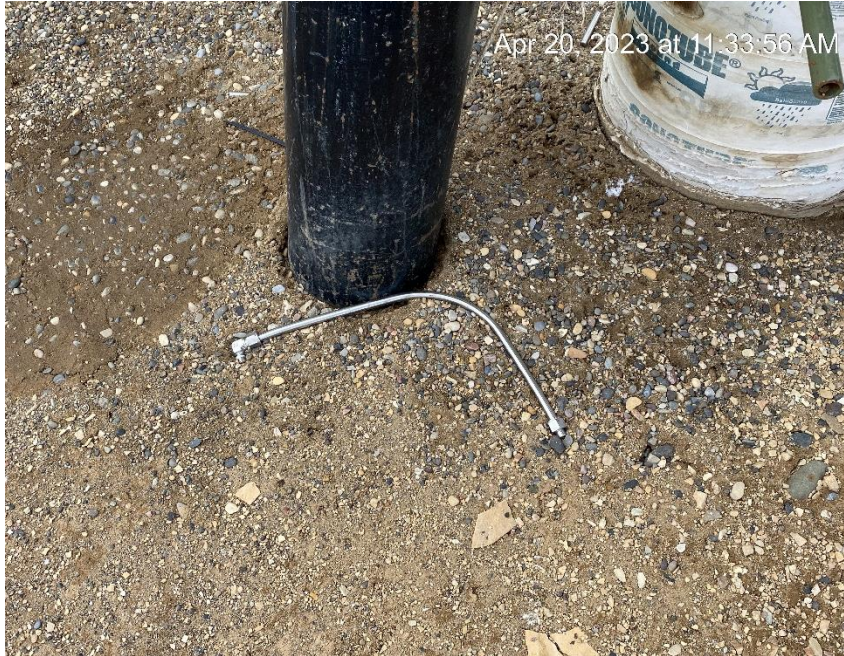
Debris

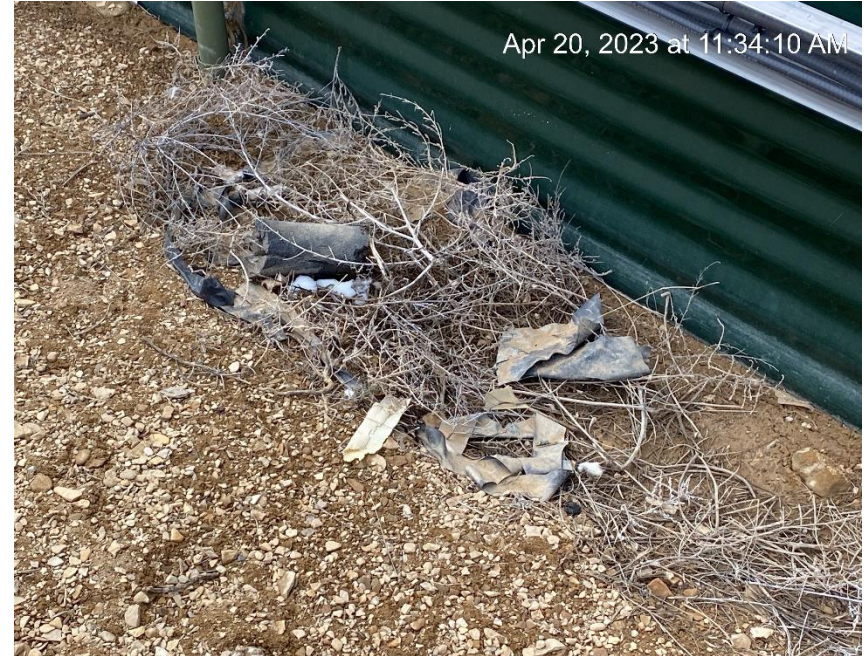
Debris

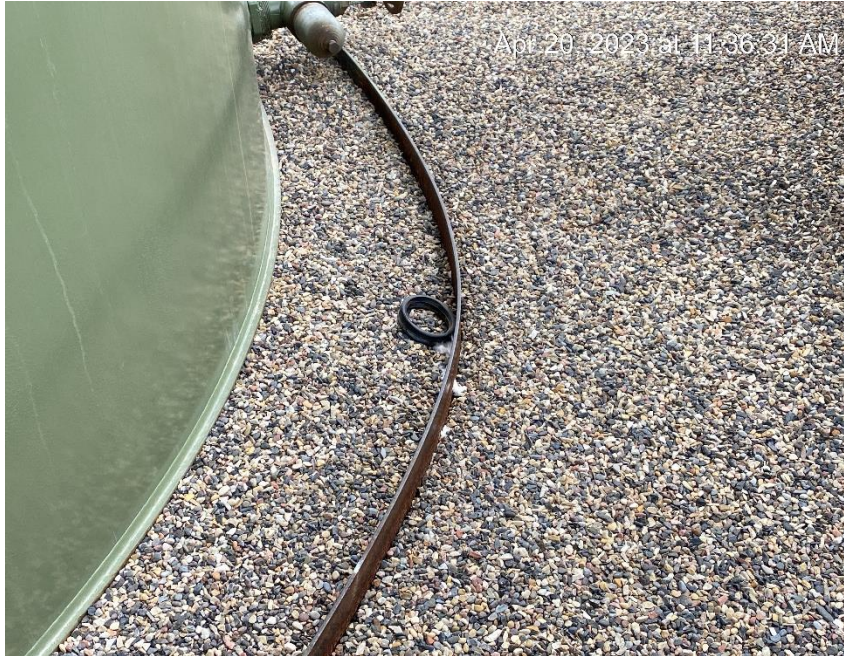
Debris

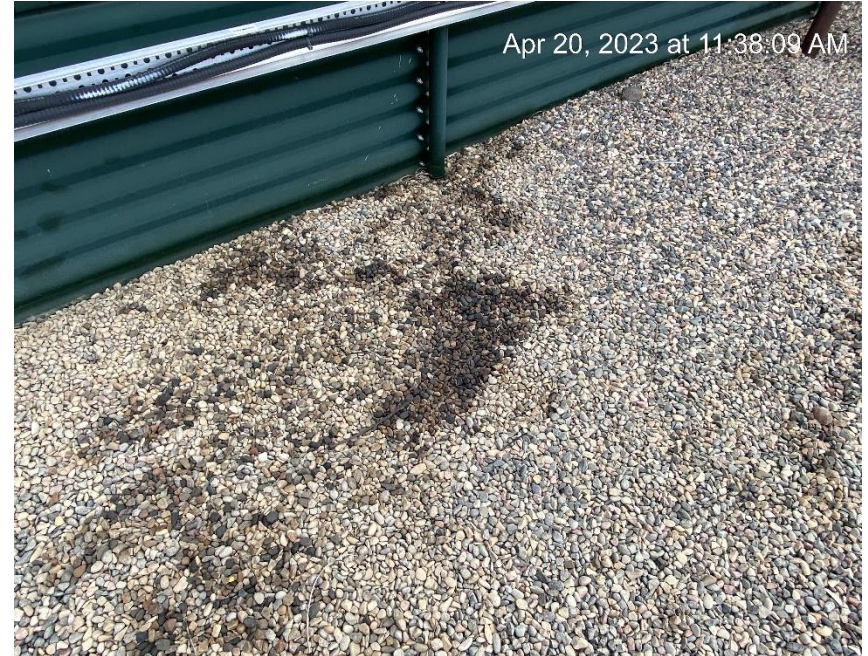
Staining

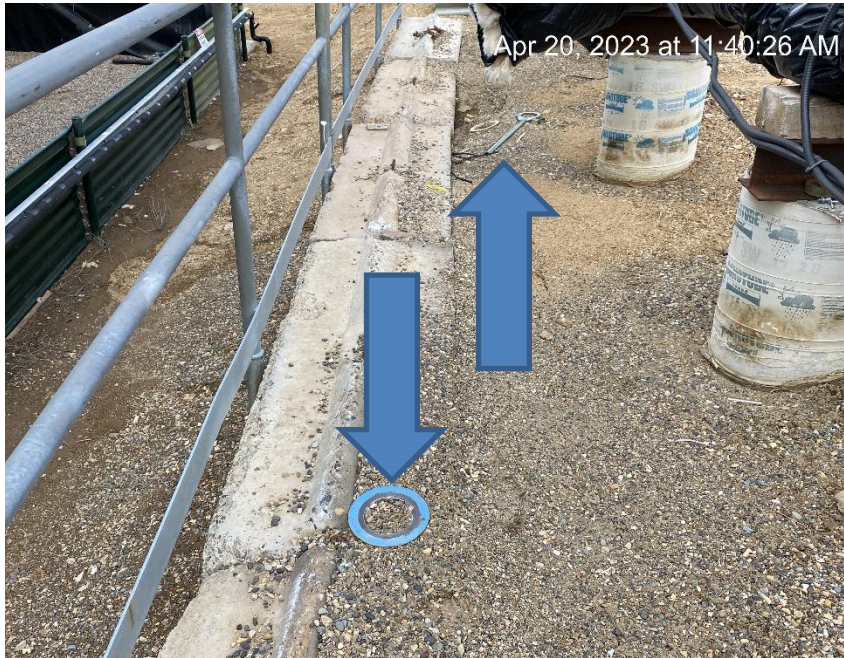
Debris

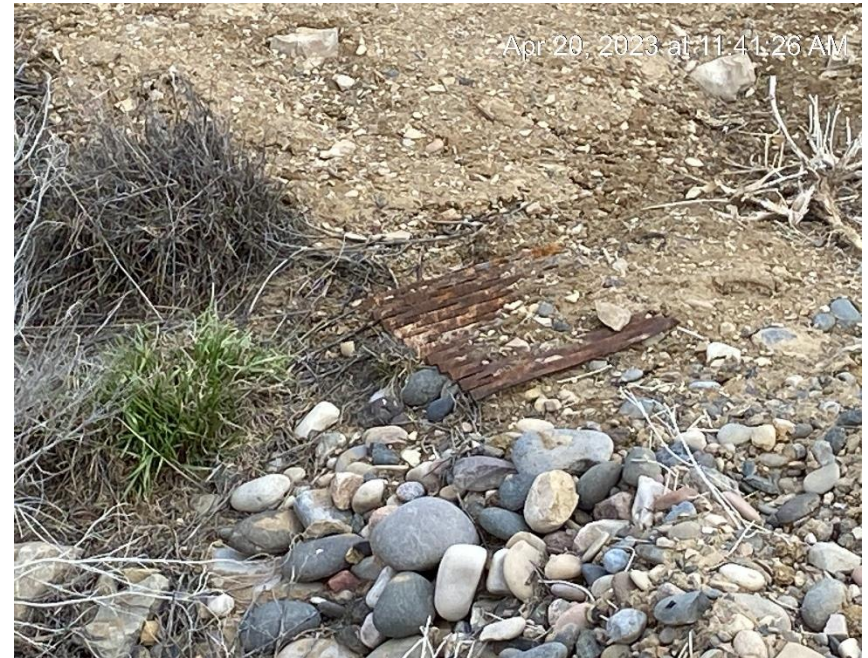
Debris

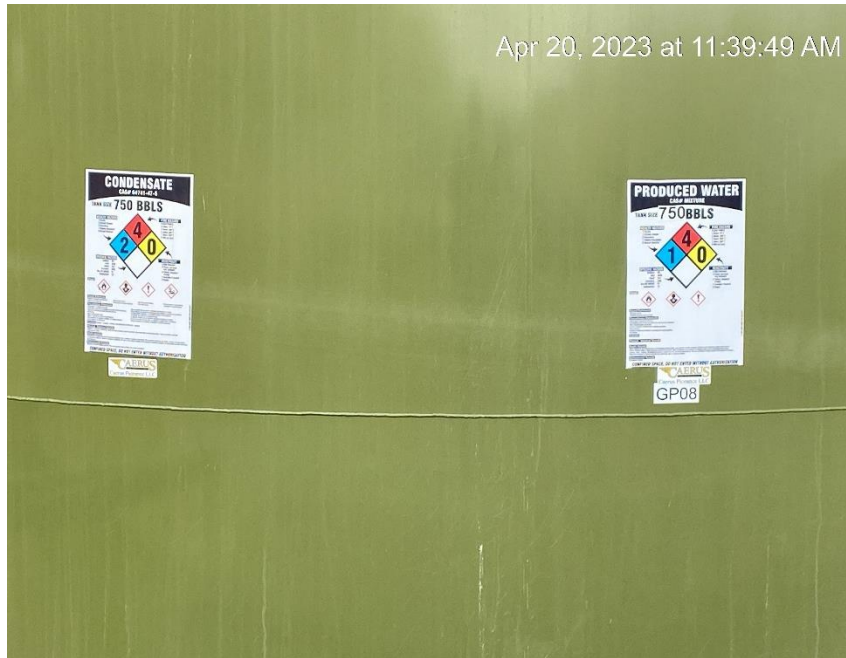
Conflicting labels

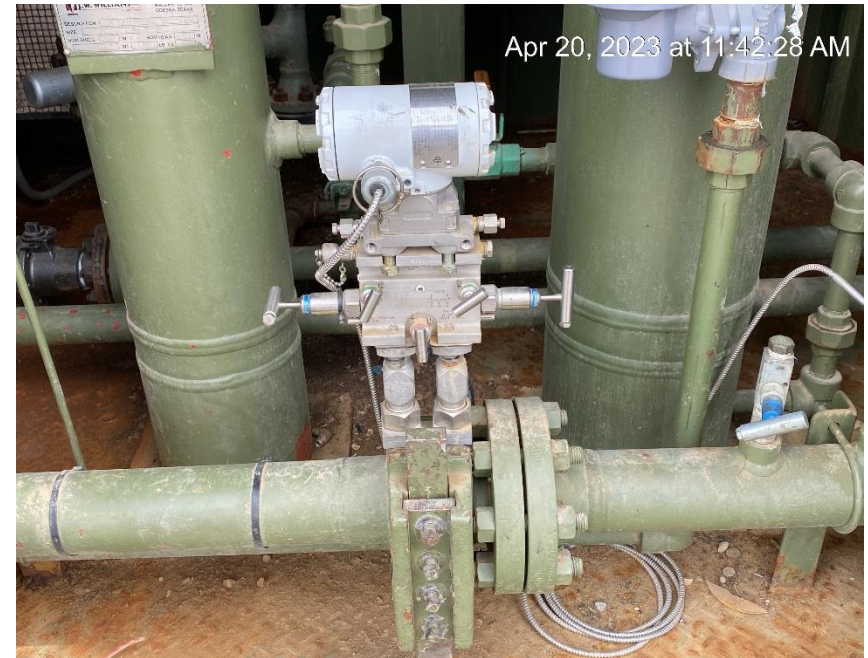
Last gas meter calibration date not posted

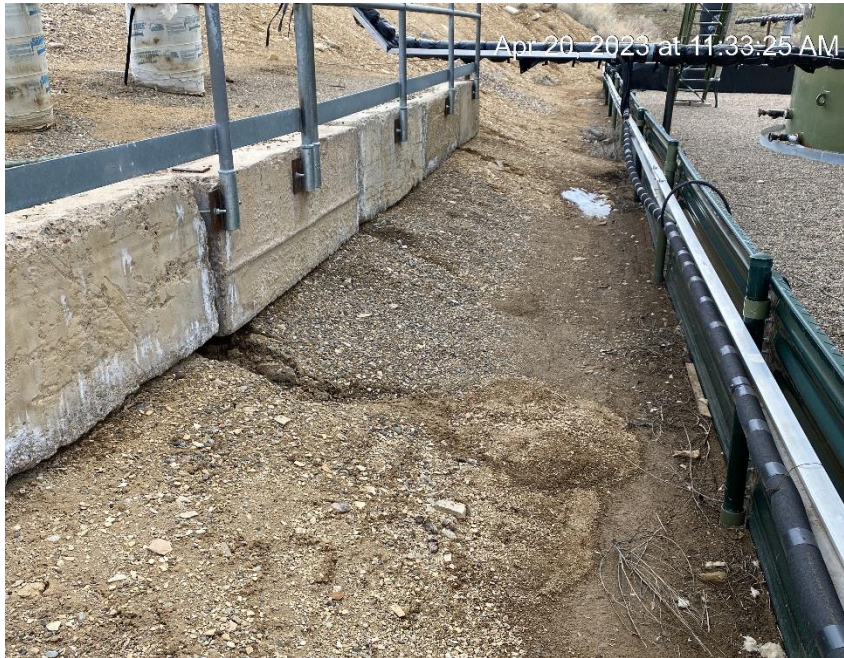
Unstable slope. Soil migration. Debris.

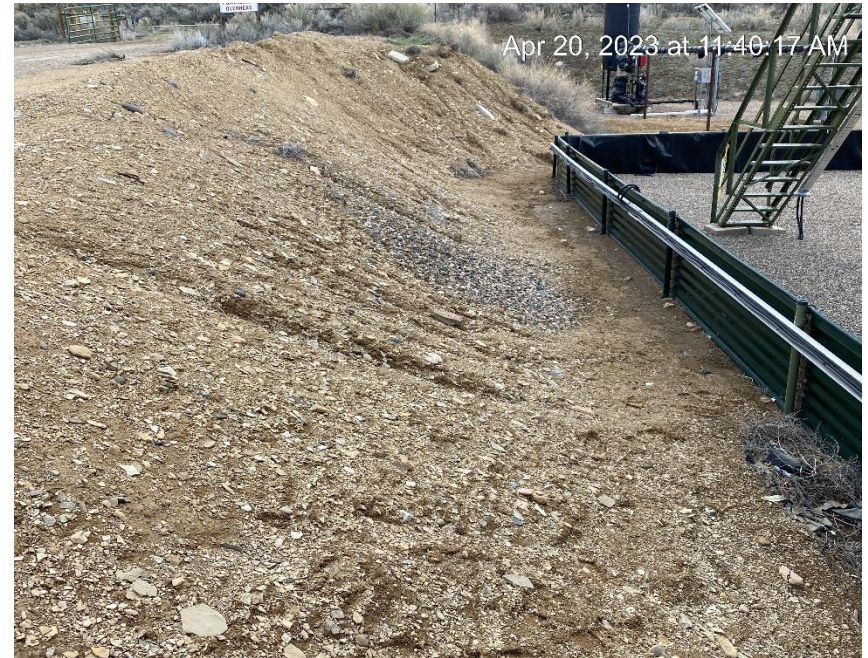
Unstable slope. Soil migration. Debris.
