# Inspection Photos

Loc: 325172

Operator: LOGOS OPERATING LLC

Inspection Date: 4/18/2023

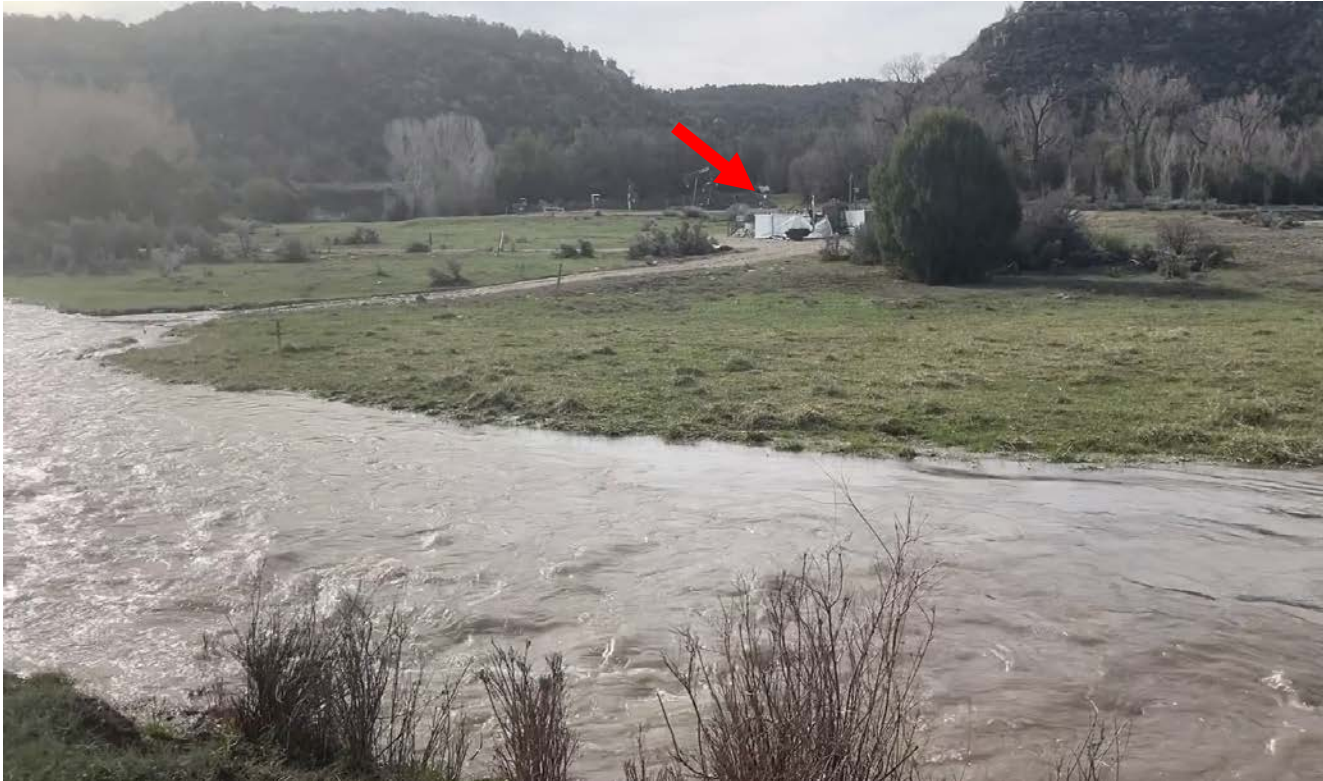
**Photo 1.** Facing southeast toward the well site at red arrow. The wellsite is located within an oxbow of the Florida River. The river is flowing very high from runoff and there is potential for flooding that could occur at the wellsite.

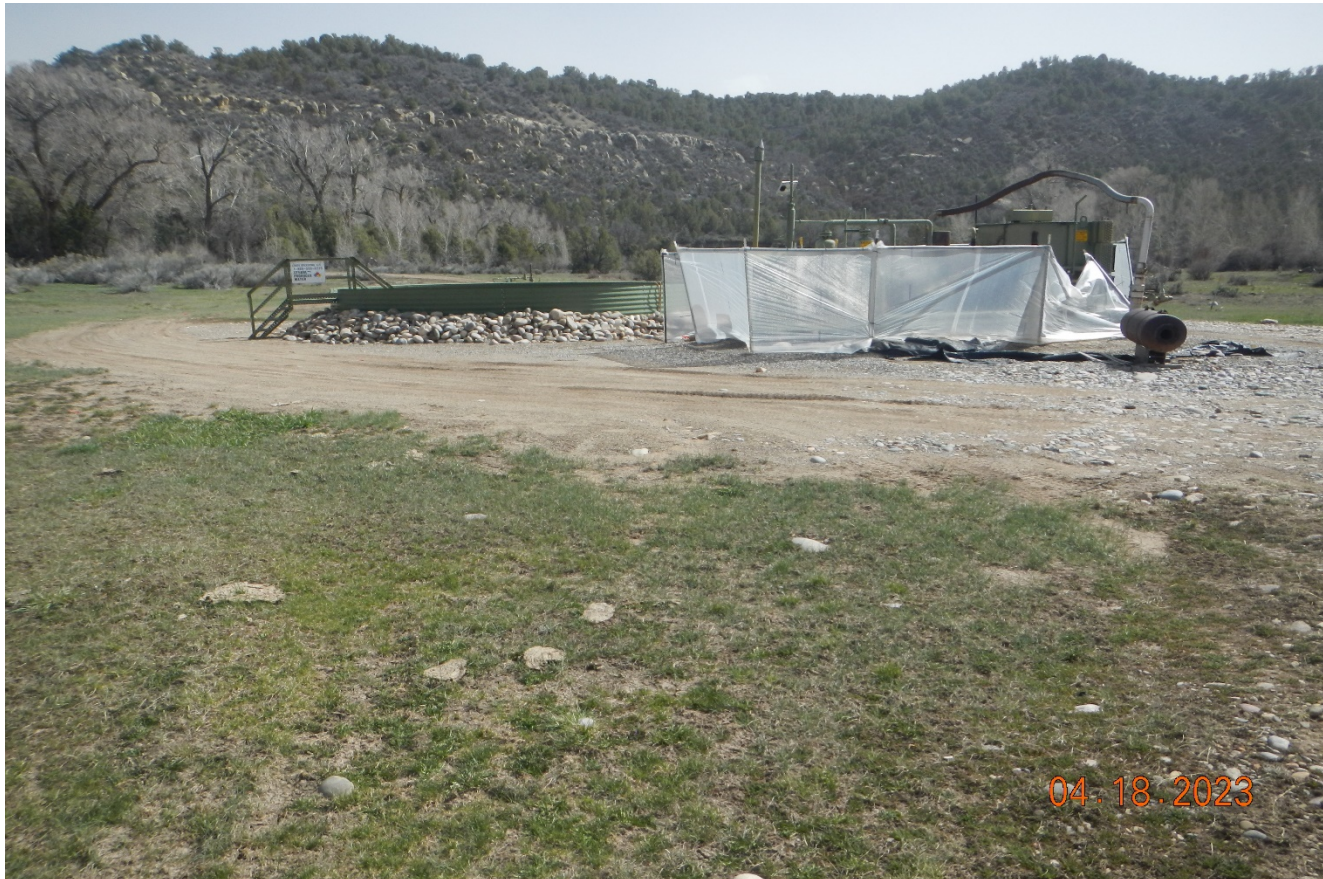
**Photo 2.** Facing southeast toward the location and production equipment.

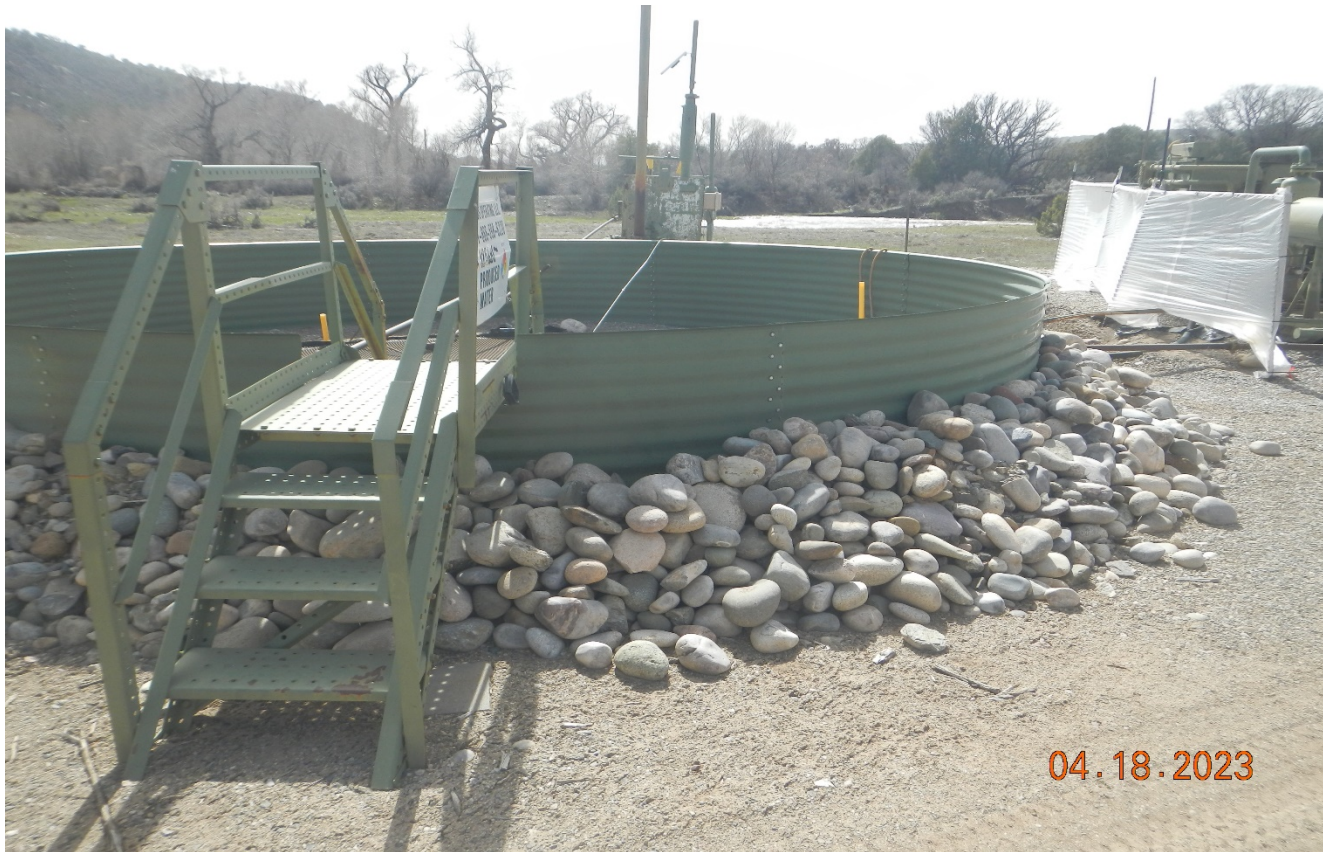
**Photo 3.** Facing toward the open top tank. There is round rock placed around the containment which will not prevent flood water from entering underneath the steel containment. The steel containment is not constructed per the Operator's SWMP. Previous corrective action has not been completed.

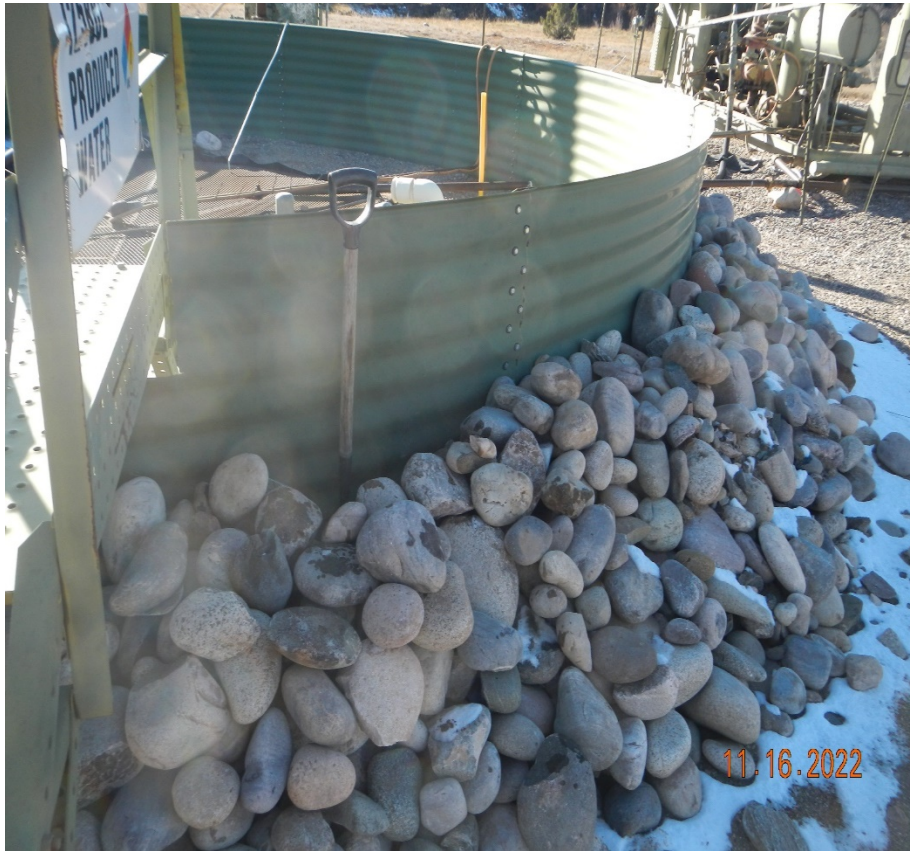
**Photo 4.** The steel containment is no constructed per the Operator's SWMP. A 3.5 ft. shovel was placed at the containment for scale.

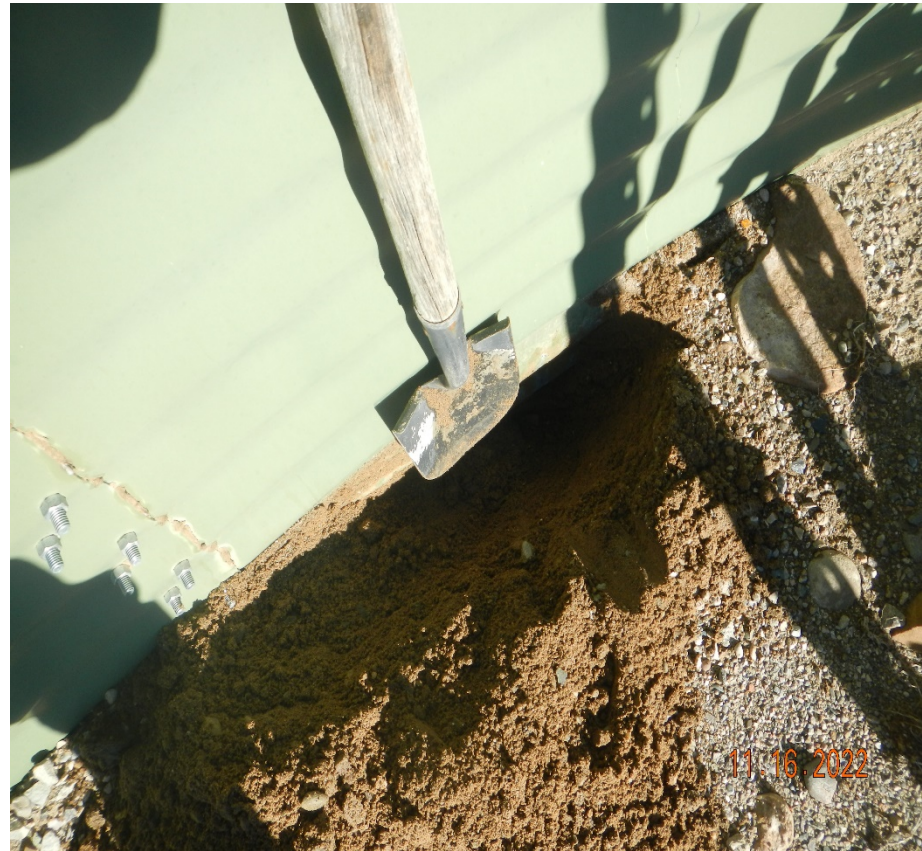
**Photo 5.** The steel containment is only about 4 inches below grade. The steel containment is not constructed per the Operator's SWMP.

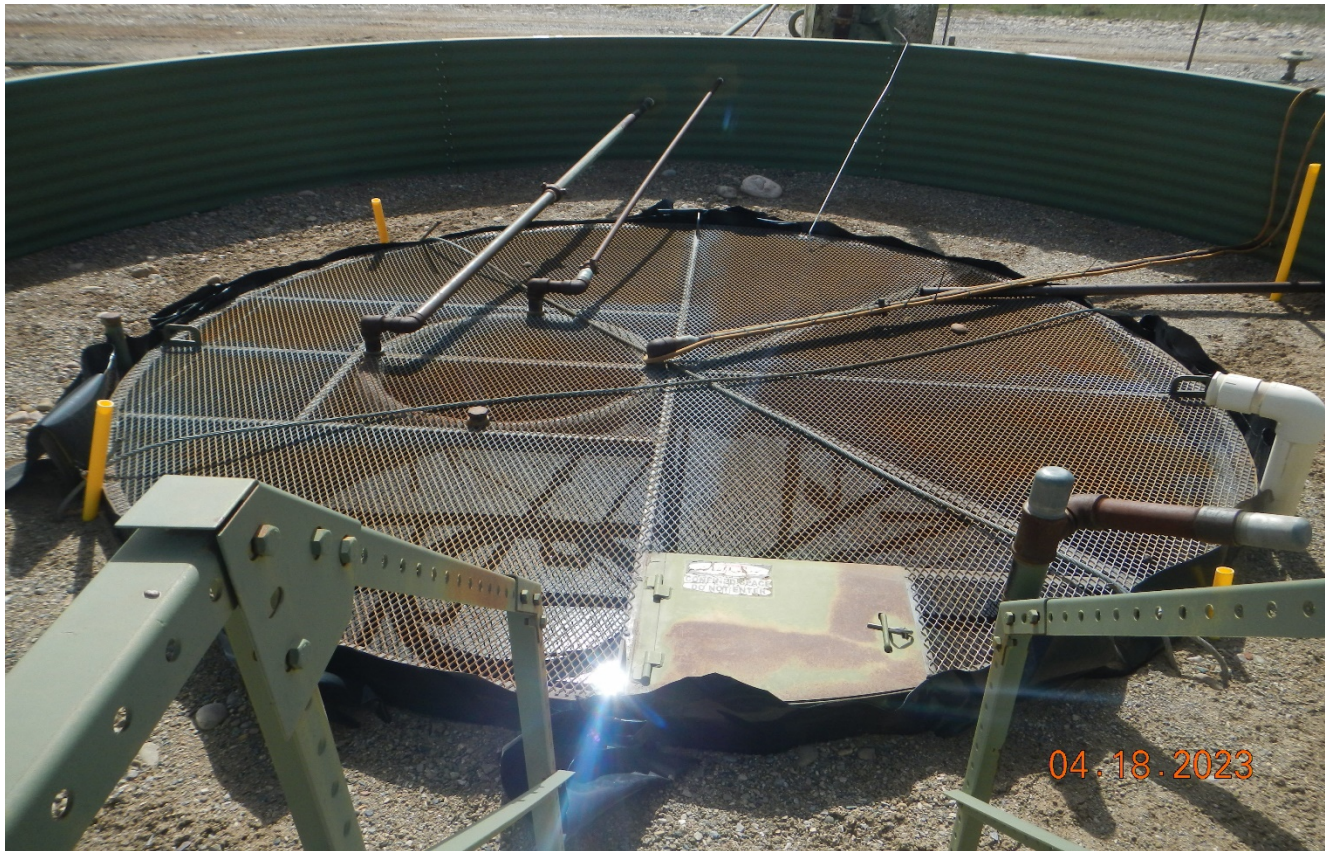
**Photo 6.** Facing toward the open top tank with produced fluids.

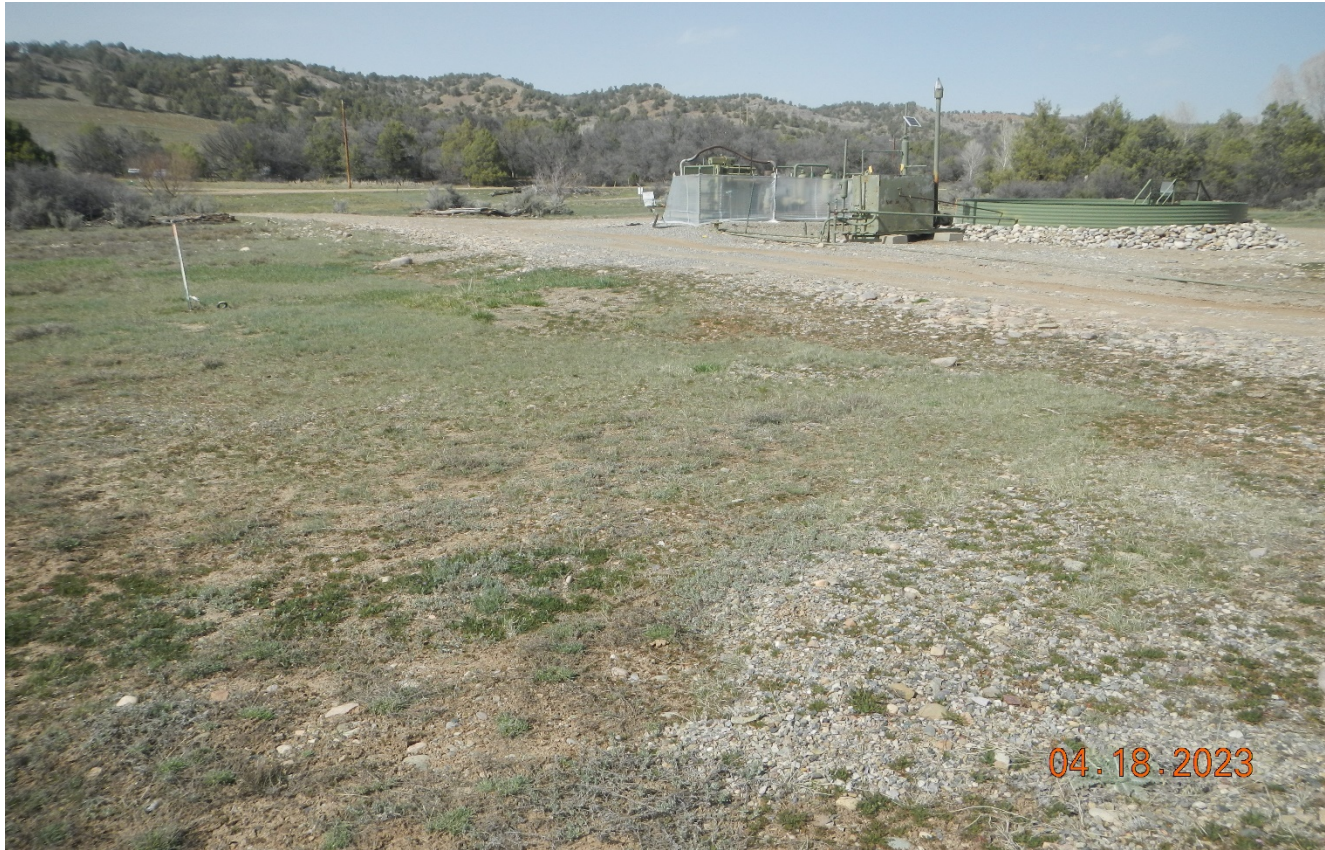
**Photo 7.** Facing northeast toward the location.

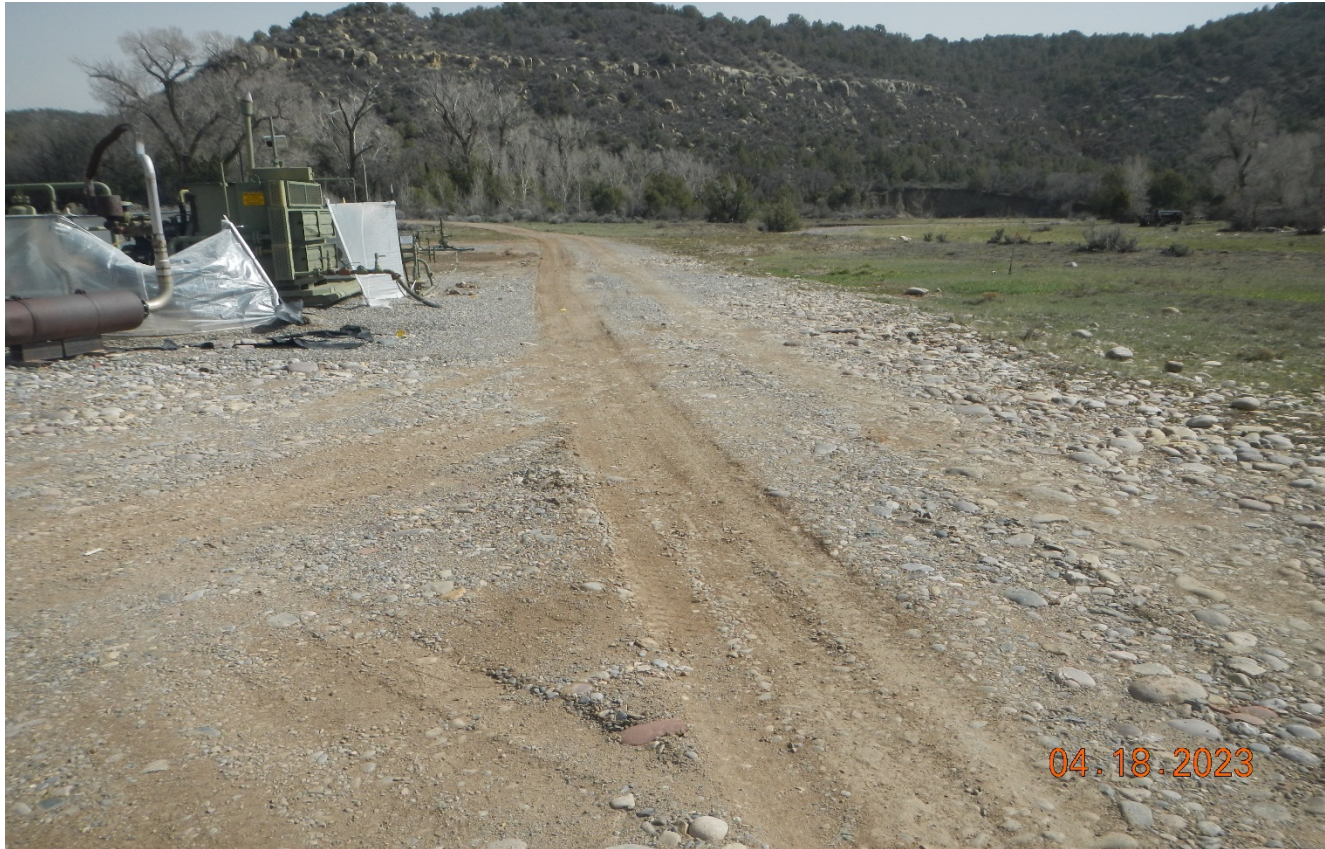
**Photo 8.** Facing southeast toward the location. The area of the road shows signs of scouring where flood flows across the road from left to right towards the Florida River.

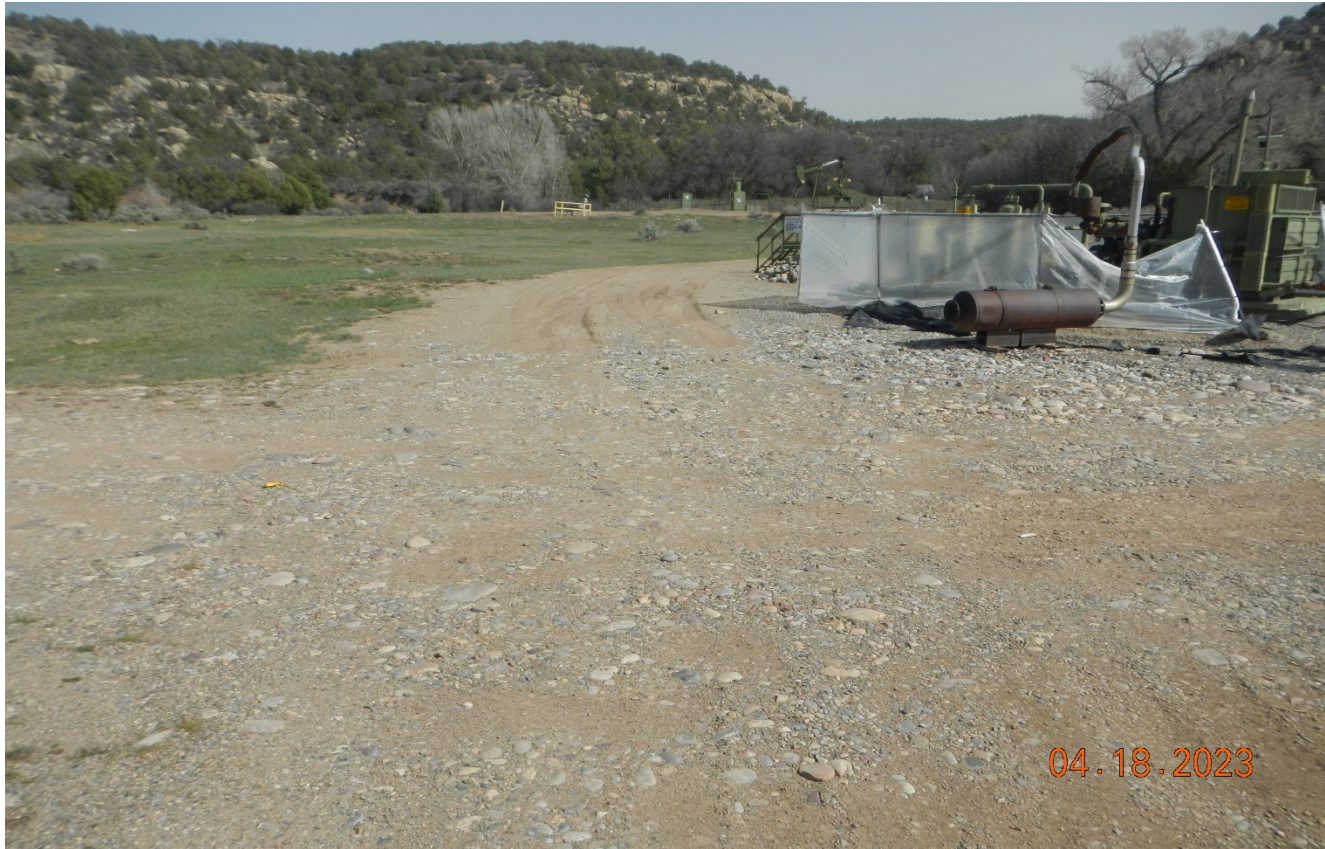
**Photo 9.** Facing southeast toward the location. The area of the road shows signs of scouring where flood flows across the road from left to right towards the Florida River.
