# Final Reclamation Inspection

Operator: BONANZA CREEK ENERGY OPERATING COMPANY LLC - #8960

Location ID: 331251

Inspection Photos  
Location Name: DOW #21-28  
Location ID: 331251

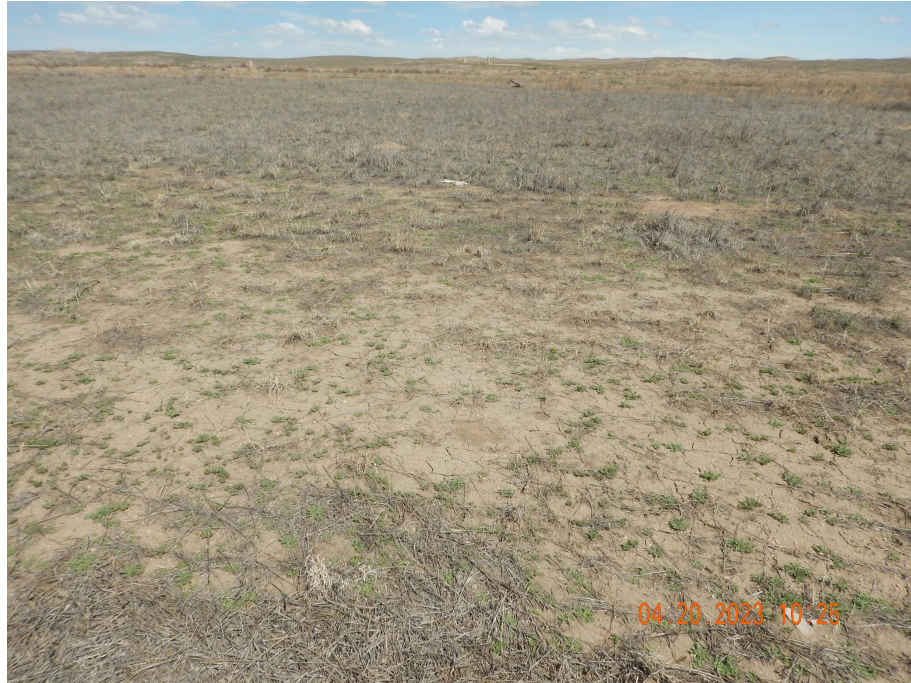
**Photo 2.** Photo taken from the well location, facing North. Photo illustrates the location consists mostly of weeds with little to no perennial vegetation that is not reflective of reference areas.

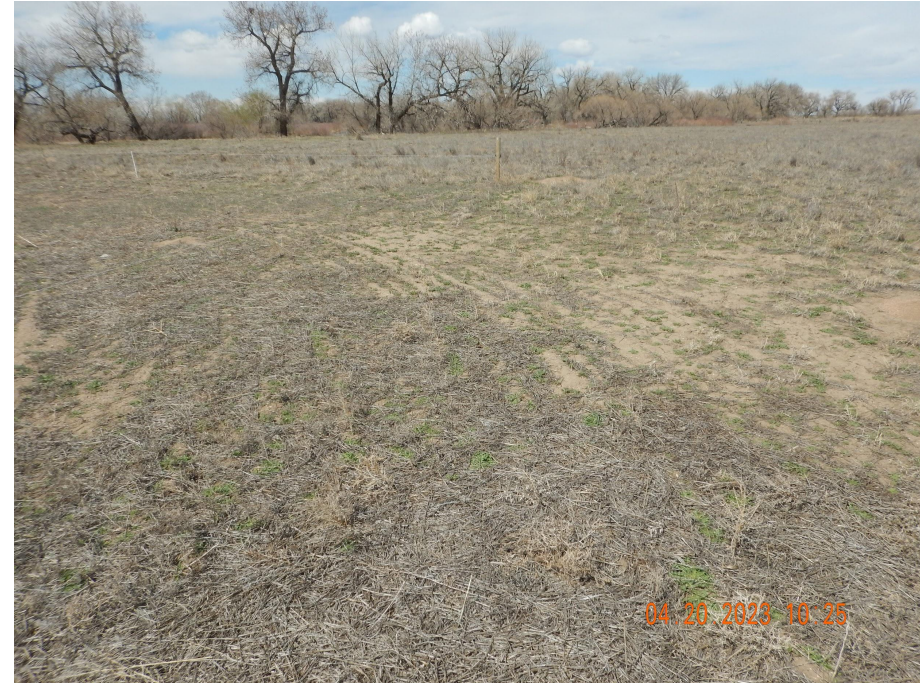
**Photo 3.** Photo taken from the well location, facing West. See comments under Photo 2.

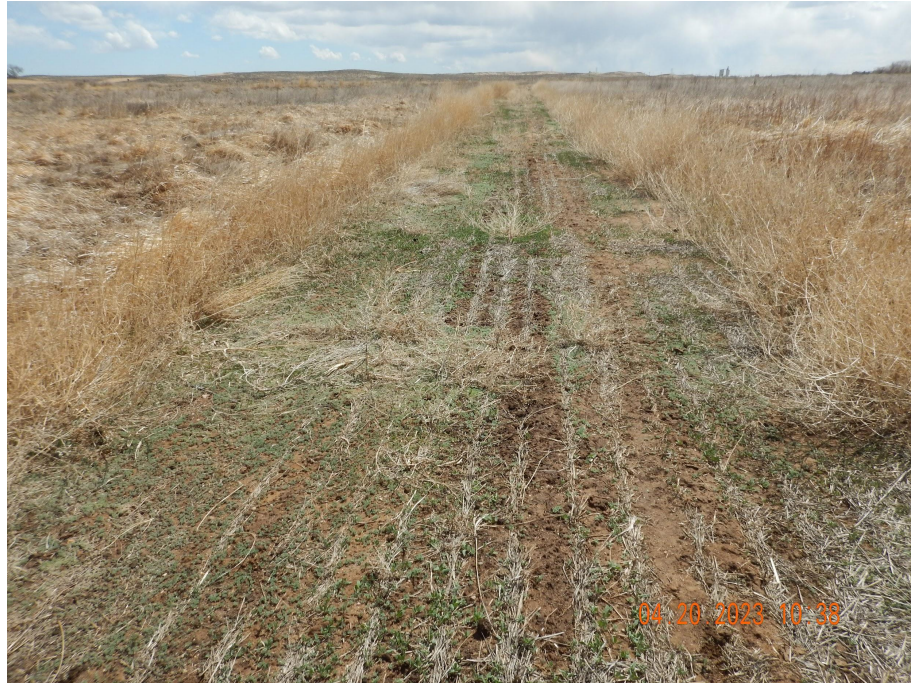
**Photo 5.** Photo taken along a section of the access road, facing East. Photo illustrates weedy establishment and weed debris growing along the access road.

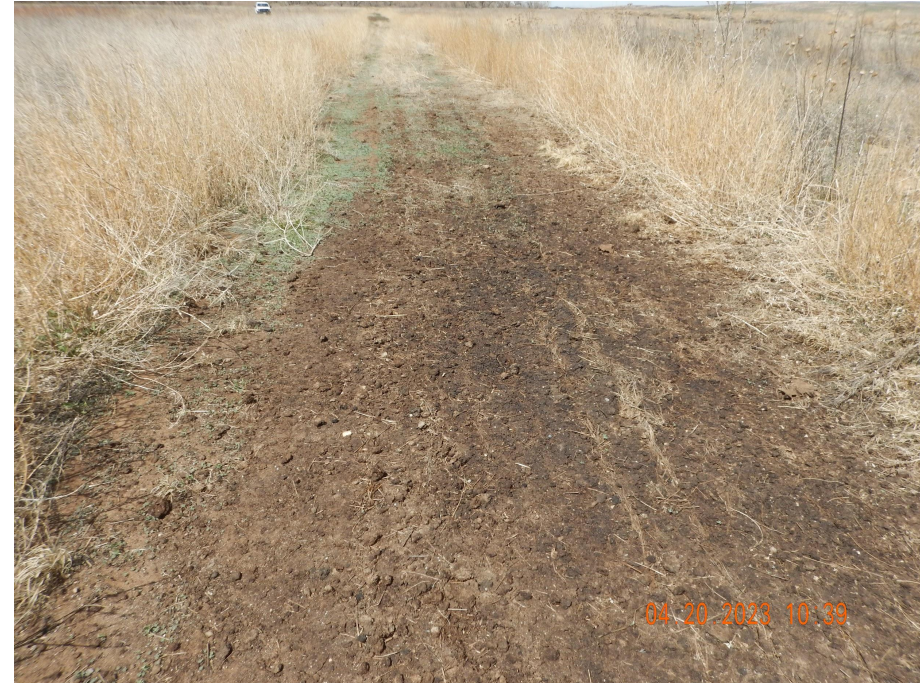
**Photo 6.** Photo taken along a section of the access road, facing West. See comments under Photo 5.

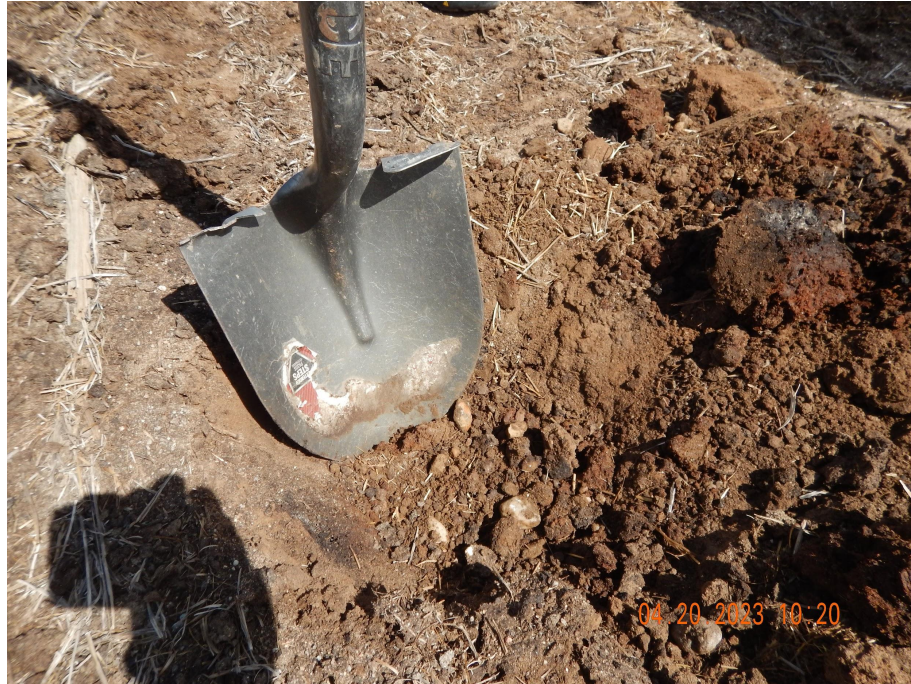
**Photo 7.** Photo taken from a portion of the access road. COGCC staff dug ~5-6" down and hit a refusal area of gravel. It does not appear the Operator removed all the gravel from the access road. This was not observed in reference areas. Refer to Photo 8.

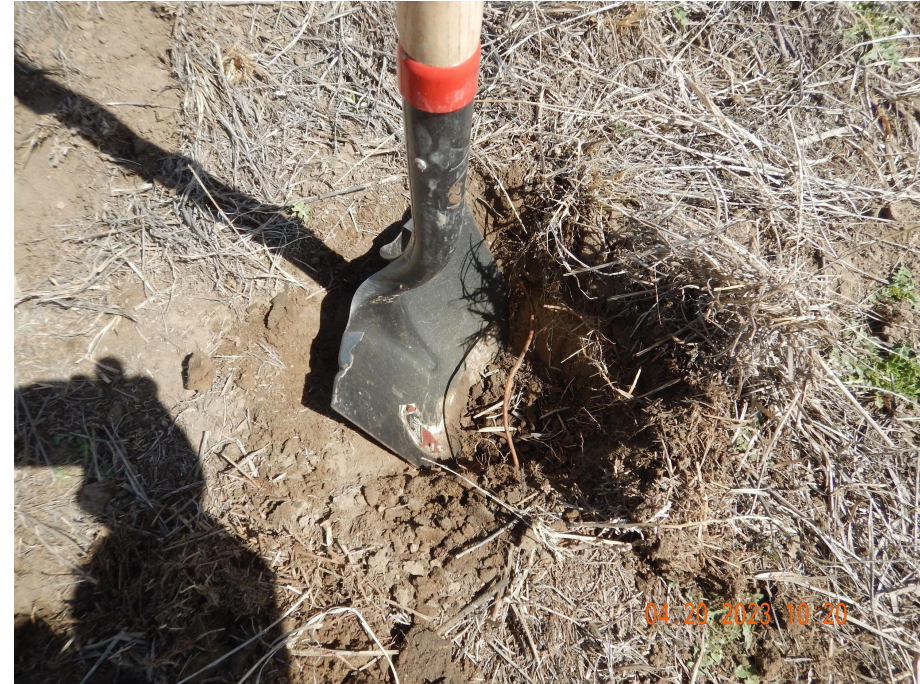
**Photo 8.** Photo taken adjacent to the previous Photo #7 within reference areas. COGCC staff was able to dig ~8" down without encountering any rock.

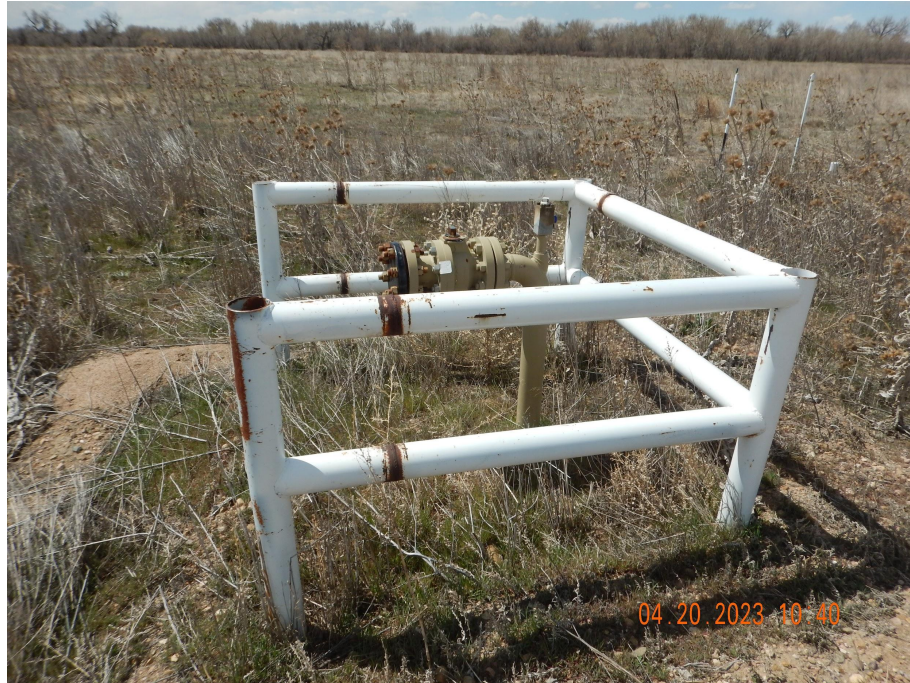
**Photo 9.** Photo taken from the offsite tank battery location, facing South. Photo illustrates what appears to be unused midstream equipment. Operator shall coordinate with the midstream Operator to get this removed.

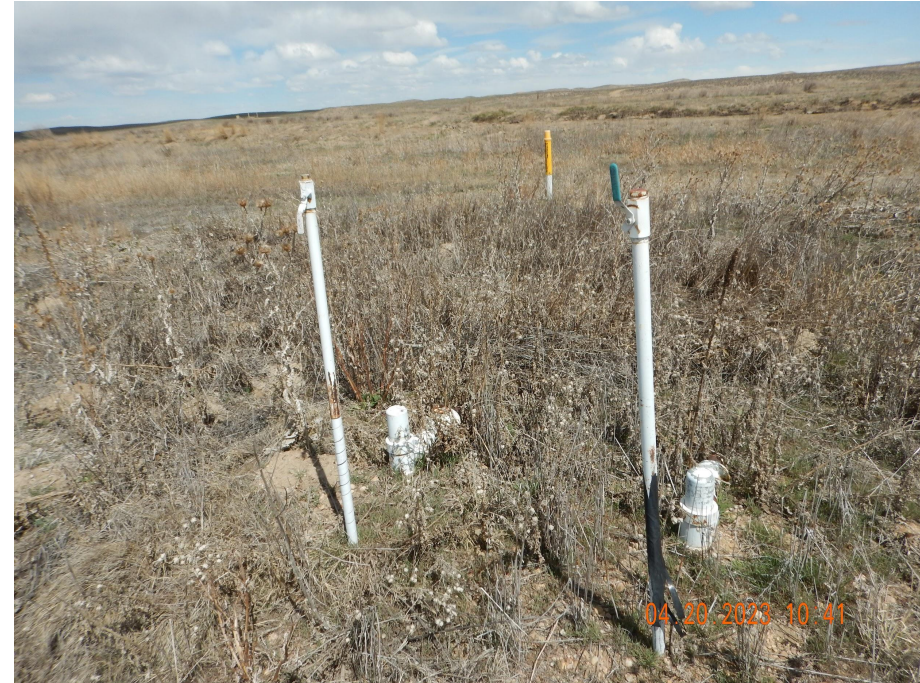
**Photo 10.** Photo taken from the offsite tank battery location, facing North. See comments under Photo 9.

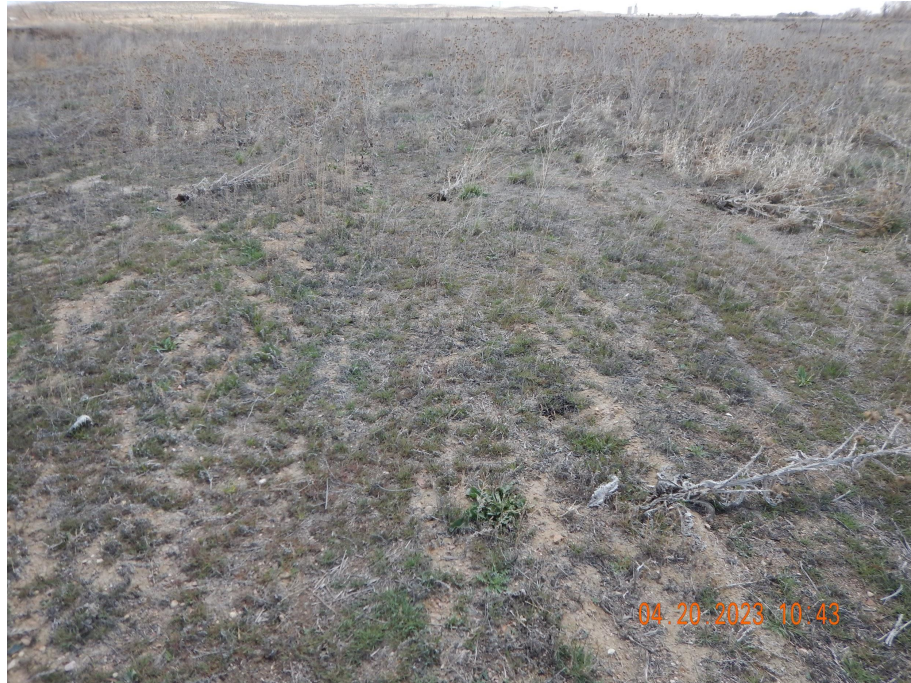
**Photo 11.** Photo taken from the offsite tank battery location, facing East. Photo illustrates the location consists mostly of weeds with some perennial vegetation that is reflective of reference areas.

Note- noxious weeds, Scotch thistle, were observed on and off the location, and the Operator shall manage the weeds on their location.

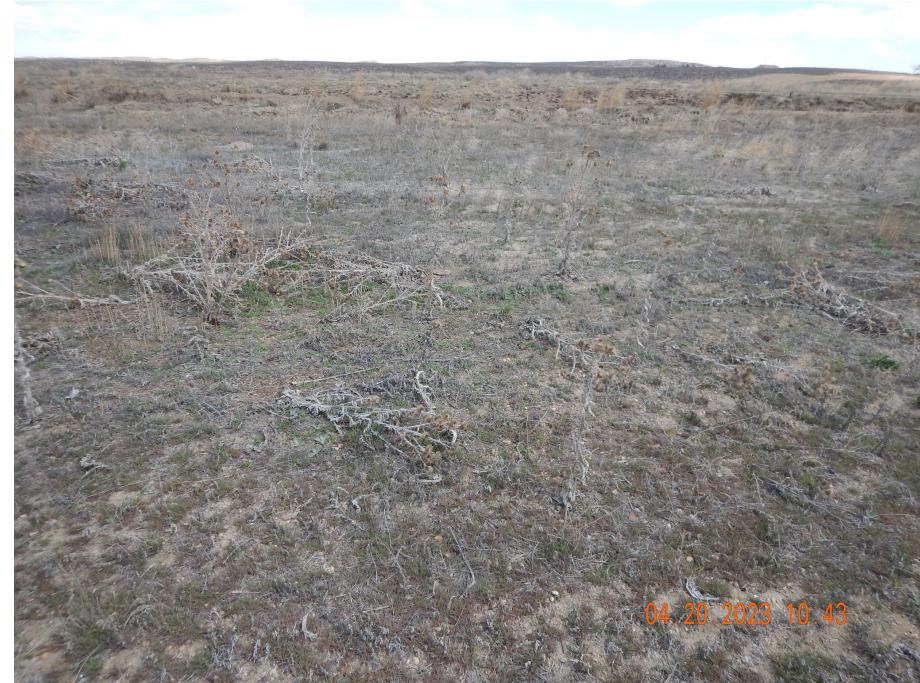
**Photo 12.** Photo taken from the offsite tank battery location, facing North. See comments under Photo 11.
