Inspection Photos

Location Name: TEP ROCKY MOUNTAIN LLC RMV 34-28 Pad

Location ID: 323913

COLORADO
Oil & Gas Conservation
Commission
Department of Natural Resources

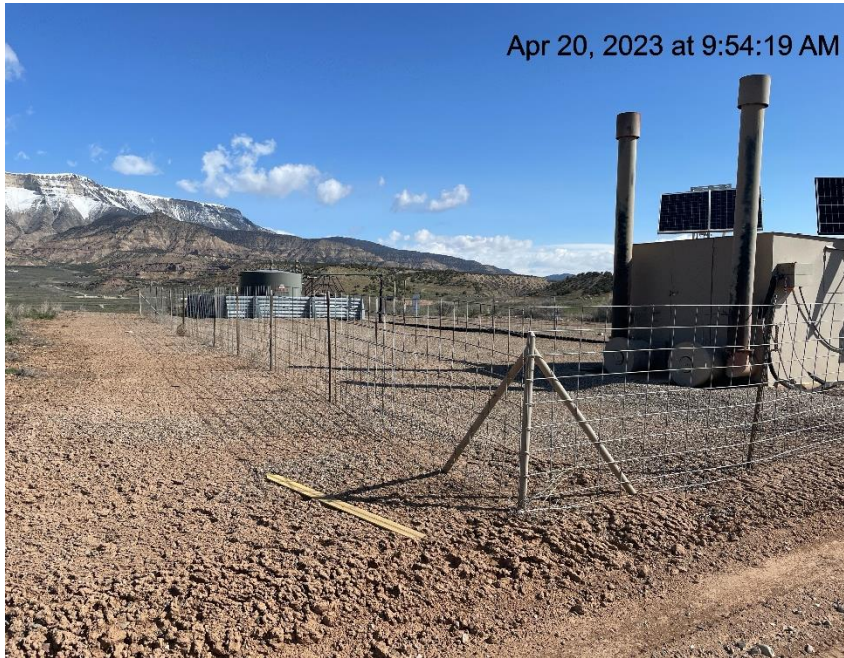
Photo # 5841 From entrance to location

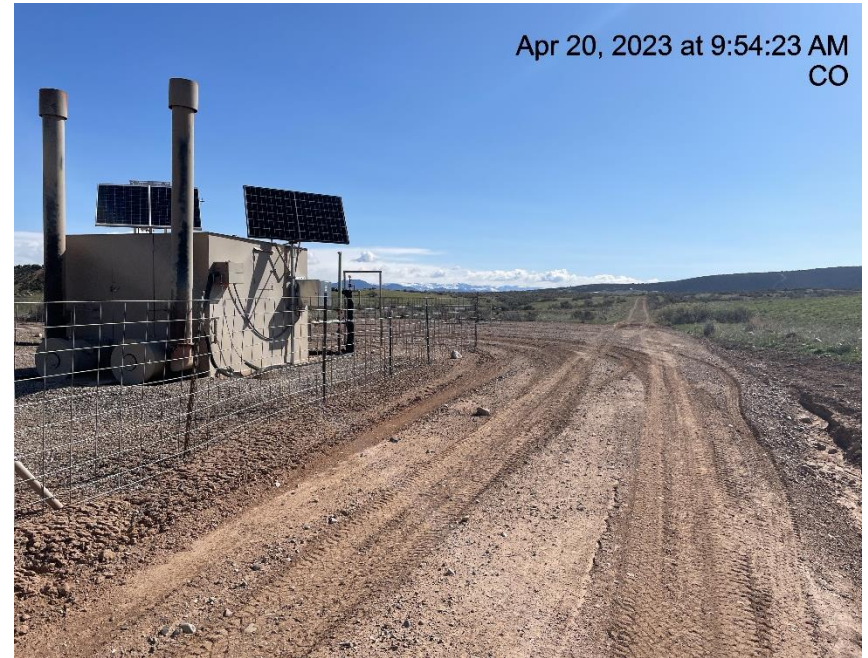
Photo # 5842 From entrance to location

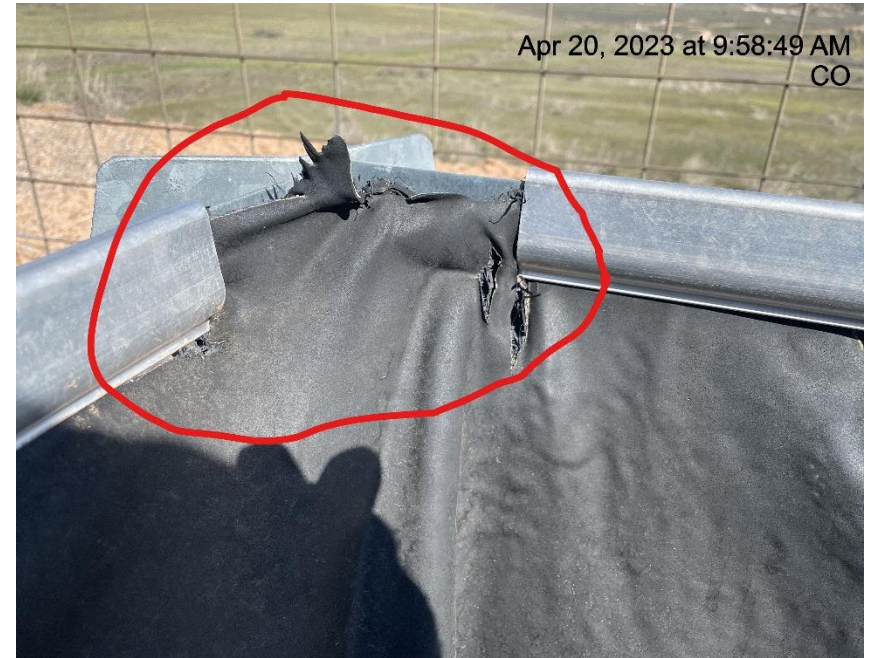
Photo # 5846 Containment liner needs maintenance

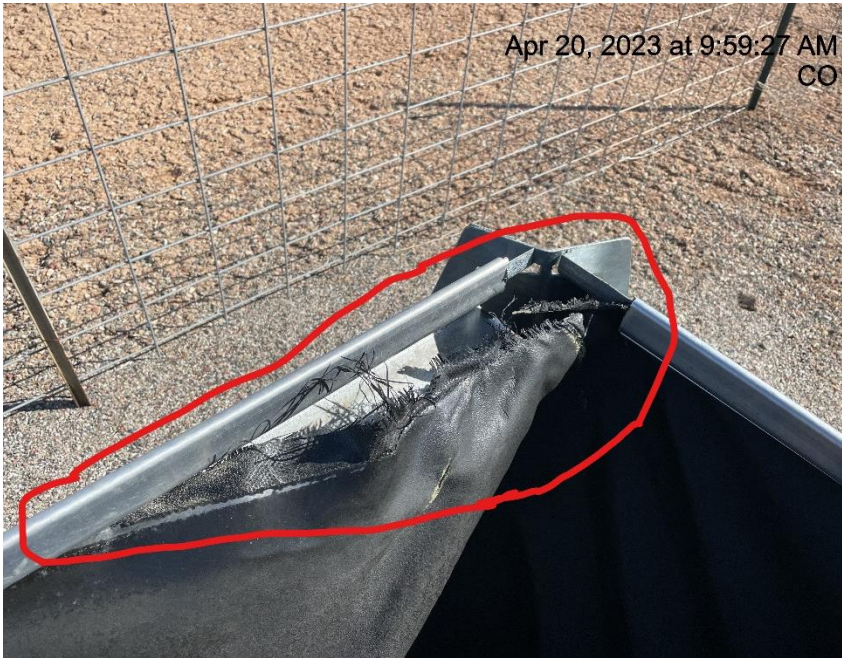
Photo # 5849 Containment liner needs maintenance

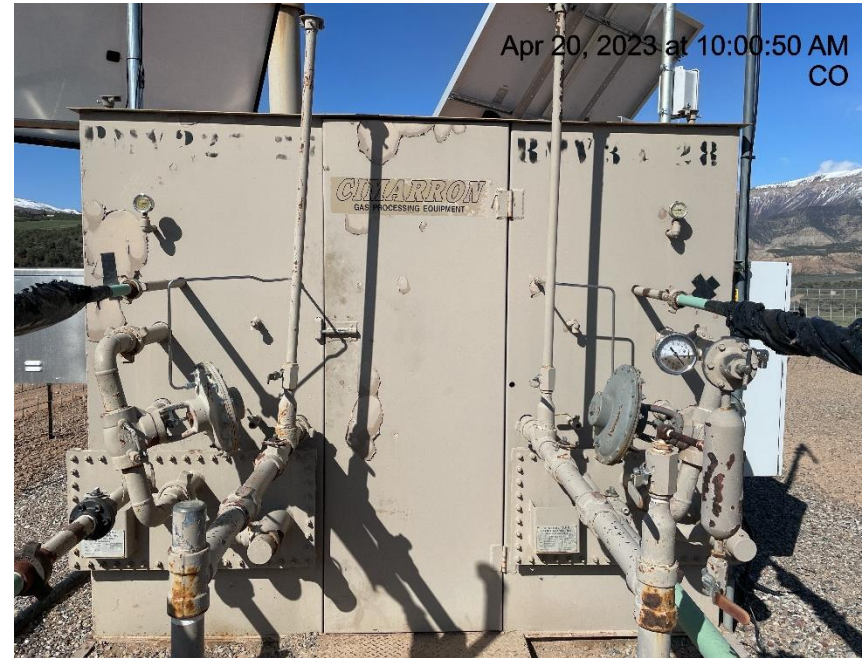
Photo # 5852 Meter calibration info not conspicuously posted

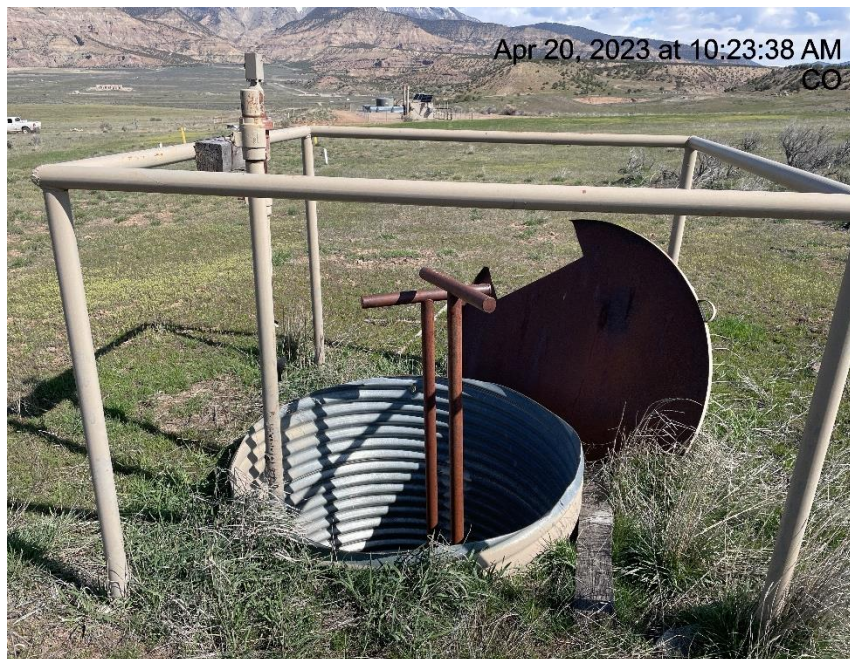
Photo # 5889 Open cellar – Wildlife Hazard (Approximately 50 yards south of location)

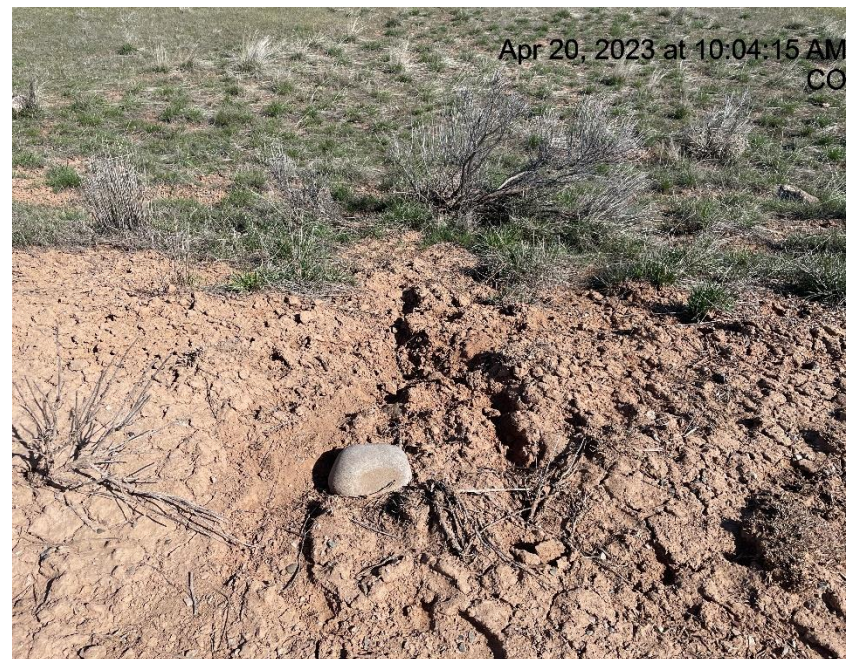
Photo # 5853 Erosion & transport of sediment off location (North side of pad on slope near production tank)

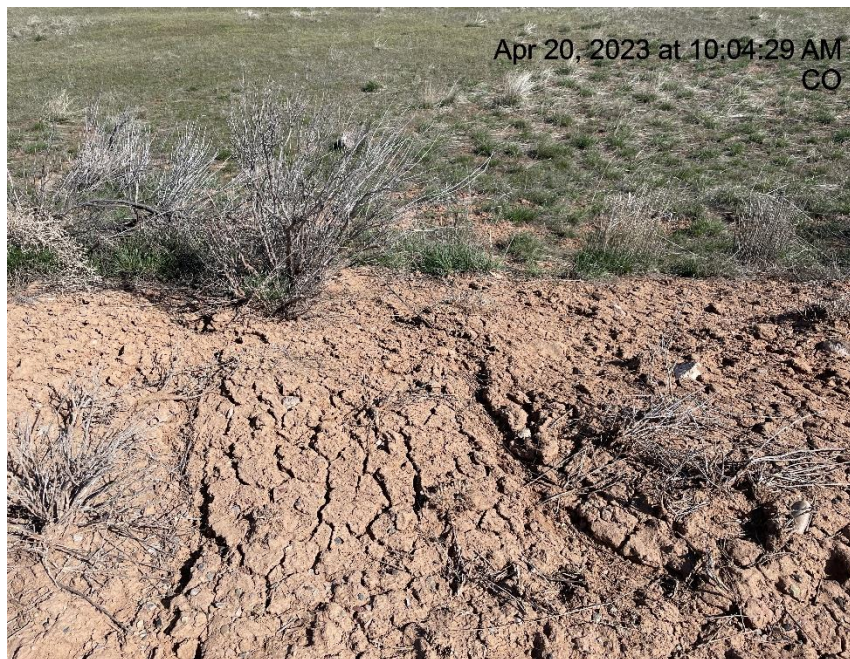
**Photo # 5854 Erosion & transport of sediment off location
(North side of pad on slope near production tank)**

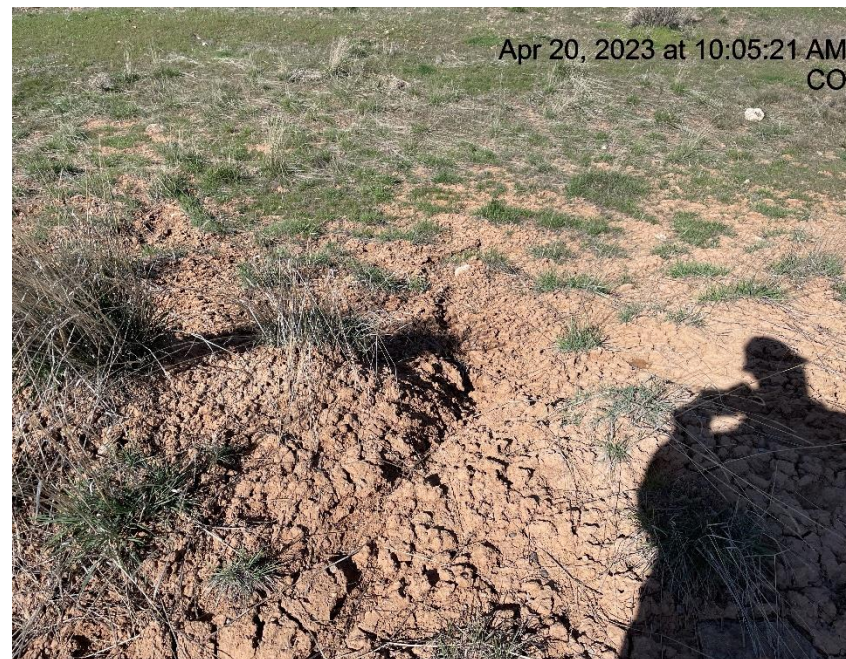
**Photo # 5856 Erosion & transport of sediment off location
(West side of pad on slope near production tank)**

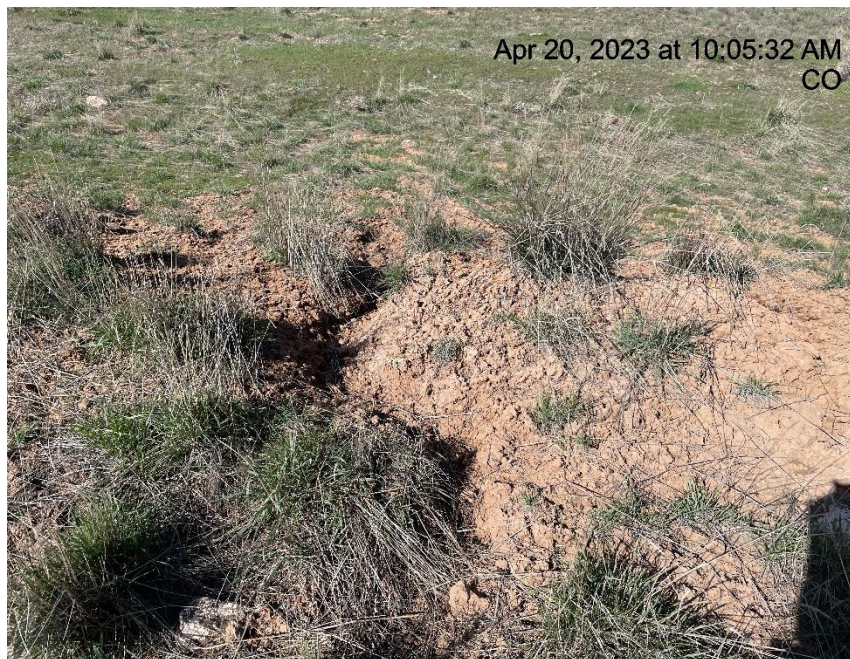
**Photo # 5857 Erosion & transport of sediment off location
(West side of pad on slope near production tank)**

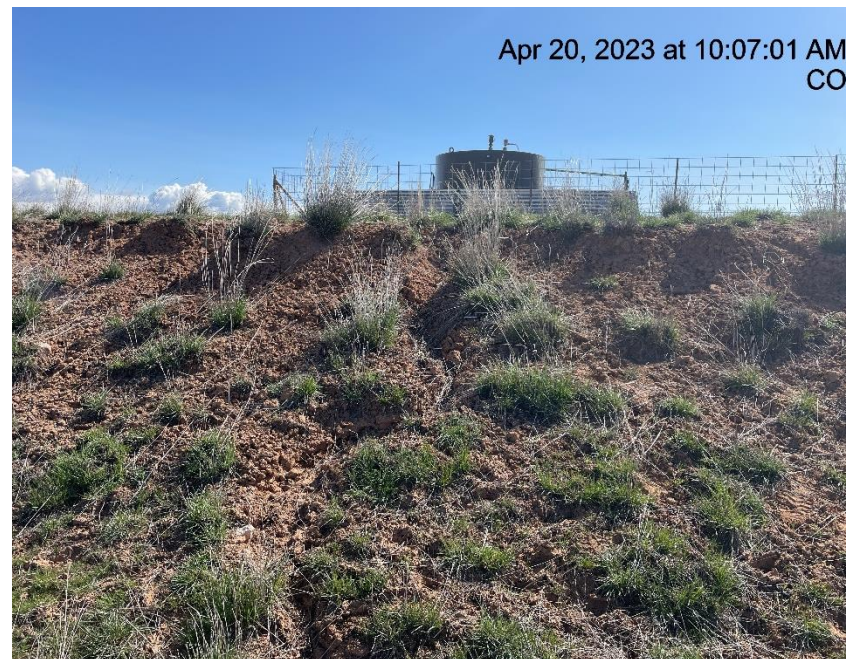
**Photo # 5862 Erosion & transport of sediment off location
(West side of pad on slope near production tank)**

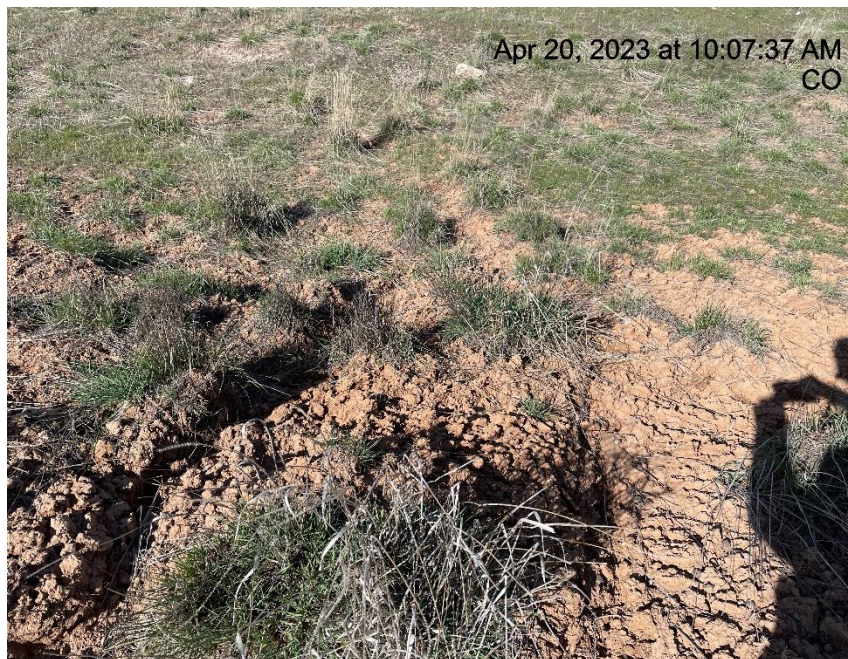
**Photo # 5864 Erosion & transport of sediment off location
(West side of pad on slope near production tank)**

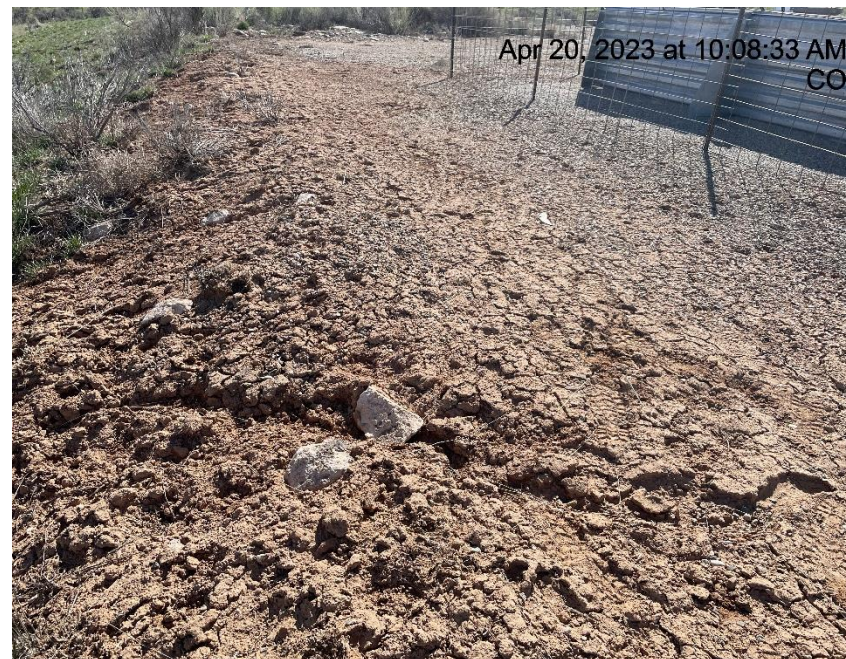
**Photo # 5865 Erosion & transport of sediment (North side of
pad on slope near production tank)**

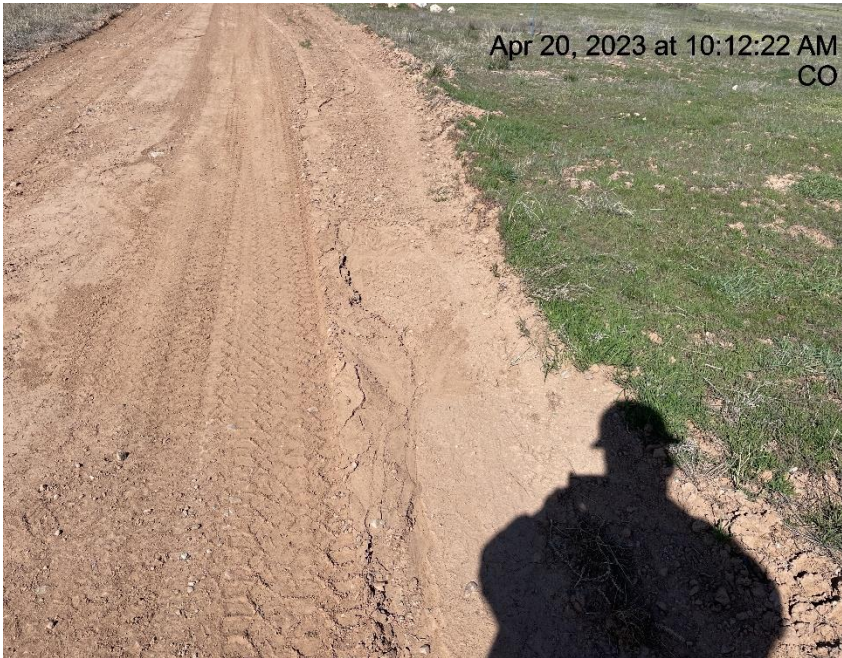
Photo # 5873 Erosion & transport of sediment down spur road

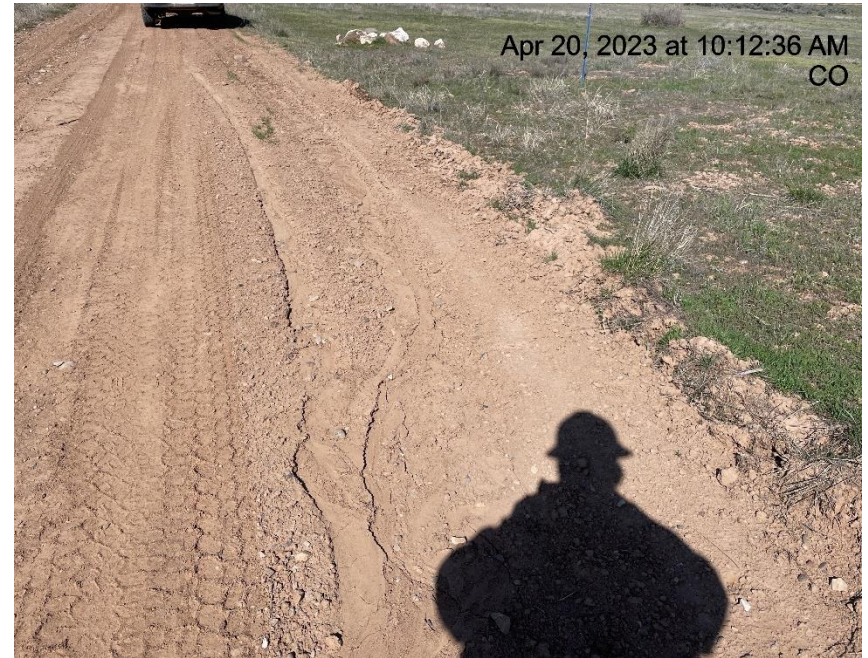
Photo # 5874 Erosion & transport of sediment down spur road

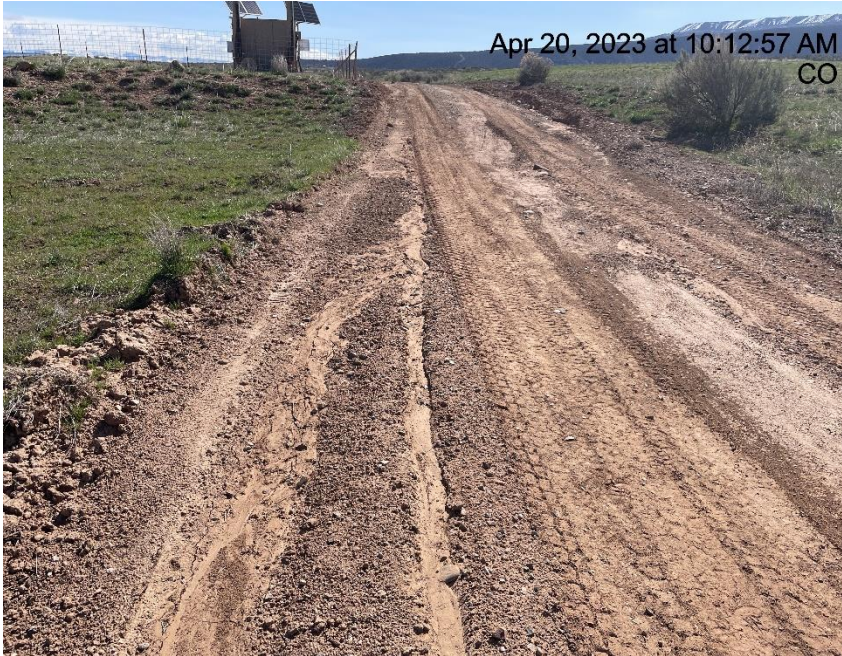
Photo # 5875 Erosion & transport of sediment down spur road

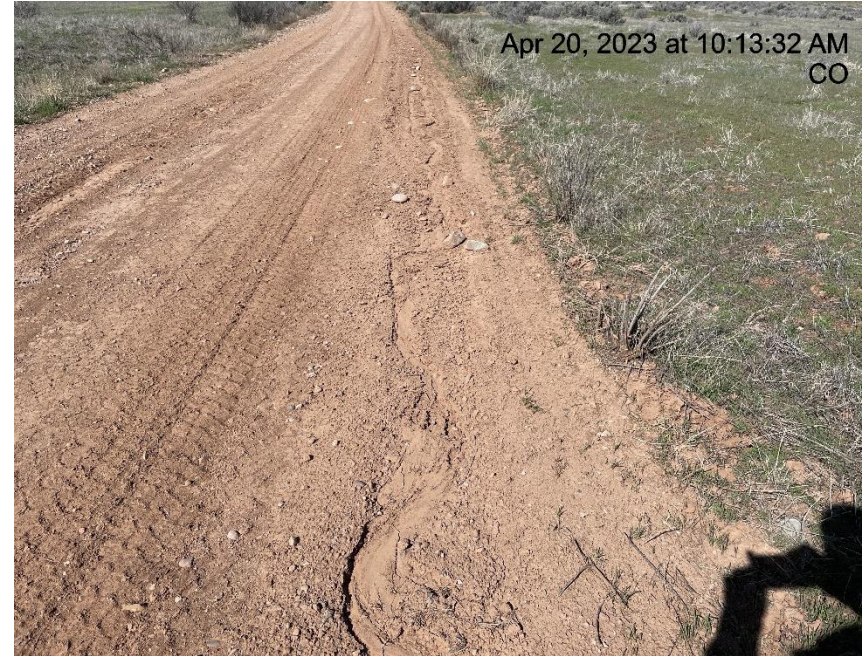
Photo # 5876 Erosion & transport of sediment down spur road

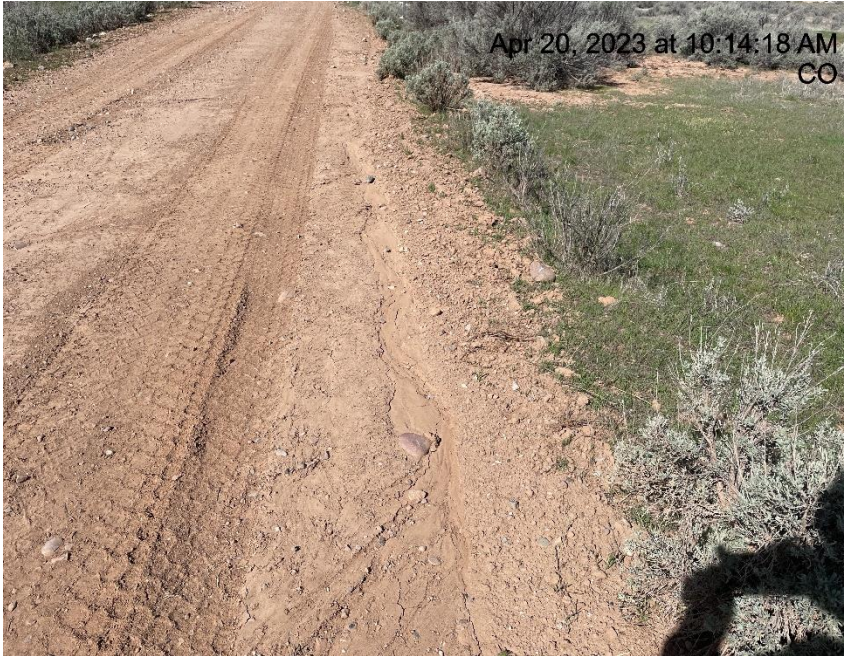
Photo # 5877 Erosion/transport of sediment down spur road & transport of sediment off of spur road into a vegetated area/insufficient BMP's

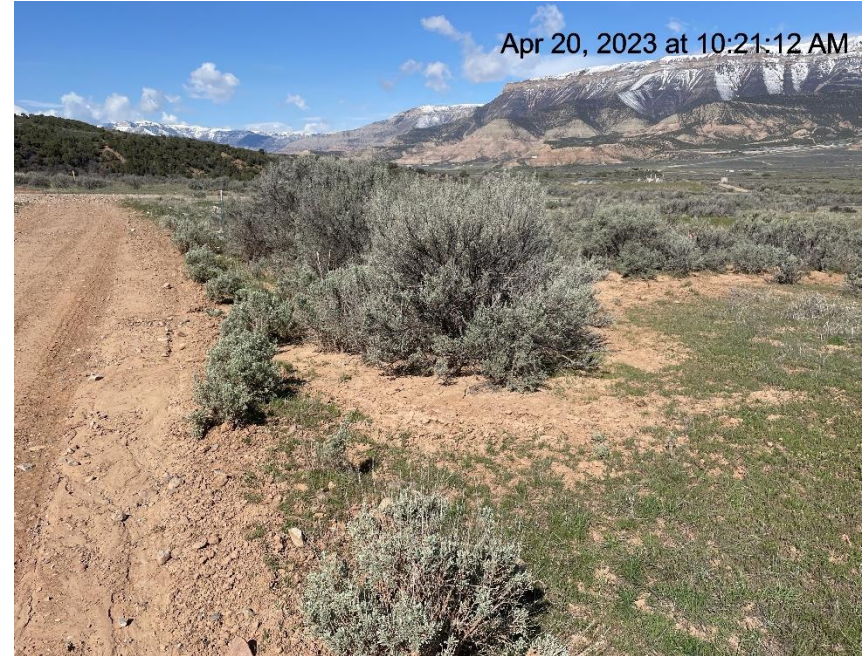
Photo # 5887 Erosion/transport of sediment down spur road & transport of sediment off of spur road & into a vegetated area/insufficient BMP's

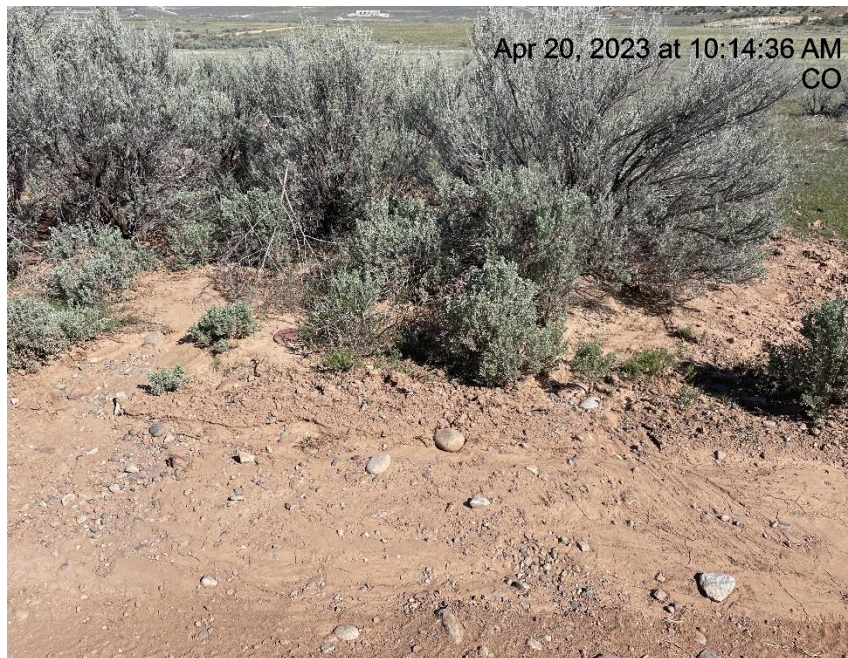
Photo # 5878 Erosion/transport of sediment down spur road & transport of sediment off of spur road into a vegetated area/insufficient BMP's

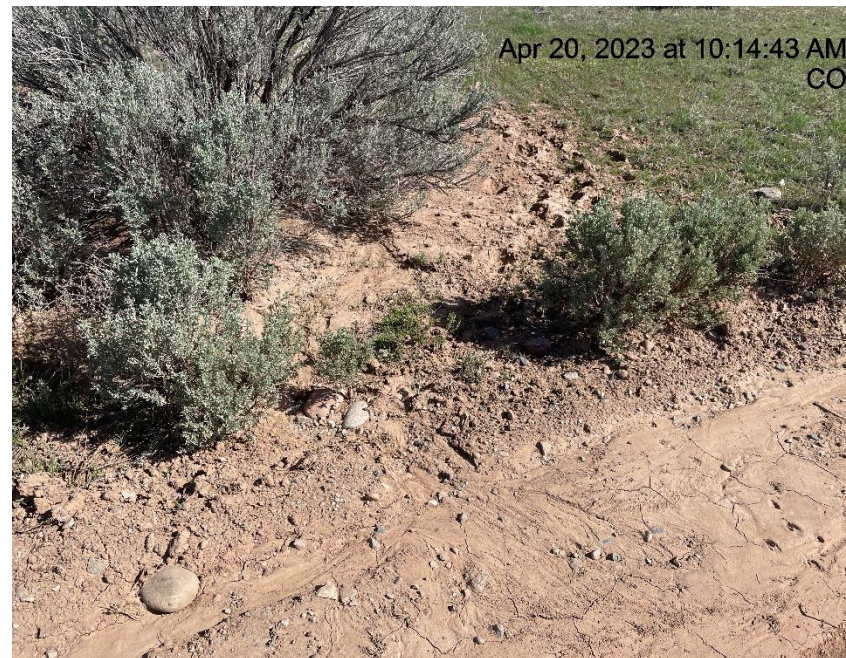
Photo # 5879 Erosion/transport of sediment down spur road & transport of sediment off of spur road into a vegetated area/insufficient BMP's

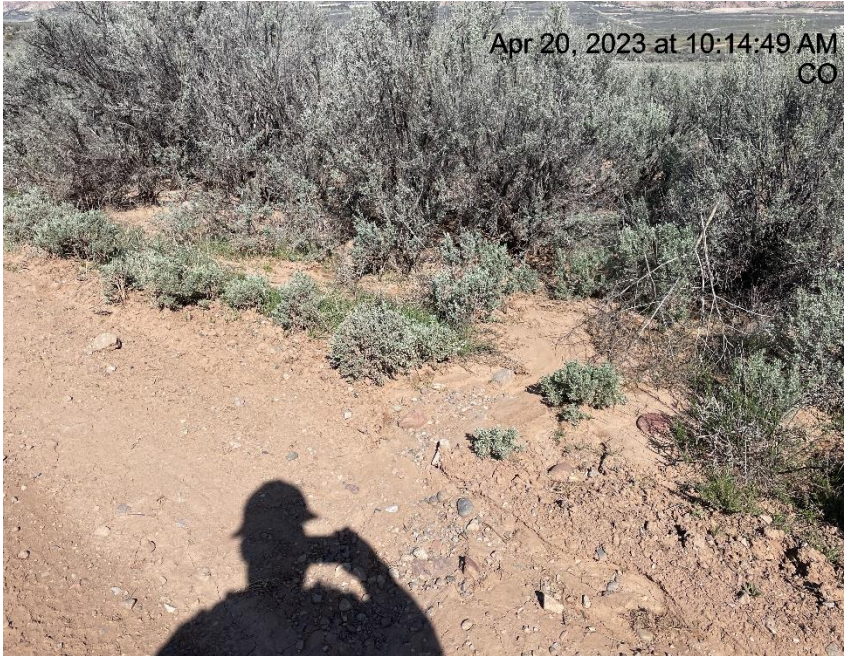
Photo # 5880 Erosion/transport of sediment down spur road & transport of sediment off of spur road into a vegetated area/insufficient BMP's

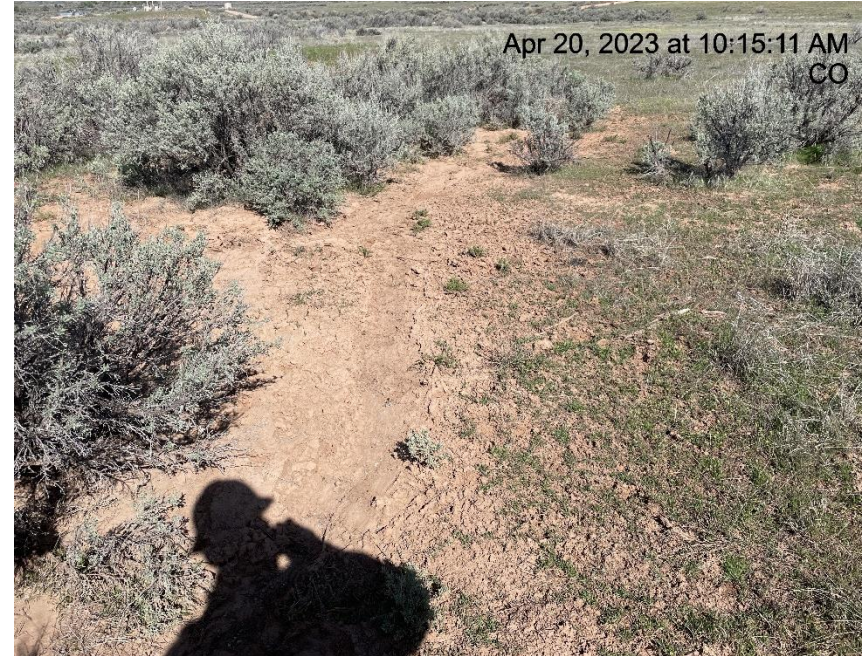
Photo # 5881 Erosion/transport of sediment down spur road & transport of sediment off of spur road into a vegetated area/insufficient BMP's

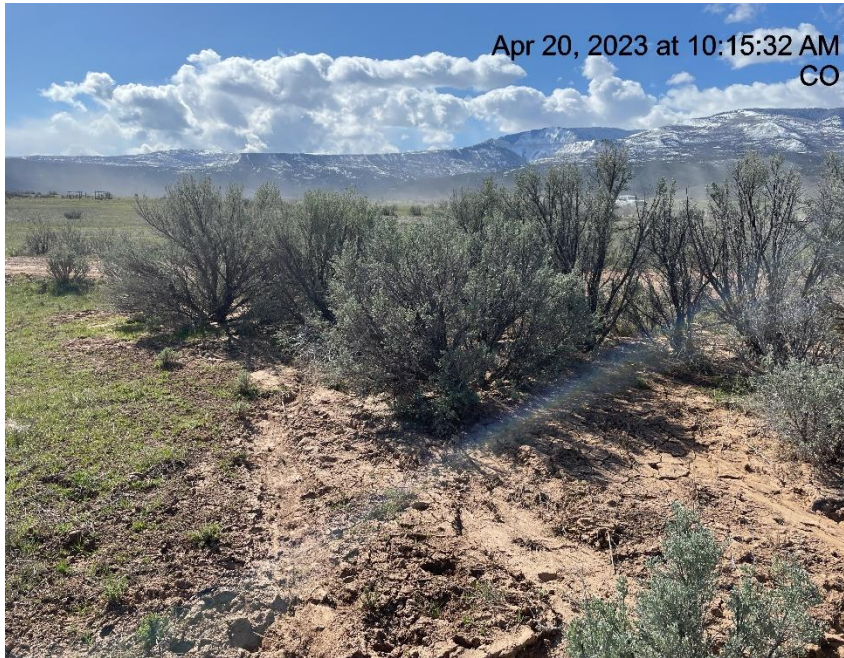
Photo # 5882 Erosion/Transport of sediment off of spur road into a vegetated area/insufficient BMP's

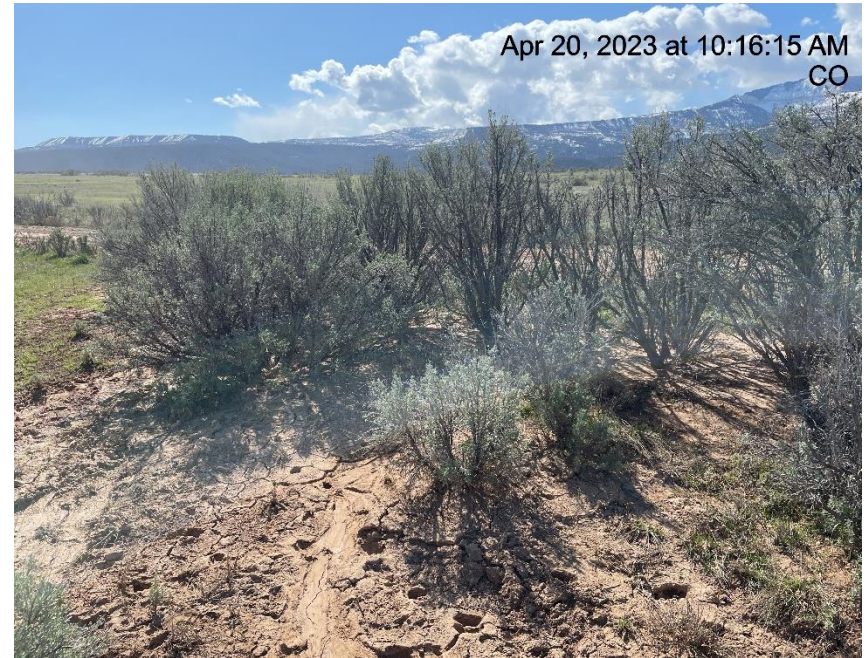
Photo # 5883 Erosion/Transport of sediment off of spur road into a vegetated area/insufficient BMP's

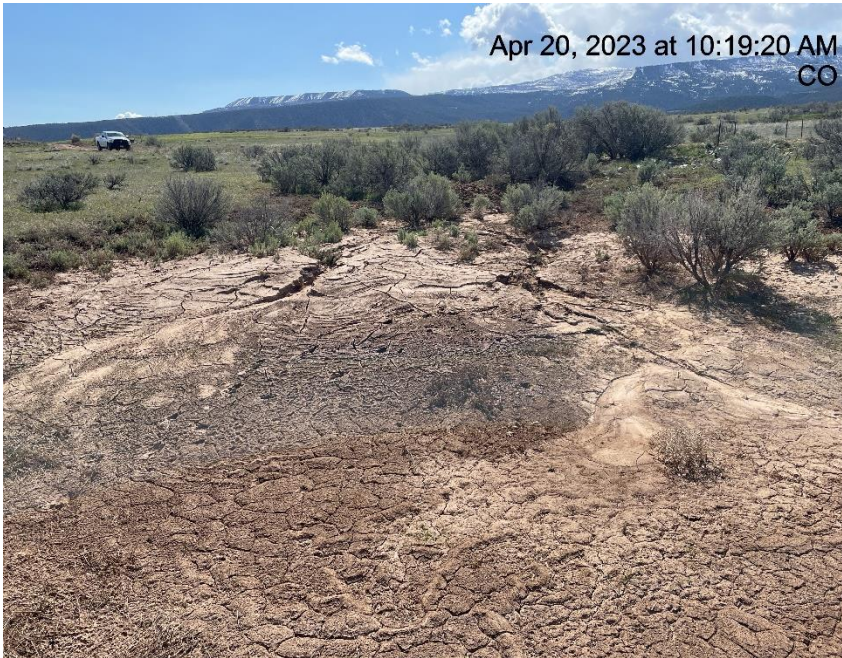
Photo # 5884 BMP's need maintenance (North side of spur road near culvert & rip rap run approximately 10-20 yards down spur road)
