Inspection Photos

Operator: TEP Rocky Mountain- #96850

Location Name: South Leverich /13-09 Pad

Inspection Document #: 702801487

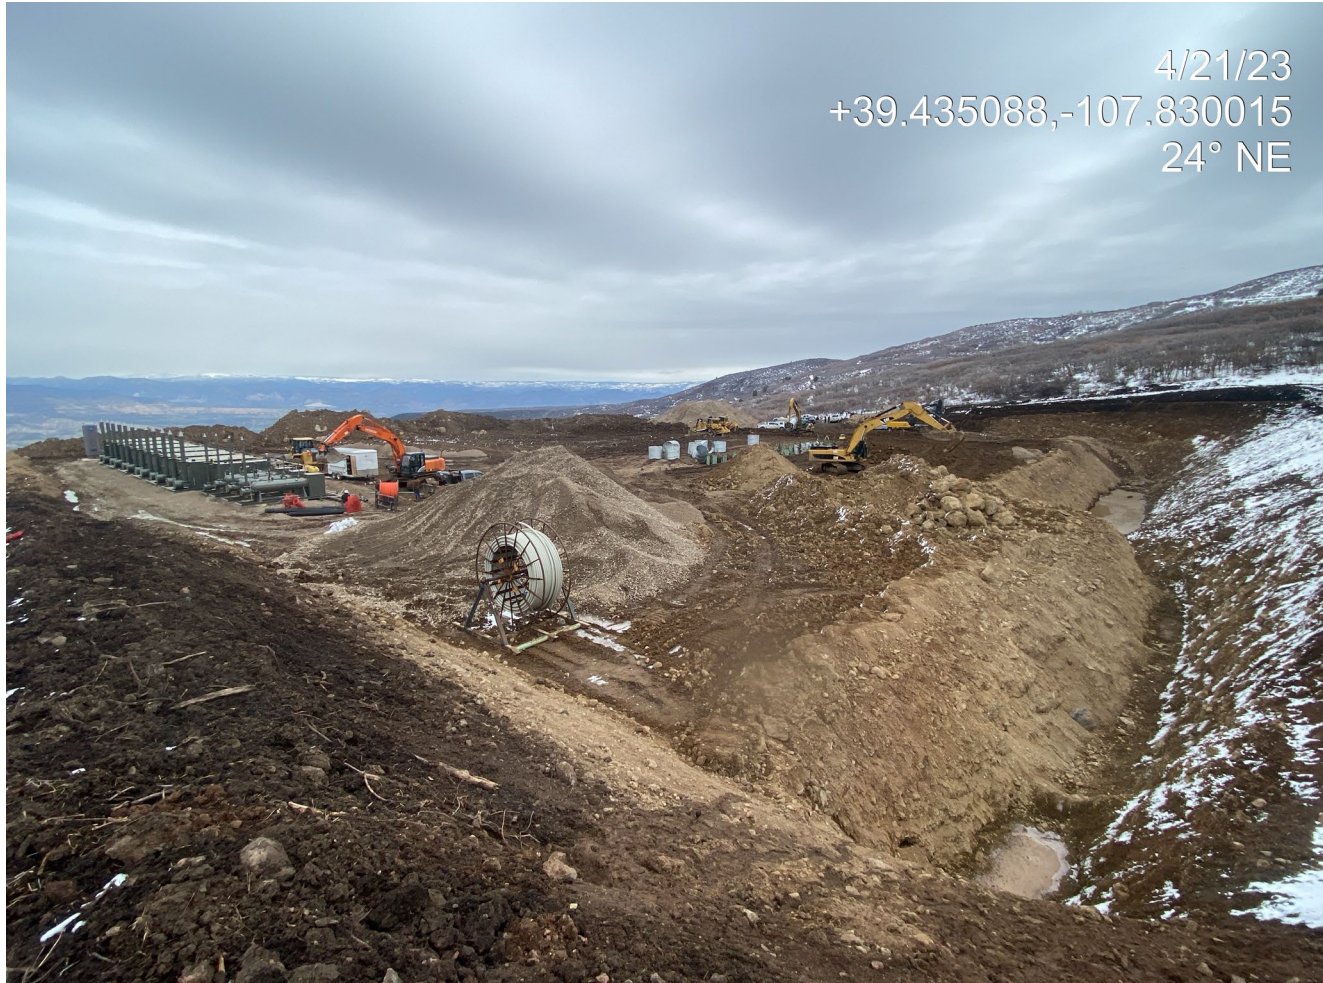
Photo 1. Photo taken from the southwest shows an overview of the working pad area.

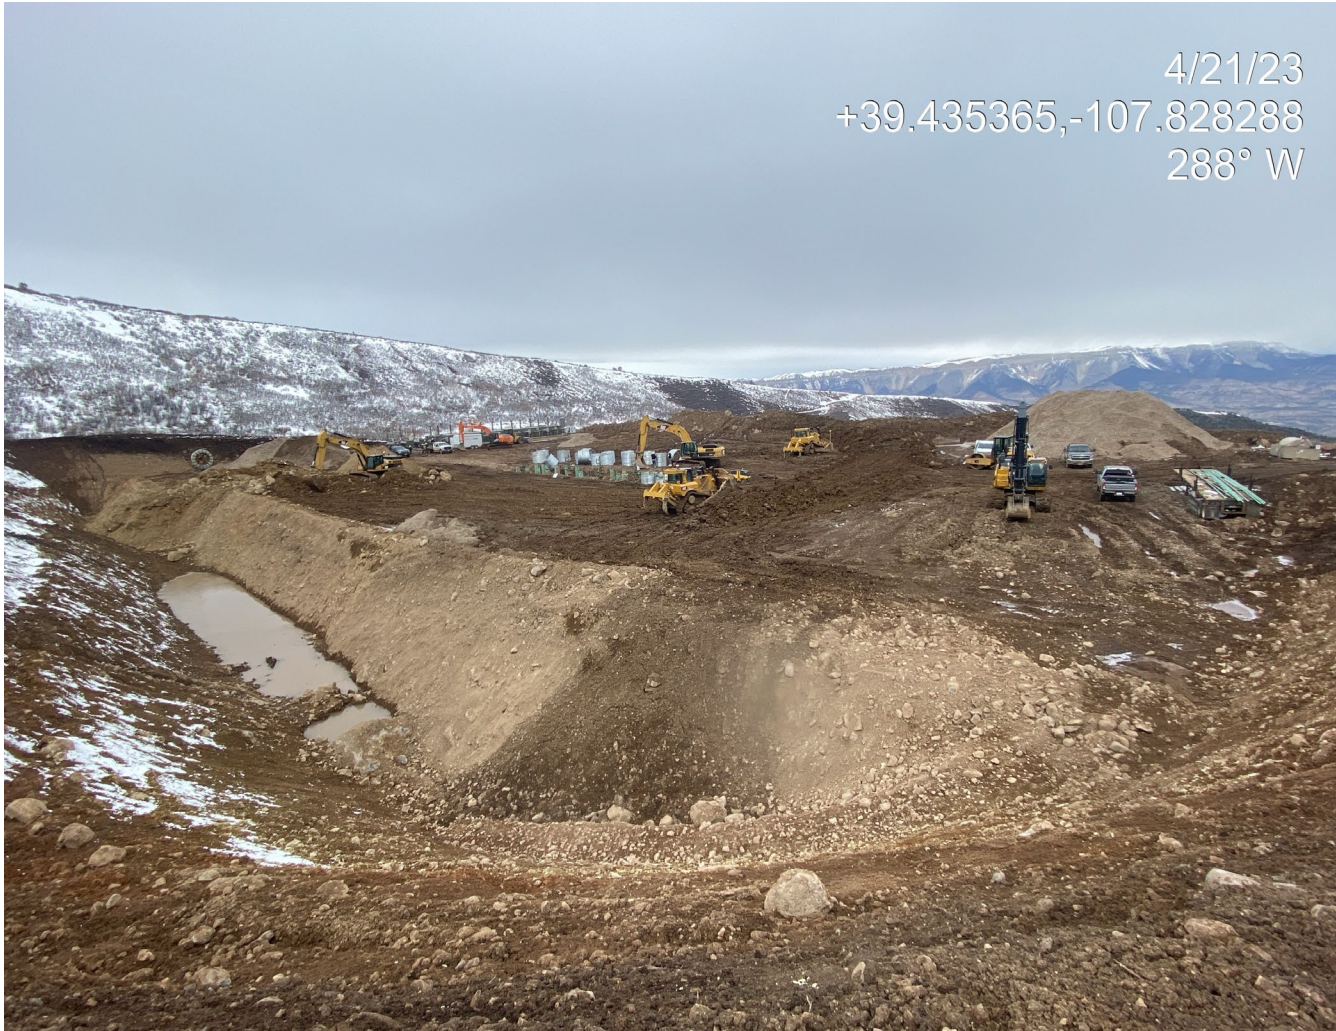
Photo 2. Photo taken from the southeast shows an overview of the working pad area.

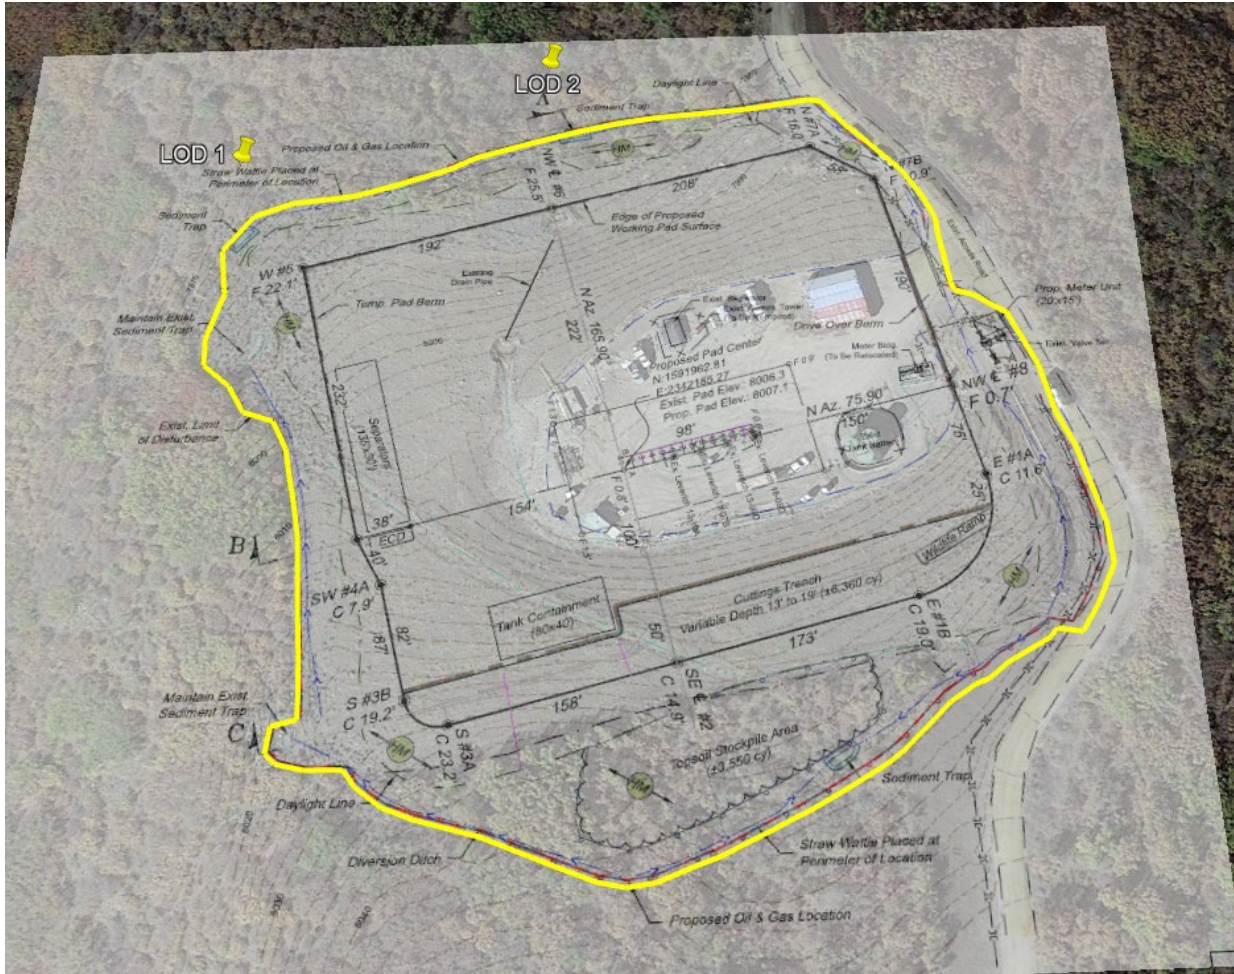
Photo 3. Photo shows the construction layout drawing overlaid on Google Earth imagery with the 2A location (yellow). “LOD” pins show GPS points of the actual location disturbance which extend approximately 70 feet beyond the permitted location.

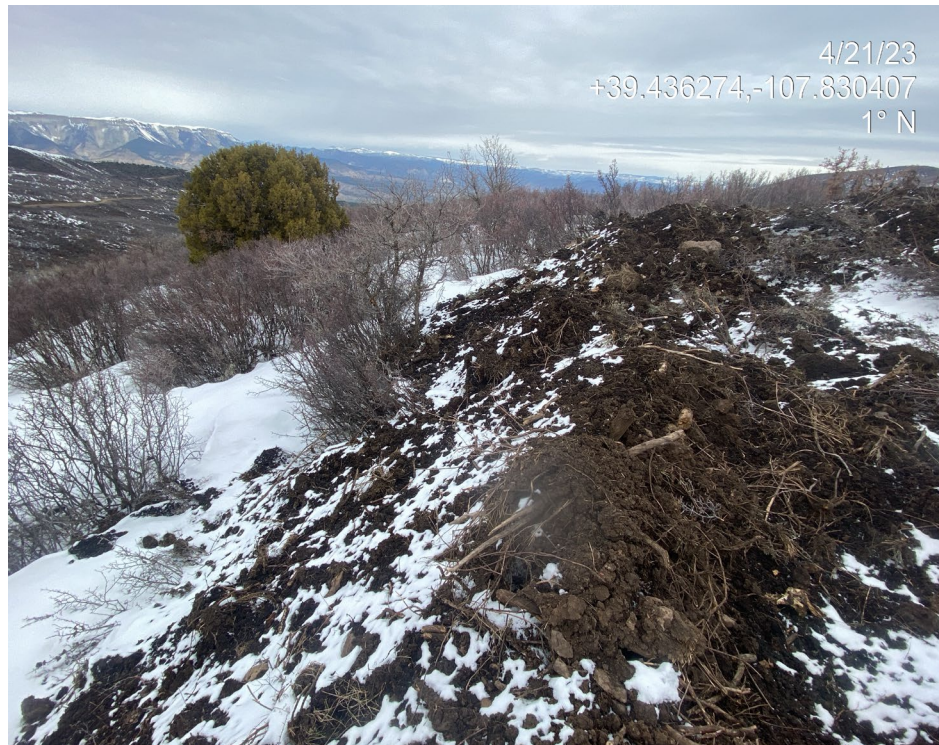
Photo 4. Photo taken from the northwestern edge of the location shows “LOD 1” from Photo 3. Note also lack of protections for unconsolidated topsoil subject to erosion.

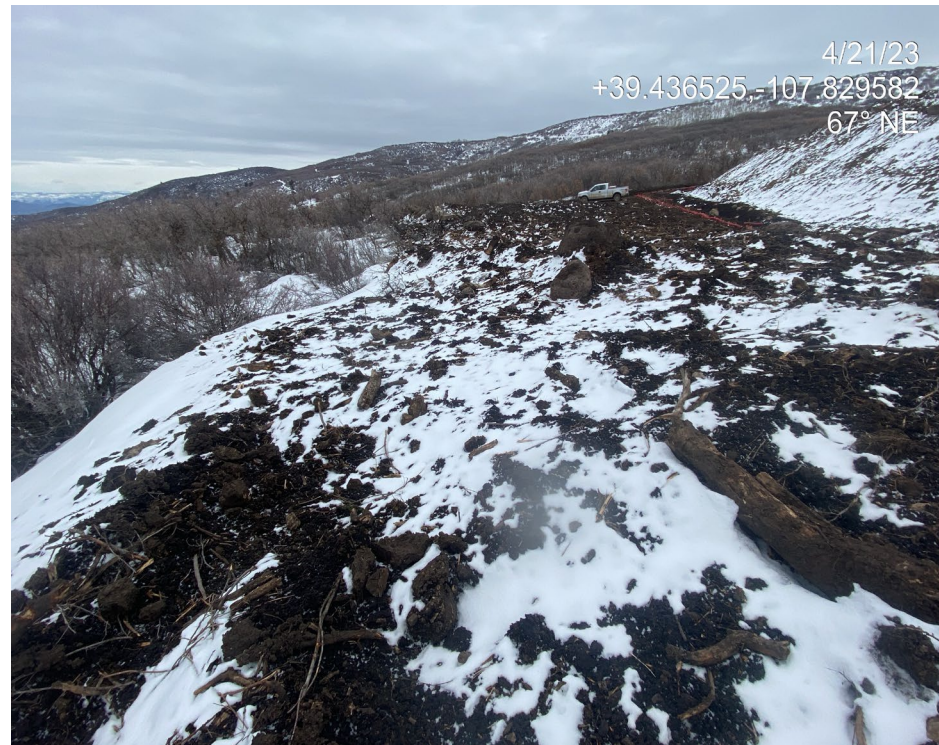
Photo 5. Photo taken from the northern edge of the location shows “LOD 2” from Photo 3. Note also lack of protections for unconsolidated topsoil susceptible to erosion.

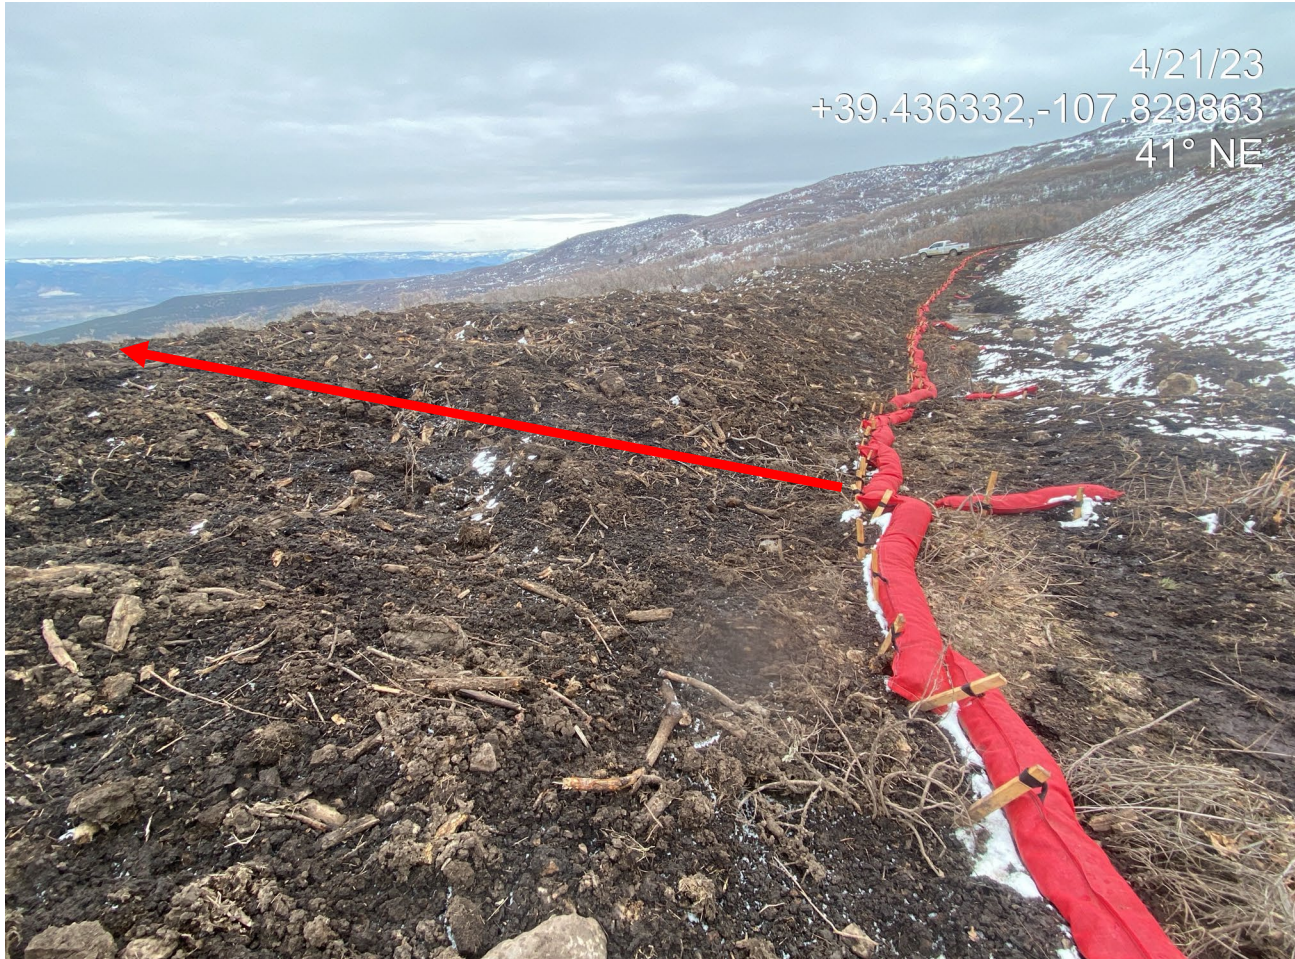
Photo 6. Photo taken from the north shows perimeter stormwater controls which are mapped at the northern edge of the location. The disturbance continues an additional ~70 feet to the north (red arrow).

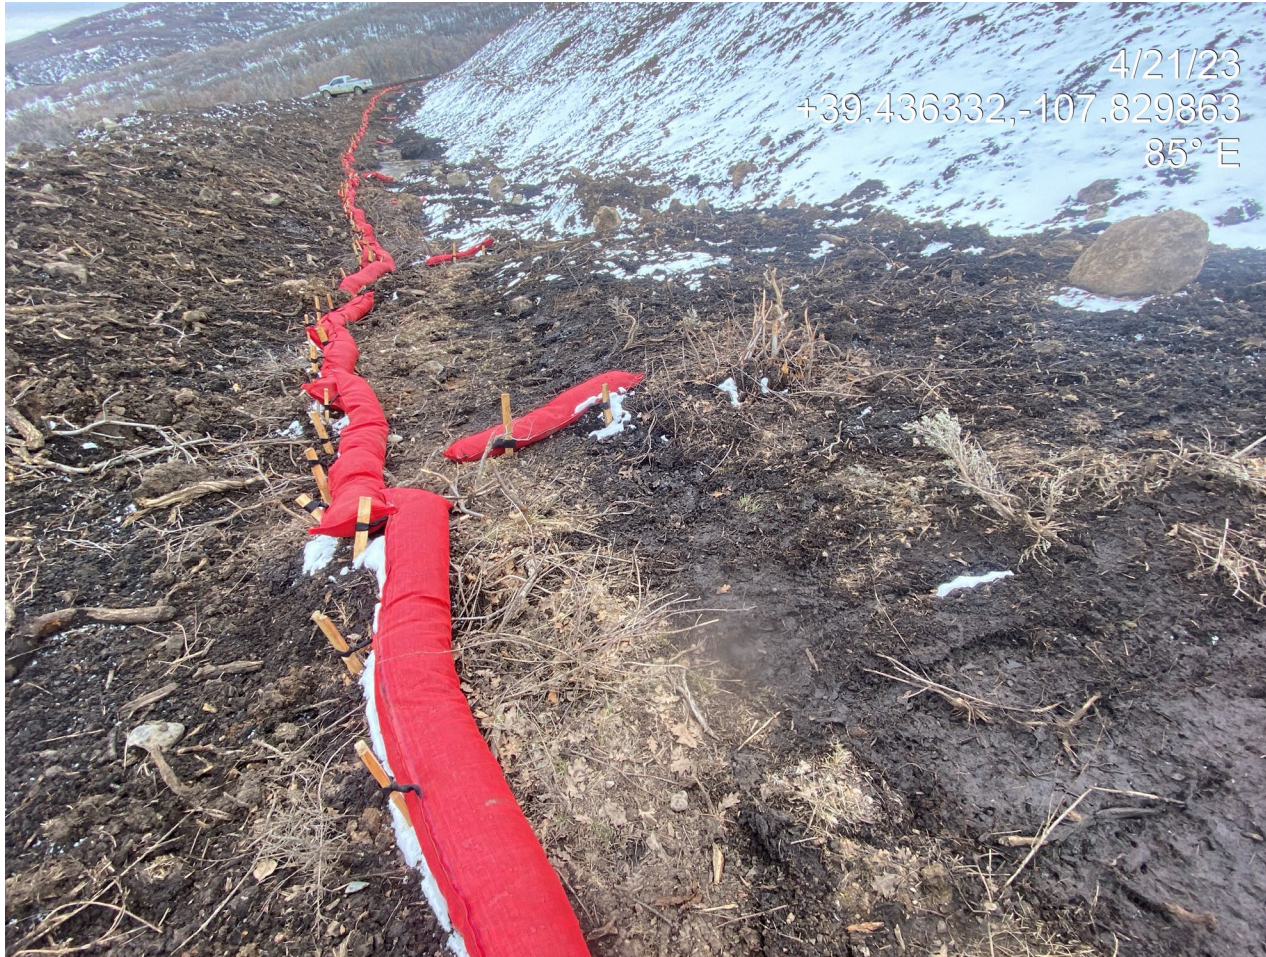
Photo 7. Photo taken from the north. Topsoil does not appear to have been salvaged at stormwater BMPs (note dark soil color and presence of vegetation). Photo also shows the diversion ditch has not been properly constructed per good engineering practices.

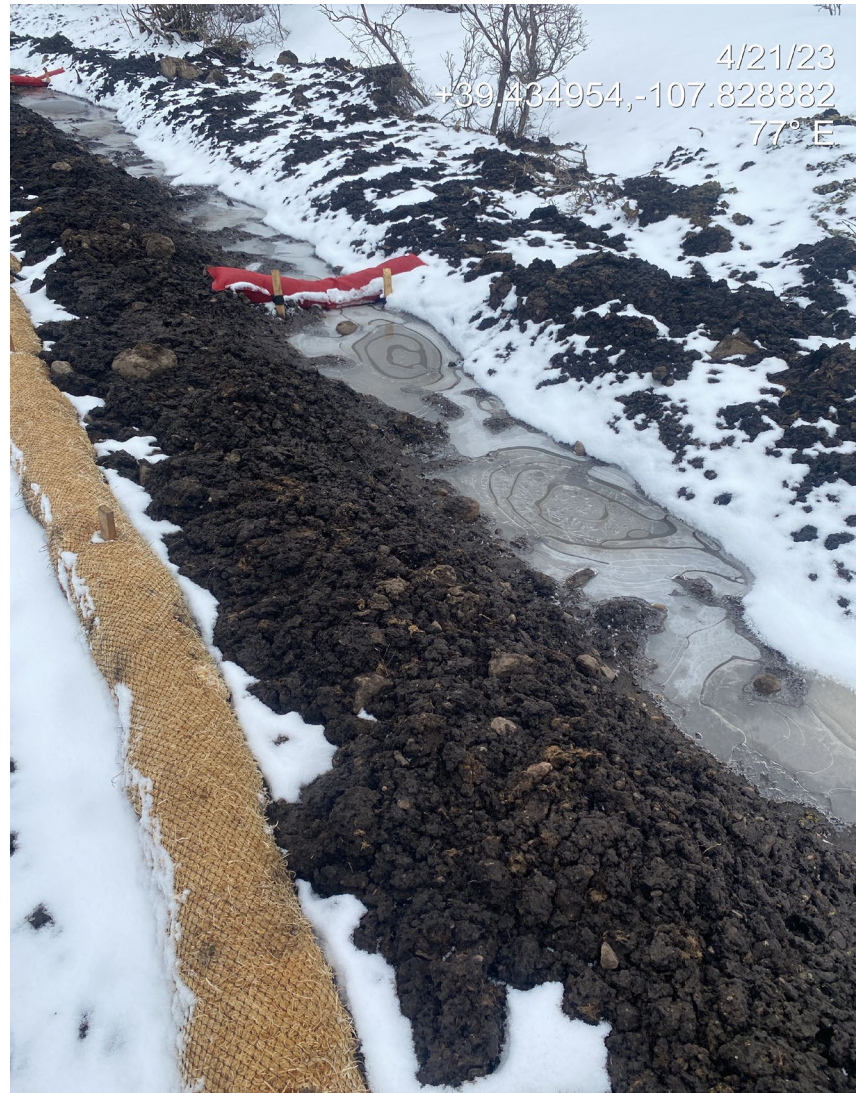
Photo 8. Photo taken from the south. Topsoil does not appear to have been salvaged. Stormwater BMPs appear to be constructed from topsoil.

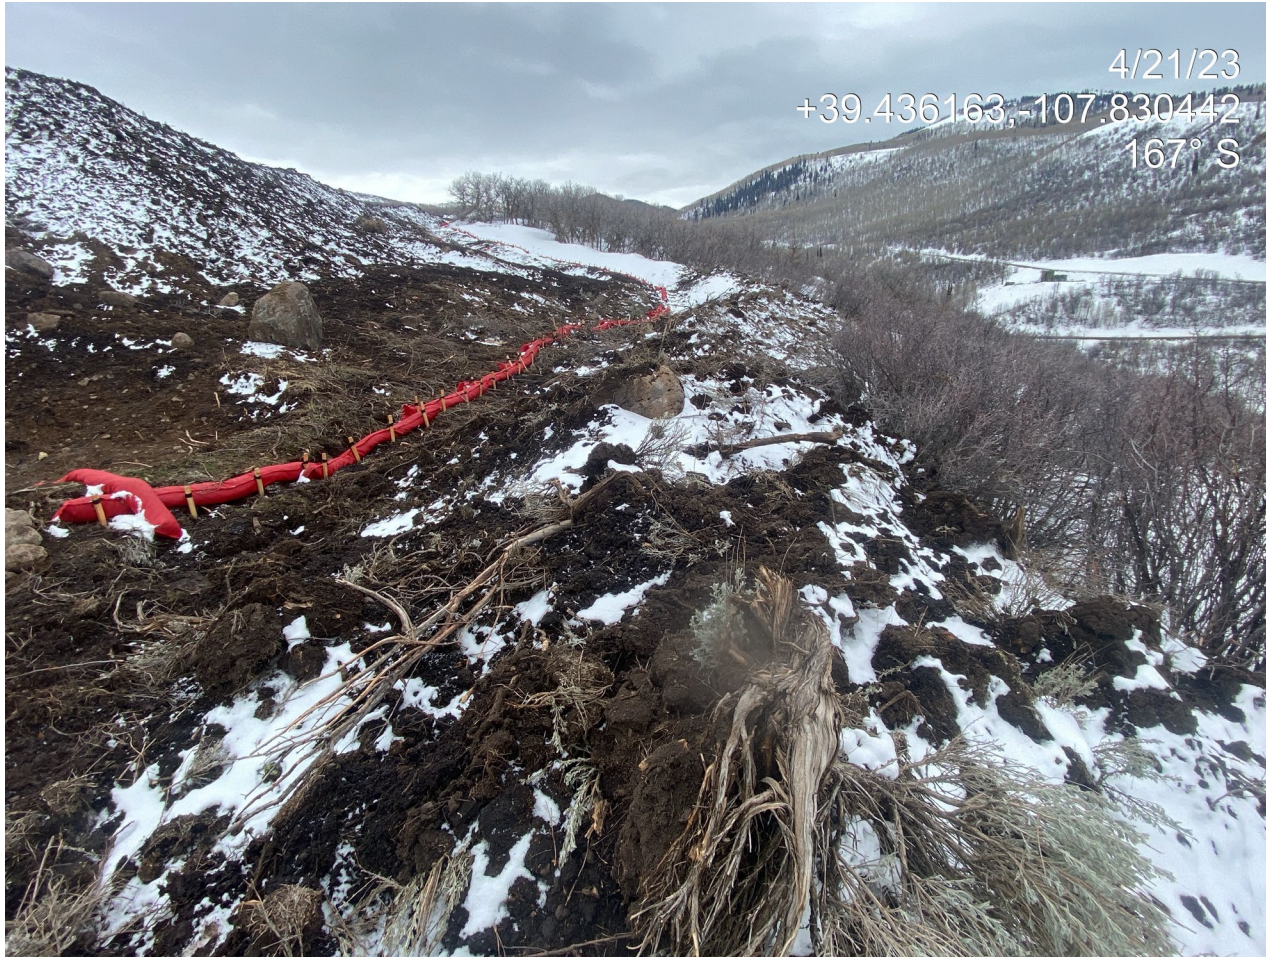
Photo 9. Photo taken from the west shows a lack of stormwater and topsoil protection BMPs. Topsoil is loose and unconsolidated and susceptible to erosion.

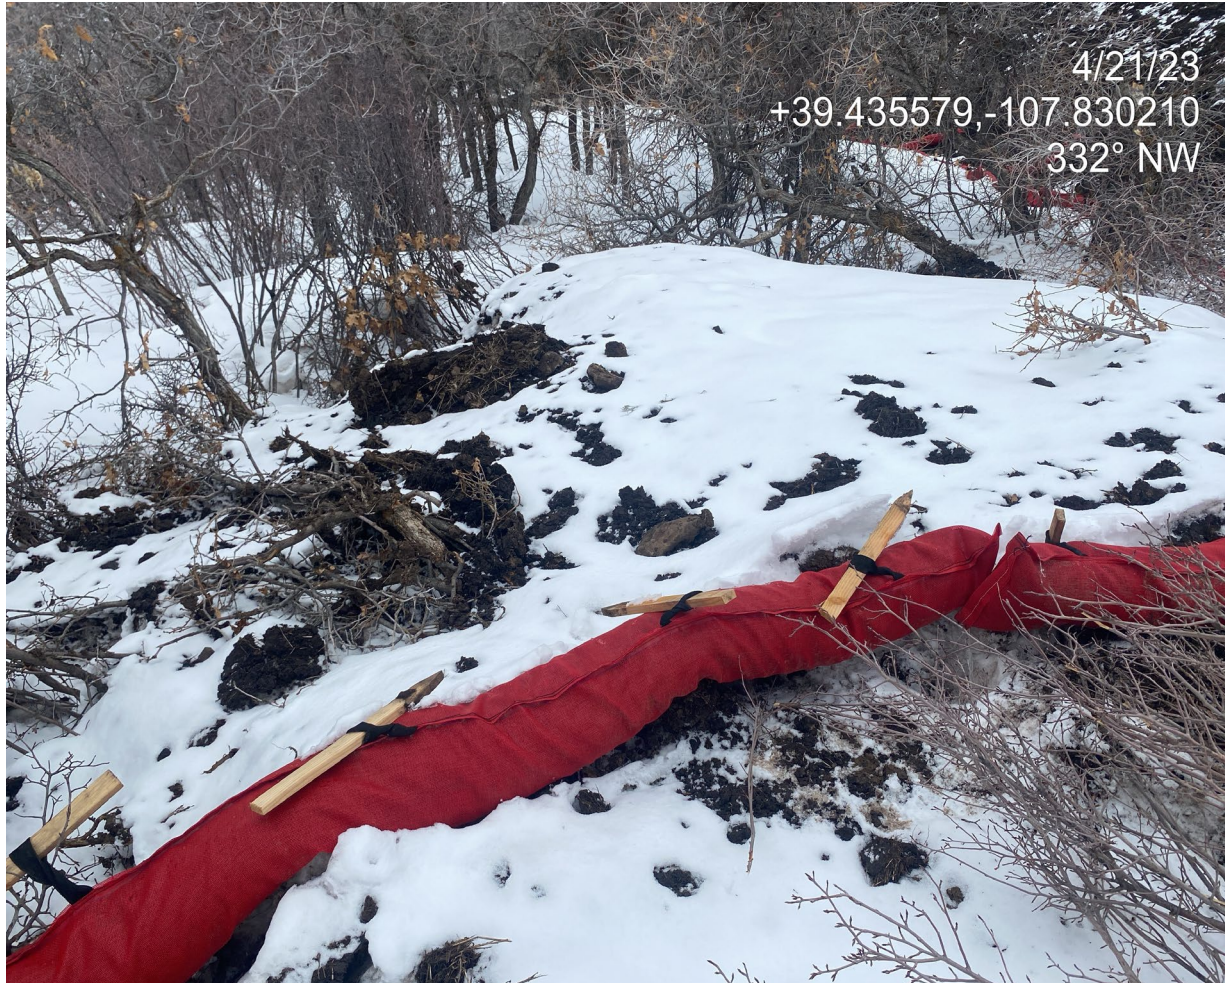
Photo 10. Photo shows perimeter stormwater BMPs at the west of the location are in disrepair.

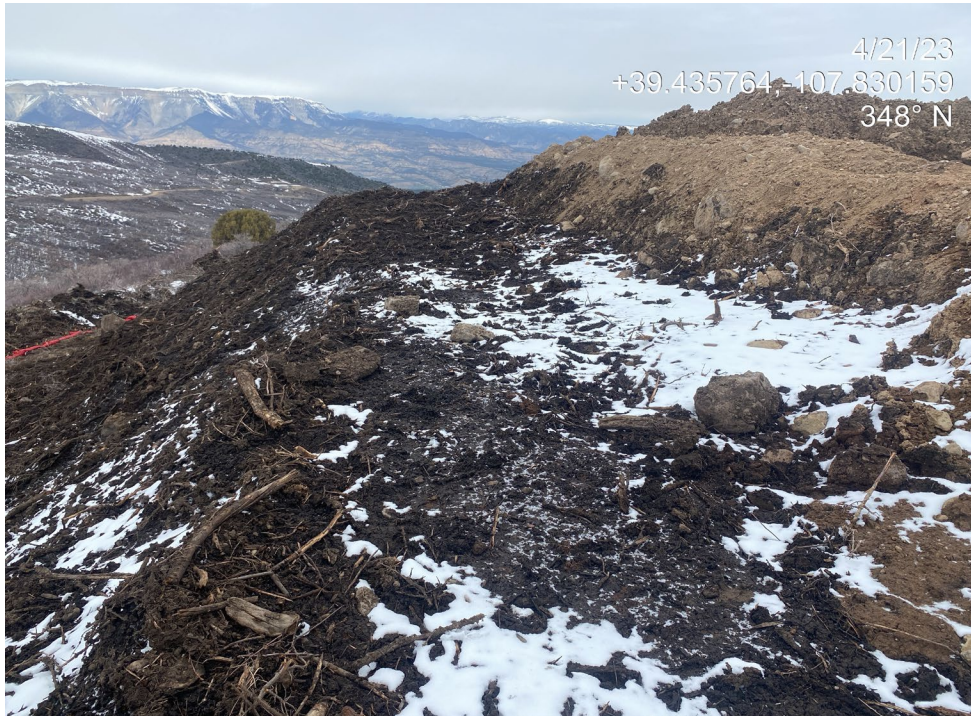
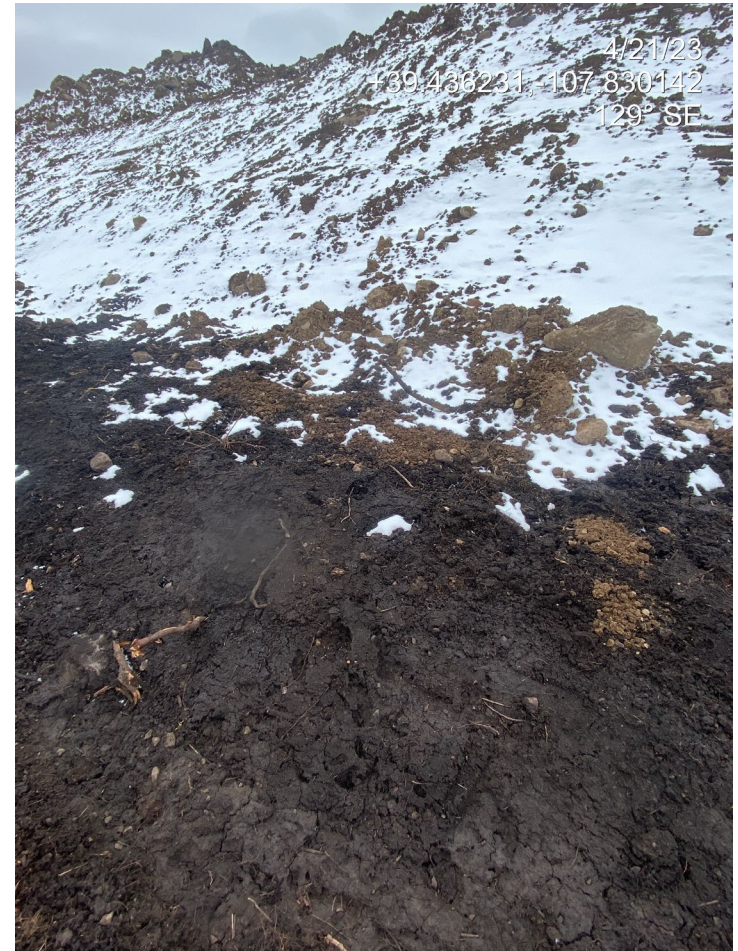
Photo 11. Photos taken from the west show the fill slope of the location. BMPs to segregate and protect topsoil from mixing with the lighter colored subsoil berm are missing/insufficient. Additionally, topsoil is bare, loose and unconsolidated and susceptible to erosion.

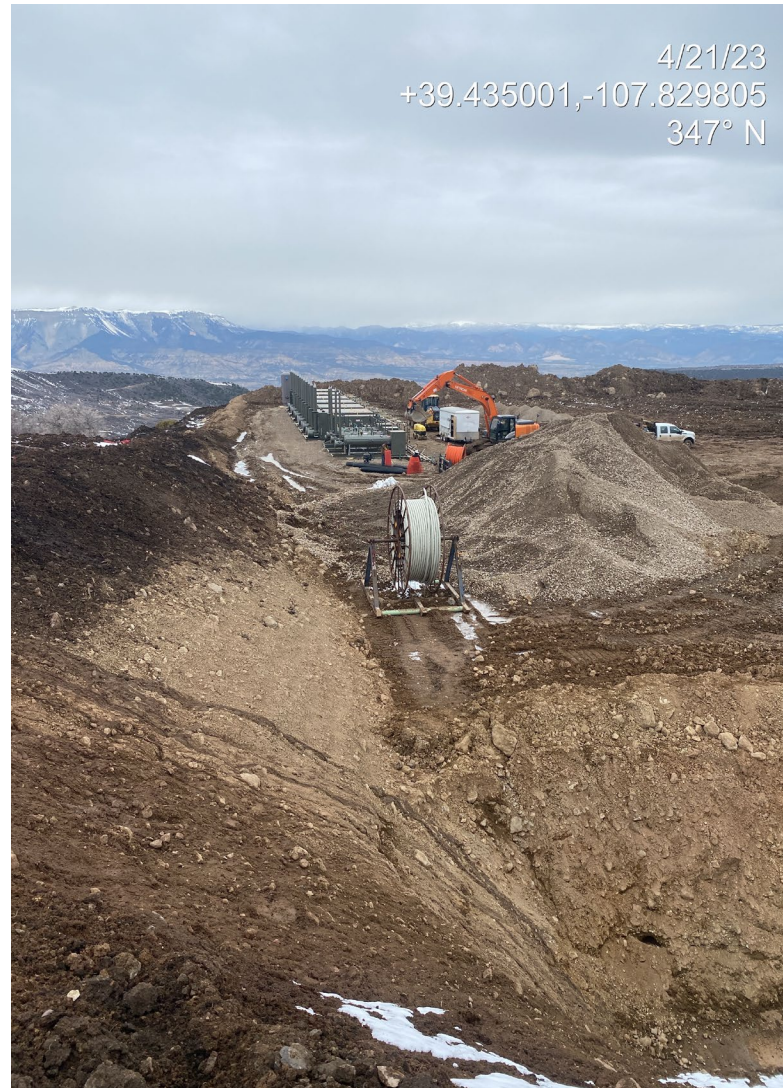
Photo 12. Photo taken from the southwest shows topsoil (darker colored) is unstabilized and eroding. BMPs to stabilize and protect topsoil are missing/insufficient.

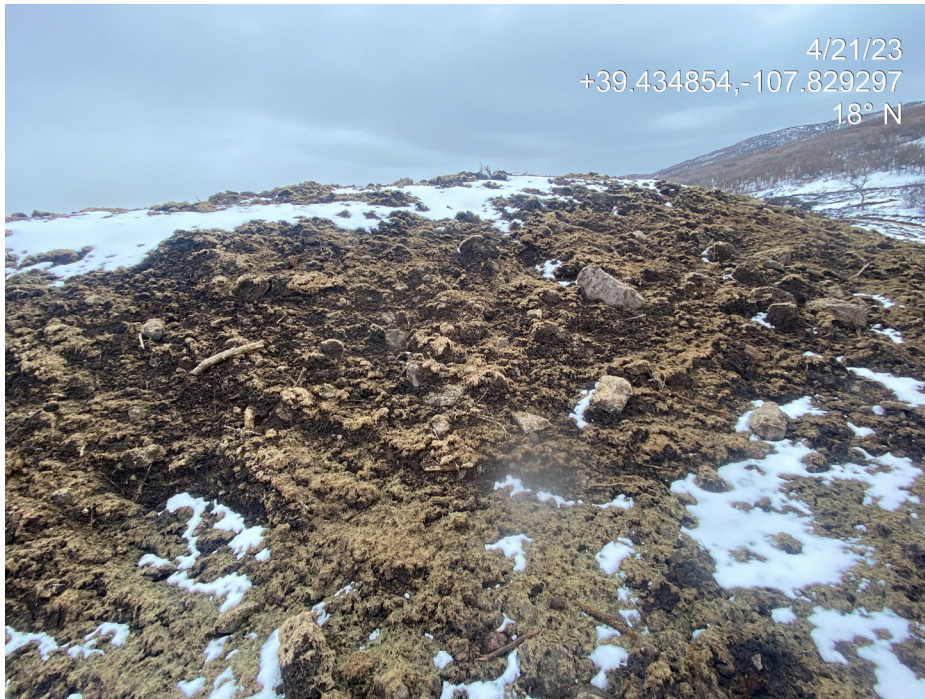
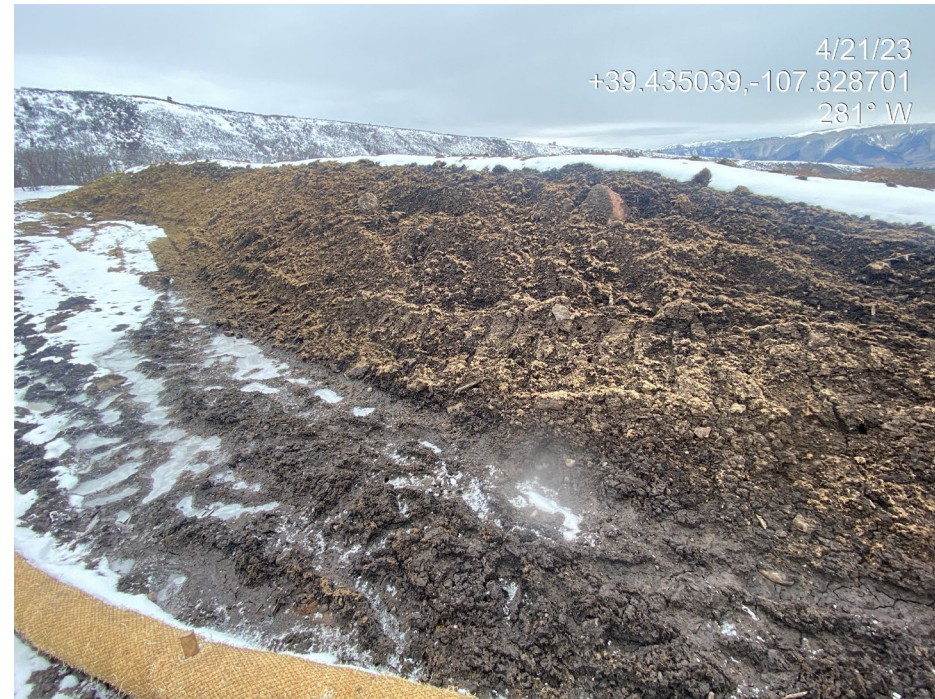
Photo 13. Photos show the topsoil stockpile at the south of the location. Hydromulch is not evenly distributed to cover the entire exposed soil surface. It appears mulch has not been applied from multiple angles to prevent shadow.

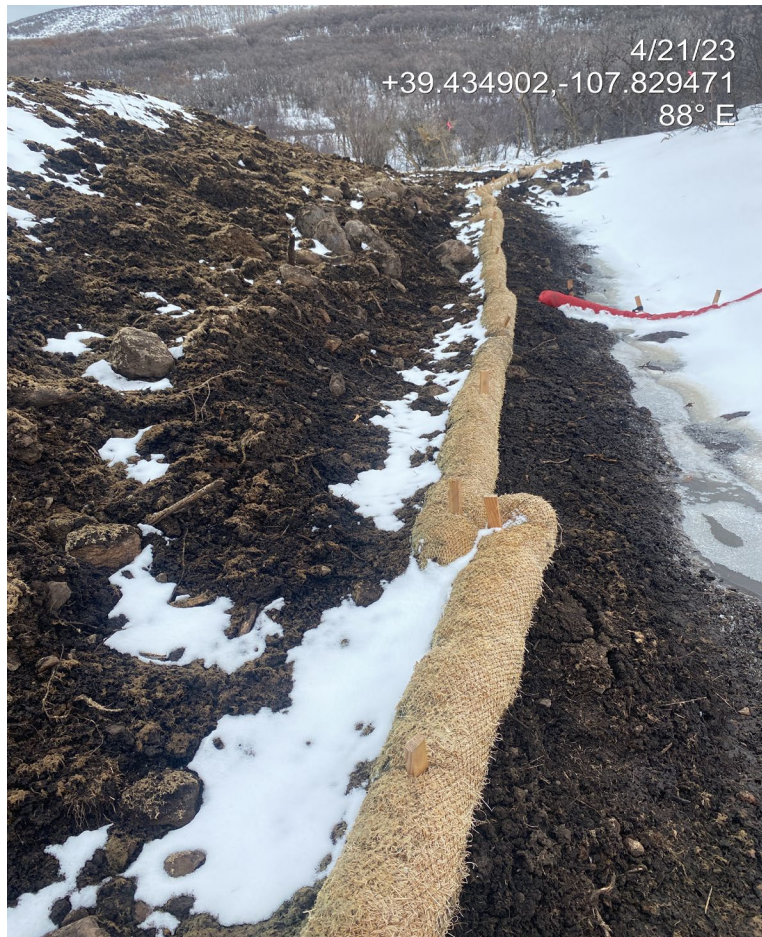
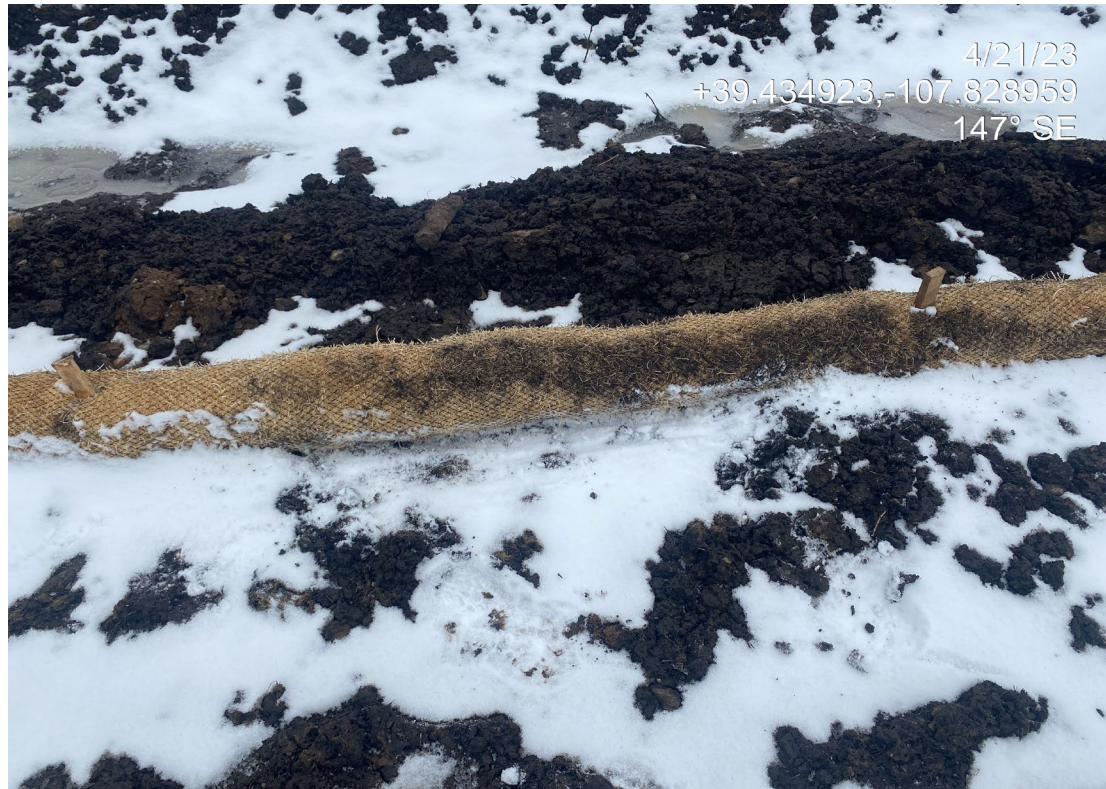
Photo 14. Photos show the topsoil stockpile at the south of the location. Some perimeter wattles are not installed in accordance with good engineering practices (trenched and backfilled).

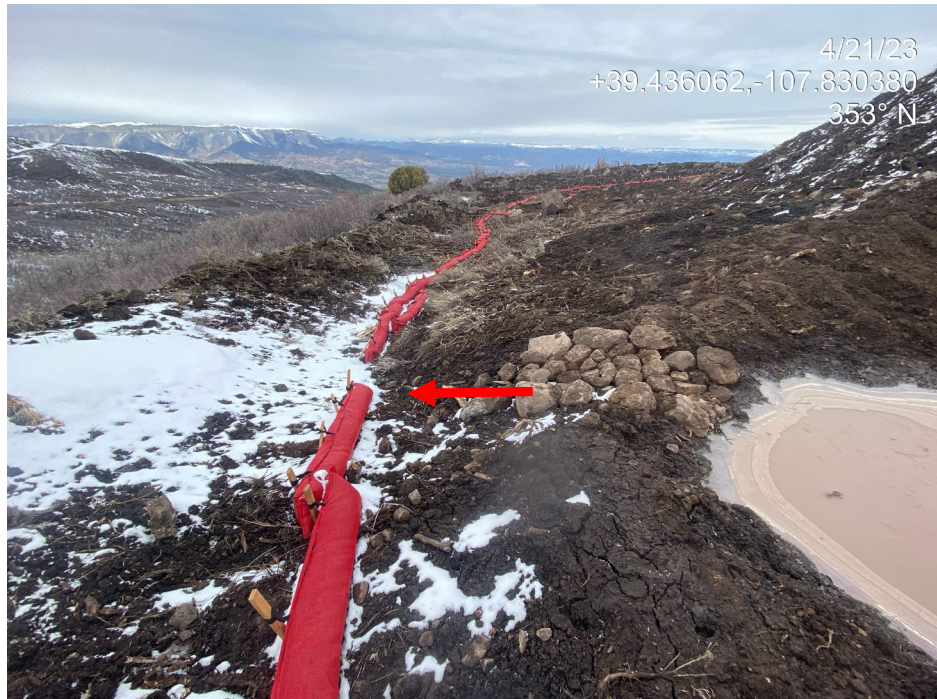
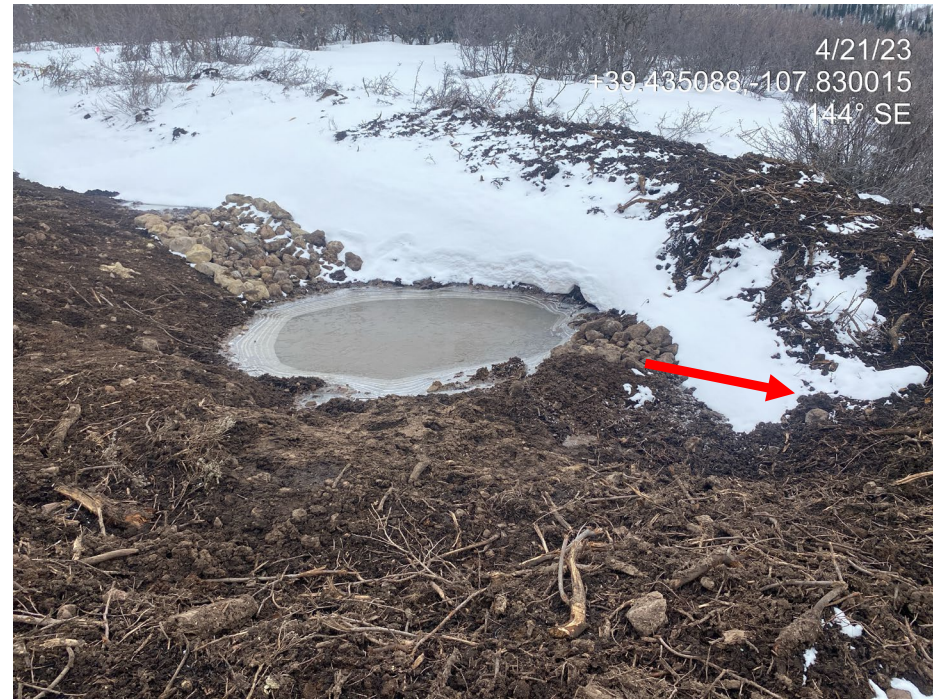
Photo 15. Photos show sediment traps at the northwest (left) and southwest (right). The outlets are designed to discharge stormwater directly into an unvegetated, unstabilized topsoil berm.

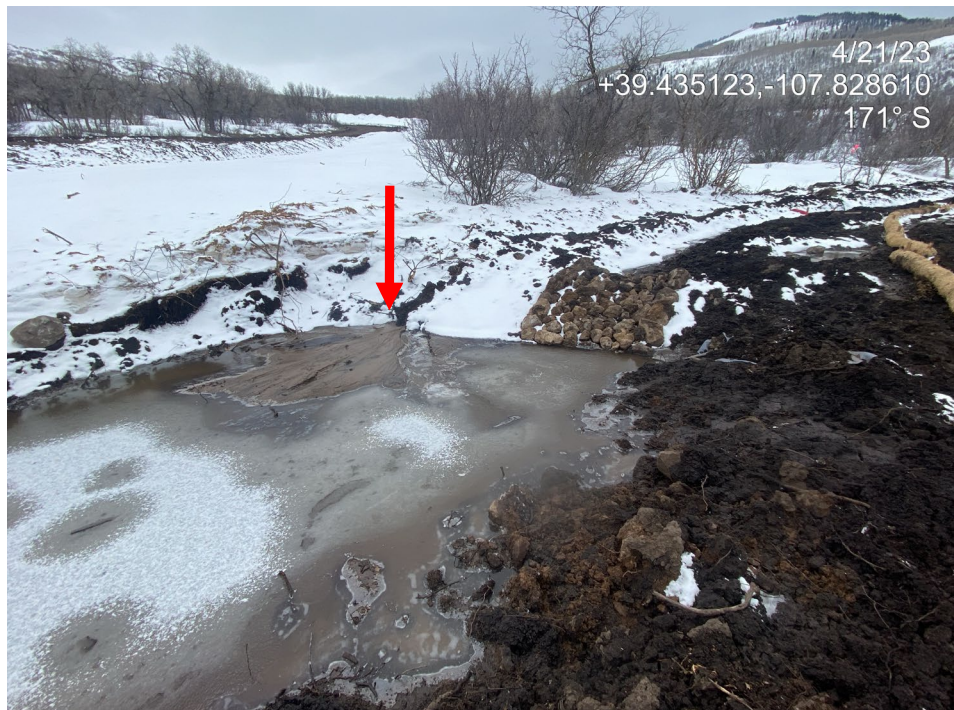
Photo 16. Photo taken from the southeast shows degradation where stormwater is bypassing an armored inlet to a sediment trap.

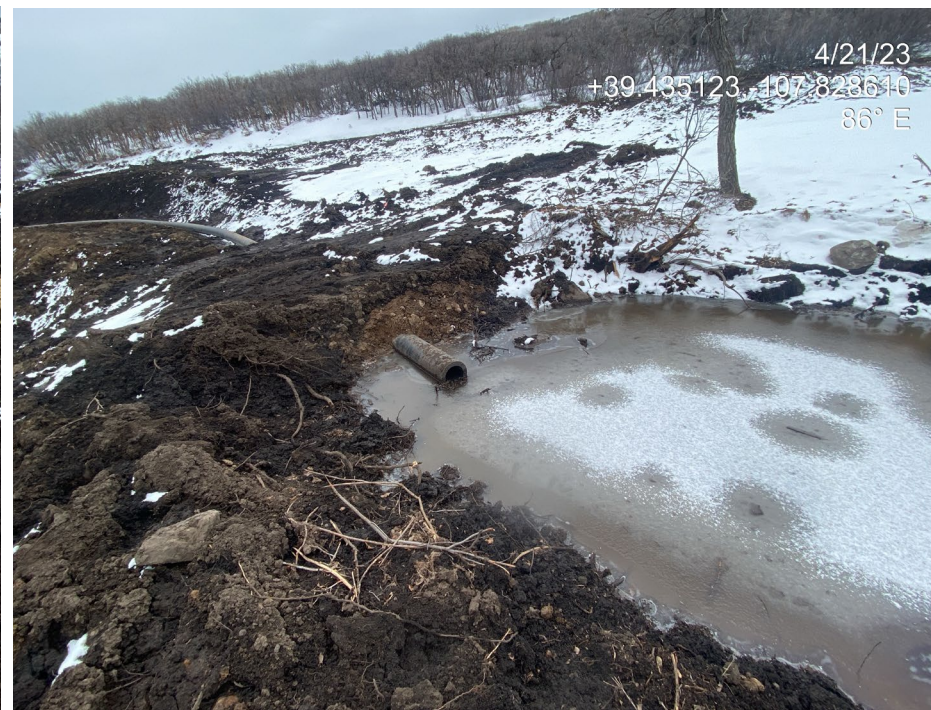
Photo 17. Photo shows the outlet pipe for the sediment trap pictured in Photo 16.

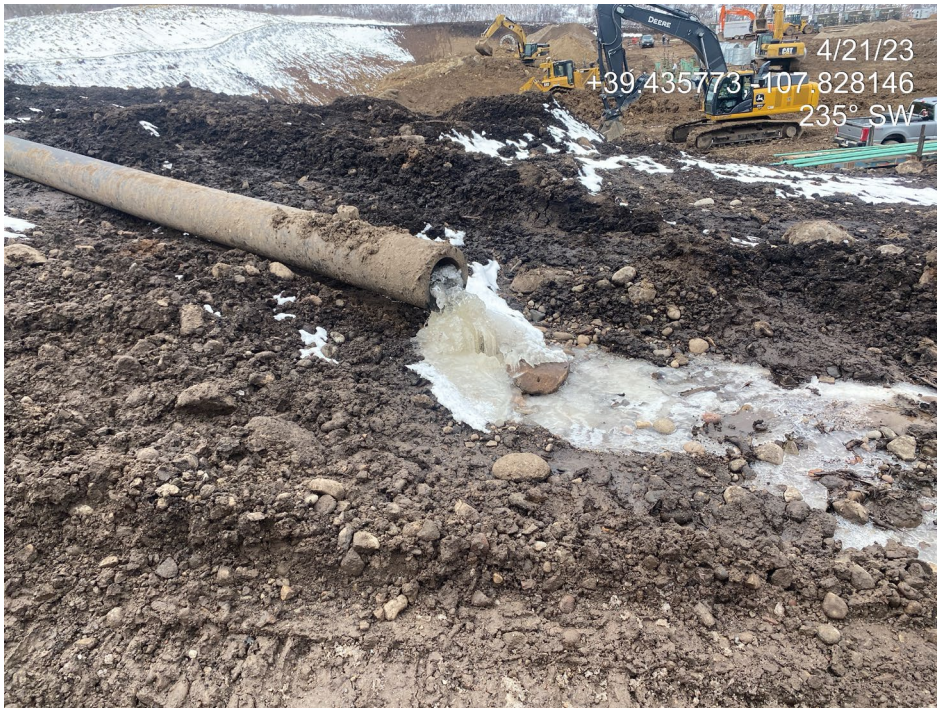
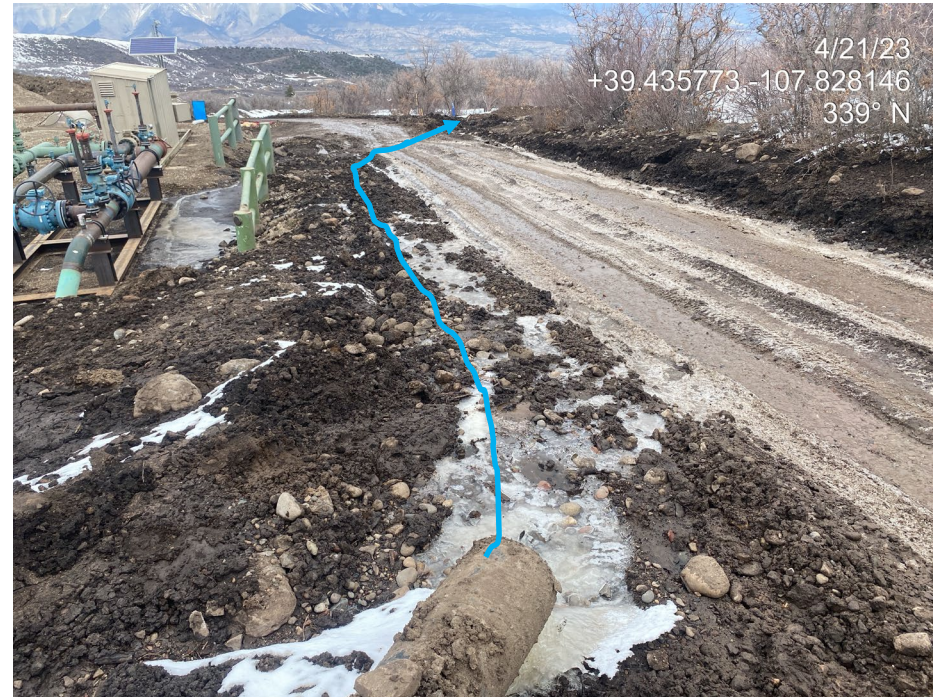
Photo 18. Photo taken from the east shows the stormwater pipe pictured in photo 17 is discharging concentrated stormwater flows without outlet protections. Stormwater is flowing down the access road where a water bar diverts it to the east of the access road without BMPs to manage flow or protect the discharge area.

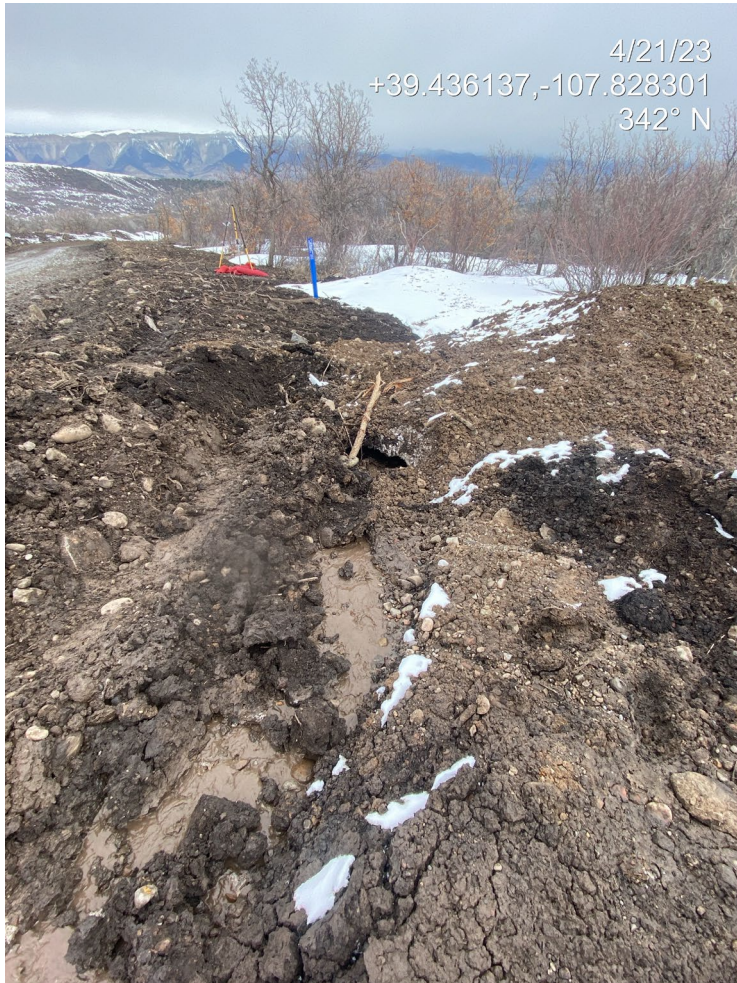
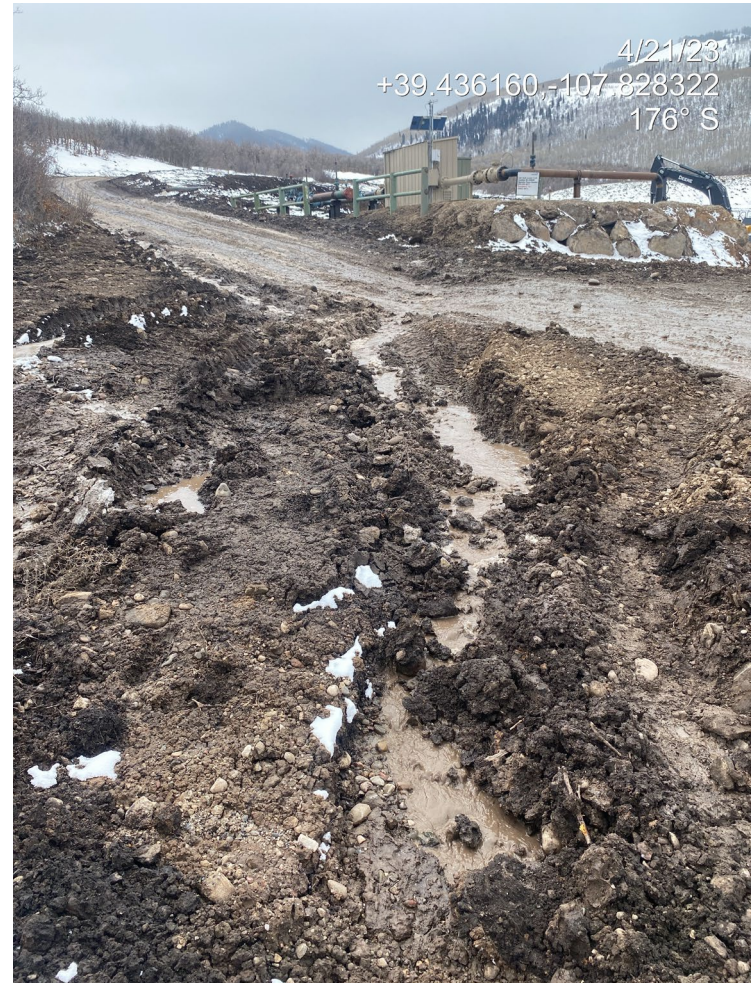
Photo 19. Refer to Photo 18 comment.
