Inspection Photos

Operator: TEP Rocky Mountain- #96850

Location Name: South Leverich /13-09 Pad

Inspection Document #: 702801487

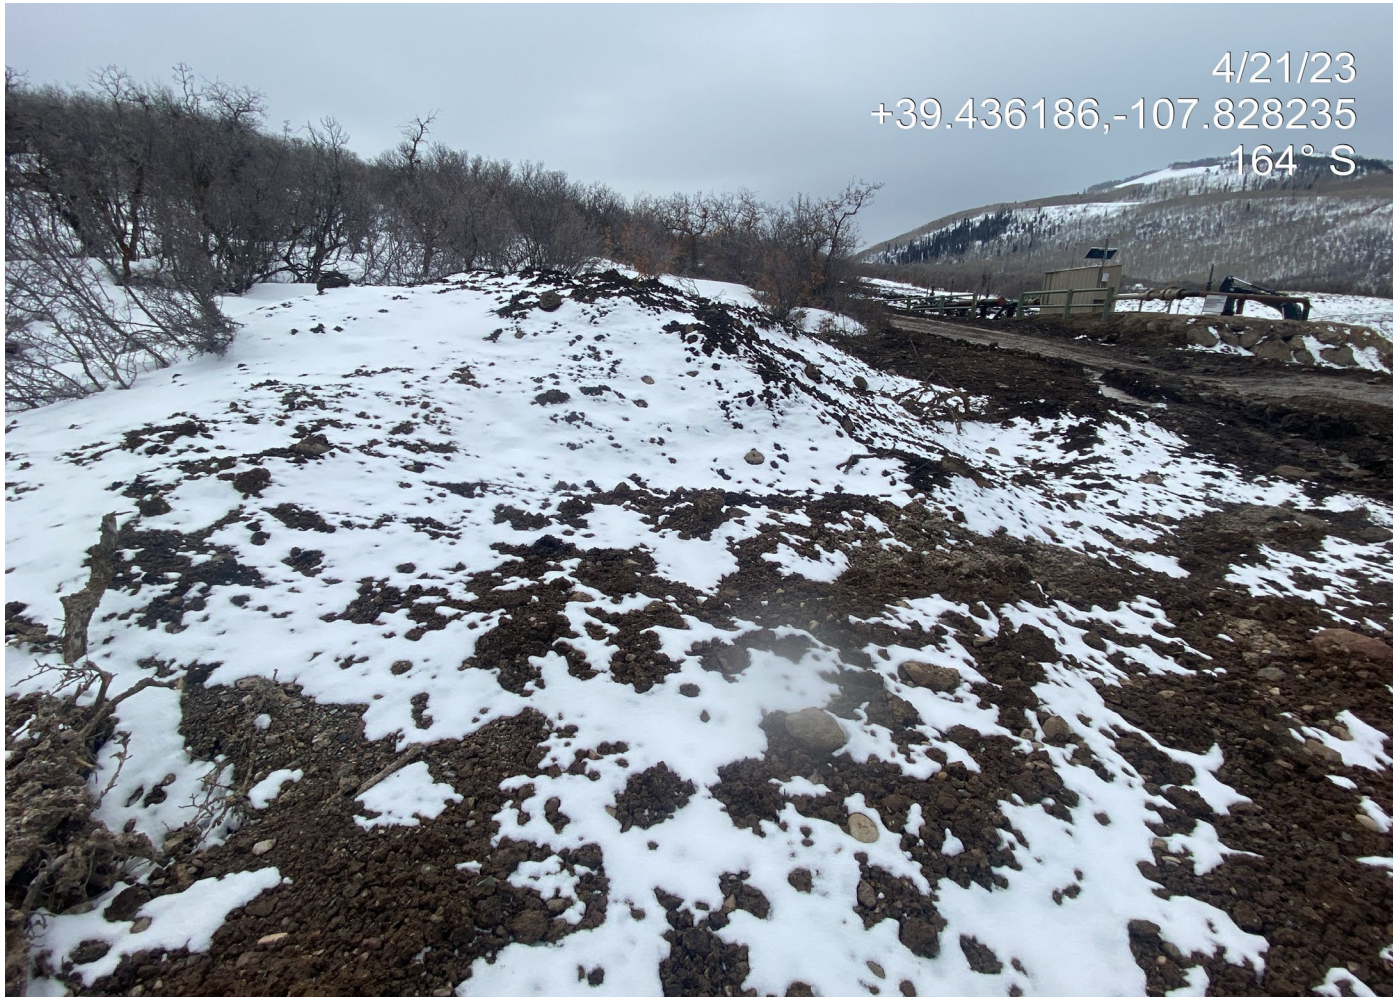
Photo 20. Refer to Photo 18 comment. Concentrated stormwater flows are being discharged into a loose, unconsolidated pile of soil to the east of the access road.

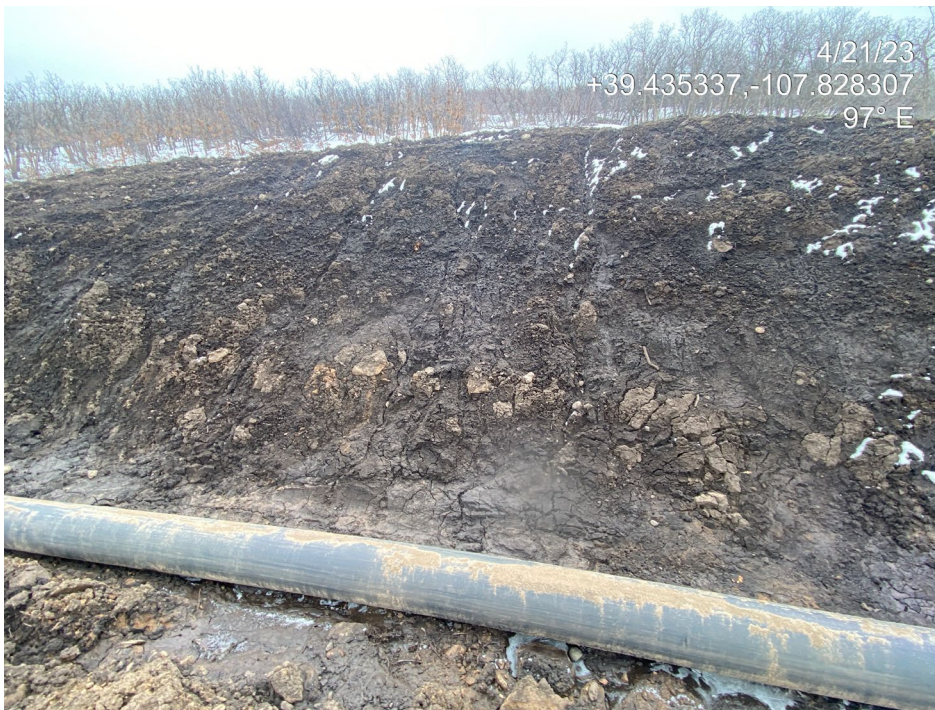
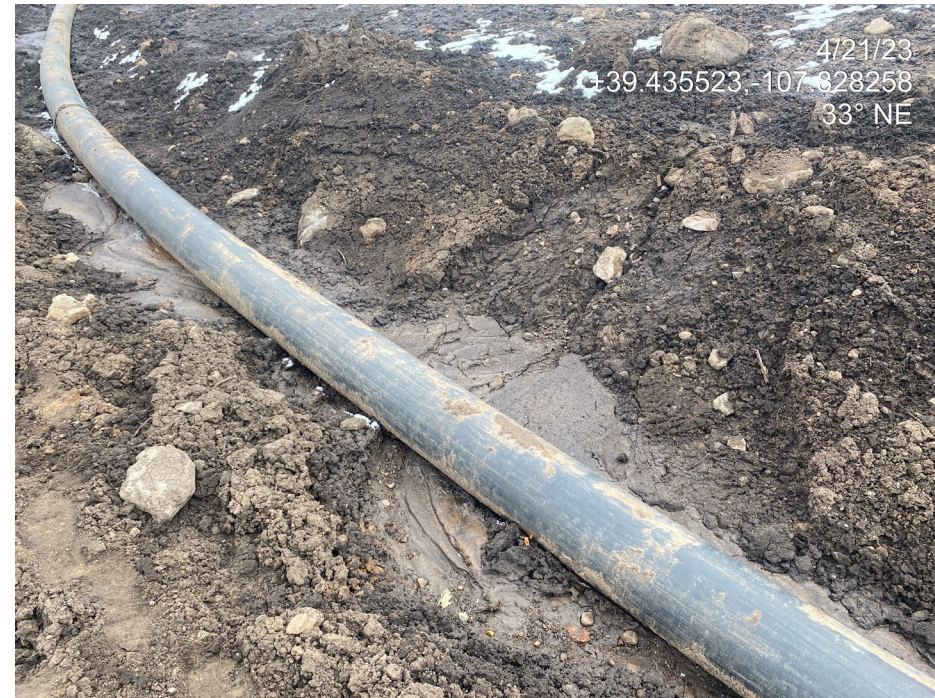
Photo 21. Photo taken from the south shows rill erosion occurring on bare, unprotected, unstabilized slopes.

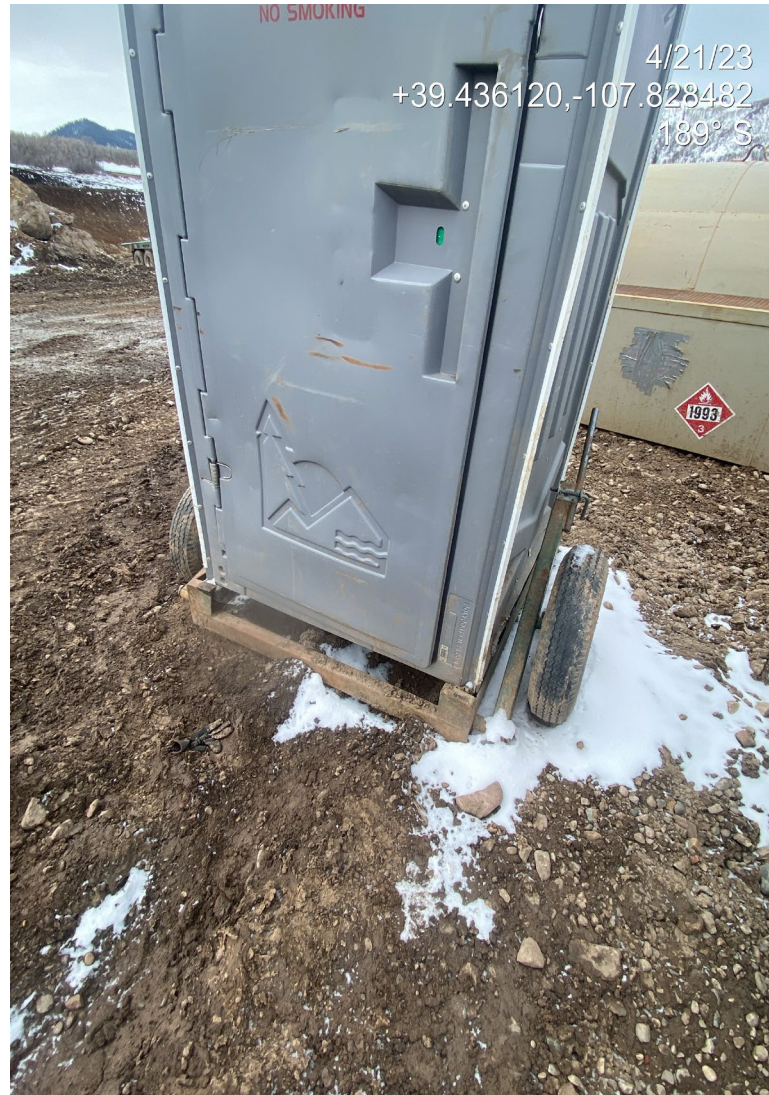
Photo 22. Photo taken from the Location entrance shows a portable toilet has not been secured to prevent a spill.

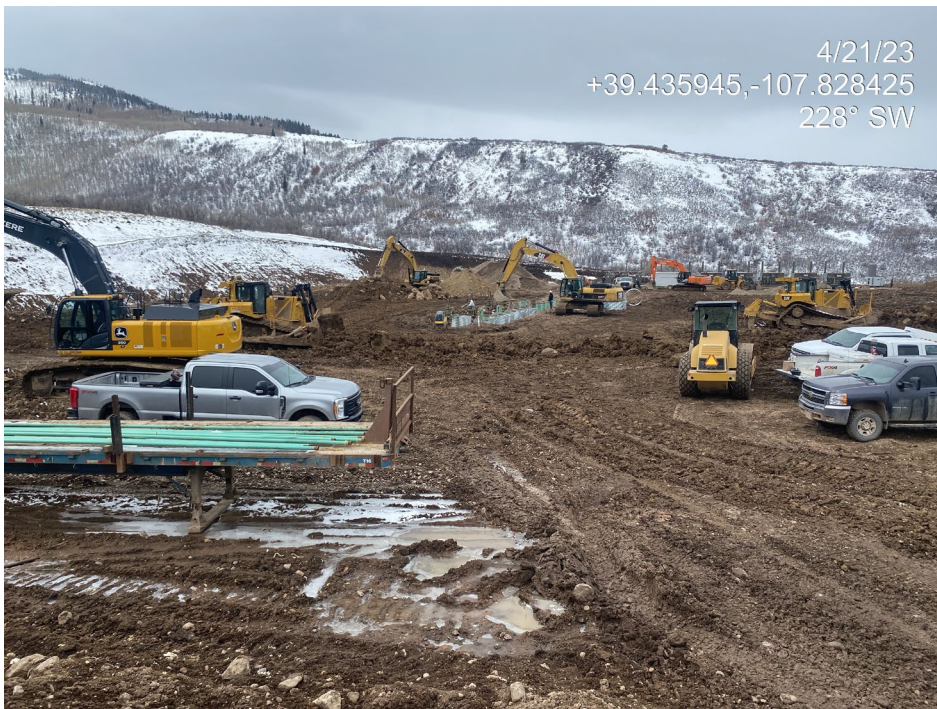
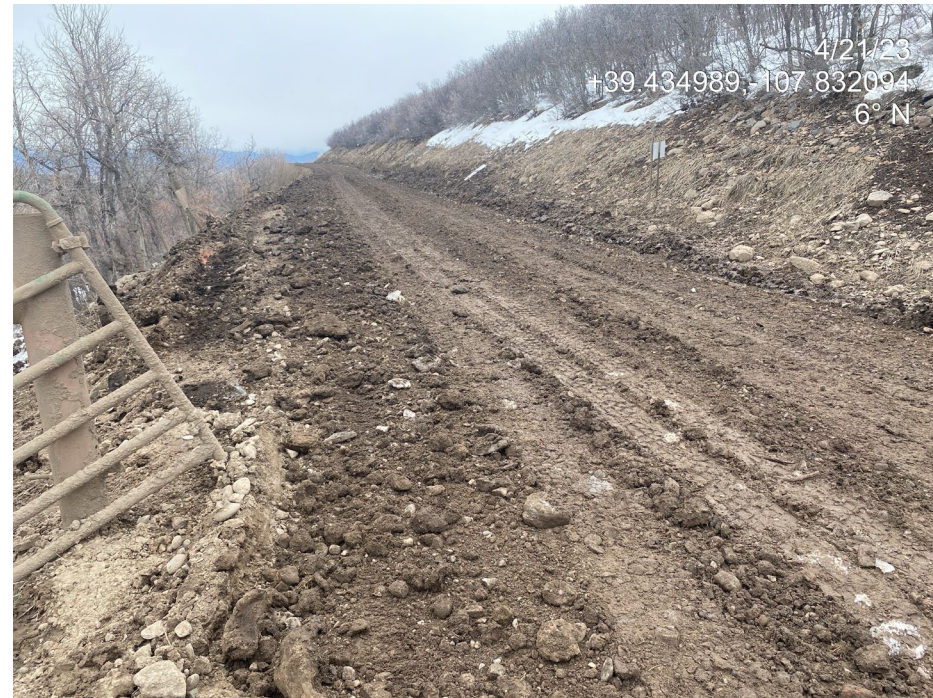
Photo 23. Photos show the location entrance (left) and the location access road (right) before it merges with county road 317. Tracking control BMPs are missing/insufficient.
