CAERUS PICEANCE LLC, PUCKETT-66S96W/31SWNE

Location # 335390

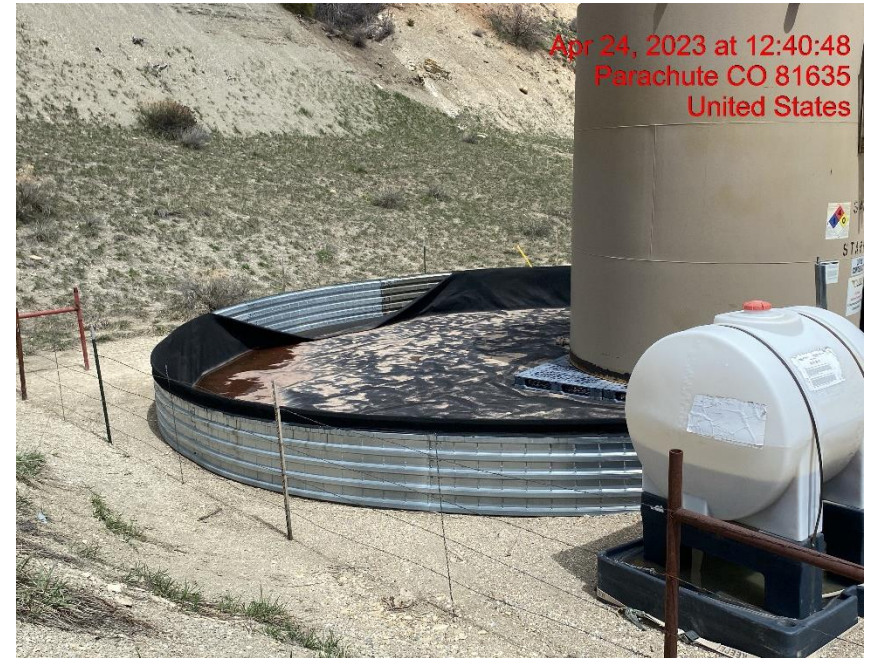
Berm Liner Damaged – Photo #02469

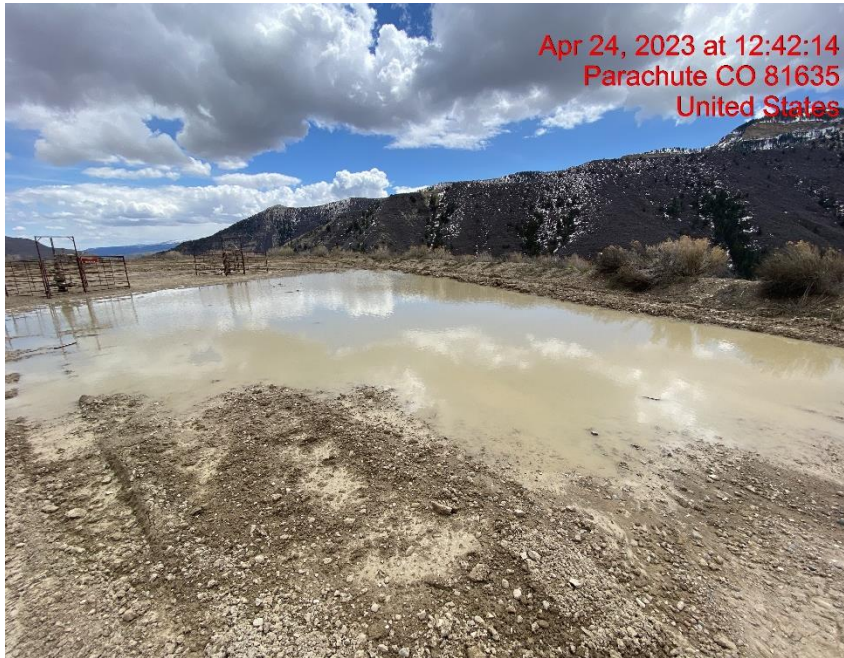
Water Accumulation – Photo #02474

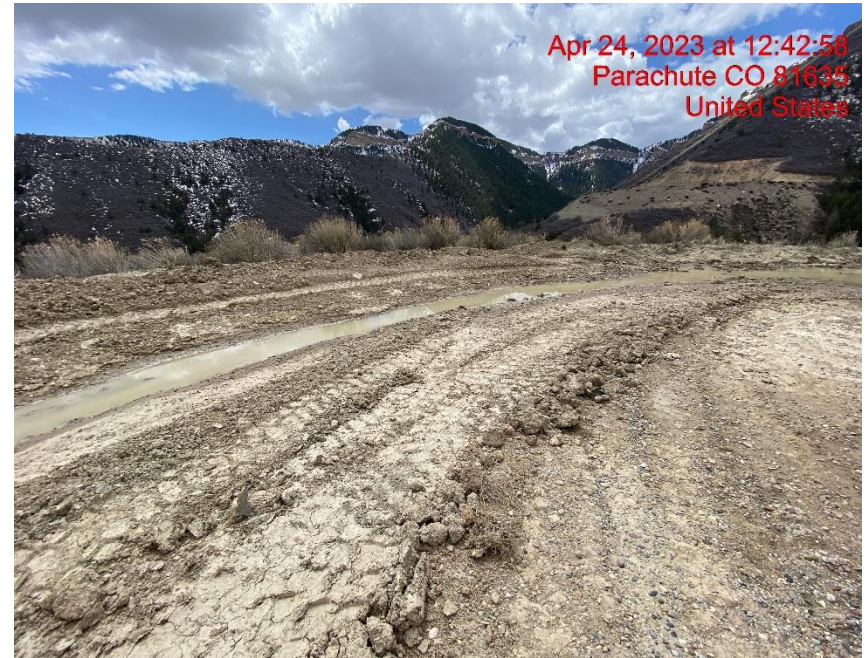
Lack of Stabilization – Photo #02475

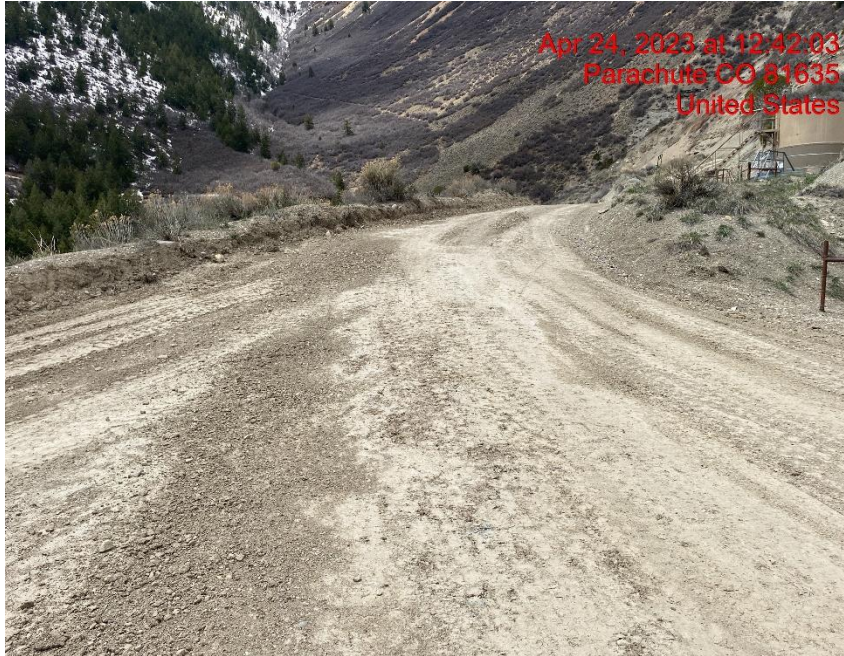
Inadequate Vehicle Tracking BMP at Location Entrance – Photo #02473

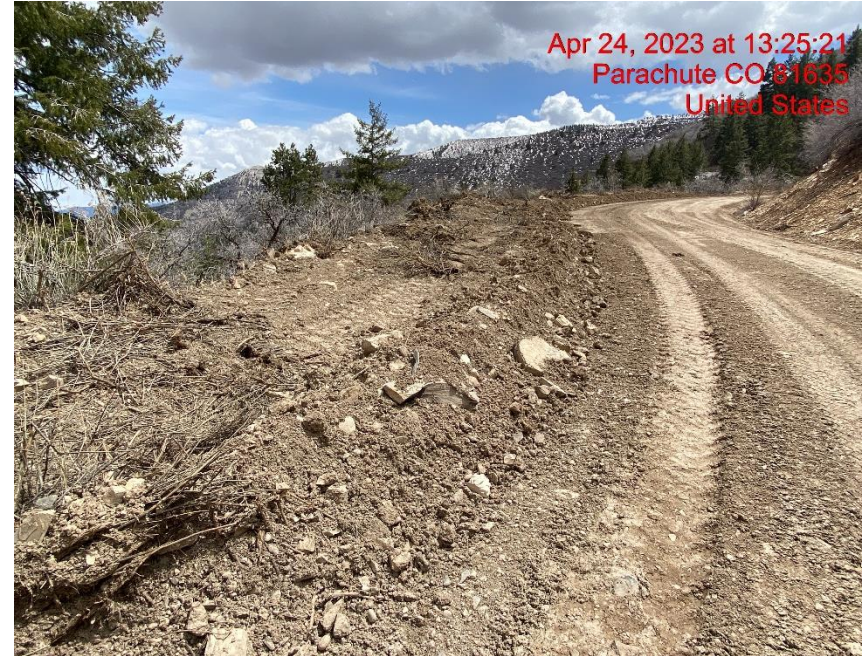
Access Road Degradation/Transportation of Sediment – Photo #02493
