Inspection Photos

Loc: 312083

Operator: SIMCOE LLC

Inspection Date: 4/18/2023

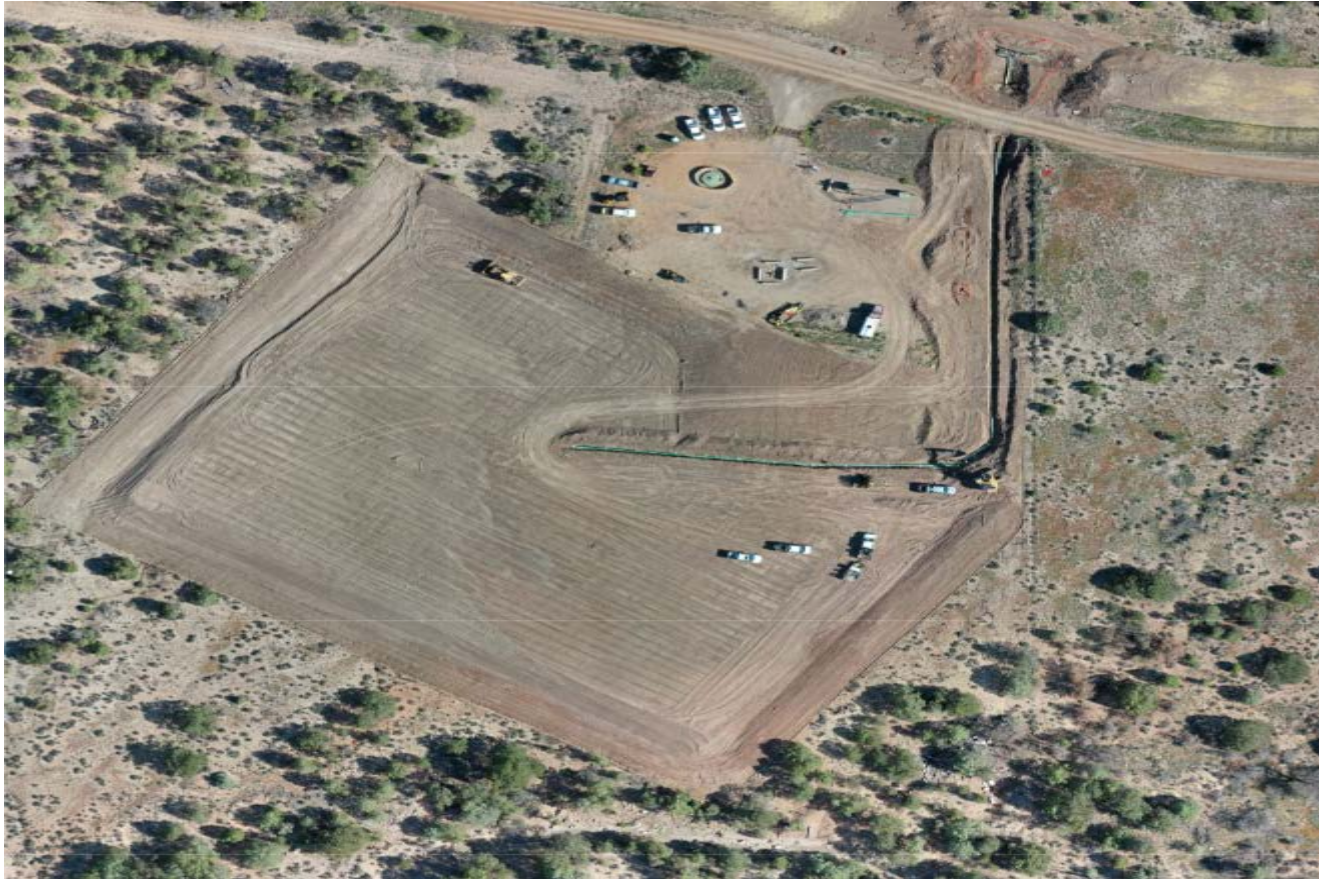
Photo 1. Drone aerial image facing down northward to the newly constructed location. Photo taken during last inspection on 8/30/2022.

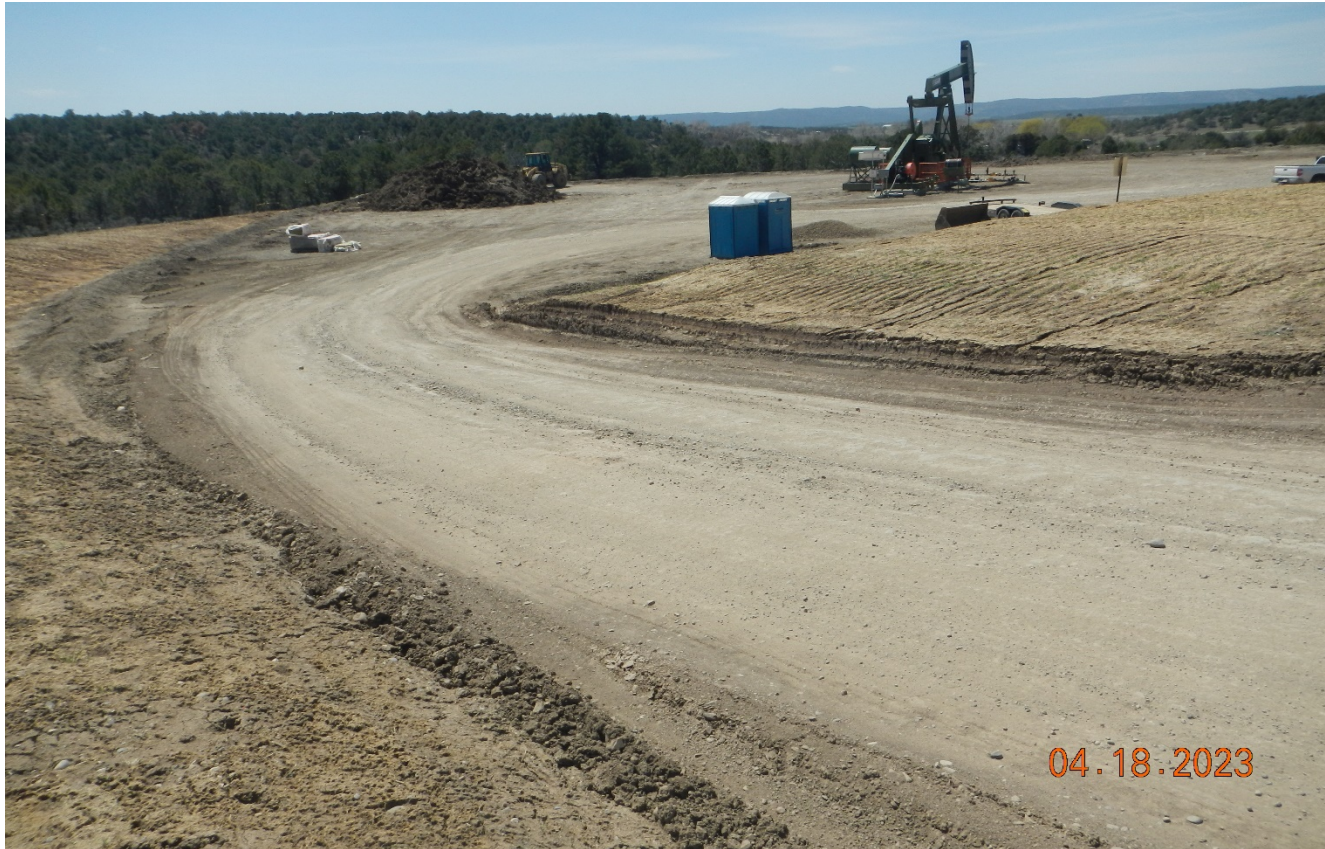
Photo 2. Facing southwest toward the location.

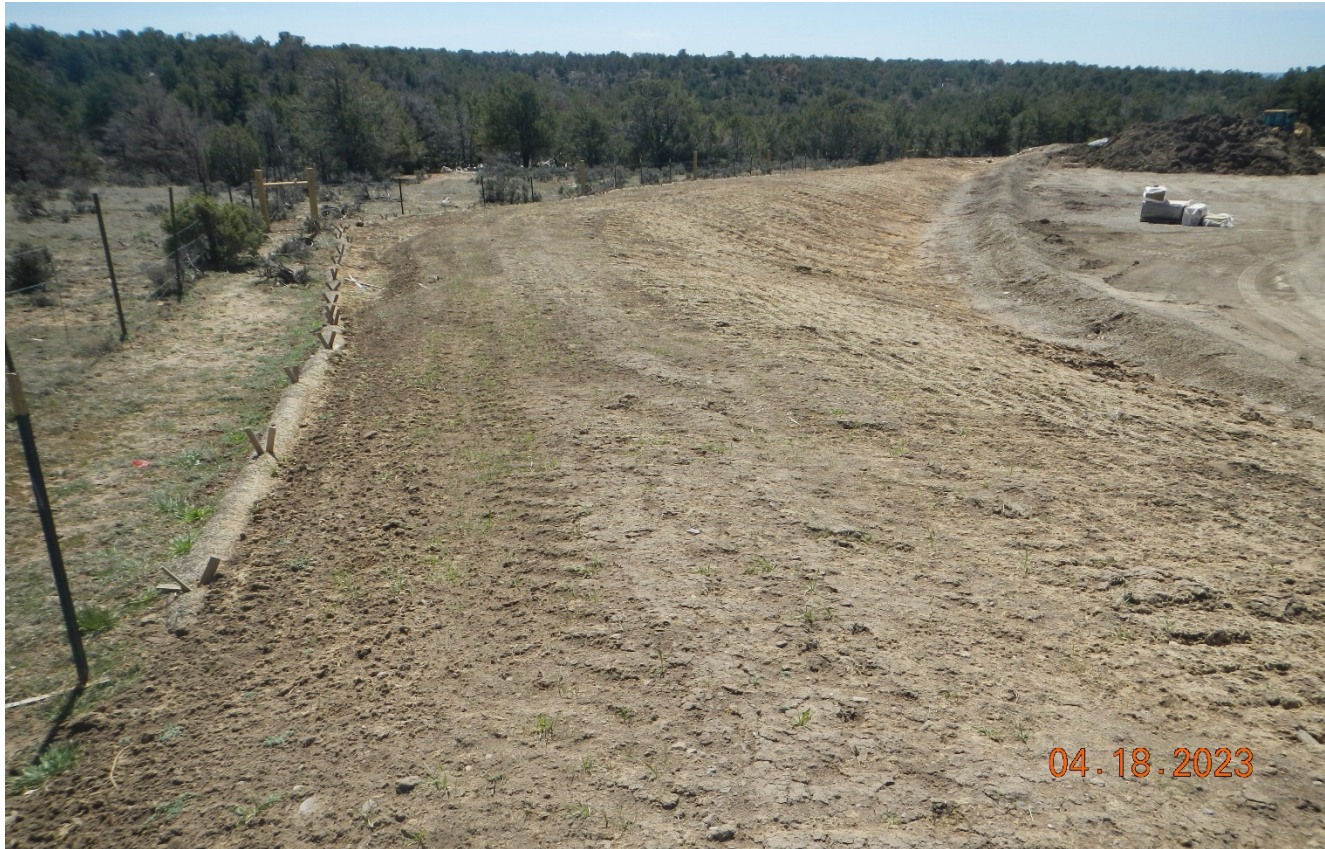
Photo 3. Facing toward the topsoil pile at the eastern side of the location which has been seeded and hydromulched.

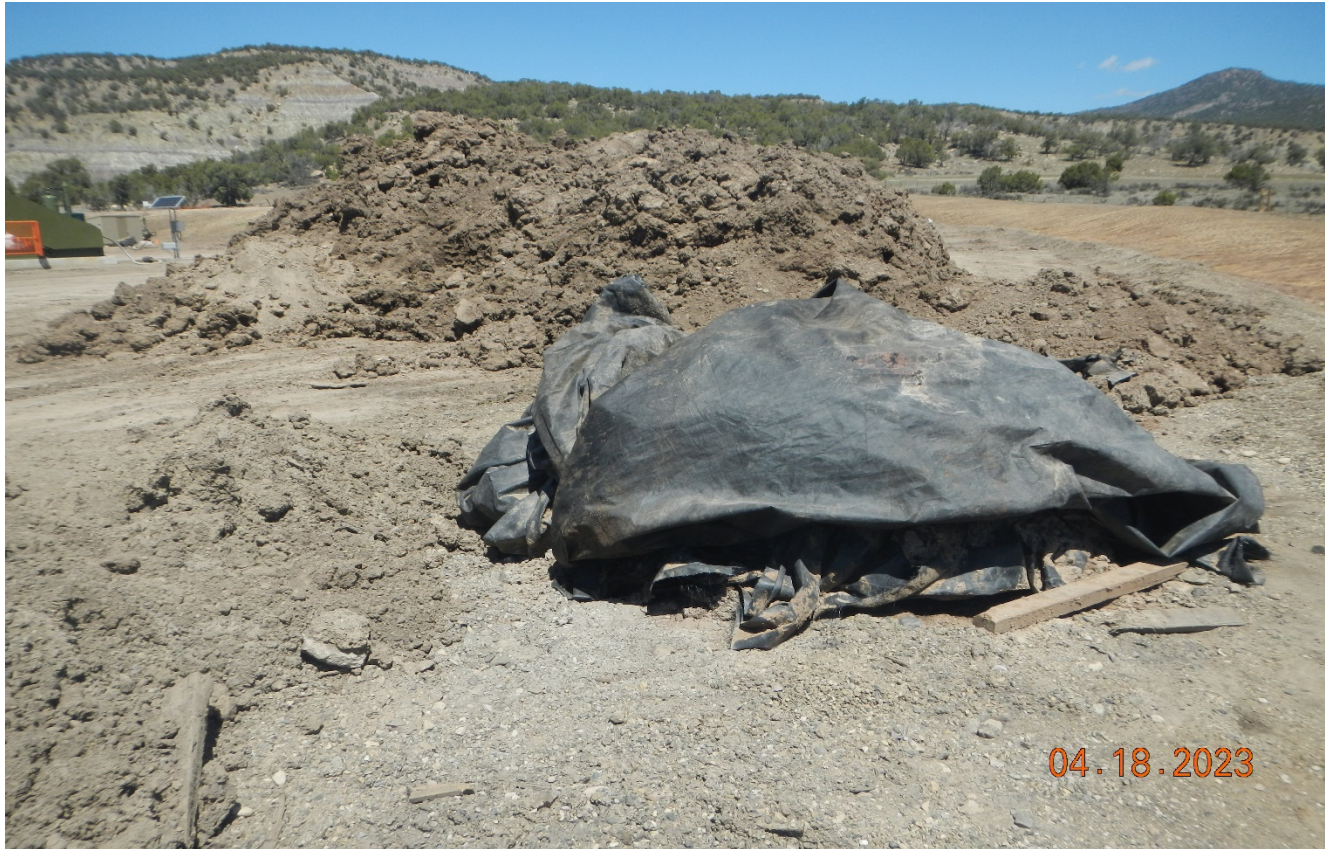
Photo 4. There is pile of soil material stored at the southeast corner of the location.

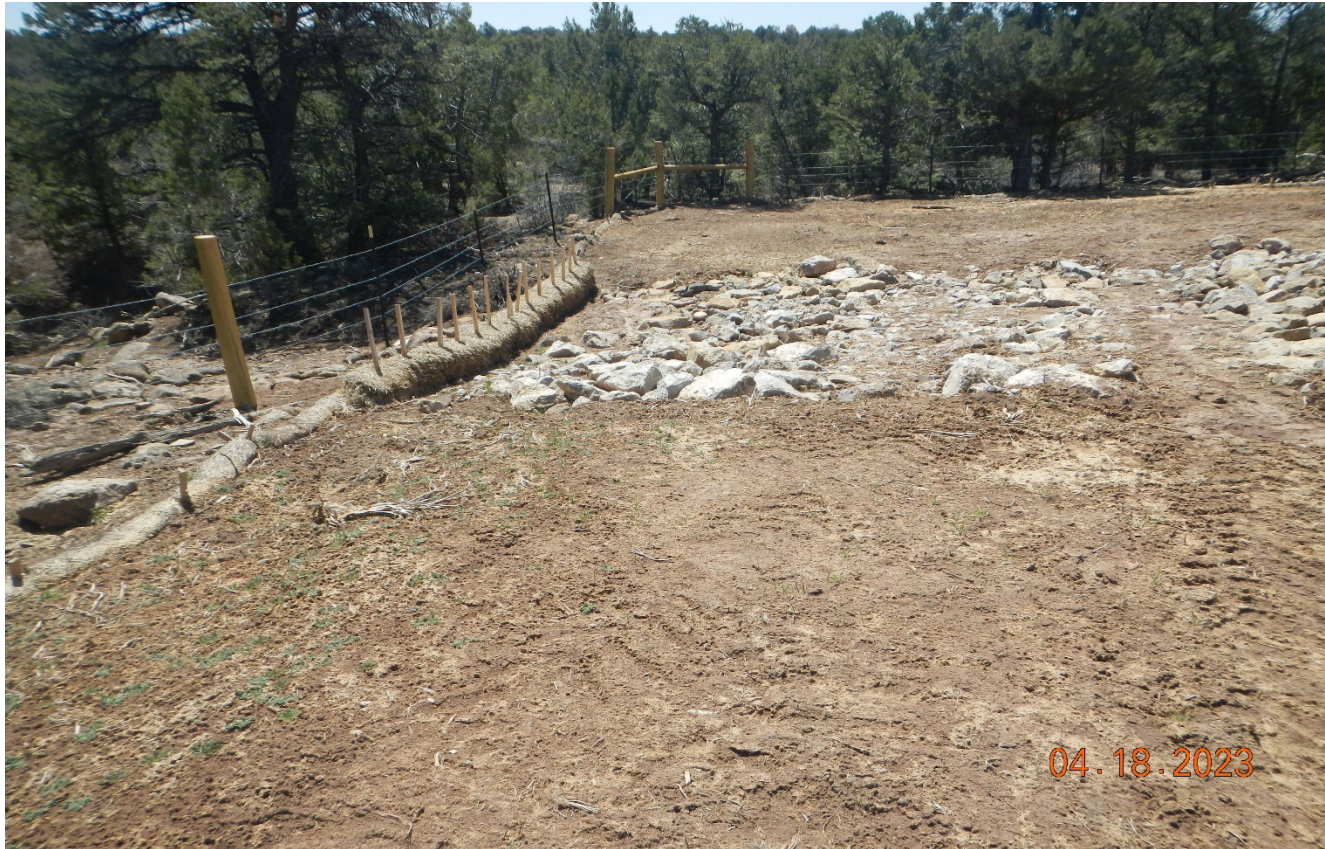
Photo 5. There has been additional BMP's installed at the southeast corner of the location which is in close proximaty to the ephemeral drainage.

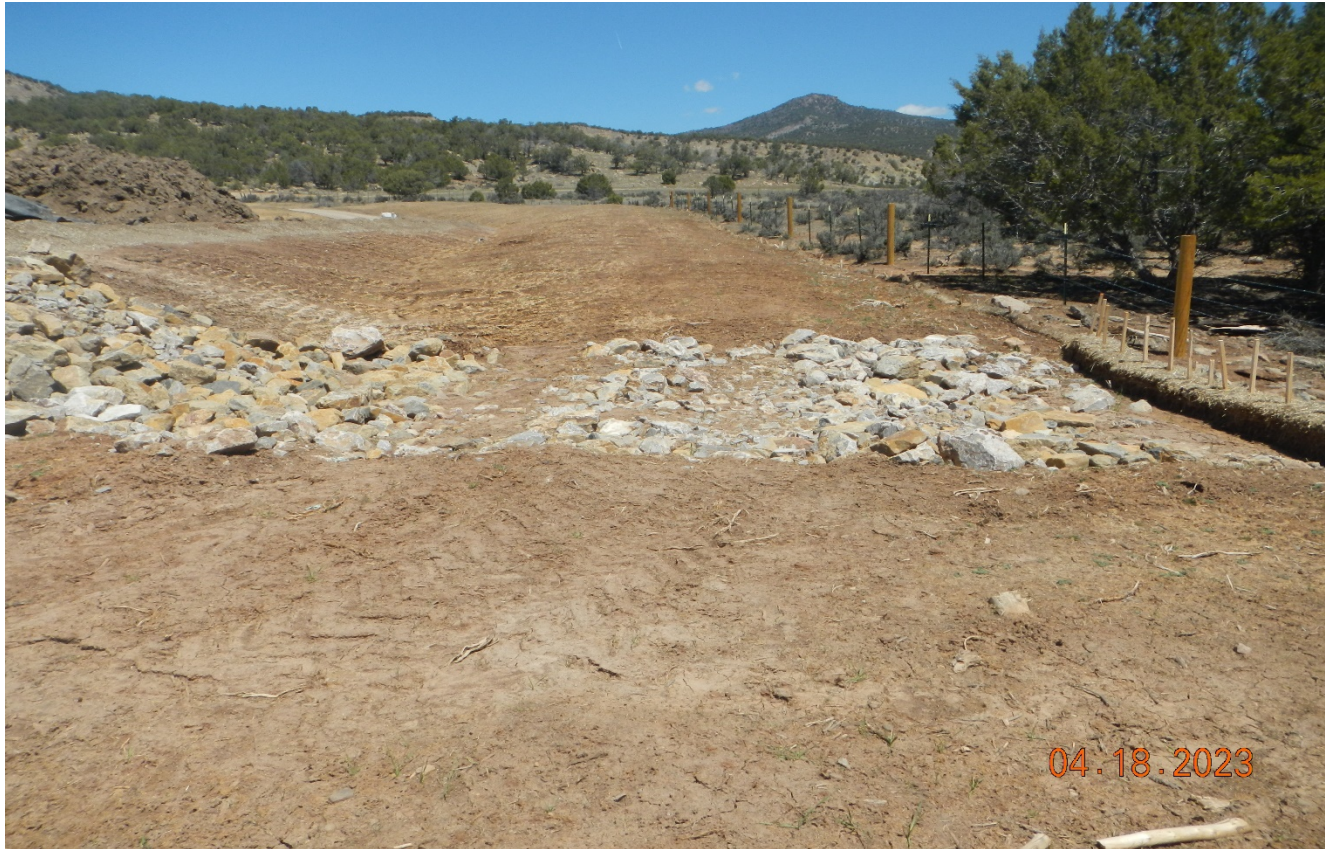
Photo 6. Southeast corner of the location facing north. There has been additional BMP's installed at the southeast corner of the location which is in close proximity to the ephemeral drainage.

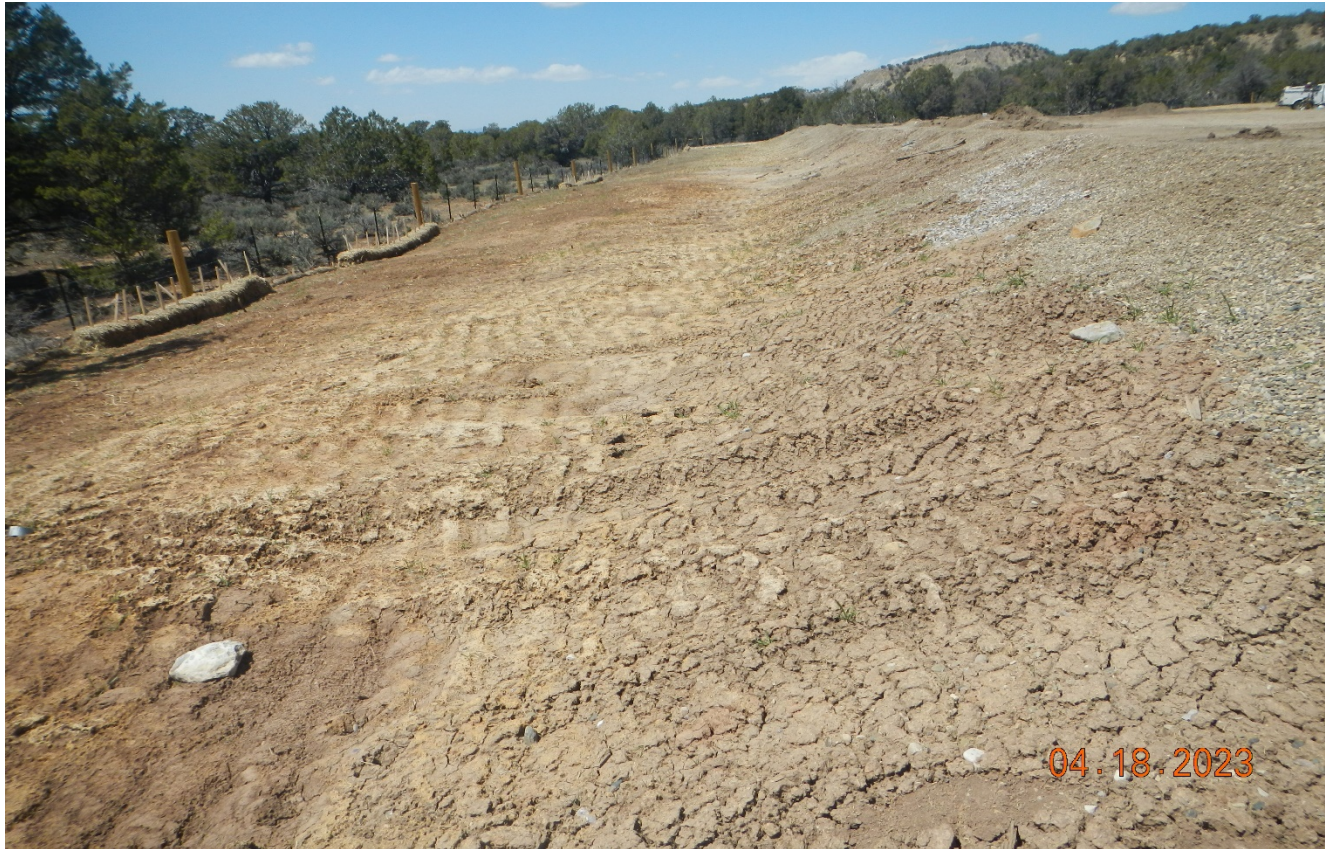
Photo 7. South side of the location facing west along the fill slope. It appears track was redone perpendicular to the slope and soils were seeded and hydromulched.

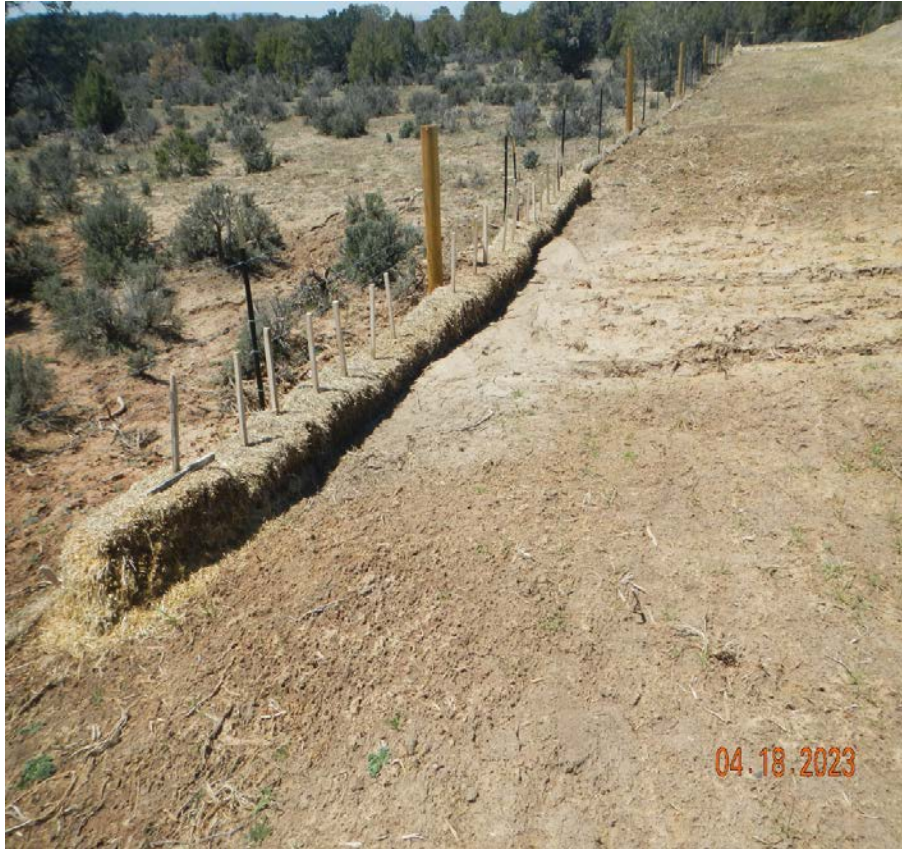
Photo 8. There were straw bales installed at about midway of the pad which have held back sediment. The sediment will need to be cleaned out so it won't overtop the bales.

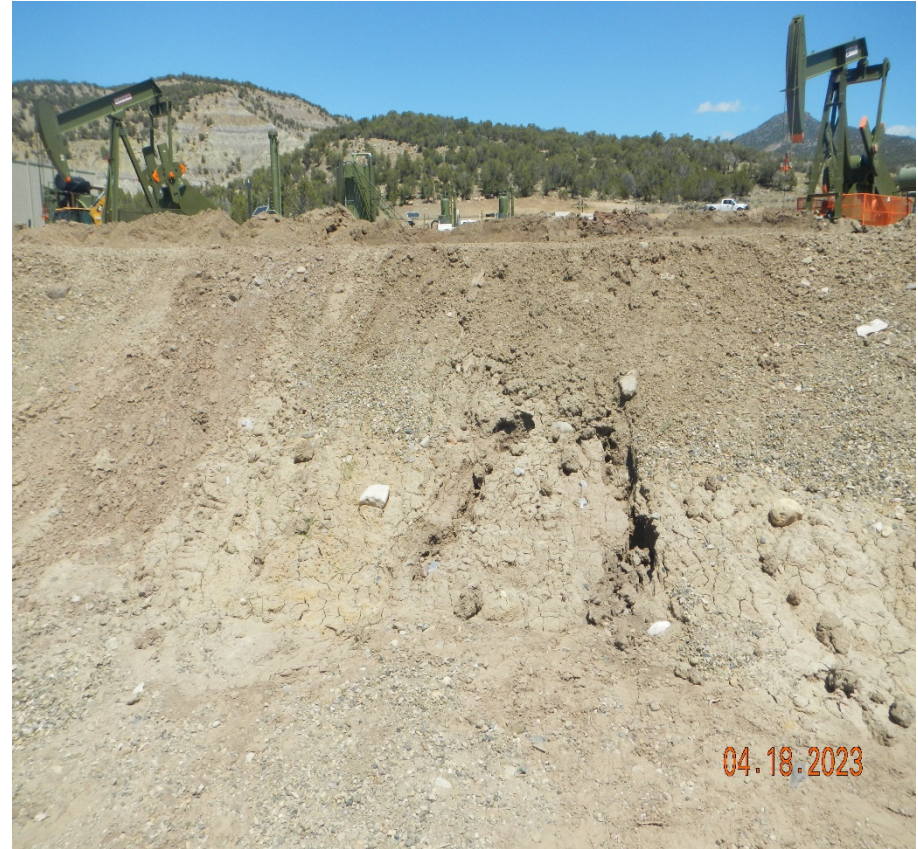
Photo 9. There was erosion that occurred off the midway of the pad. The erosion was graded back in but should be better stabilized to prevent erosion in this area.

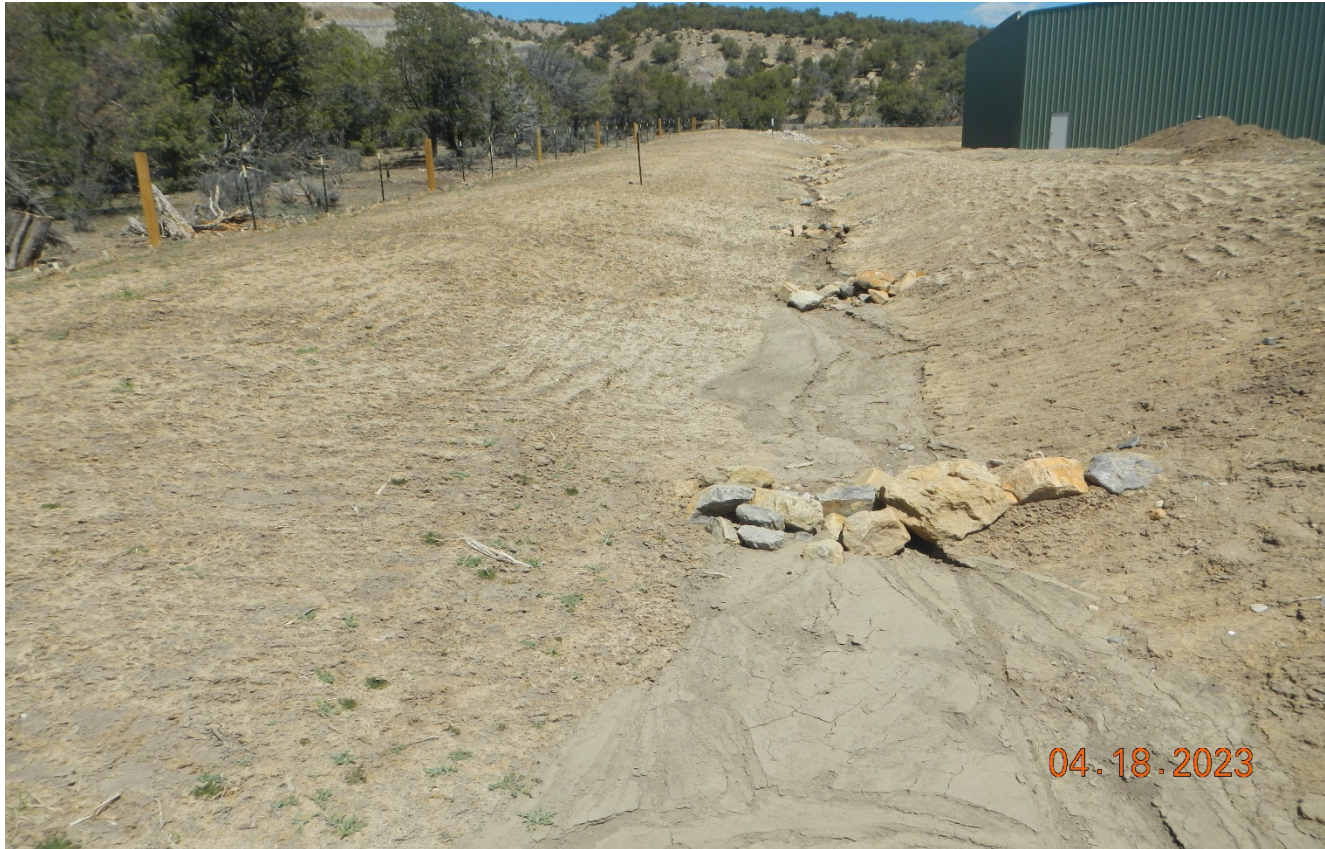
Photo 10. Southwest corner of the pad facing north. The rock check dams are slowing down stormwater flow but need maintenance to prevent washing out underneath or around the check dams.

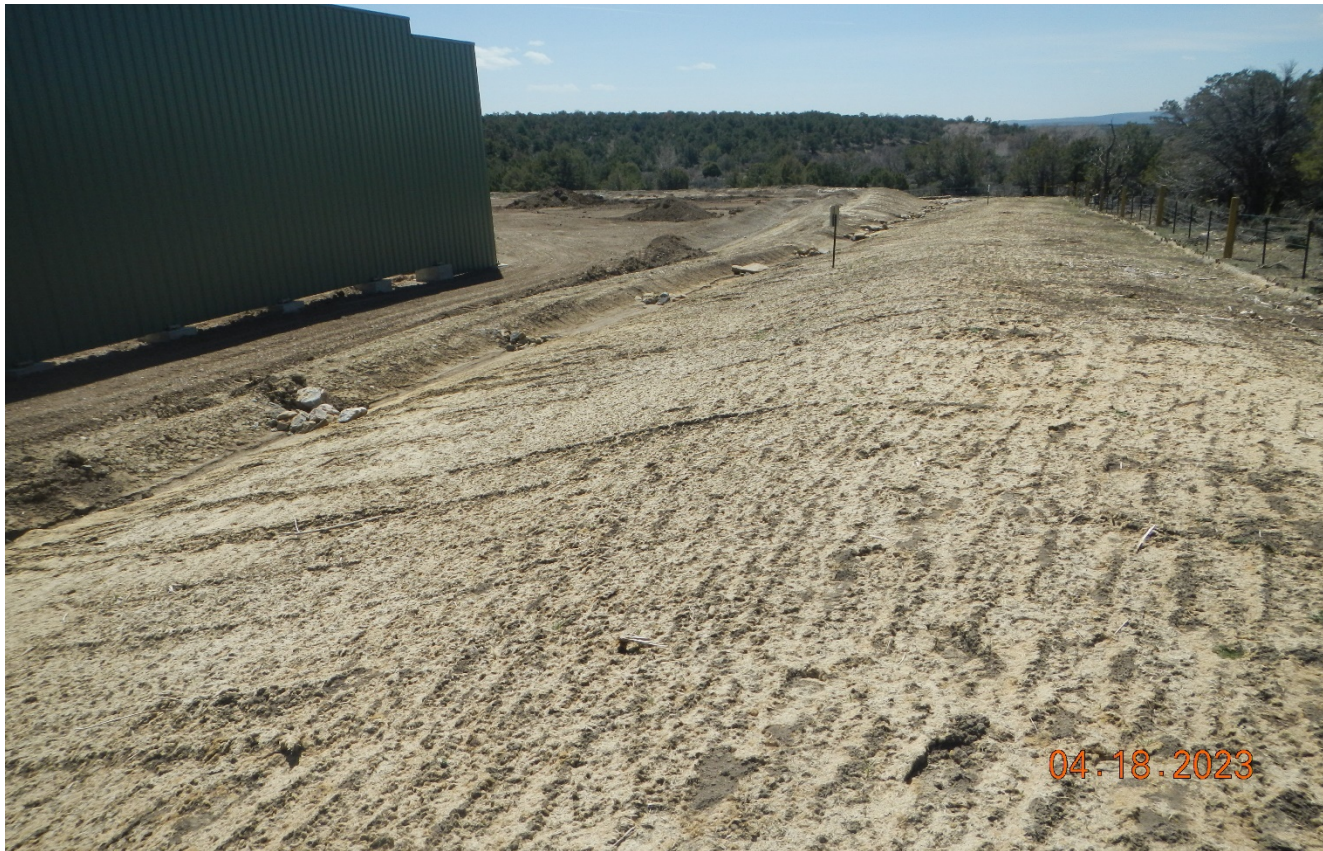
Photo 11. Facing south at the western side of the of the location which has been seeded and hydromulched.

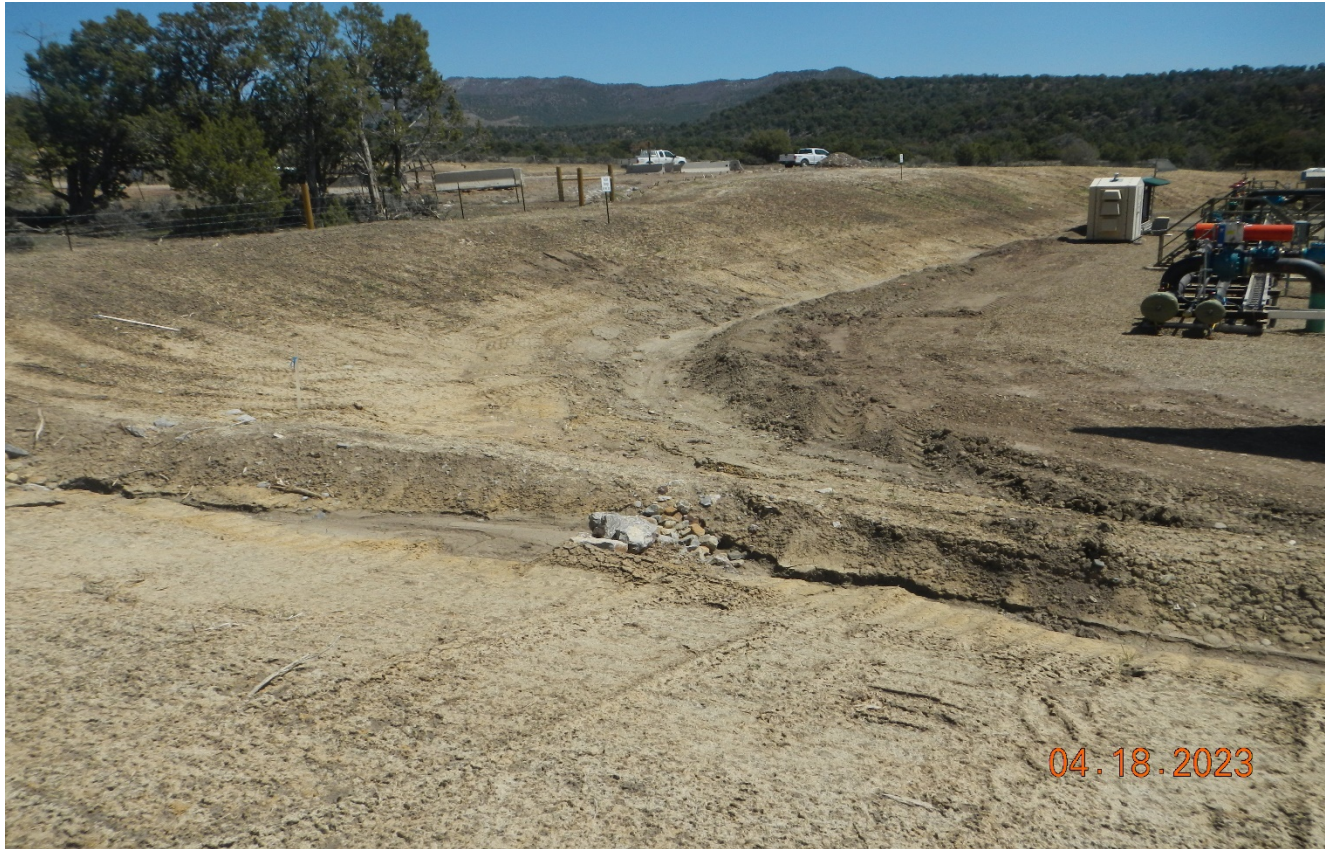
Photo 12. Facing northeast toward the cut slope of the location.

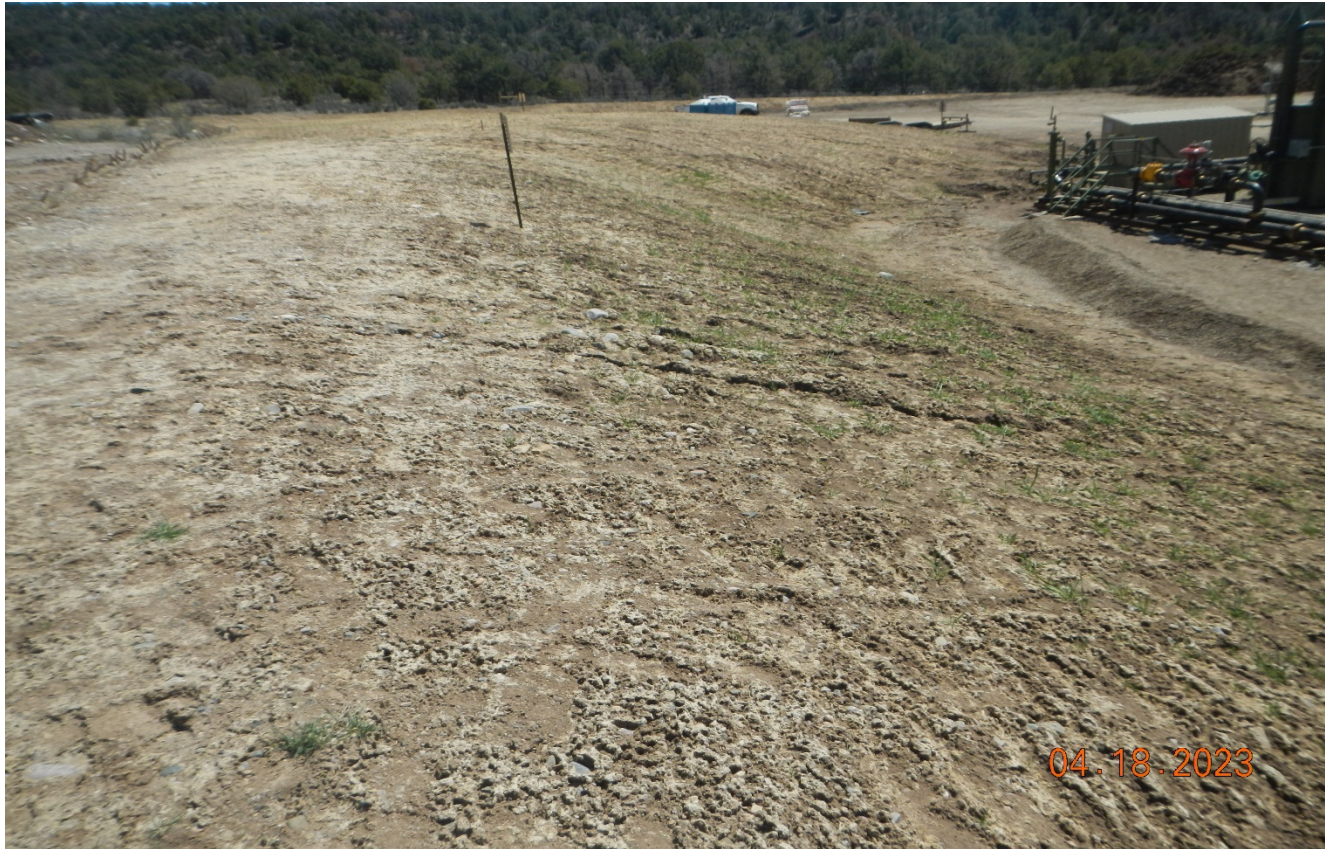
Photo 13. Facing east along the cut slope which was seeded and hydromulched.

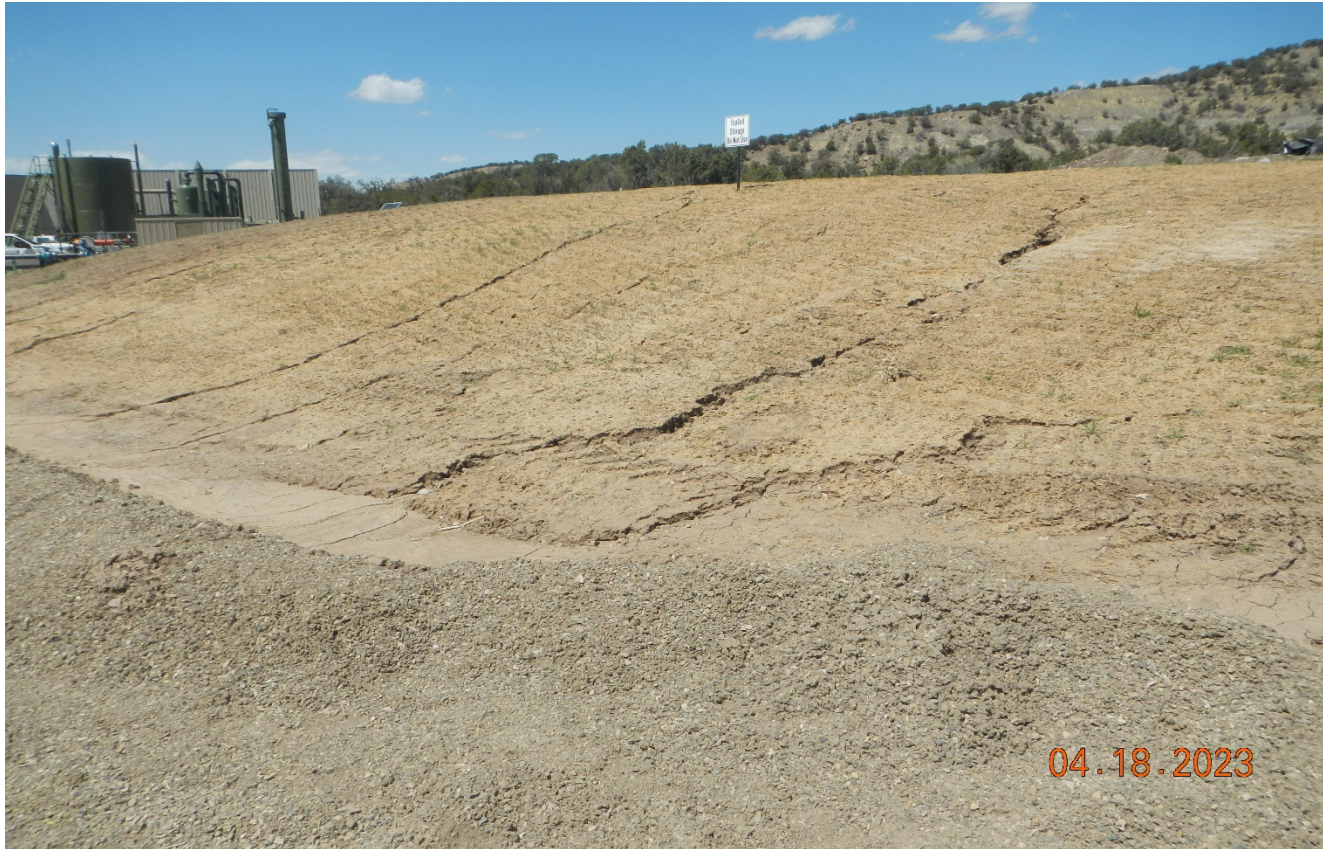
Photo 14. There are some rills beginning to occur along the cut slope. Additional BMP's need to be installed to prevent further erosion.

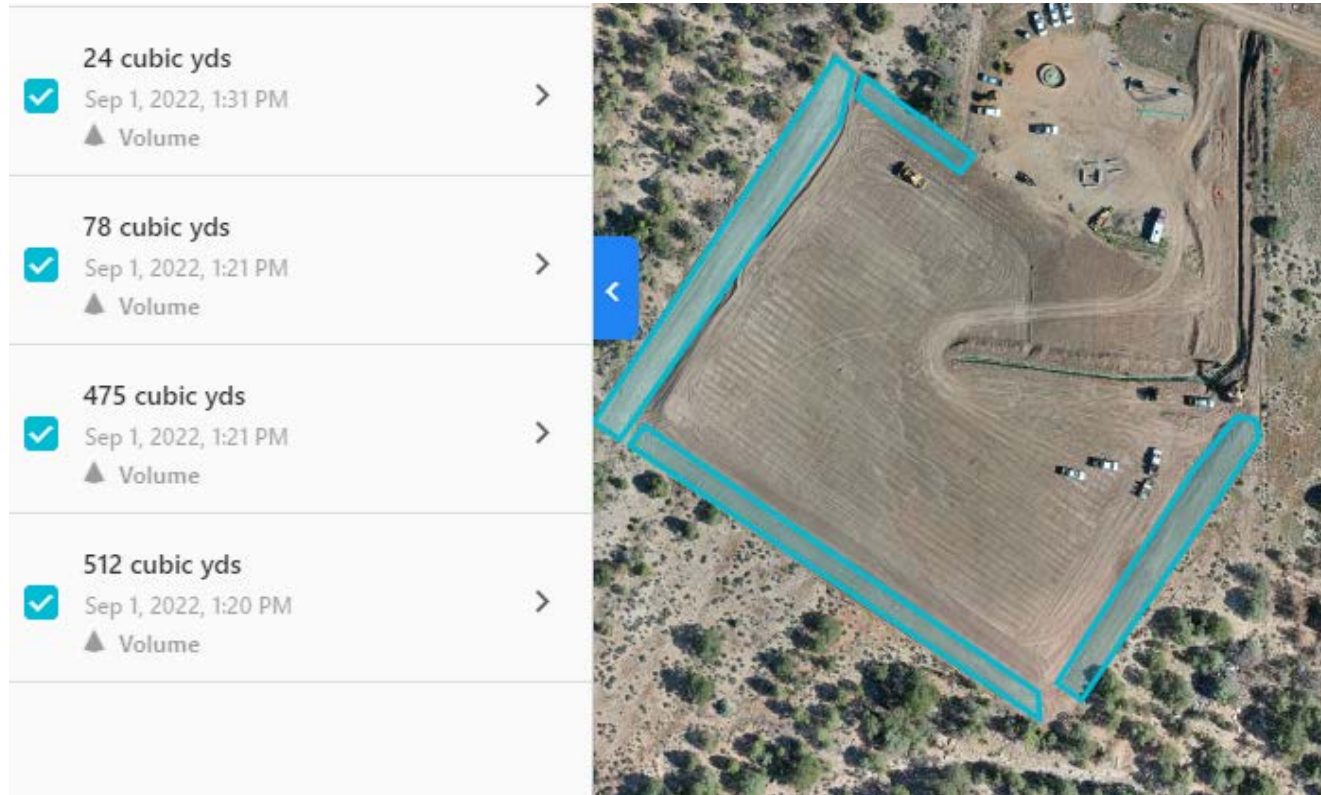
Photo 15. Drone aerial calculations of topsoil piles indicates approximately 1089 cubic feet of topsoil was salvaged and stored at the location.
