Inspection Photos

4/24/2023

Operator: WINDSOR ENERGY GROUP LLC -
10081

Location #315696
Rio Blanco County, CO

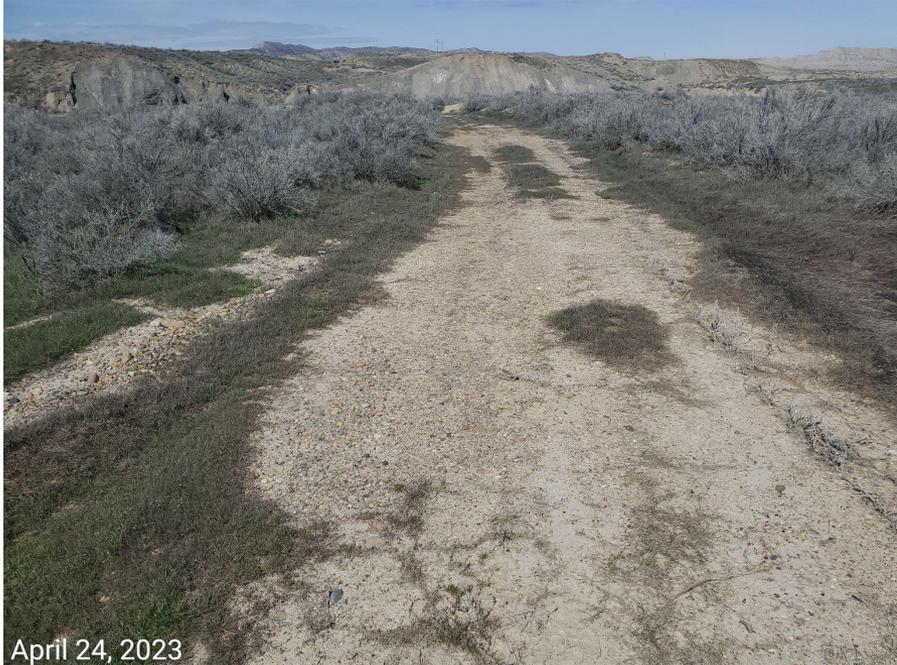
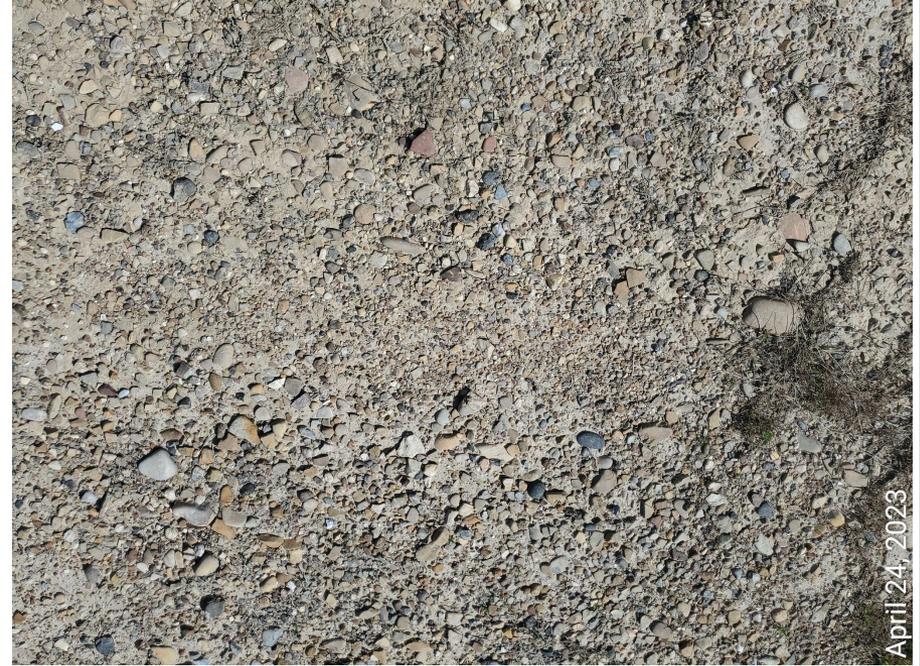
Photo 1: Photos taken from the northern access road. Photo shows Final Reclamation activities, including but not limited to, removal of road base/gravel, compaction alleviation, recontouring/regrading and reclamation has not been completed.

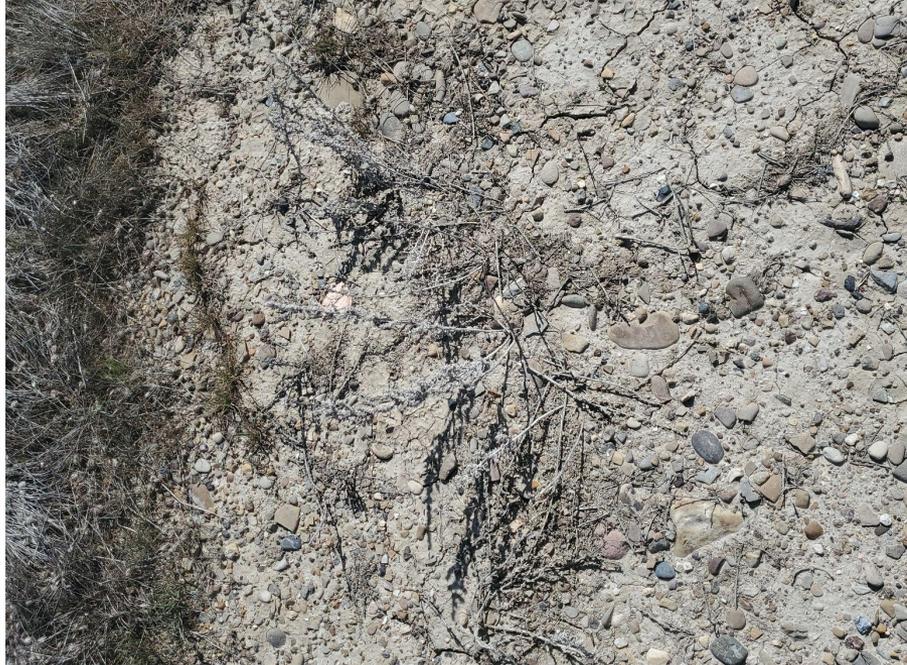
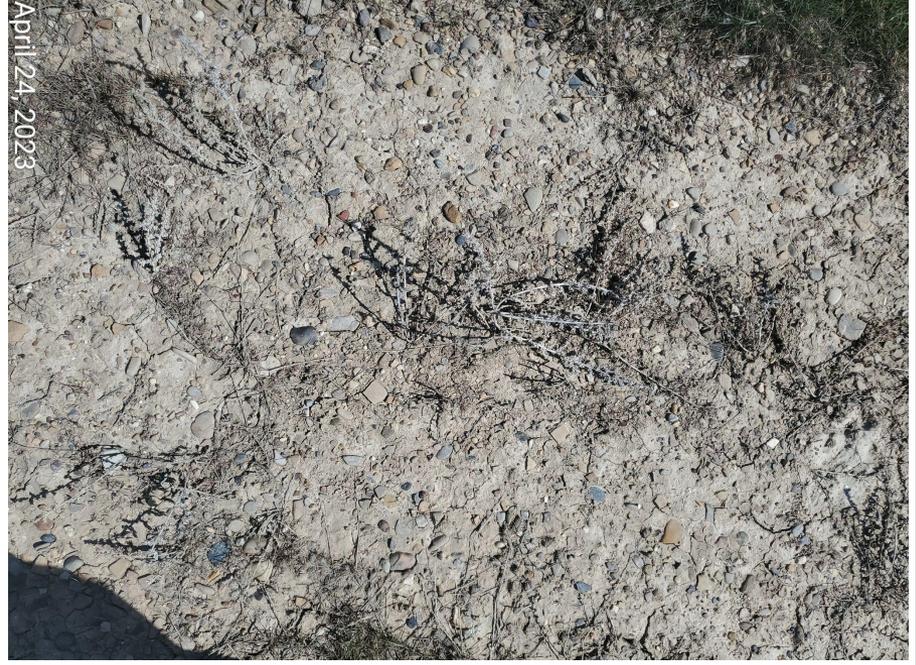
Photo 2: Undesirable Plant Species (Halogeton) from the previous growing season observed on Location. Weed management is not occurring; weed germination observed.

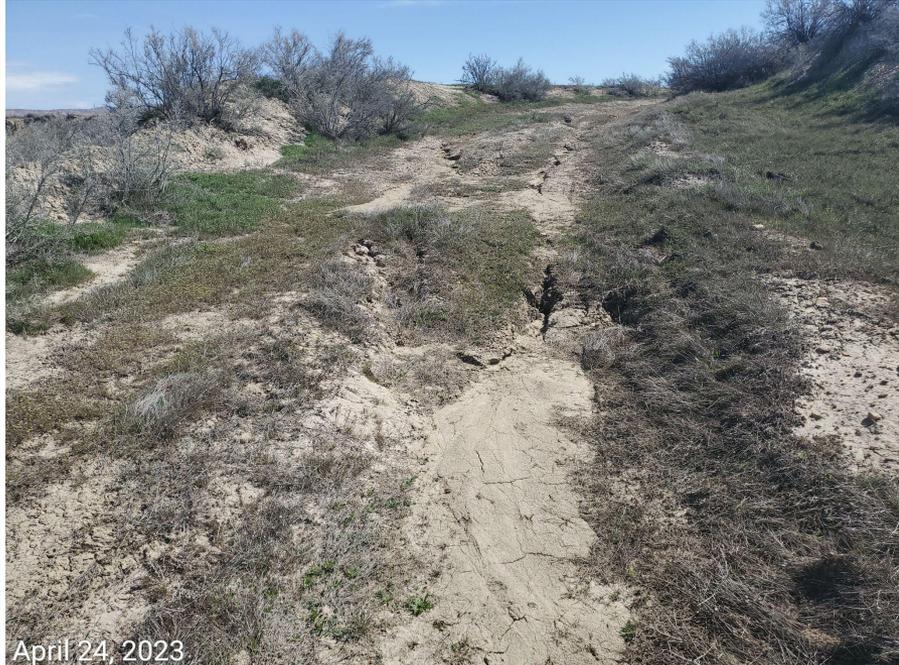
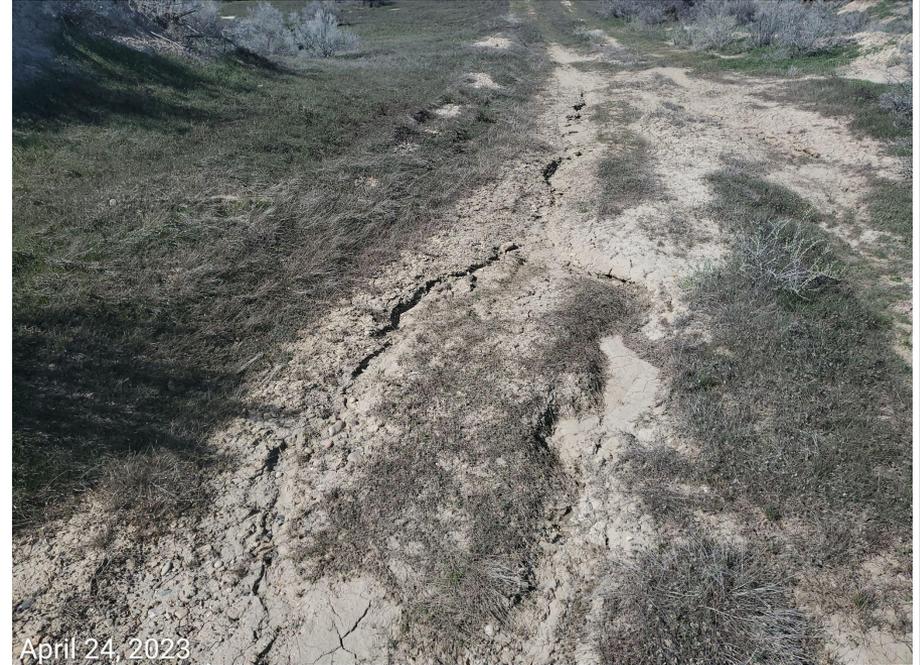
Photo 3: Photos taken from the northern access road. Photo shows stormwater and erosion control BMPs remain missing or insufficient on the Location and access road. Erosion degradation has persisted.

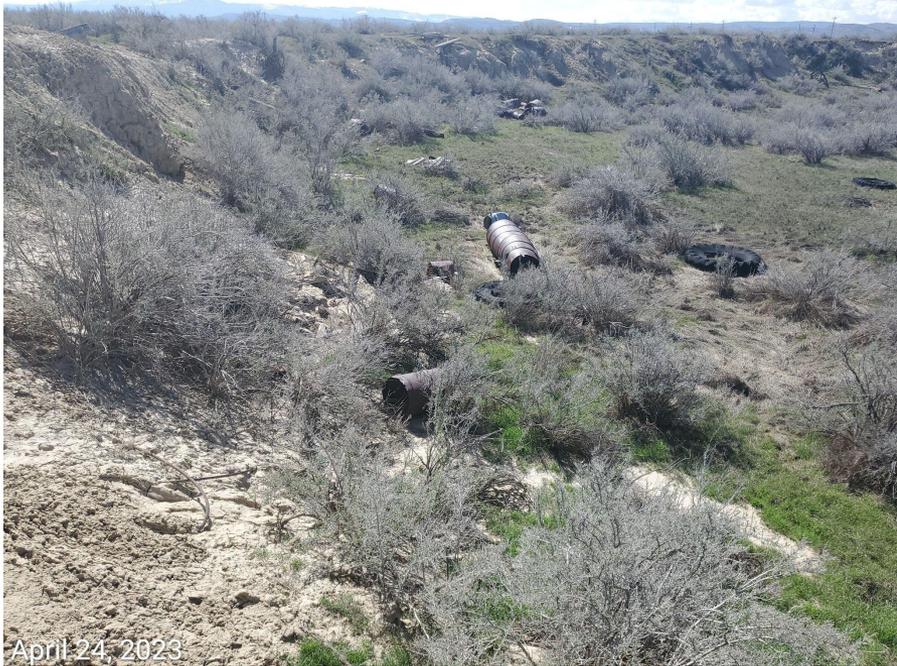
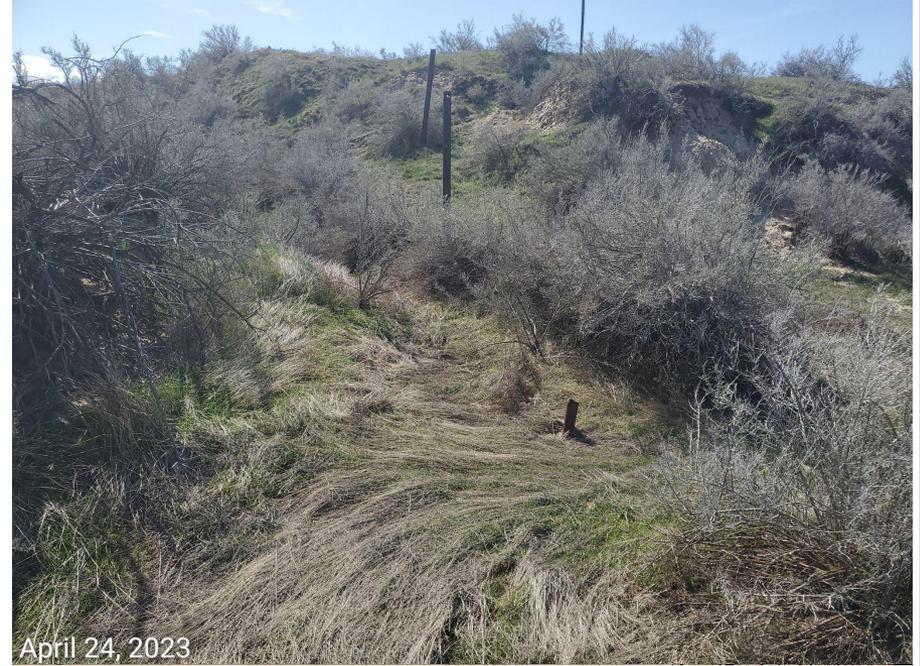
Photo 4: Photos examples showing various trash debris and pipe equipment observed along access road, and Location.

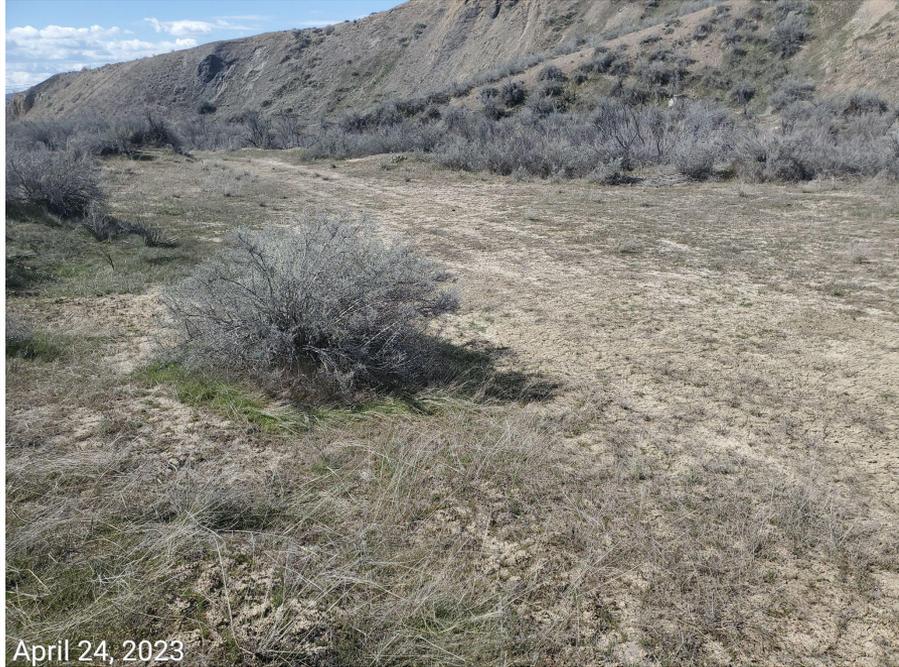
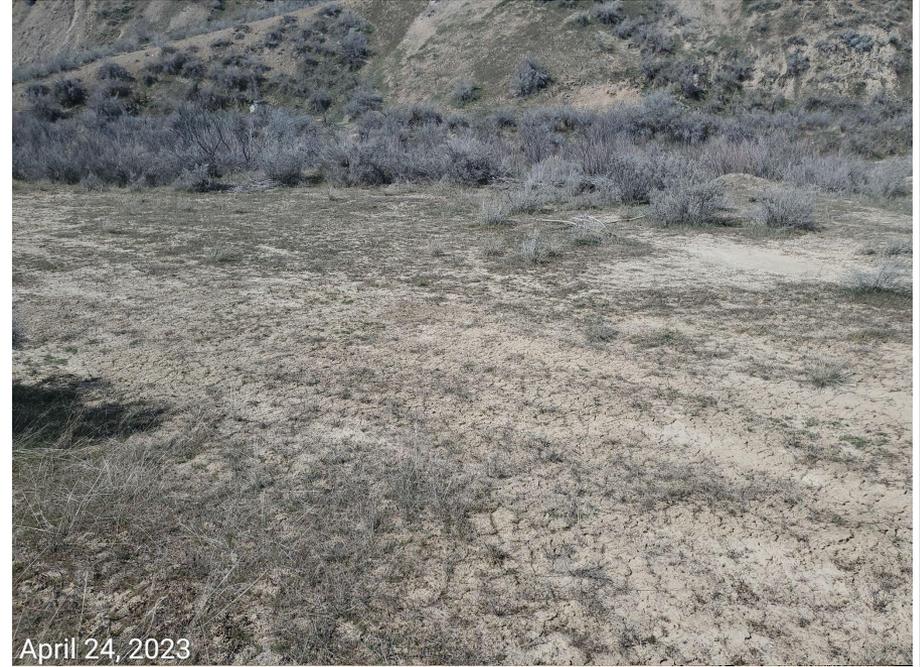
Photo 5: Photos 5-6 taken from the east end of the well site. Photos provide an overview from south, southwest, northwest to north. Final reclamation activities, including but not limited to, removal of road base/gravel, compaction alleviation, recontouring/regrading and reclamation has not been completed.

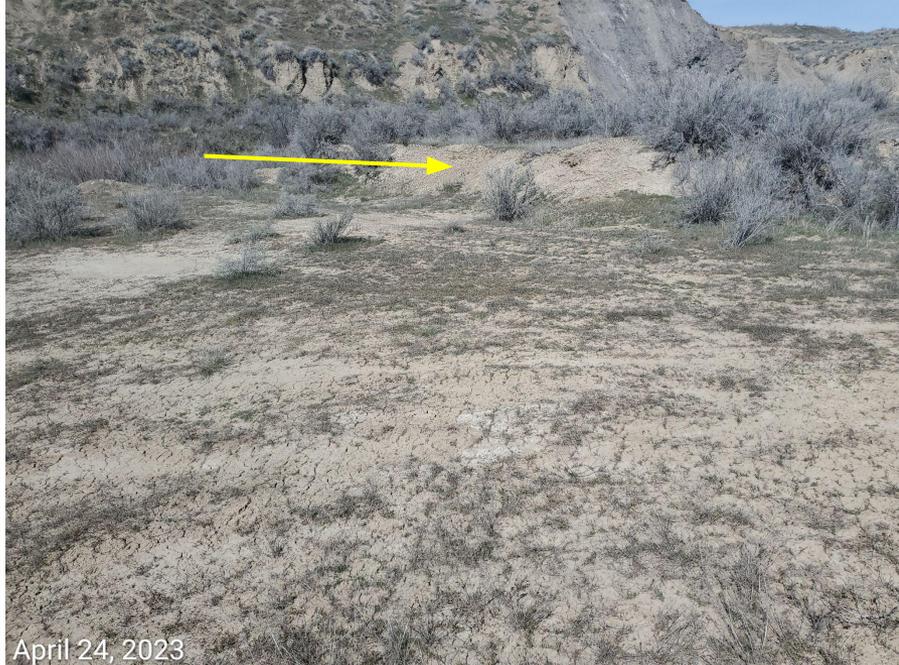
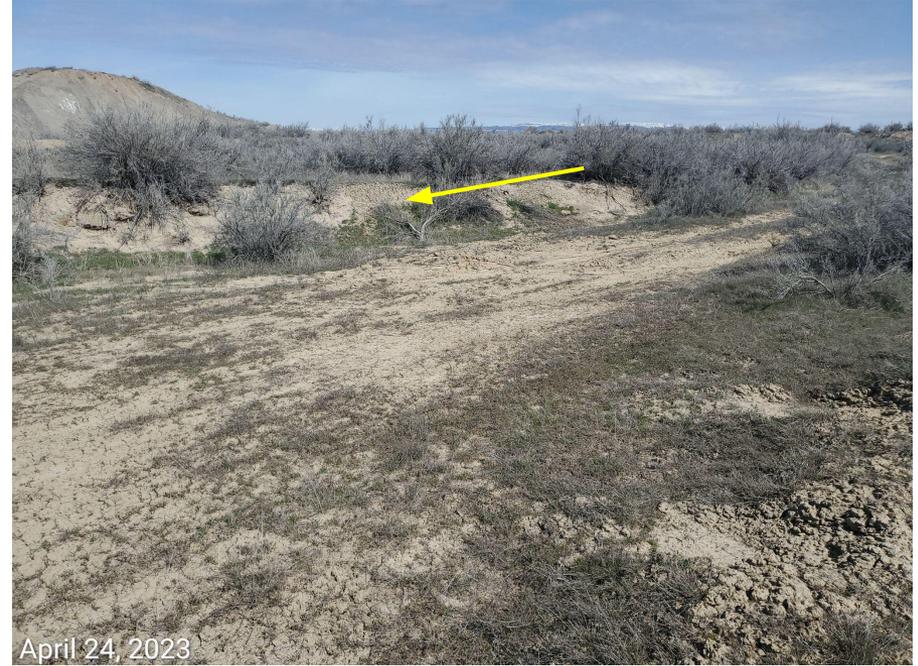
Photo 6: See comments under photo 5. Yellow arrow shows apparent cuts; Location has not been properly contoured.

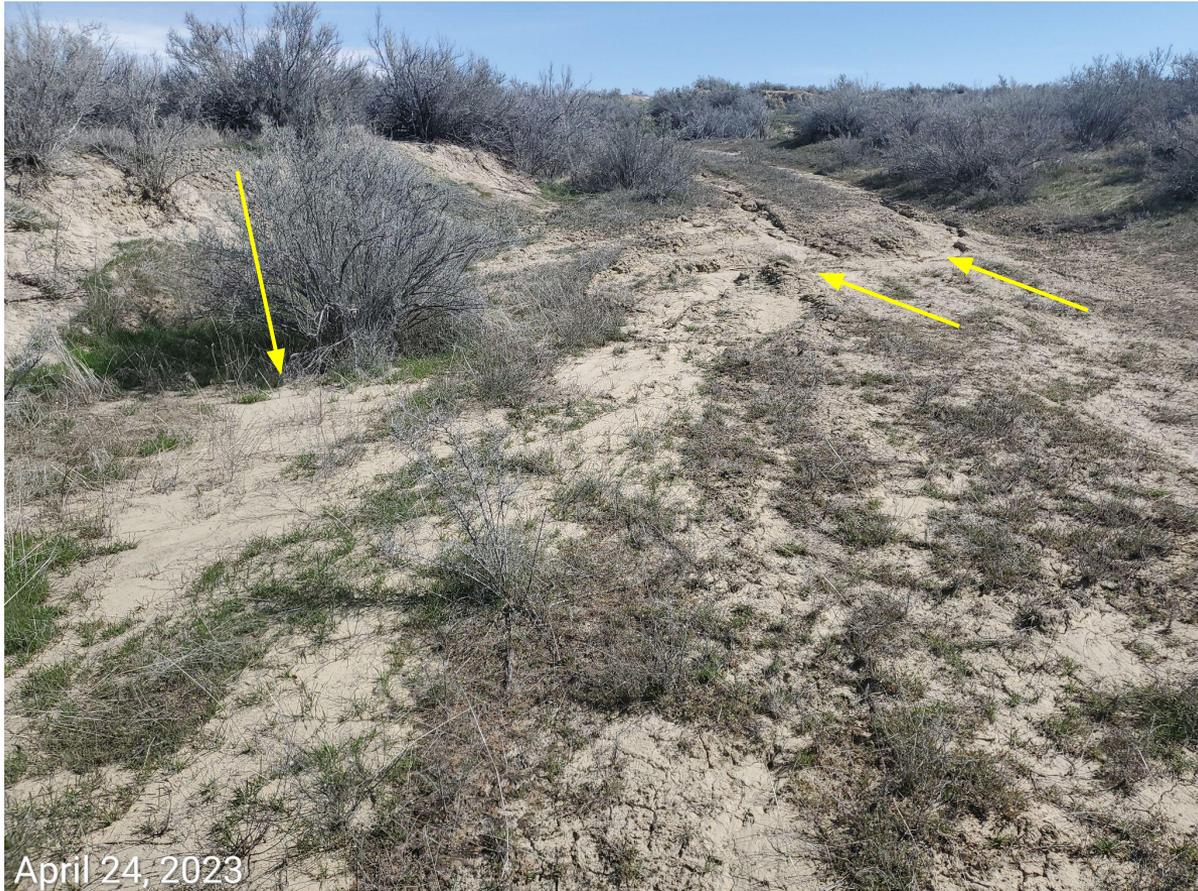
Photo 7: Photo shows area where the northern access road meets the Location. Photo shows sediment deposition due to erosion degradation and runoff from the access road.

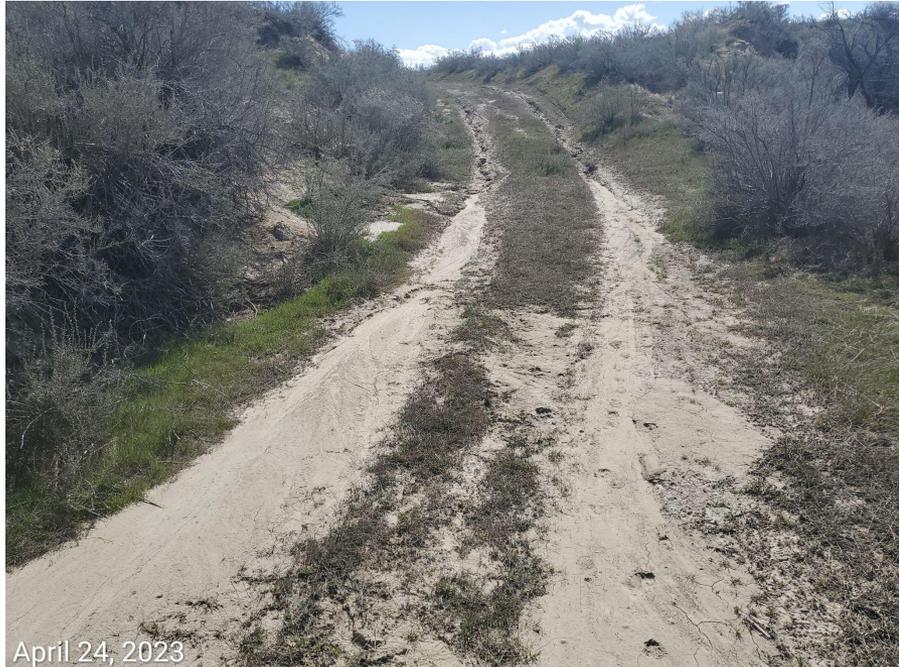
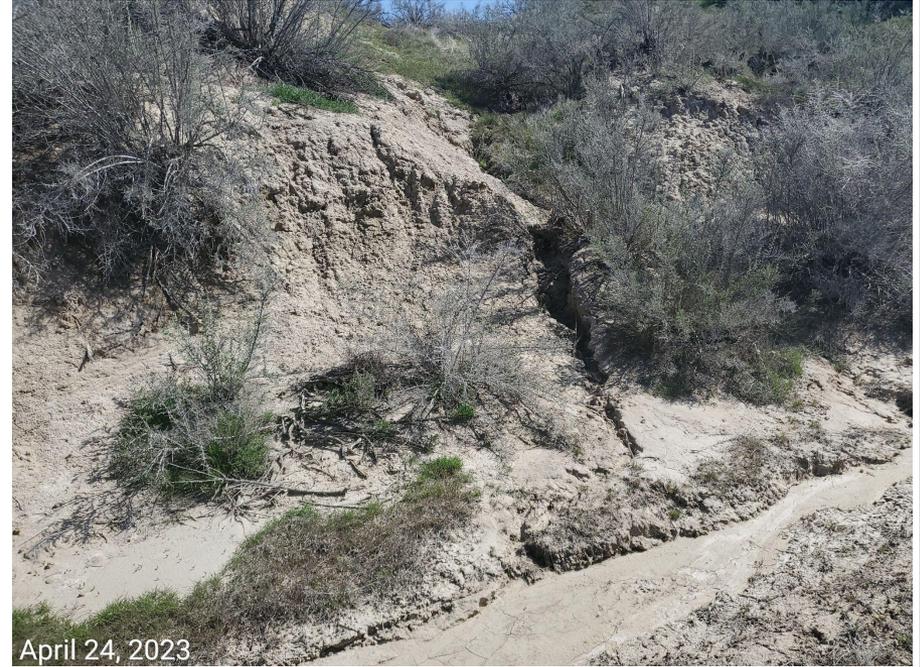
Photo 8: Photos taken from the southern access road. Photo shows stormwater and erosion control BMPs remain missing or insufficient on the Location and access road. Erosion degradation has persisted. Photos also show Final Reclamation activities, including but not limited to, removal of road base/gravel, compaction alleviation, recontouring/regrading and reclamation has not been completed.

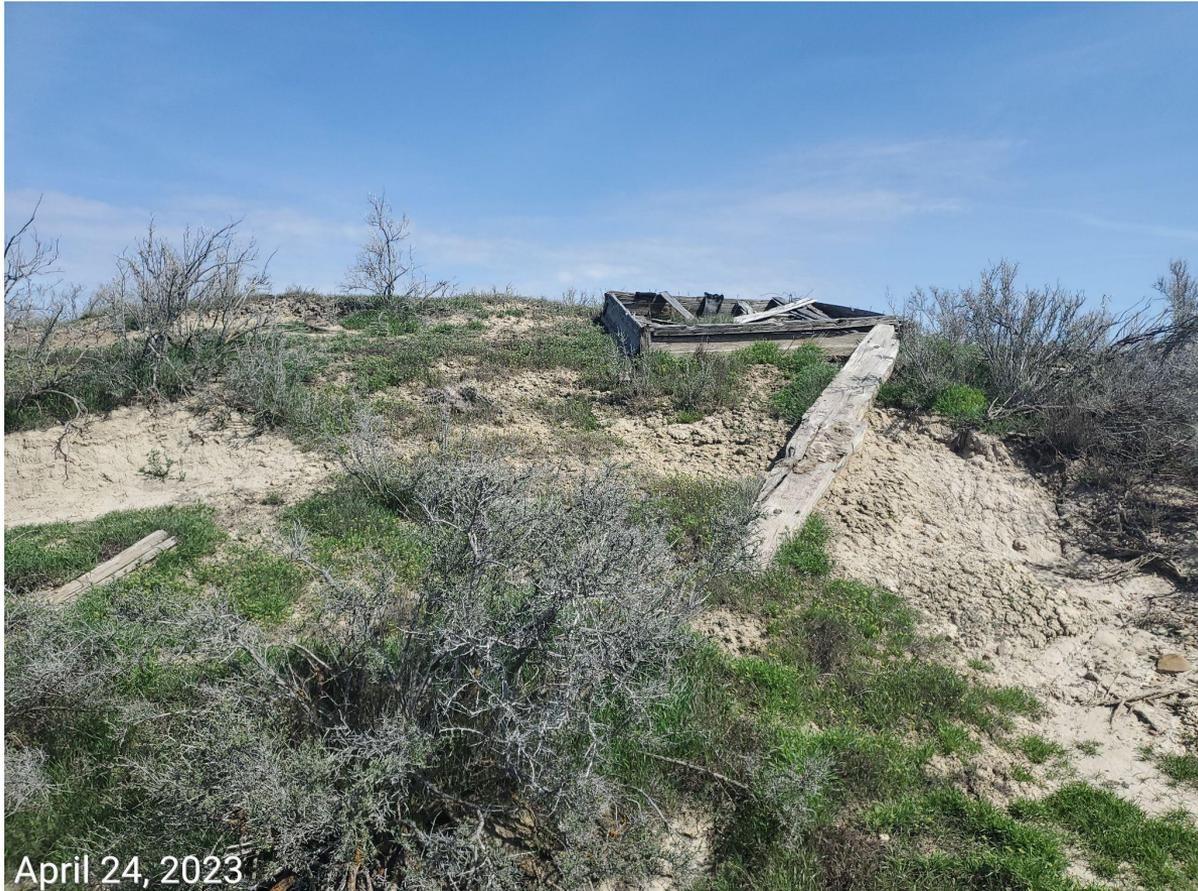
Photo 9: Trash debris remaining along southern access road.

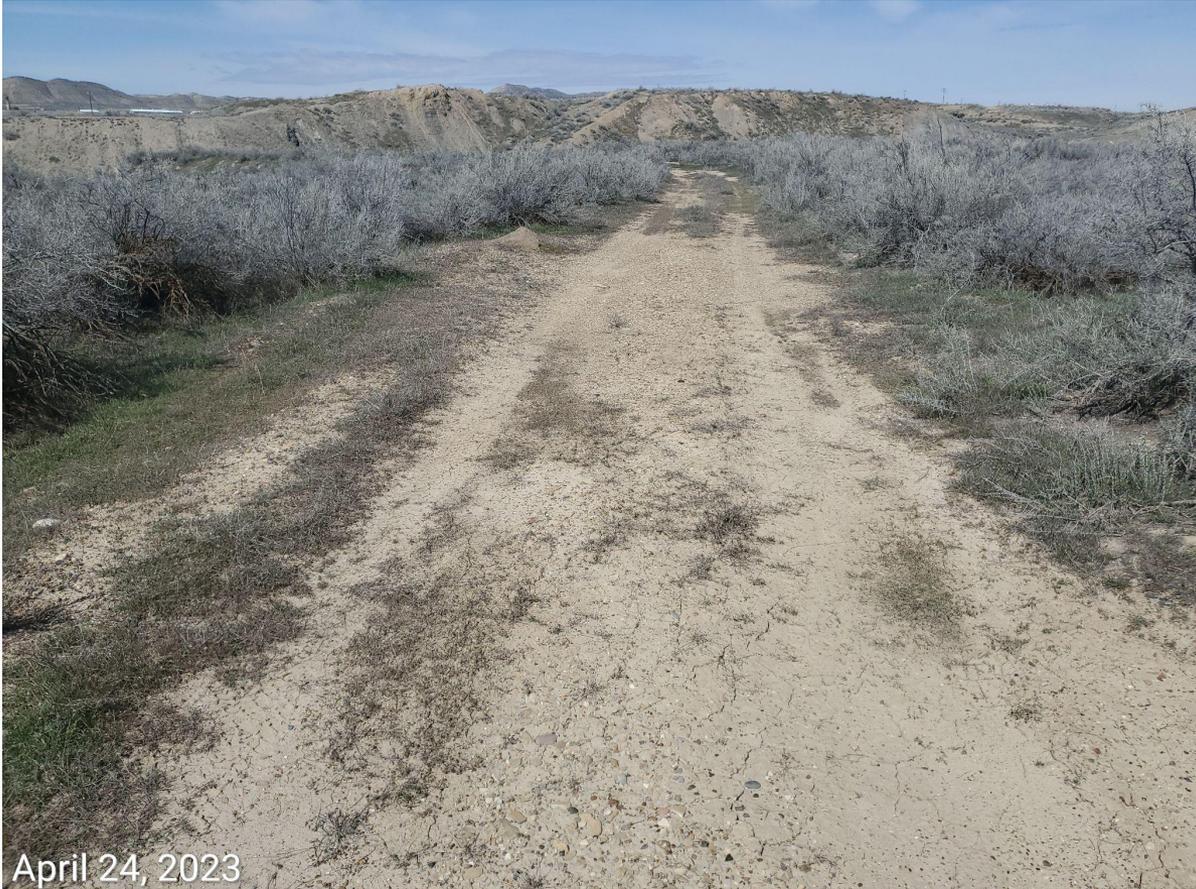
Photo 10: Photos taken from the southern access road. Photo shows Final Reclamation activities, including but not limited to, removal of road base/gravel, compaction alleviation, recontouring/regrading and reclamation has not been completed.
