Stormwater Management and Erosion control

Access Road/Assoc. Location Name: TEP ROCKY MOUNTAIN LLC PA-66S95W /34SWSW

Access Road/Assoc. Location #: 334929

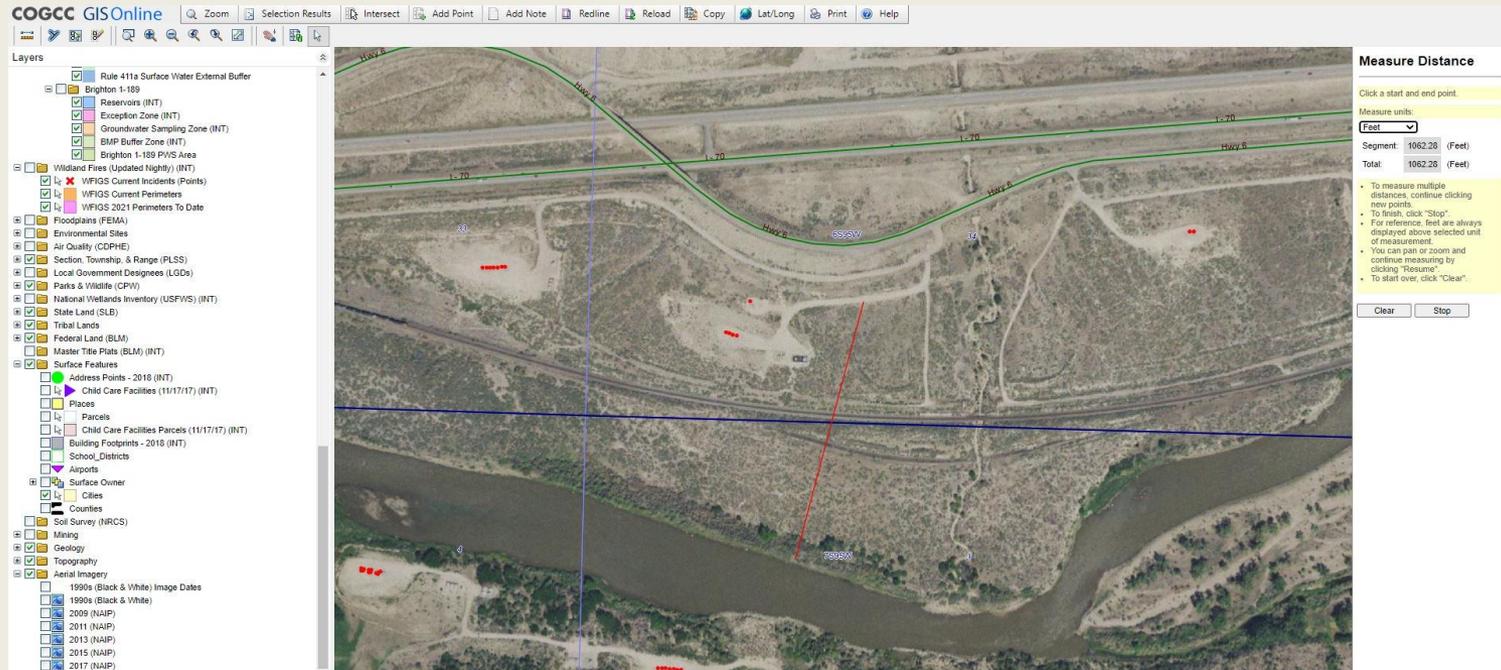
Access Road overview: The access road is approximately 350 yards from the Colorado River.

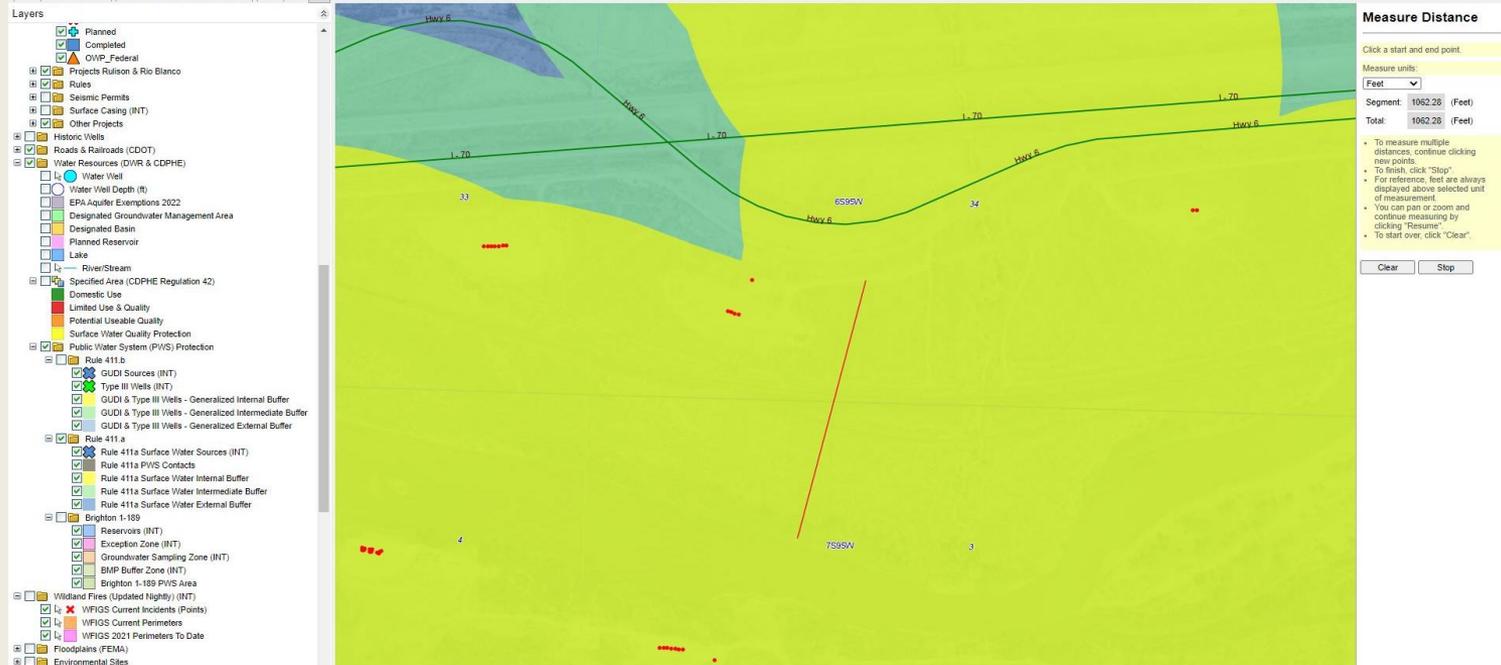
**Access Road overview: The access road is located in a 411 a.
internal buffer zone.**

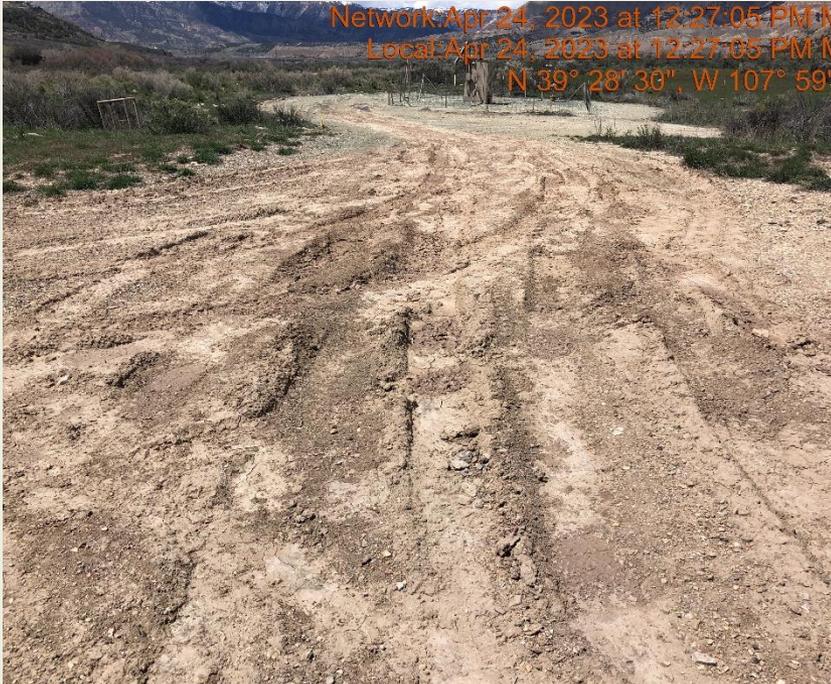
Photo #9700 Access road lacks stabilization.

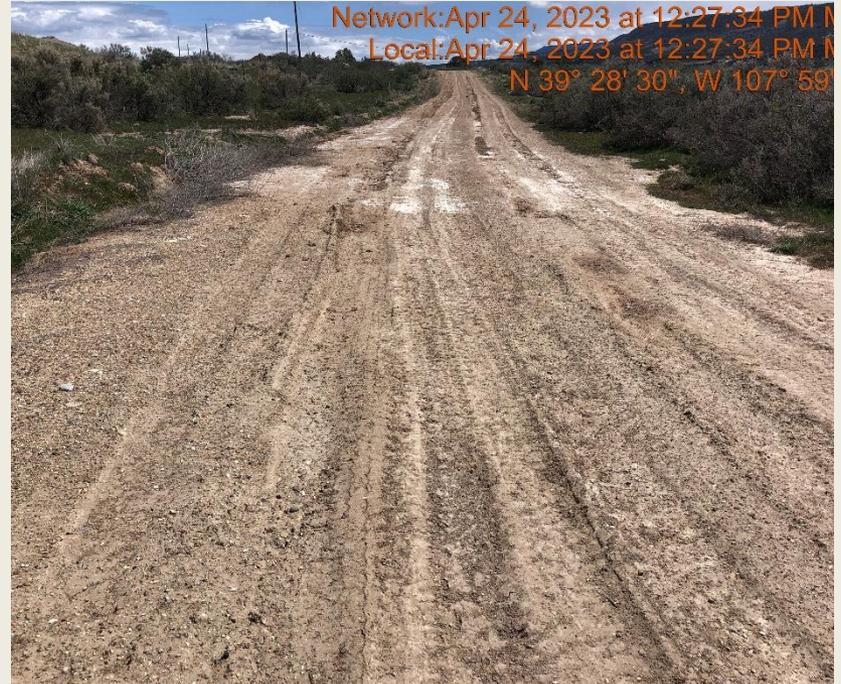
Photo #9702 Access road lacks stabilization.

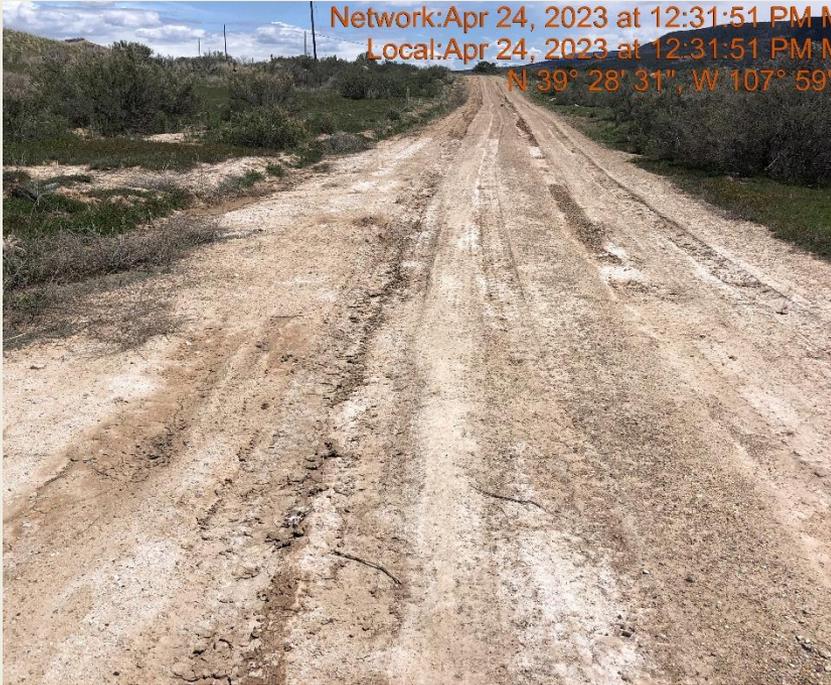
Photo #9706 Access road lacks stabilization.

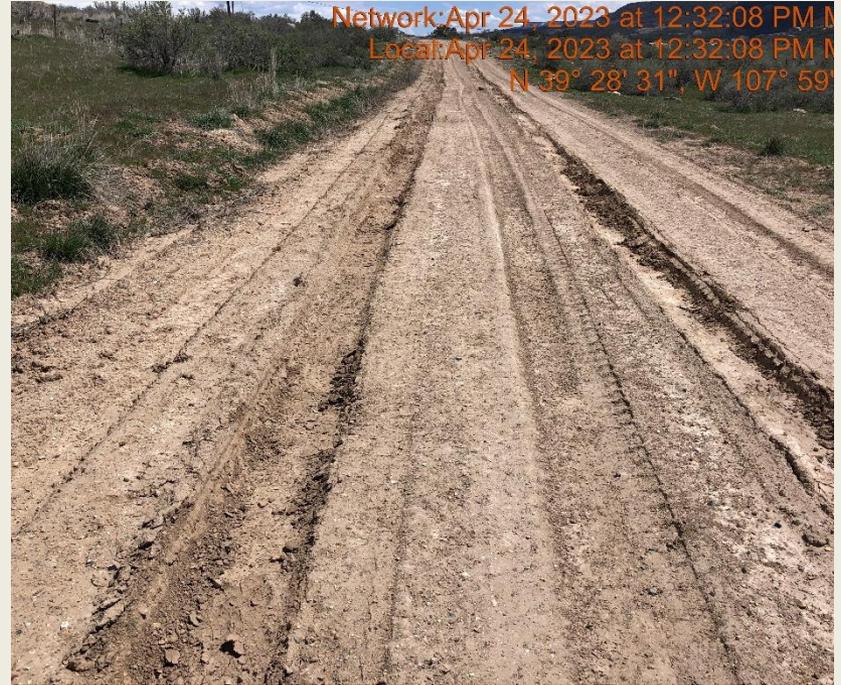
Photo #9707 Access road lacks stabilization.

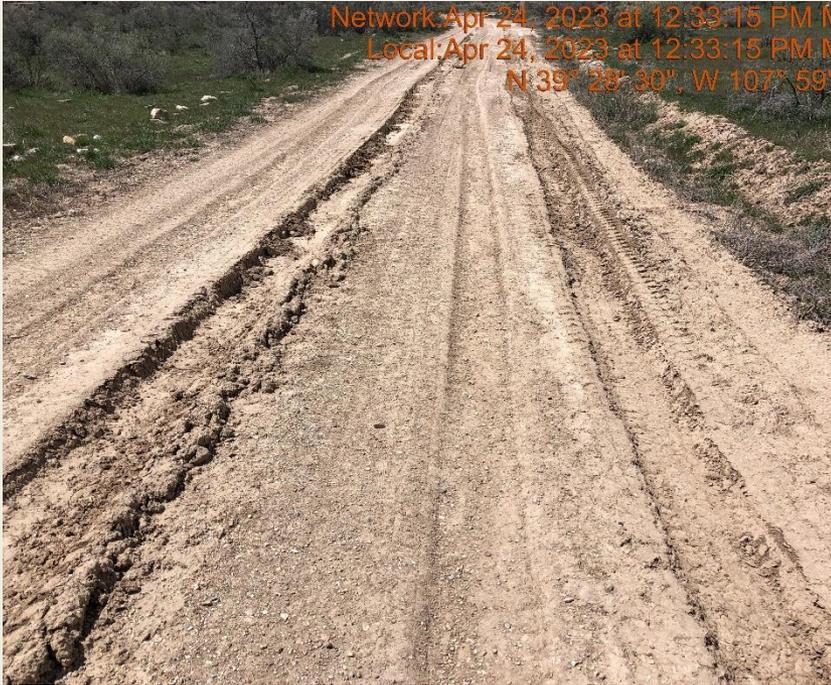
Photo #9708 Access road lacks stabilization.

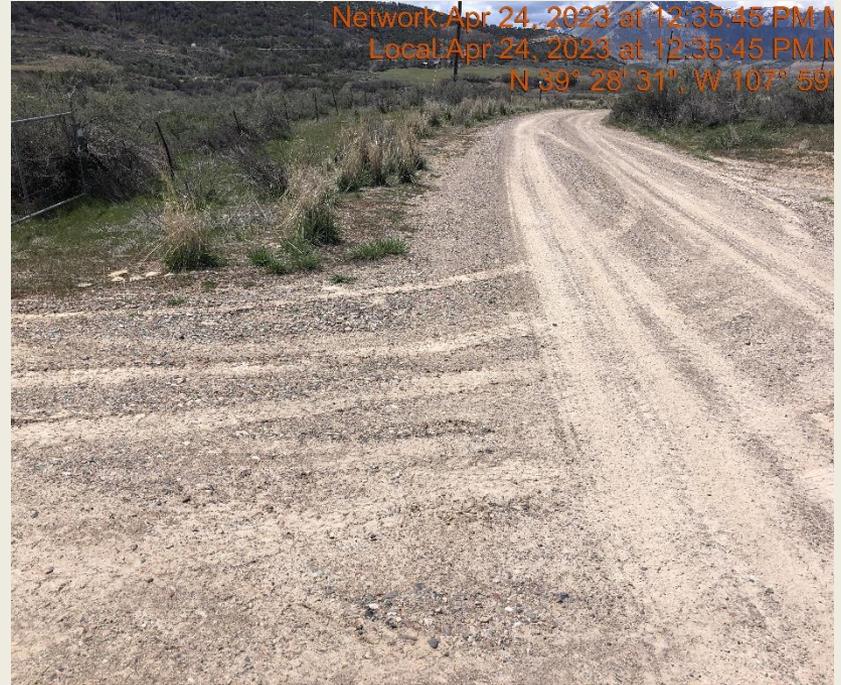
Photo #9709 Insufficient tracking BMP to minimize the transport of sediment.

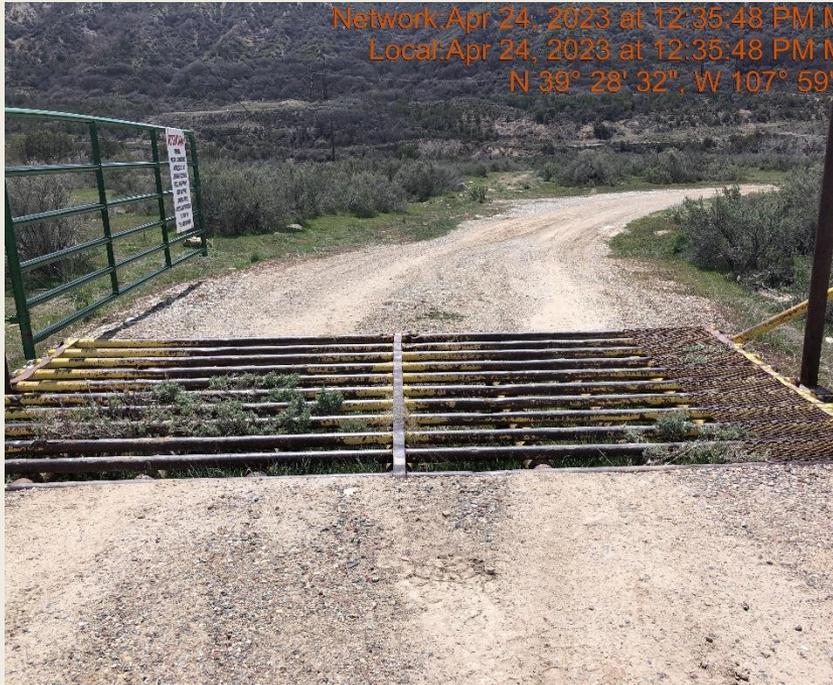
Photo #9710 Insufficient tracking BMP to minimize the transport of sediment.

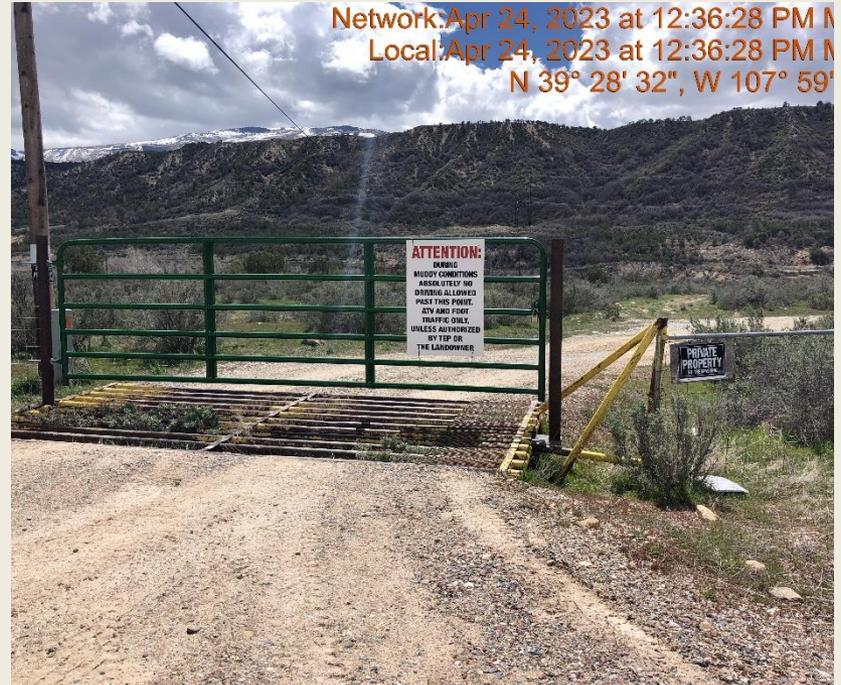
Photo #9711 Insufficient tracking BMP to minimize the transport of sediment.
