Stormwater Management and Erosion control

Location Name: TEP ROCKY MOUNTAIN LLC PUCKETT/TOSCO-66S95W /34SESW

Location #: 324218

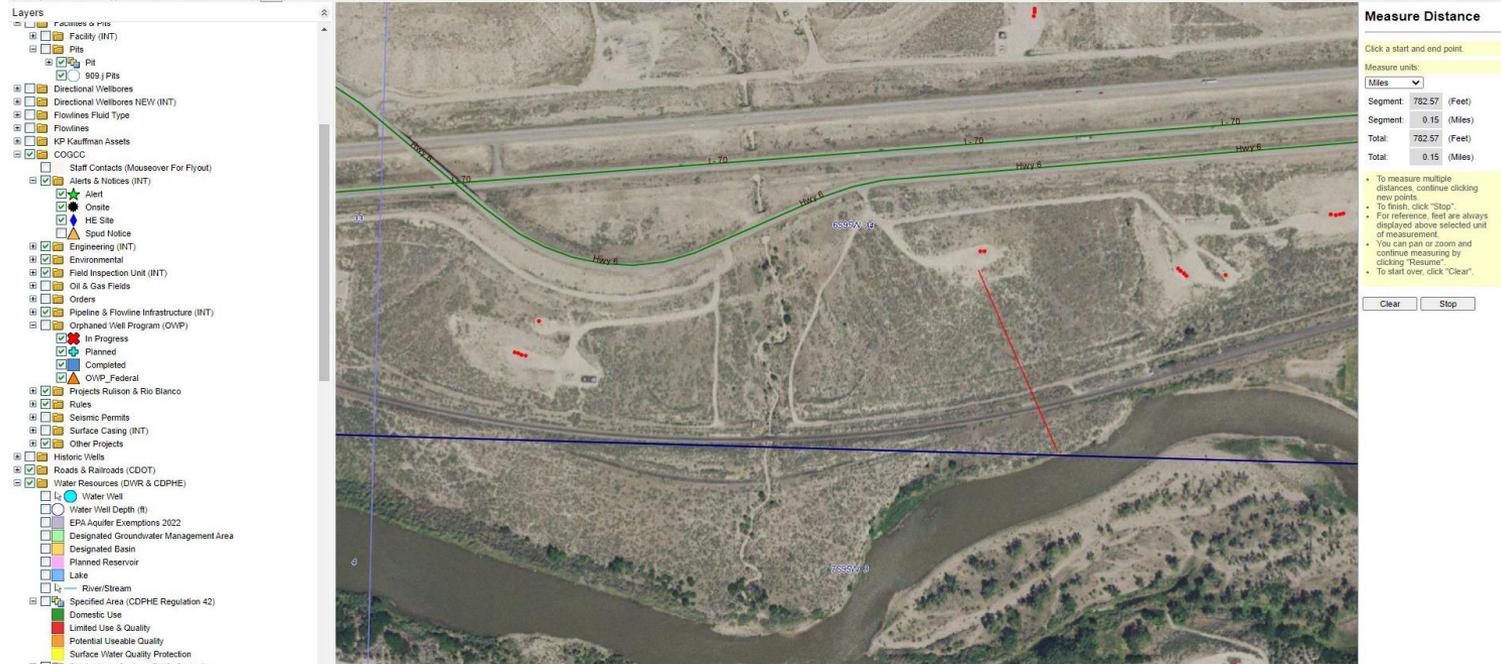
Location Overview: The location is located approximately 260 yards from the Colorado river.
Section/Township/Range: 34 6S95W

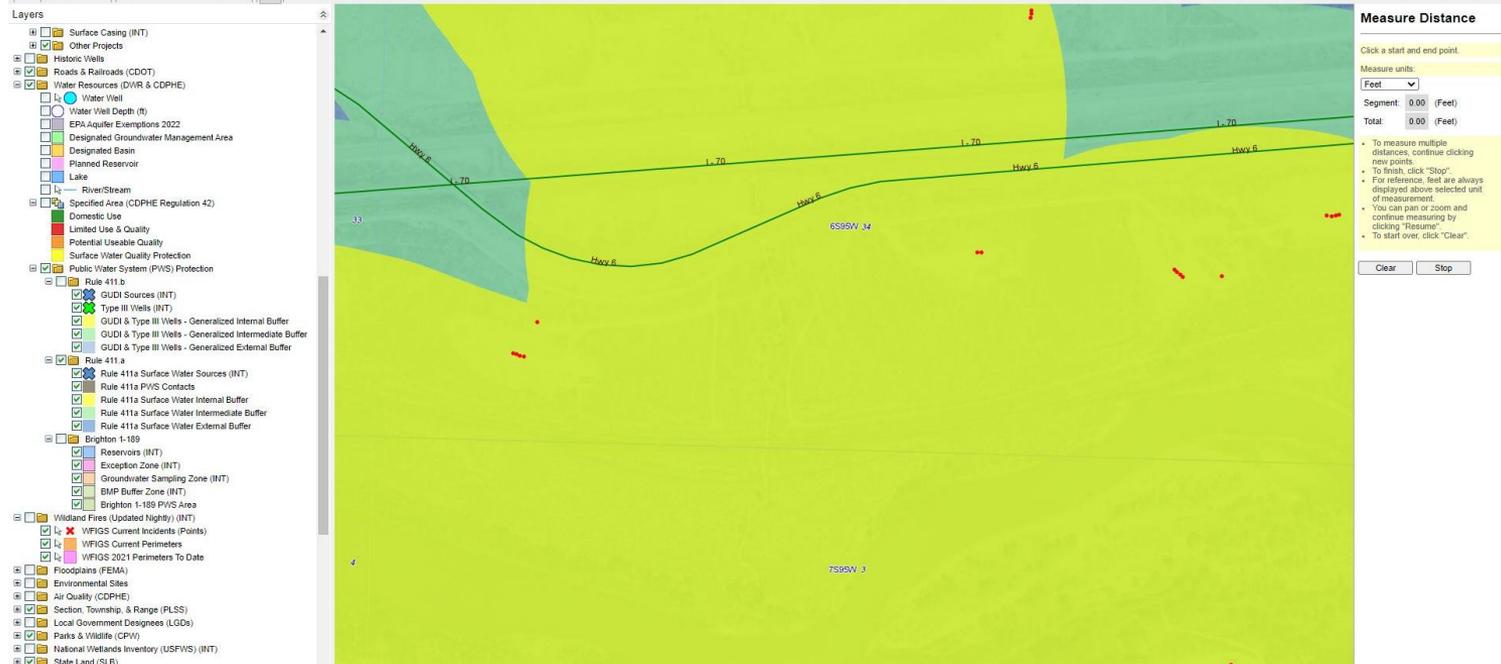
Location Overview: The location is located in a 411 a. internal buffer zone.

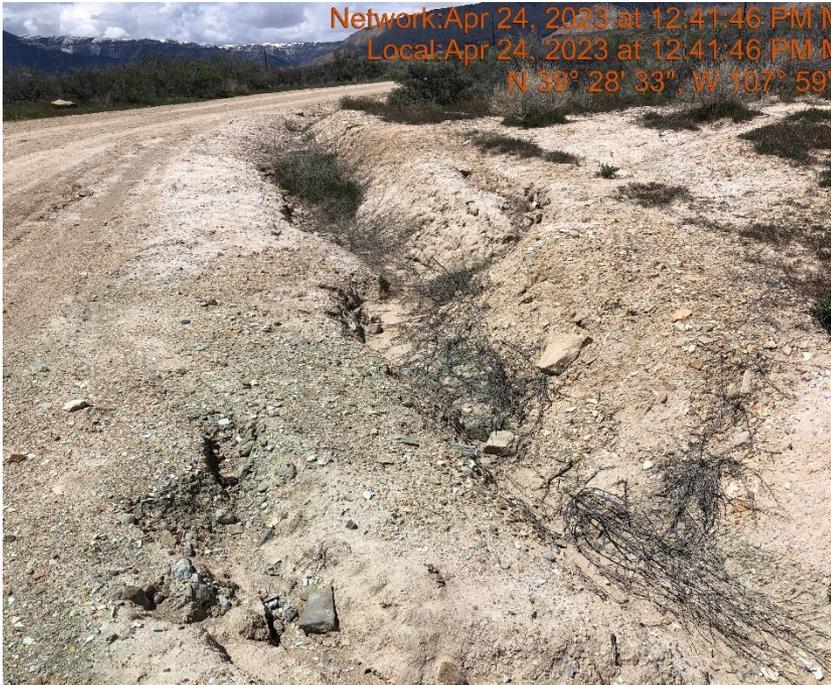
Photo #9716 Insufficient velocity BMP's.

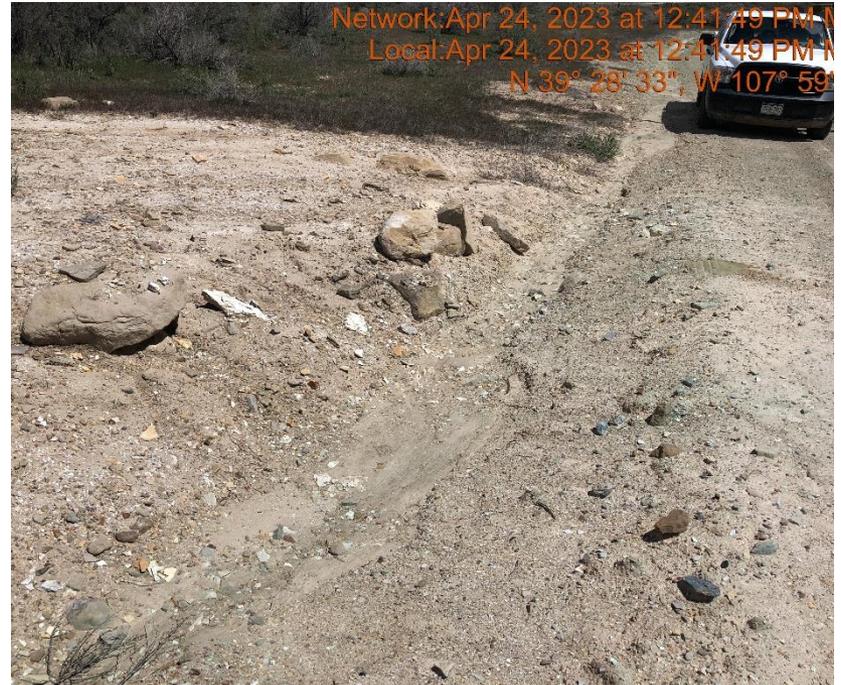
Photo #9717 Insufficient velocity BMP's.

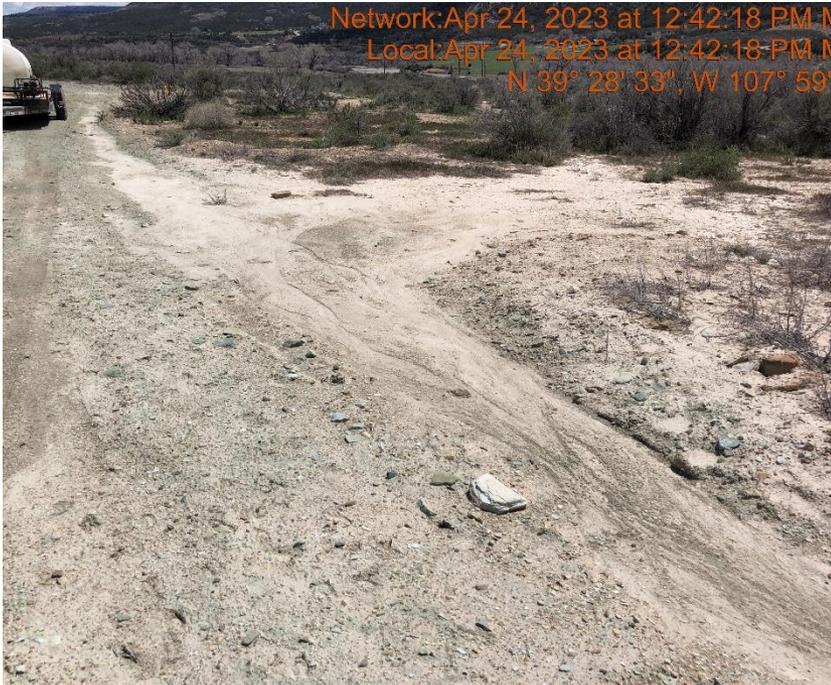
Photo #9720 Sediment migration off location.

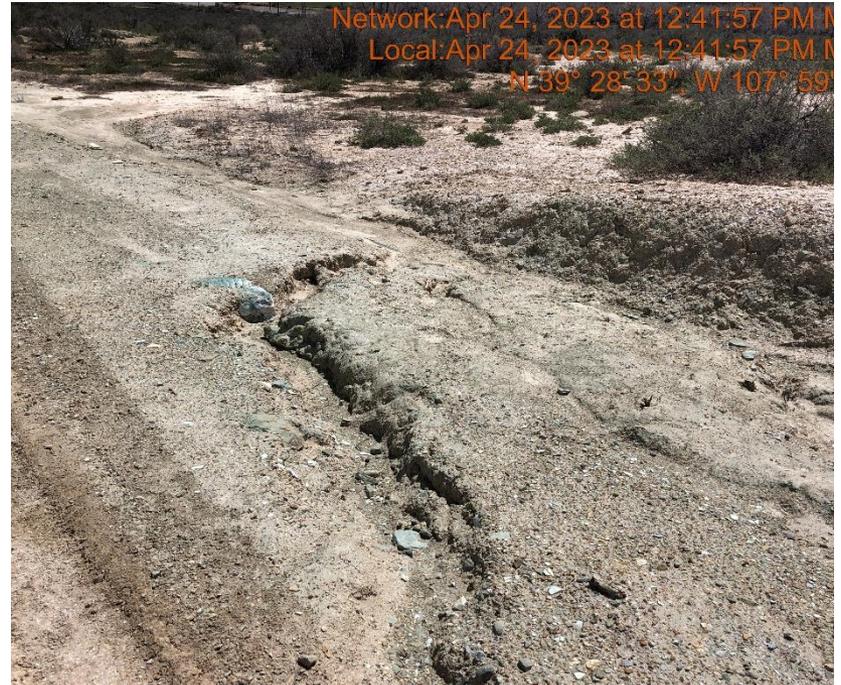
Photo #9718 Rill erosion occurring on location.

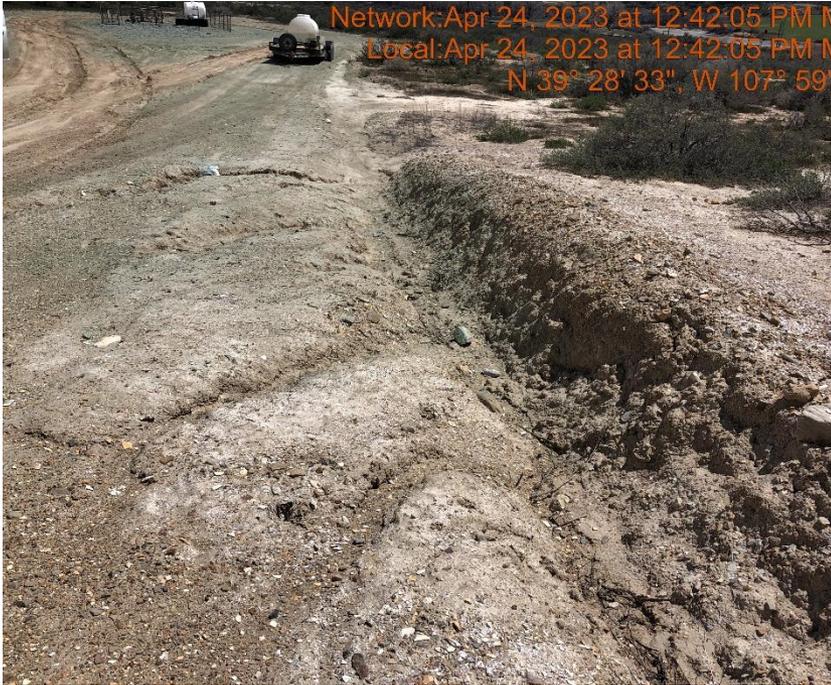
Photo #9719 Rill erosion occurring on location.

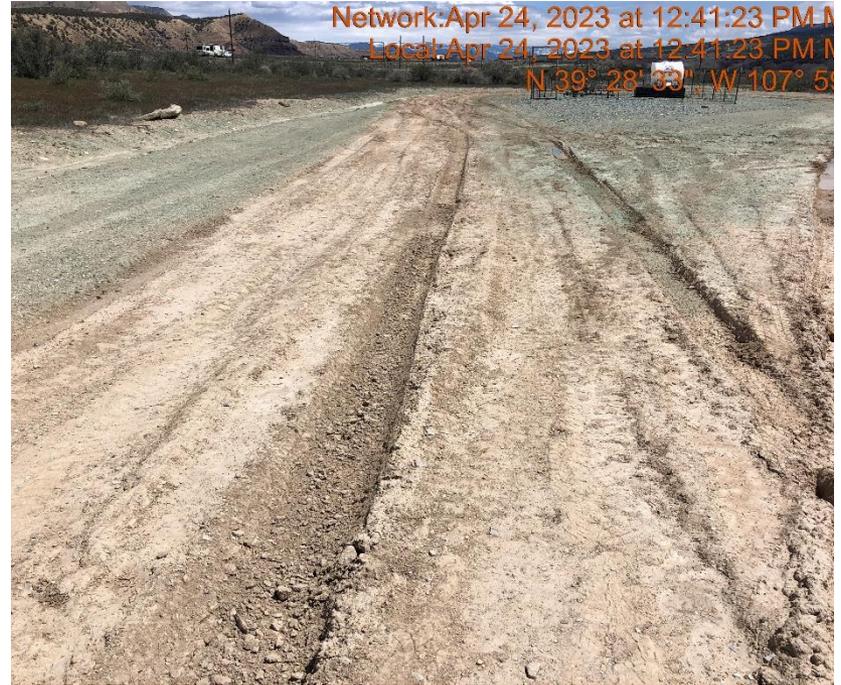
Photo #9714 Location lacks stabilization.

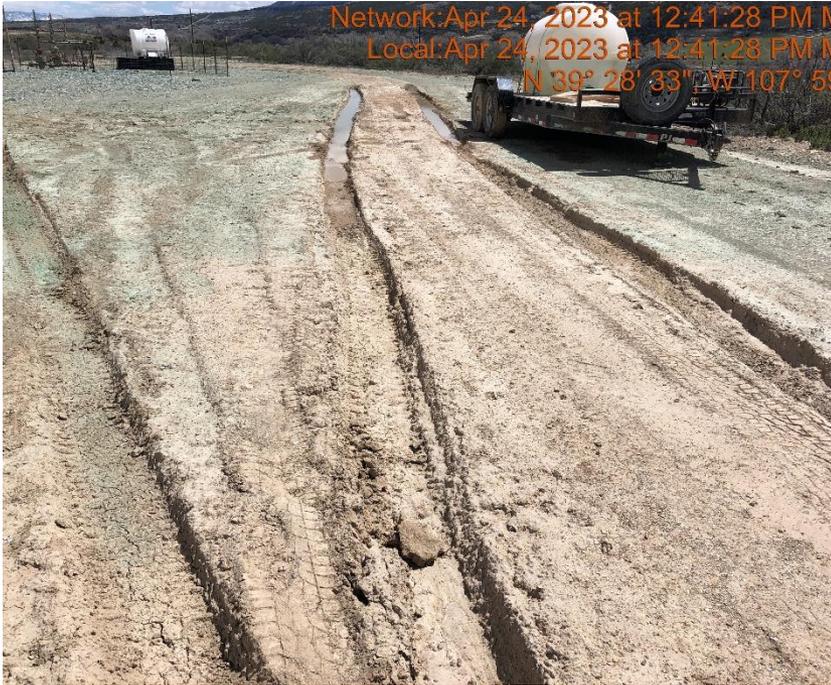
Photo #9715 Location lacks stabilization.

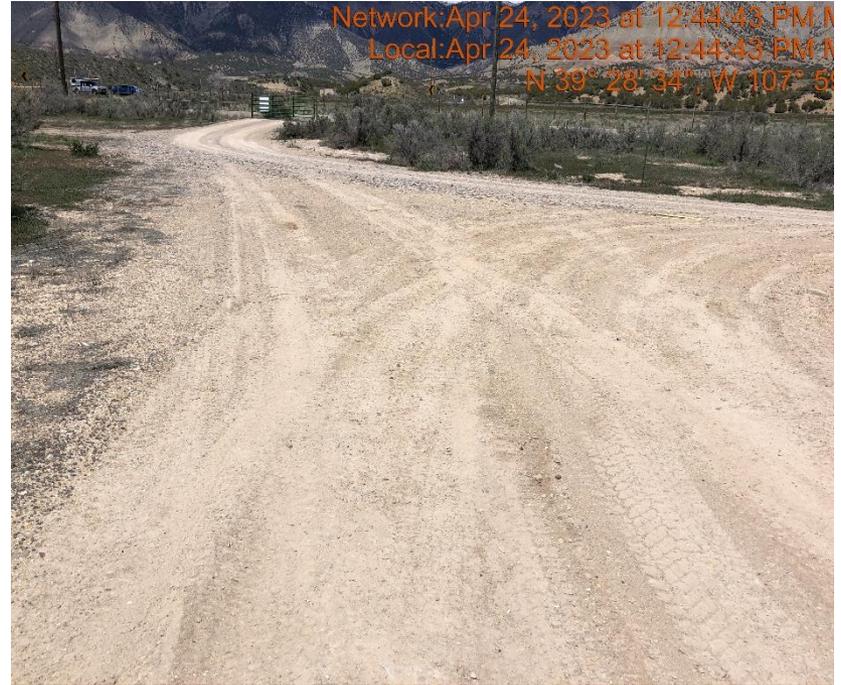
Photo #9725 Insufficient tracking BMP to minimize the transport of sediment.
