Scout Energy LLC Associated Unit A 2X Location #316438

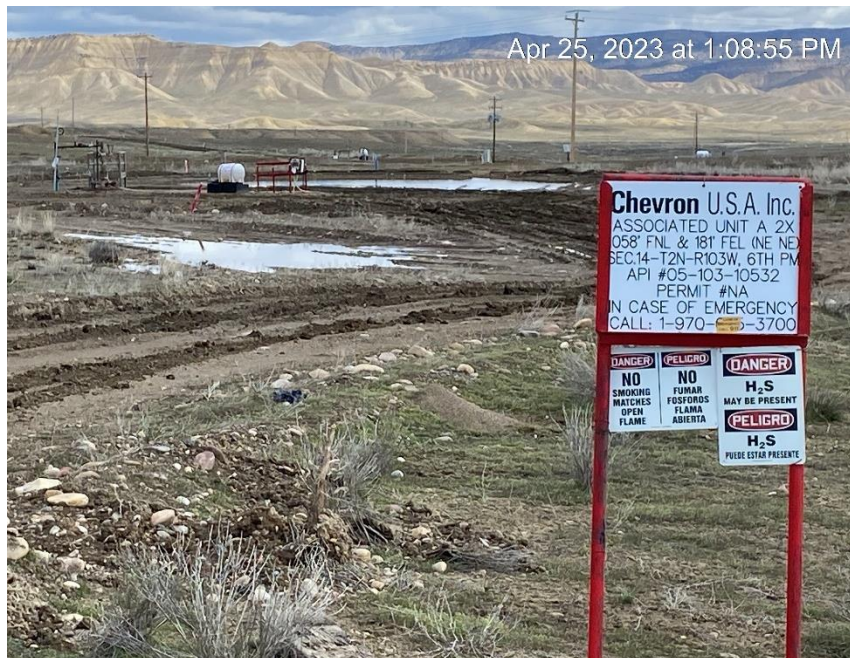
Access and location from lease road

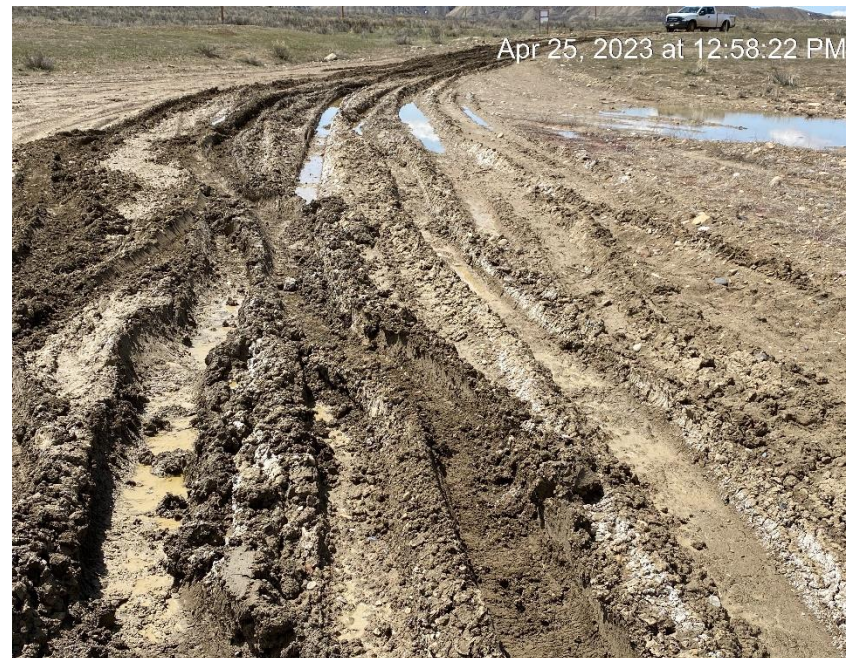
Access to location entrance

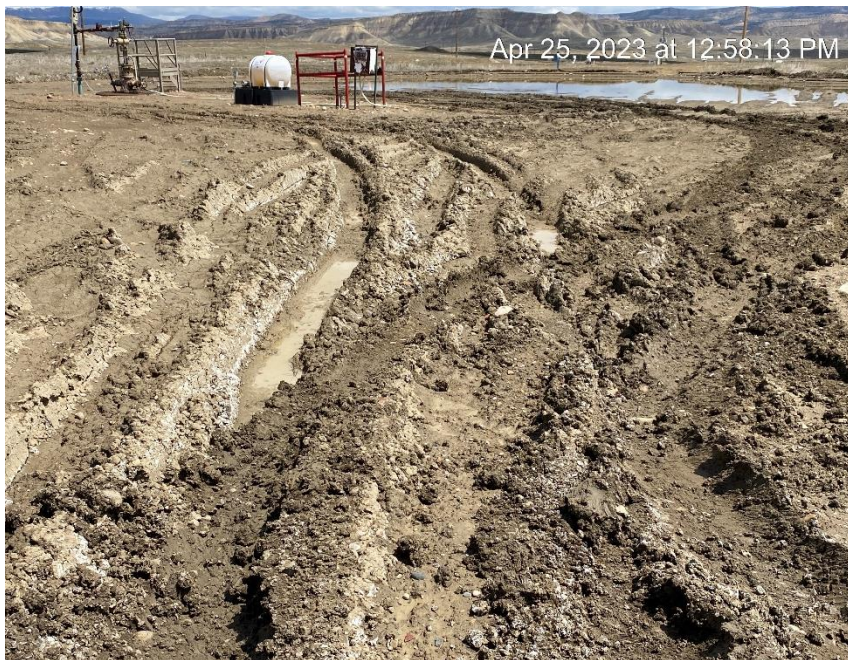
Entrance to location

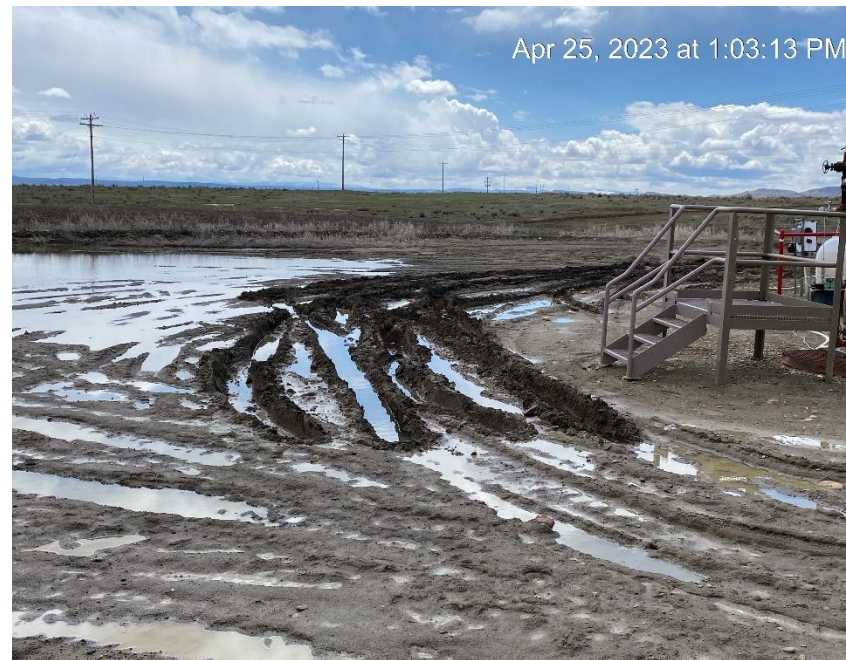
Lack of stabilization

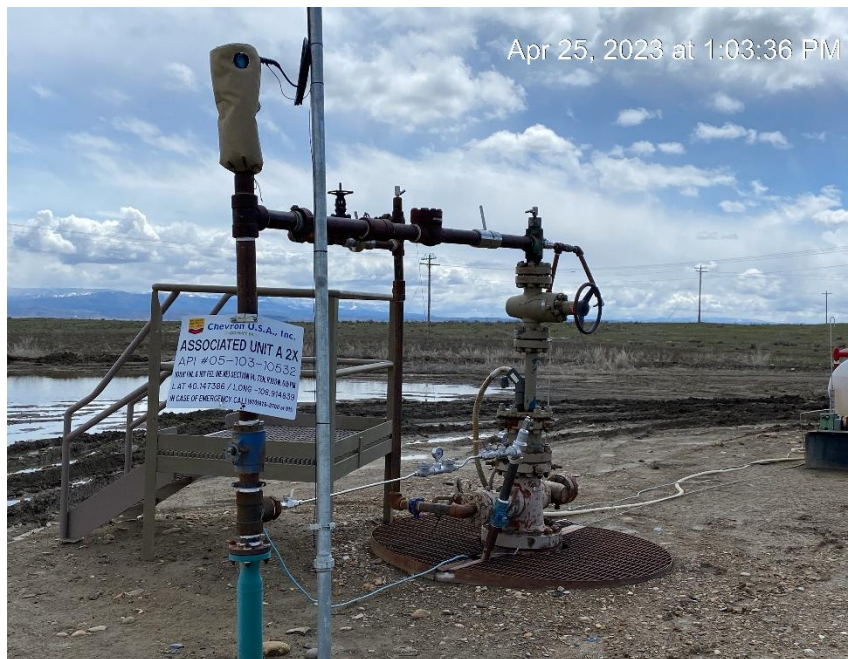
Wellhead equipment

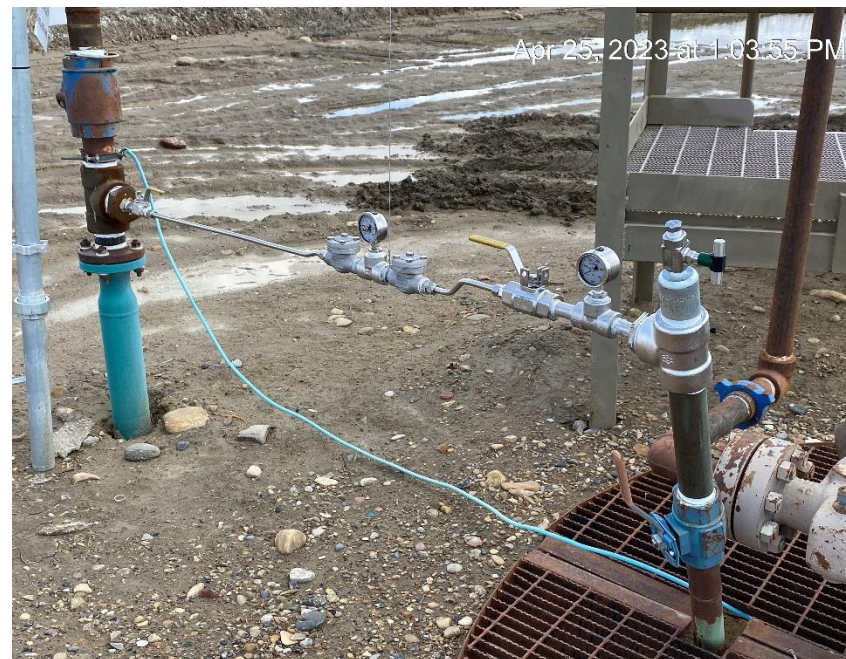
Surface casing to flowline

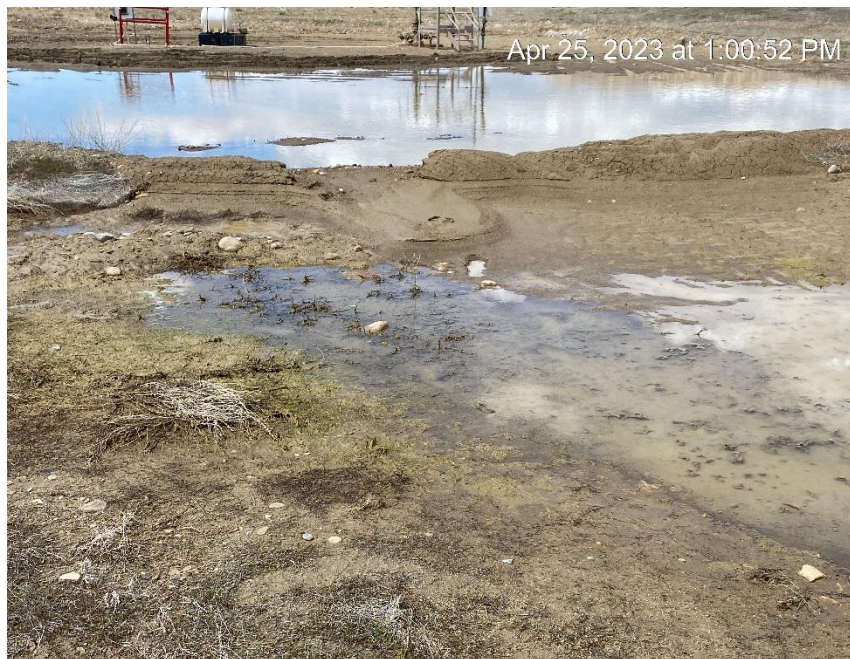
Erosion and sediment migration

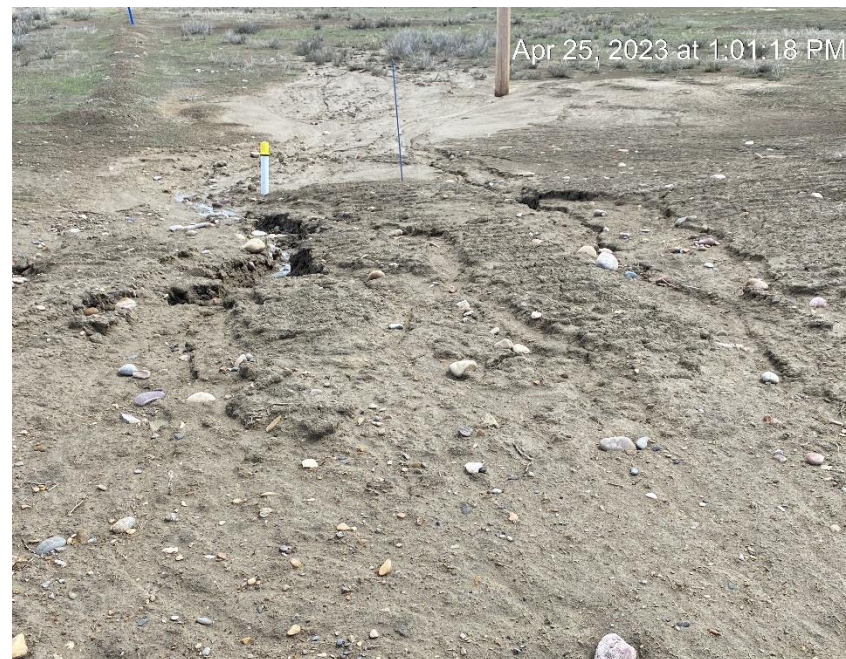
Erosion and sediment migration

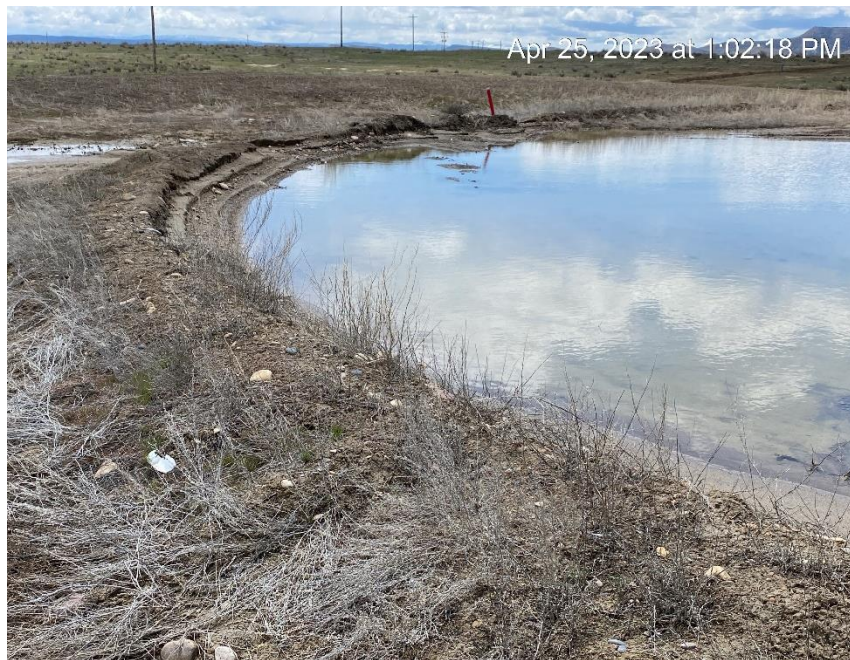
Lack of stabilization

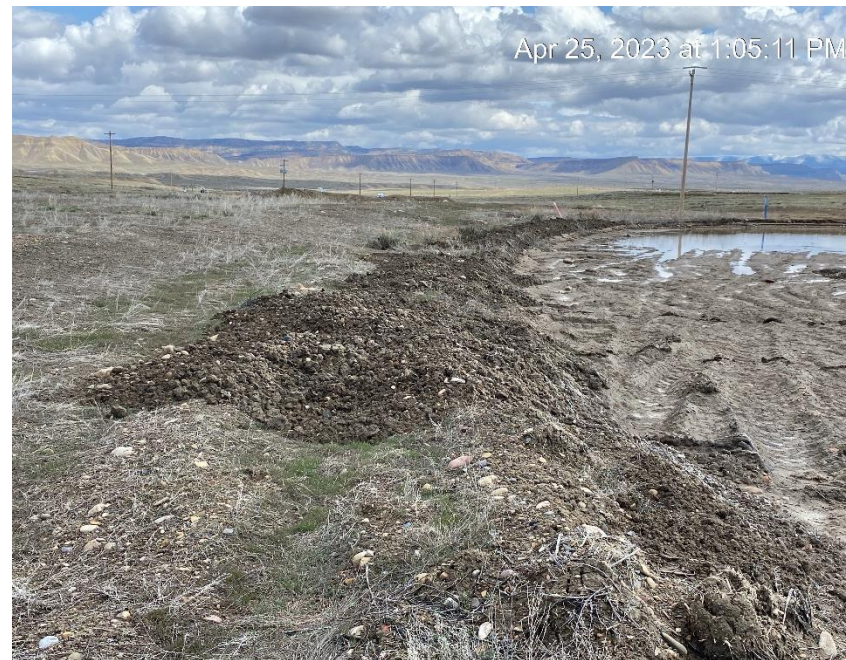
Sediment movement
