Inspection Photos

Location Name: TEP ROCKY MOUNTAIN LLC RWF CLOUGH 19 Pad

Location ID: 322456

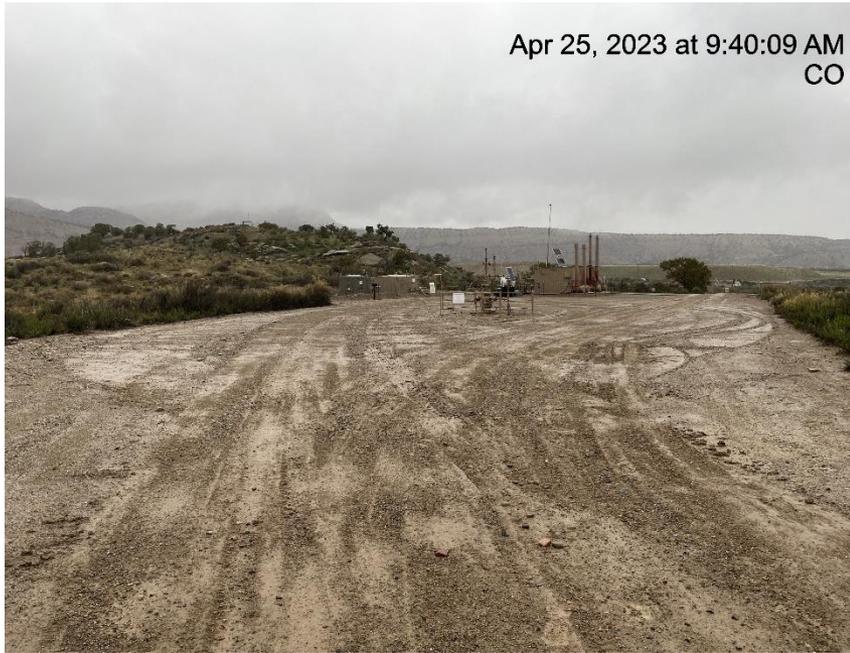
Photo # 6239 From entrance to location

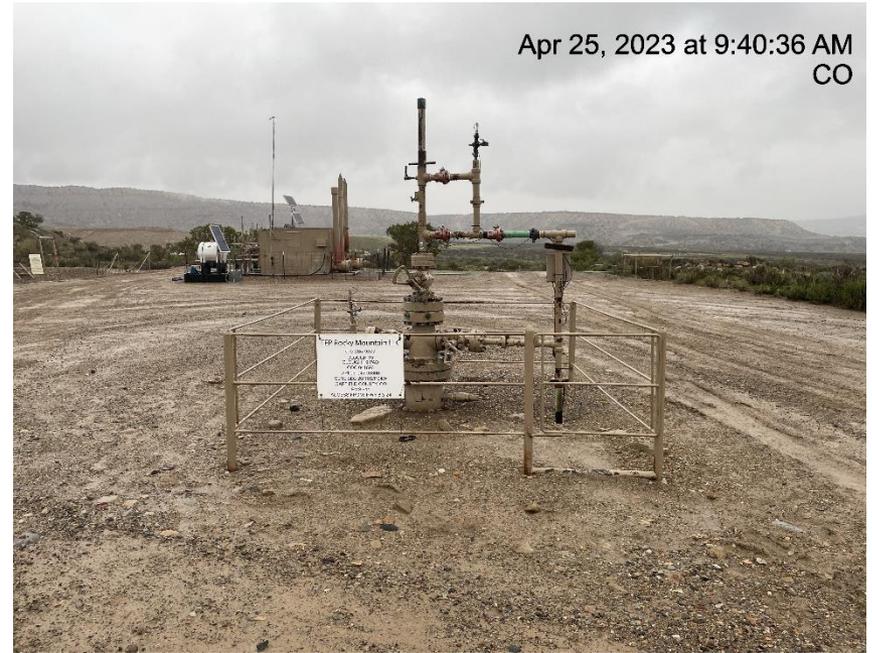
Photo # 6240 Location

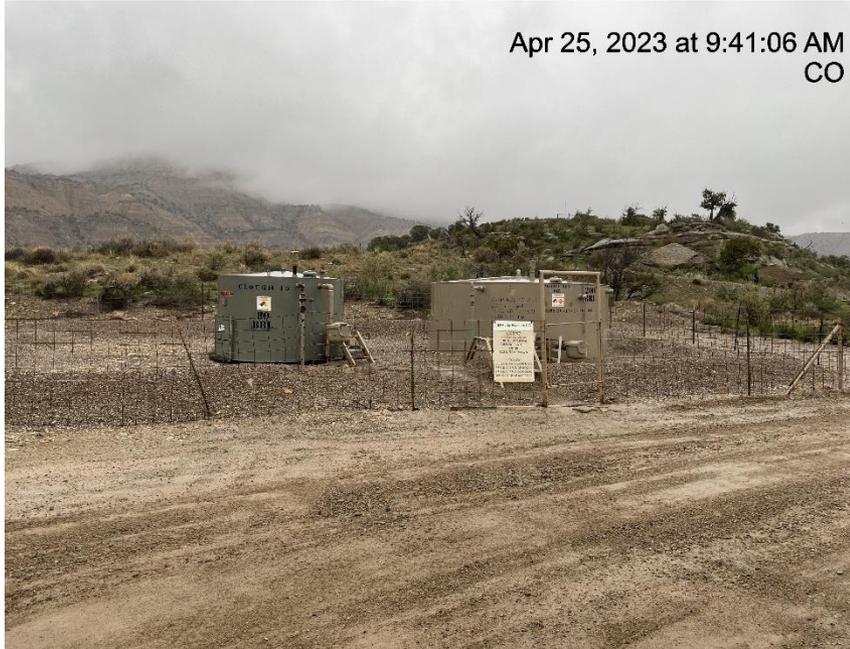
Photo # 6241 Location

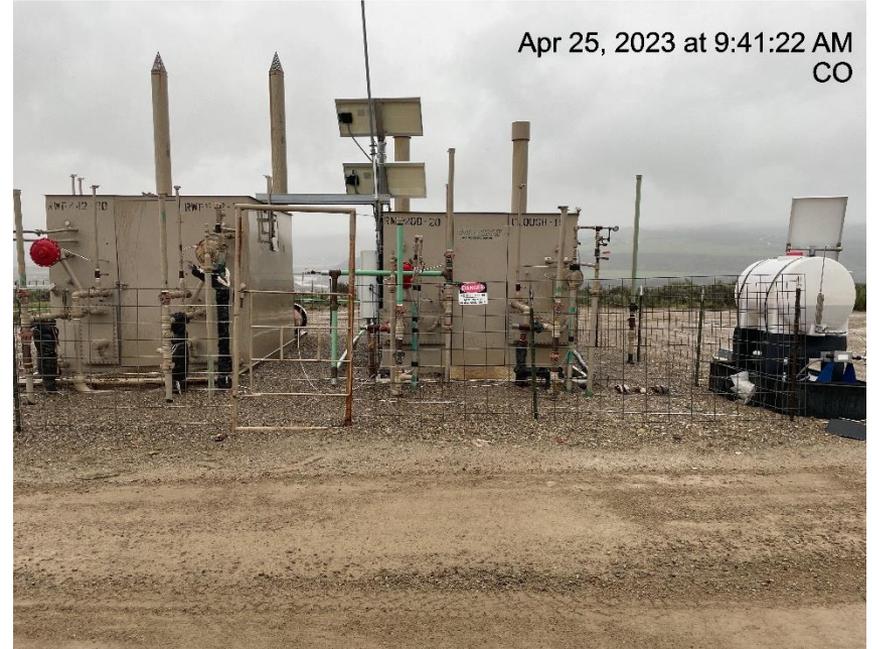
Photo # 6242 Location

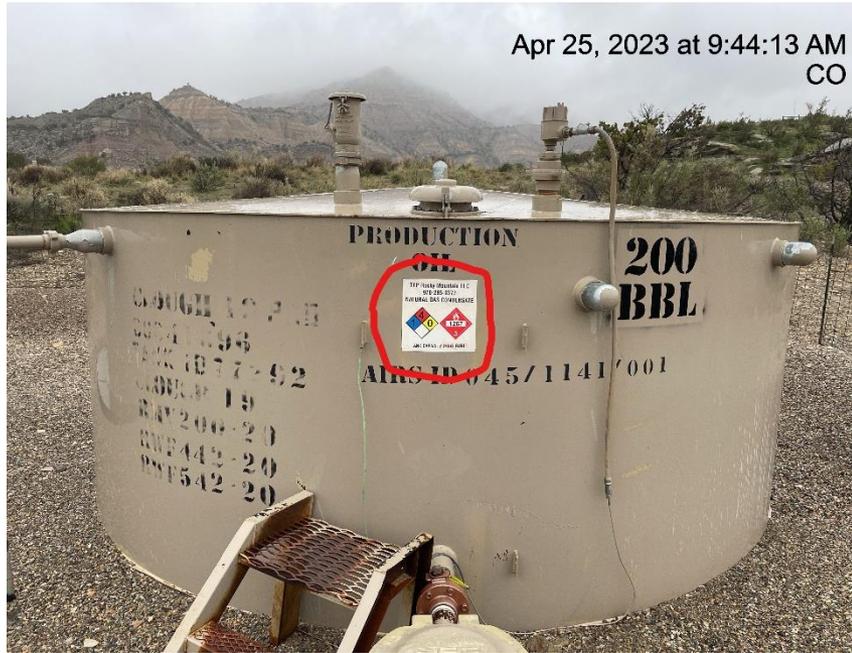
Photo # 6243 Tank label inaccurate/incorrect information

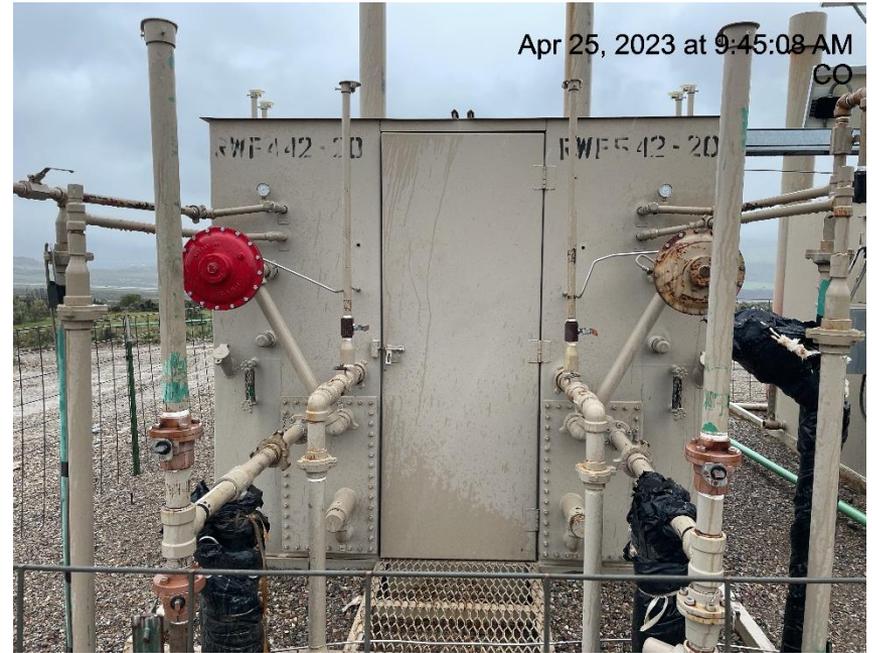
Photo # 6244 Meter calibration info not conspicuously posted

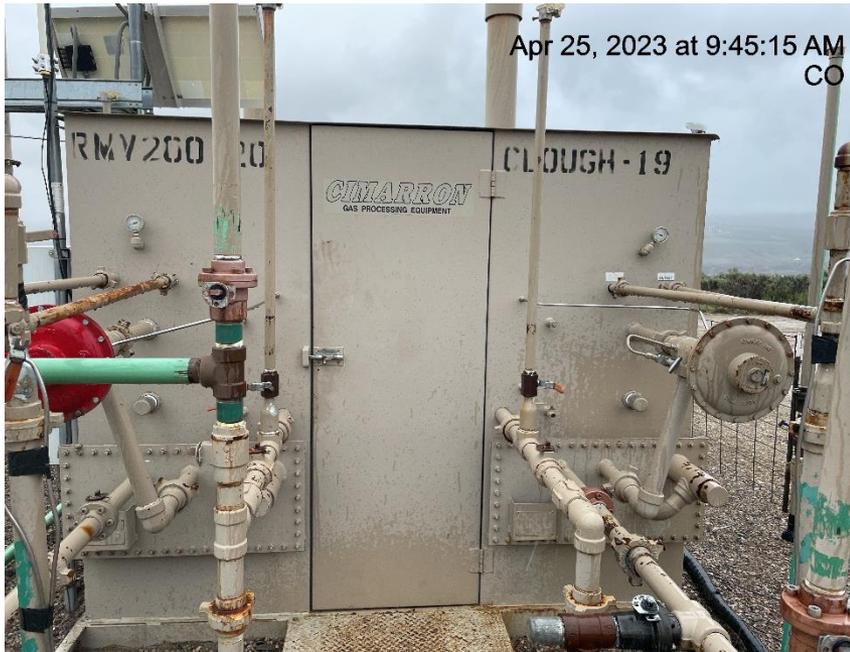
Photo # 6245 Meter calibration info not conspicuously posted

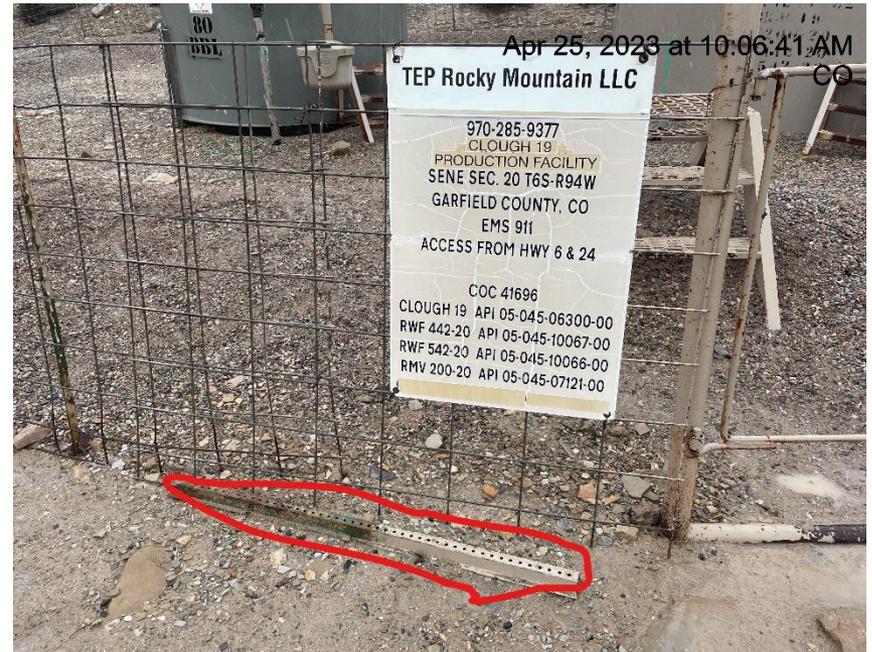
Photo # 6262 Debris

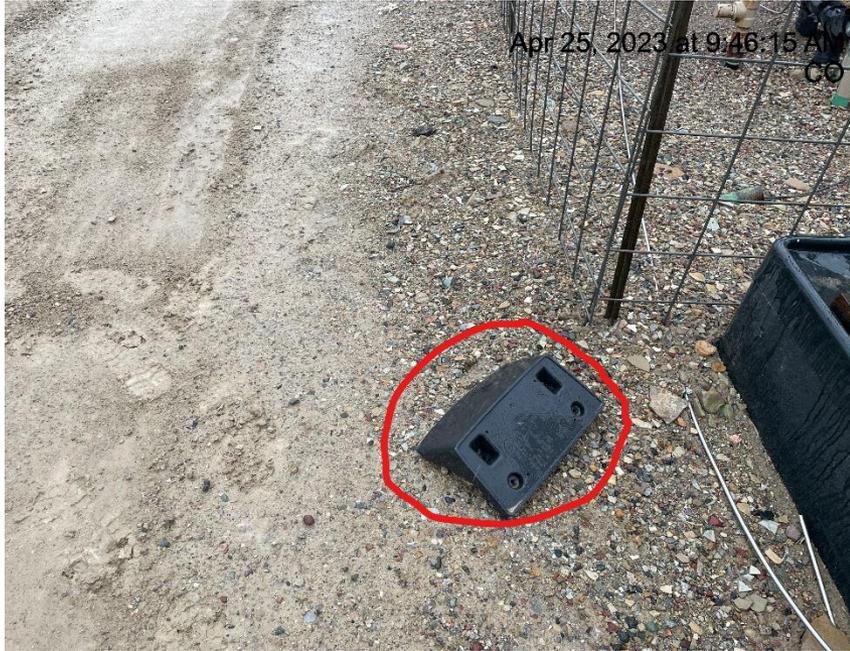
Photo # 6246 Debris

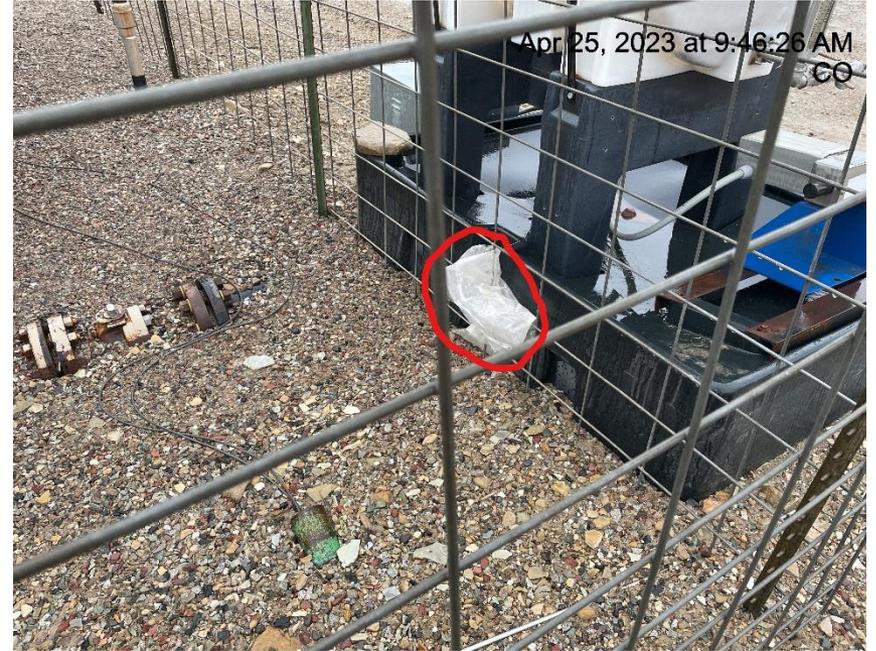
Photo # 6247 Debris

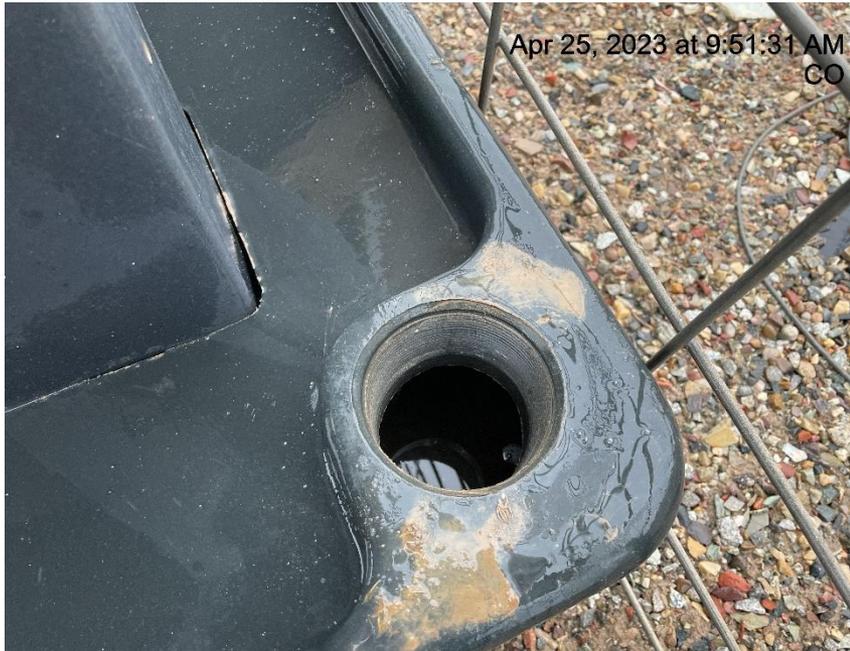
Photo # 6253 Chemical containment is approximately 3/4 full/Failure to maintain chemical BMP

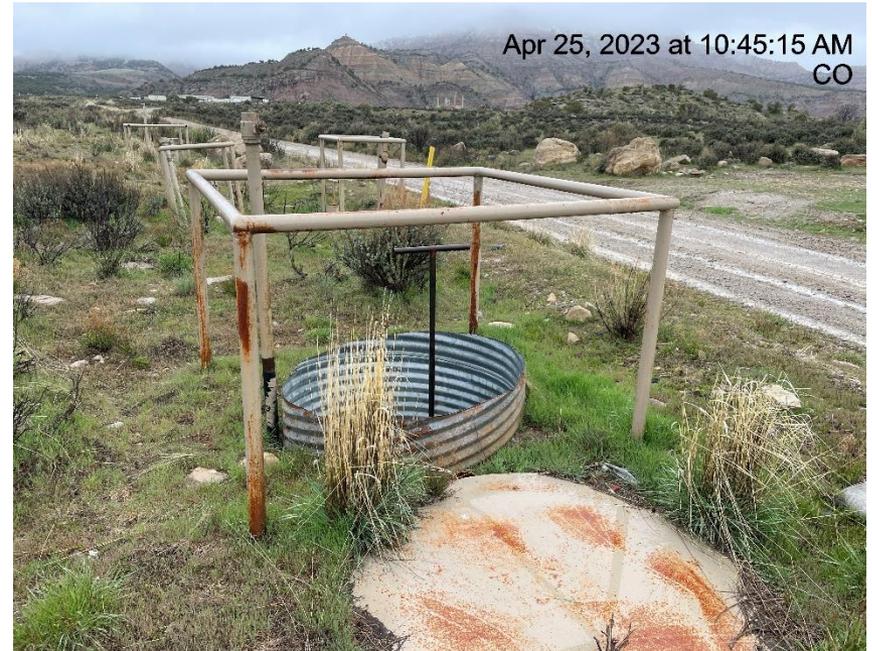
Photo # 6346 Open cellar/wildlife hazard (Cellar is on lease road approximately 1/10 of a mile from entrance to location)
