Inspection Photos

Location Name: TEP ROCKY MOUNTAIN LLC RWF 313-16 Pad

Location ID: 335453

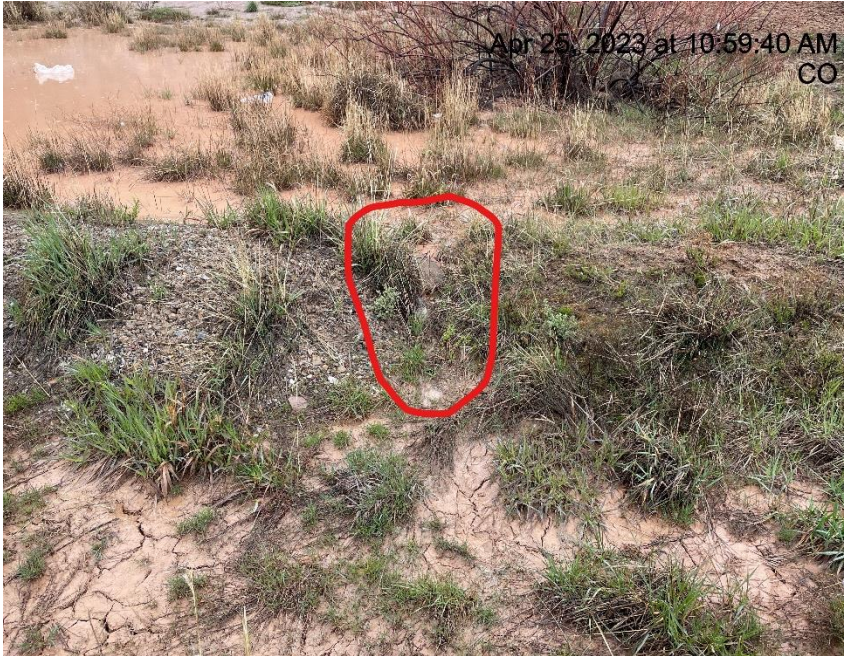
Photo # 6353 Berm needs maintenance/erosion & transport of sediment (E/NE area of berm)

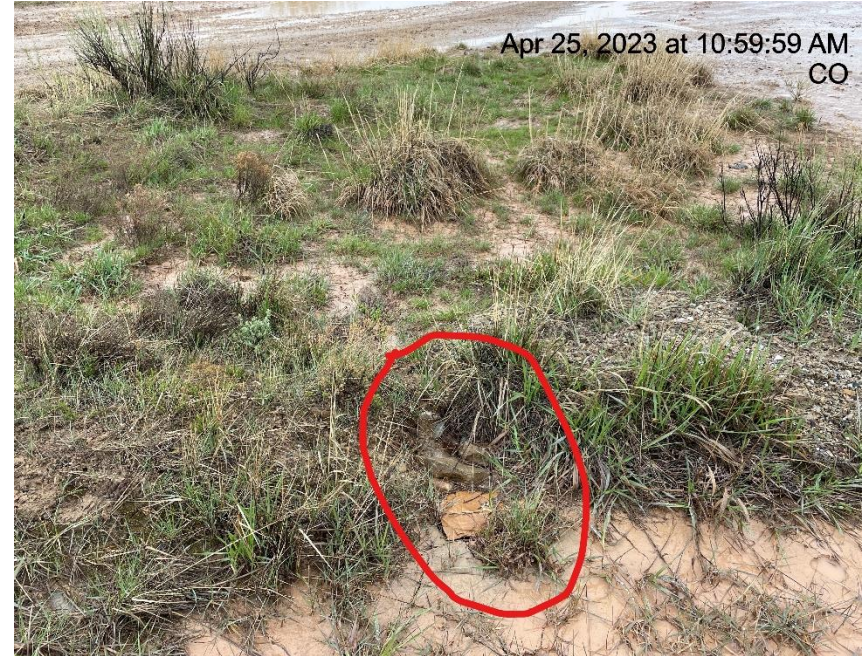
Photo # 6354 Berm needs maintenance/erosion & transport of sediment (E/NE area of berm)

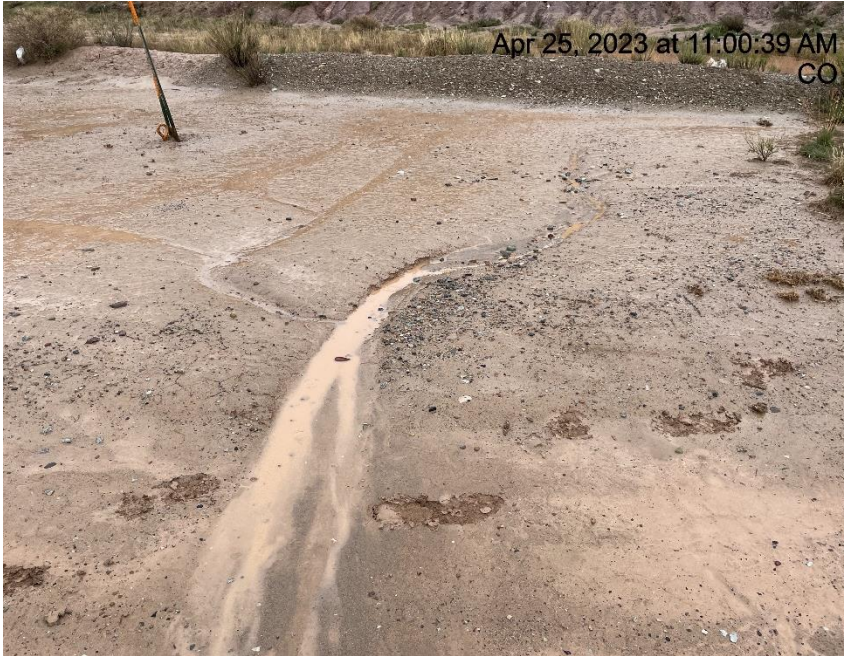
Photo # 6355 Erosion & transport of sediment on location (E/NE area of location)

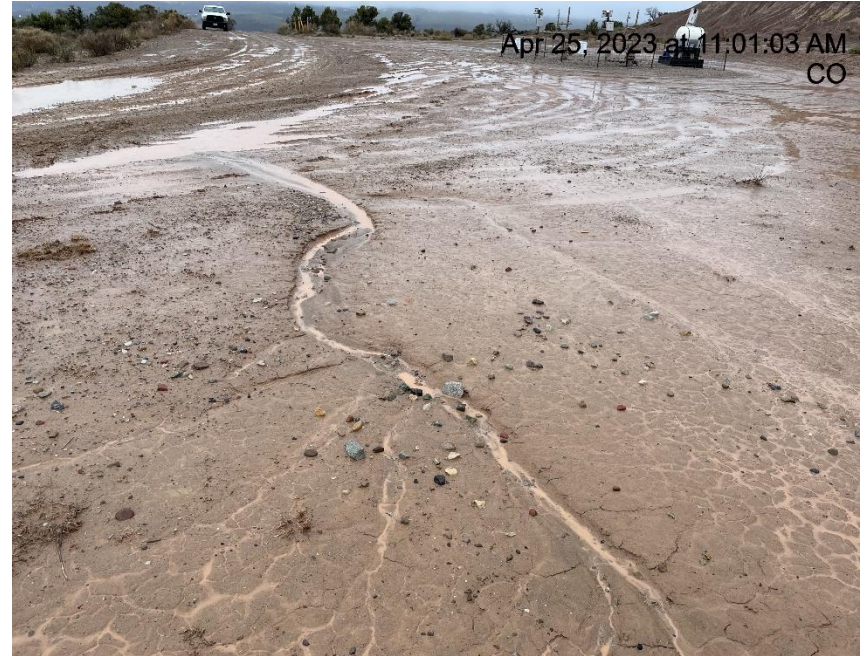
Photo # 6357 Erosion & transport of sediment on location (E/NE area of location)

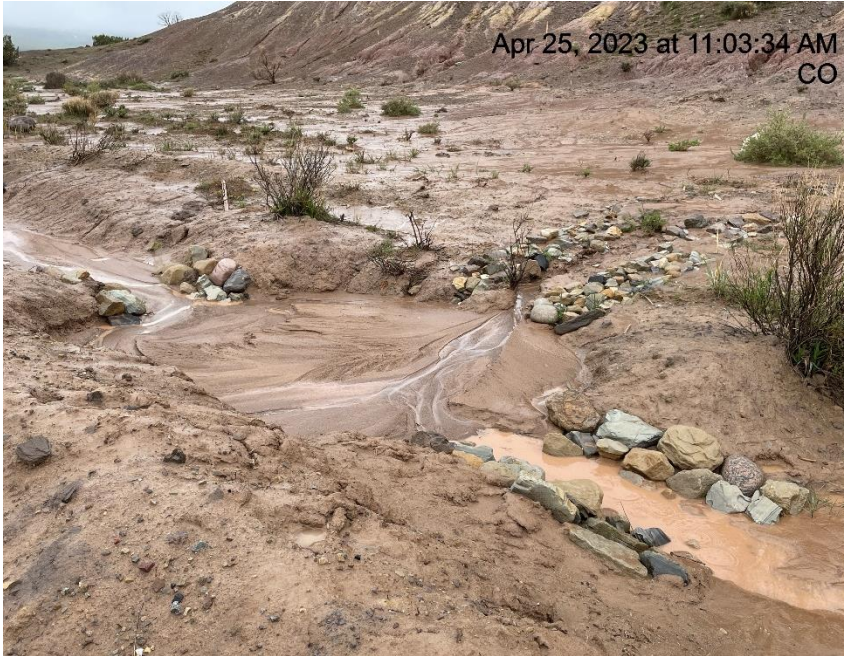
Photo # 6364 Sediment trap & Rip Rap need maintenance

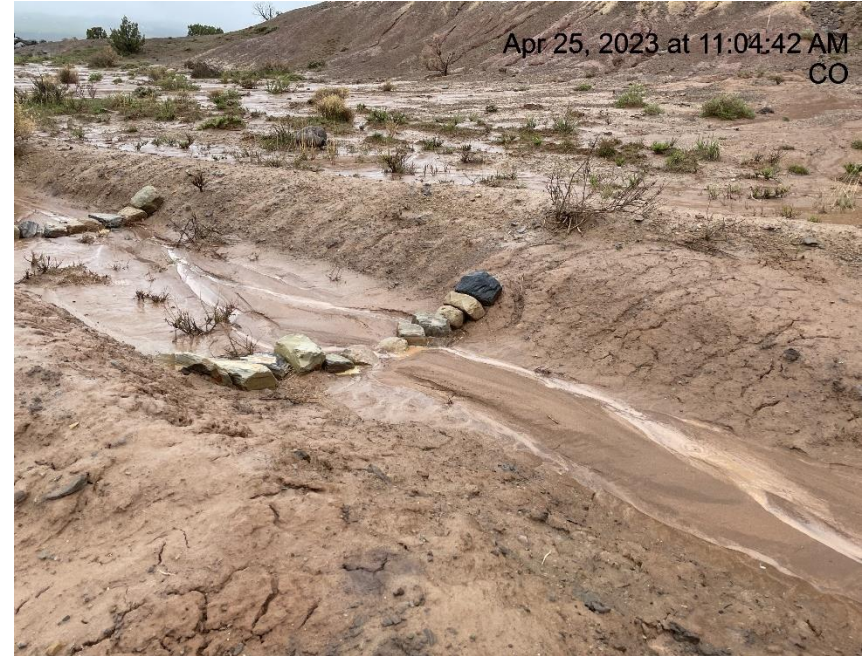
Photo # 6368 Check dams need maintenance

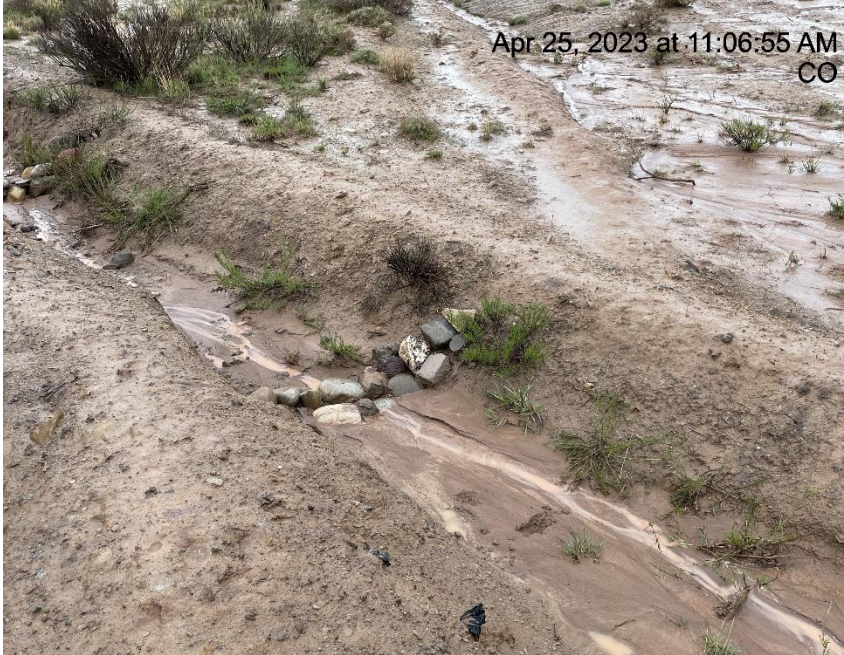
Photo # 6372 Check dams need maintenance

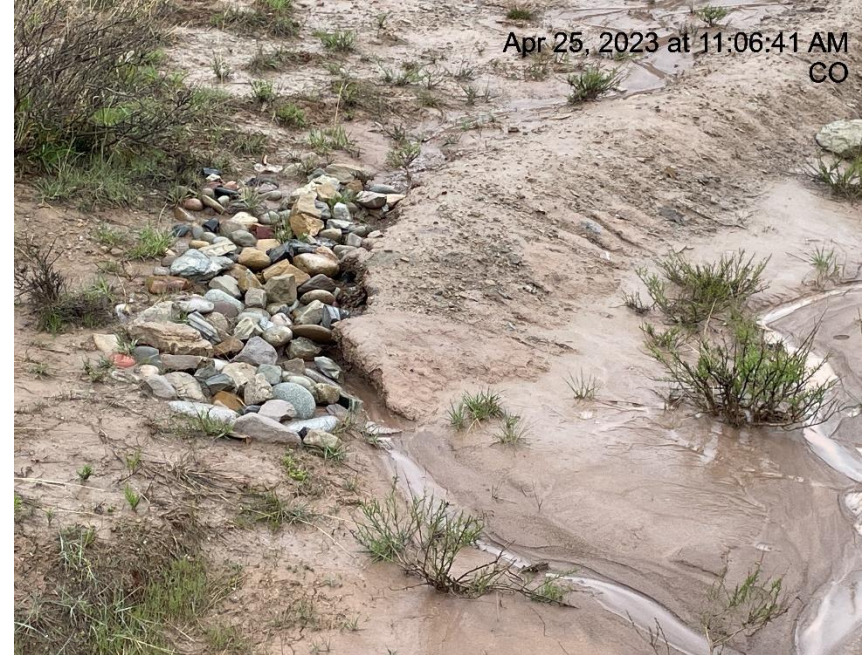
Photo # 6373 Rip Rap run needs maintenance

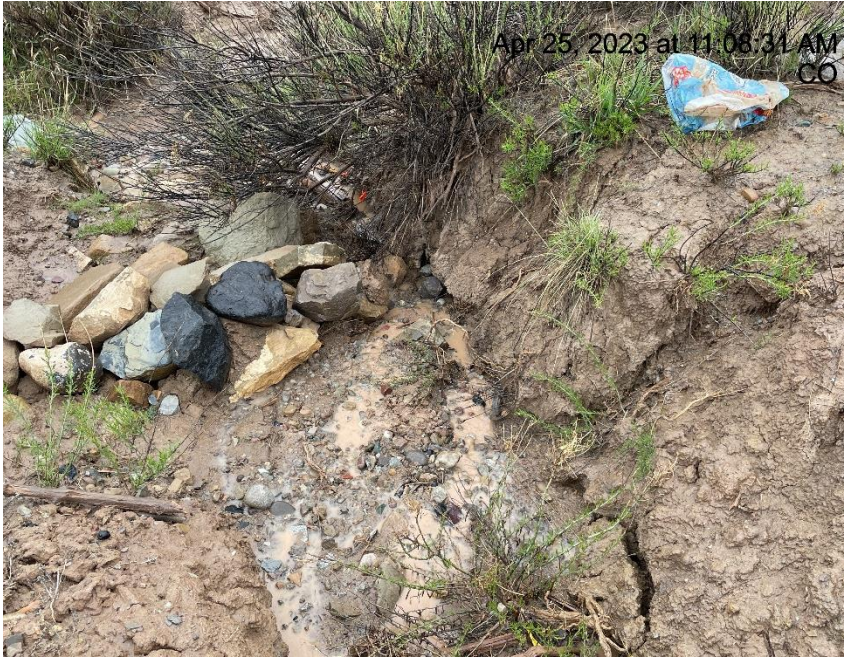
Photo # 6374 Ditch & Rip Rap need maintenance (near culvert at entrance to location)

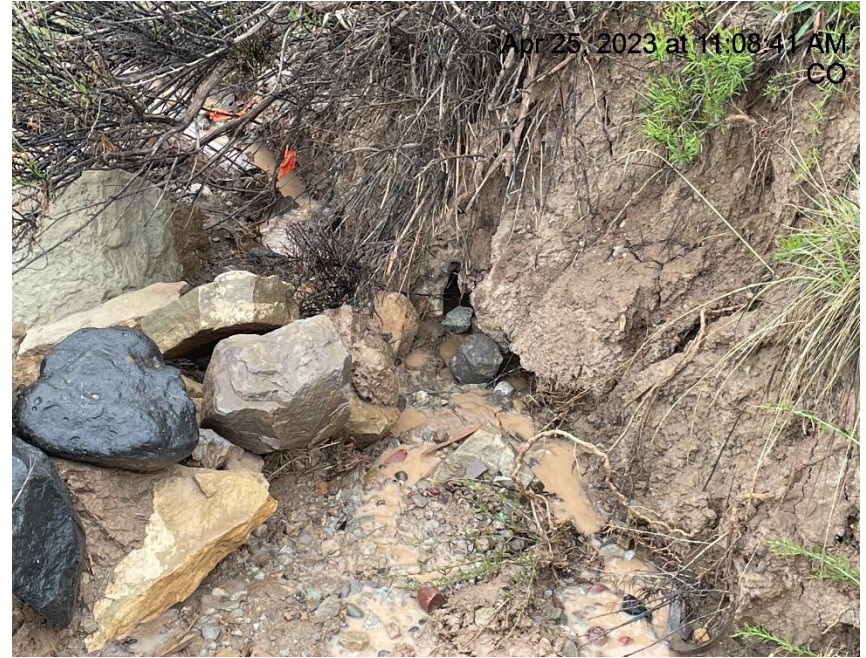
Photo # 6375 Ditch & Rip Rap need maintenance (near culvert at entrance to location)

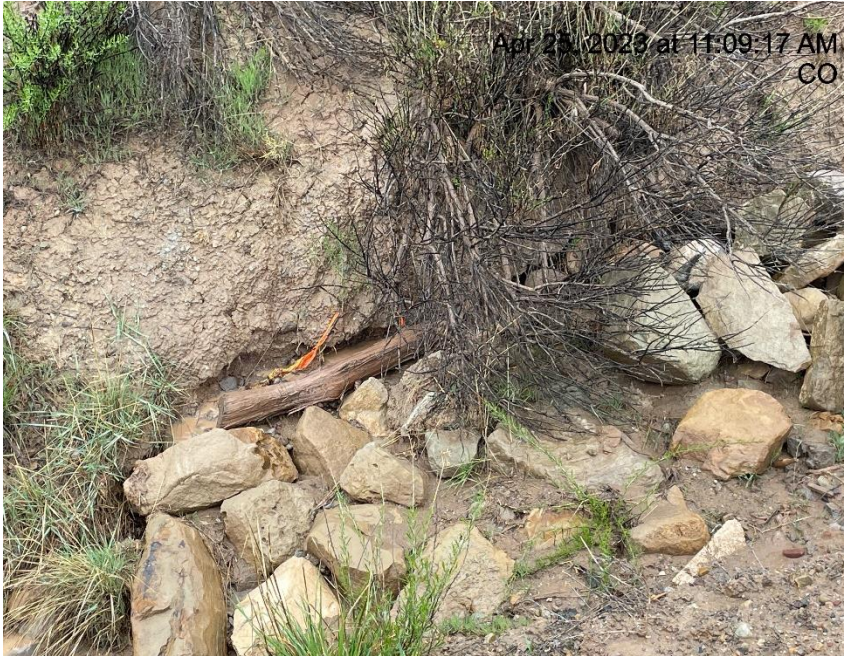
Photo # 6376 Rip Rap needs maintenance (near culvert at entrance to location)

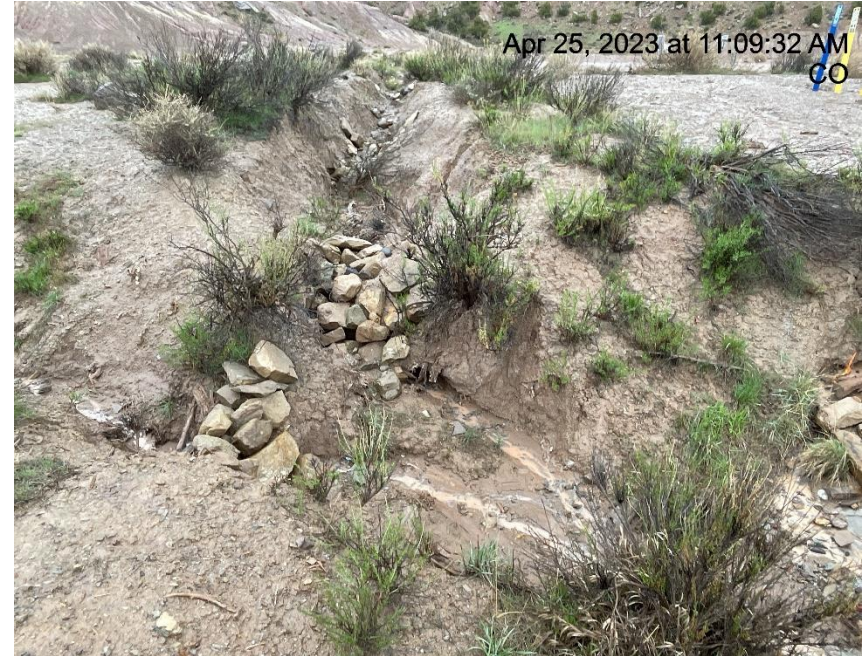
Photo # 6377 Rip Rap needs maintenance (near culvert at entrance to location)

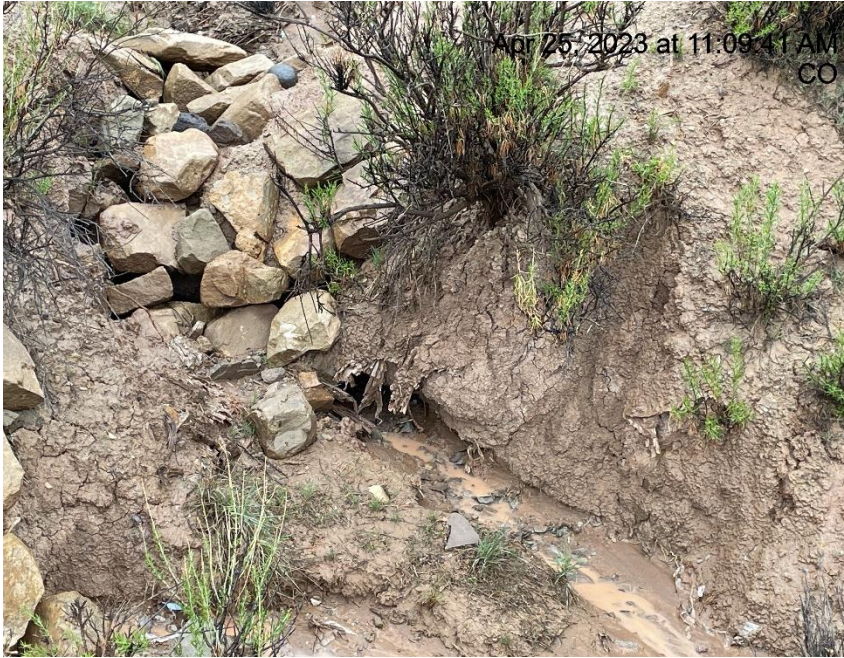
Photo # 6378 Rip Rap needs maintenance (near culvert at entrance to location)

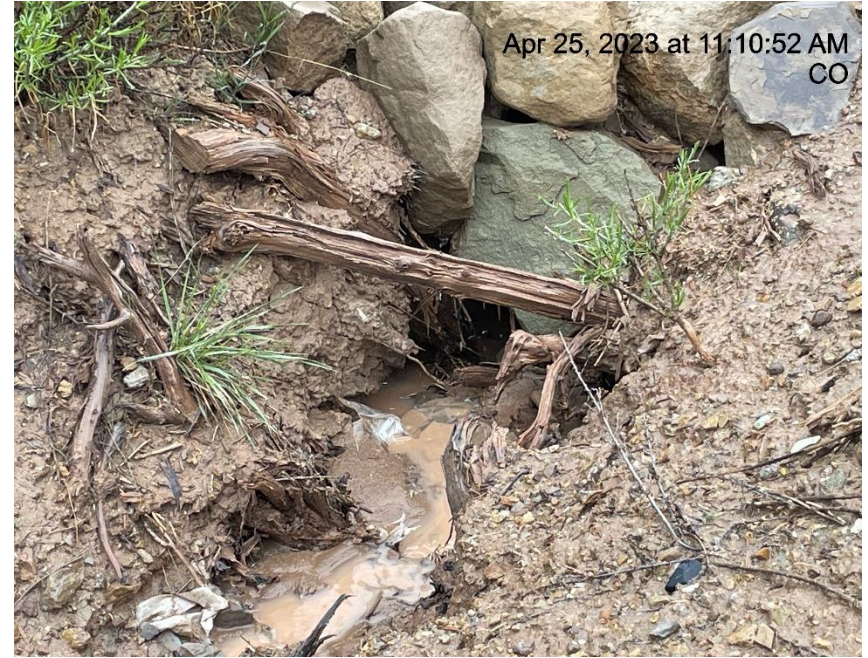
Photo # 6379 Rip Rap needs maintenance (near culvert at entrance to location)

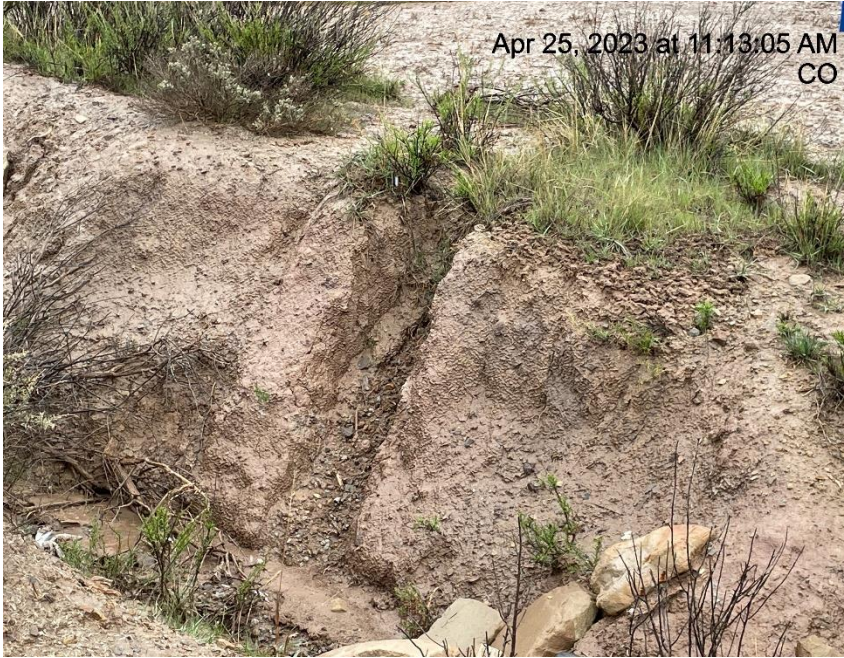
Photo # 6385 Erosion on slope of ditch near Rip Rap

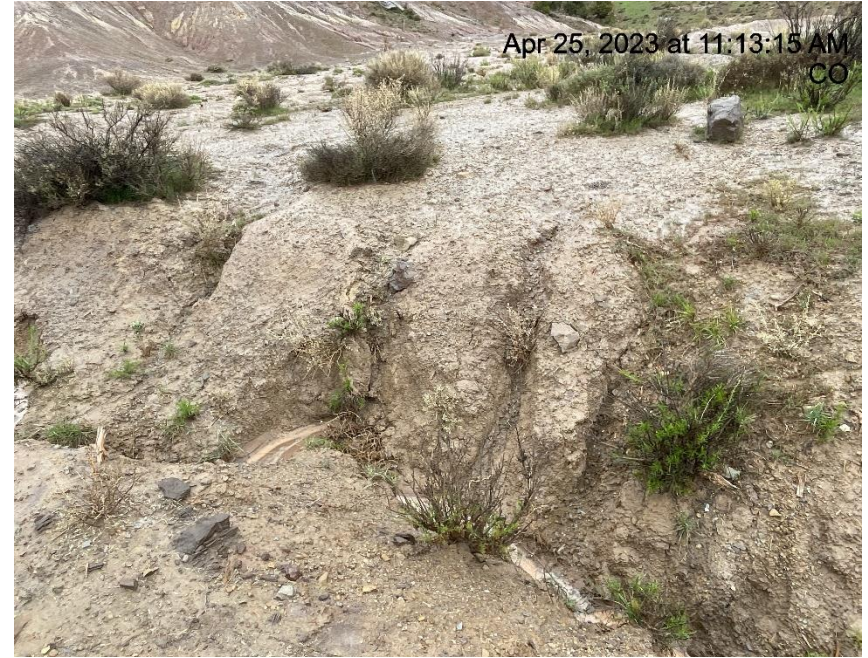
Photo # 6386 Erosion in multiple spots on slope of ditch

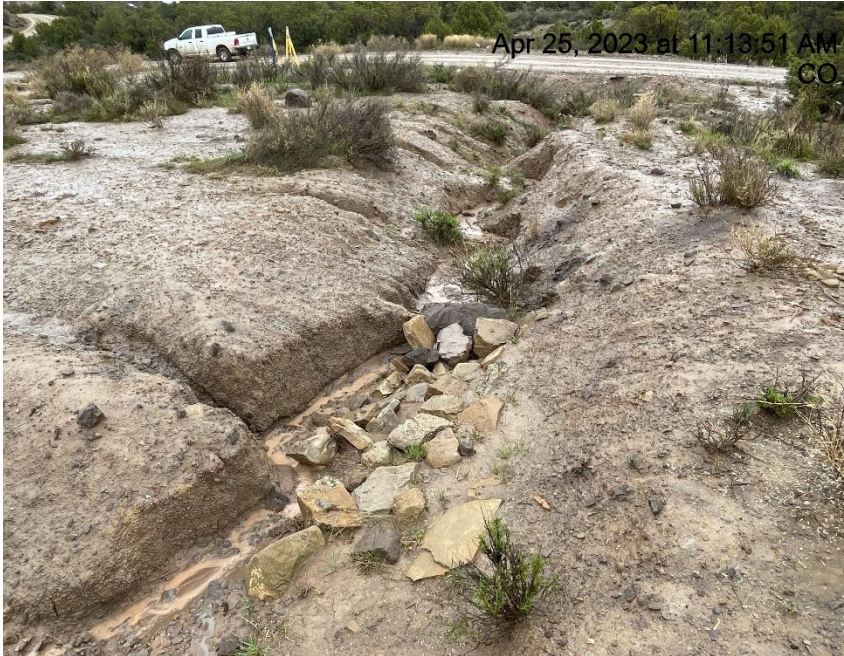
Photo # 6387 Erosion on slope going into ditch

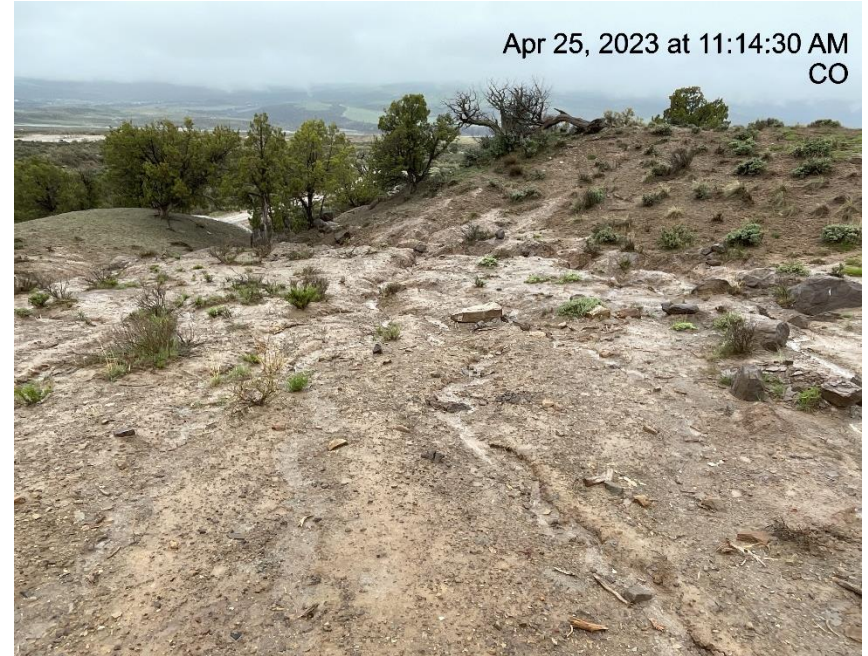
Photo # 6389 Erosion & transport of sediment on slope just off location (S/SW area)

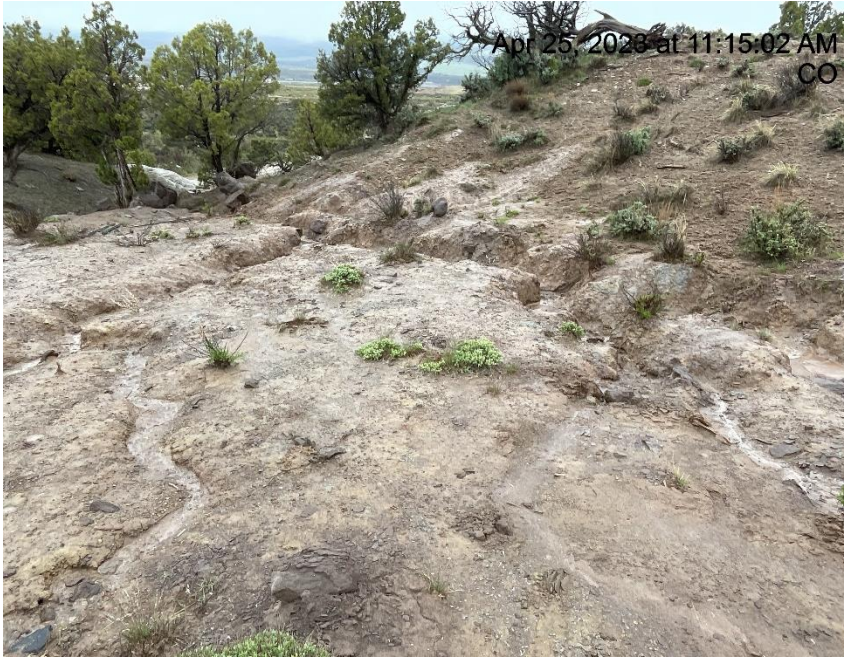
Photo # 6390 Erosion & transport of sediment on slope just off location (S/SW area)

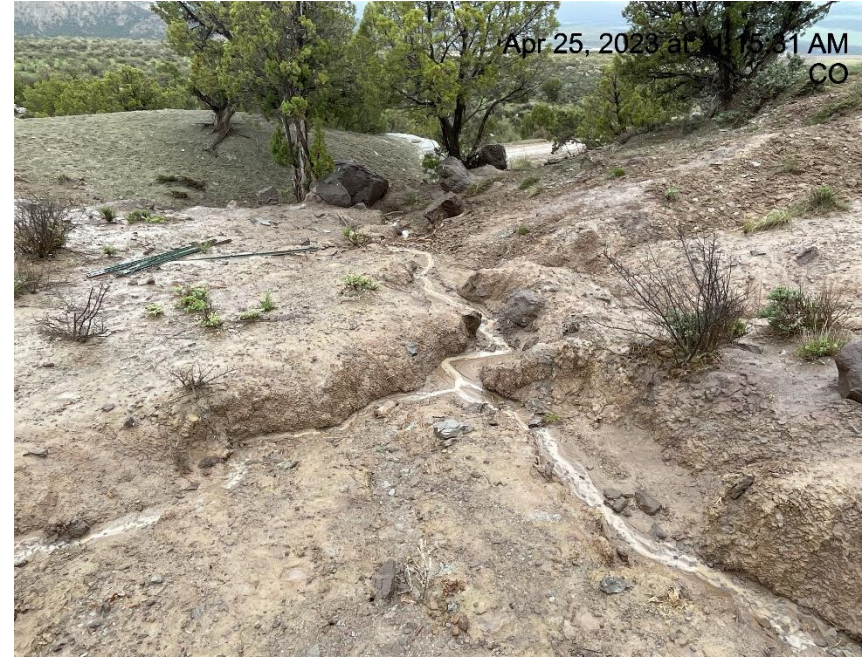
Photo # 6391 Erosion & transport of sediment on slope just off location (S/SW area)

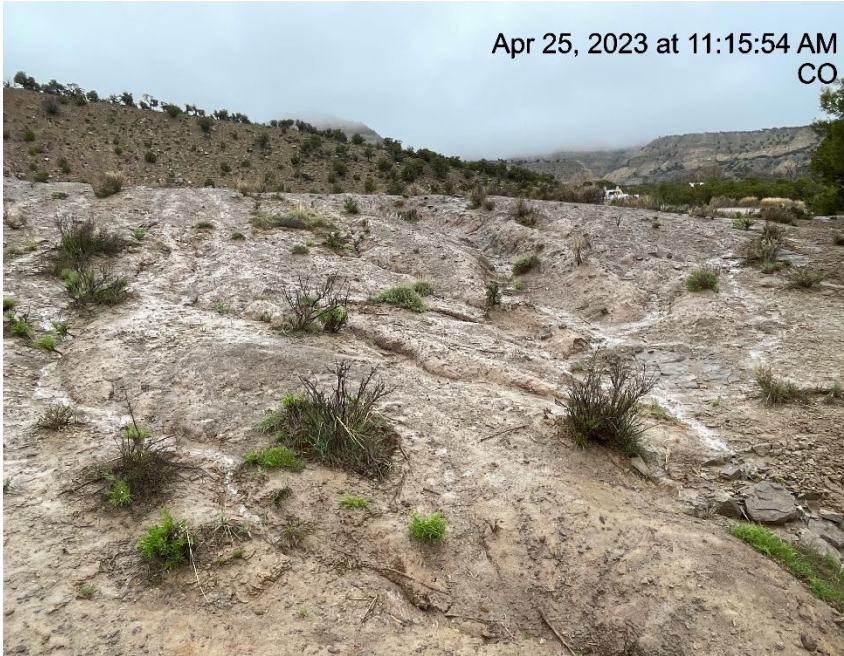
Photo # 6393 Erosion & transport of sediment on slope just off location (S/SW area)

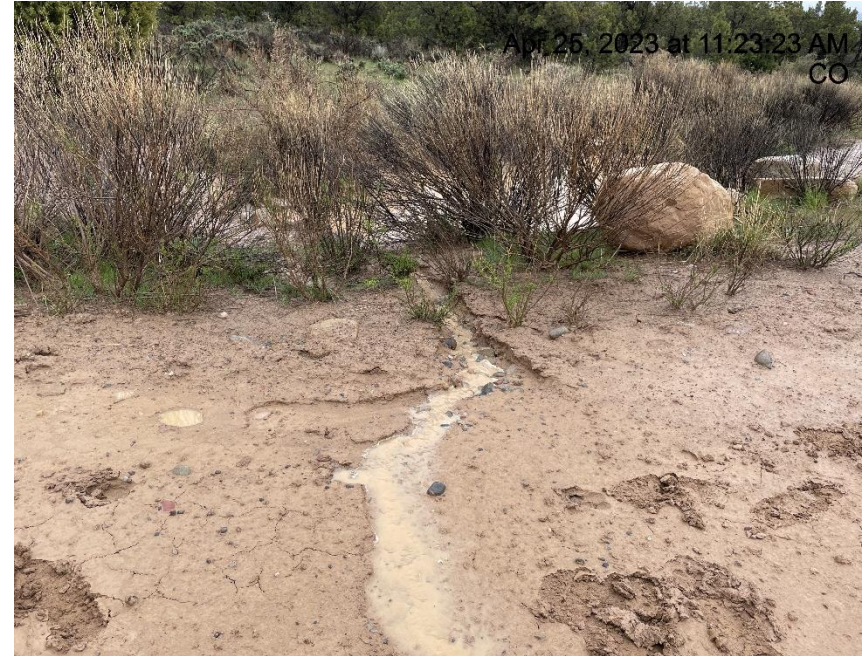
Photo 6149 Erosion & transport of sediment on edge of location (S/SE area of location)

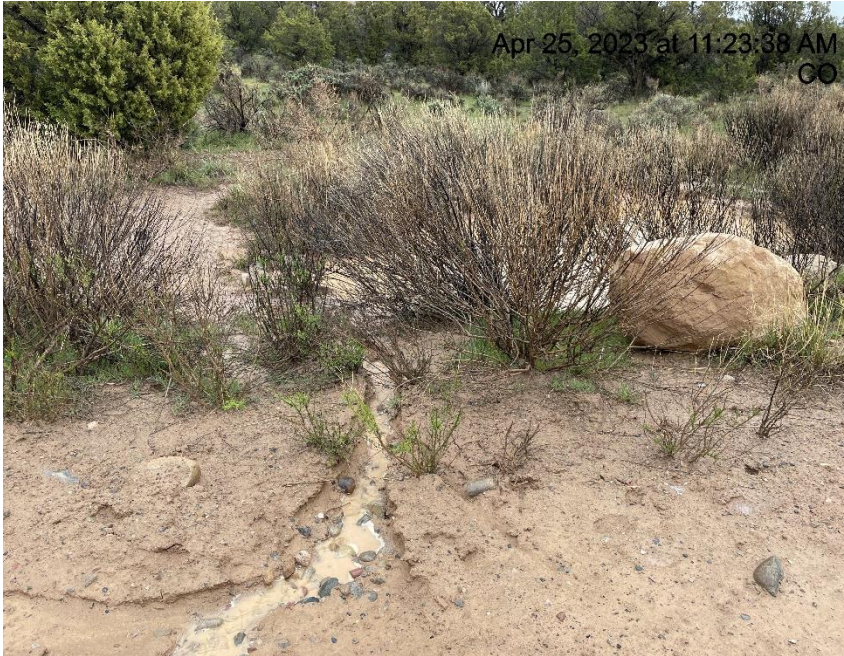
Photo # 6399 Erosion & transport of sediment on edge of location (S/SE area of location)
